Expertise

Protocol number: 46370713  
Order No. / Reference: 26678329  
Inspection date: 6 Jul 2026

Manufacturer: Volkswagen

Model: Caddy Cargo 2.0 TDI BMT

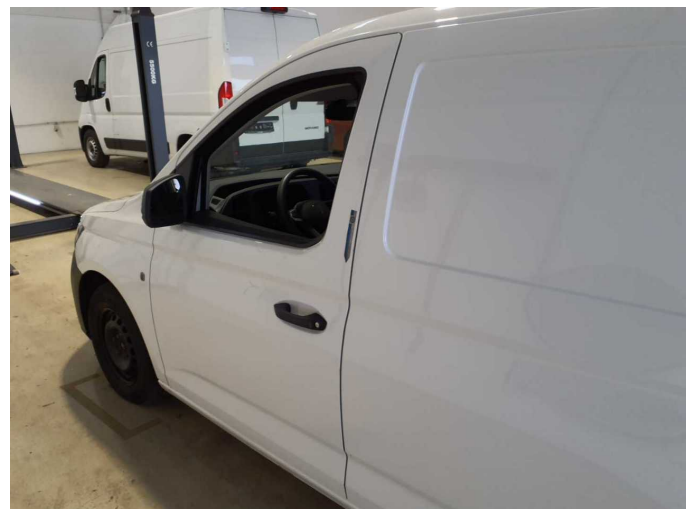
| No. | Component group | Description |
|---|---|---|
| 1 | Door - front left side | Door edge - Scratch(es) - Smart repair |

Damage 1: Door - front left side: Door edge - Scratch(es) - Smart repair

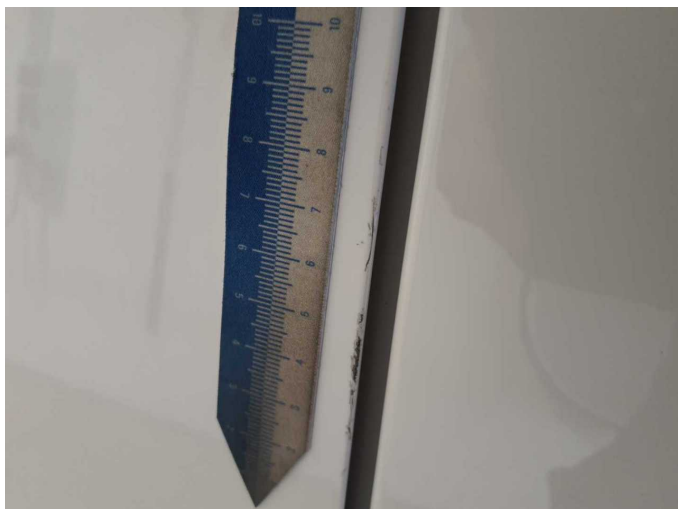
**Damage 1:** Door - front left side: Door edge - Scratch(es) - Smart repair

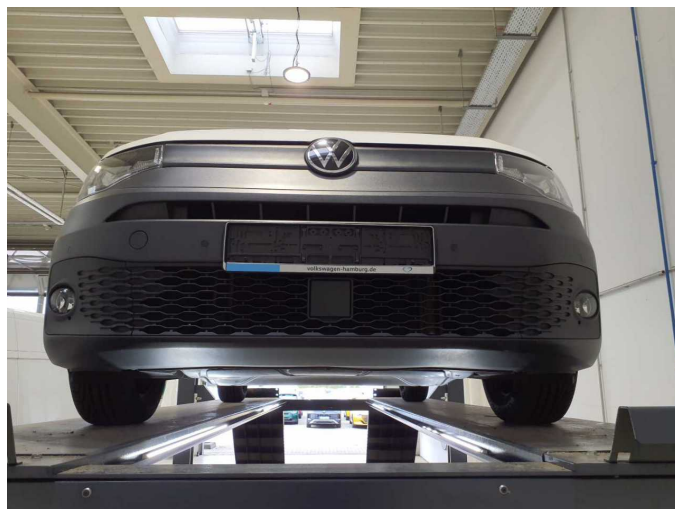
| No. | Component group | Description |
|---|---|---|
| 2 | Front bumper | Front bumper (unpainted) - Scratch(es) - Loss in value |

**Damage 2:** Front bumper: Front bumper (unpainted) - Scratch(es) - Loss in value

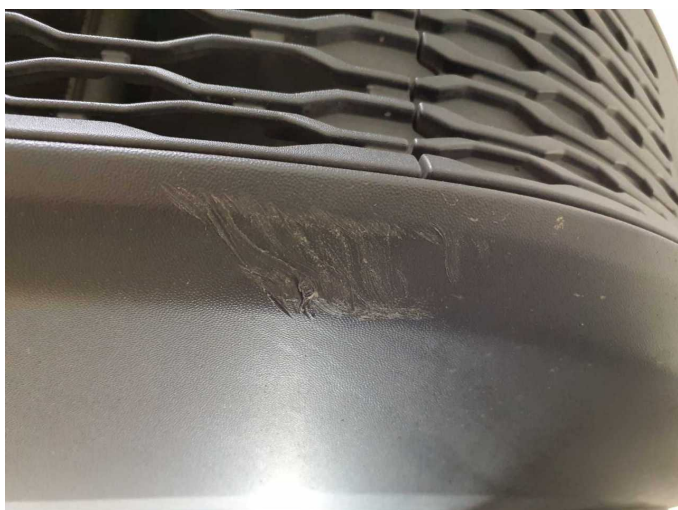
**Damage 2:** Front bumper: Front bumper (unpainted) - Scratch(es) - Loss in value

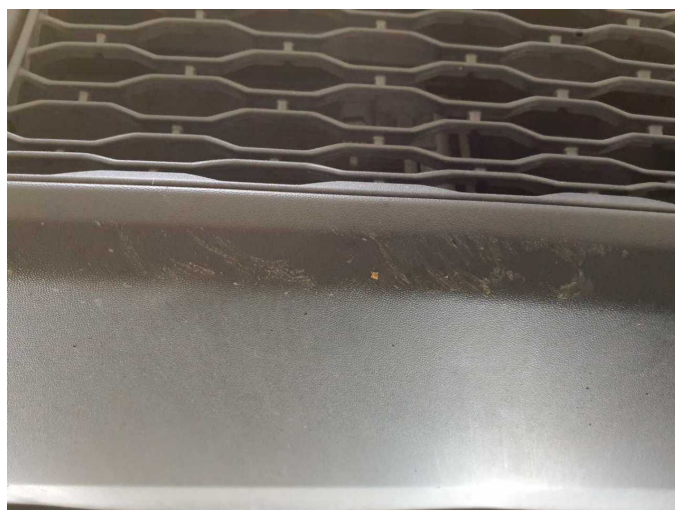
**Damage 2:** Front bumper: Front bumper (unpainted) - Scratch(es) - Loss in value

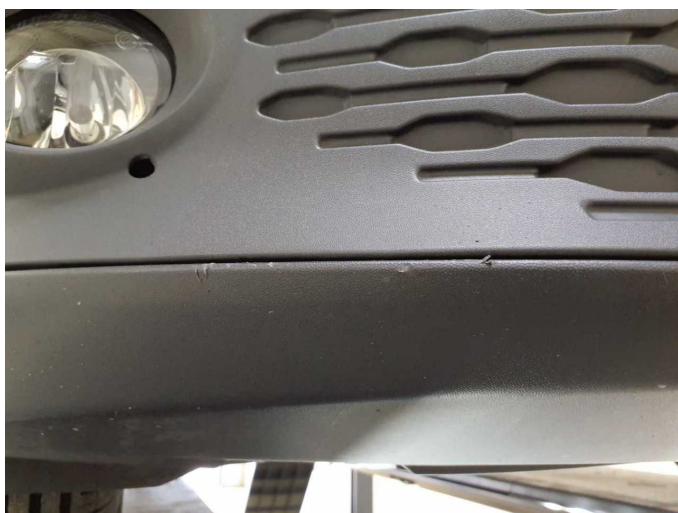
**Damage 2:** Front bumper: Front bumper (unpainted) - Scratch(es) - Loss in value

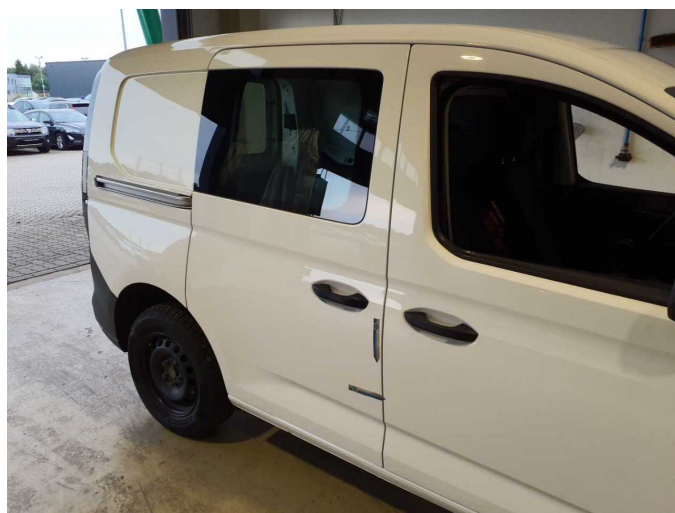
| No. | Component group | Description |
|---|---|---|
| 3 | Sliding door, right | Sliding door - Dent / paintcoat damage - Smart repair |

**Damage 3:** Sliding door, right: Sliding door - Dent / paintcoat damage - Smart repair

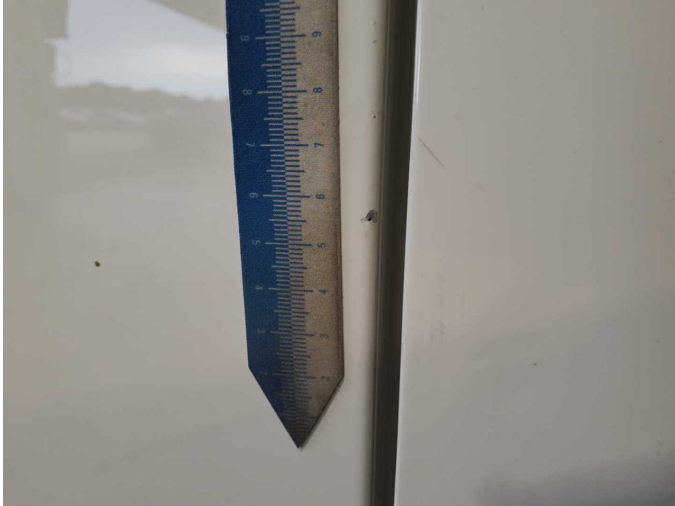
**Damage 3:** Sliding door, right: Sliding door - Dent / paintcoat damage - Smart repair

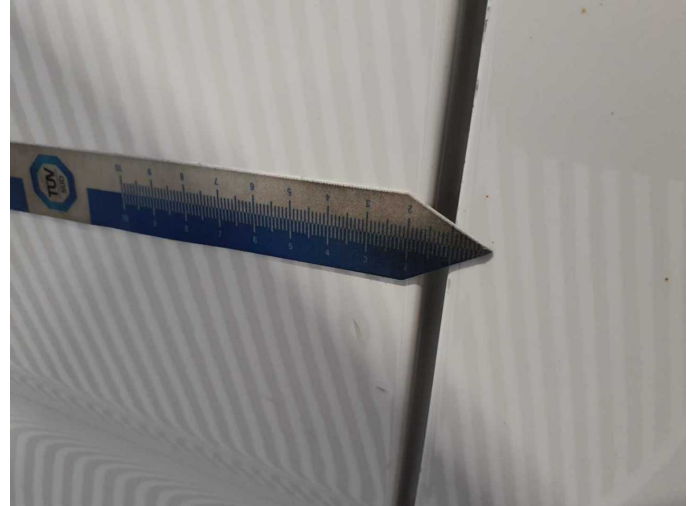
**Damage 3:** Sliding door, right: Sliding door - Dent / paintcoat damage - Smart repair

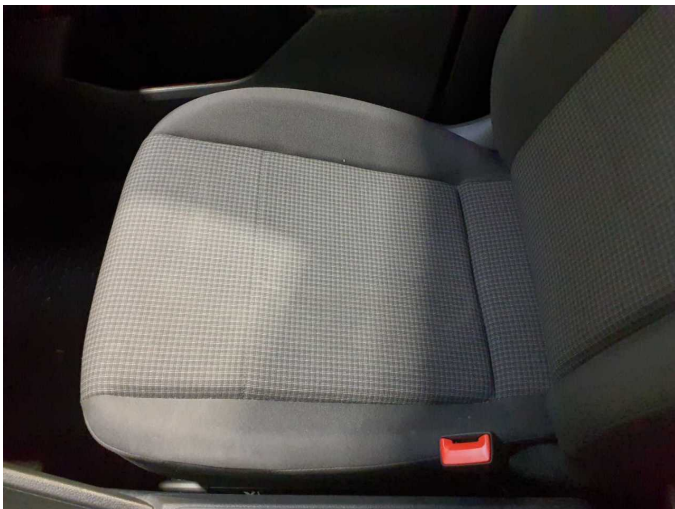
| No. | Component group | Description |
|---|---|---|
| 4 | Seat - front | Seat cover - right side - Holes - Smart repair |

**Damage 4:** Seat - front: Seat cover - right side - Holes - Smart repair

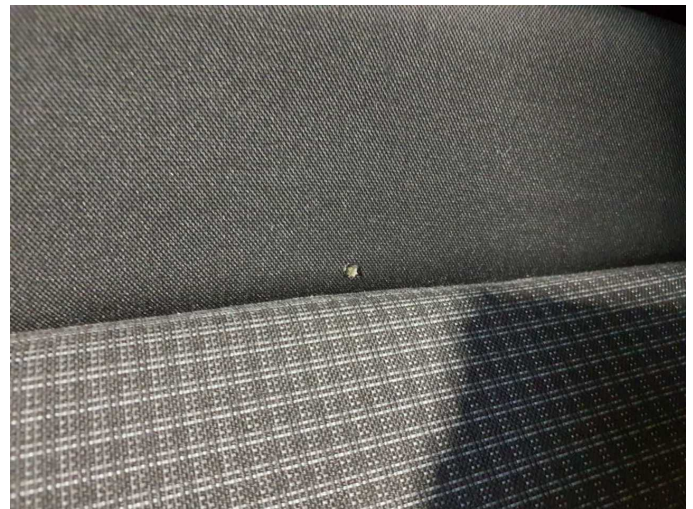
**Damage 4:** Seat - front: Seat cover - right side - Holes - Smart repair

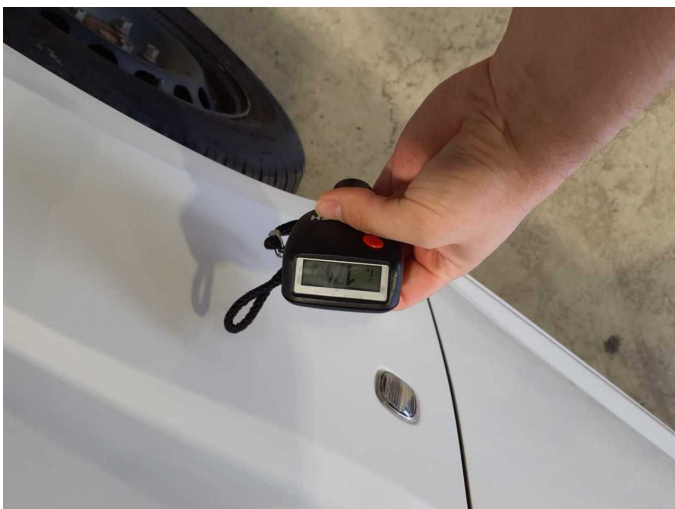
| No. | Repainting |
|---|---|
| 1 | Mudguard - right side, Side panel - rear right side, Professionally carried out |

| Mudguard - right side | 174 µm | Side panel - rear right side | 190 µm |

**Repainting 1:** Mudguard - right side, Side panel - rear right side

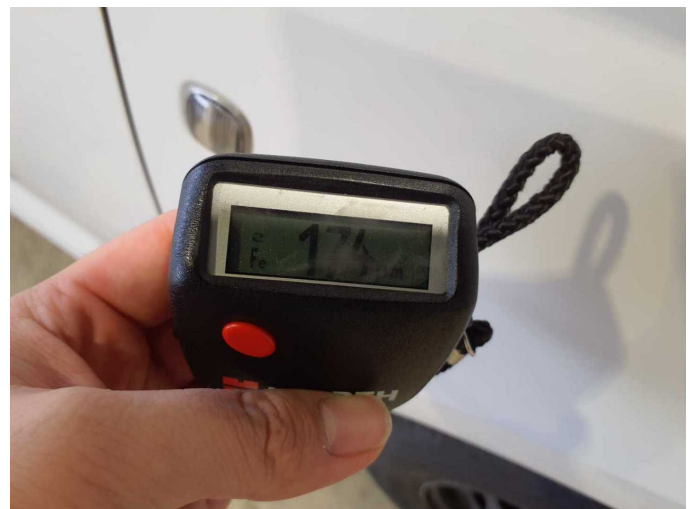
**Repainting 1:** Mudguard - right side, Side panel - rear right side

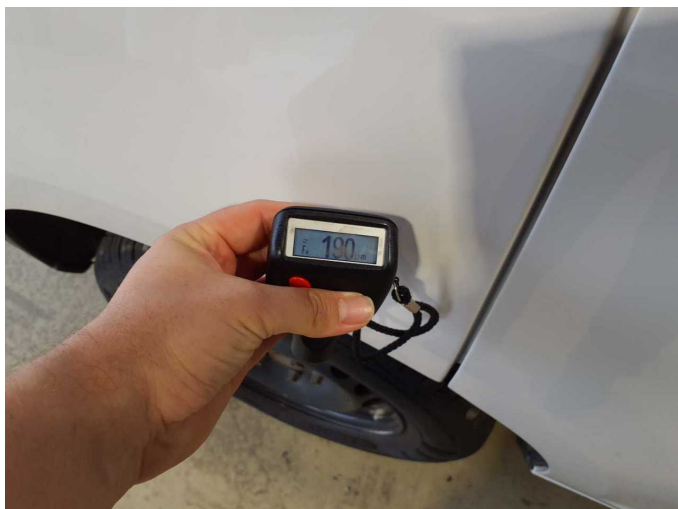
**Repainting 1:** Mudguard - right side, Side panel - rear right side

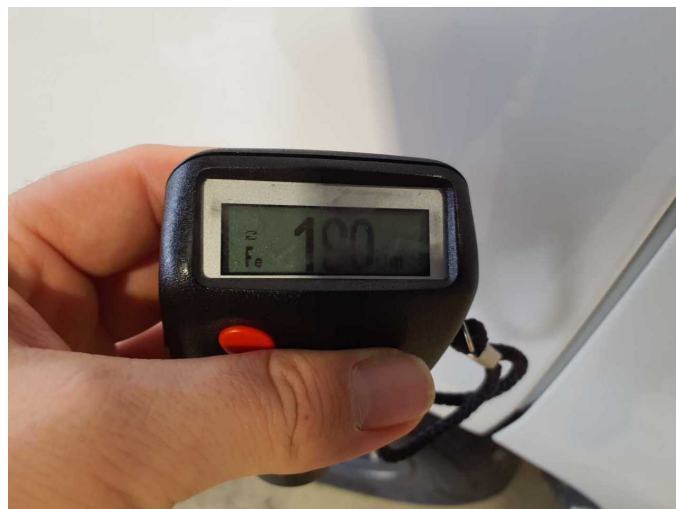
**Repainting 1:** Mudguard - right side, Side panel - rear right side
