Expertise

Protocol number: 46345779
Order No. / Reference: 26546923
Inspection date: 6 Jul 2026

Manufacturer: MAN

Model: TGE 3,5T 4x2F (03V)

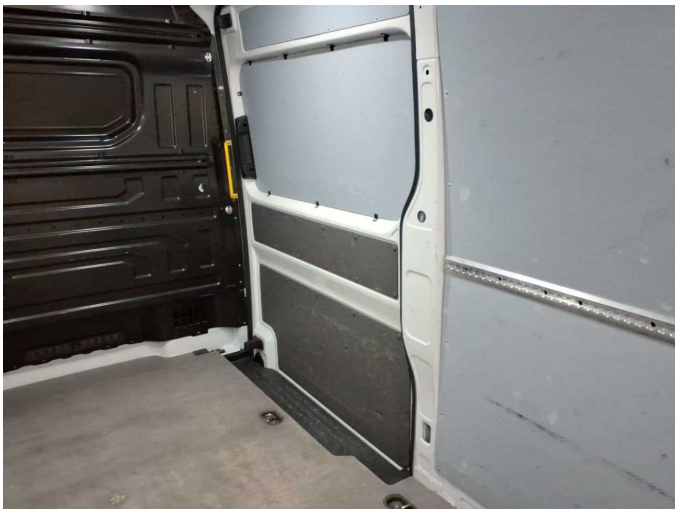
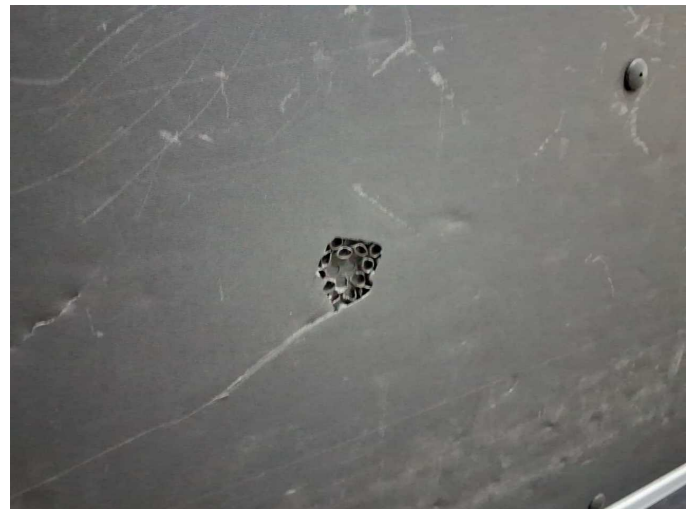
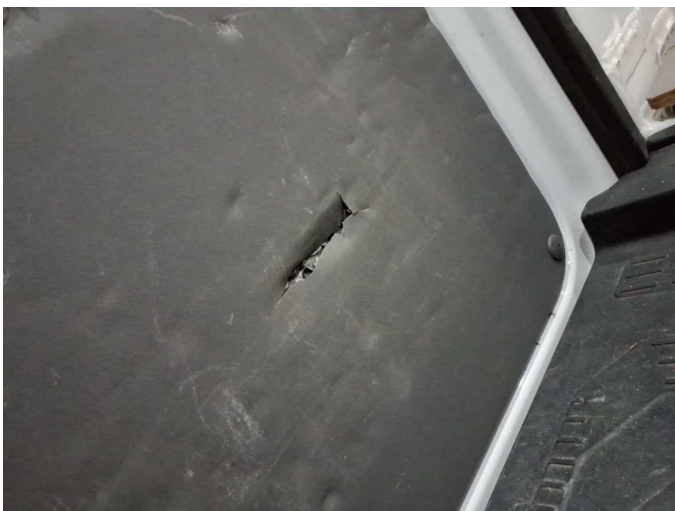
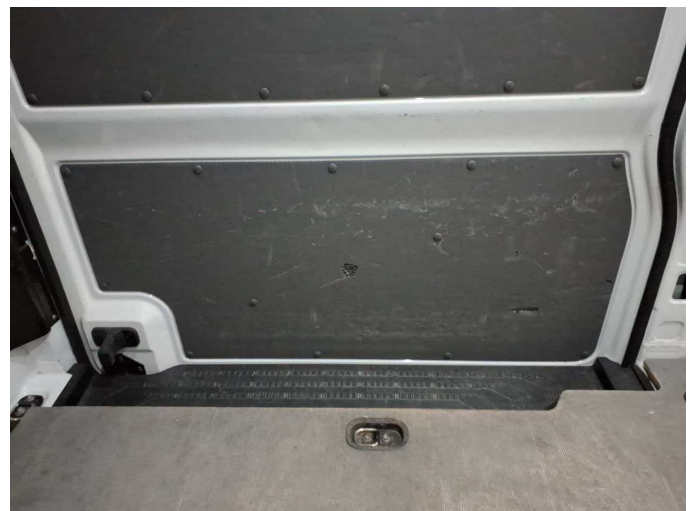
Damage 2: Sliding door, right: Trim (Unten) - Broken / torn - Replace

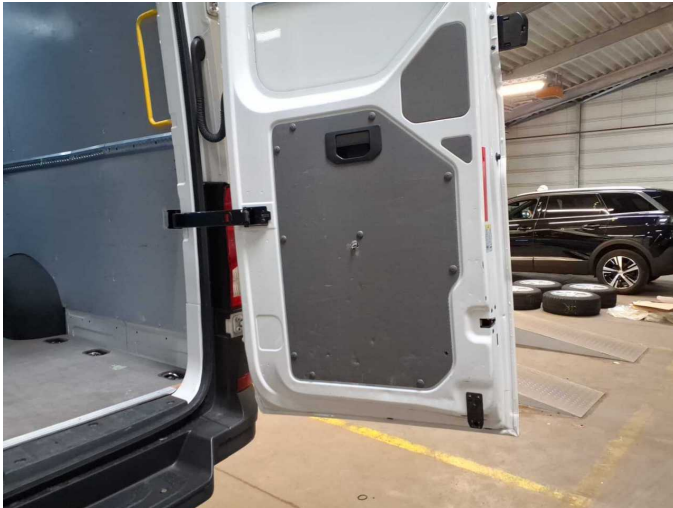
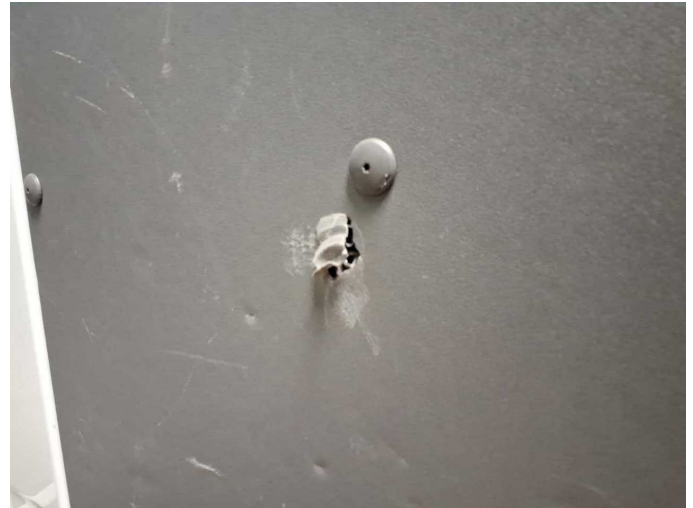
Damage 3: Boot lid / rear door: Trim rear door - hard fibre - lower (Rechts) - Broken / torn - Replace

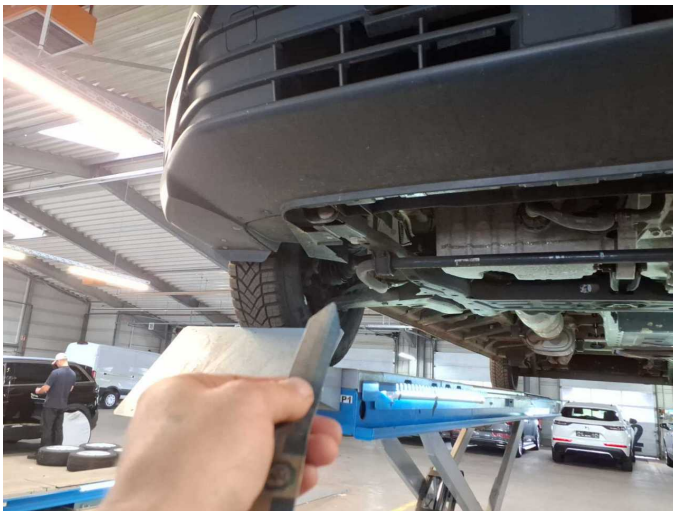
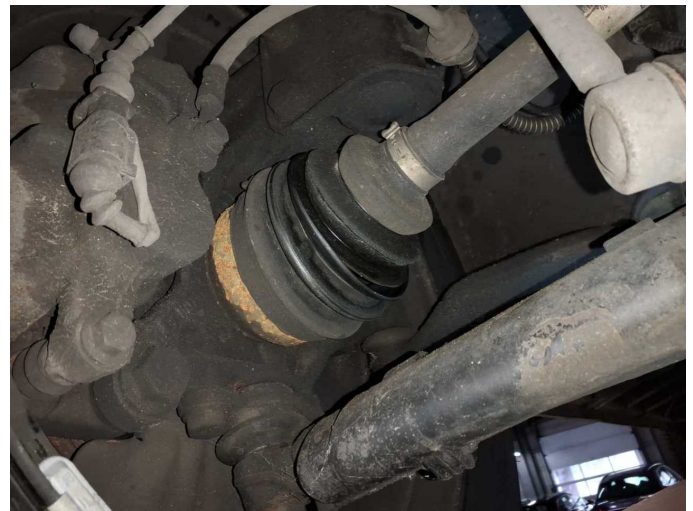
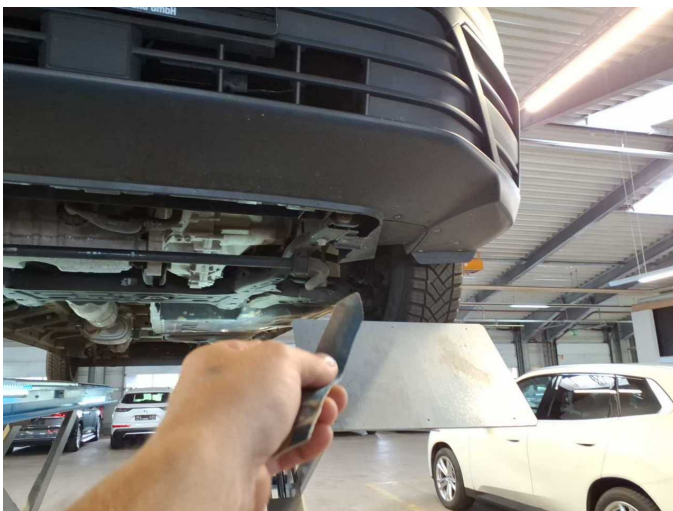
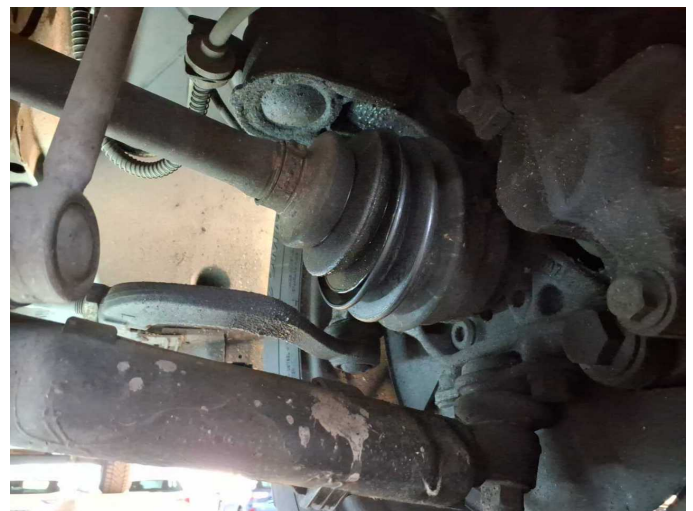
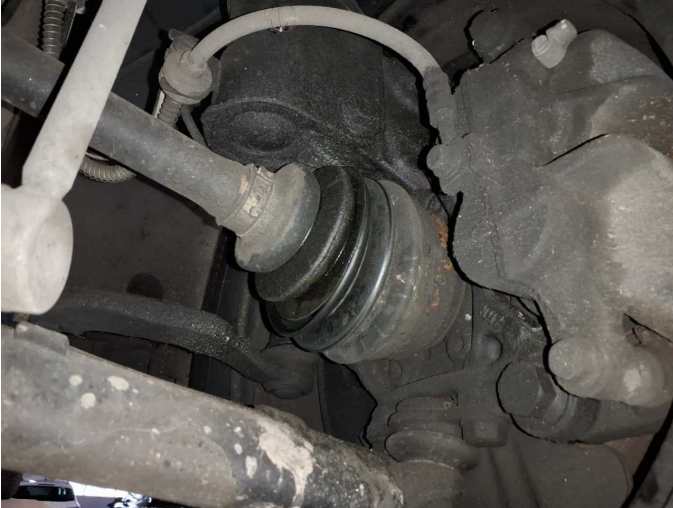
Damage 4: Drive train: Sleeve prop shaft - front left side (+ Rechts) - Broken / torn - Replace

Damage 4: Drive train: Sleeve prop shaft - front left side (+ Rechts) -
Broken / torn - Replace
