Expertise

Protocol number: 46352087  
Order No. / Reference: 26617485  
Inspection date: 2 Jul 2026

Model: EQA 250 Progressive

VIN: W1N2437011J034524

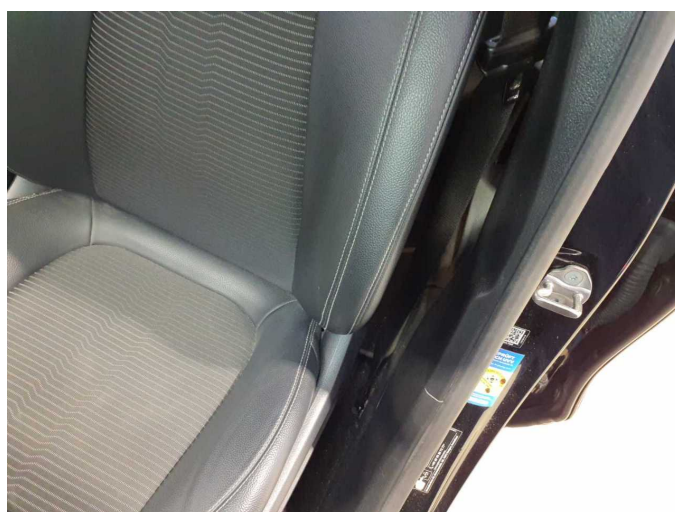
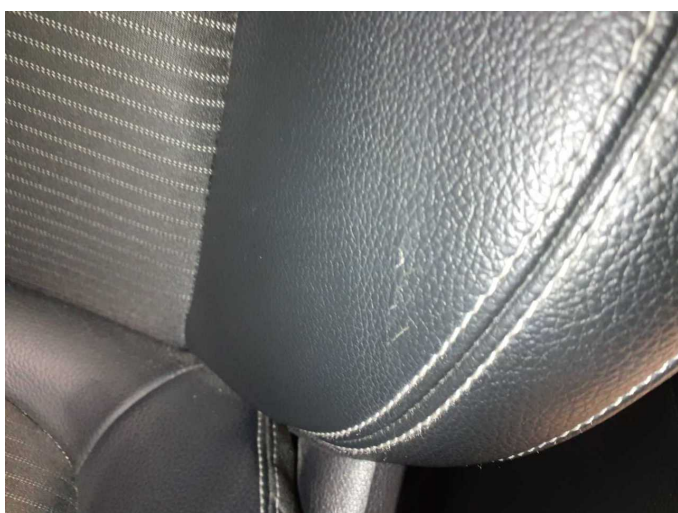
| No. | Component group | Description |
|---|---|---|
| 3 | Seat - front | Seat cover - left side - Scratch(es) - Smart repair |

**Damage 3:** Seat - front: Seat cover - left side - Scratch(es) - Smart repair

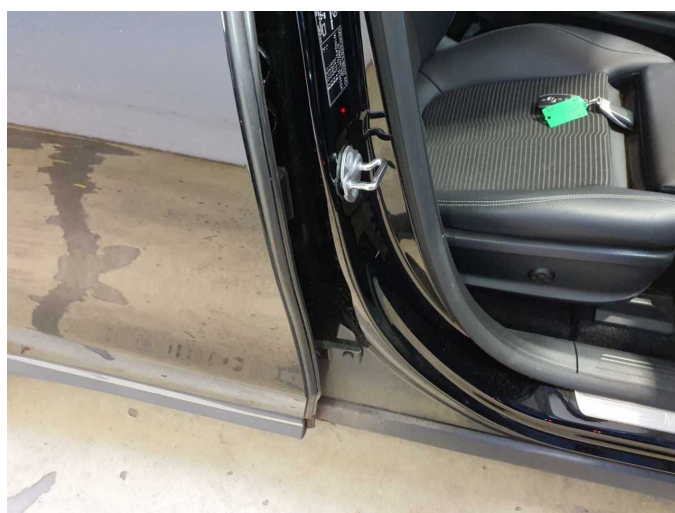
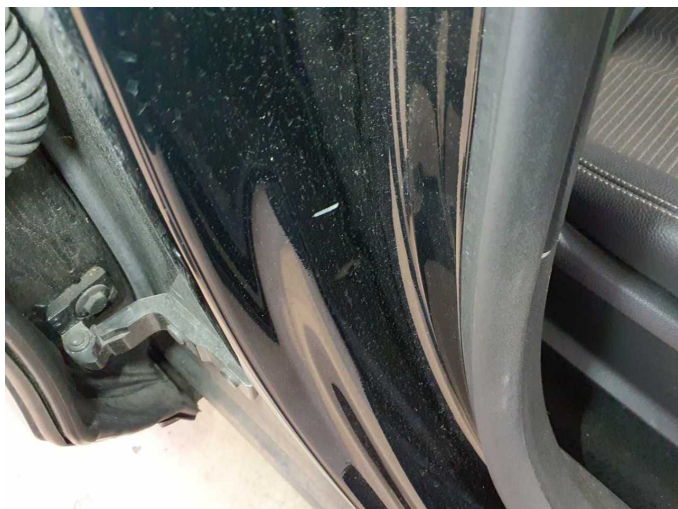
| No. | Component group | Description |
|---|---|---|
| 4 | Sill - right side | Sill - Dent / paintcoat damage - Smart repair |

**Damage 4:** Sill - right side: Sill - Dent / paintcoat damage - Smart repair

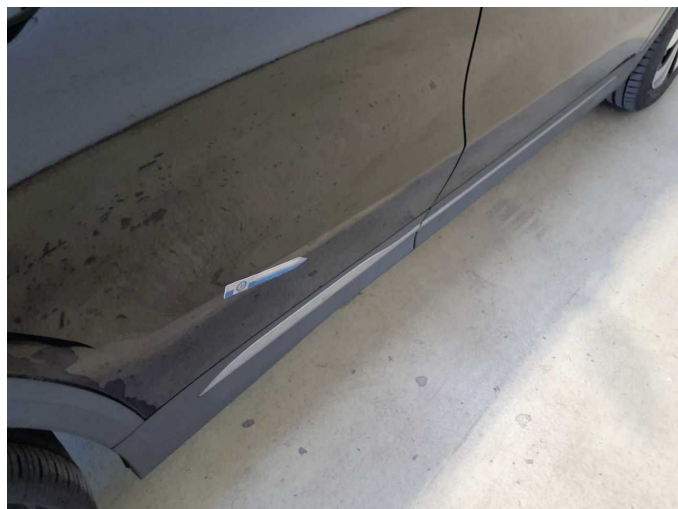
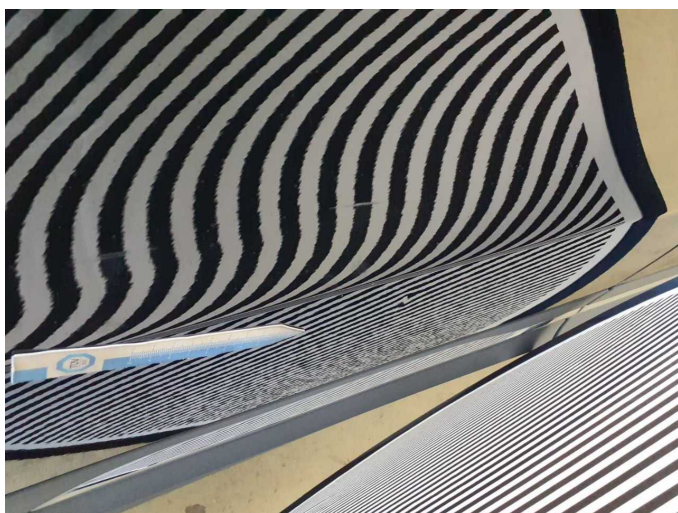
| No. | Component group | Description |
|---|---|---|
| 5 | Door - rear right side | Door - Dent / paintcoat damage - Smart repair |

**Damage 5:** Door - rear right side: Door - Dent / paintcoat damage - Smart repair

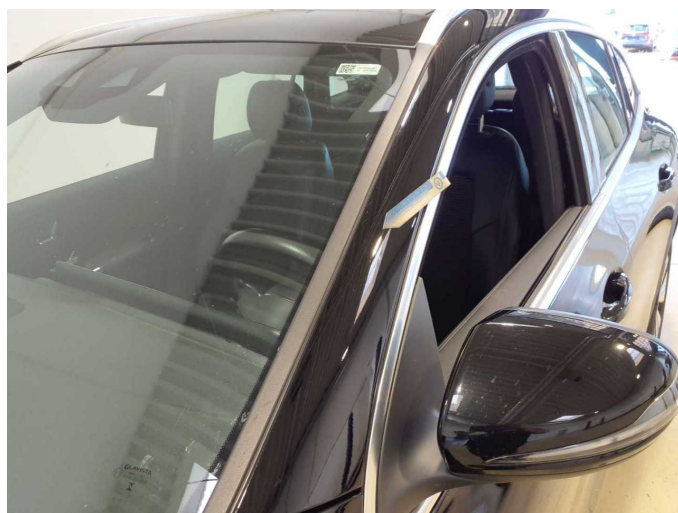
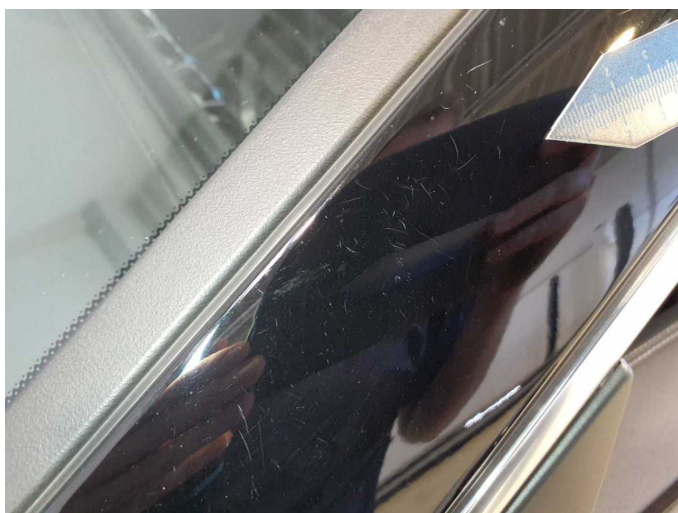
| No. | Component group | Description |
|---|---|---|
| 6 | Body | A-pillar - left side - Scratch(es) - Smart repair |

**Damage 6:** Body: A-pillar - left side - Scratch(es) - Smart repair

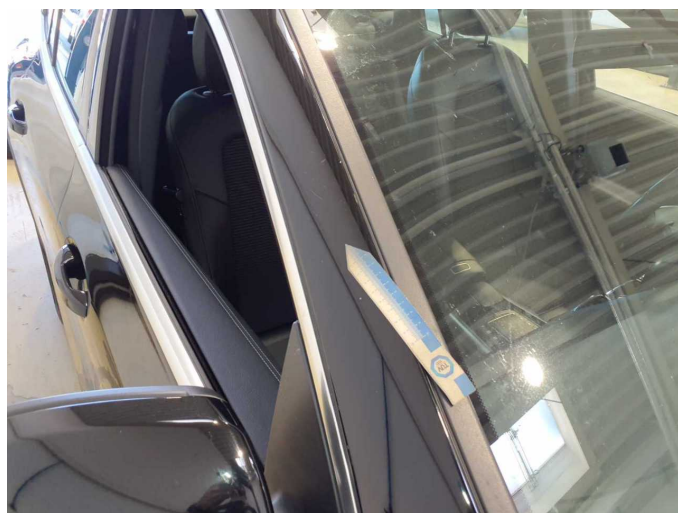
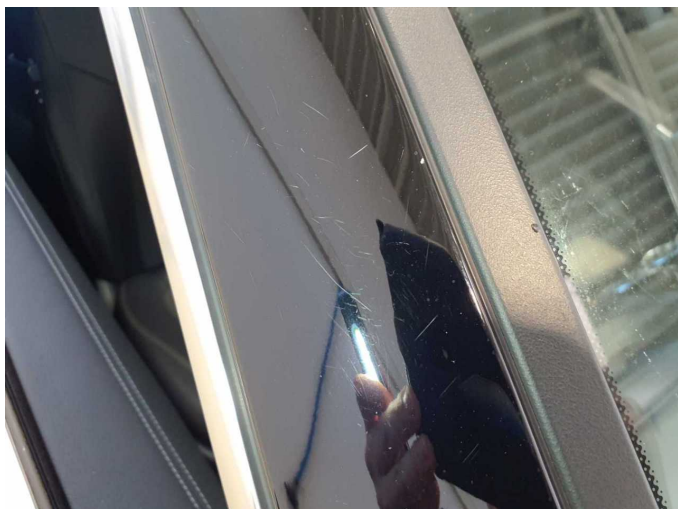
| No. | Component group | Description |
|---|---|---|
| 7 | Body | A-pillar - right side - Scratch(es) - Smart repair |

**Damage 7:** Body: A-pillar - right side - Scratch(es) - Smart repair

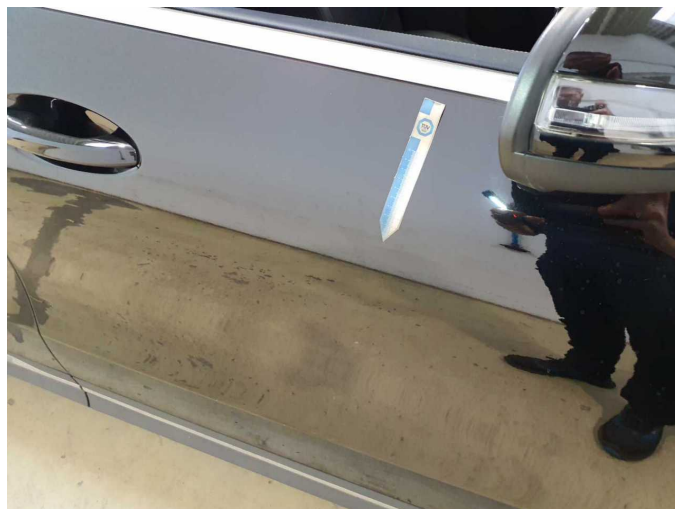
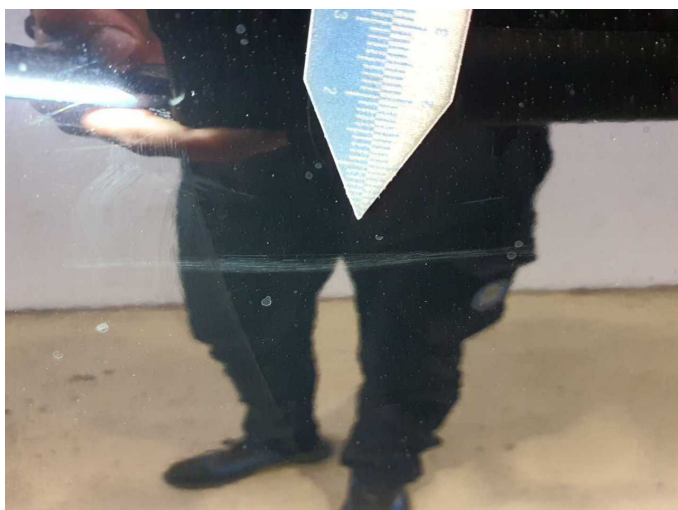
| No. | Component group | Description |
|---|---|---|
| 8 | Door - front right side | Door - Scratch(es) - Smart repair |

**Damage 8:** Door - front right side: Door - Scratch(es) - Smart repair

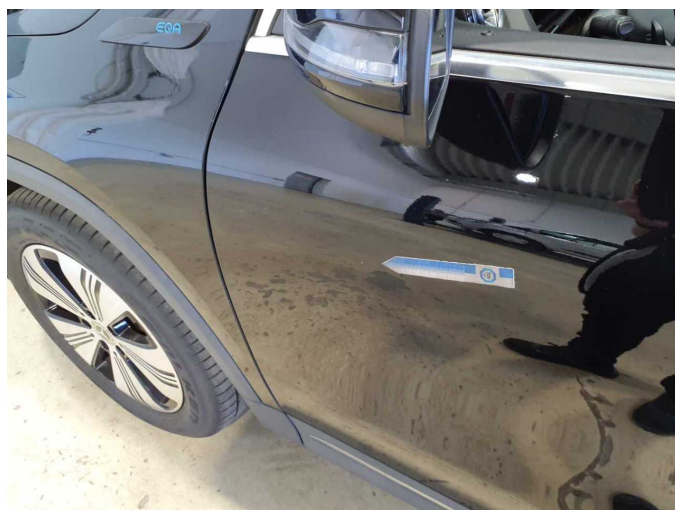
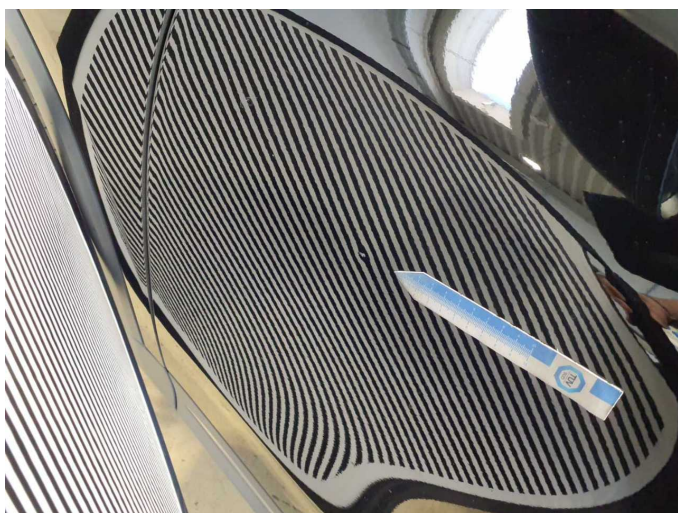
| No. | Component group | Description |
|---|---|---|
| 9 | Door - front left side | Door - Dent / paintcoat damage - Smart repair |

**Damage 9:** Door - front left side: Door - Dent / paintcoat damage - Smart repair

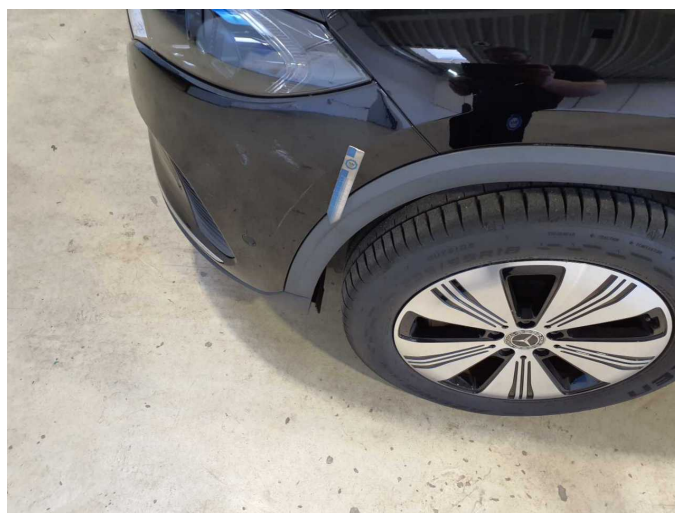
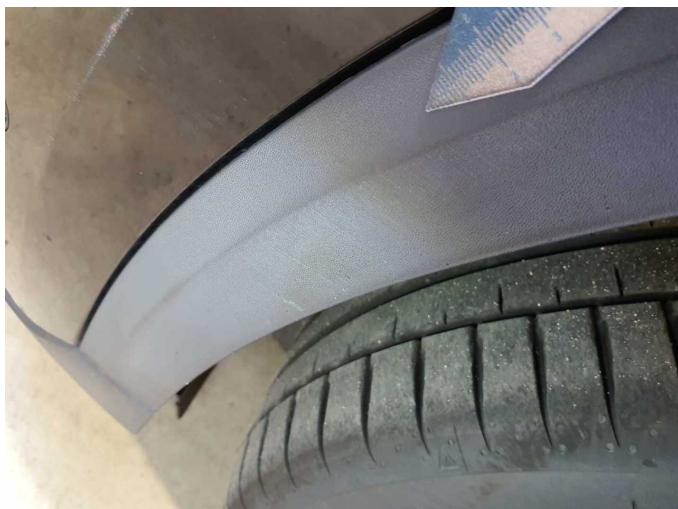
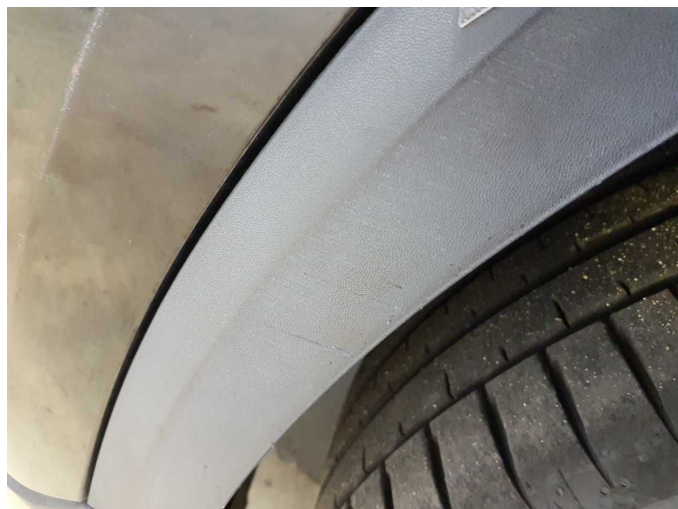
| No. | Component group | Description |
|---|---|---|
| 10 | Mudguard - left side | Wheel well extension - Scratch(es) - Replace |

**Damage 10:** Mudguard - left side: Wheel well extension - Scratch(es) - Replace

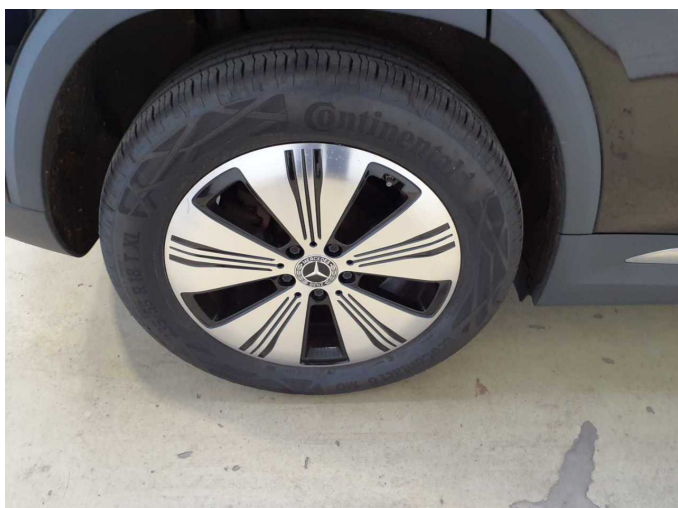
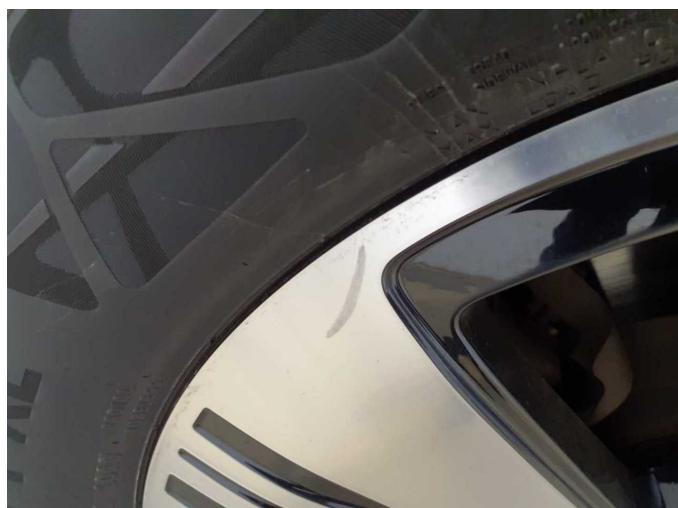
| No. | Component group | Description |
|---|---|---|
| 11 | Wheel / tyres | Alloy rim - rear right side - Scratch(es) - Loss in value |

**Damage 11:** Wheel / tyres: Alloy rim - rear right side - Scratch(es) - Loss in value

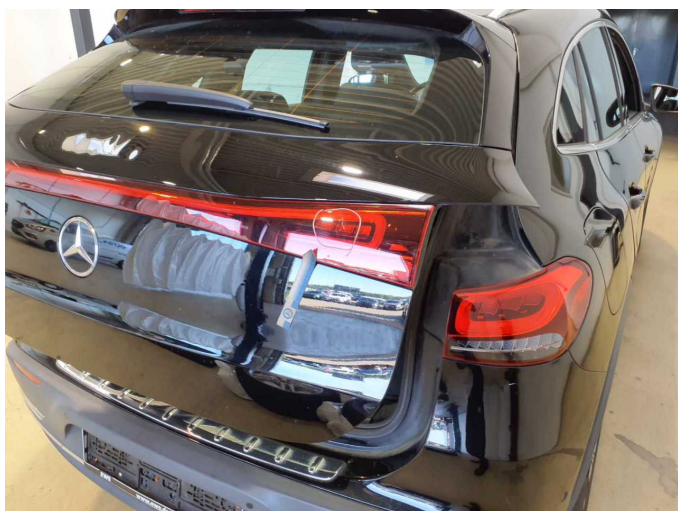
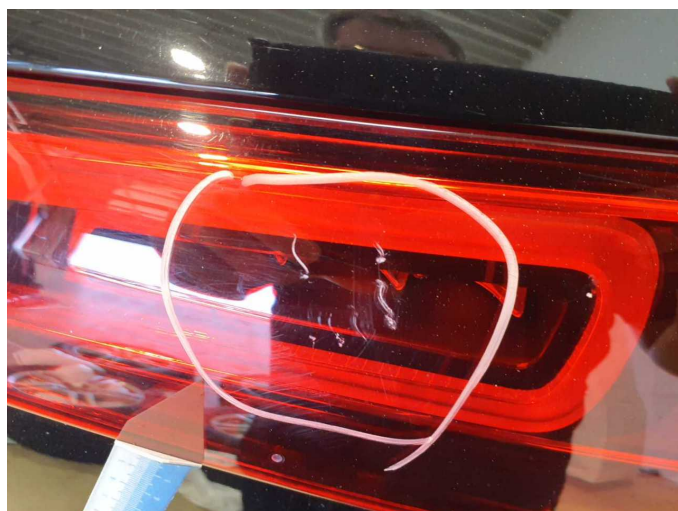
| No. | Component group | Description |
|---|---|---|
| 12 | Tail light | Tail light - Scratch(es) - Replace |

**Damage 12:** Tail light: Tail light - Scratch(es) - Replace

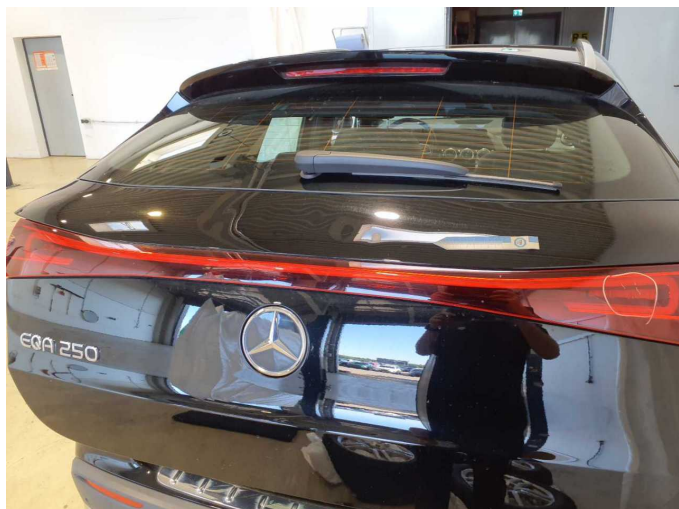
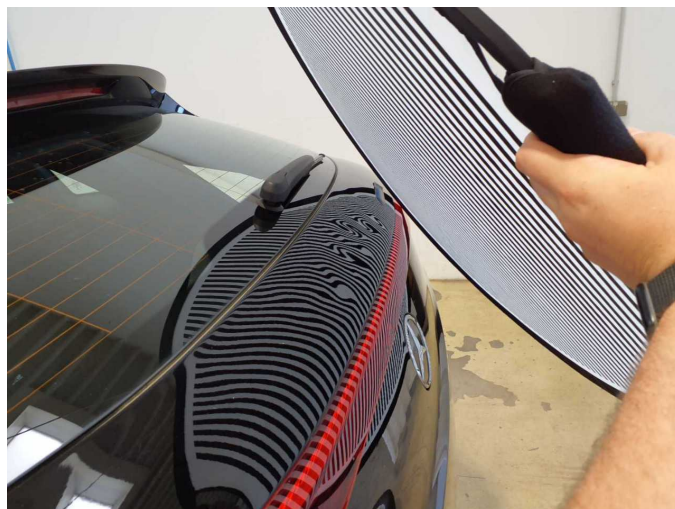
| No. | Component group | Description |
|---|---|---|
| 13 | Boot lid / rear door | Boot lid - dent(s) - Repair and paint |

**Damage 13:** Boot lid / rear door: Boot lid - dent(s) - Repair and paint

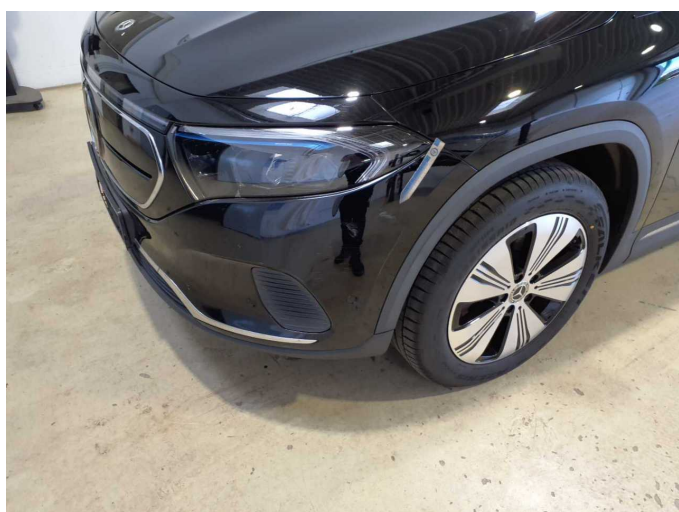
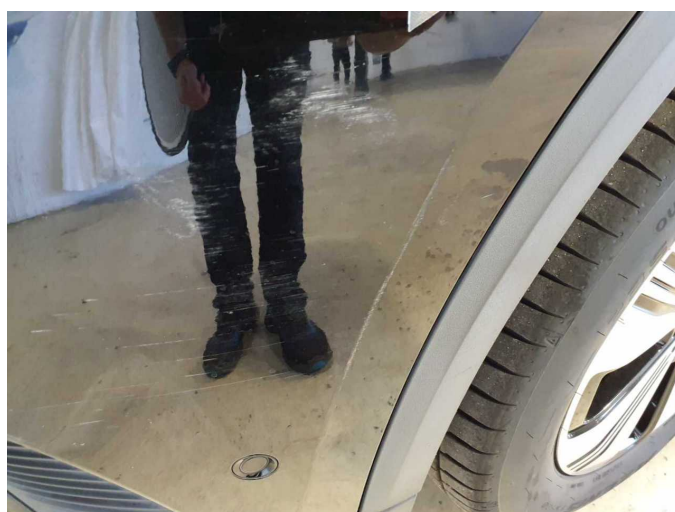
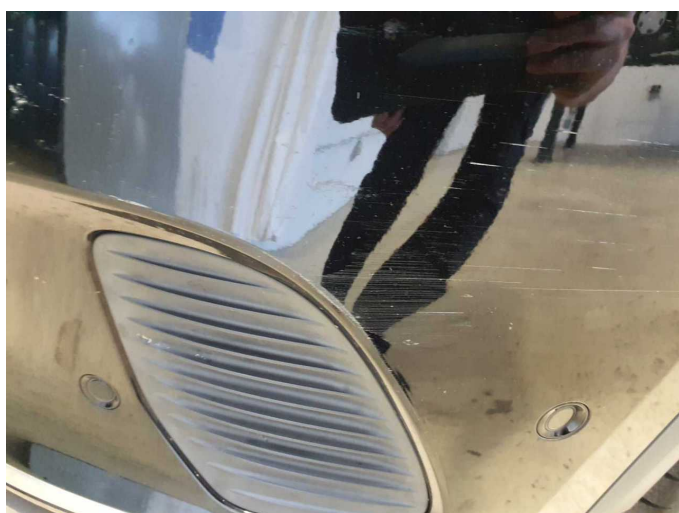
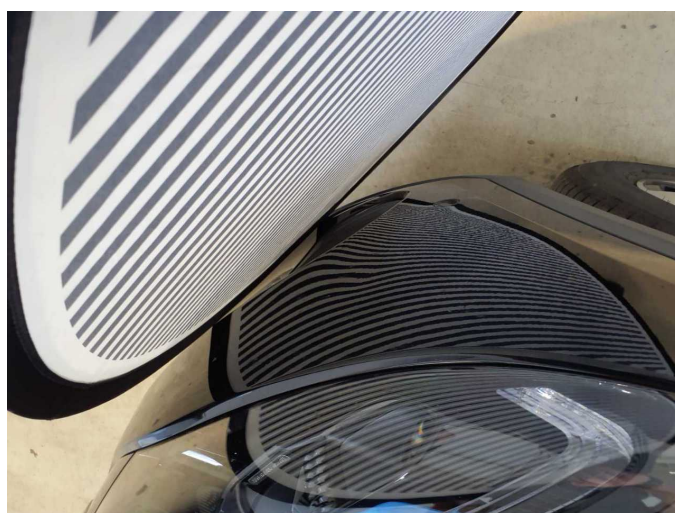
| No. | Component group | Description |
|---|---|---|
| 14 | Front bumper | Front bumper - Dent / paintcoat damage - Repair and paint |

**Damage 14:** Front bumper: Front bumper - Dent / paintcoat damage - Repair and paint

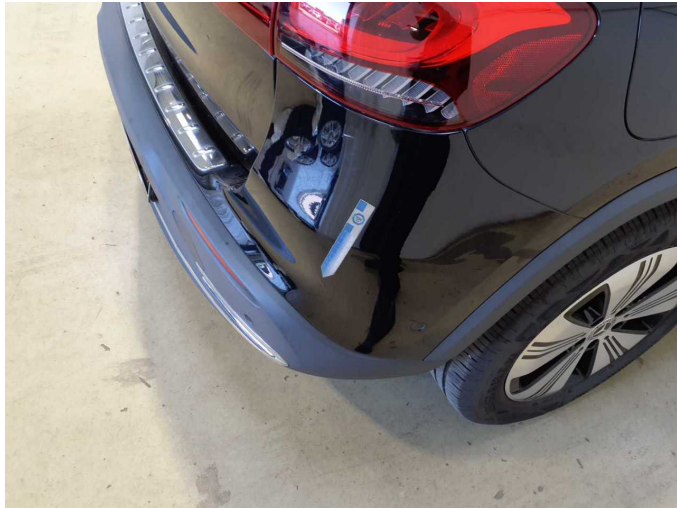
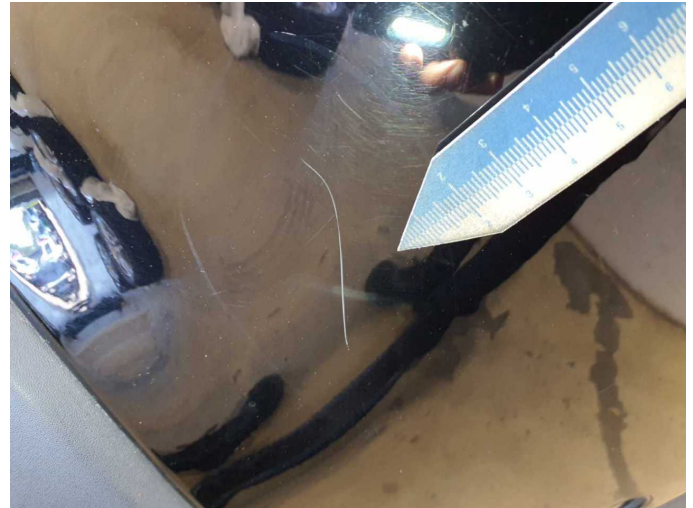
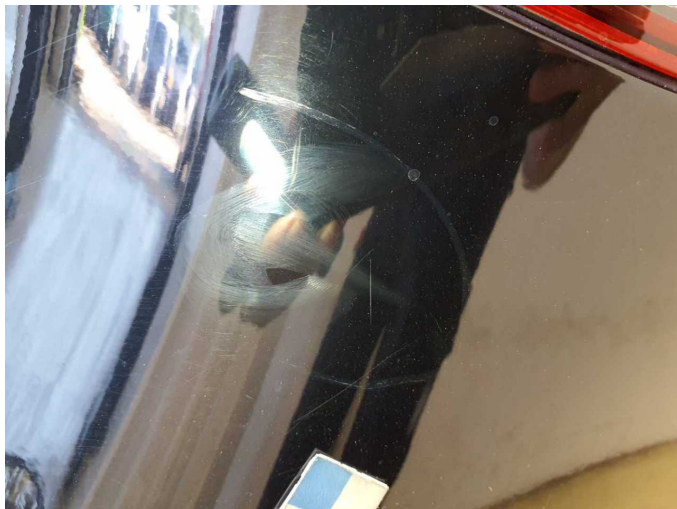
| No. | Component group | Description |
|---|---|---|
| 15 | Rear bumper | Bumper - rear right side - Scratch(es) - Paint |

**Damage 15:** Rear bumper: Bumper - rear right side - Scratch(es) - Paint
