Expertise

Protocol number: 45829984
Order No. / Reference: 25933217
Inspection date: 8 Jun 2026

Model: Vito 116 CDI Extralang HA Aut. PRO

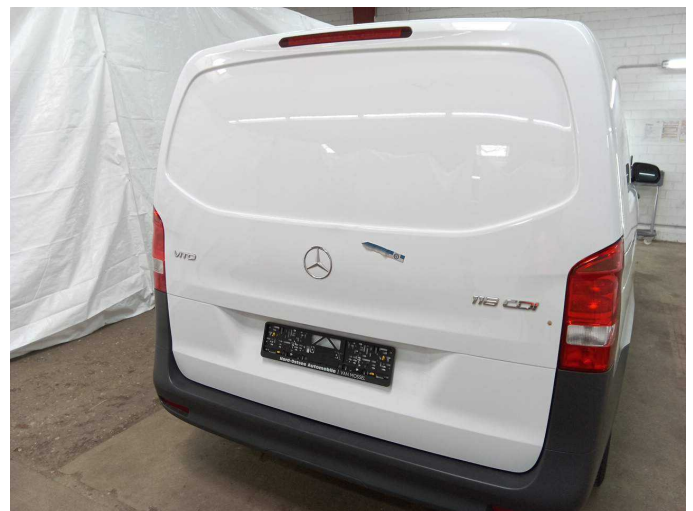
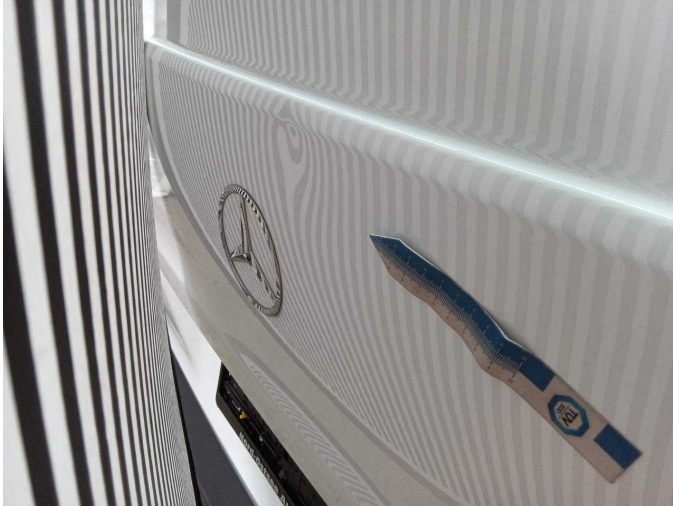
| No. | Component group | Description |
|---|---|--|
| 1 | Boot lid / rear door | Boot lid - dent(s) - Smooth repair work |

Damage 1: Boot lid / rear door: Boot lid - dent(s) - Smooth repair work

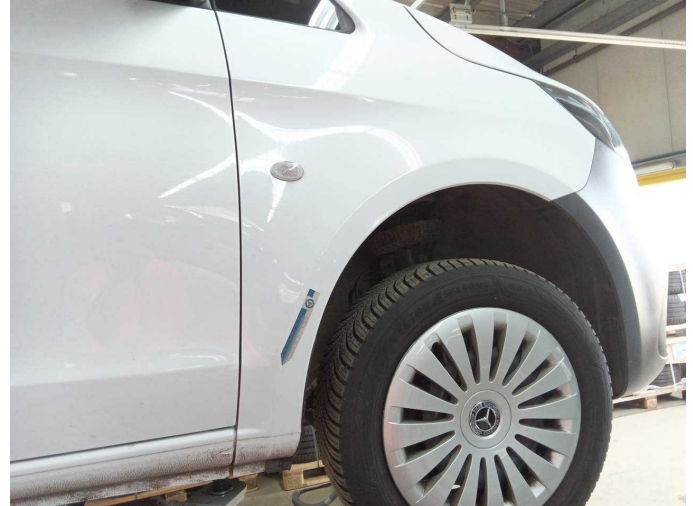
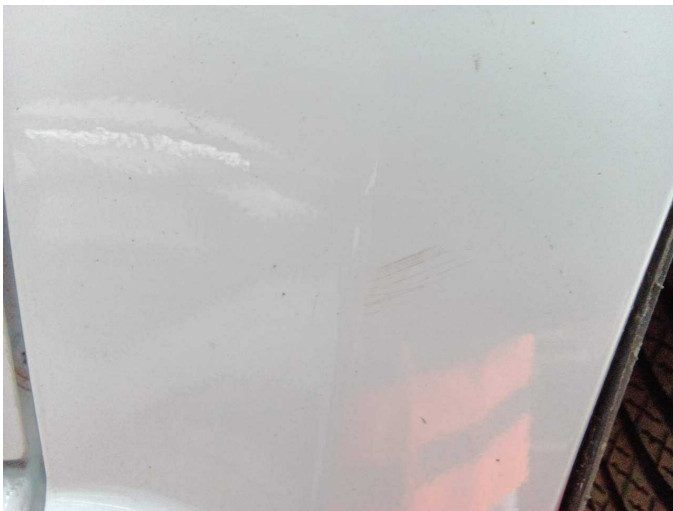
| No. | Component group | Description |
|---|---|--|
| 2 | Mudguard - right side | Mudguard - right side - Scratch(es) - Smart repair |

Damage 2: Mudguard - right side: Mudguard - right side - Scratch(es) - Smart repair

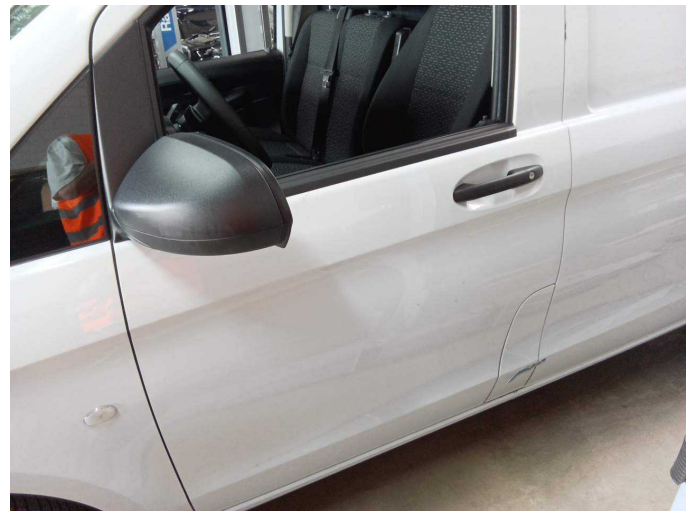
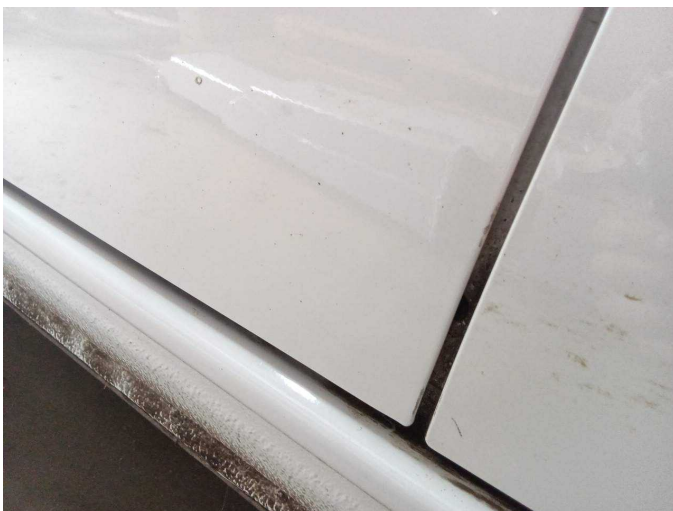
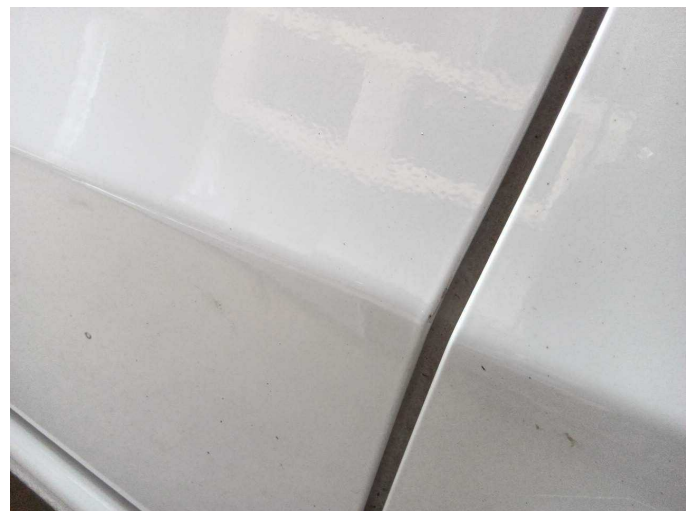
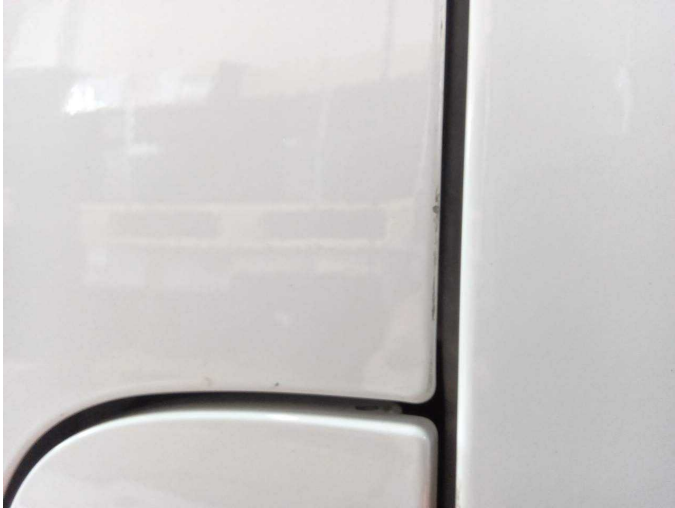
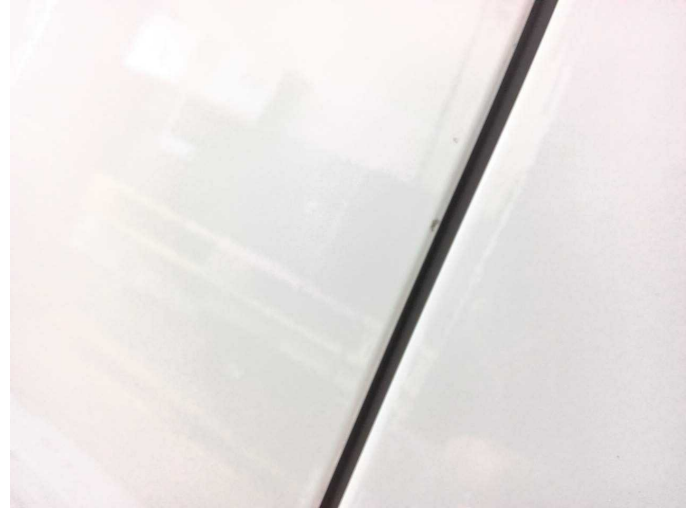
| No. | Component group | Description |
|---|---|--|
| 3 | Door - front left side | Door edge - Scratch(es) - Smart repair |

Damage 3: Door - front left side: Door edge - Scratch(es) - Smart repair

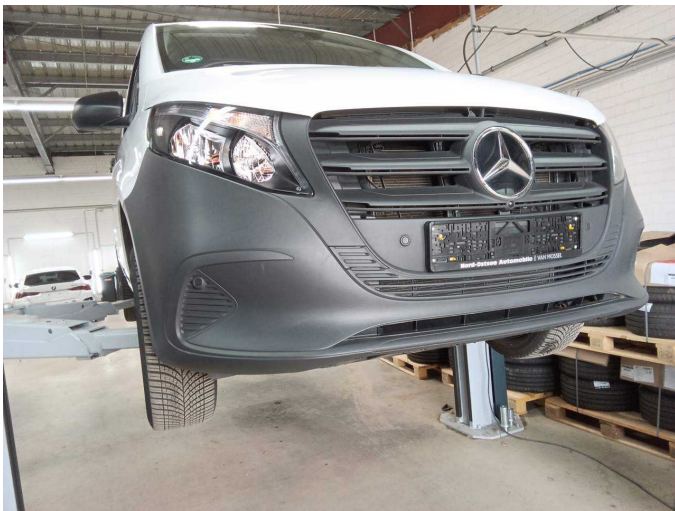
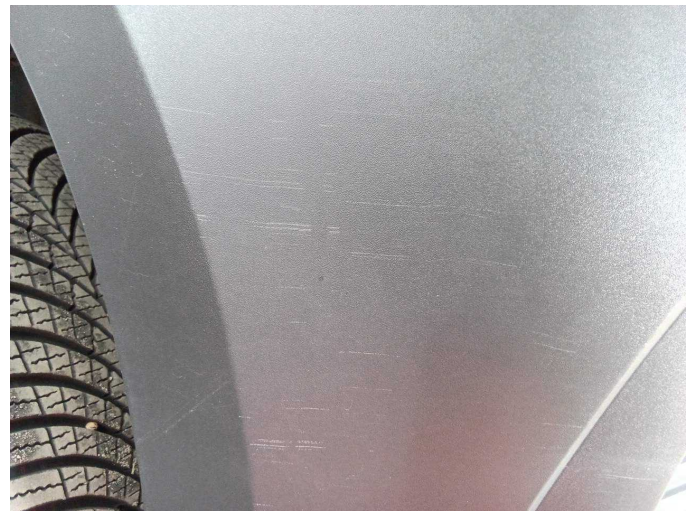
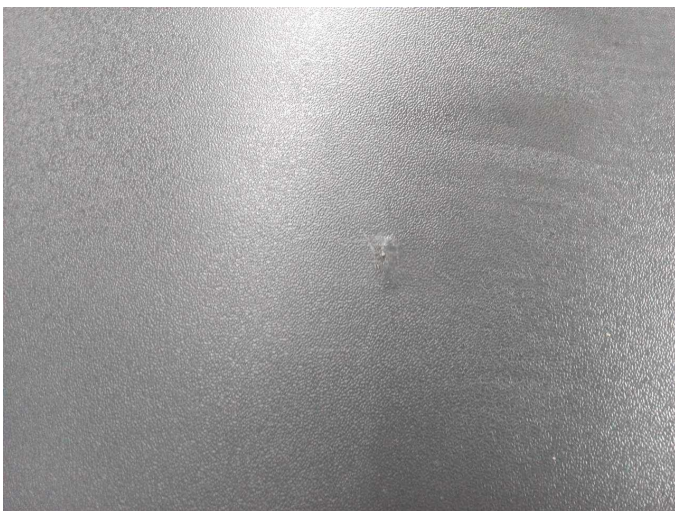
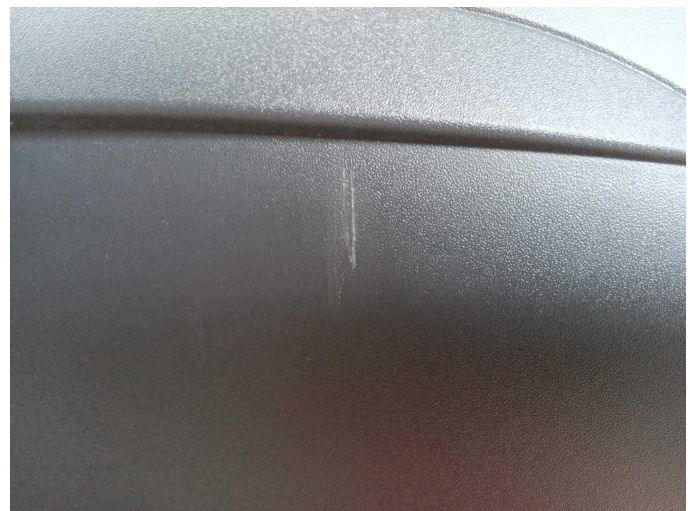
| No. | Component group | Description |
|---|---|--|
| 4 | Front bumper | Front bumper - Scratch(es) - Loss in value |

Damage 4: Front bumper: Front bumper - Scratch(es) - Loss in value

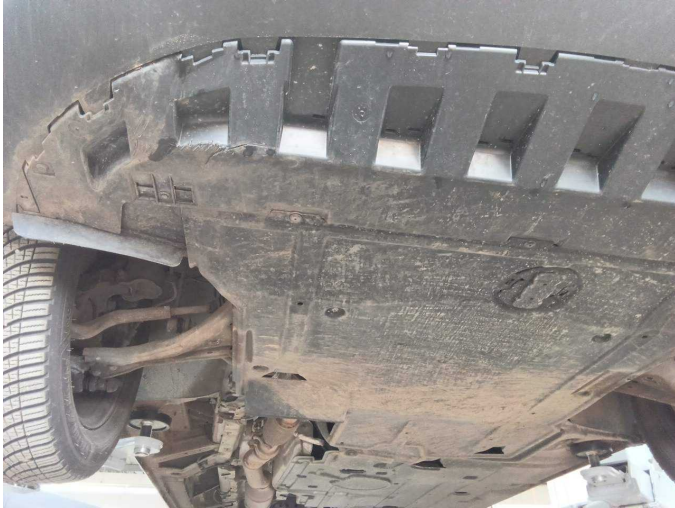
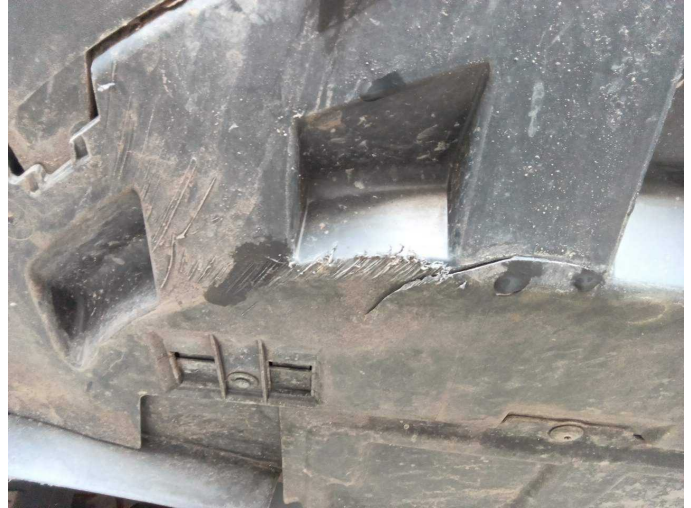
| No. | Component group | Description |
|---|---|--|
| 5 | Body | Underbody panelling - Broken / torn - Replace |

Damage 5: Body: Underbody panelling - Broken / torn - Replace

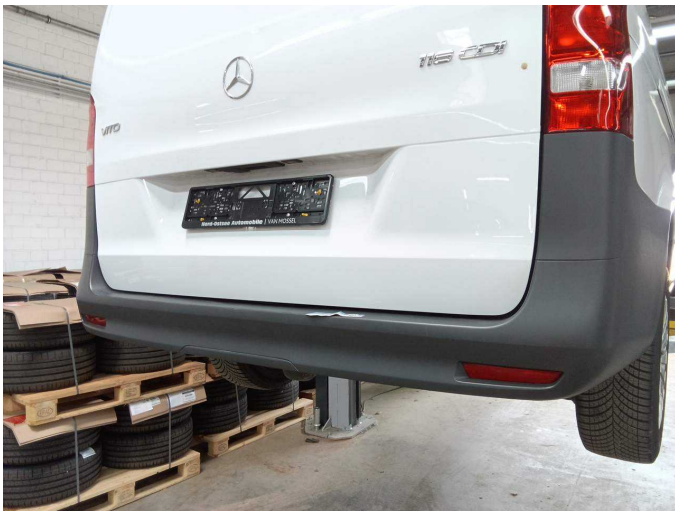
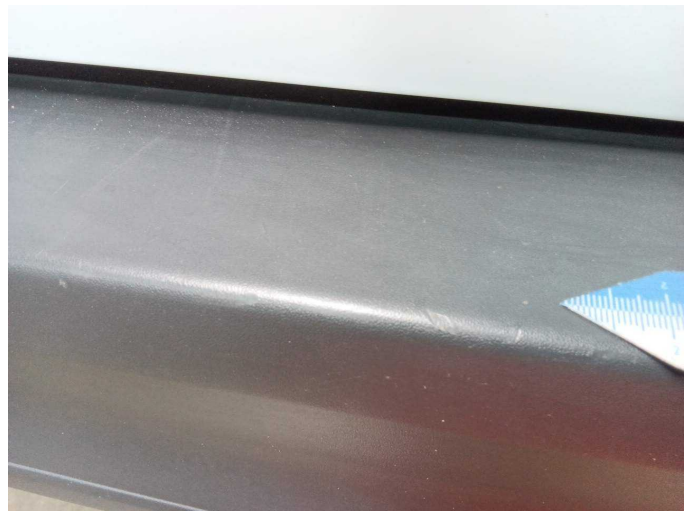
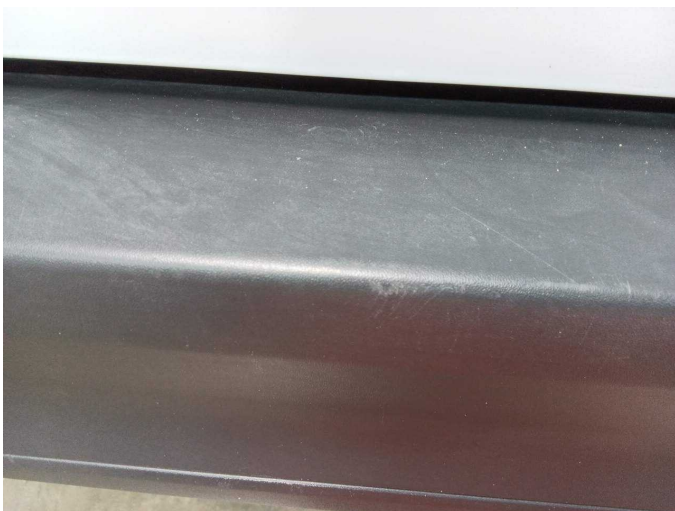
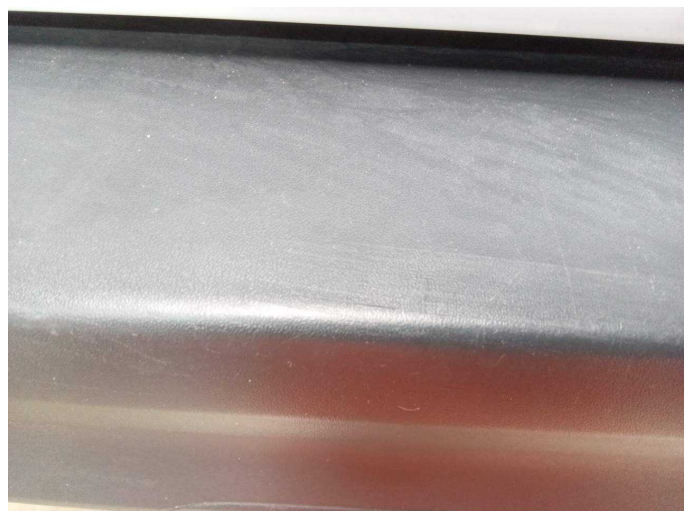
| No. | Component group | Description |
|---|---|--|
| 3 | Rear bumper | Rear bumper - Scratch(es) - No deduction |

Wear and tear 3: Rear bumper: Rear bumper - Scratch(es) - No deduction

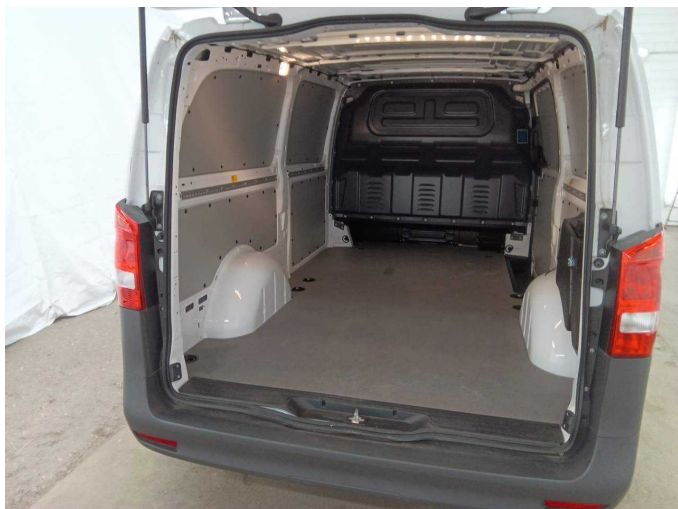
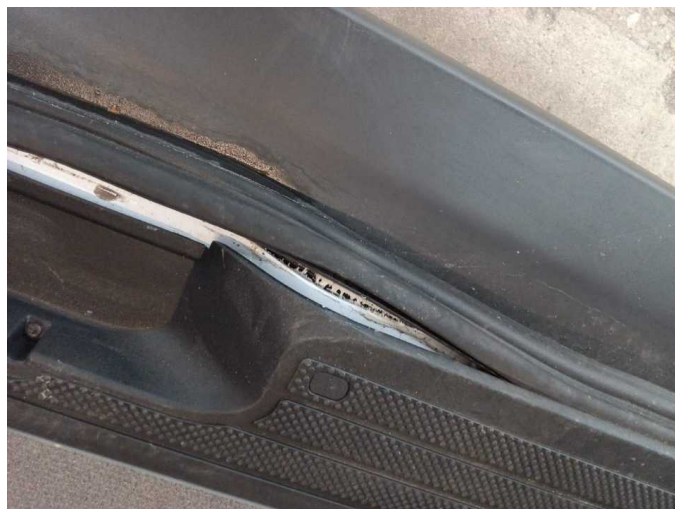
| No. | Component group | Description |
|---|---|--|
| 4 | Boot lid / rear door | Seal - Malposition - Replace |

Wear and tear 4: Boot lid / rear door: Seal - Malposition - Replace
