Expertise

Protocol number: 45569585
Order No. / Reference: 26320182
Inspection date: 11 May 2026

Manufacturer: Opel

Model: Astra Sports Tourer 1.5 D Automatik GS Line

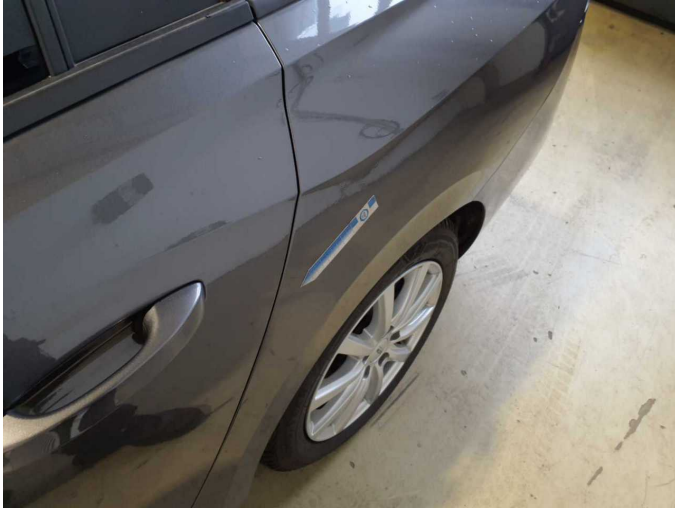
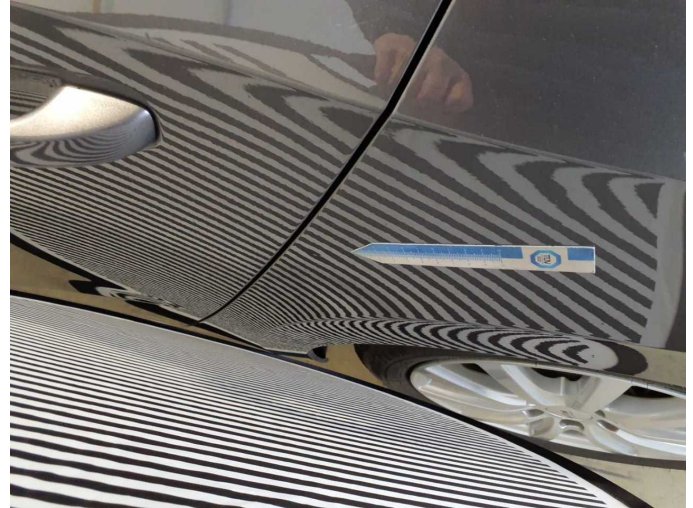
Damage 1: Side panel - rear left side: Side panel - dent(s) - Smooth repair work

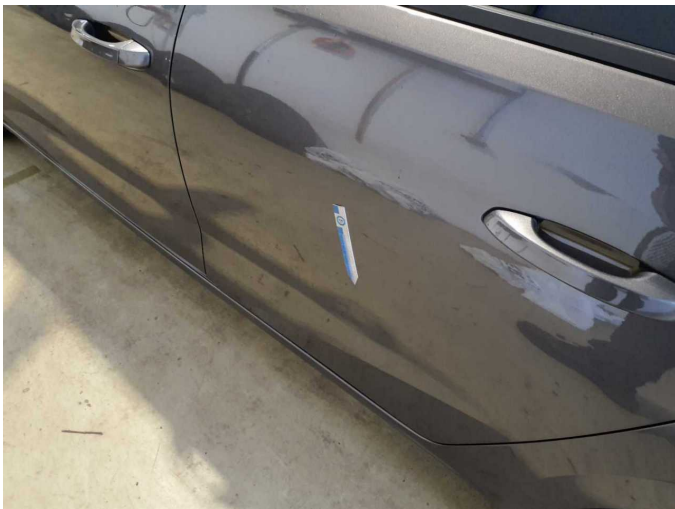
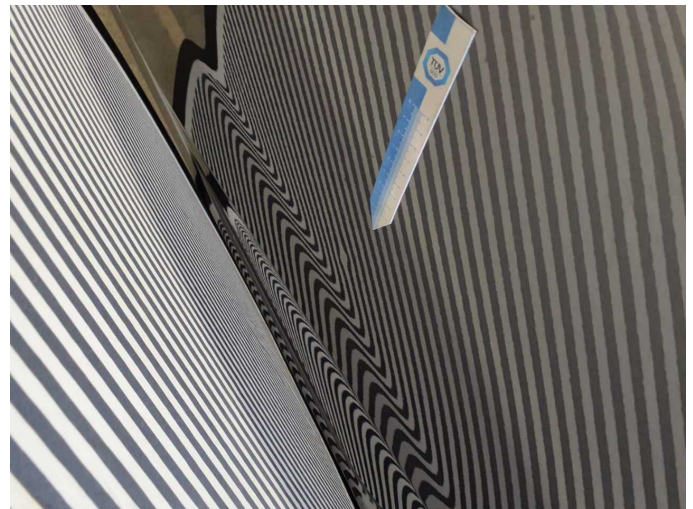
Damage 2: Door - rear left side: Door - dent(s) - Smooth repair work

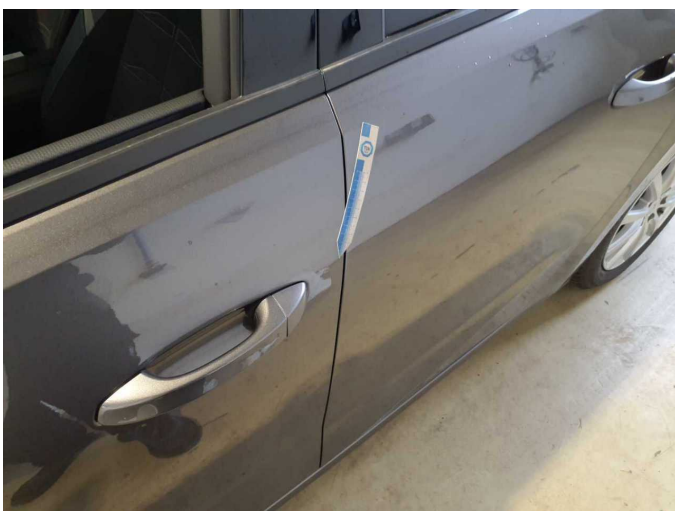
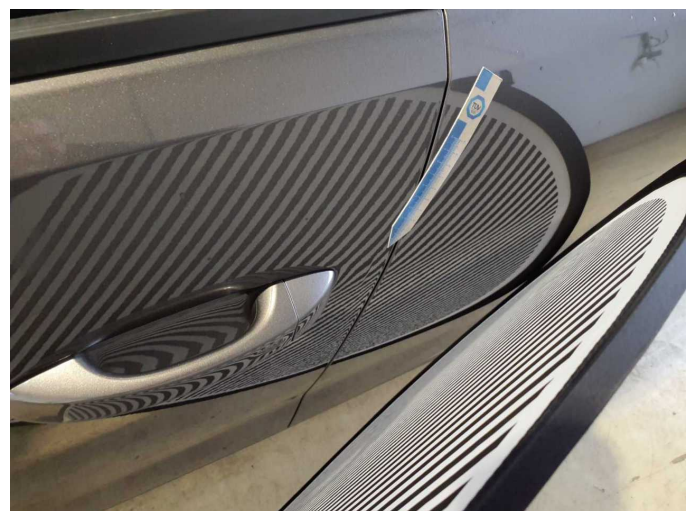
Damage 3: Door - front left side: Door - dent(s) - Smooth repair work

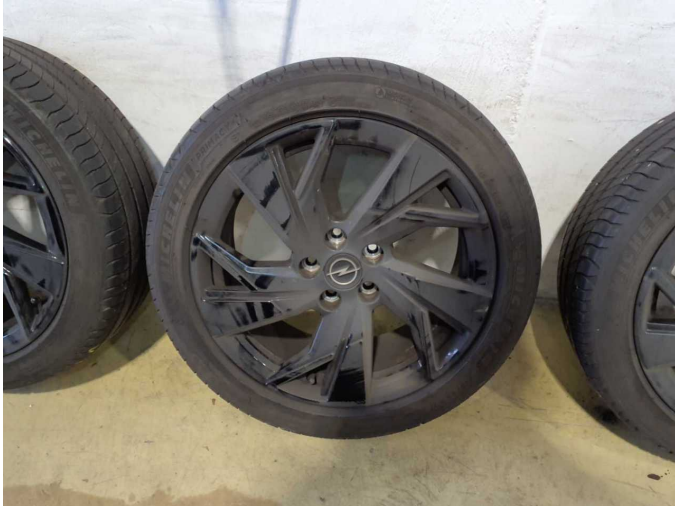
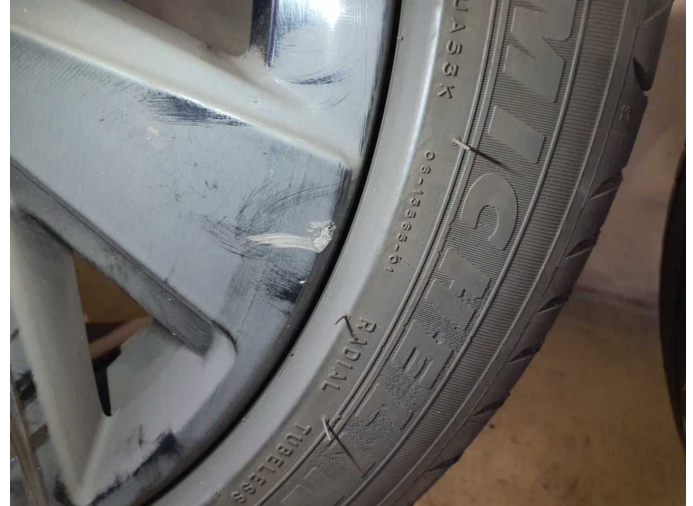
Damage 4: 2nd wheel set: 1 alloy rim - Scratch(es) - Loss in value

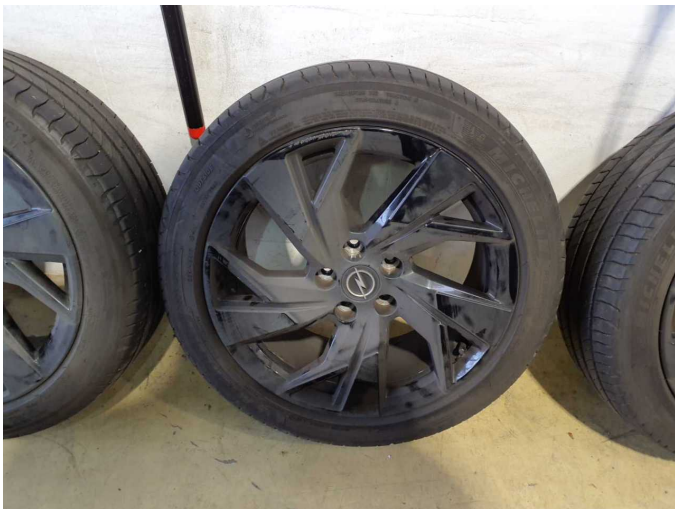
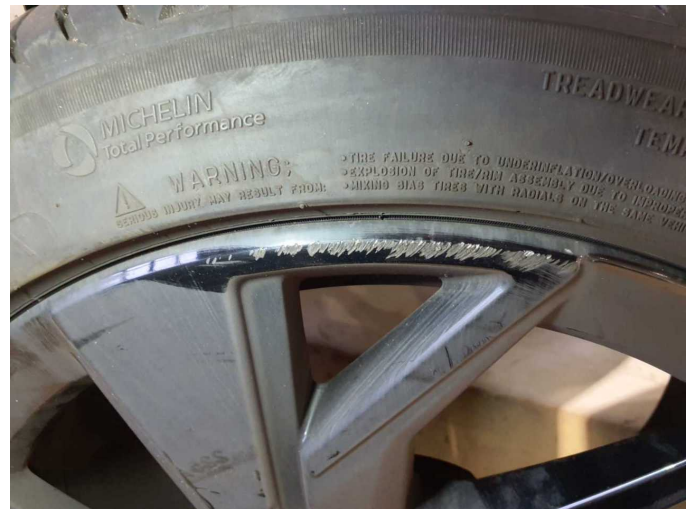
Damage 5: 2nd wheel set: 1 alloy rim - Scratch(es) - Loss in value

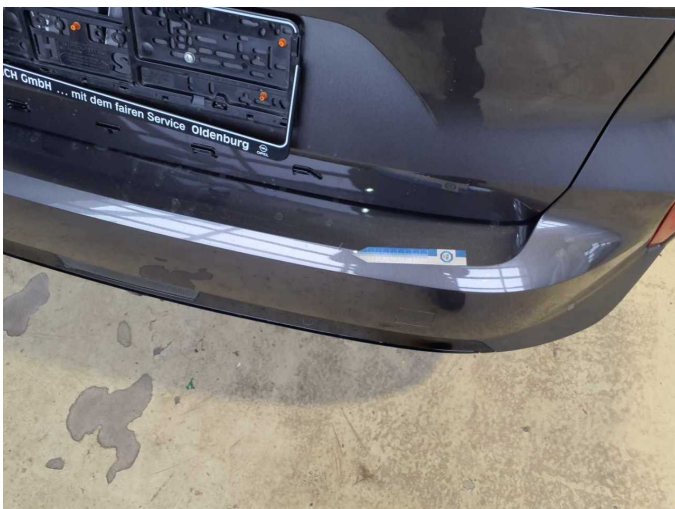
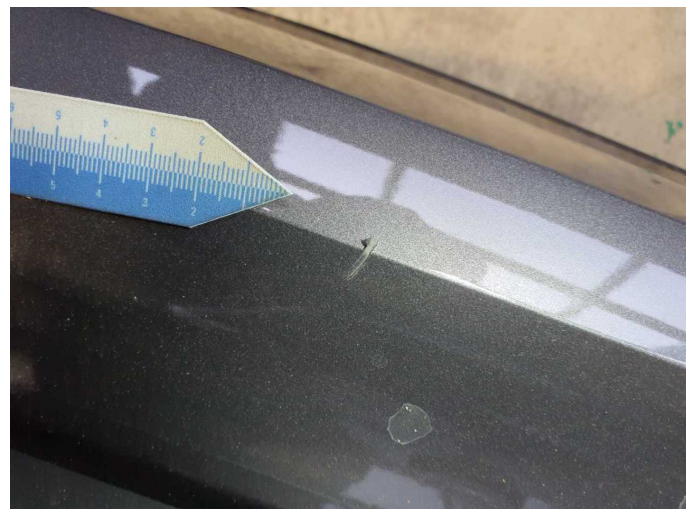
Damage 6: Rear bumper: Rear bumper - Scratch(es) - Smart repair

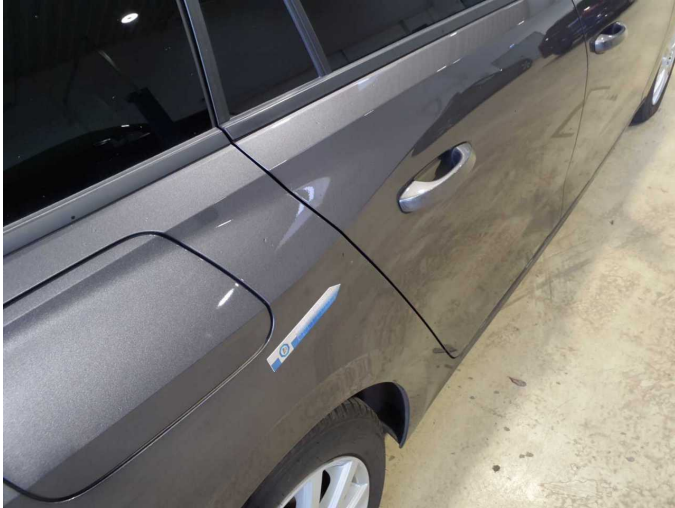
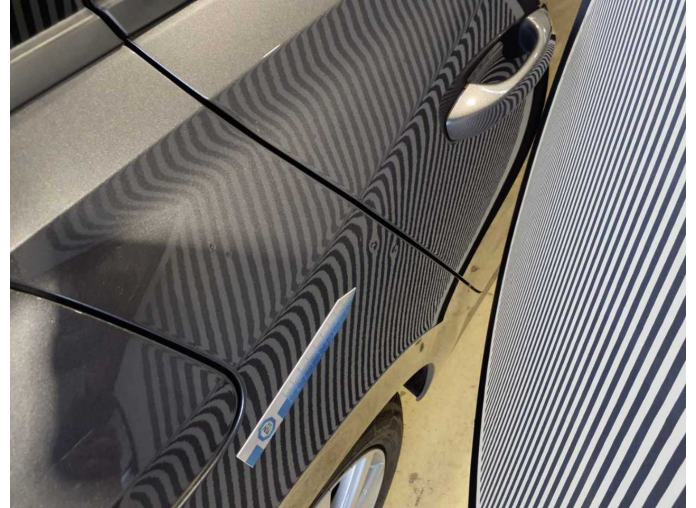
Damage 7: Side panel - rear right side: Side panel - Dent / paintcoat damage - Smart repair

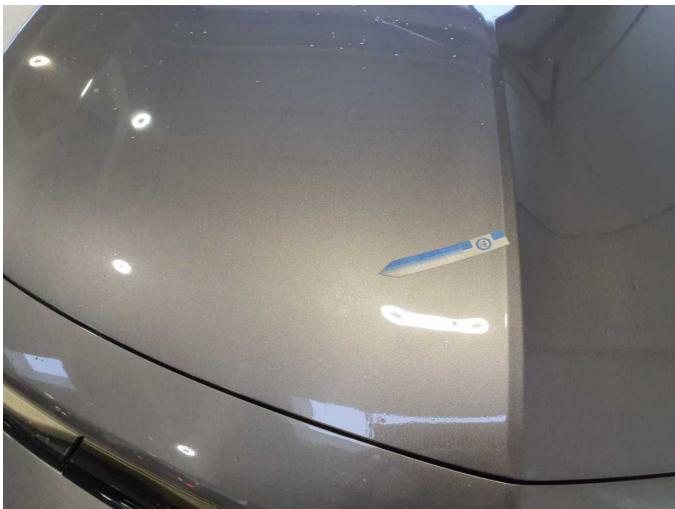
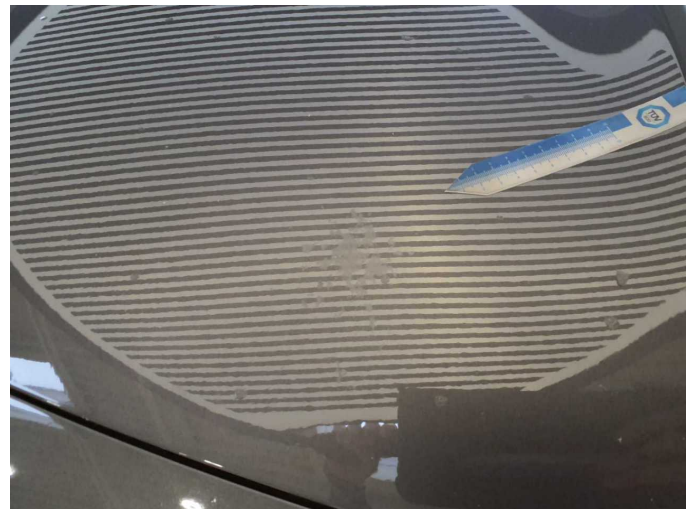
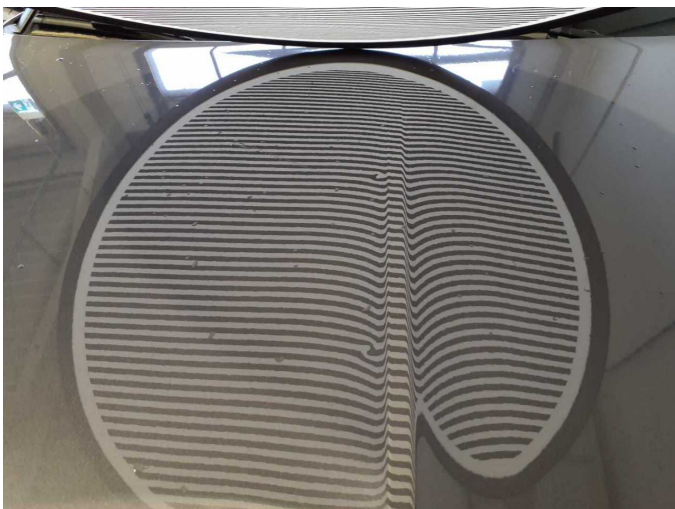
Damage 8: Bonnet: Bonnet (Verätzung) - Paint defect - Paint

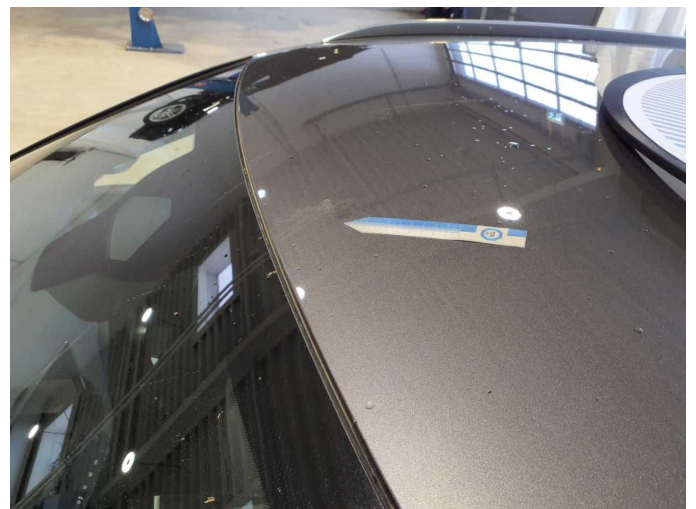
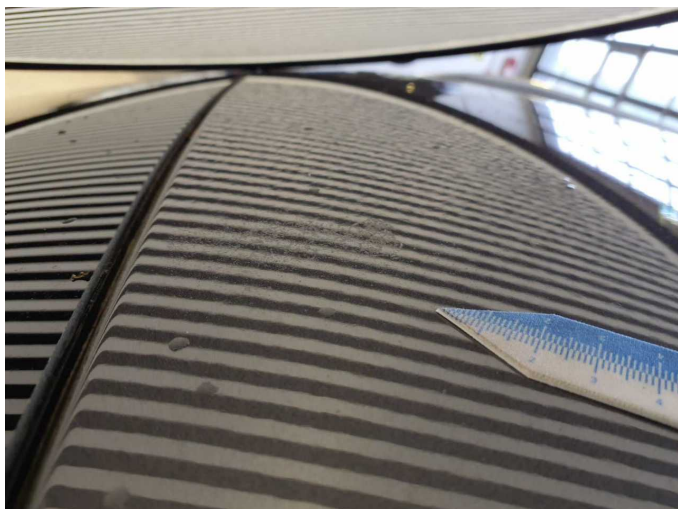
Damage 9: Roof: Roof (Verätzung) - Paint defect - Paint

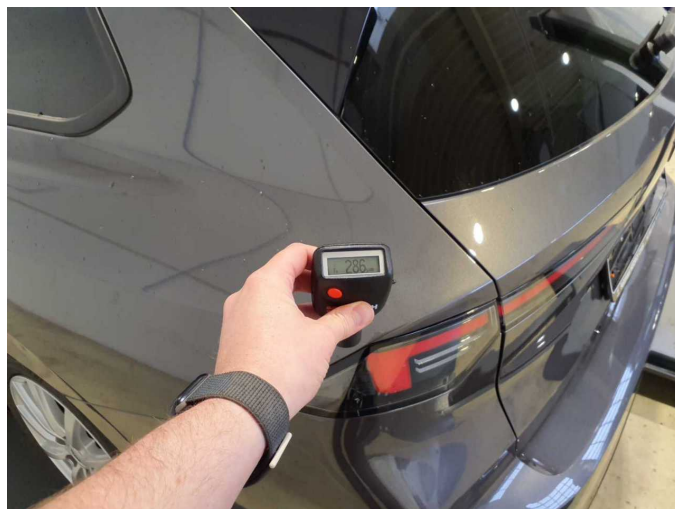
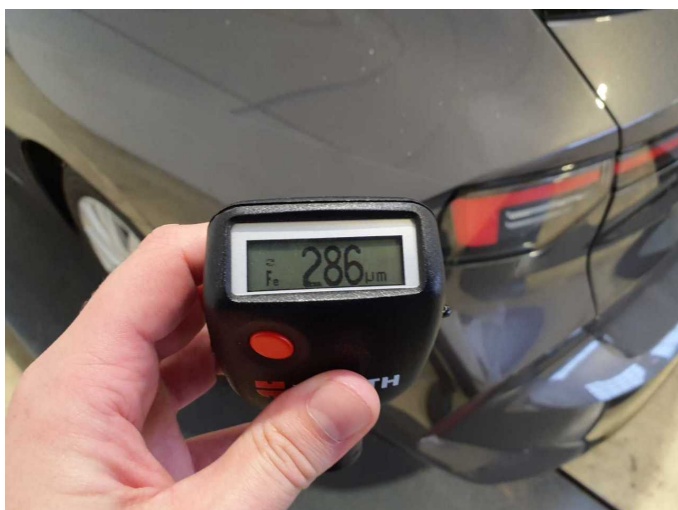
No.	Repainting
1	Side panel - rear left side, Professionally carried out, Invoice of repair done Non-existent

Side panel - rear left side	286 µm
-----------------------------	--------

Repainting 1: Side panel - rear left side
