Expertise

Protocol number: 46366670
Order No. / Reference: 26466985
Inspection date: 2 Jul 2026

Manufacturer: Ford

Model: Kuga 2.0 EcoBlue 4x4 Aut. TITANIUM

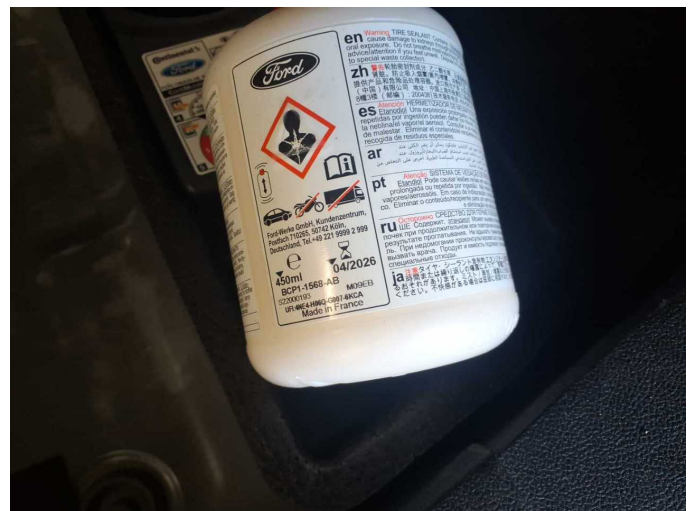
Damage 1: Equipment: Tirefit filler - Expired - Replace

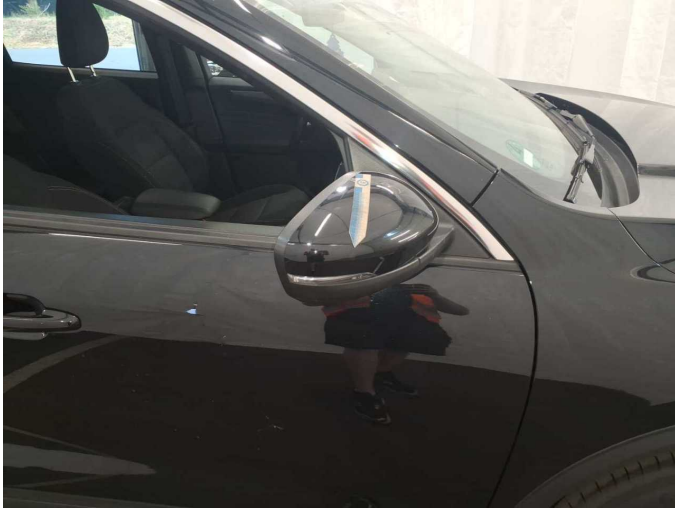
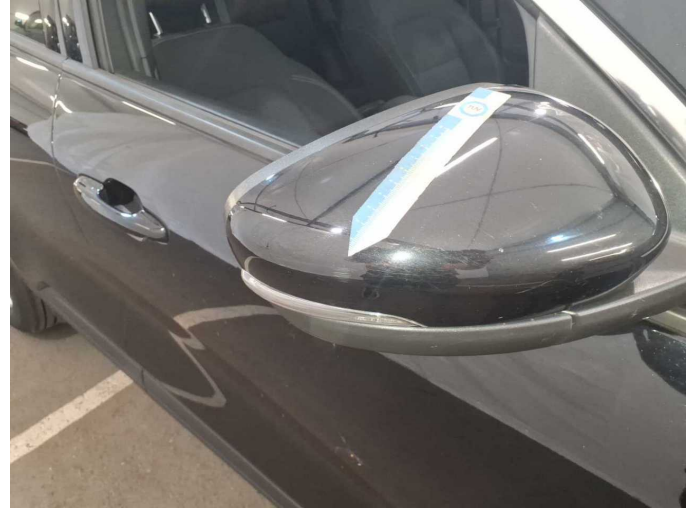
Damage 2: Wing mirror - right side: Cap - Scratch(es) - Smart repair

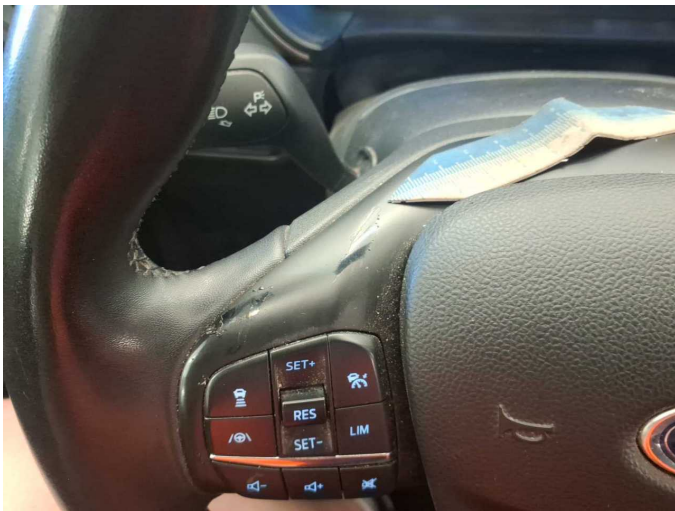
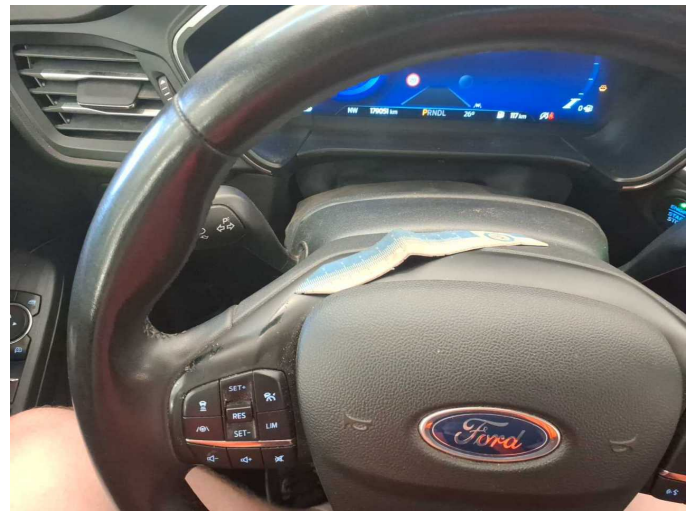
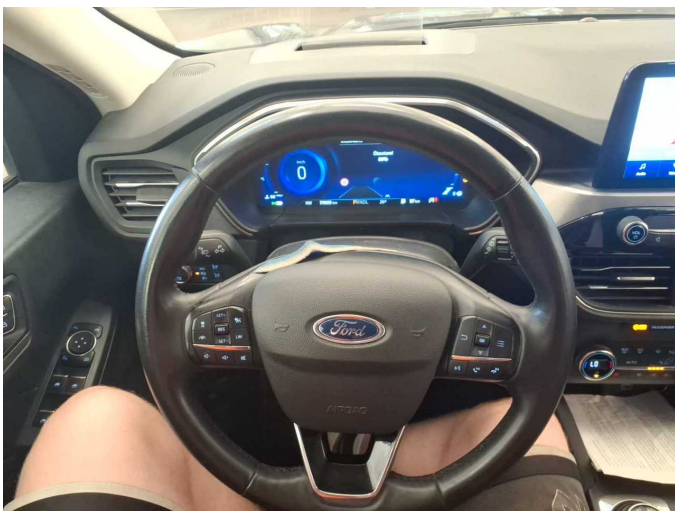
Damage 3: Steering system: Steering wheel (Blende Multifunktionslenkrad) - Paint defect - Loss in value

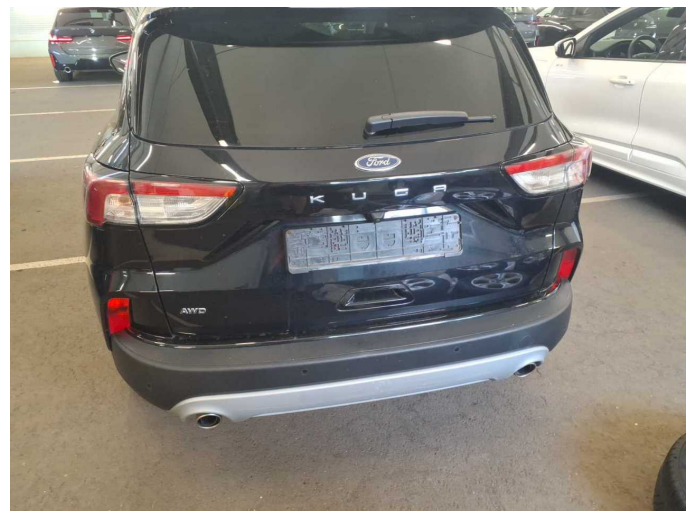
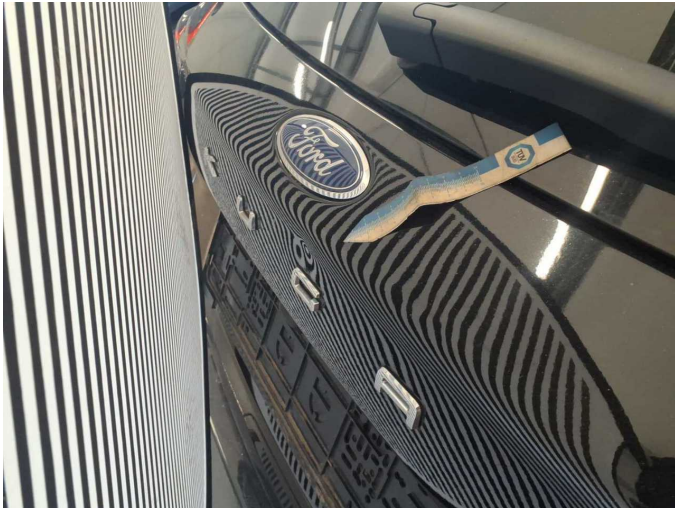
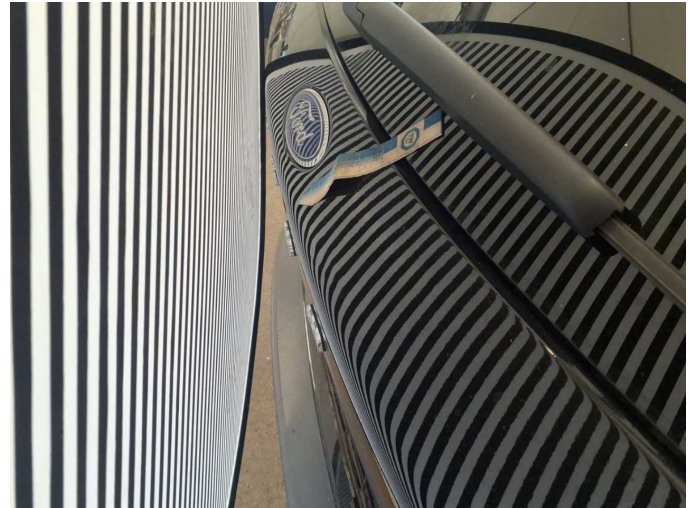
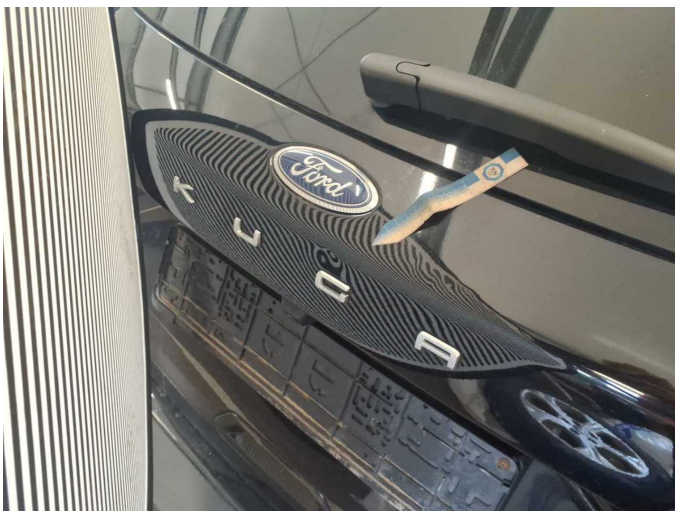
Damage 4: Boot lid / rear door: Boot lid - dent(s) - Smooth repair work

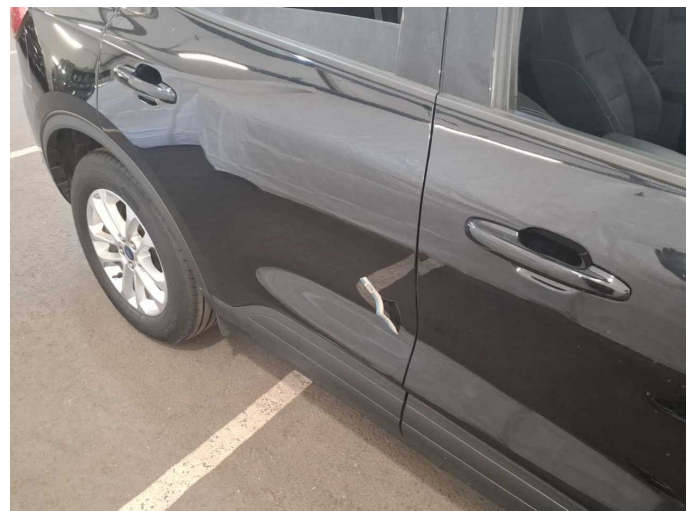
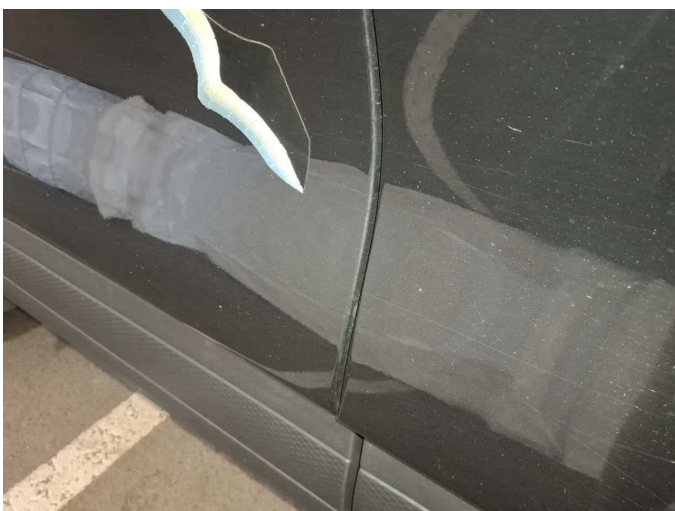
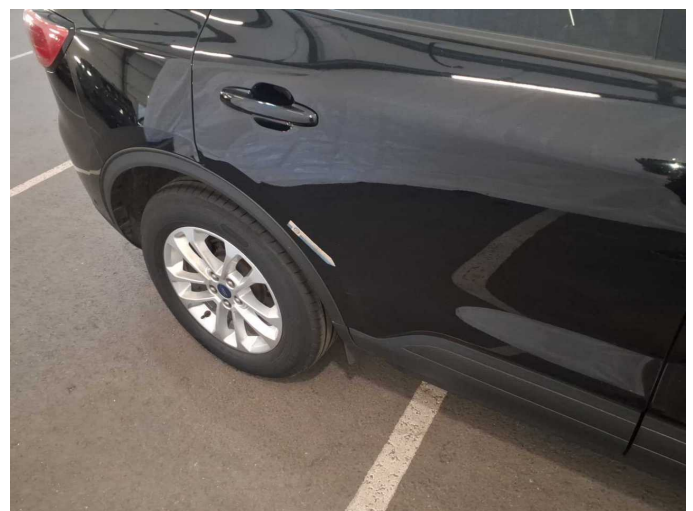
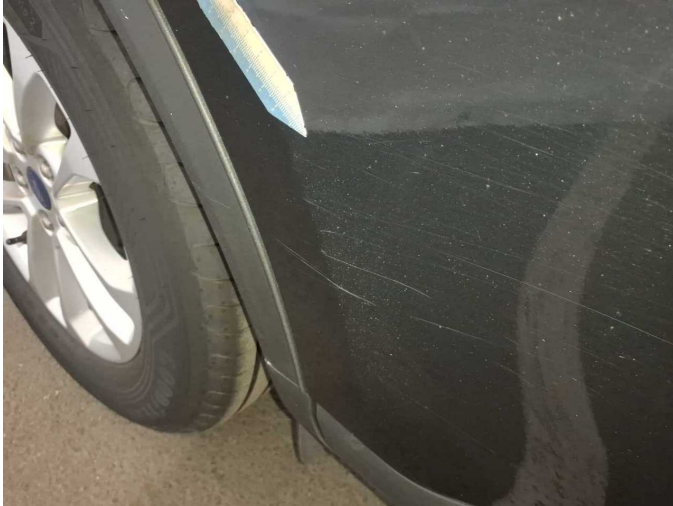
Damage 5: Door - rear right side: Door (schleifen + polieren) - Scratch(es) - Smart repair

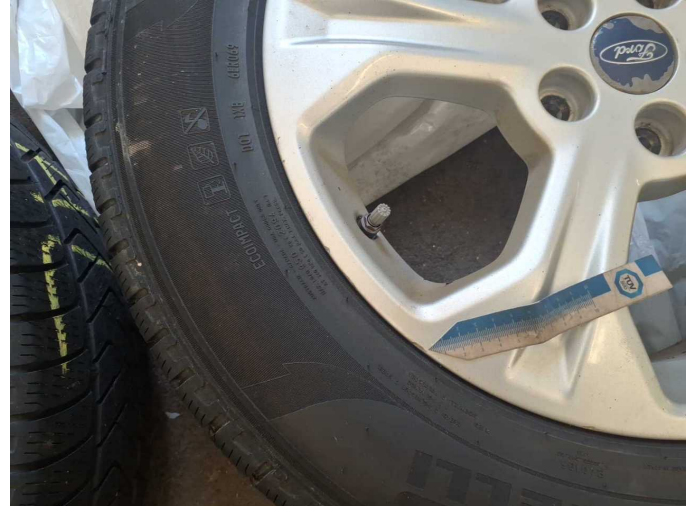
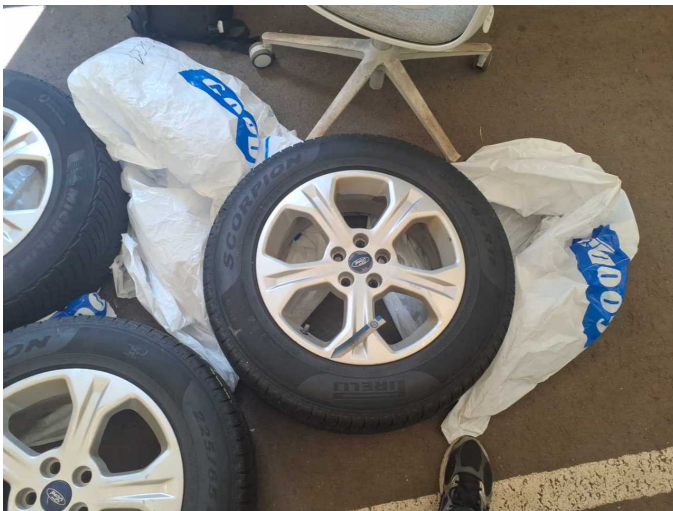
Damage 6: 2nd wheel set: 1 alloy rim - Scratch(es) - Loss in value

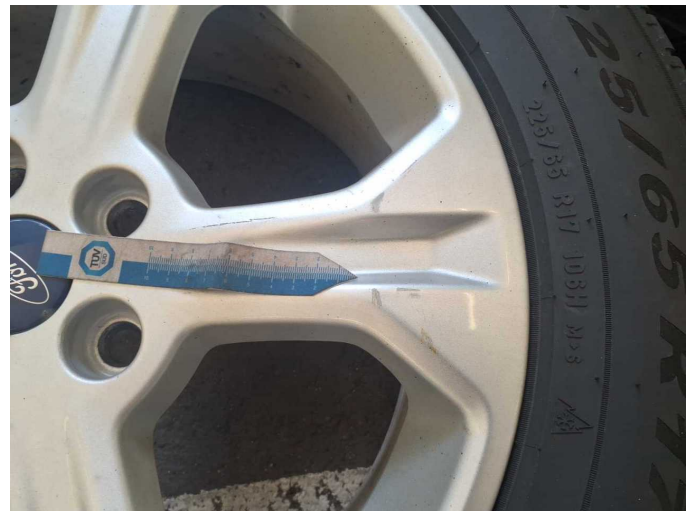
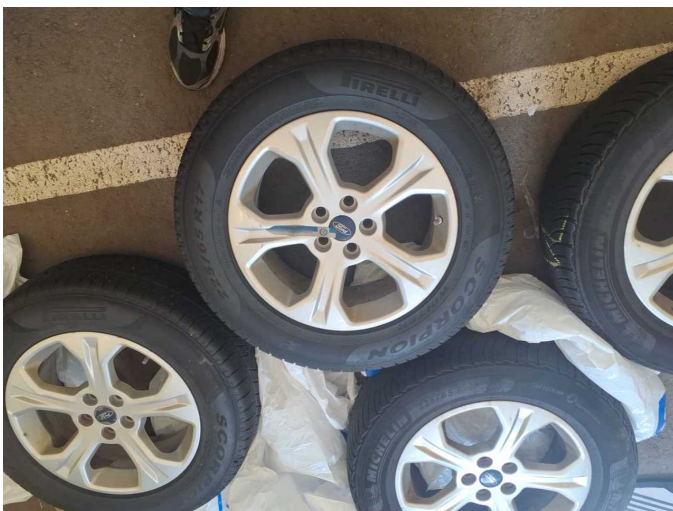
Damage 7: 2nd wheel set: 1 alloy rim - Scratch(es) - Loss in value

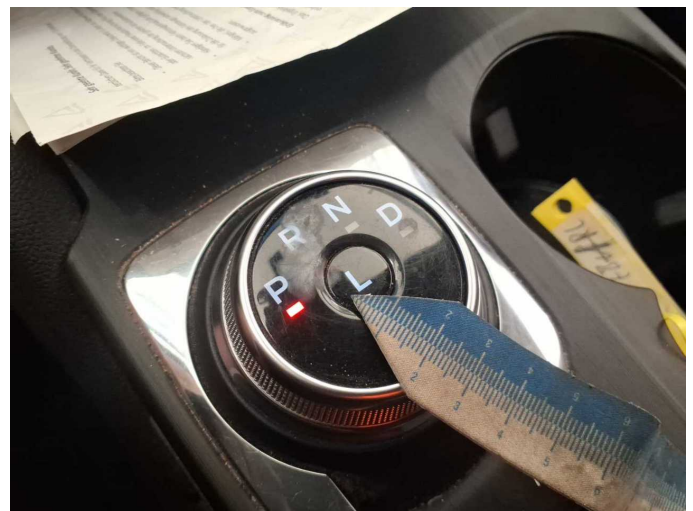
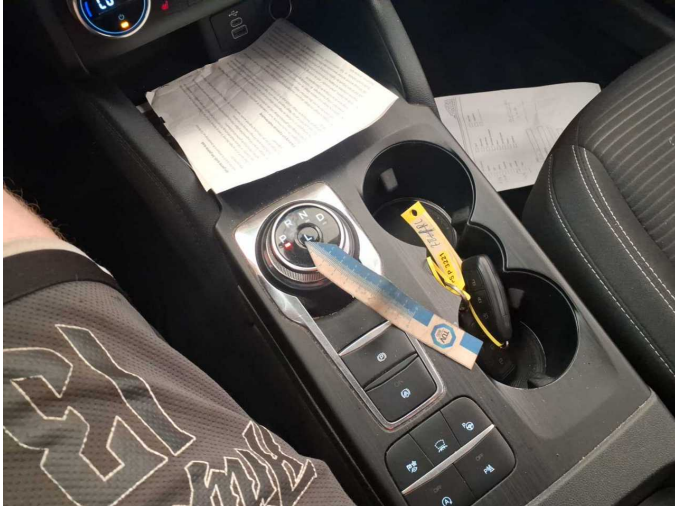
Damage 8: Gearbox: Gear knob - Scratch(es) - Replace

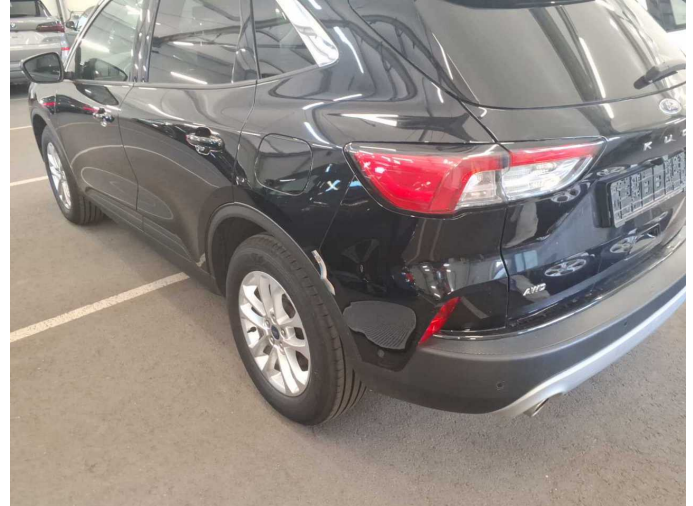
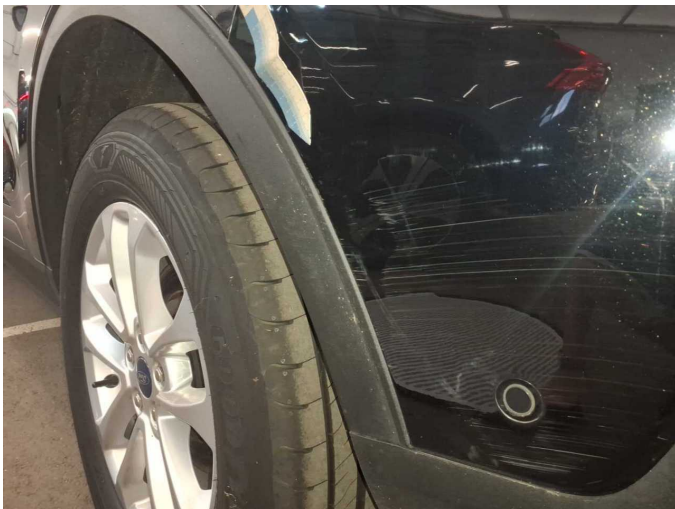
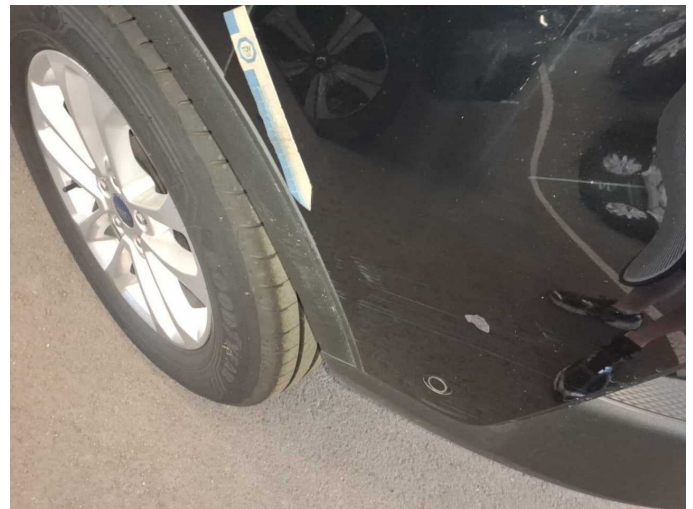
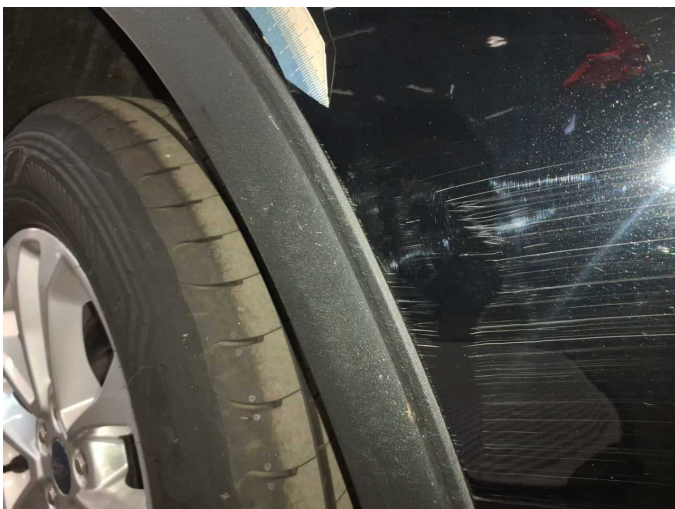
Damage 9: Rear bumper: Bumper - rear left side - Scratch(es) - Paint

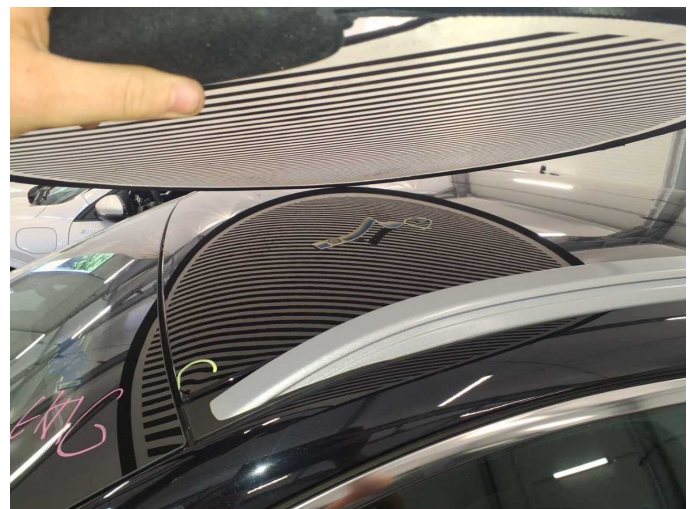
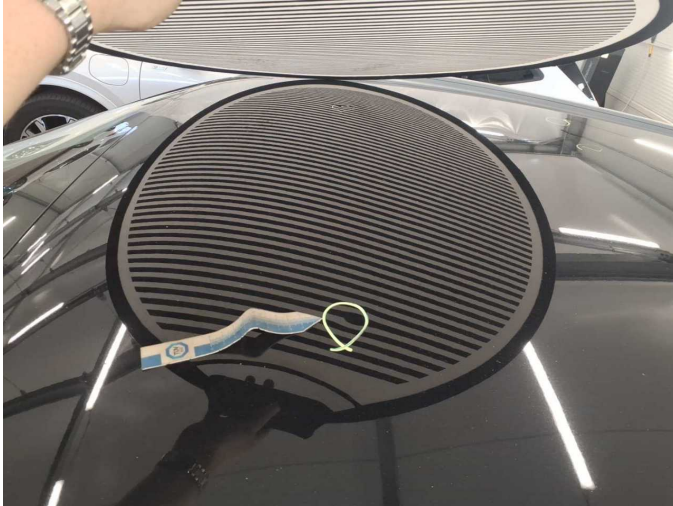
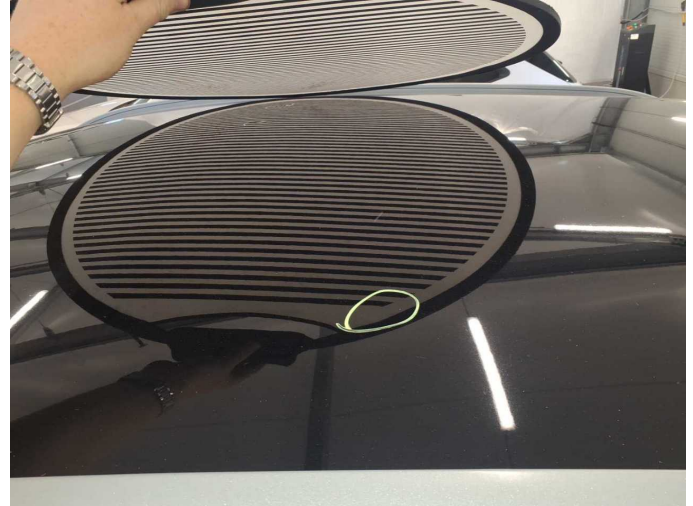
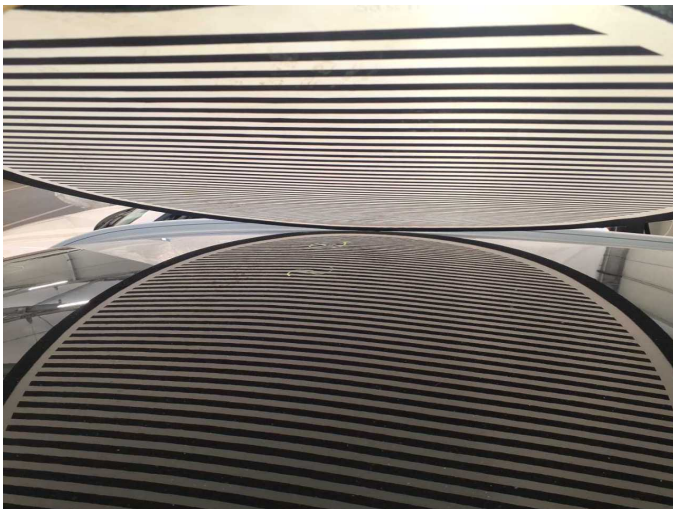
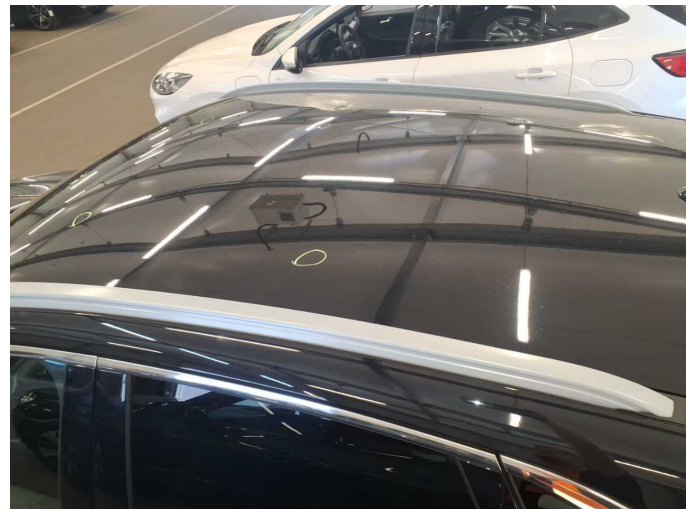
Damage 10: Roof: Roof - dent(s) - Smooth repair work

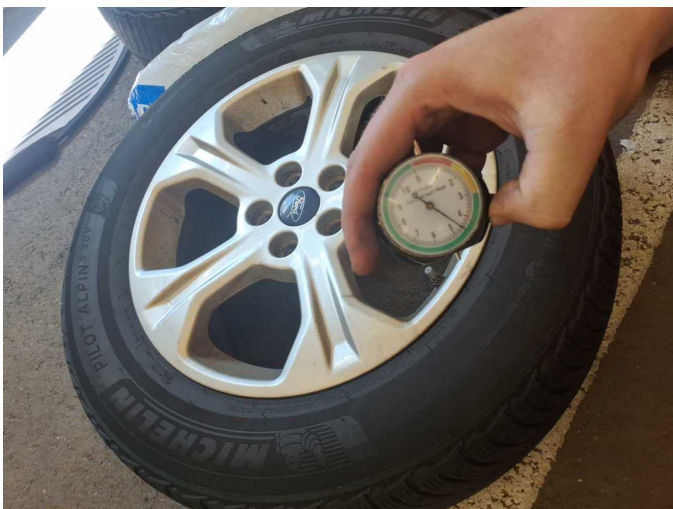
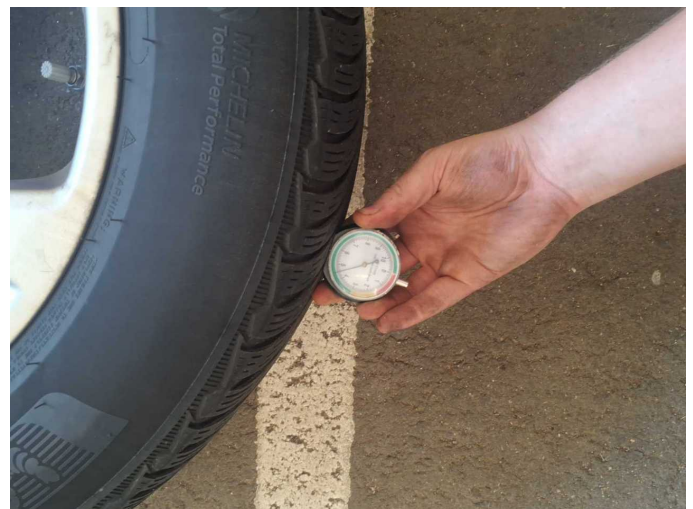
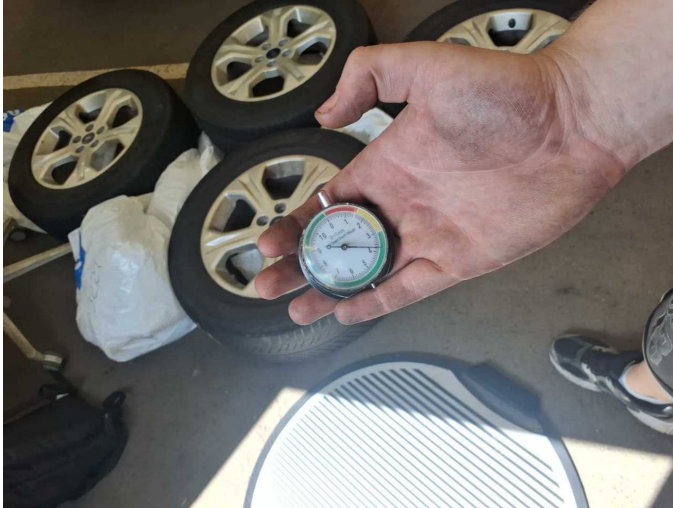
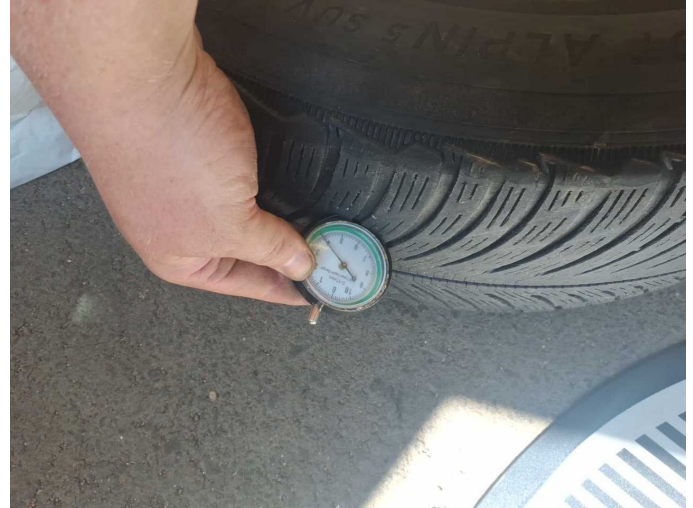
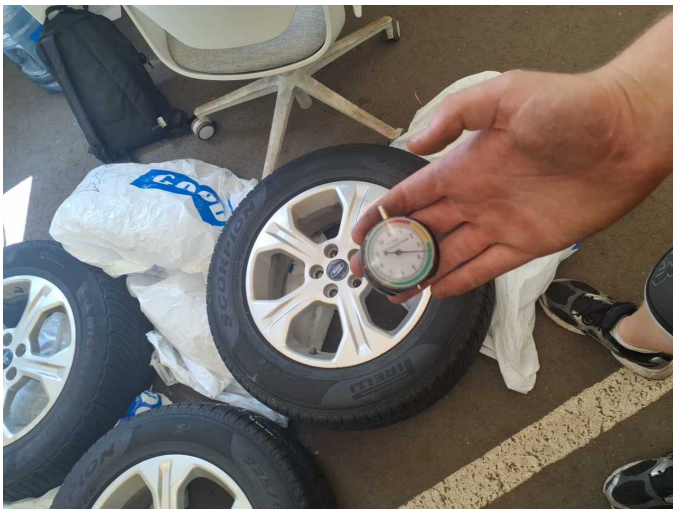
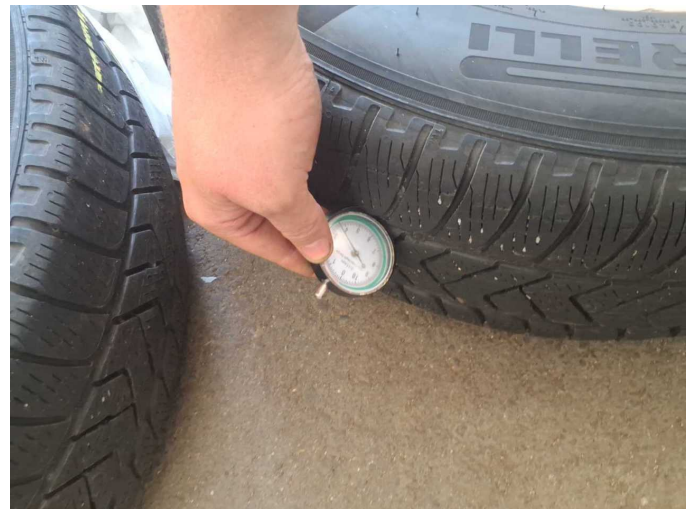
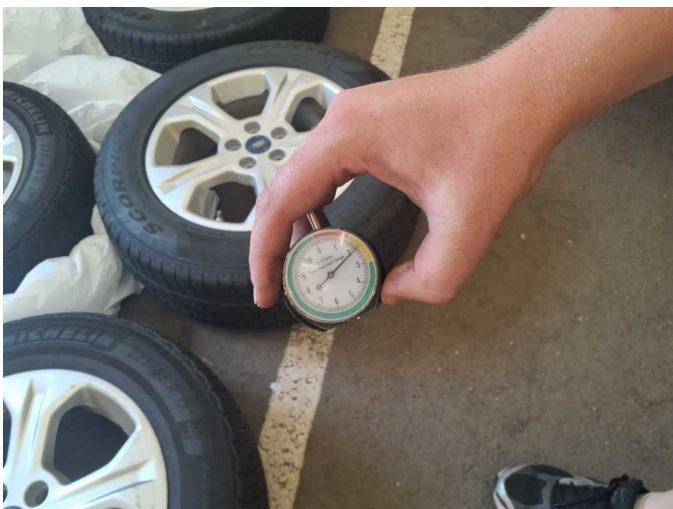
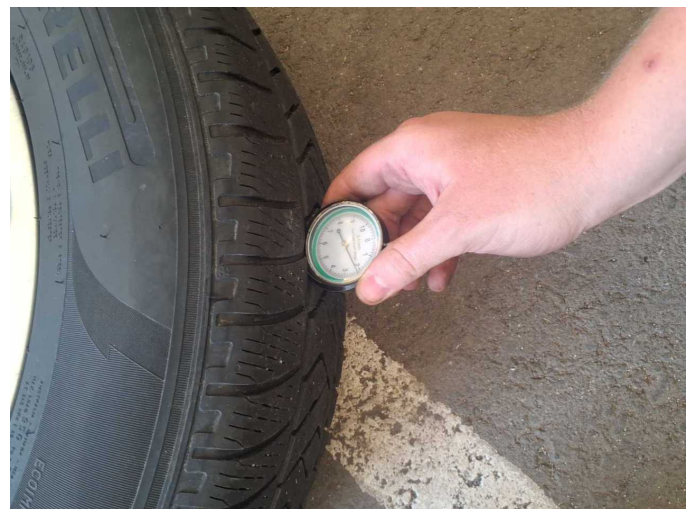
Damage 11: 2nd wheel set: Tyres - complete set - Does not meet the leasing specifications - Replace

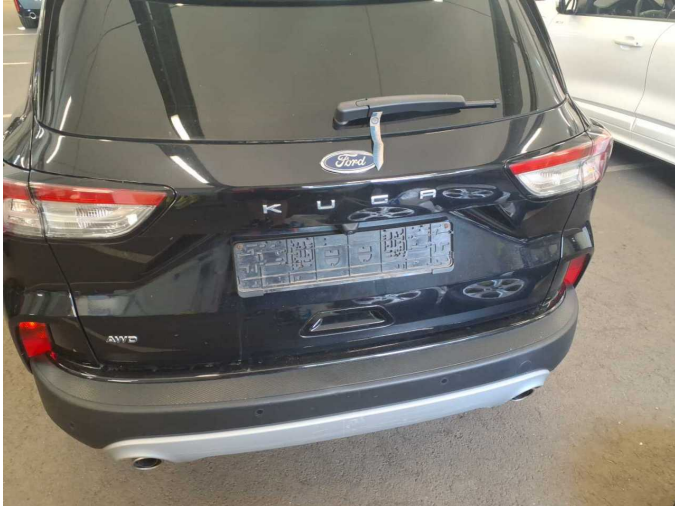
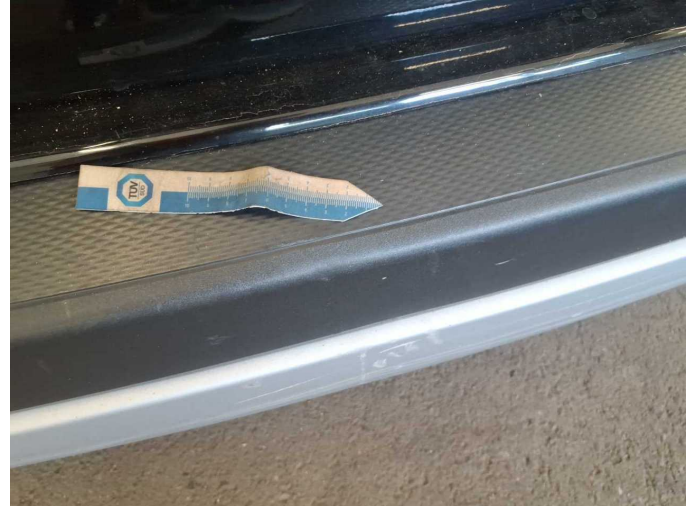
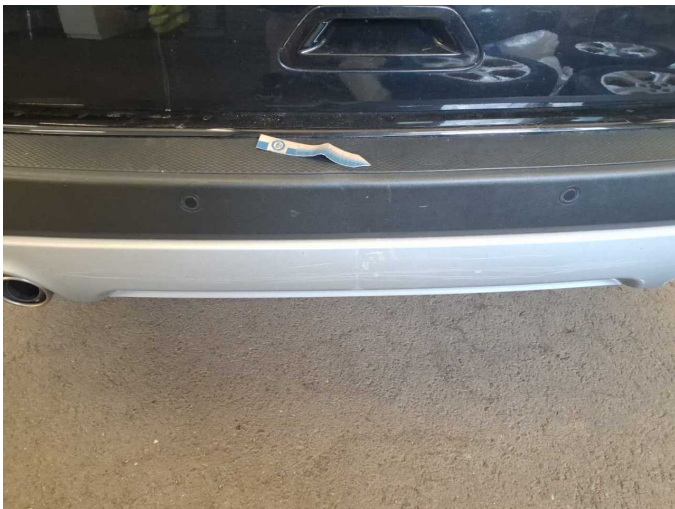
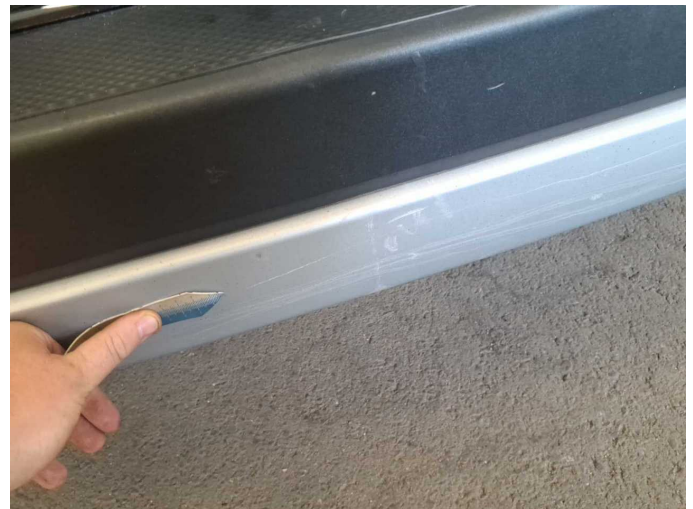
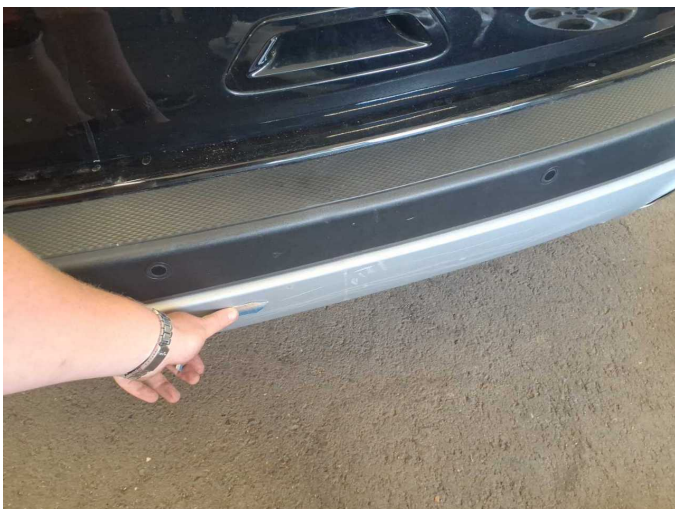
Damage 12: Rear bumper: Spoiler (inkl. Diffusor) - Scratched - Replace

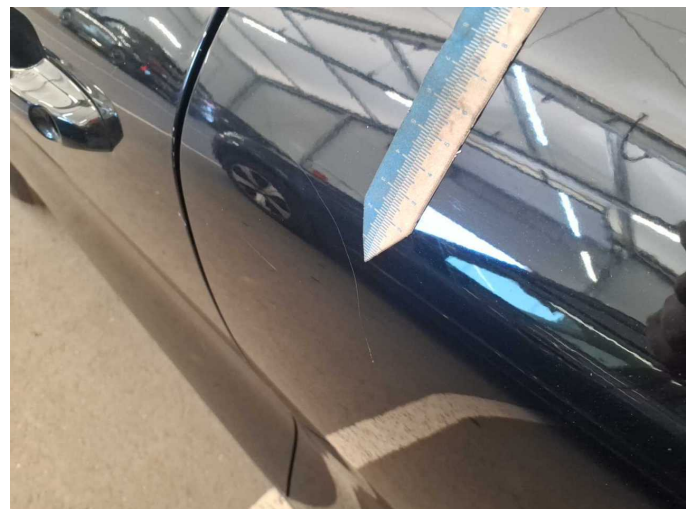
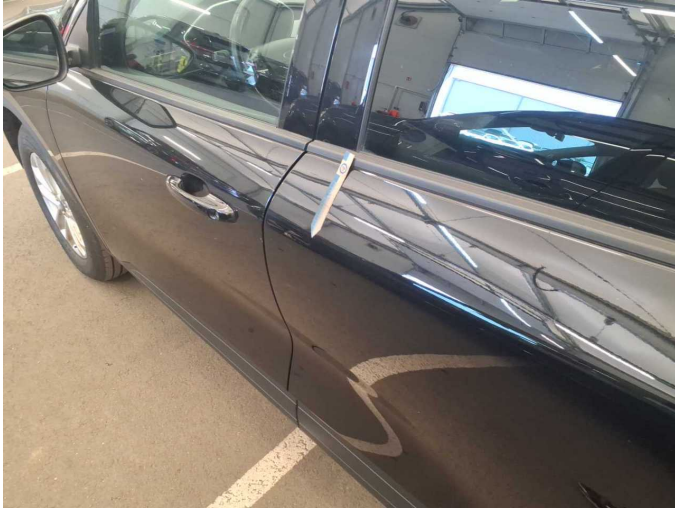
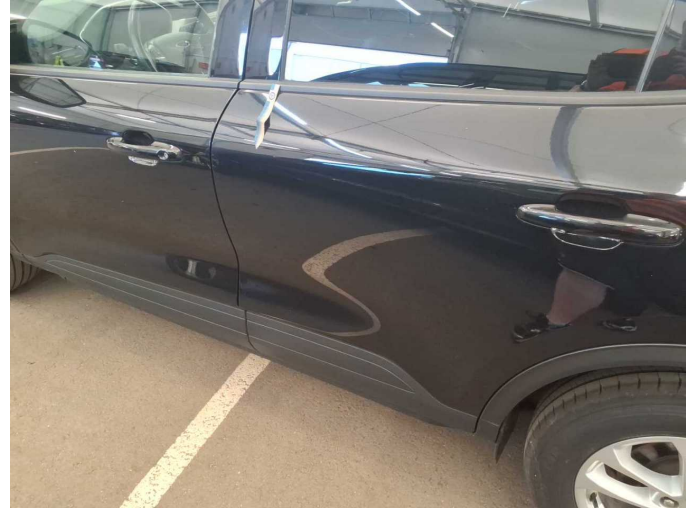
Damage 13: Door - rear left side: Door - Scratch(es) - Paint

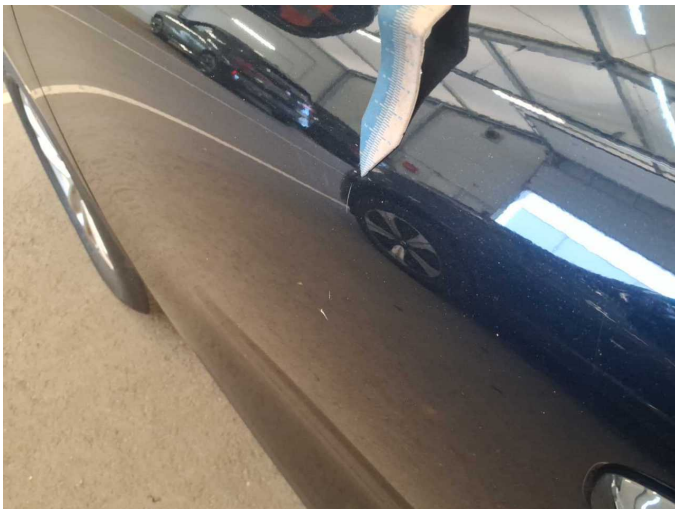
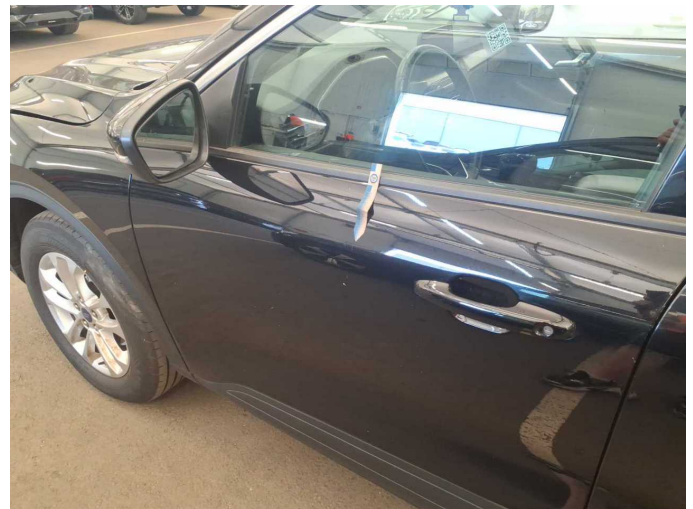
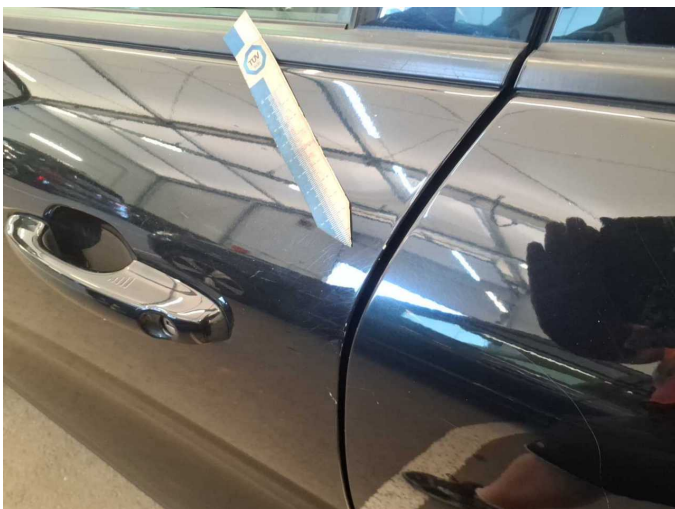
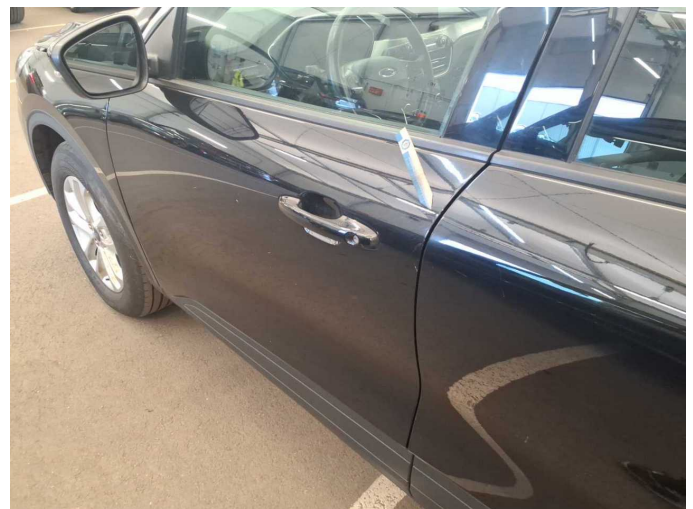
Damage 14: Door - front left side: Door - Scratch(es) - Paint

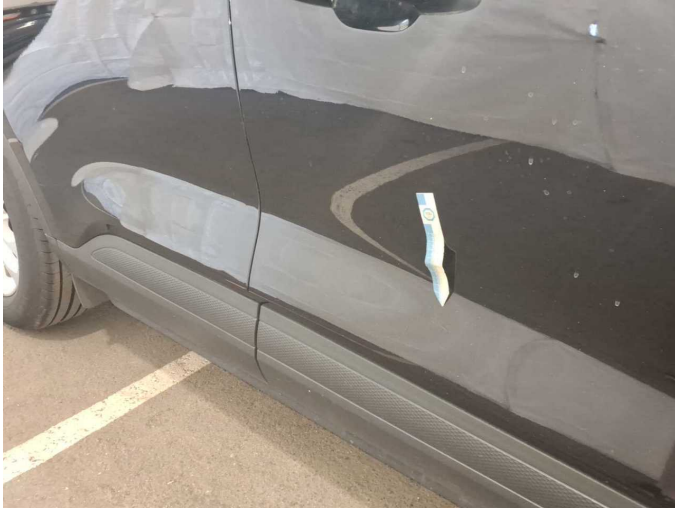
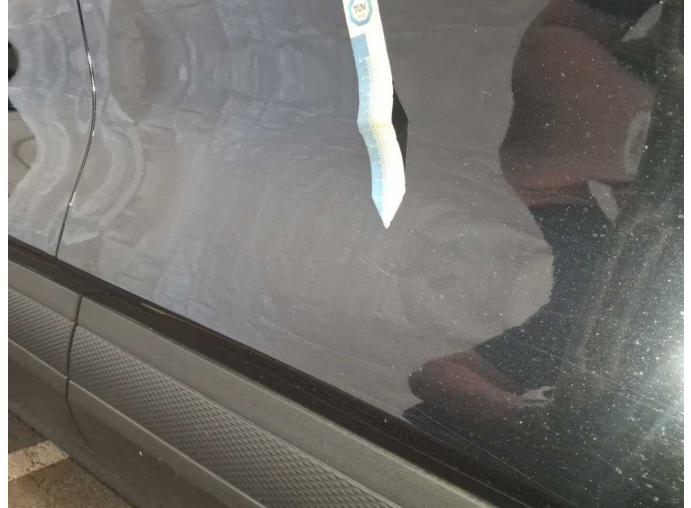
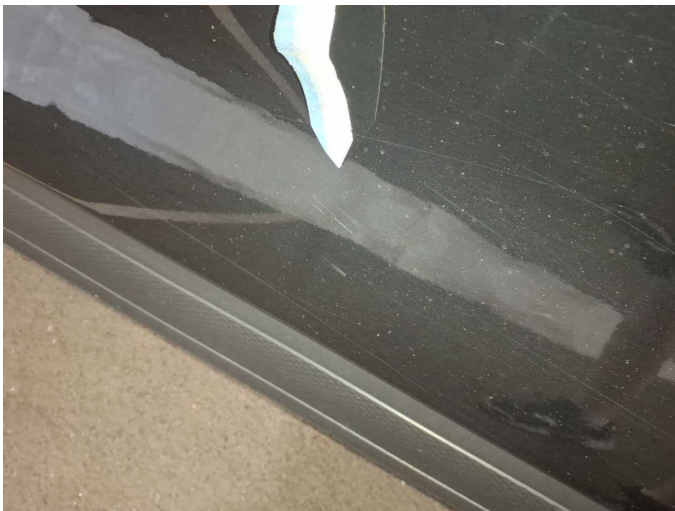
Damage 15: Door - front right side: Door - Scratch(es) - Paint

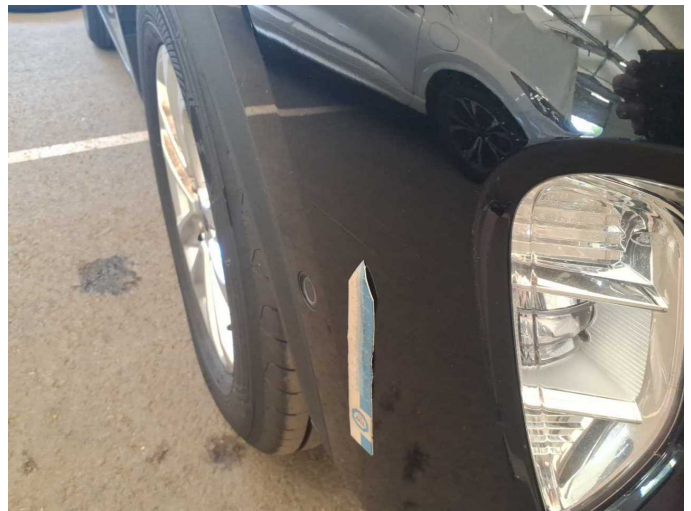
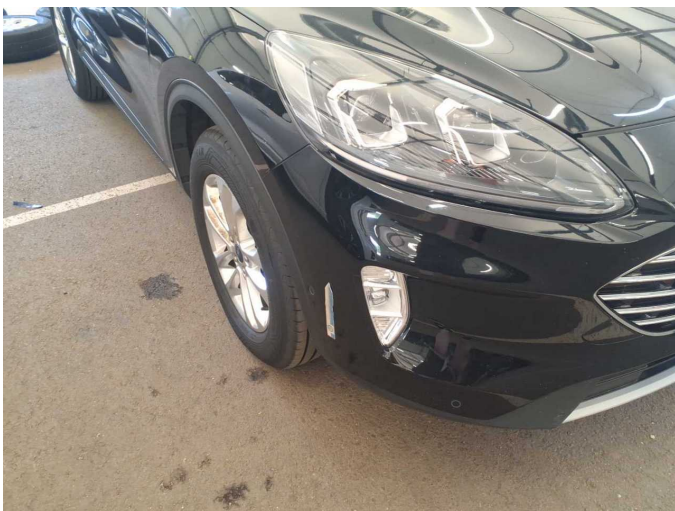
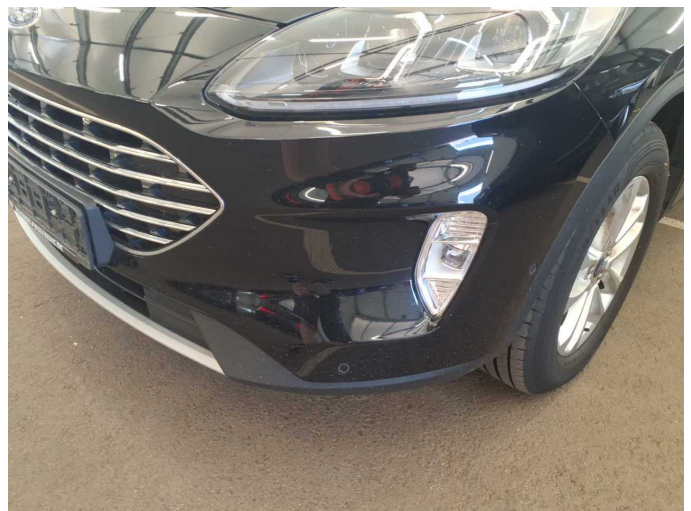
Damage 16: Front bumper: Front bumper - Scratch(es) - Paint

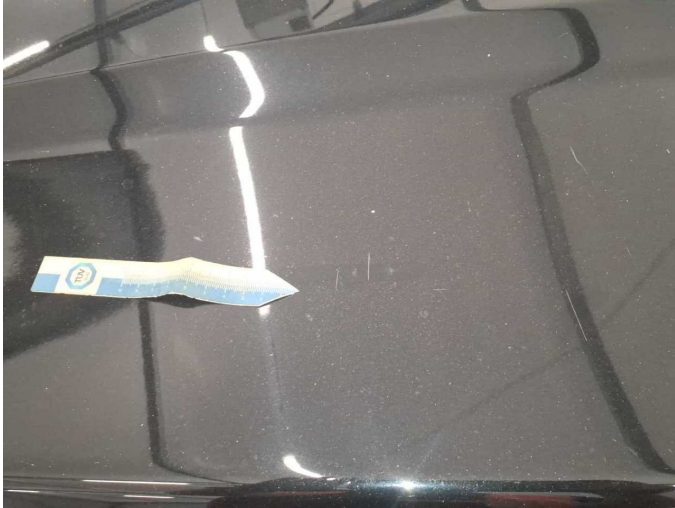
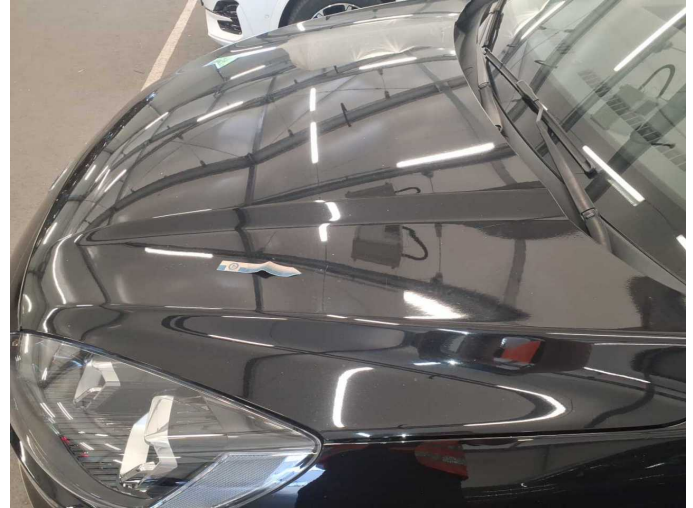
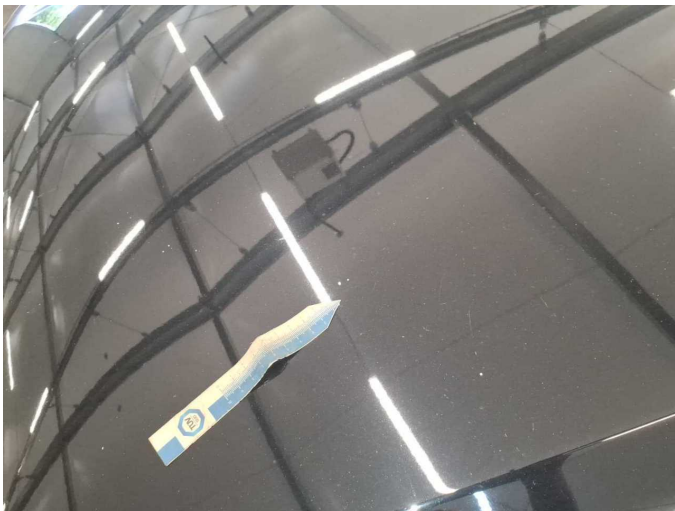
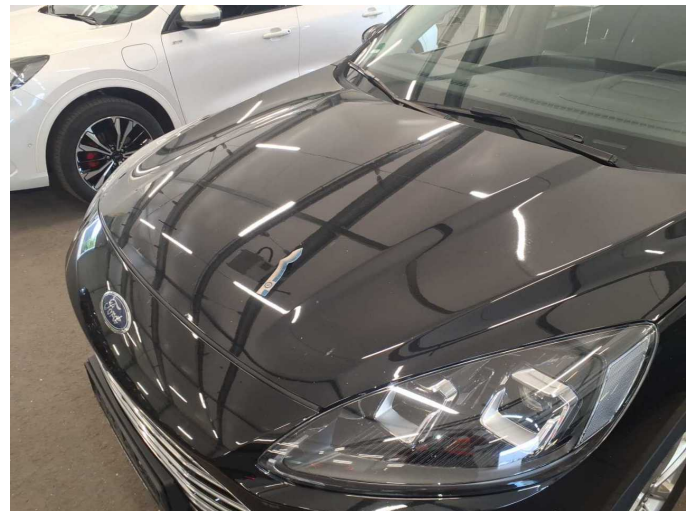
Damage 17: Bonnet: Bonnet - Scratched - Paint

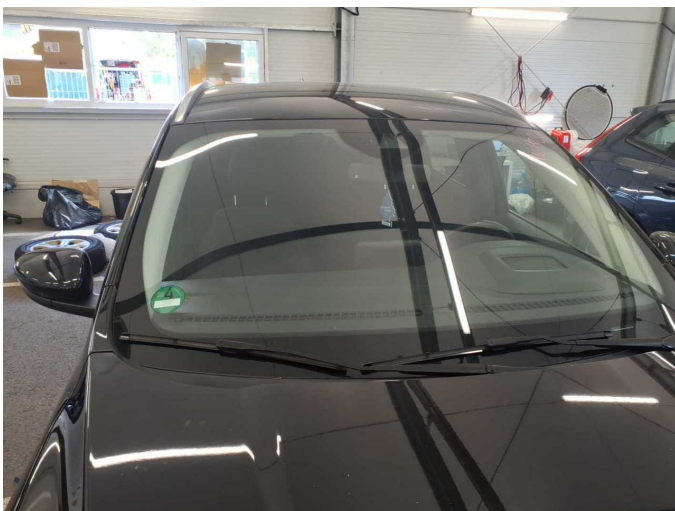
Wear and tear 2: Vehicle glazing: Windscreen - Stone chips - No deduction

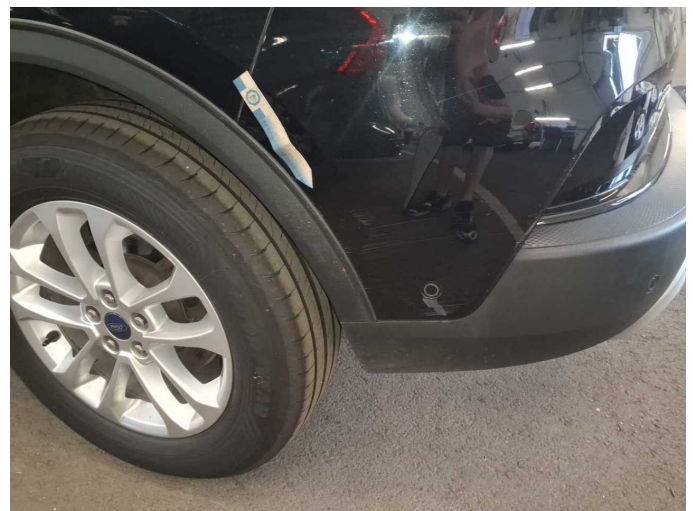
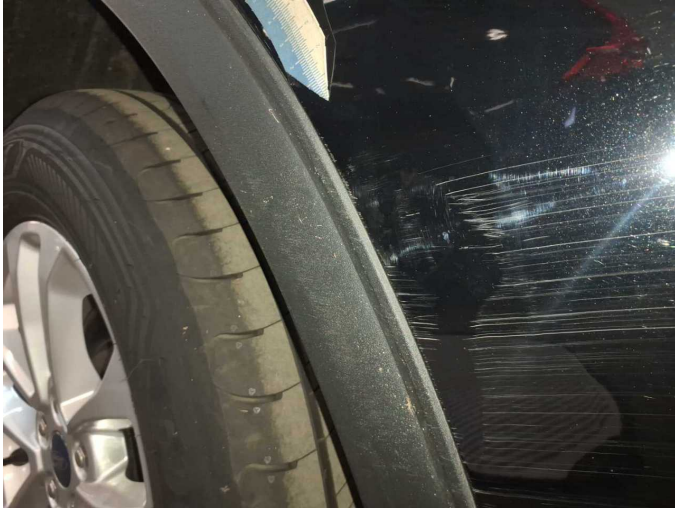
Wear and tear 3: Side panel - rear left side: Wheel arch - Scratch(es) - No deduction

Wear and tear 3: Side panel - rear left side: Wheel arch - Scratch(es) -
No deduction
