Expertise

Protocol number: 46518986  
Order No. / Reference: 26509848  
Inspection date: 14 Jul 2026

Manufacturer: Nissan

Model: Leaf 62 kWh e+ N-Connecta

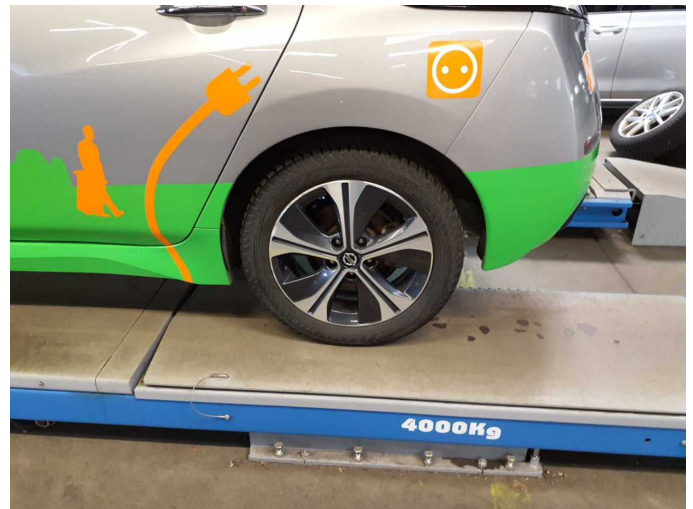
| No. | Component group | Description |
|---|---|---|
| 1 | Wheel / tyres | Alloy rim - rear left side - Paint defect - Loss in value |

**Damage 1:** Wheel / tyres: Alloy rim - rear left side - Paint defect - Loss in value

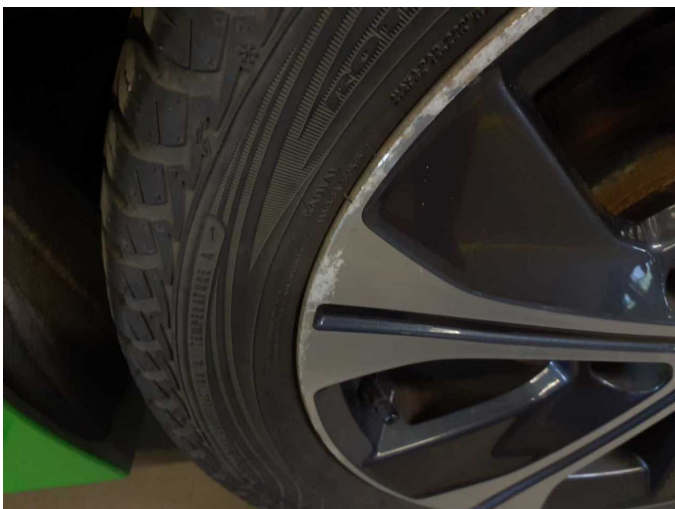
**Damage 1:** Wheel / tyres: Alloy rim - rear left side - Paint defect - Loss in value

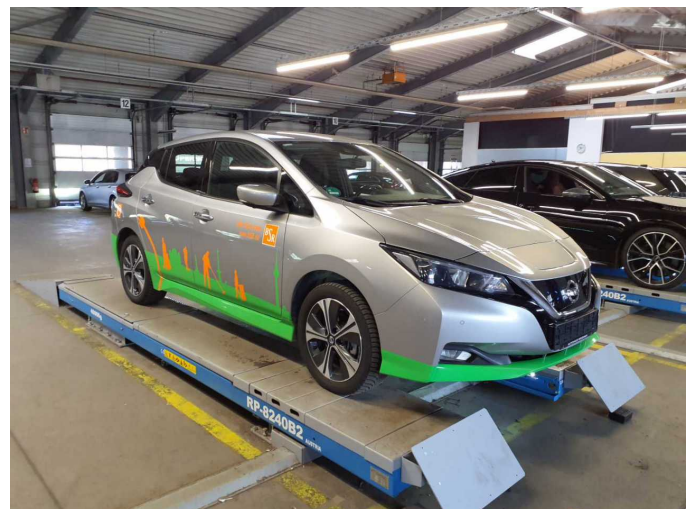
| No. | Component group | Description |
|---|---|---|
| 2 | Body | Body - Glued / labelled - De-glue / neutralise |

**Damage 2:** Body: Body - Glued / labelled - De-glue / neutralise

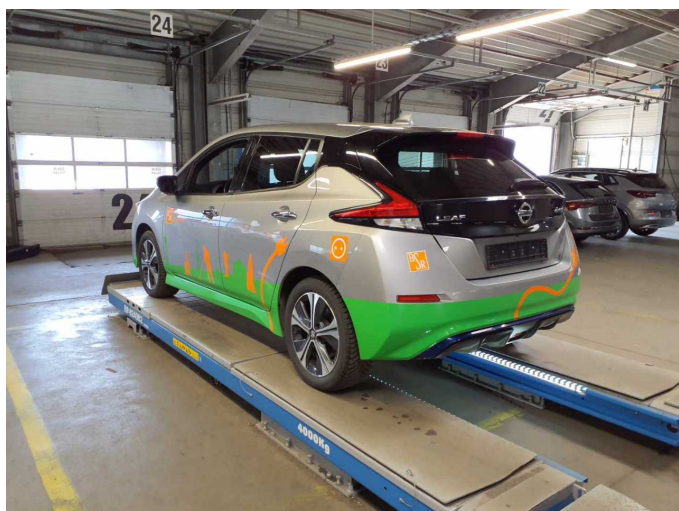
**Damage 2:** Body: Body - Glued / labelled - De-glue / neutralise

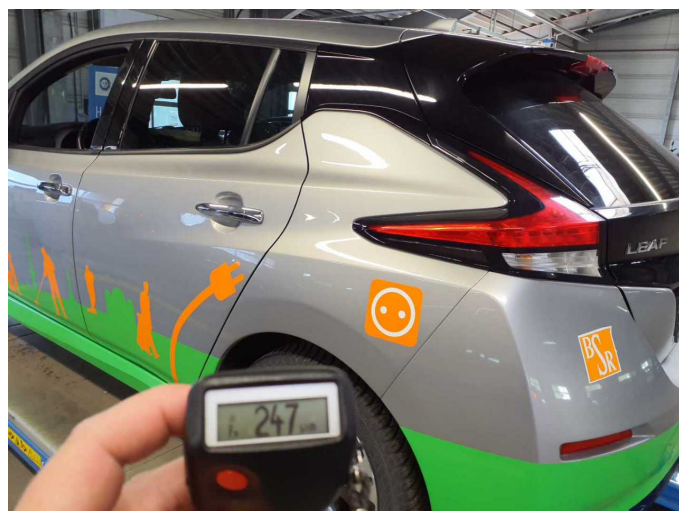
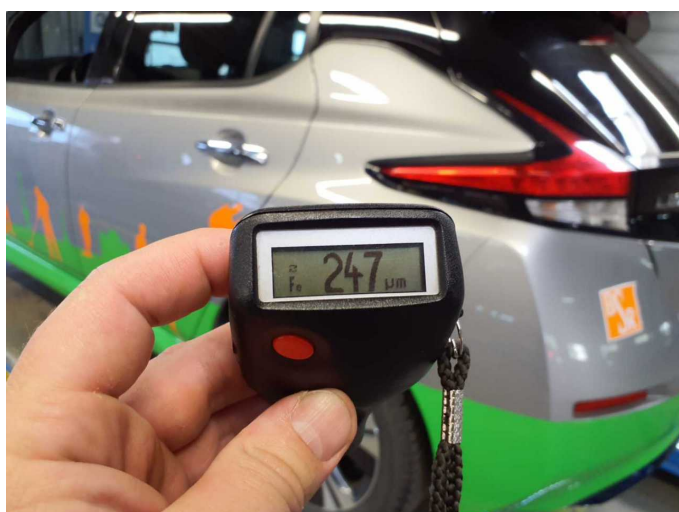
| Side panel - rear left side | 247 µm | Door - rear left side | 288 µm |

**Repainting 1:** Side panel - rear left side

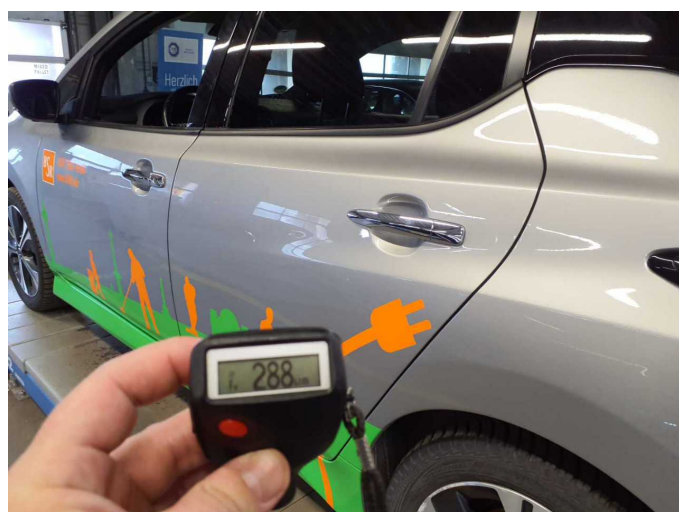
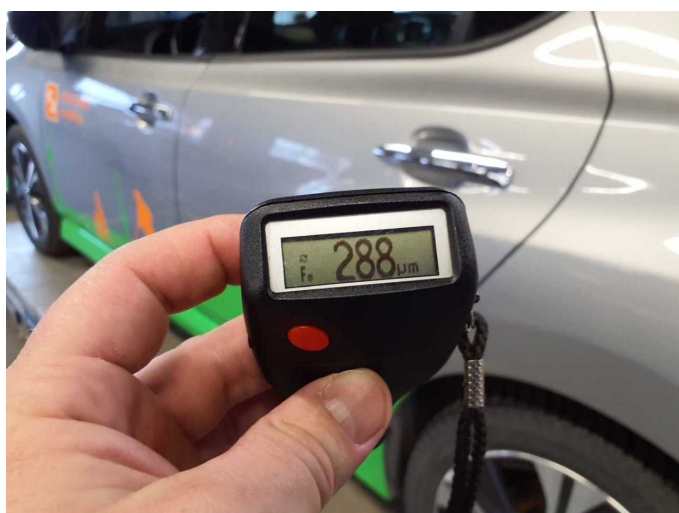
**Repainting 2:** Door - rear left side

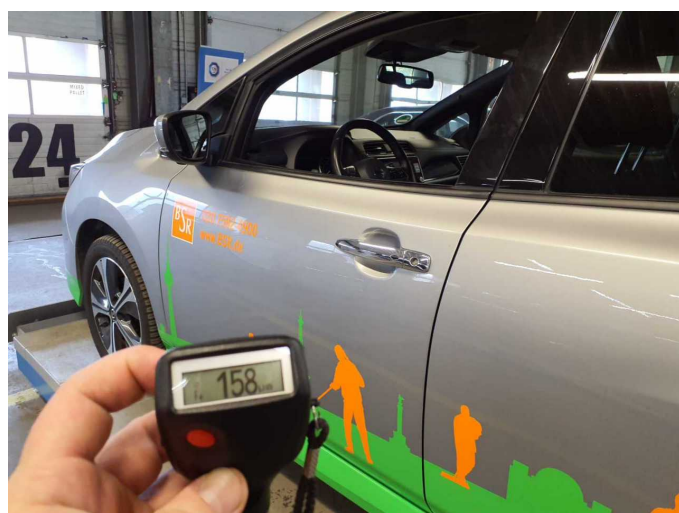
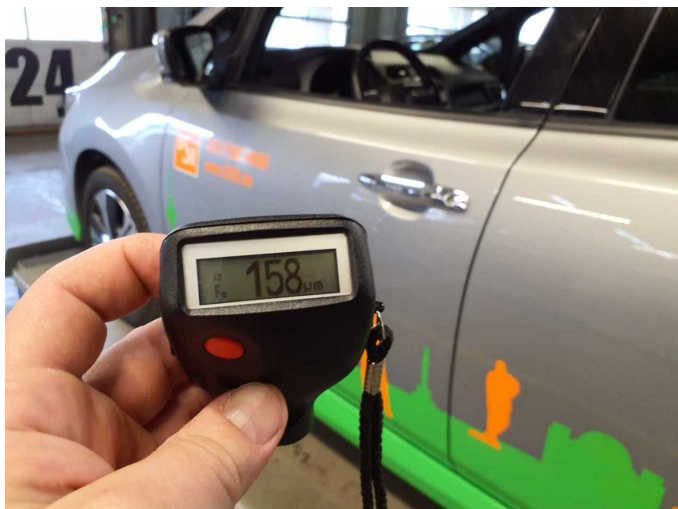
| Door - front left side | 158 µm | | |

**Repainting 3:** Door - front left side
