Expertise

Protocol number: 45472151
Order No. / Reference: 26379956
Inspection date: 12 May 2026

Manufacturer: Opel

Model: Astra Sports Tourer 1.5 D Automatik Business Elegance

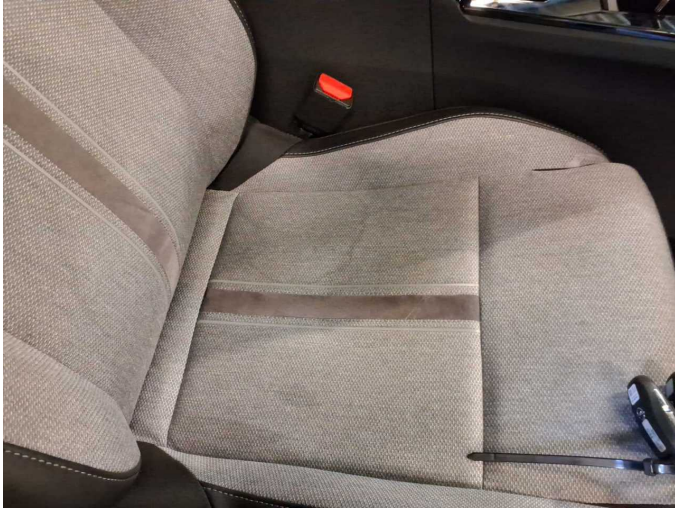
Damage 3: Seat - front: Seat cover - right side - Soiled - Clean

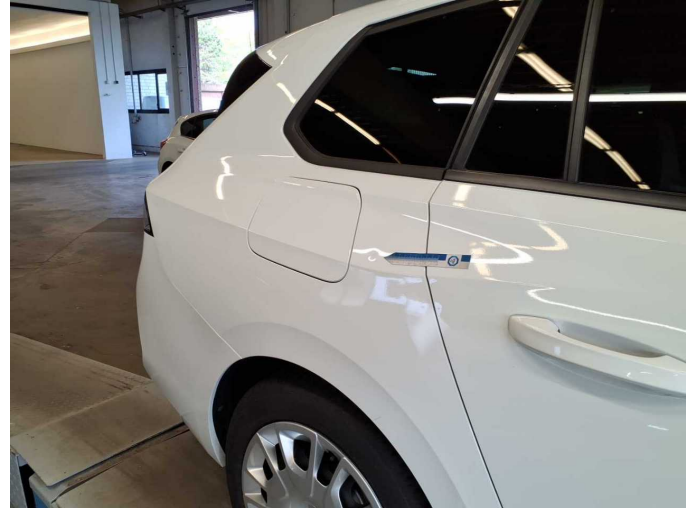
Damage 4: Side panel - rear right side: Side panel - Dent / paintcoat damage - Smart repair

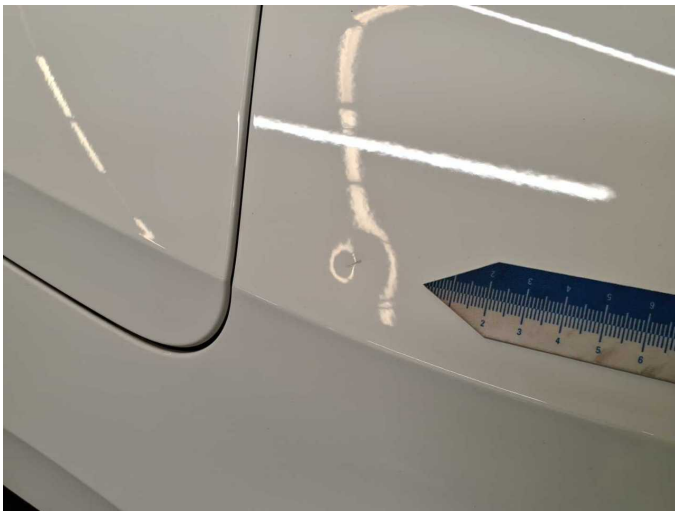
Damage 4: Side panel - rear right side: Side panel - Dent / paintcoat damage - Smart repair

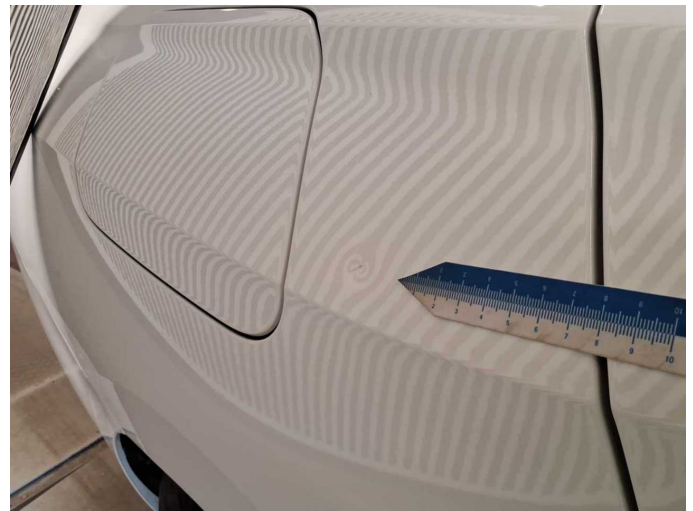
Damage 4: Side panel - rear right side: Side panel - Dent / paintcoat damage - Smart repair

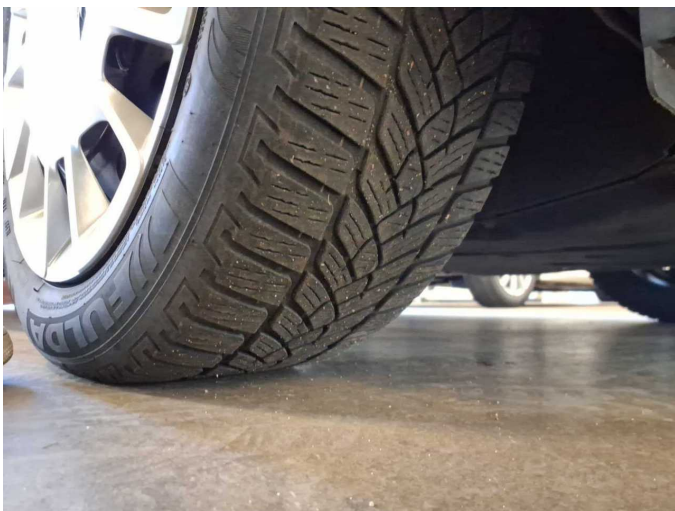
Damage 5: Wheel / tyres: Tyre - front (4mm) - Does not meet the leasing specifications - Replace

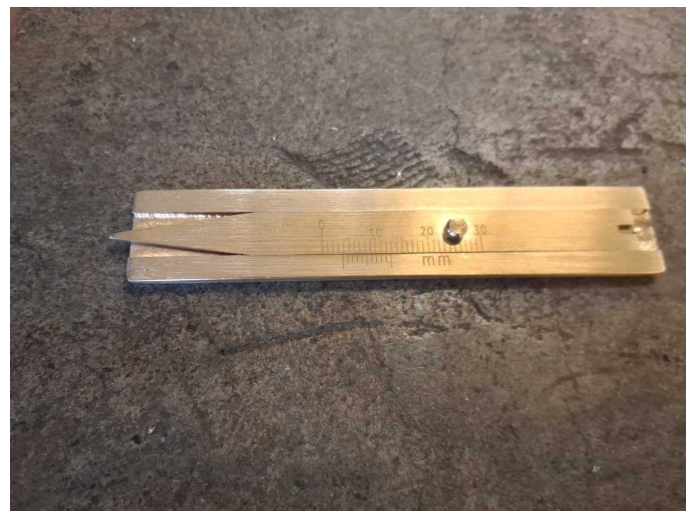
Damage 5: Wheel / tyres: Tyre - front (4mm) - Does not meet the leasing specifications - Replace

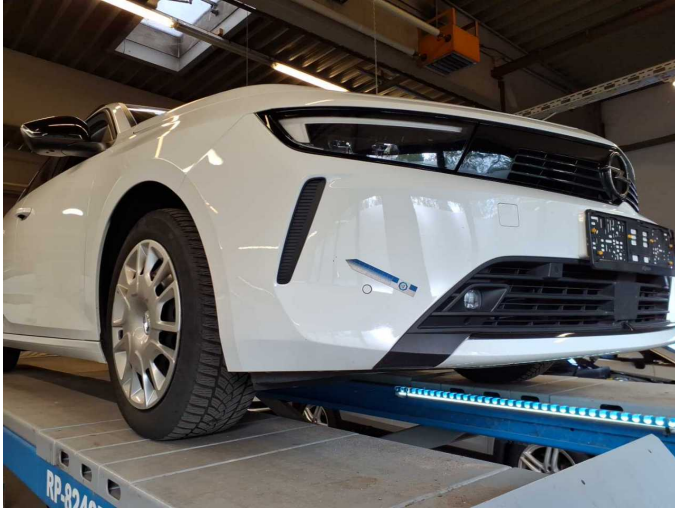
Damage 6: Front bumper: Front bumper - Scratch(es) - Paint

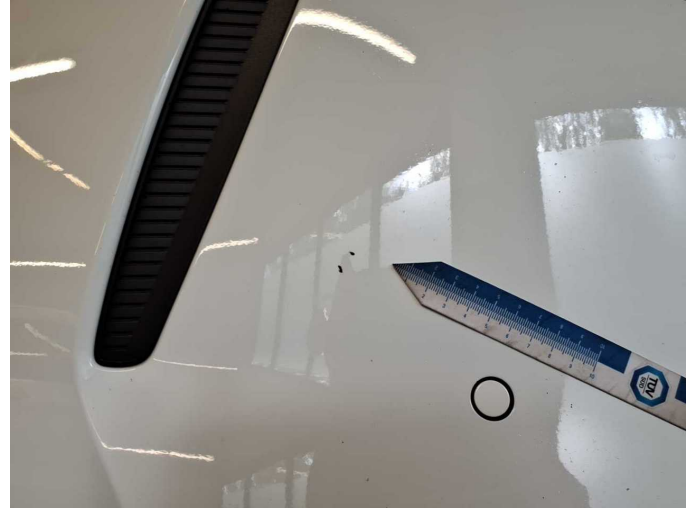
Damage 6: Front bumper: Front bumper - Scratch(es) - Paint

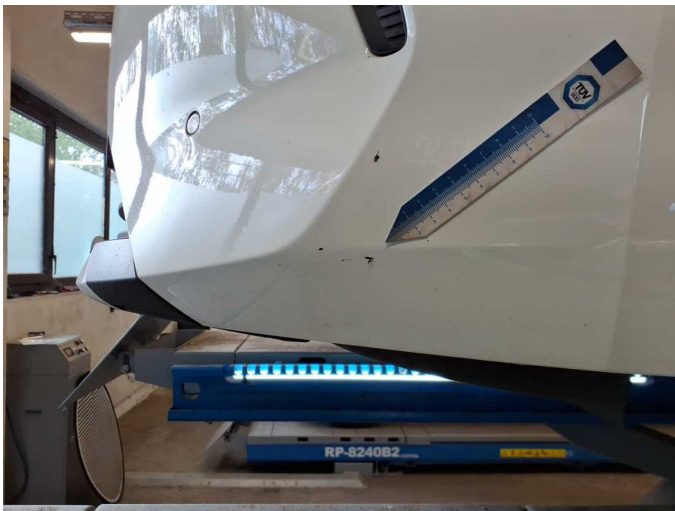
Damage 6: Front bumper: Front bumper - Scratch(es) - Paint

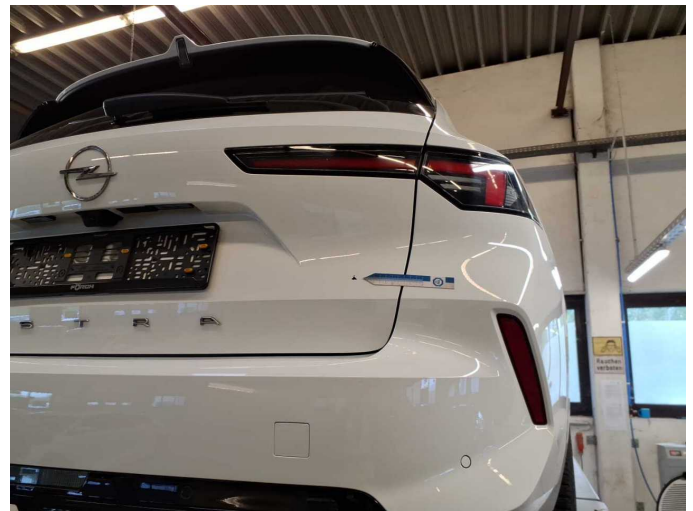
Damage 7: Boot lid / rear door: Boot lid - Scratch(es) - Paint

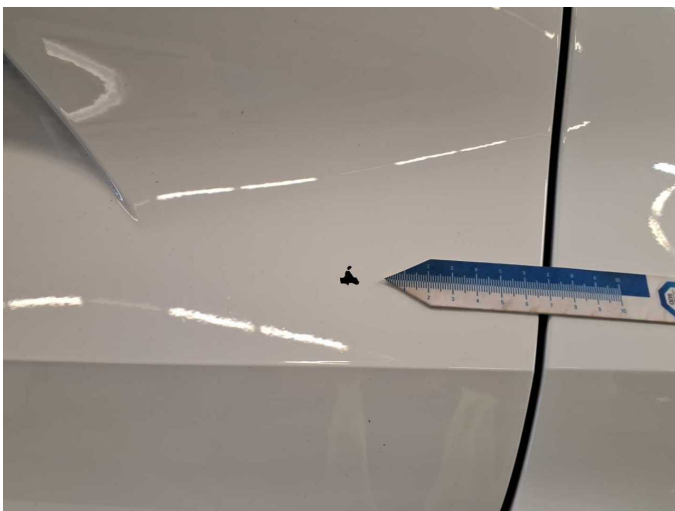
Damage 7: Boot lid / rear door: Boot lid - Scratch(es) - Paint
