## Expertise

Protocol number: 45918606  
Order No. / Reference: 26406423  
Inspection date: 10 Jun 2026

Manufacturer: Skoda

Model: Kodiaq 2.0 TDI DSG Ambition

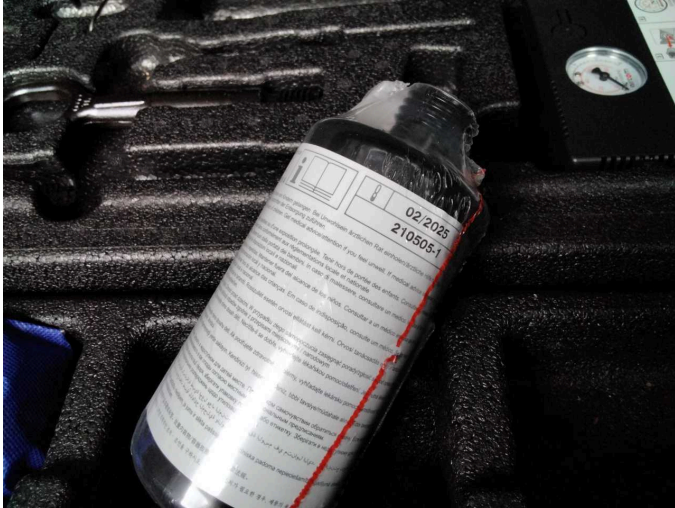
**Damage 1:** Equipment: Tirefit filler - Expired - Replace

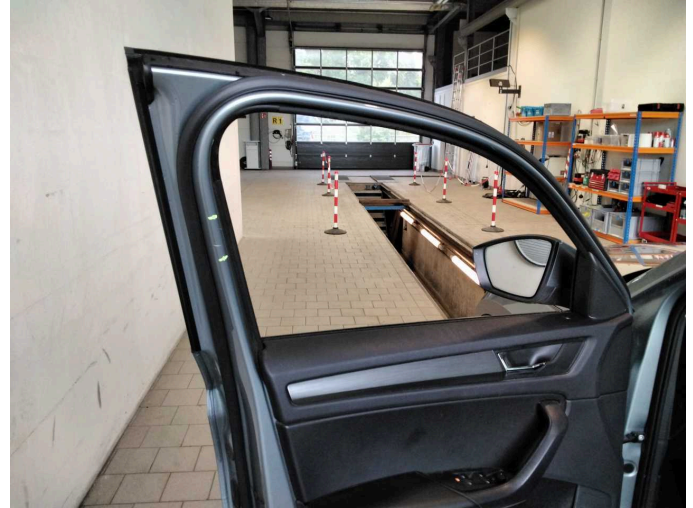
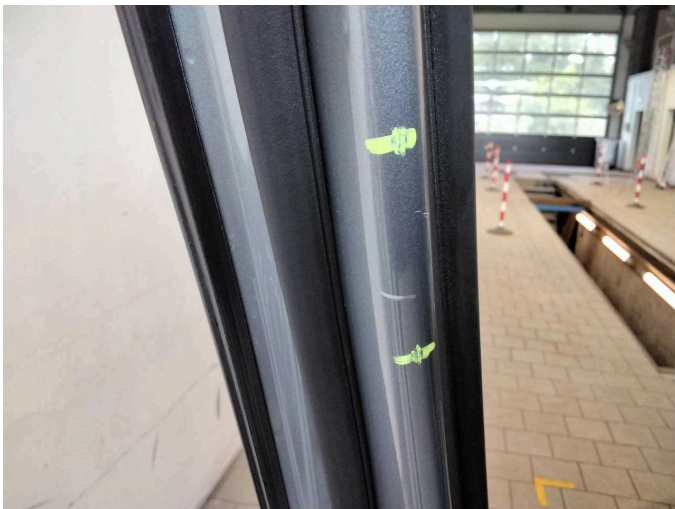
**Damage 2:** Door - front left side: Door (Innen) - Scratch(es) - Smart repair

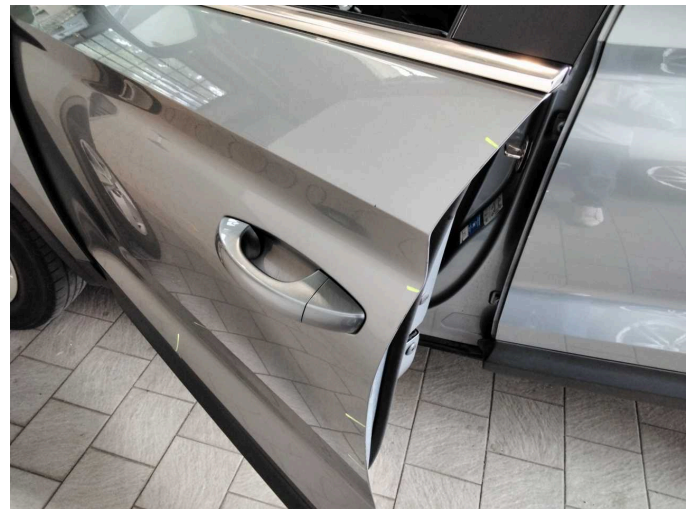
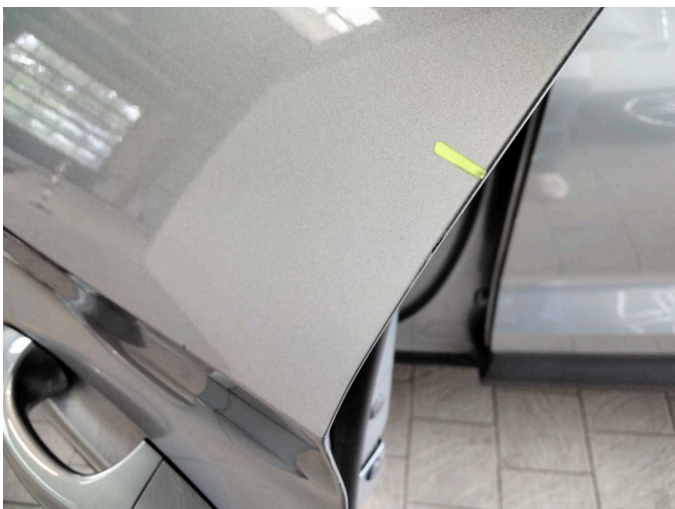
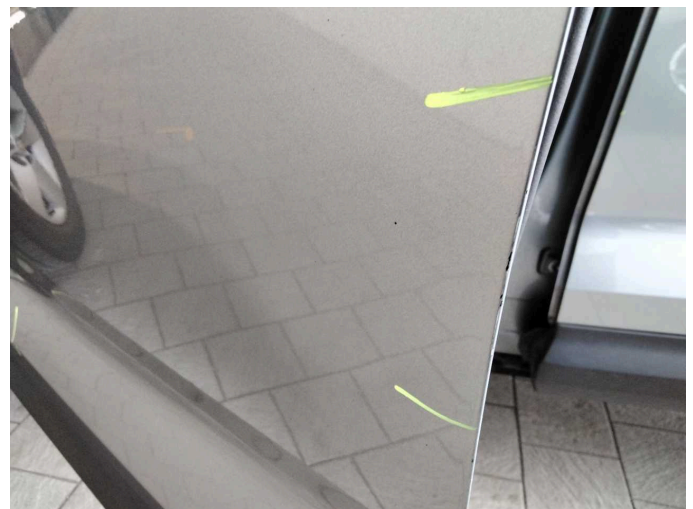
**Damage 3:** Door - front left side: Door edge - Scratch(es) - Smart repair

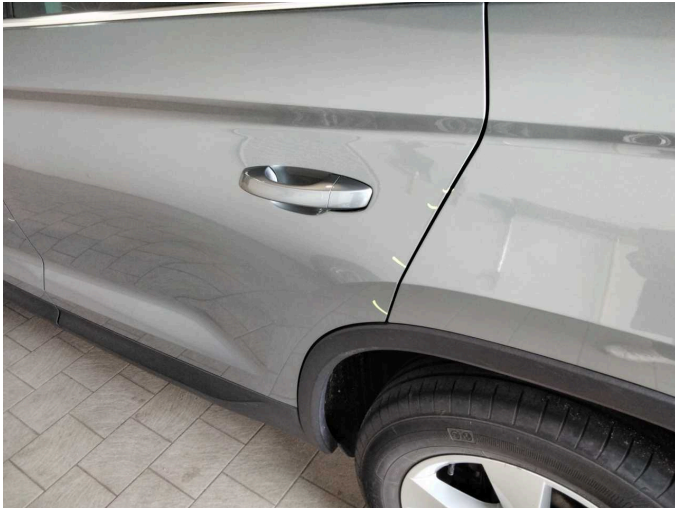
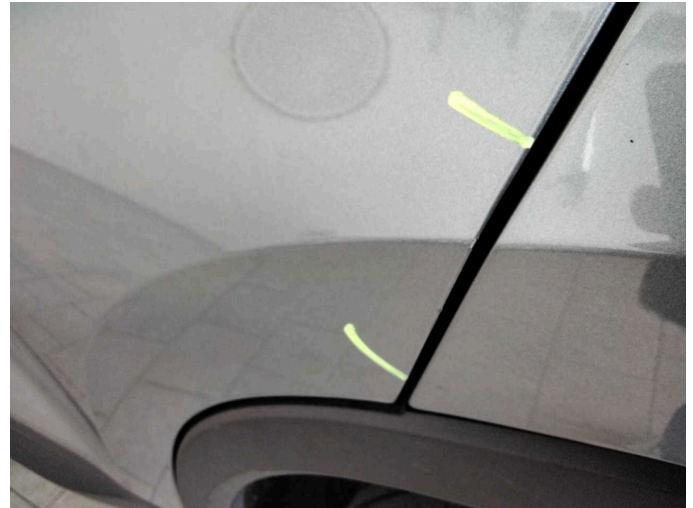
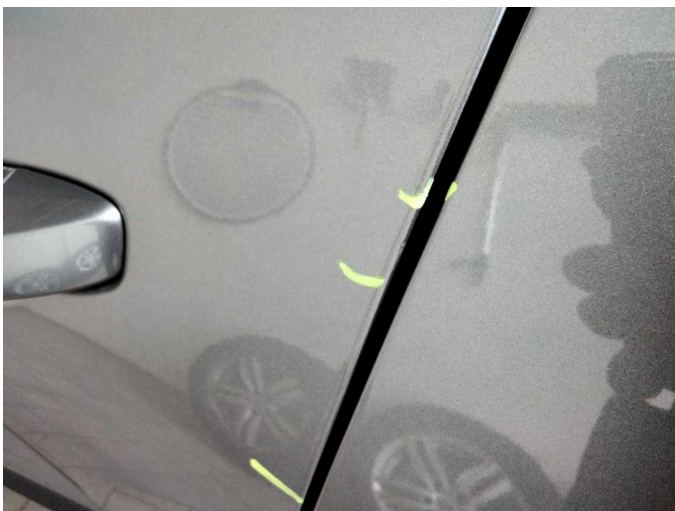
**Damage 4:** Door - rear left side: Door edge - Scratch(es) - Smart repair

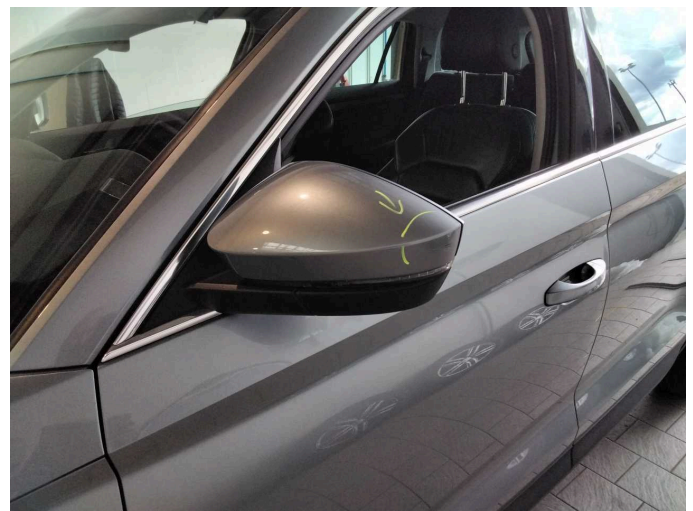
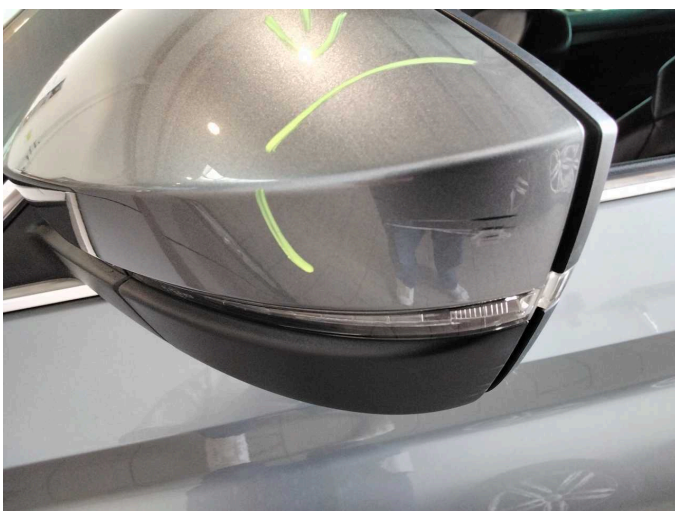
**Damage 5:** Wing mirror - left side: Cap - Scratch(es) - Smart repair

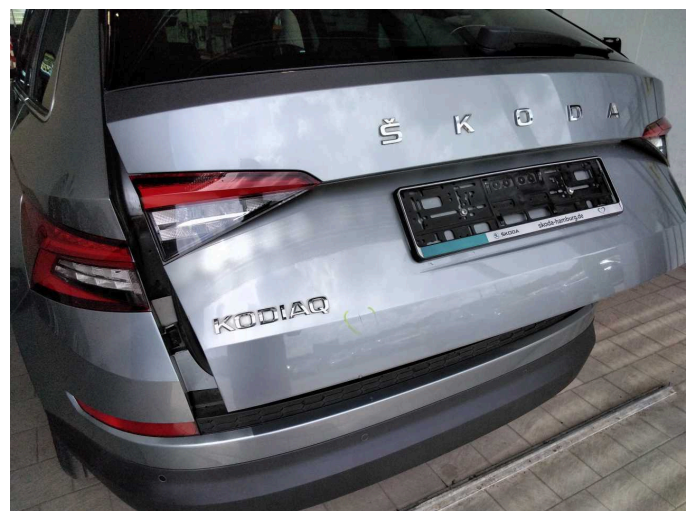
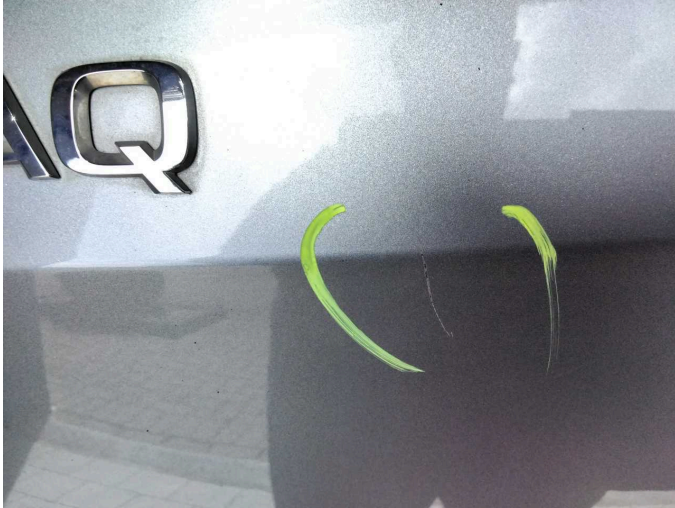
**Damage 6:** Boot lid / rear door: Boot lid - Scratch(es) - Smart repair

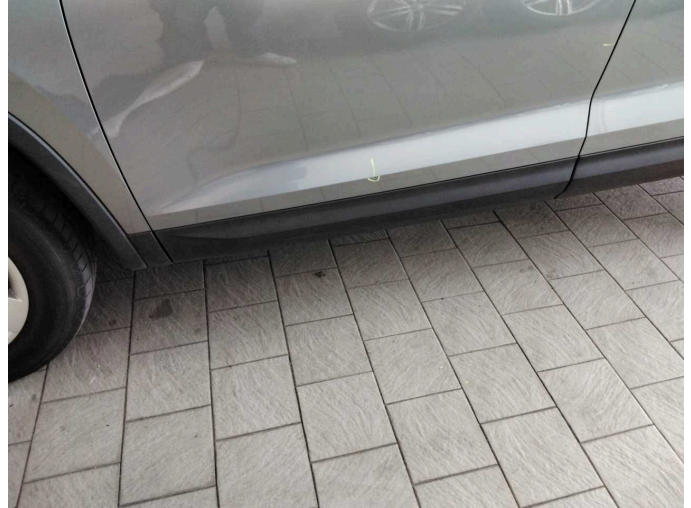
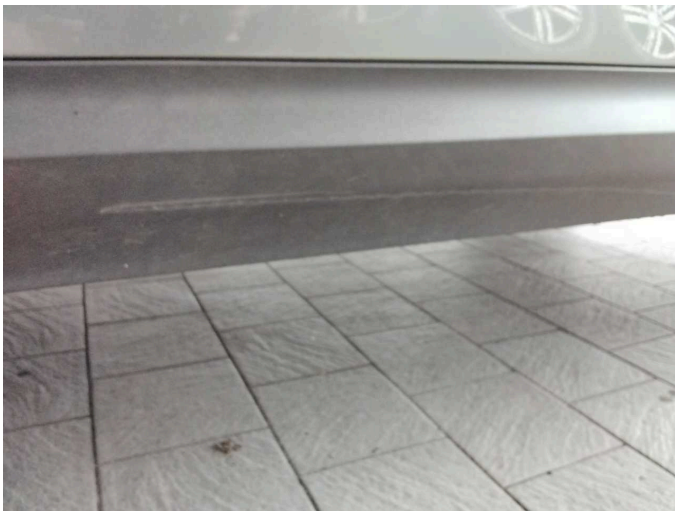
**Damage 7:** Door - front left side: Brightware - lower - Scratch(es) - Smart repair

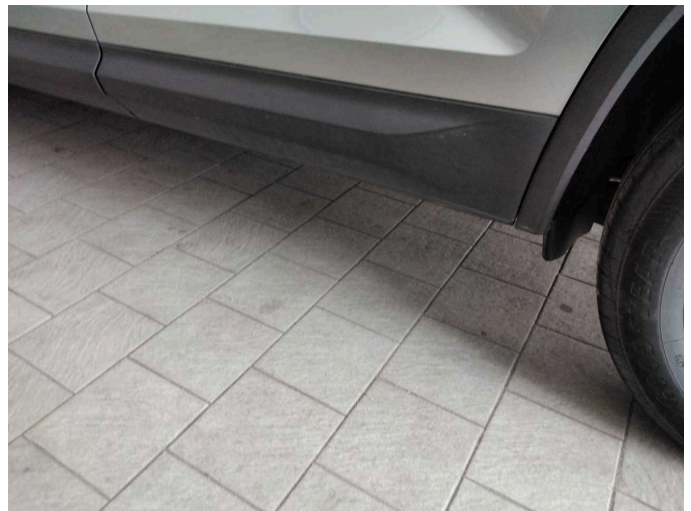
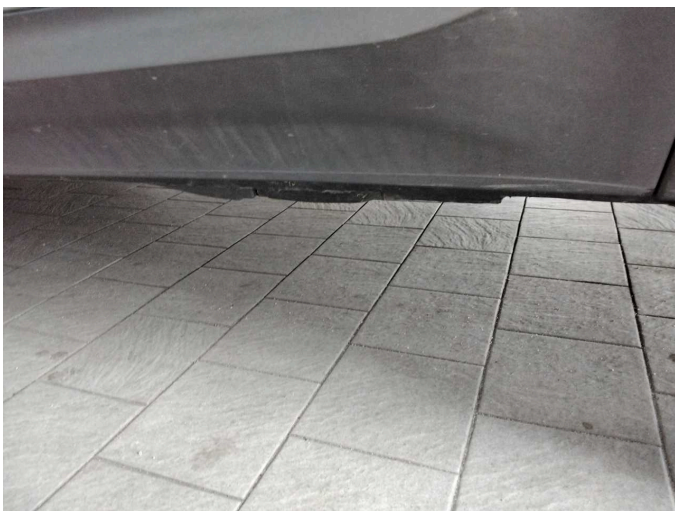
**Damage 8:** Door - rear left side: Brightware - lower - Scratch(es) - Smart repair

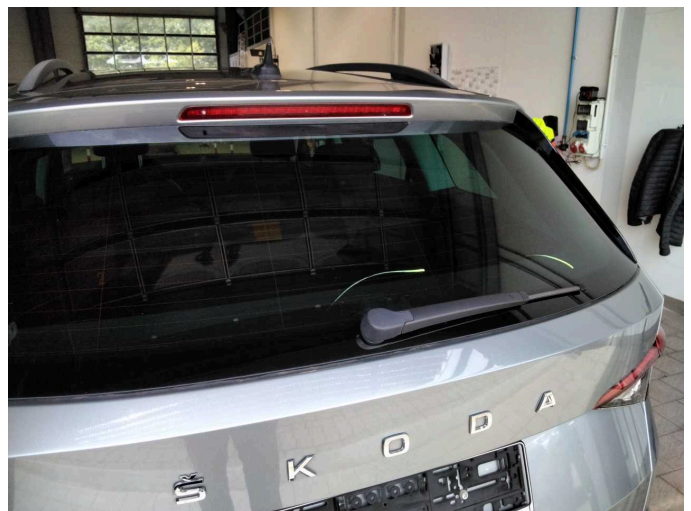
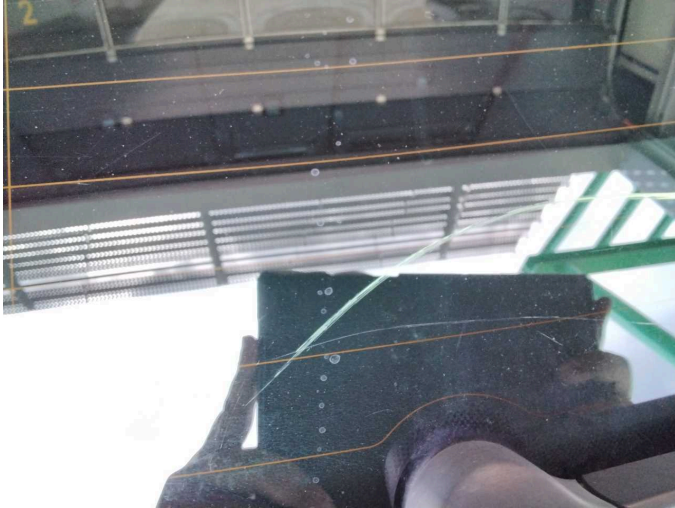
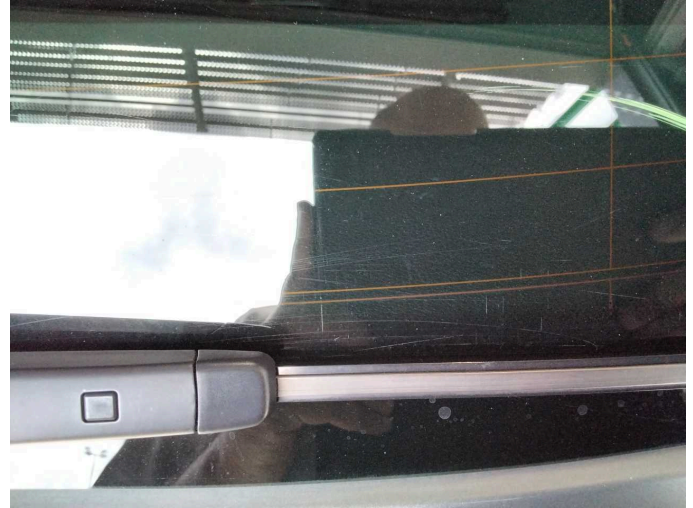
**Damage 9:** Vehicle glazing: Rear window - Scratch(es) - Loss in value

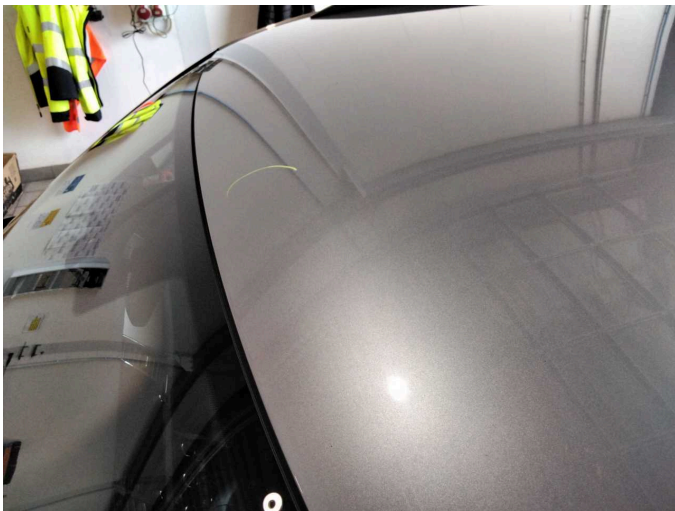
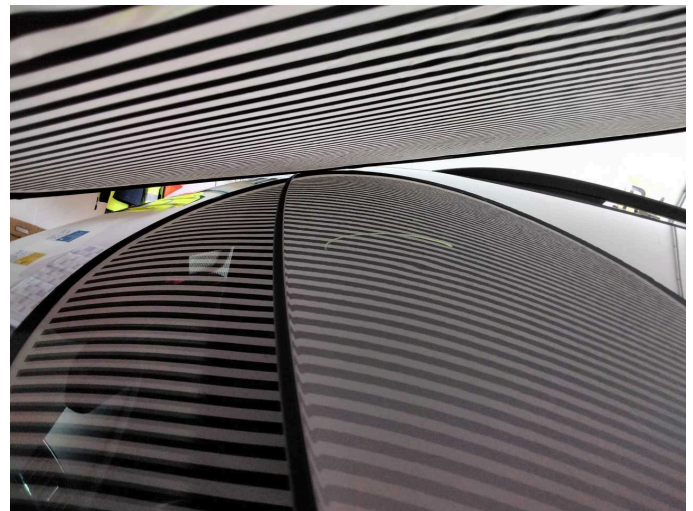
**Wear and tear 1:** Roof: Roof - dent(s) - No deduction

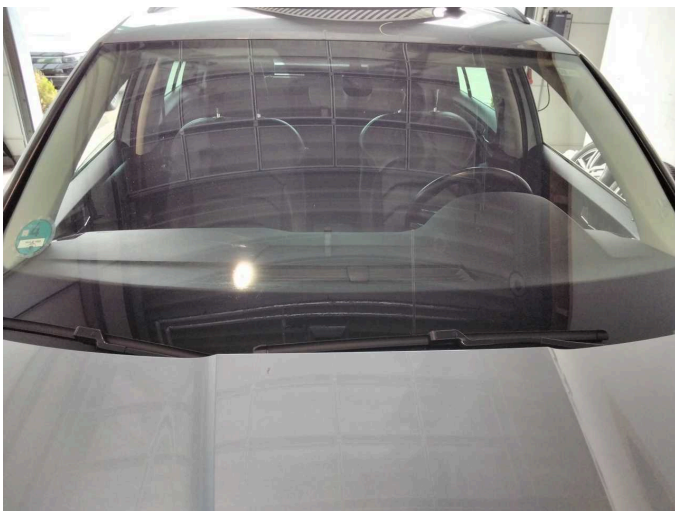
**Wear and tear 2:** Vehicle glazing: Windscreen - Stone chips - No deduction

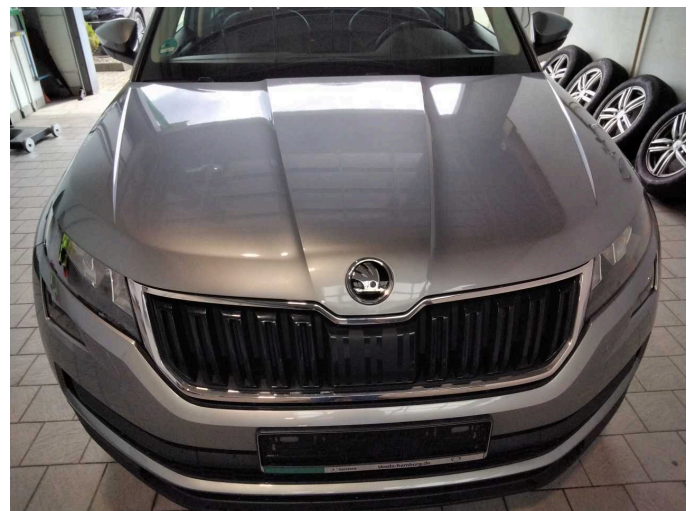
**Wear and tear 3:** Bonnet: Bonnet - Stone chips - No deduction

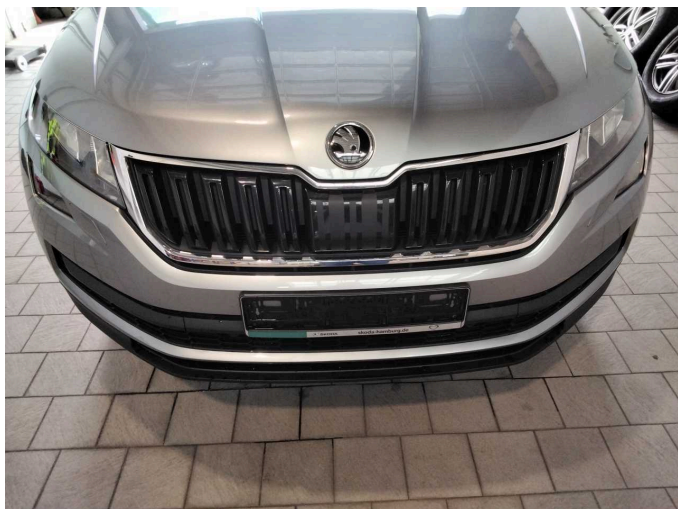
**Wear and tear 4:** Front bumper: Front bumper - Stone chips - No deduction

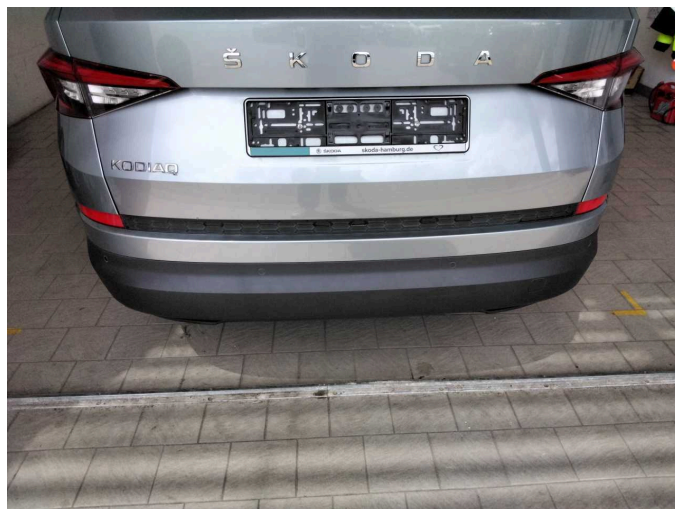
**Wear and tear 5:** Rear bumper: Rear bumper - Scratch(es) - No deduction
