Expertise

Protocol number: 46512508  
Order No. / Reference: 26029335  
Inspection date: 13 Jul 2026

Model: Vito 116 CDI Tourer Lang Aut. SELECT

VIN: W1VVLFEZXT4546222

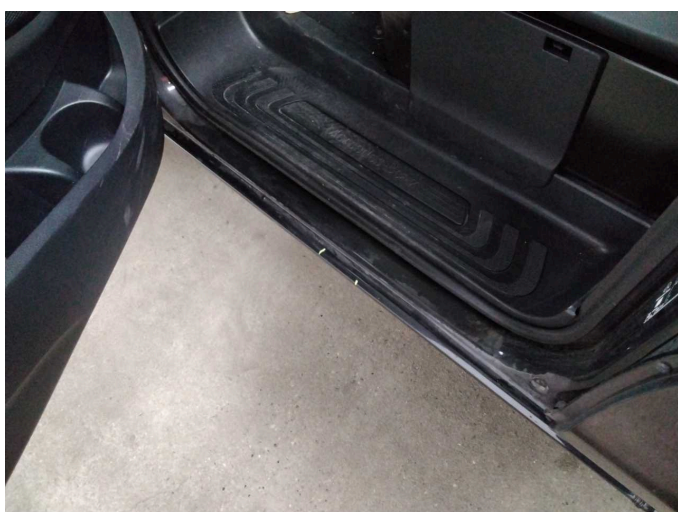
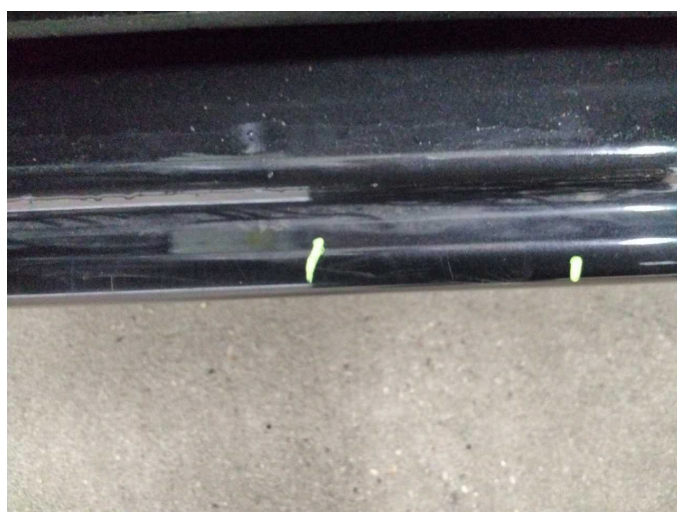
| No. | Component group | Description |
|---|---|---|
| 1 | Sill - left side | Sill - Scratch(es) - Smart repair |

**Damage 1:** Sill - left side: Sill - Scratch(es) - Smart repair

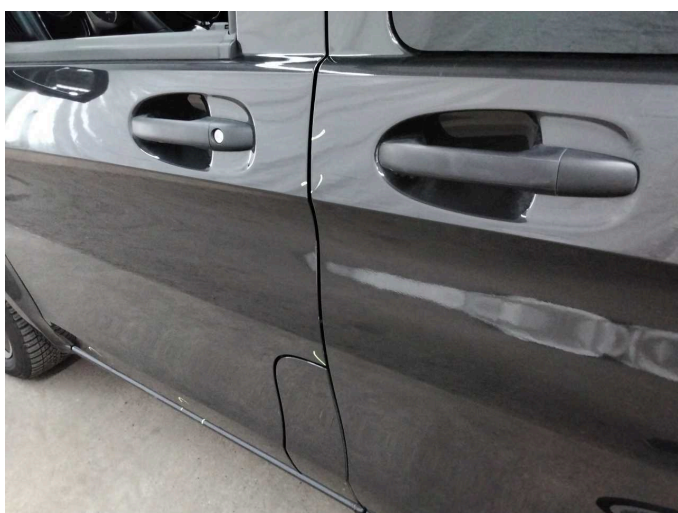
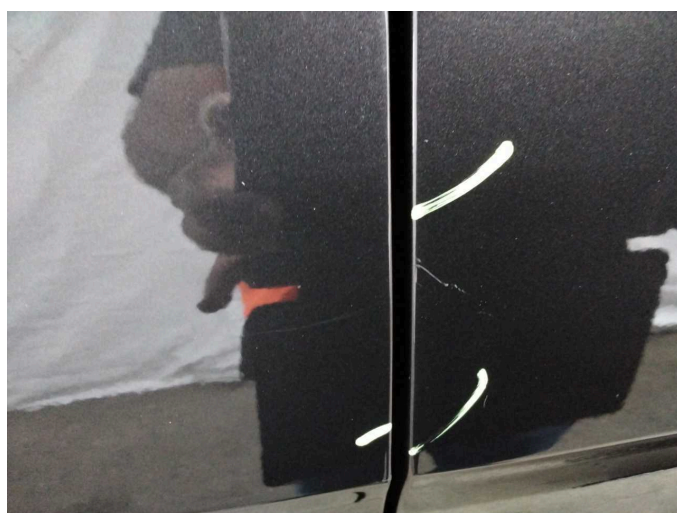
| No. | Component group | Description |
|---|---|---|
| 2 | Sliding door - left side | Sliding door with glass panel - Scratch(es) - Smart repair |

**Damage 2:** Sliding door - left side: Sliding door with glass panel - Scratch(es) - Smart repair

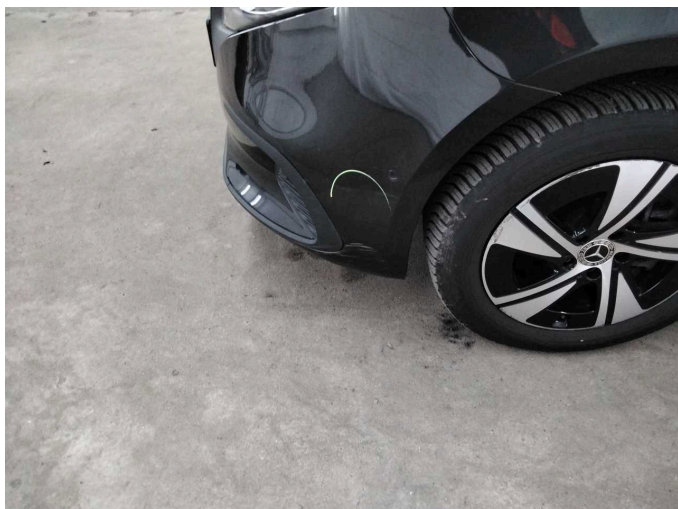
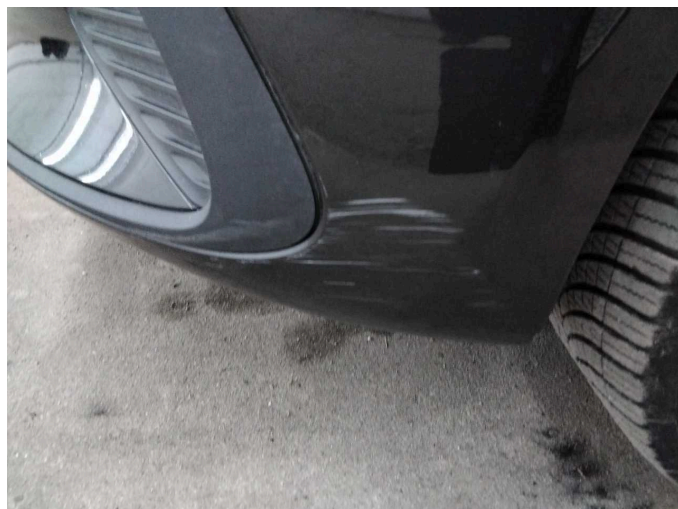
| No. | Component group | Description |
|---|---|---|
| 3 | Front bumper | Front bumper - Scratch(es) - Smart repair |

**Damage 3:** Front bumper: Front bumper - Scratch(es) - Smart repair

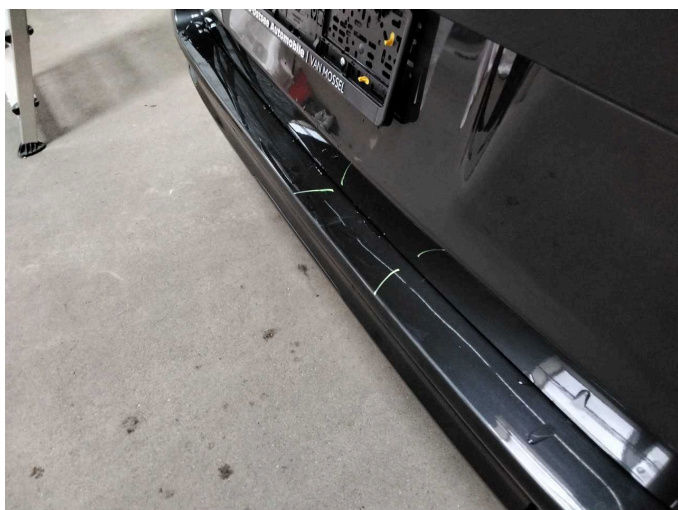
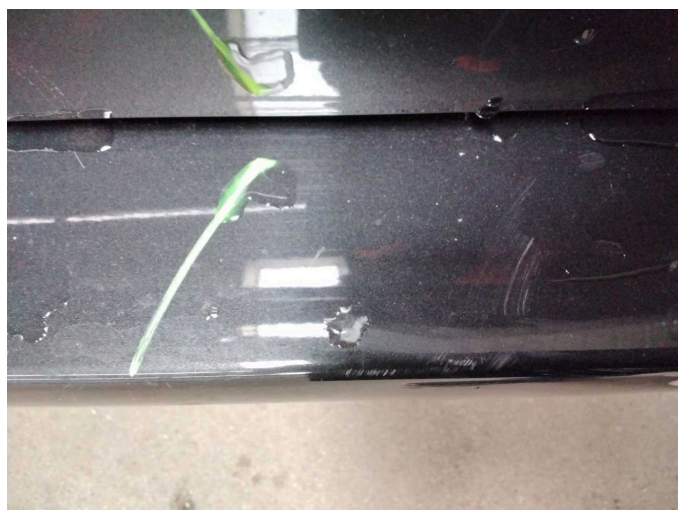
| No. | Component group | Description |
|---|---|---|
| 4 | Rear bumper | Rear bumper - Scratch(es) - Smart repair |

**Damage 4:** Rear bumper: Rear bumper - Scratch(es) - Smart repair

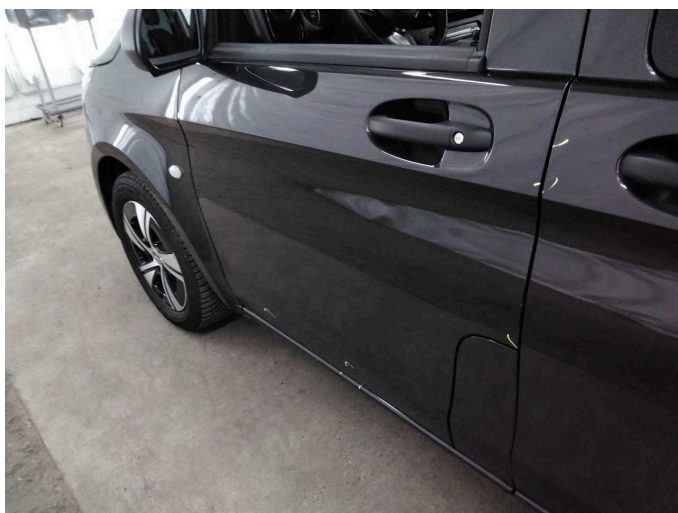
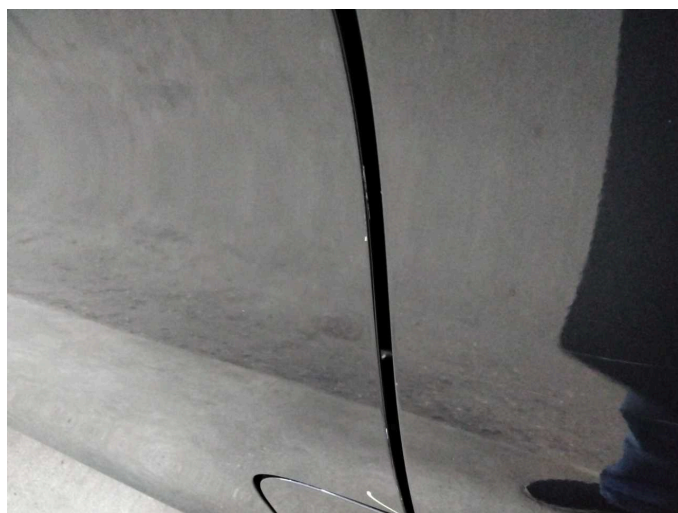
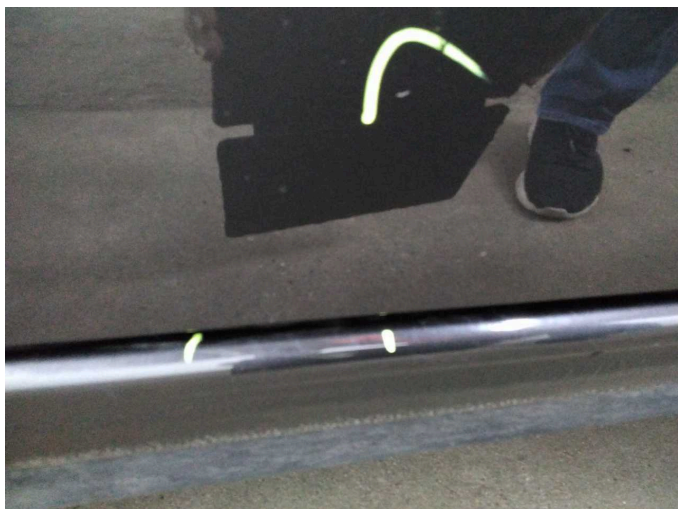
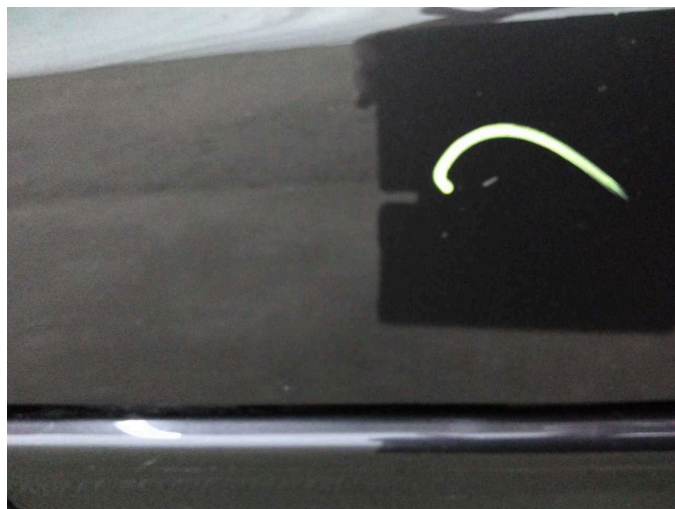
| No. | Component group | Description |
|---|---|---|
| 5 | Door - front left side | Door - Scratch(es) - Paint |

**Damage 5:** Door - front left side: Door - Scratch(es) - Paint

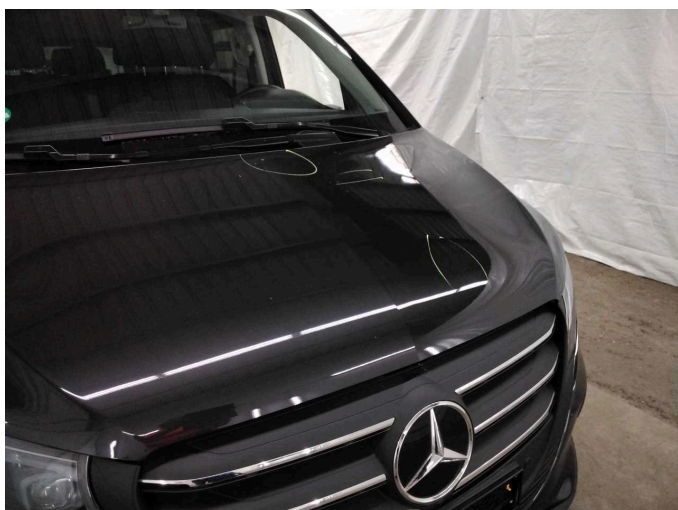
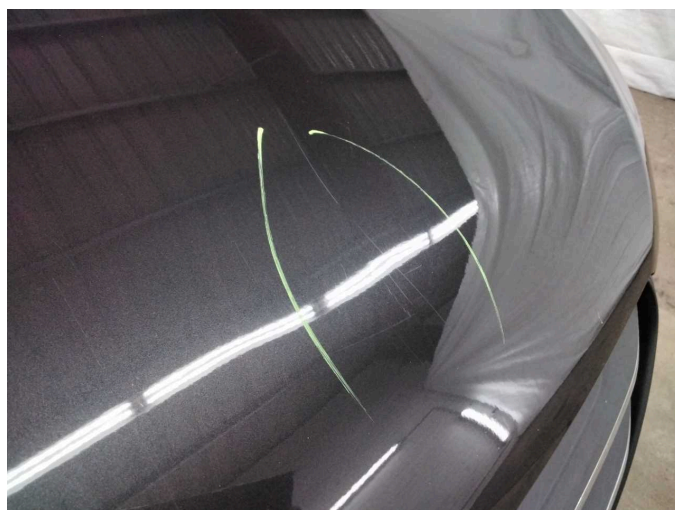
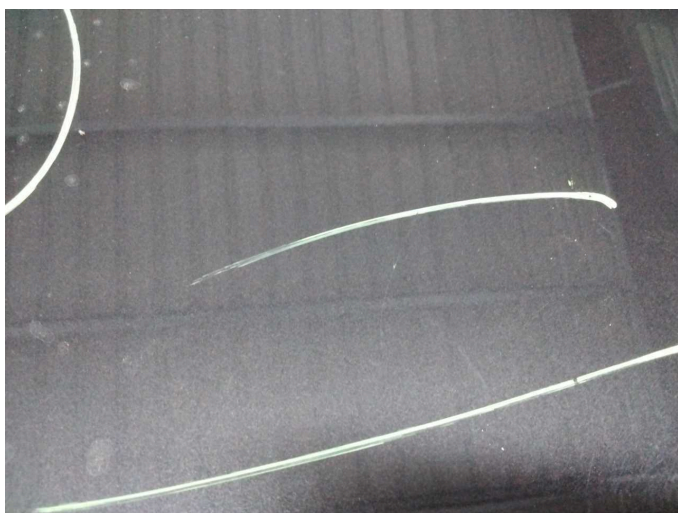
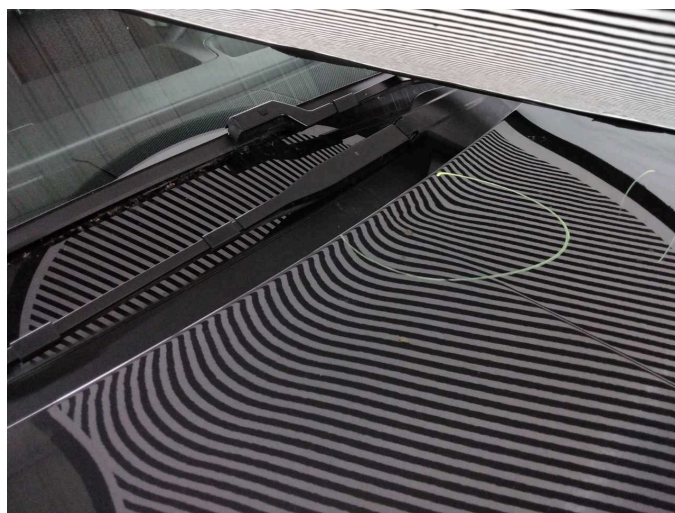
| No. | Component group | Description |
|---|---|---|
| 6 | Bonnet | Bonnet - Dent / paintcoat damage - Repair and paint |

**Damage 6:** Bonnet: Bonnet - Dent / paintcoat damage - Repair and paint

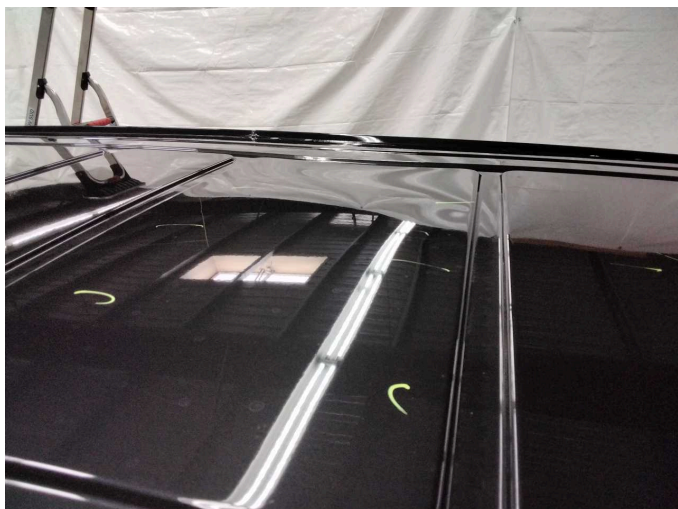
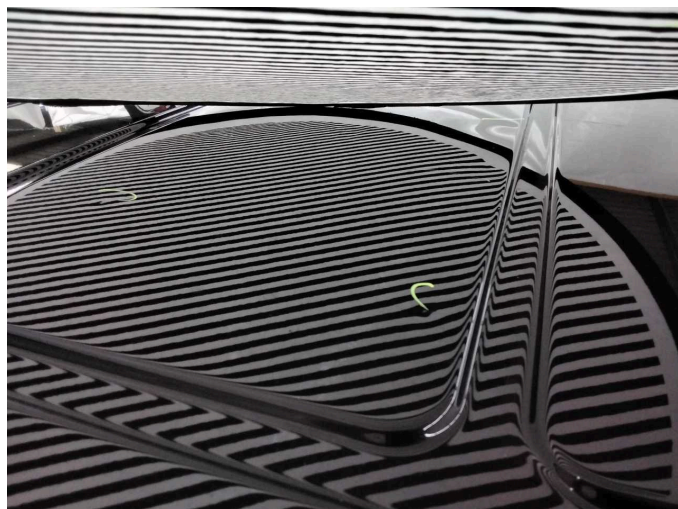
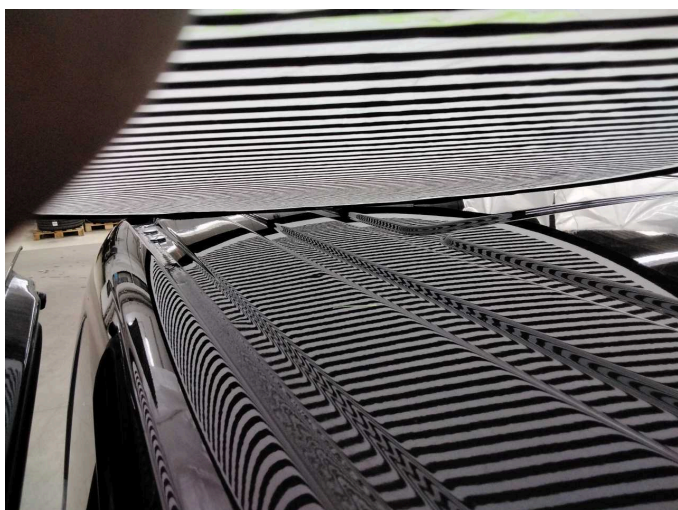
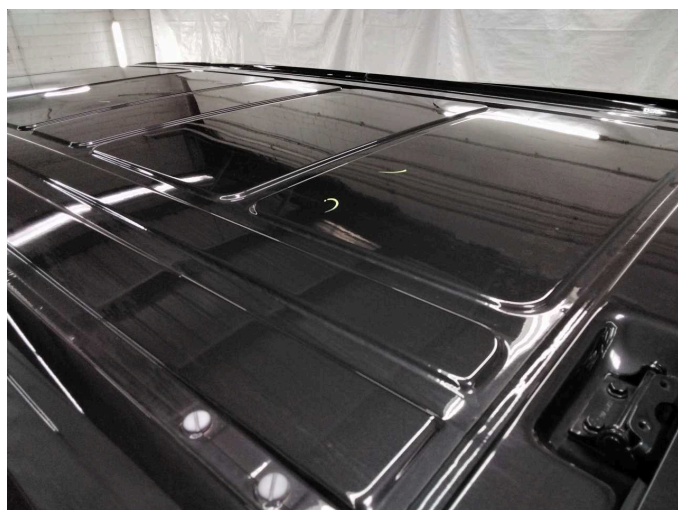
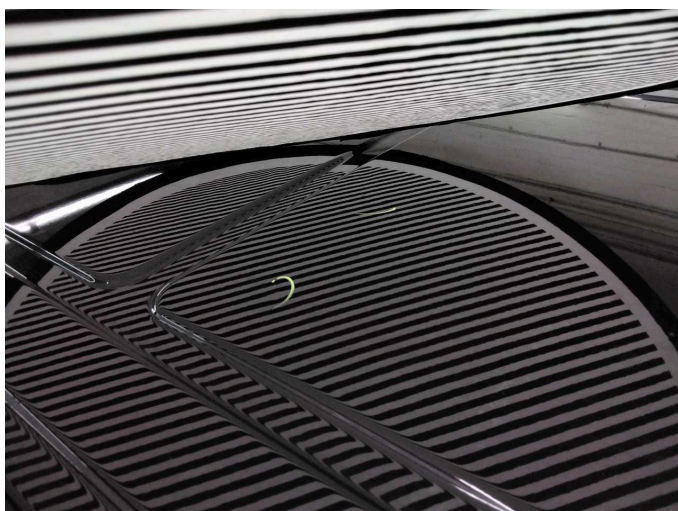
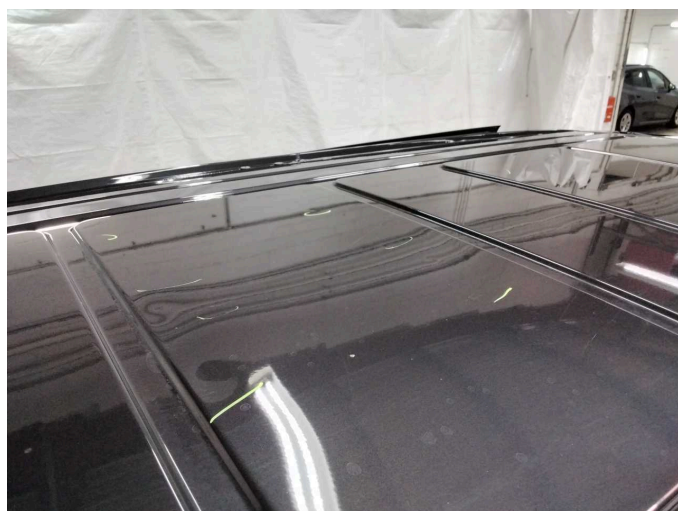
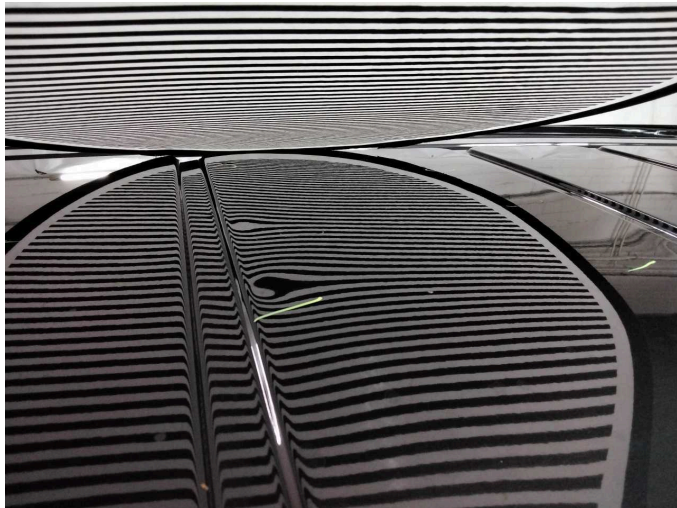
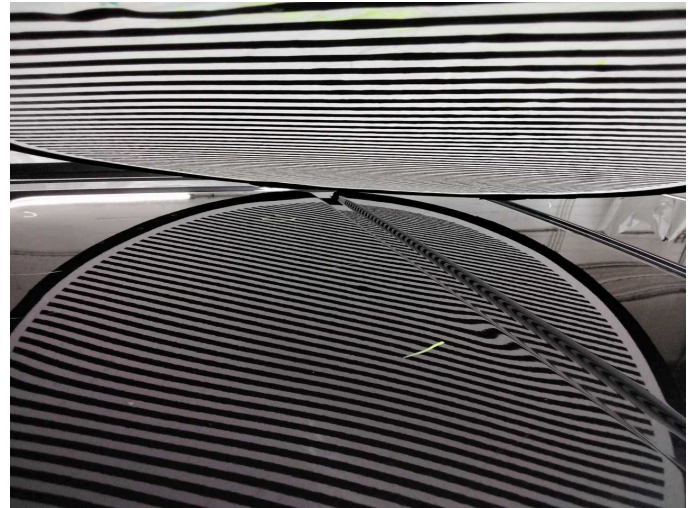
| No. | Component group | Description |
|---|---|---|
| 7 | Roof | Roof - Damage by hail - Smooth repair work |

**Damage 7:** Roof: Roof - Damage by hail - Smooth repair work

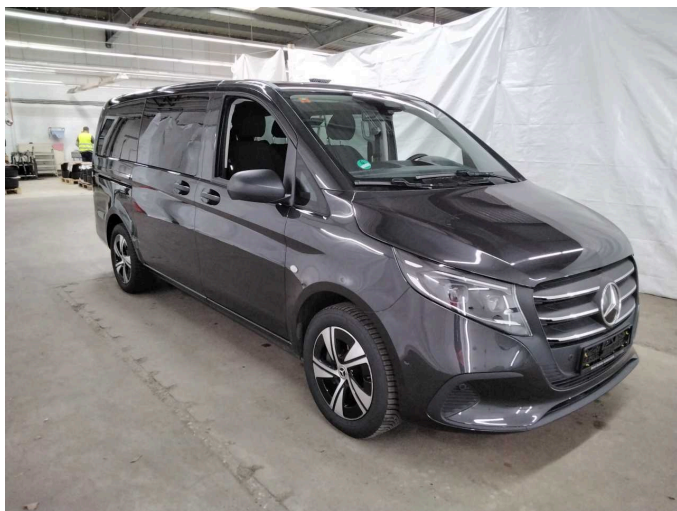
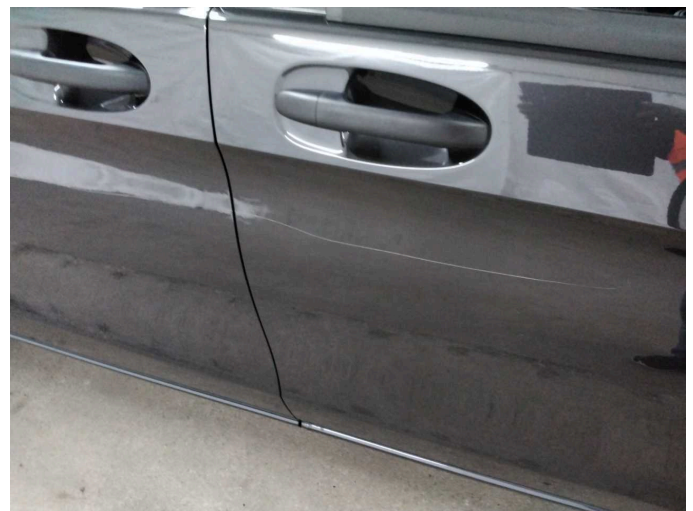
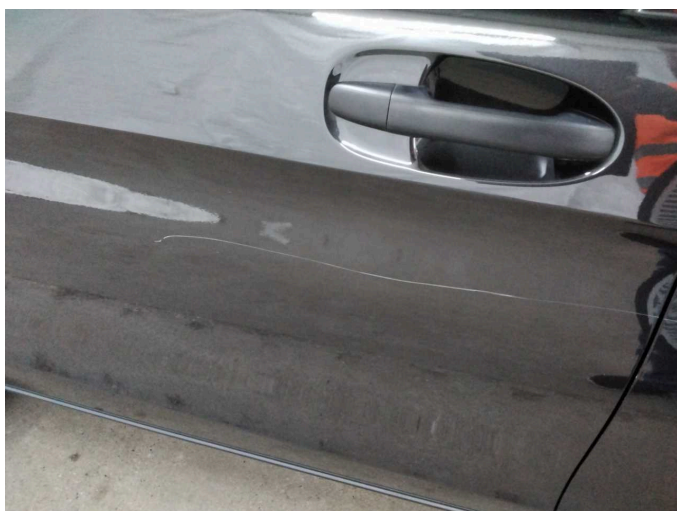
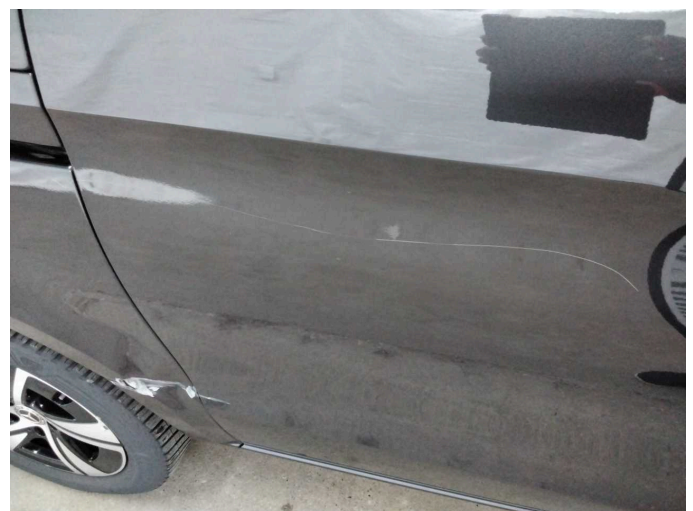
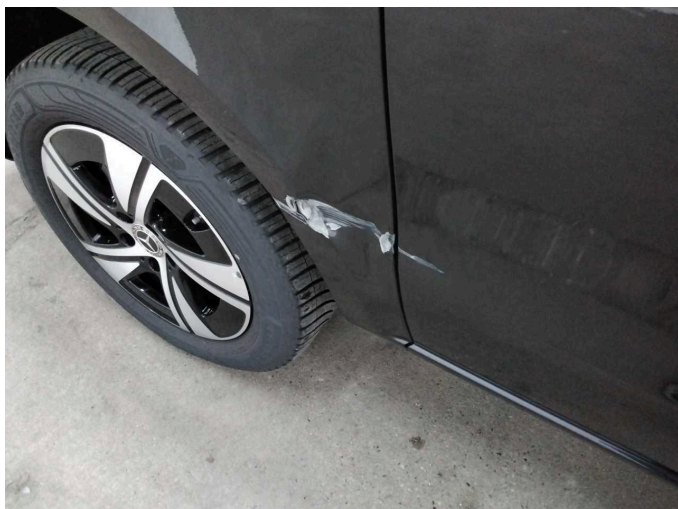
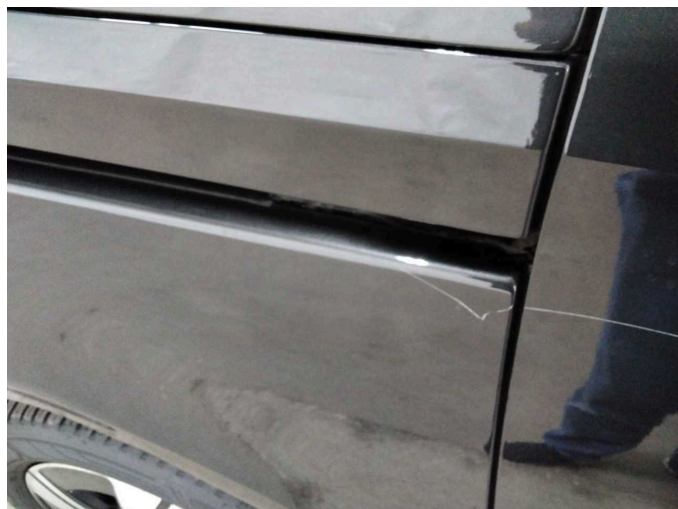
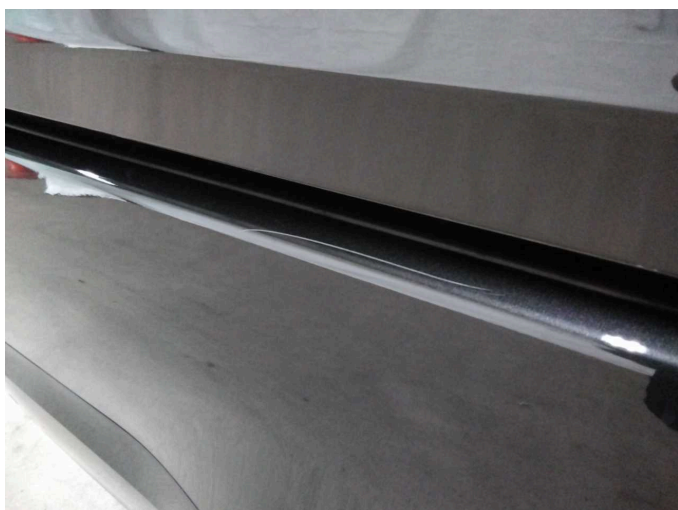
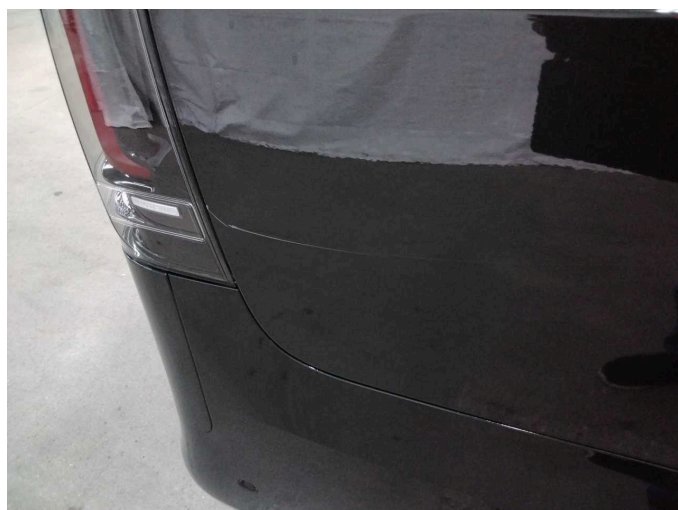
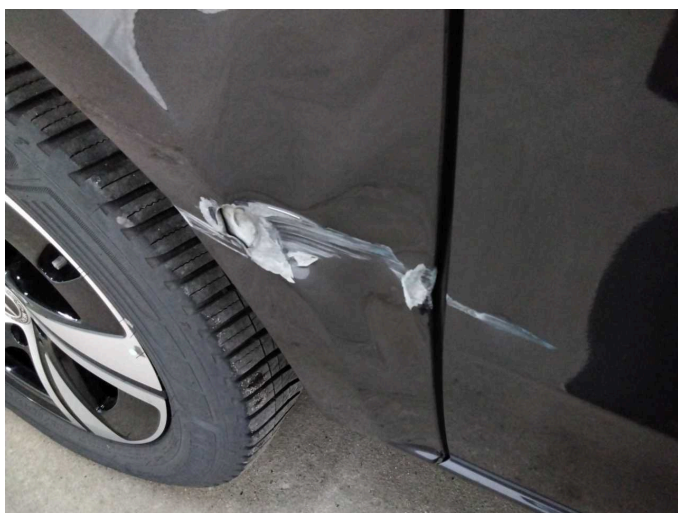
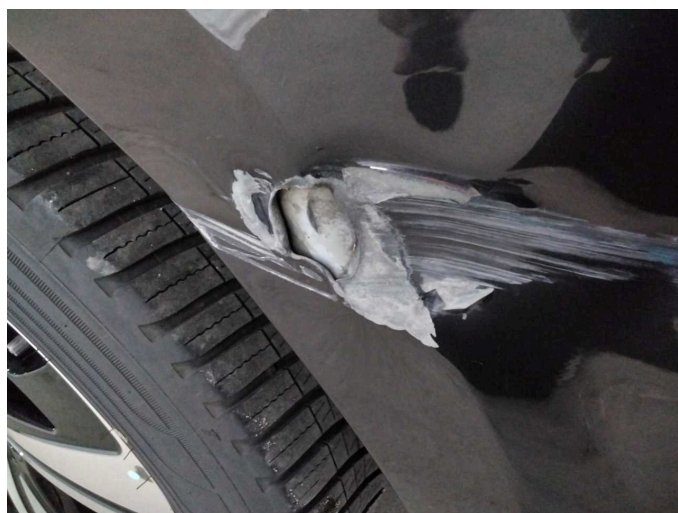
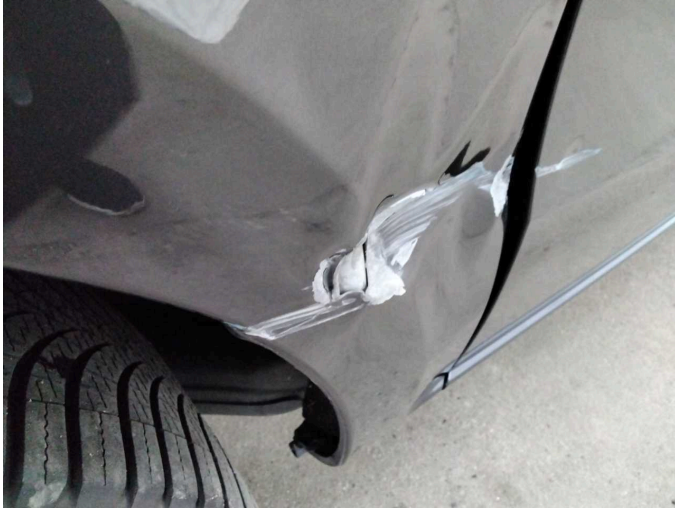
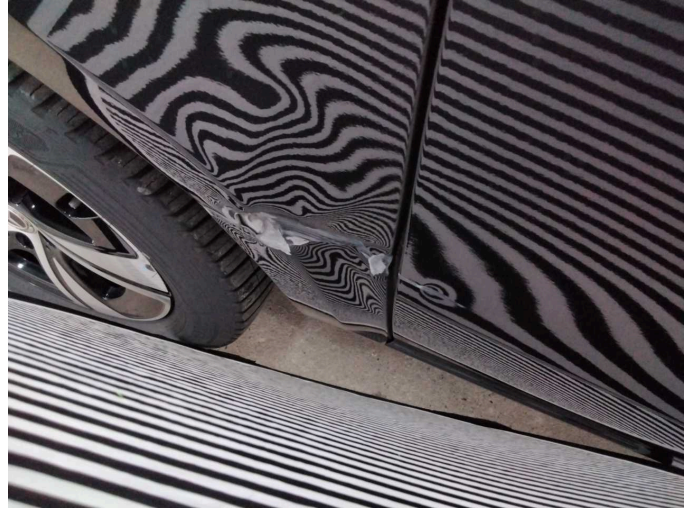
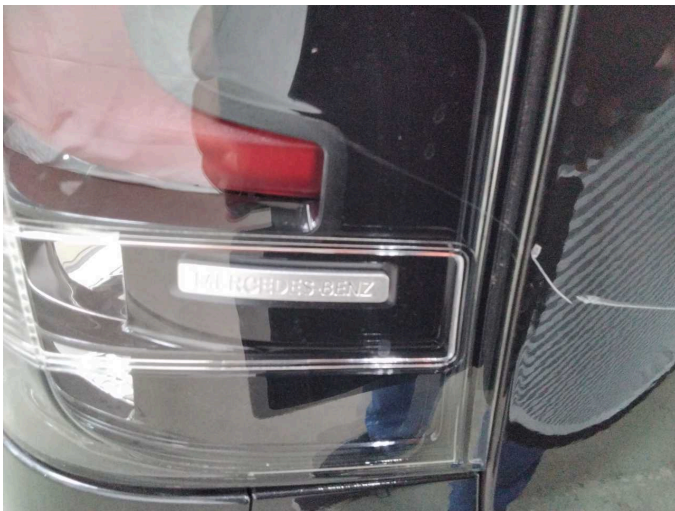
| 1 | Side right |

**Accident 1:** Side right

**Accident 1: Side right**
