Expertise

Protocol number: 46014579
Order No. / Reference: 26307675
Inspection date: 17 Jun 2026

Manufacturer: Ford

Model: Transit Connect 220 L1 Trend

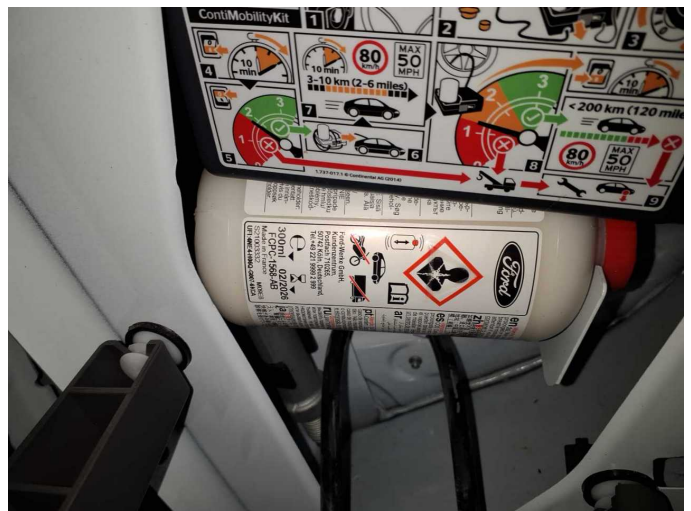
Damage 1: Equipment: Tirefit filler - Expired - Replace

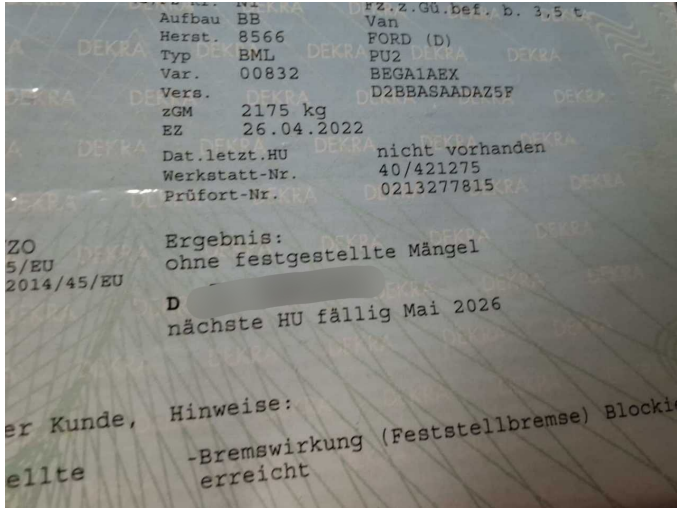
Damage 2: Misc.: Main inspection - Expired - Perform

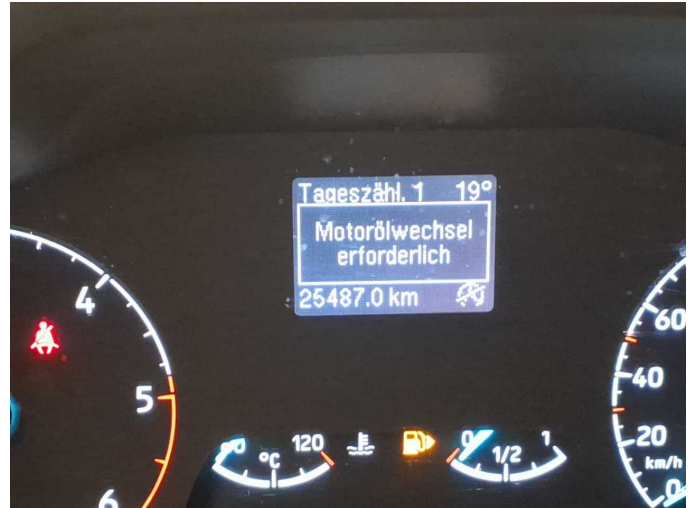
Damage 3: Misc.: Inspection / maintenance - Expired - Perform

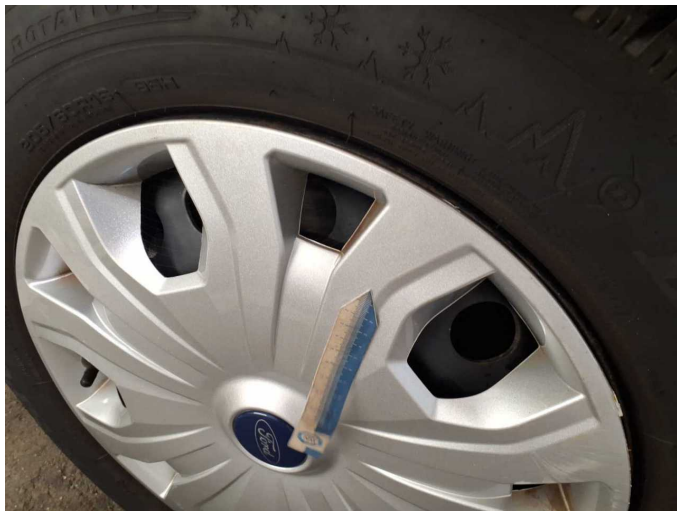
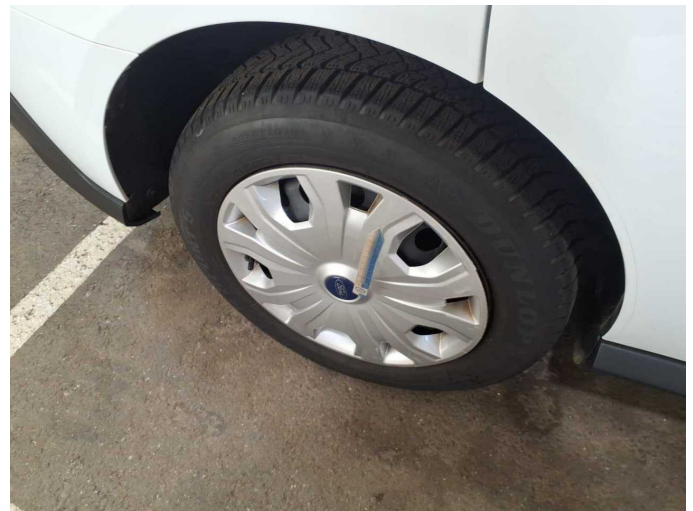
Wear and tear 5: Wheel / tyres: Wheel cover - rear right side - Scratch(es) - No deduction

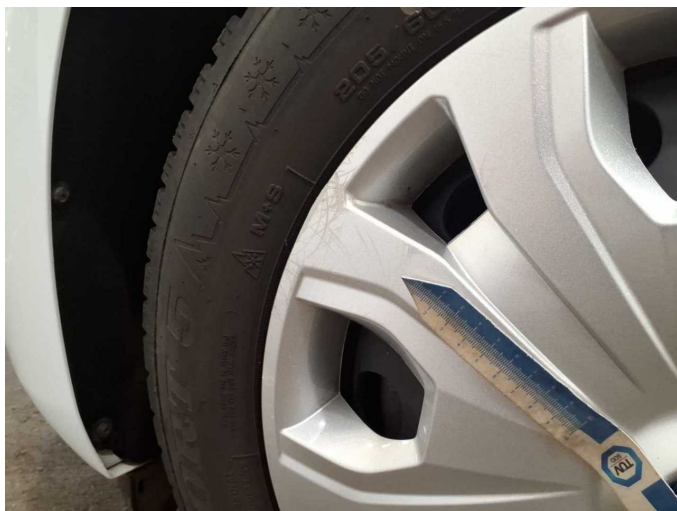
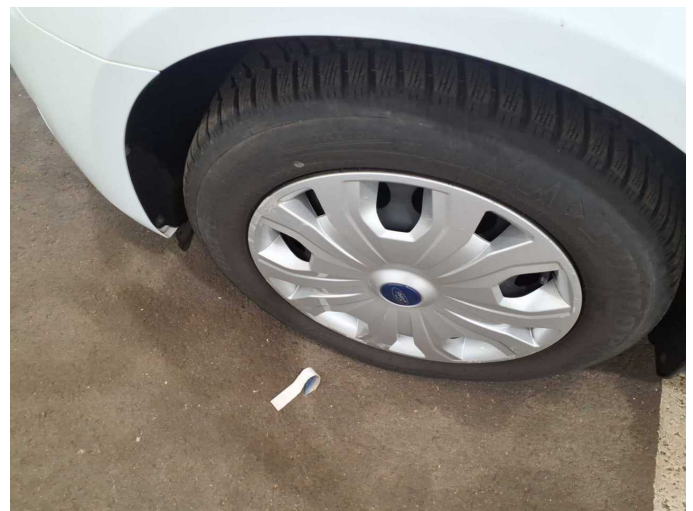
Wear and tear 6: Wheel / tyres: Wheel cover - front left side - Scratch(es) - No deduction

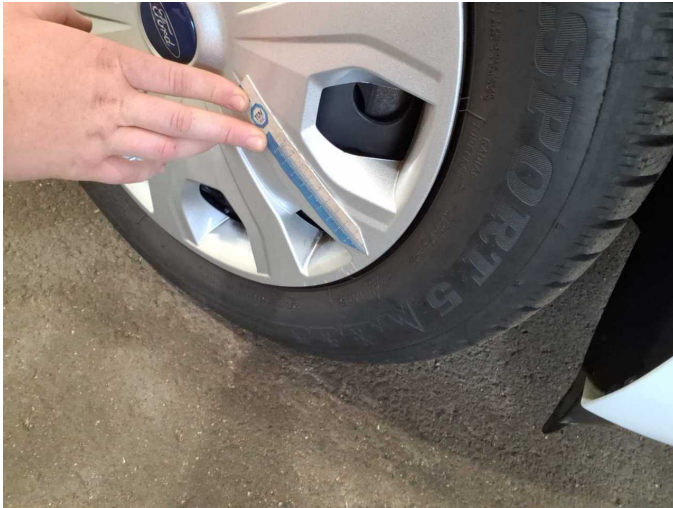
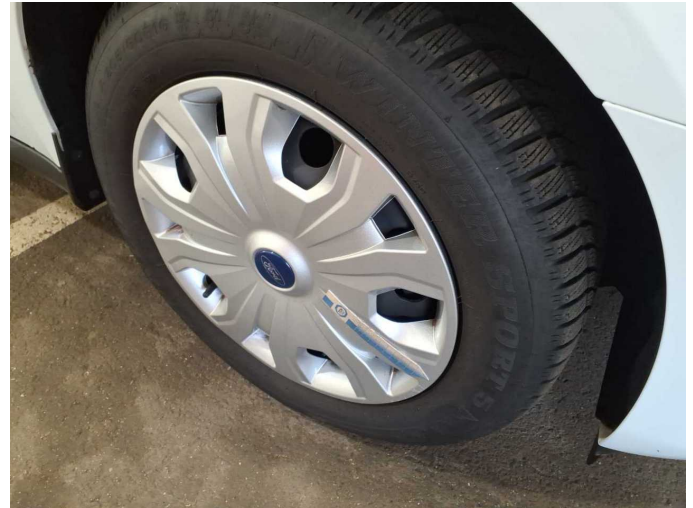
Wear and tear 7: Wheel / tyres: Wheel cover - front right side -
Scratch(es) - No deduction

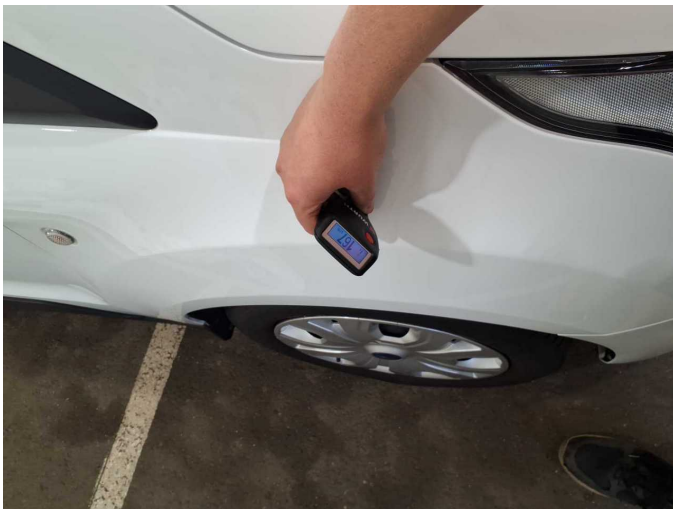
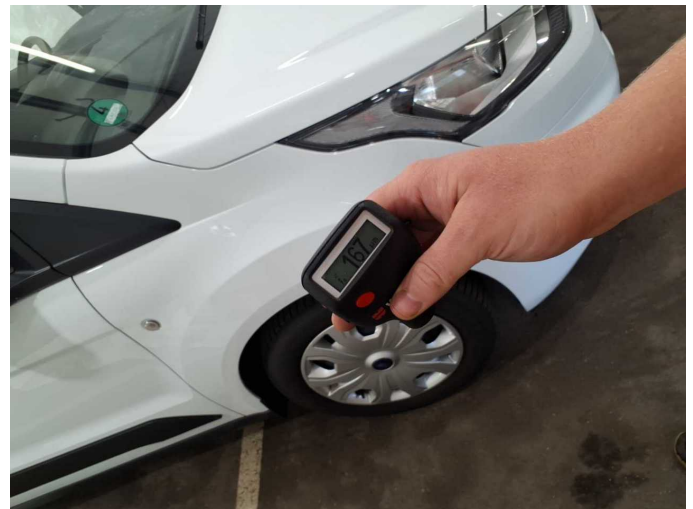
Mudguard - right side	167 µm	Door - front right side	139 µm
-----------------------	--------	-------------------------	--------

Repainting 1: Mudguard - right side

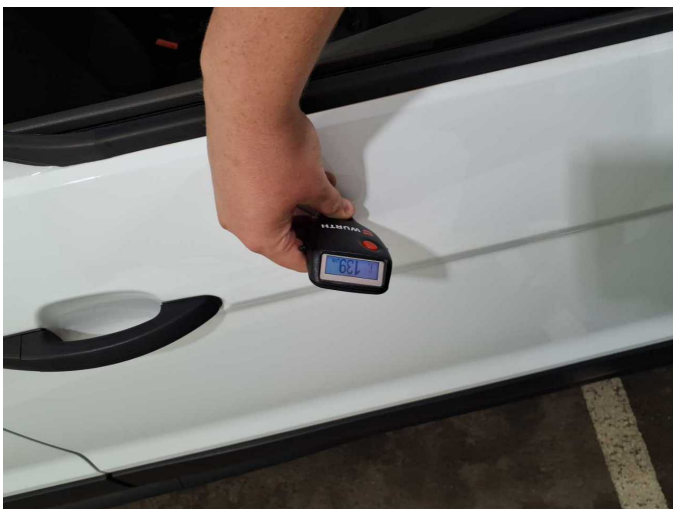
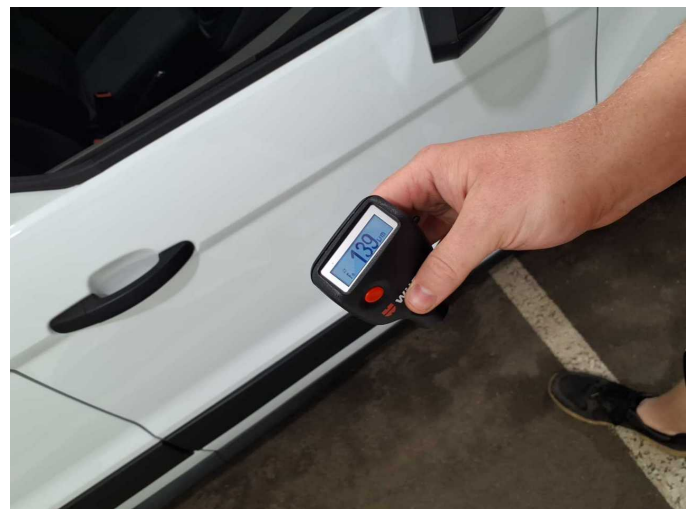
Repainting 2: Door - front right side
