Expertise

Protocol number: 46589825  
Order No. / Reference: 26152551  
Inspection date: 29 Jun 2026

Manufacturer: Mercedes-Benz

Model: Vito 116 CDI Tourer Lang Aut. PRO

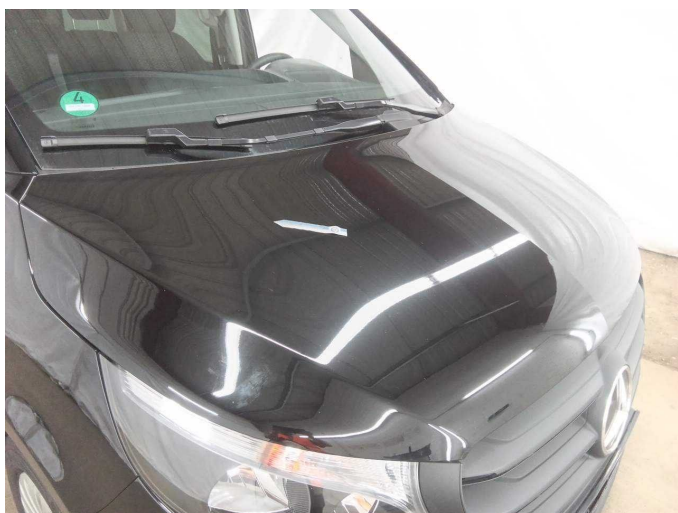
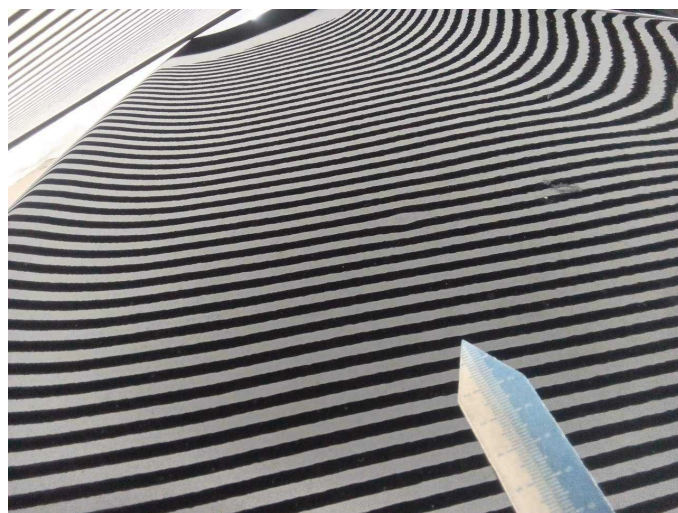
| No. | Component group | Description |
|---|---|---|
| 3 | Bonnet | Bonnet (1) - dent(s) - Smart repair |

**Damage 3:** Bonnet: Bonnet (1) - dent(s) - Smart repair

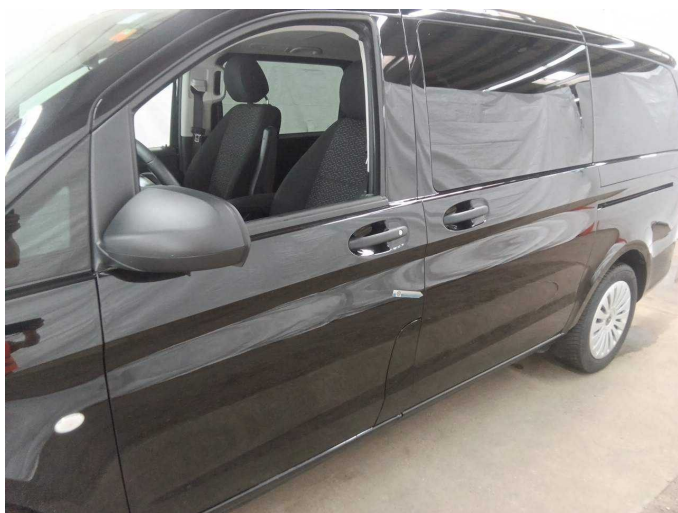
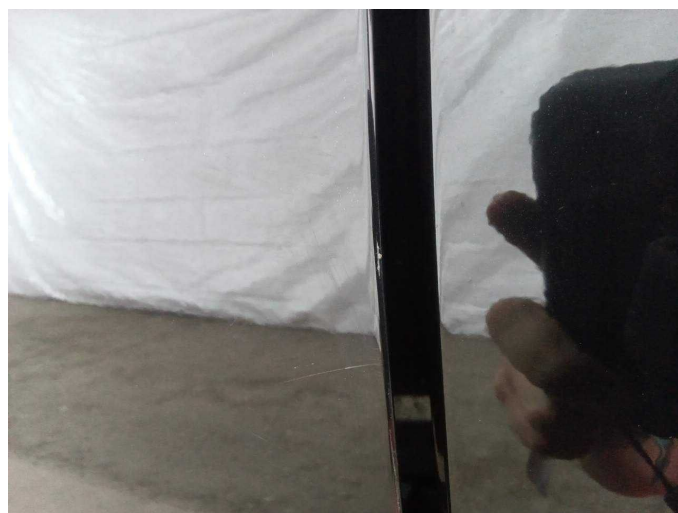
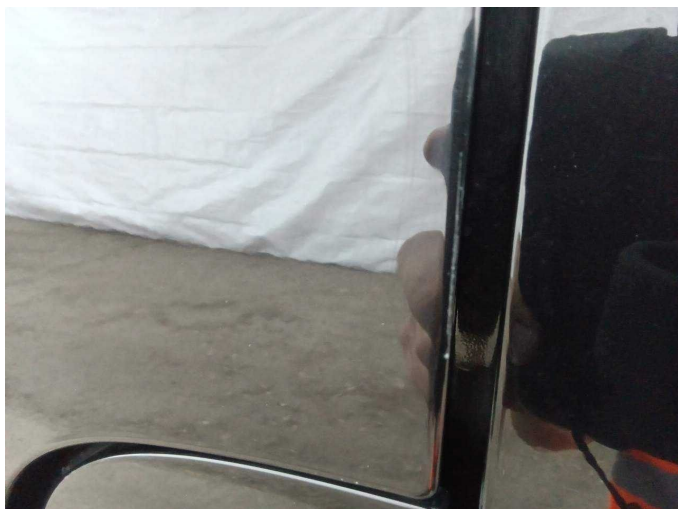
| No. | Component group | Description |
|---|---|---|
| 4 | Door - front left side | Door edge - Scratch(es) - Smart repair |

**Damage 4:** Door - front left side: Door edge - Scratch(es) - Smart repair

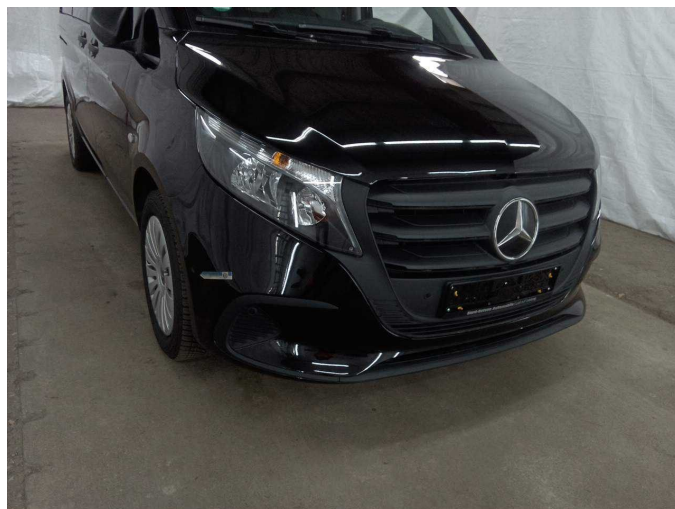
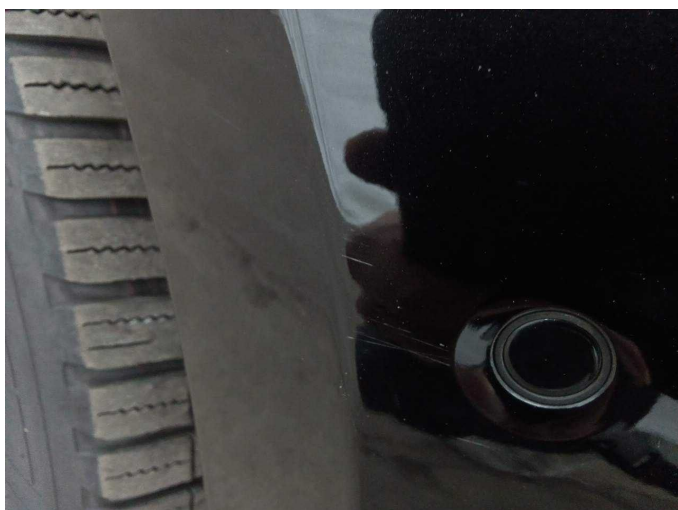
| No. | Component group | Description |
|---|---|---|
| 5 | Front bumper | Front bumper - Scratch(es) - Smart repair |

**Damage 5:** Front bumper: Front bumper - Scratch(es) - Smart repair

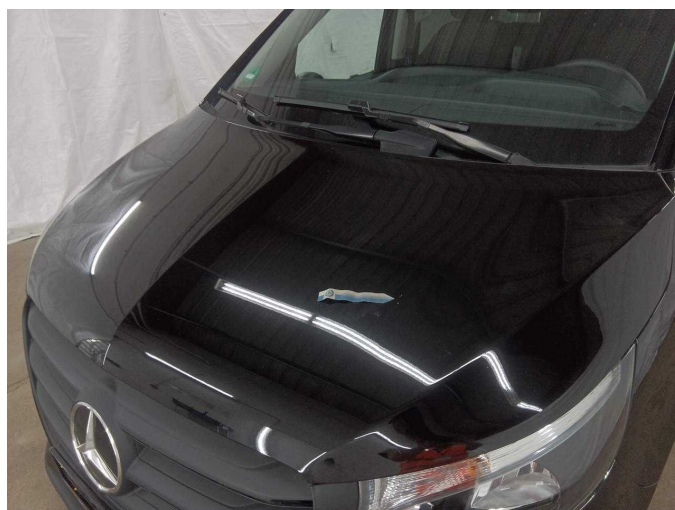
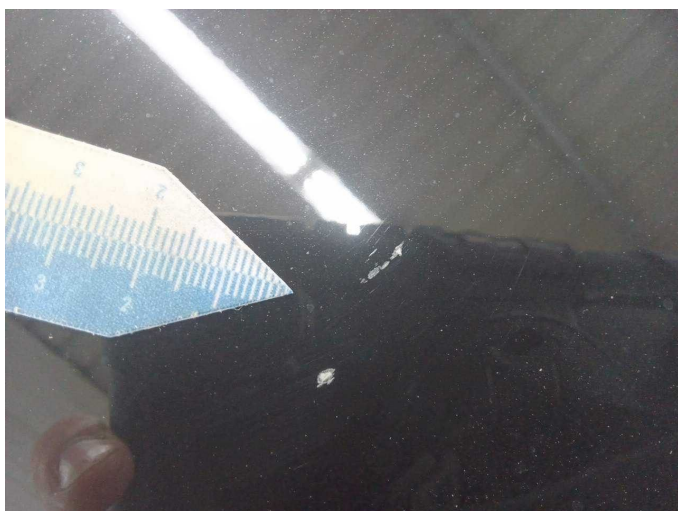
| No. | Component group | Description |
|---|---|---|
| 6 | Bonnet | Bonnet - Stone chips - Paint |

**Damage 6:** Bonnet: Bonnet - Stone chips - Paint

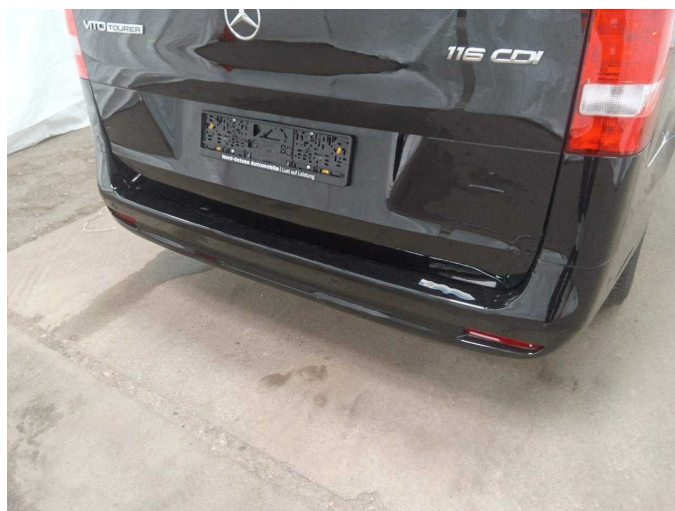
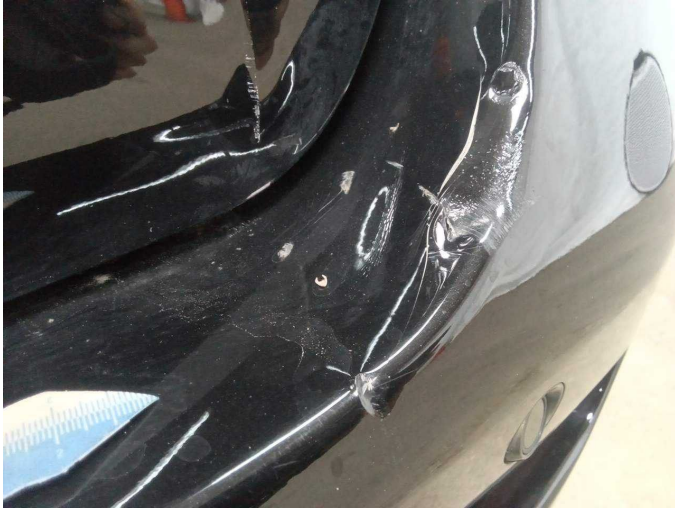
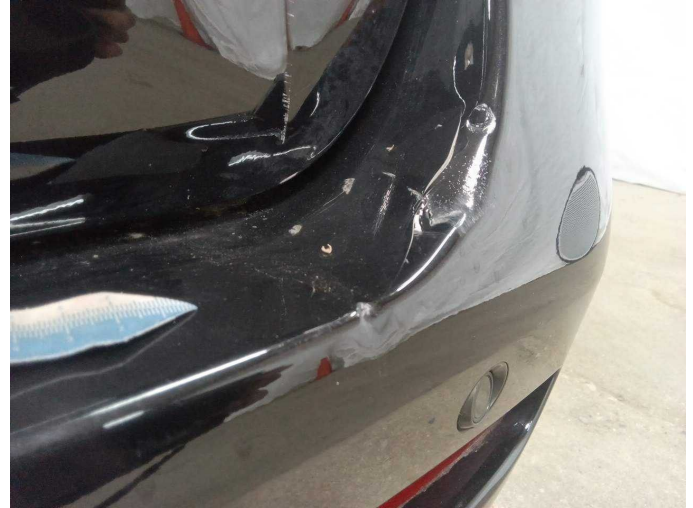
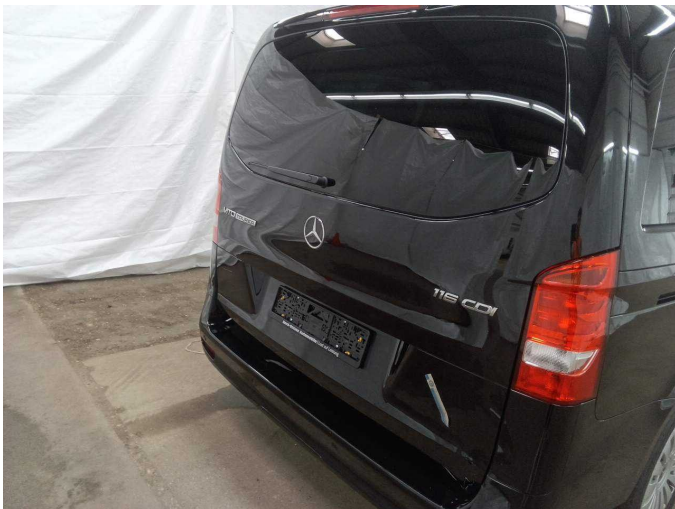
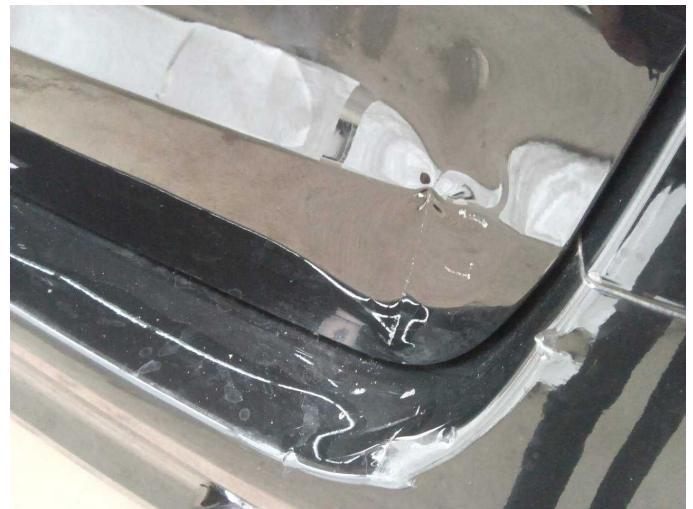
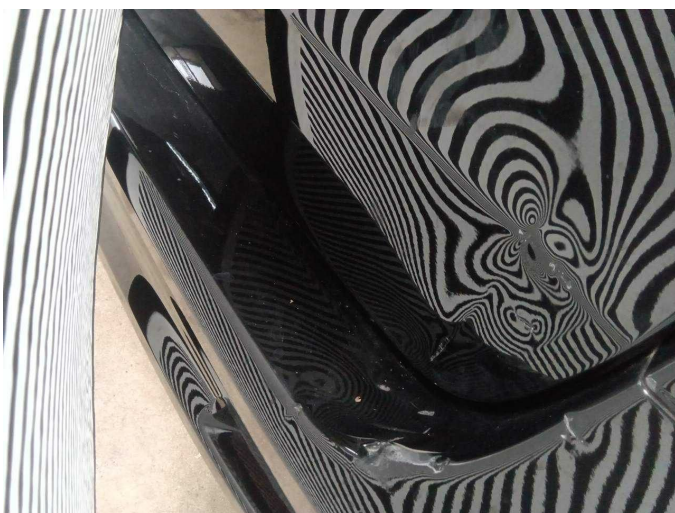
| No. | Accident |
|---|---|
| 1 | Rear |

Non-repaired previous damages were found at the vehicle. The necessary repair costs are listed in the expert report or if necessary, are listed in detail in a separately enclosed repair cost calculation.

**Accident 1:** Rear

**Accident 1: Rear**
