Expertise

Protocol number: 46901206  
Order No. / Reference: 26801193  
Inspection date: 5 Aug 2026

| Manufacturer: Opel | Model: Astra 1.5 D Start/Stop Sports Tourer Automatik Elegance |

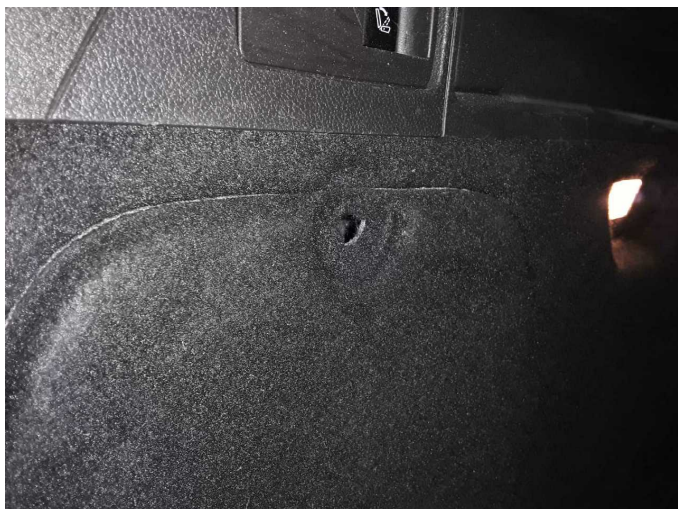
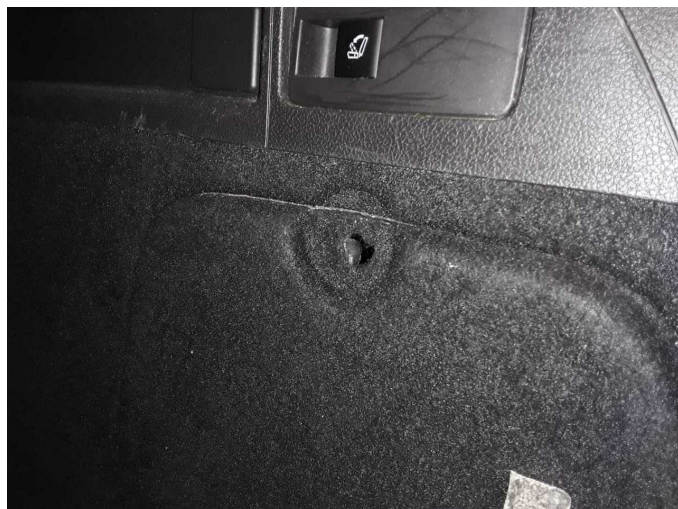
| No. | Component group | Description |
|---|---|---|
| 1 | Trim / covers | Boot lining (Auf beiden Seiten fehlt die Verriegelung) - Damaged - Replace |

**Damage 1:** Trim / covers: Boot lining (Auf beiden Seiten fehlt die Verriegelung) - Damaged - Replace

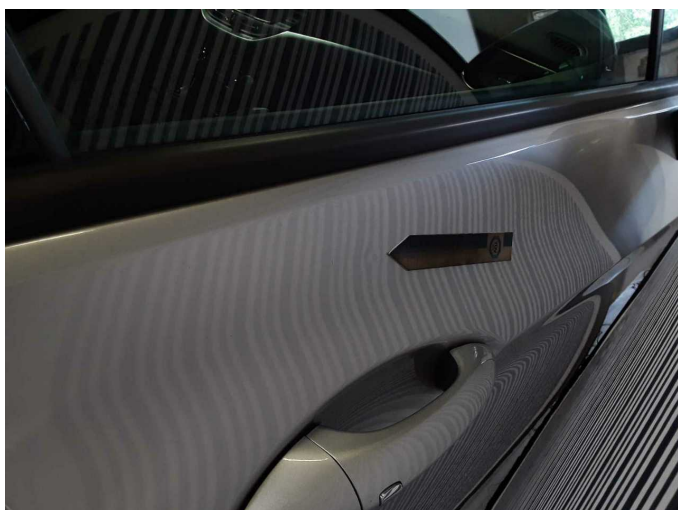
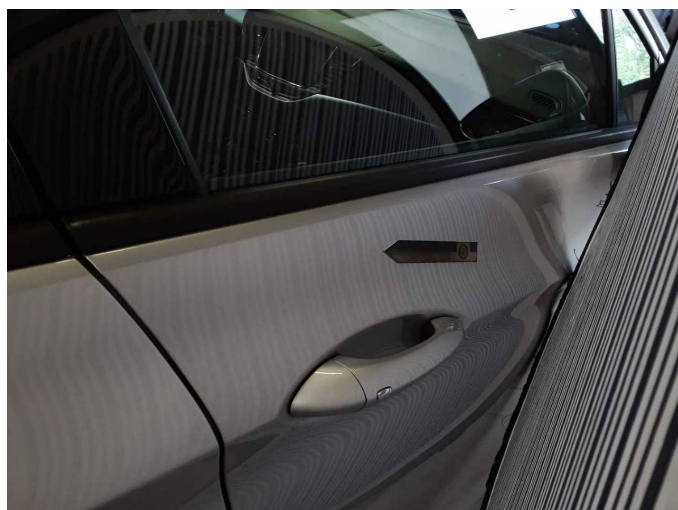
| No. | Component group | Description |
|---|---|---|
| 2 | Door - front right side | Door - dent(s) - Smooth repair work |

**Damage 2:** Door - front right side: Door - dent(s) - Smooth repair work

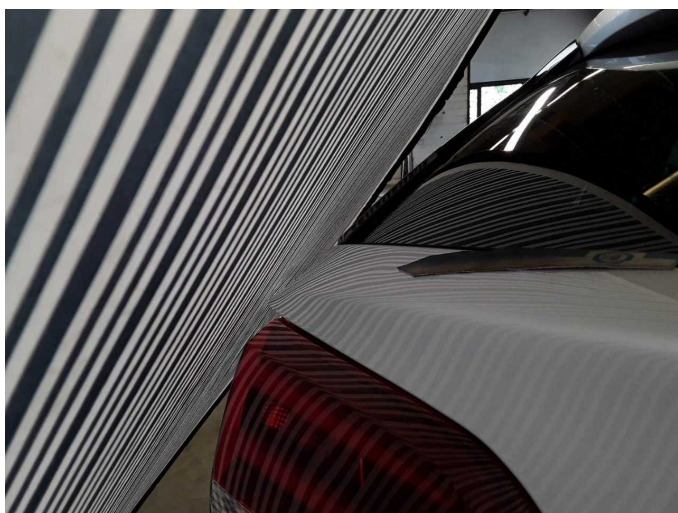
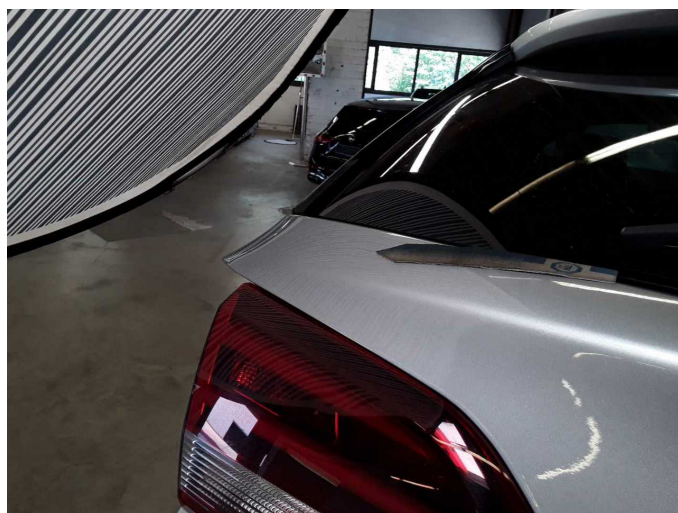
| No. | Component group | Description |
|---|---|---|
| 3 | Boot lid / rear door | Boot lid - dent(s) - Smooth repair work |

**Damage 3:** Boot lid / rear door: Boot lid - dent(s) - Smooth repair work

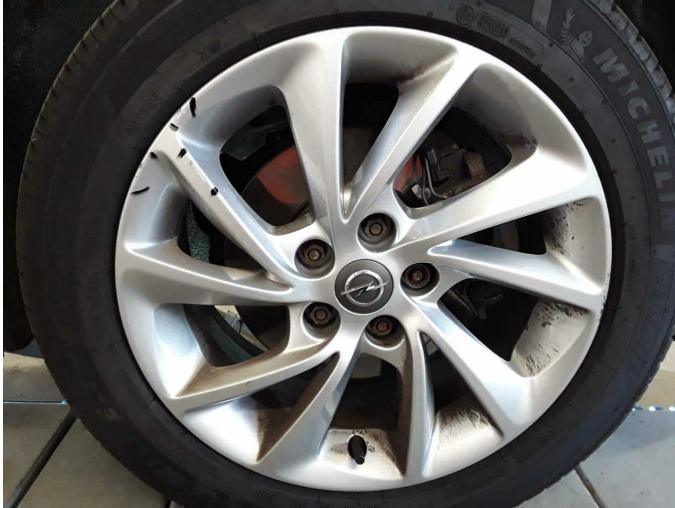
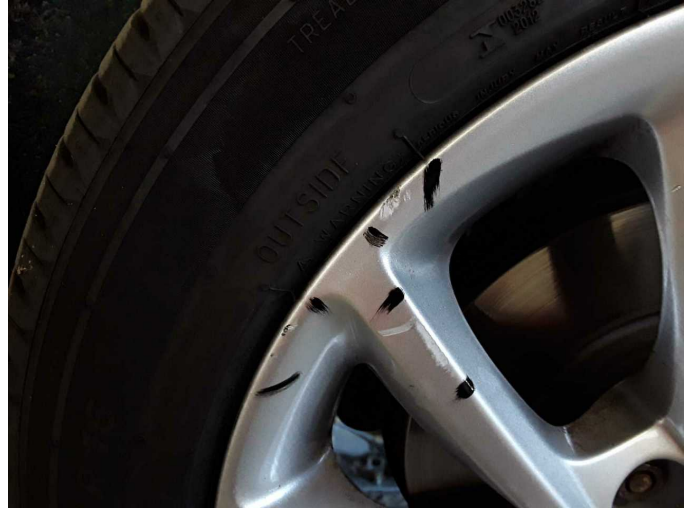
| No. | Component group | Description |
|---|---|---|
| 4 | Wheel / tyres | Alloy rim - front right side - Scratch(es) - Loss in value |

**Damage 4:** Wheel / tyres: Alloy rim - front right side - Scratch(es) - Loss in value

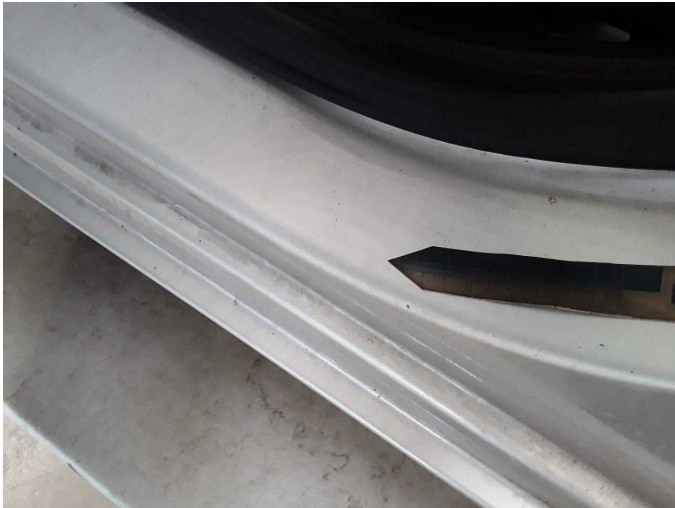
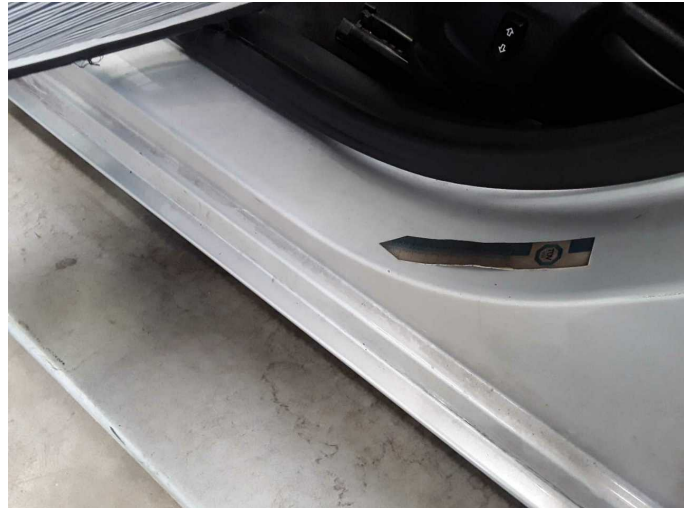
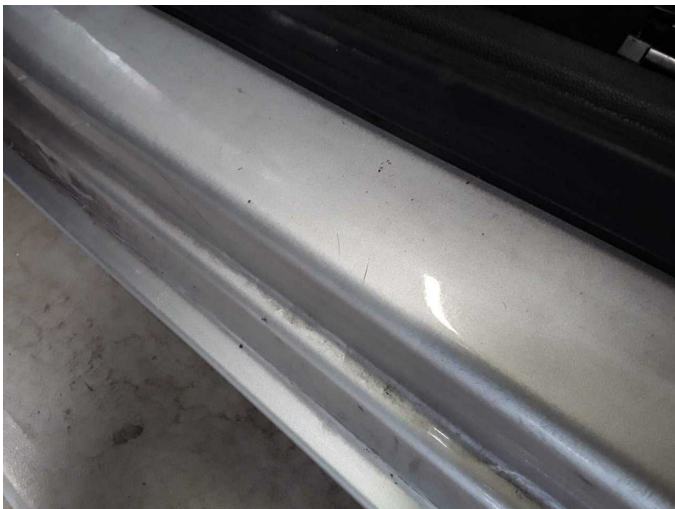
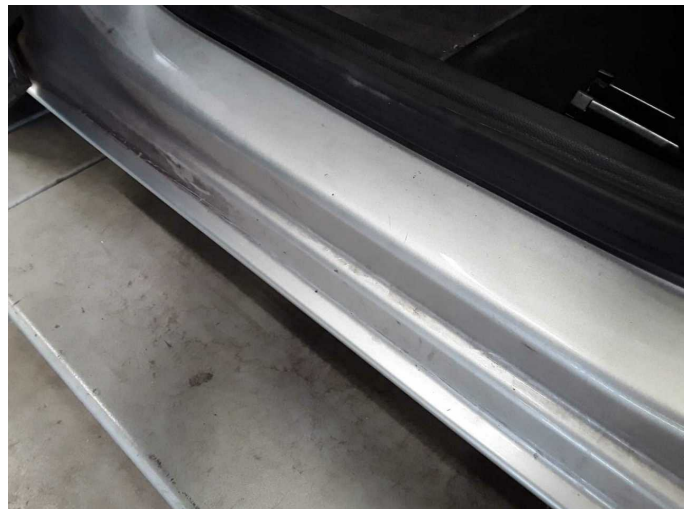
| No. | Component group | Description |
|---|---|---|
| 6 | Sill - left side | Sill - Dent / paintcoat damage - Smart repair |

**Damage 6:** Sill - left side: Sill - Dent / paintcoat damage - Smart repair

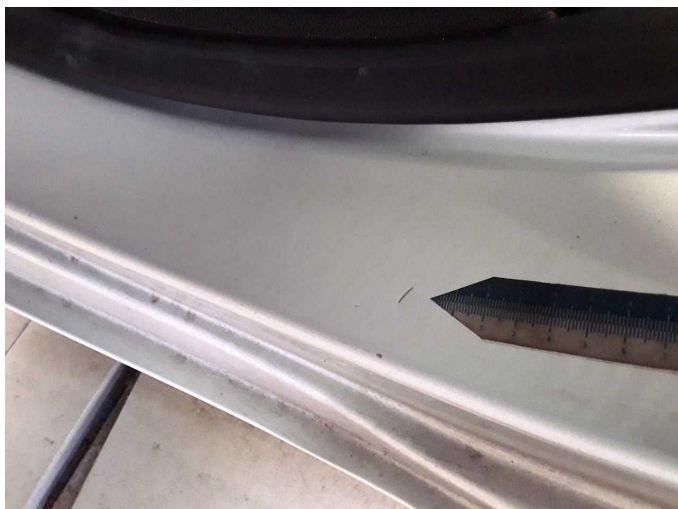
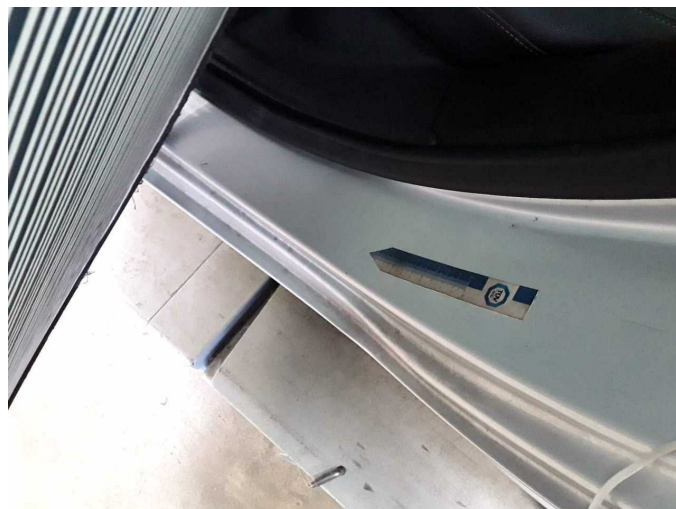
| No. | Component group | Description |
|---|---|---|
| 7 | Side panel - rear left side | Sill - Dent / paintcoat damage - Smart repair |

**Damage 7:** Side panel - rear left side: Sill - Dent / paintcoat damage - Smart repair

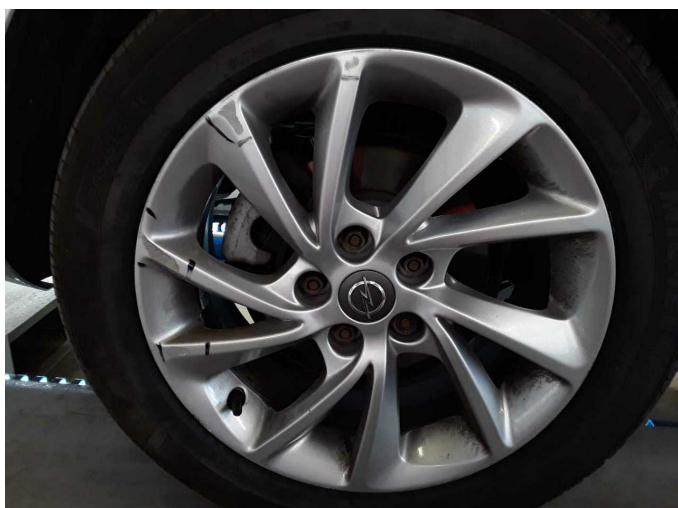
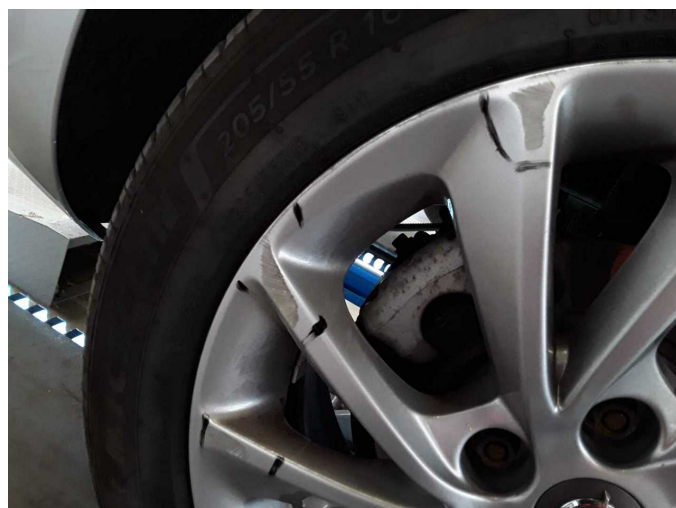
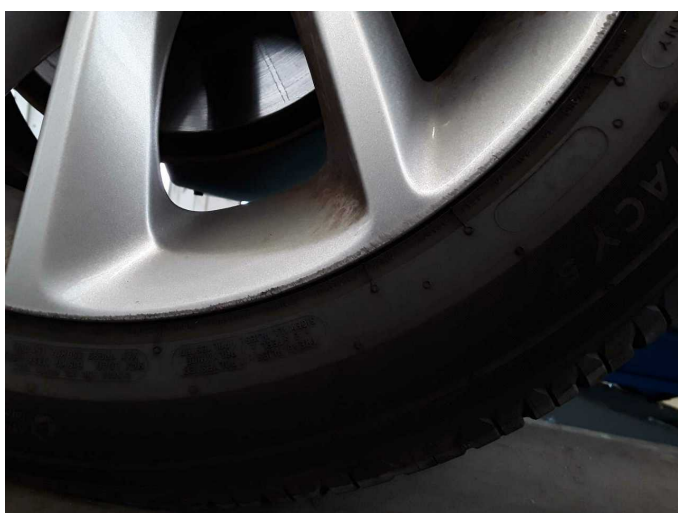
| No. | Component group | Description |
|---|---|---|
| 8 | Wheel / tyres | Alloy rim - rear right side - Scratched - Replace |

**Damage 8:** Wheel / tyres: Alloy rim - rear right side - Scratched - Replace

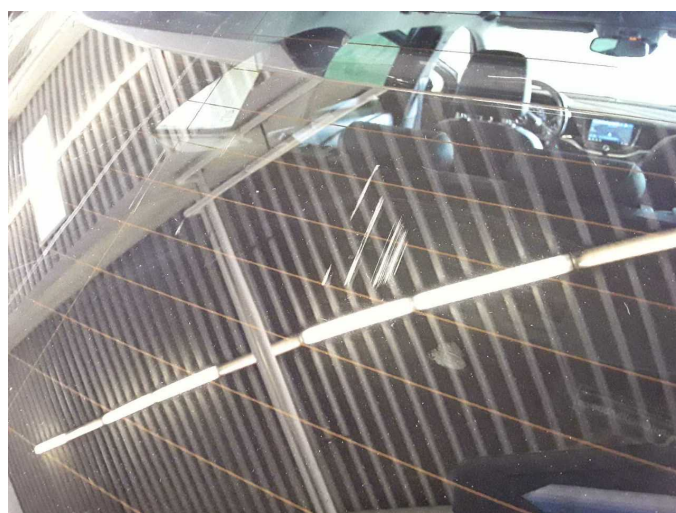
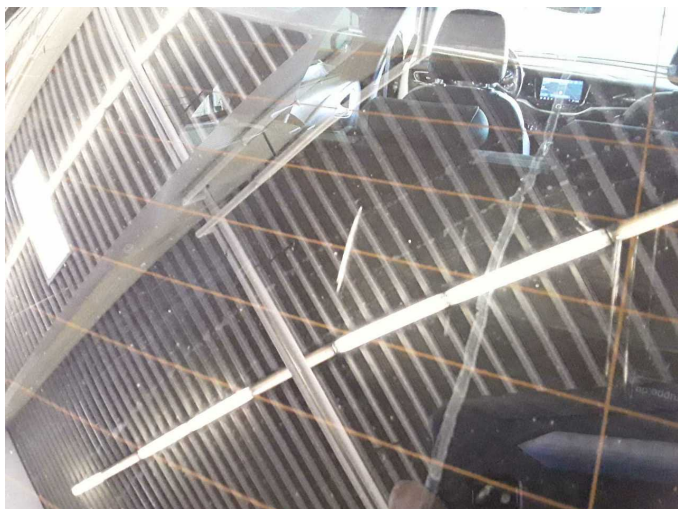
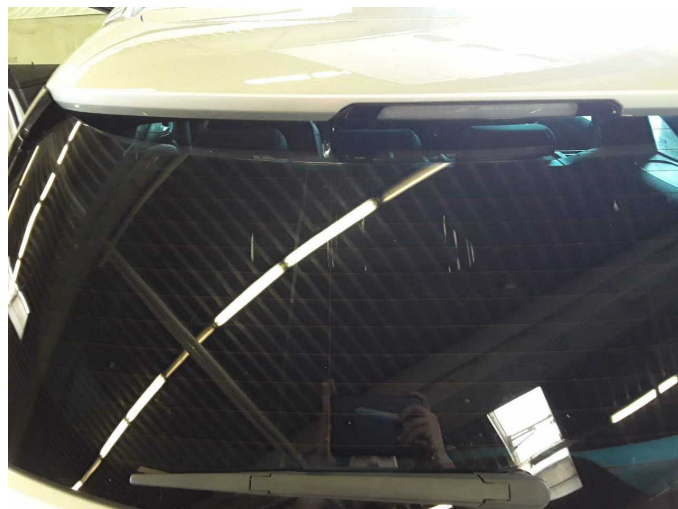
| No. | Component group | Description |
|---|---|---|
| 9 | Vehicle glazing | Rear window - Scratch(es) - Replace |

**Damage 9:** Vehicle glazing: Rear window - Scratch(es) - Replace

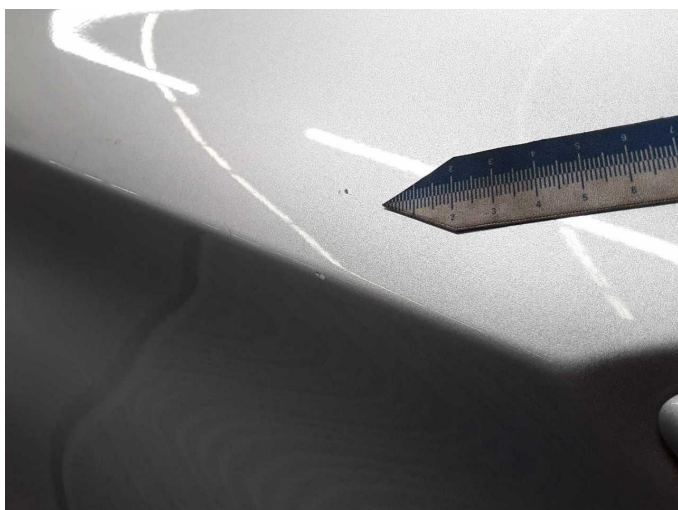
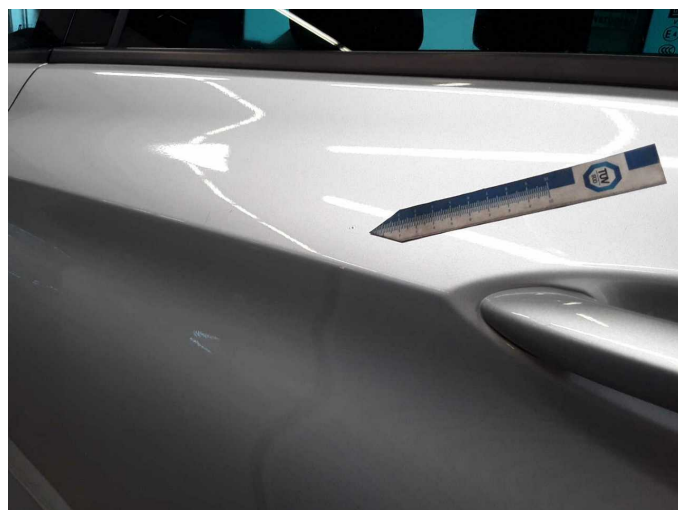
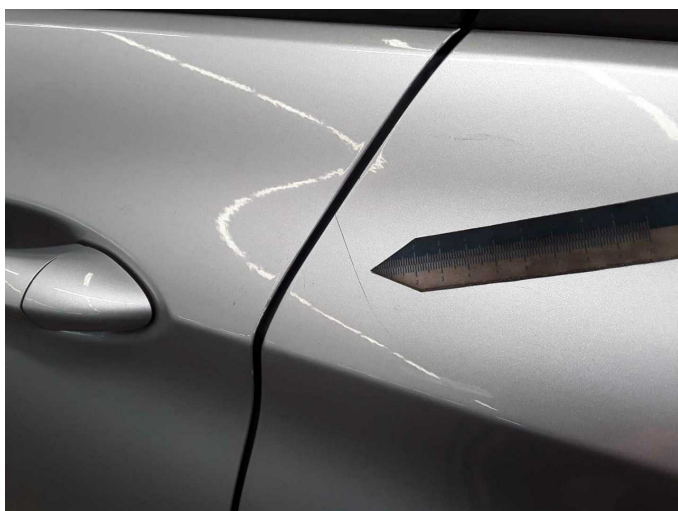
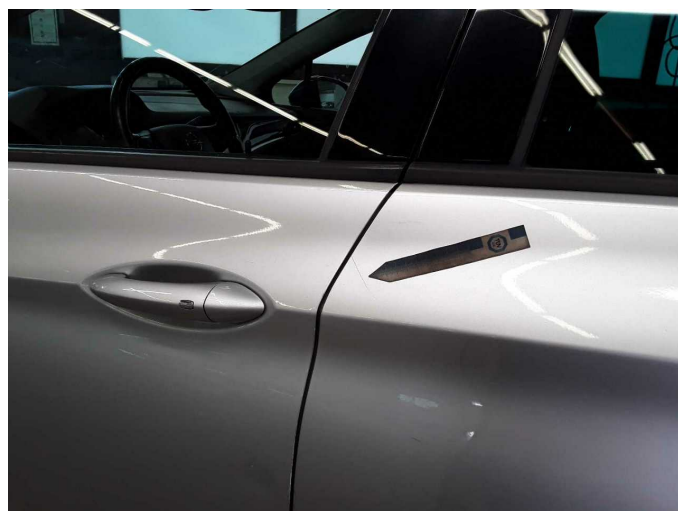
| No. | Component group | Description |
|---|---|---|
| 10 | Door - rear left side | Door - Scratch(es) - Paint |

**Damage 10:** Door - rear left side: Door - Scratch(es) - Paint

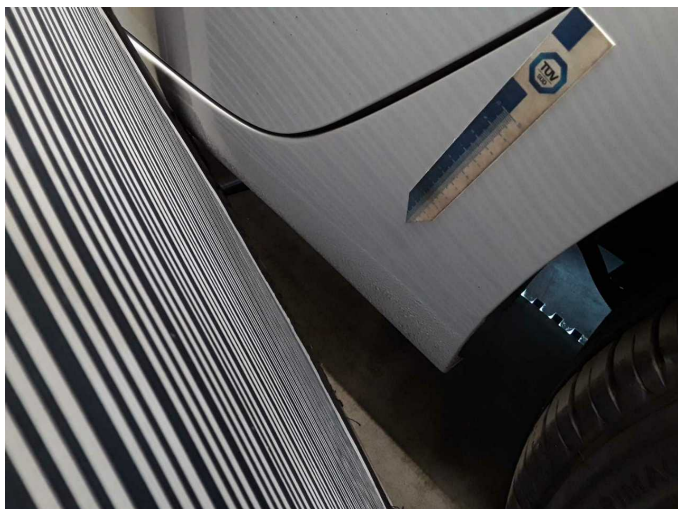
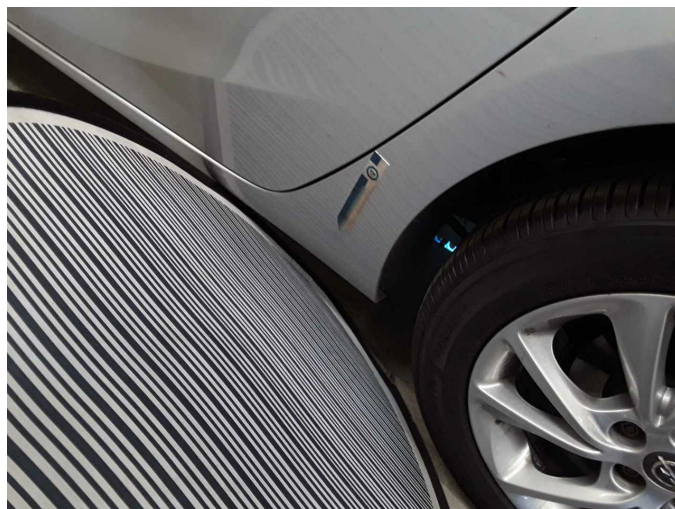
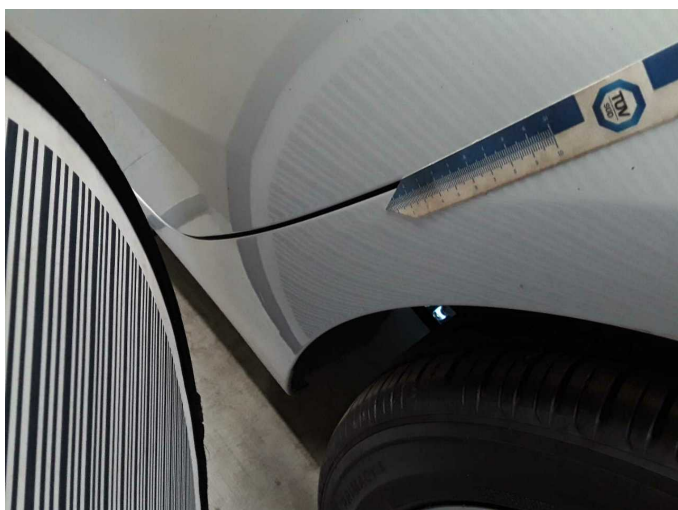
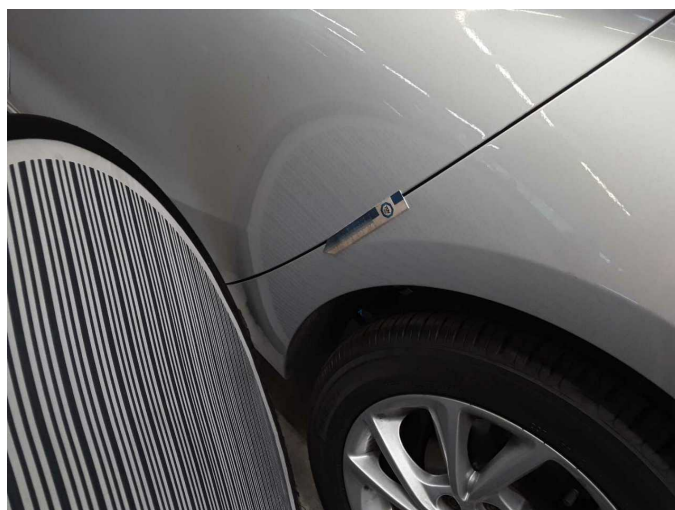
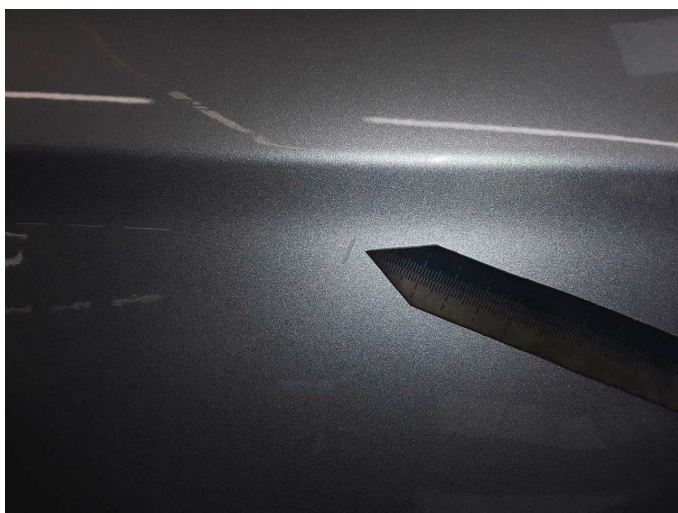
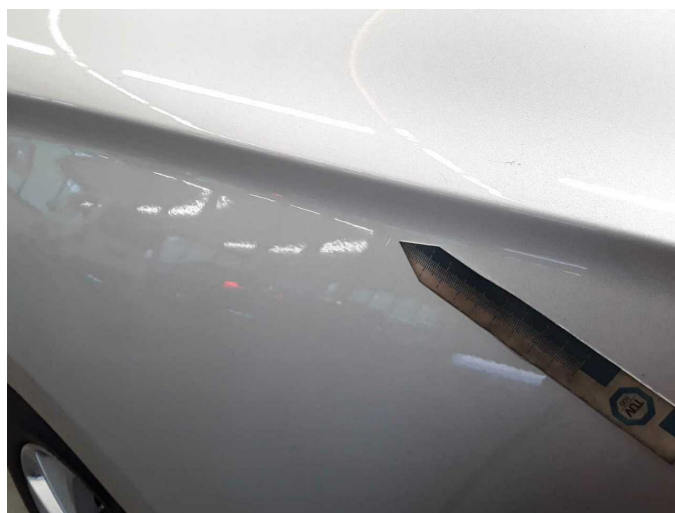
| No. | Component group | Description |
|---|---|---|
| 11 | Side panel - rear left side | Side panel - Dent / paintcoat damage - Repair and paint |

**Damage 11:** Side panel - rear left side: Side panel - Dent / paintcoat damage - Repair and paint

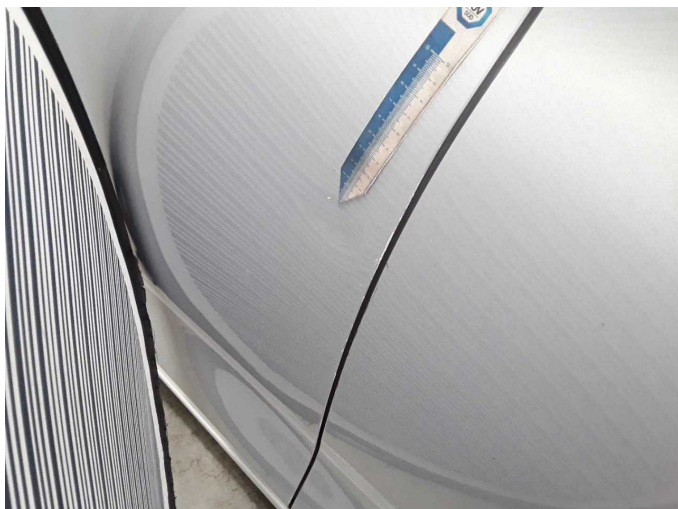
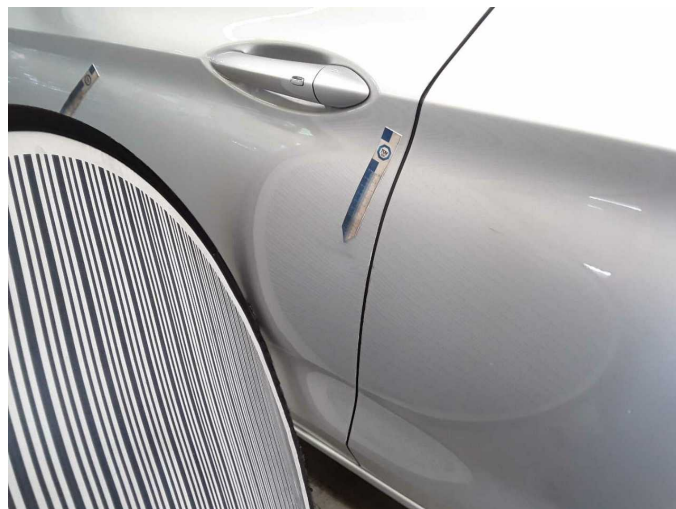
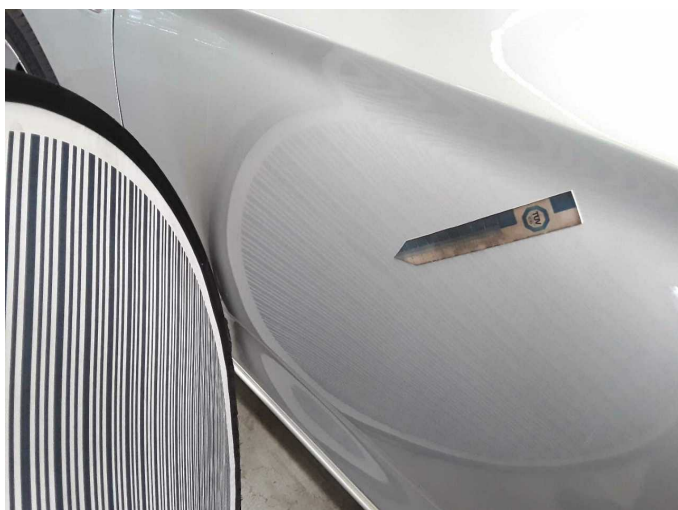
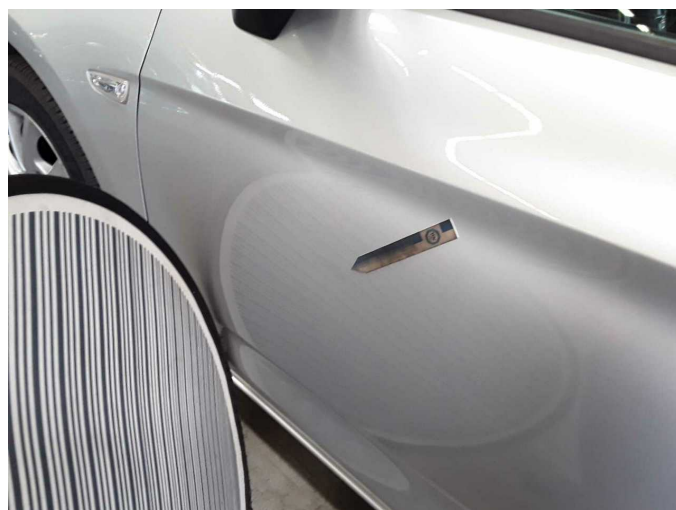
| No. | Component group | Description |
|---|---|---|
| 12 | Door - front left side | Door - Dent / paintcoat damage - Repair and paint |

**Damage 12:** Door - front left side: Door - Dent / paintcoat damage - Repair and paint

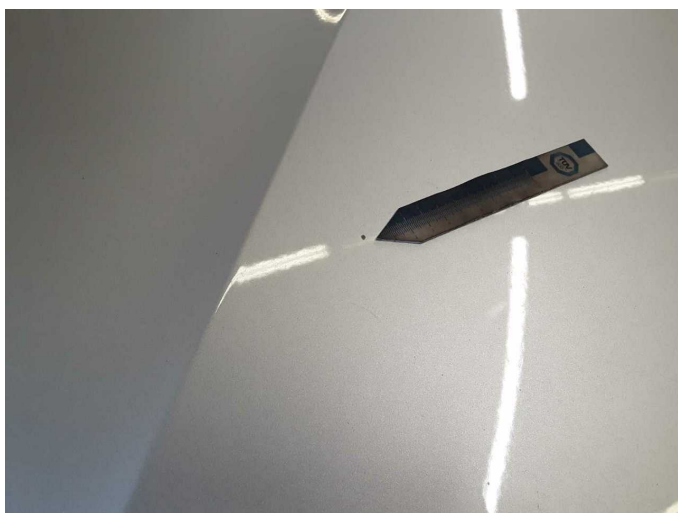
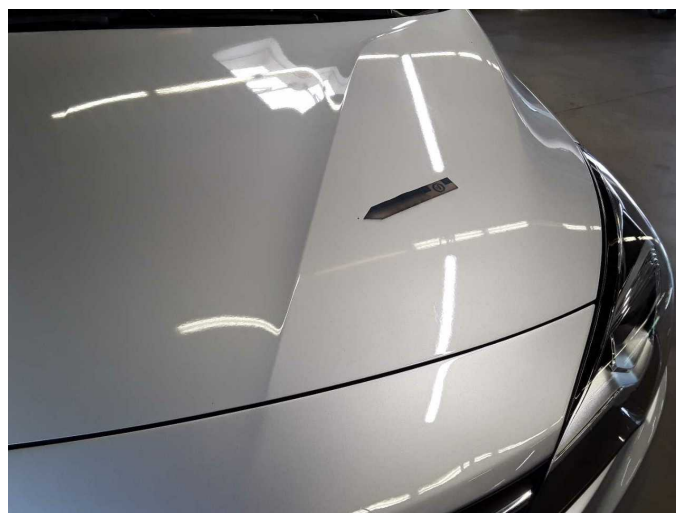
| 1 | Bonnet | Bonnet - Stone chips - No deduction |

**Wear and tear 1:** Bonnet: Bonnet - Stone chips - No deduction

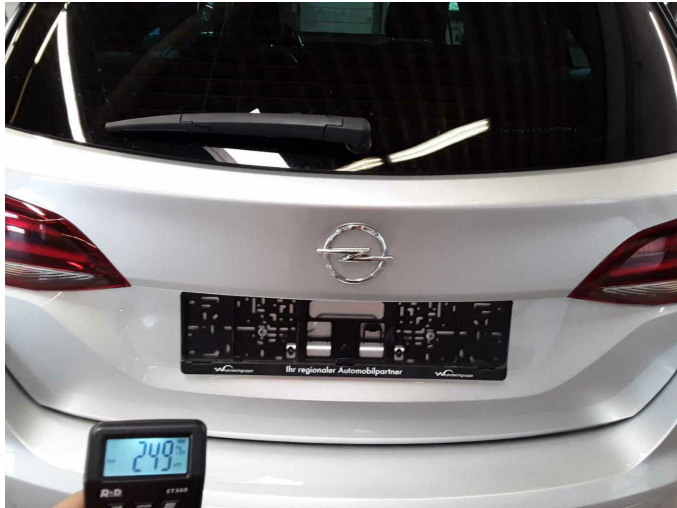
| 1 | Boot lid / rear door, Side panel - rear right side, Door - rear right side, Professionally carried out |

Boot lid / rear door: 249 µm

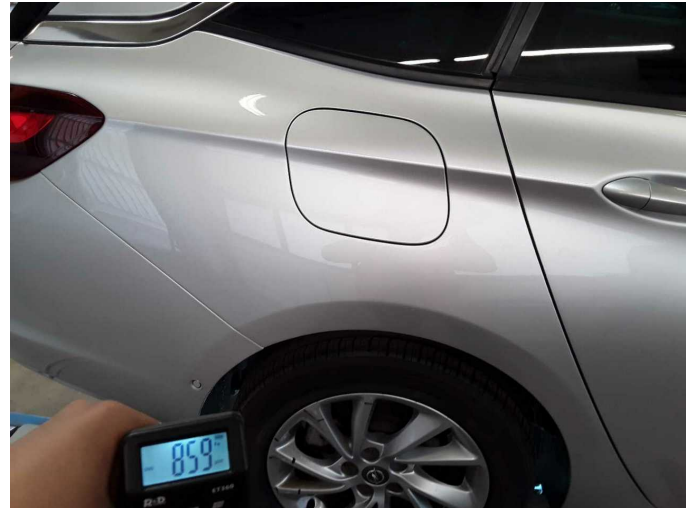
Side panel - rear right side: 859 µm

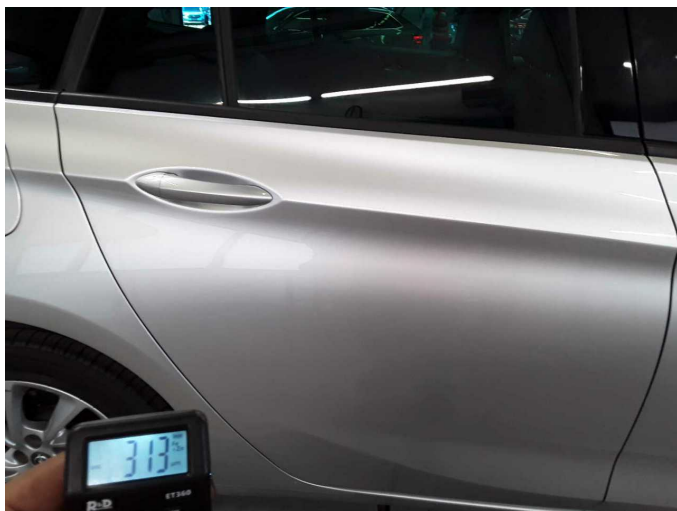
Door - rear right side: 313 µm
