Expertise

Protocol number: 46174457
Order No. / Reference: 26588270
Inspection date: 25 Jun 2026

Model: Vito 116 CDI Extralang HA PRO Kasten

VIN: W1V44760513977316

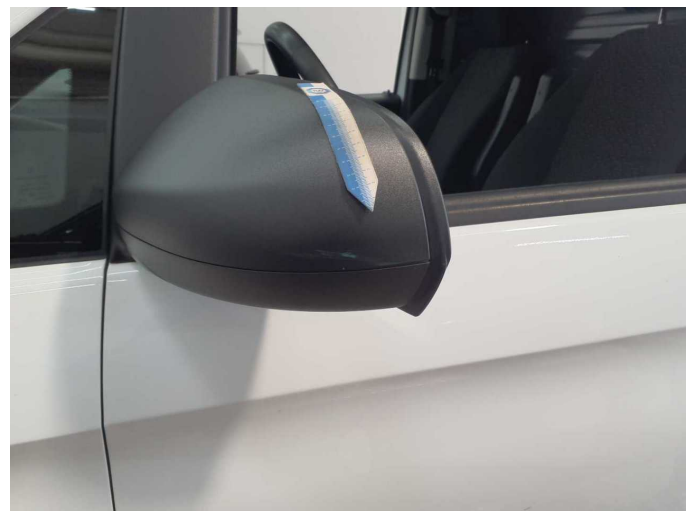
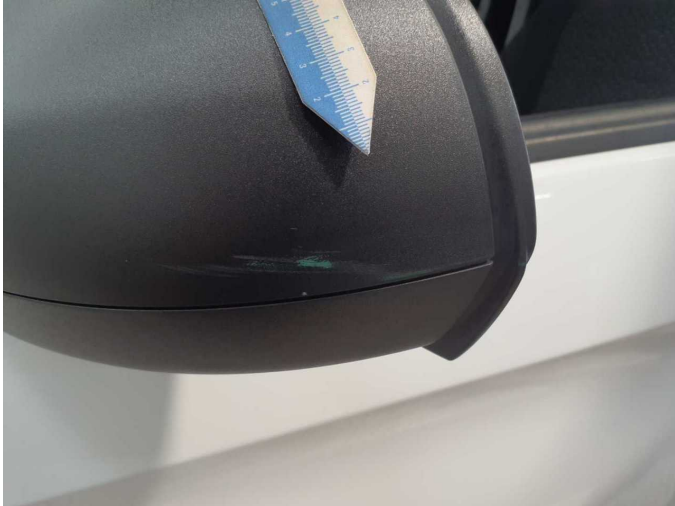
Damage 1: Wing mirror - left side: Mirror housing - Scratch(es) - Loss in value

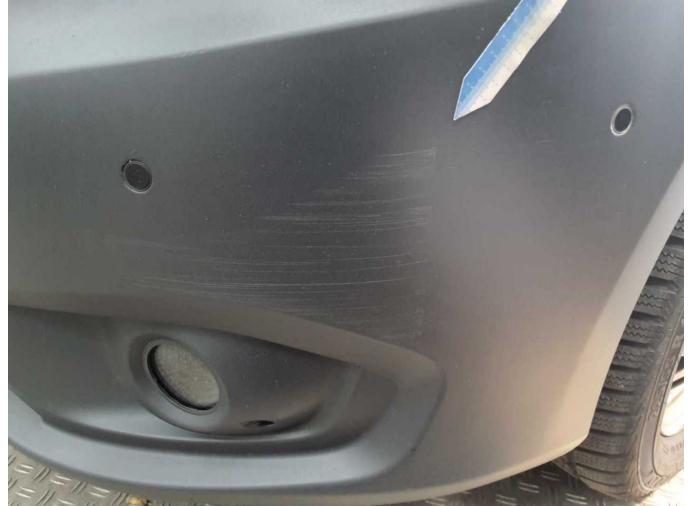
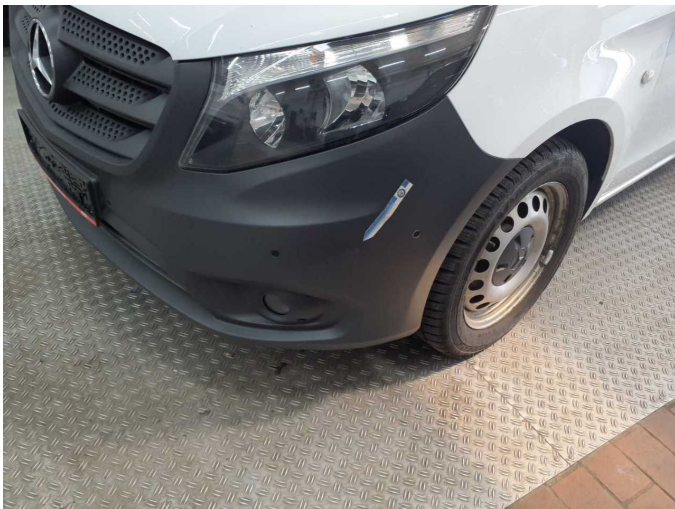
Damage 2: Front bumper: Front bumper - Scratch(es) - Loss in value

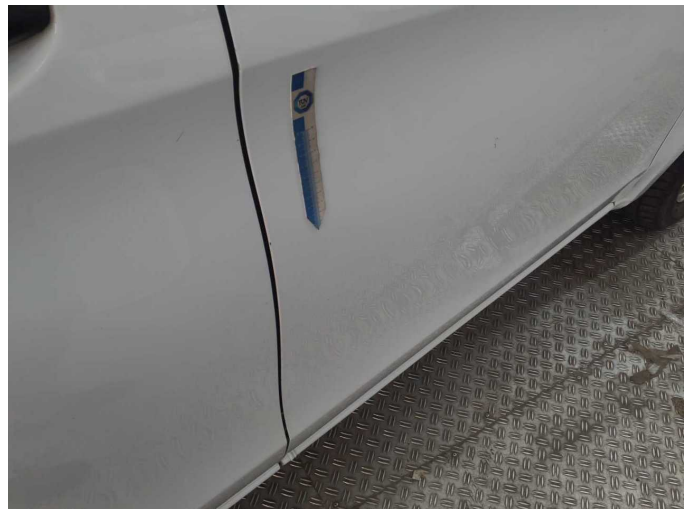
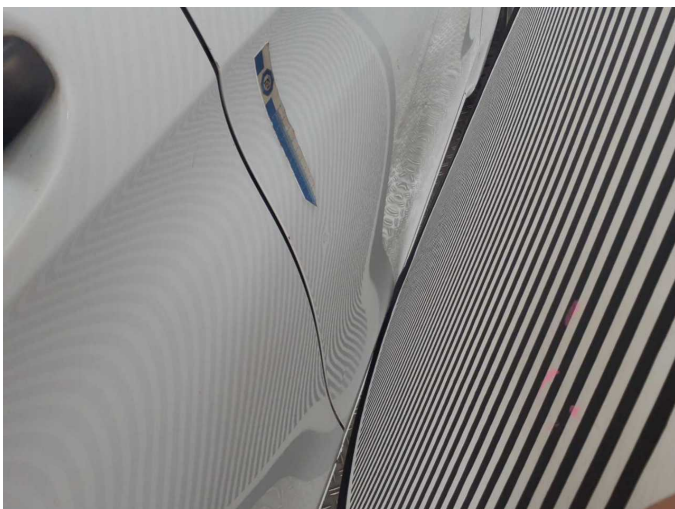
Damage 3: Door - front right side: Door - dent(s) - Smooth repair work

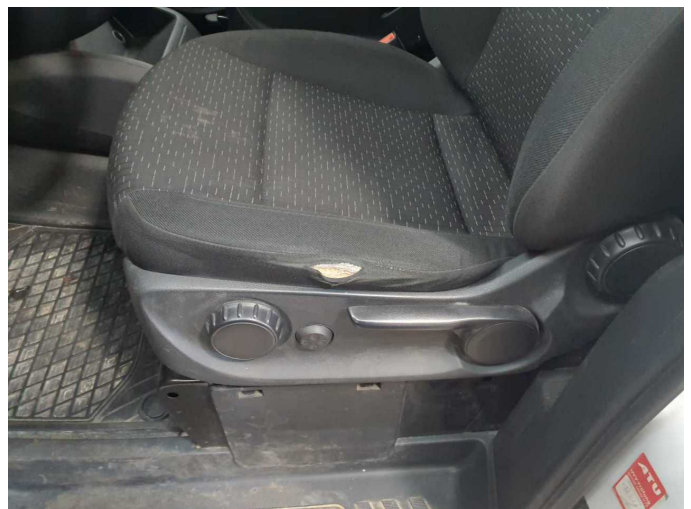
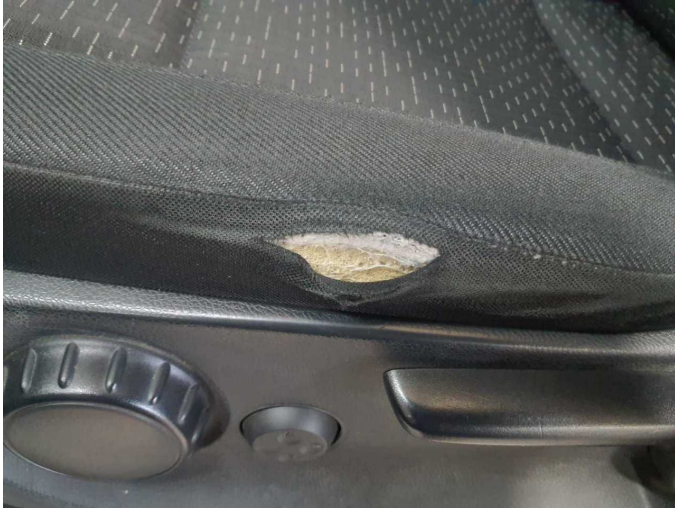
Damage 4: Seat - front: Seat cover - left side - Holes - Smart repair

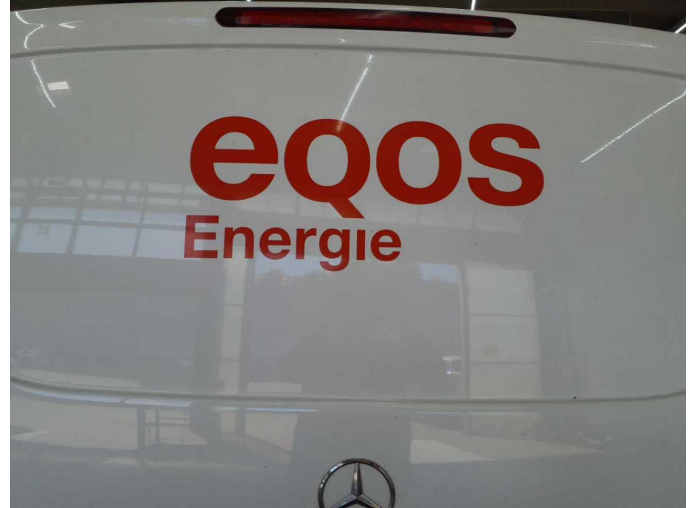
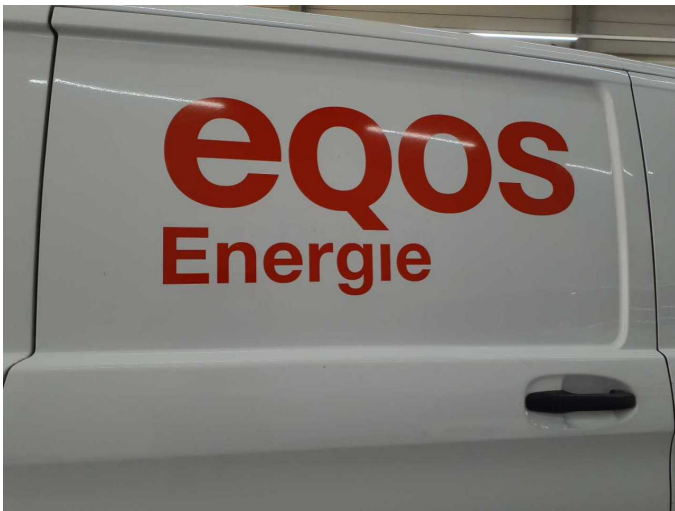
Damage 5: Body: Body - Glued / labelled - De-glude / neutralise

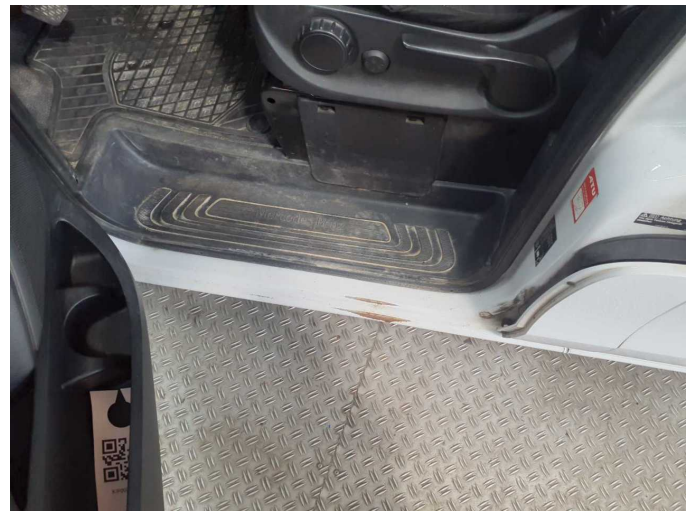
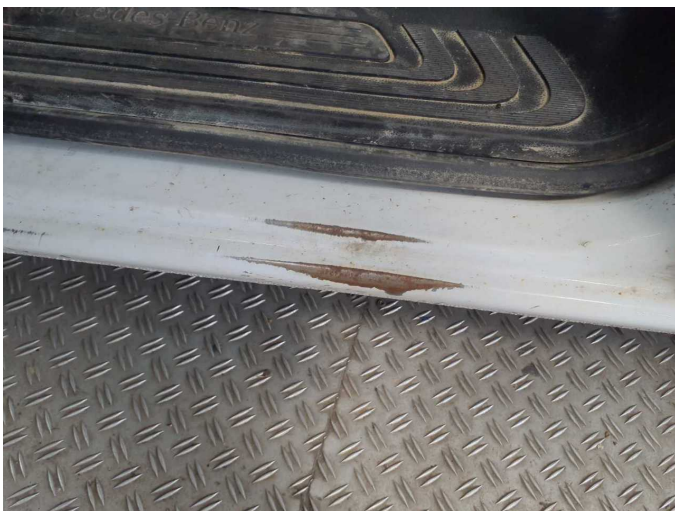
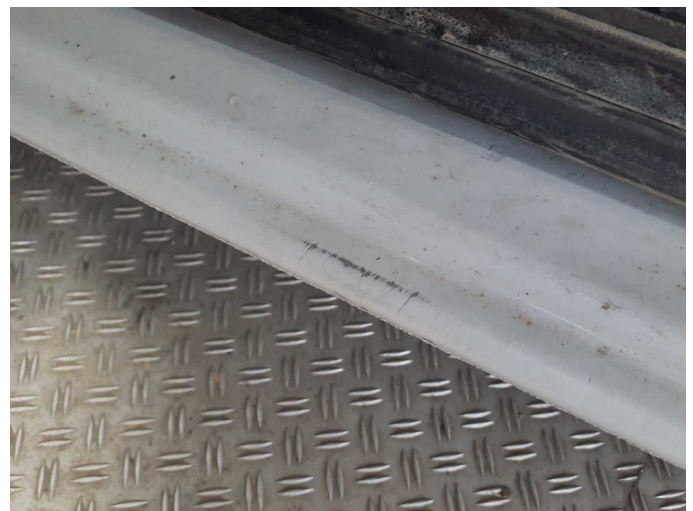
Damage 6: Sill - left side: Sill - Corrosion - Repair and paint

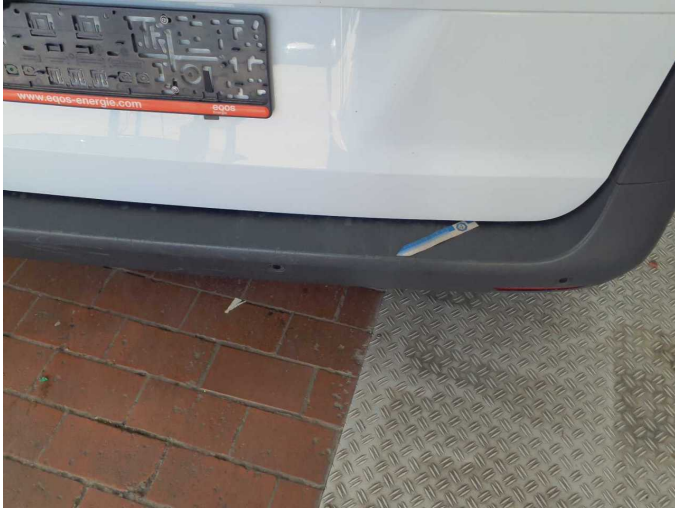
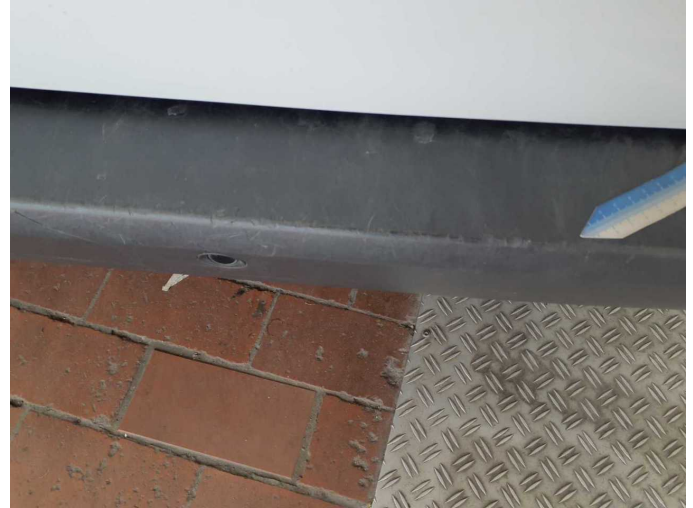
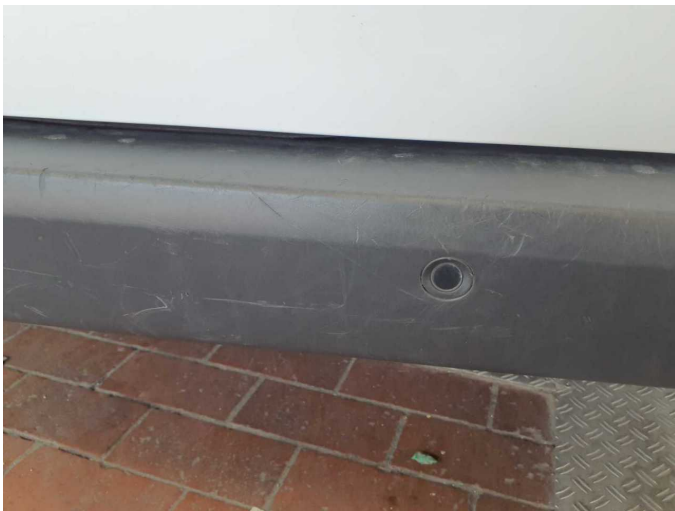
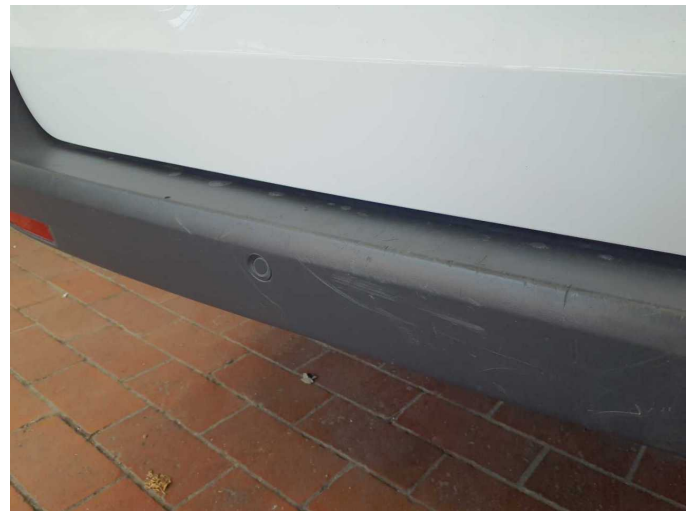
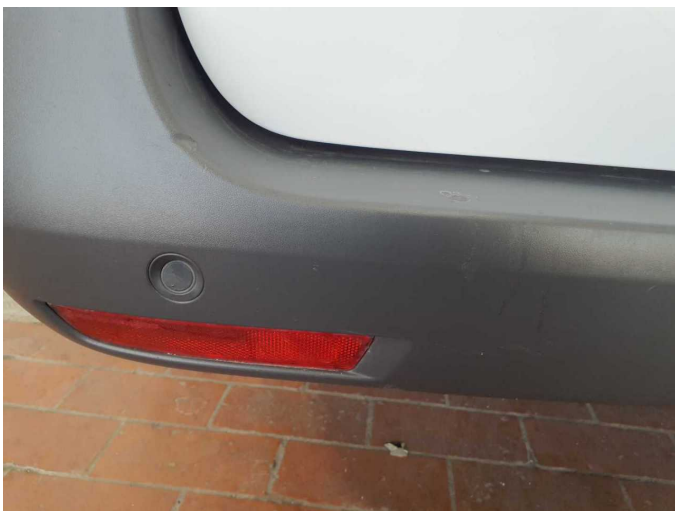
Damage 7: Rear bumper: Rear bumper - Scratched - Replace

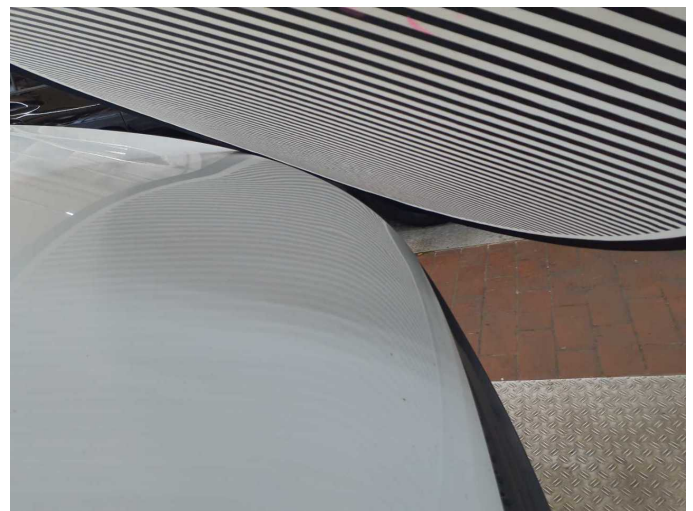
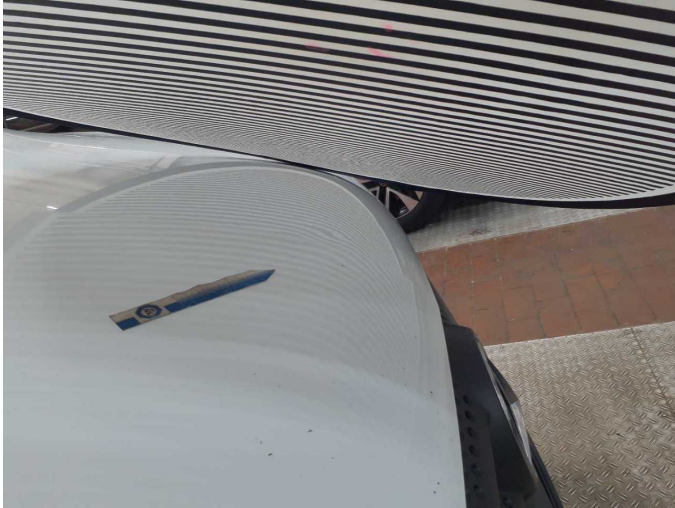
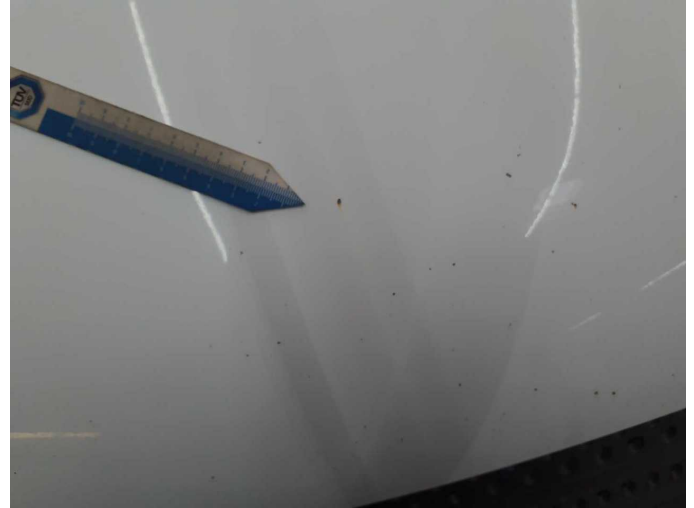
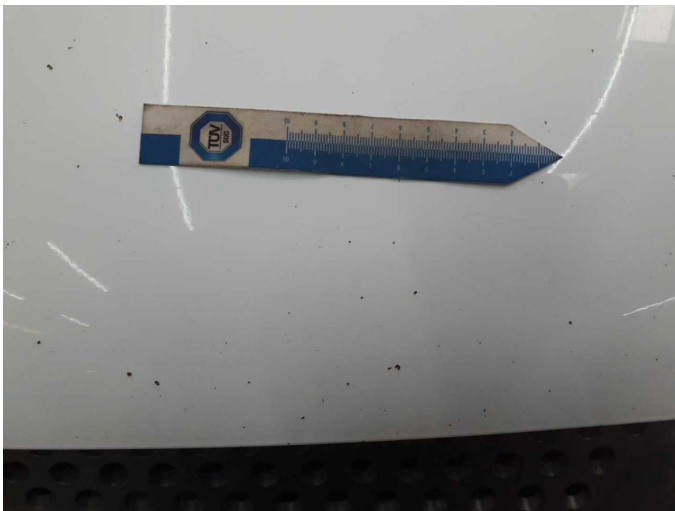
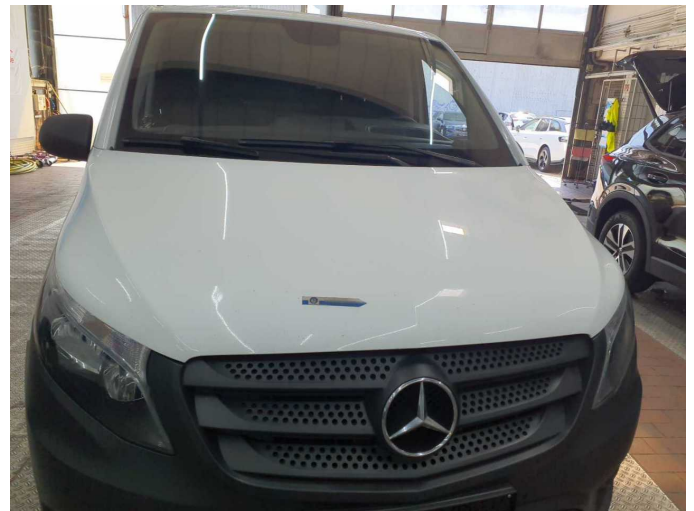
Damage 8: Bonnet: Bonnet - Dent / paintcoat damage - Repair and paint

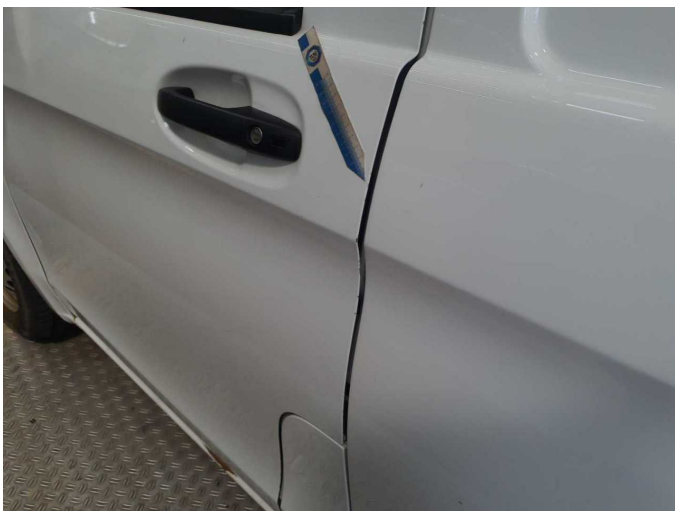
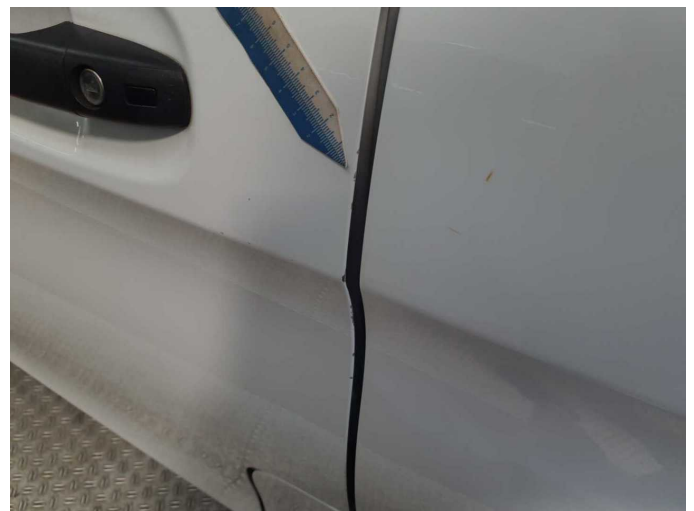
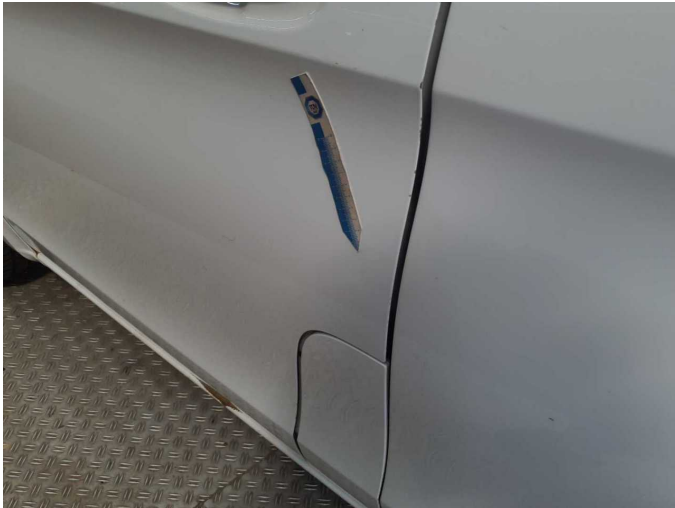
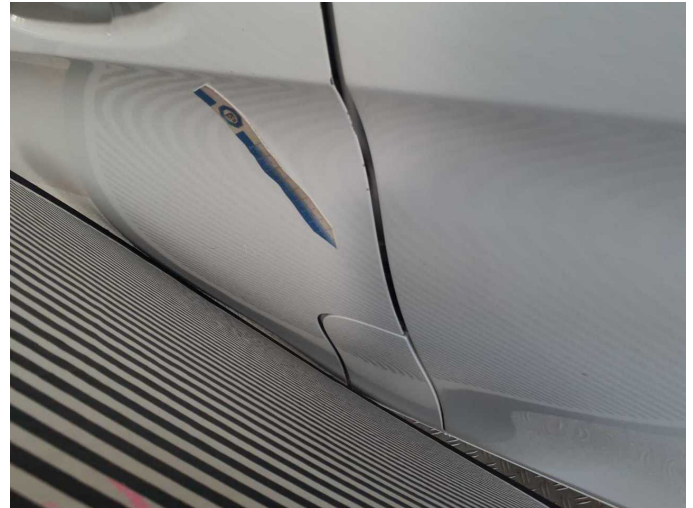
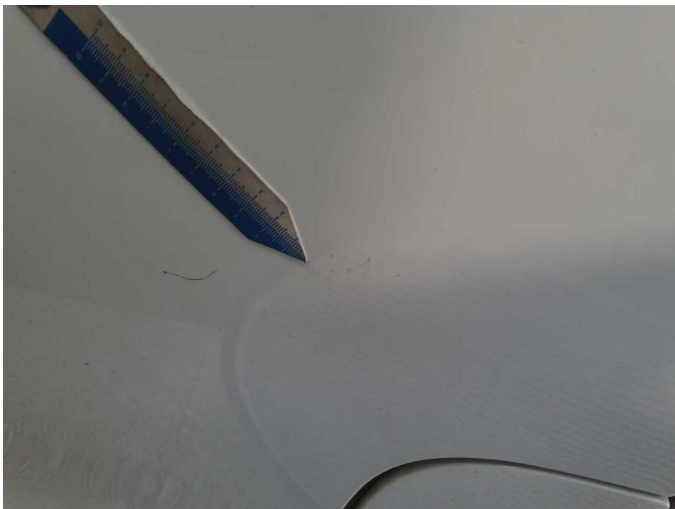
Damage 9: Door - front left side: Door - Dent / paintcoat damage - Repair and paint

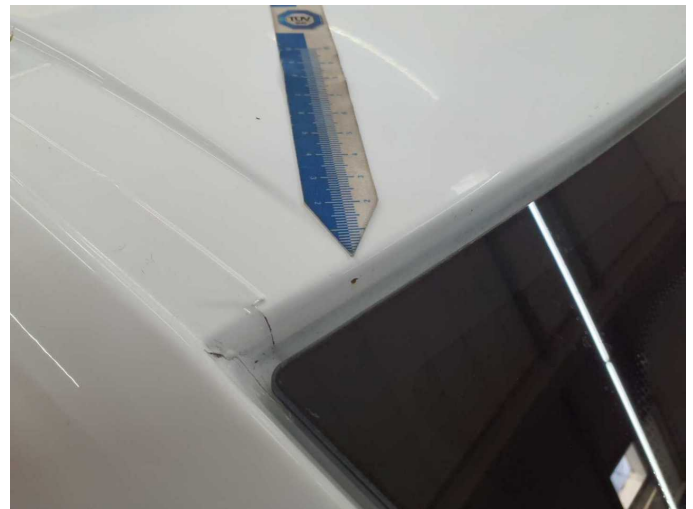
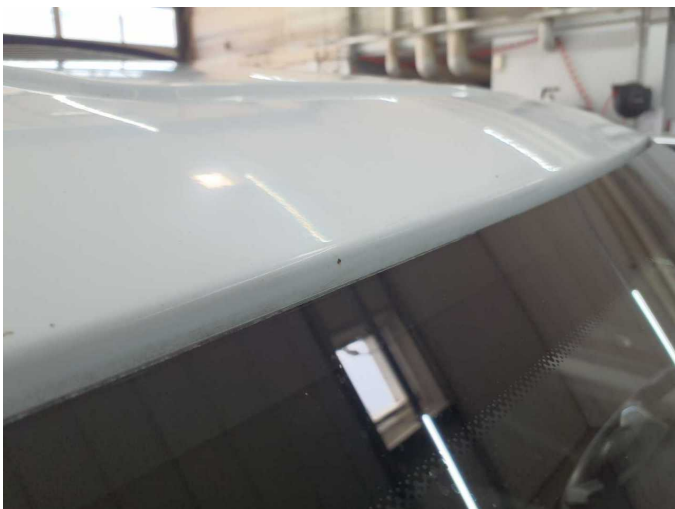
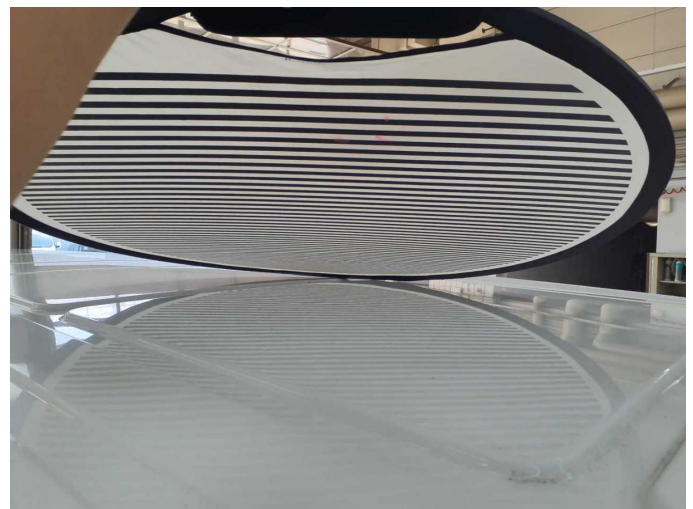
Damage 10: Roof: Roof - Dent / paintcoat damage - Repair and paint

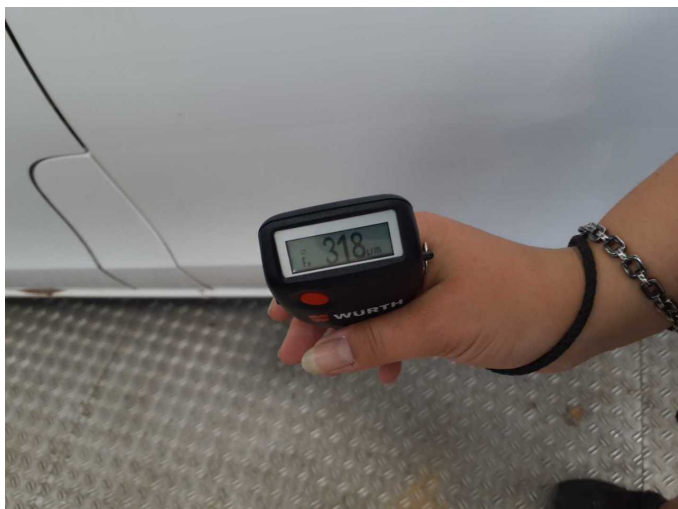
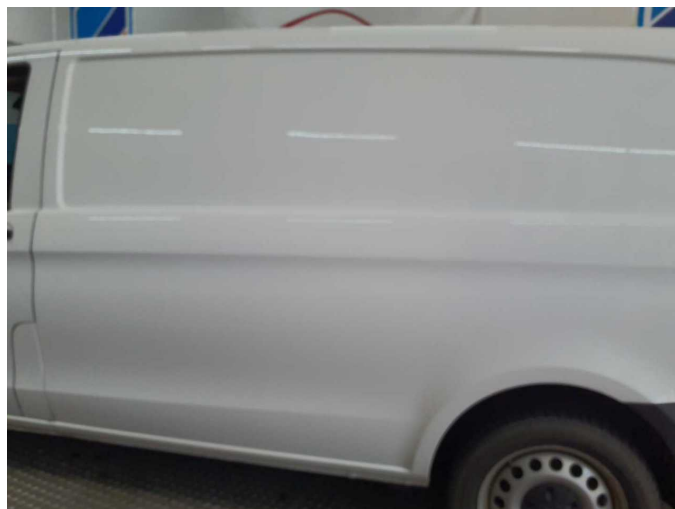
Side panel - rear right side 318 μm |

Repainting 1: Side panel - rear right side
