Expertise

Protocol number: 46053741  
Order No. / Reference: 26308092  
Inspection date: 20 Jun 2026

Manufacturer: Opel

Model: Astra Sports Tourer 1.2 Turbo Automatik GS

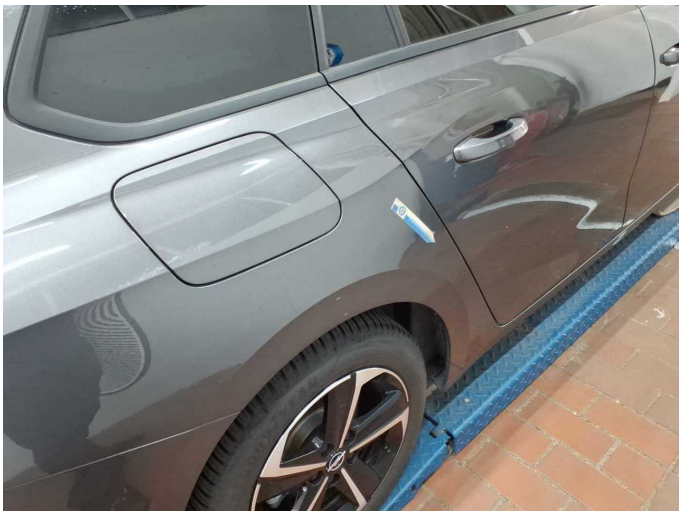
| No. | Component group | Description |
|---|---|---|
| 1 | Side panel - rear right side | Side panel - dent(s) - Smooth repair work |

Damage 1: Side panel - rear right side: Side panel - dent(s) - Smooth repair work

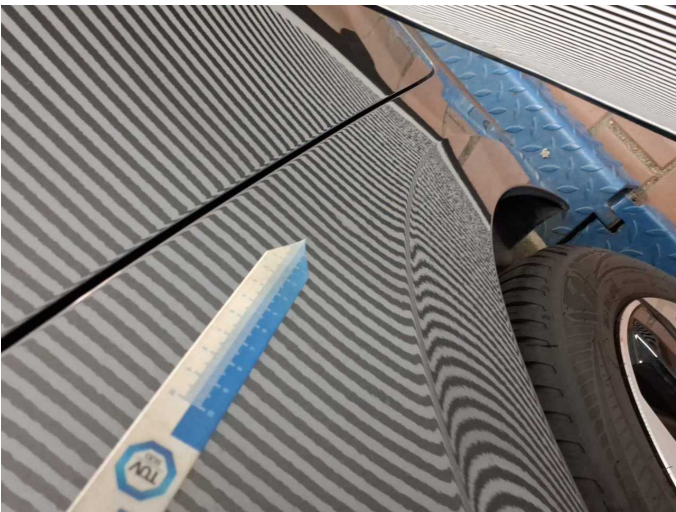
Damage 1: Side panel - rear right side: Side panel - dent(s) - Smooth repair work

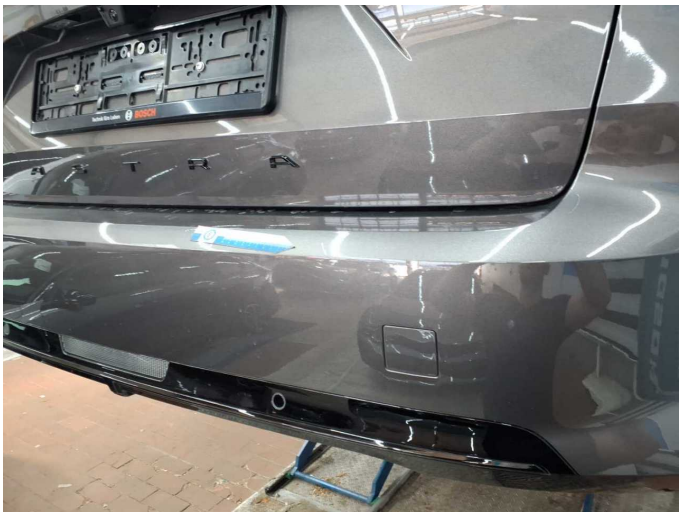
| No. | Component group | Description |
|---|---|---|
| 2 | Rear bumper | Rear bumper - Scratch(es) - Smart repair |

Damage 2: Rear bumper: Rear bumper - Scratch(es) - Smart repair

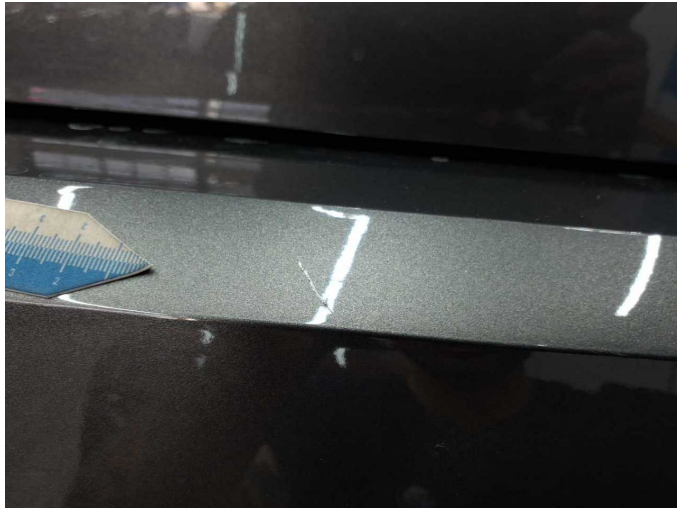
**Damage 2:** Rear bumper: Rear bumper - Scratch(es) - Smart repair

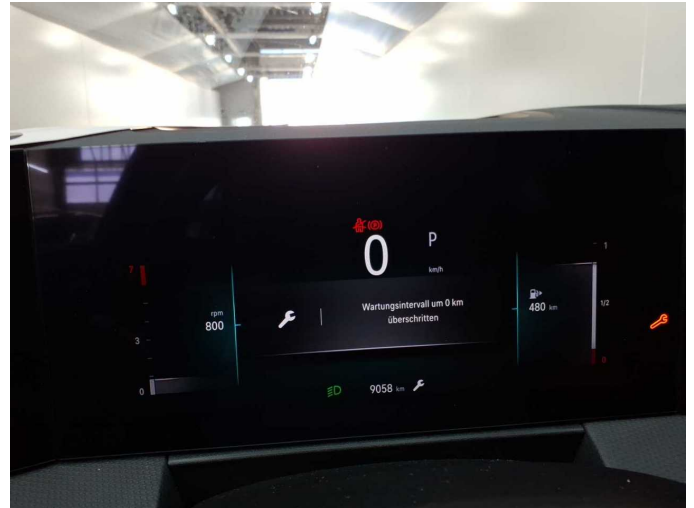
| No. | Component group | Description |
|---|---|---|
| 3 | Misc. | Inspection / maintenance - Due - Replace |

**Damage 3:** Misc.: Inspection / maintenance - Due - Replace

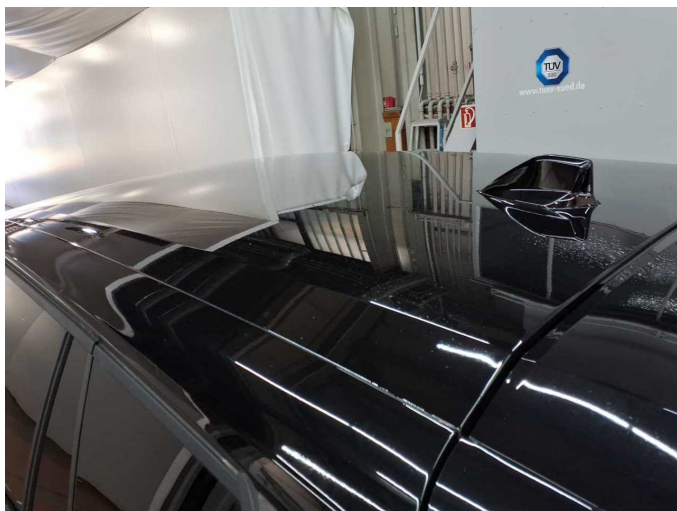
| No. | Component group | Description |
|---|---|---|
| 4 | Roof | Roof (Anhaftung hartz) - Paint defect - Paint |

**Damage 4:** Roof: Roof (Anhaftung hartz) - Paint defect - Paint

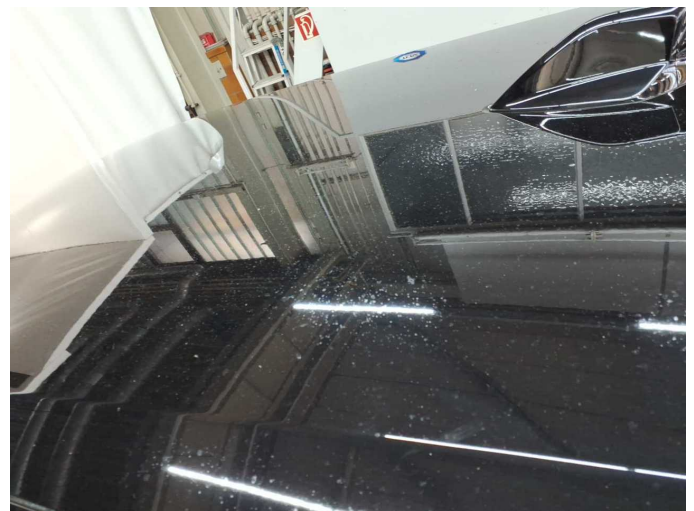
**Damage 4:** Roof: Roof (Anhaftung hartz) - Paint defect - Paint

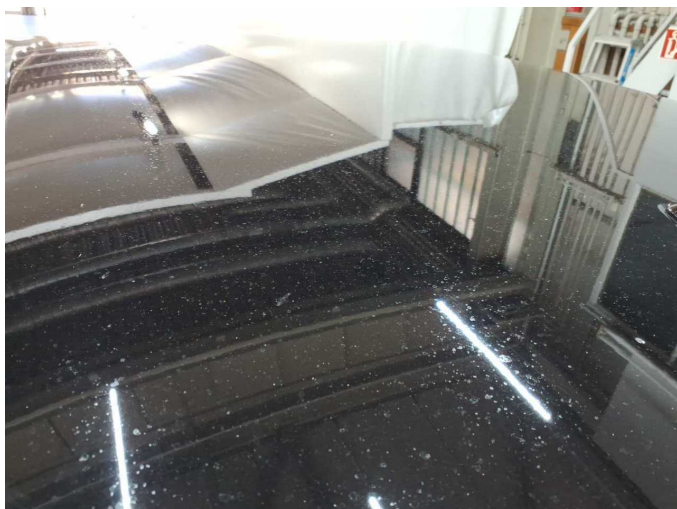
**Damage 4:** Roof: Roof (Anhaftung hartz) - Paint defect - Paint

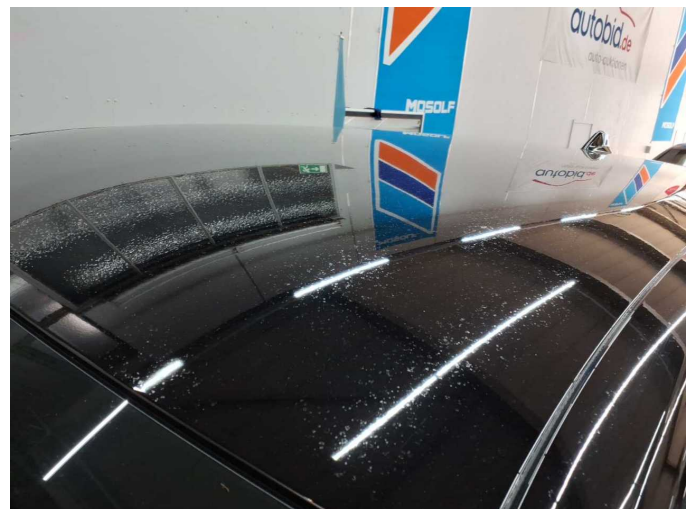
**Damage 4:** Roof: Roof (Anhaftung hartz) - Paint defect - Paint
