Expertise

Protocol number: 46175414  
Order No. / Reference: 26568445  
Inspection date: 24 Jun 2026

| Manufacturer: Ford | Model: Focus Turnier 1.5 EcoBlue Start-Stopp-System Aut. TITANIUM |
| VIN: WF0PXXGCHPPE77000 | |

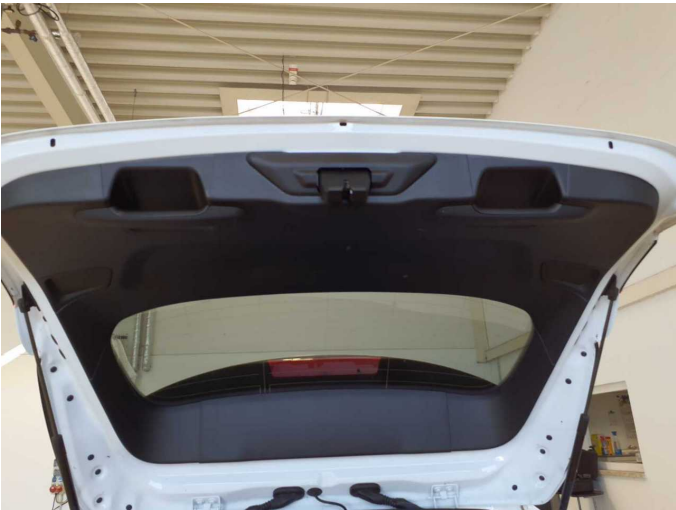
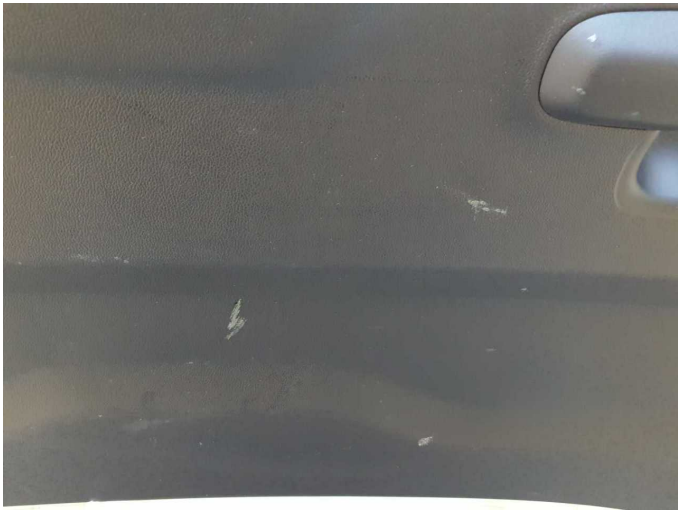
| No. | Component group | Description |
|---|---|---|
| 2 | Trim / covers | Boot lid - interior trim - Scratch(es) - Loss in value |

Damage 2: Trim / covers: Boot lid - interior trim - Scratch(es) - Loss in value

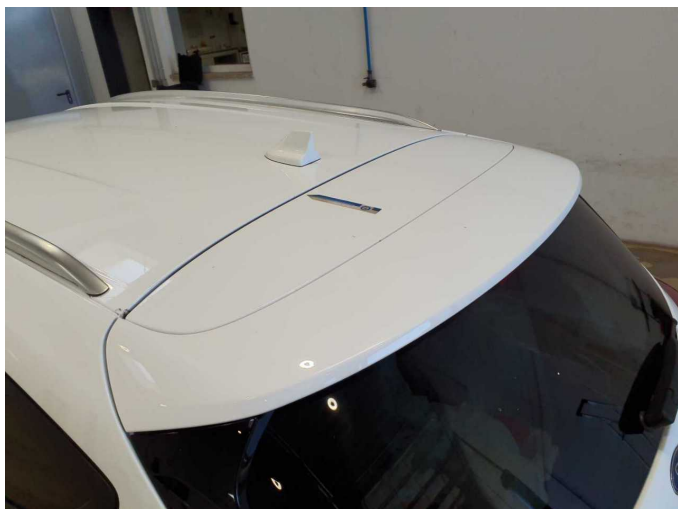
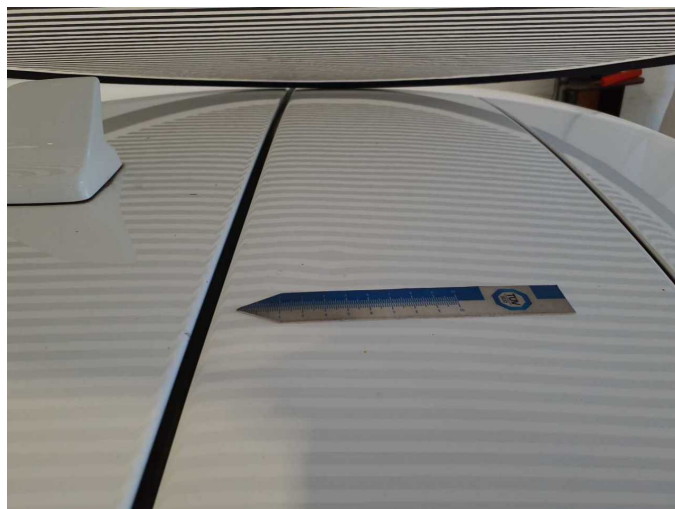
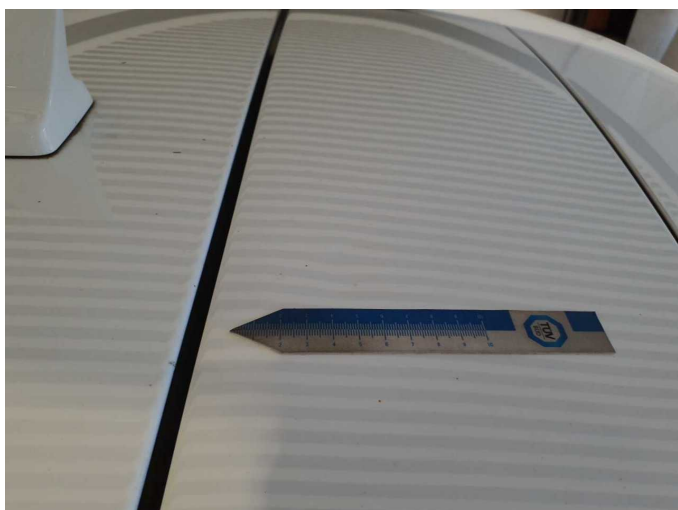
| No. | Component group | Description |
|---|---|---|
| 3 | Boot lid / rear door | Rear spoiler - dent(s) - Smooth repair work |

**Damage 3:** Boot lid / rear door: Rear spoiler - dent(s) - Smooth repair work

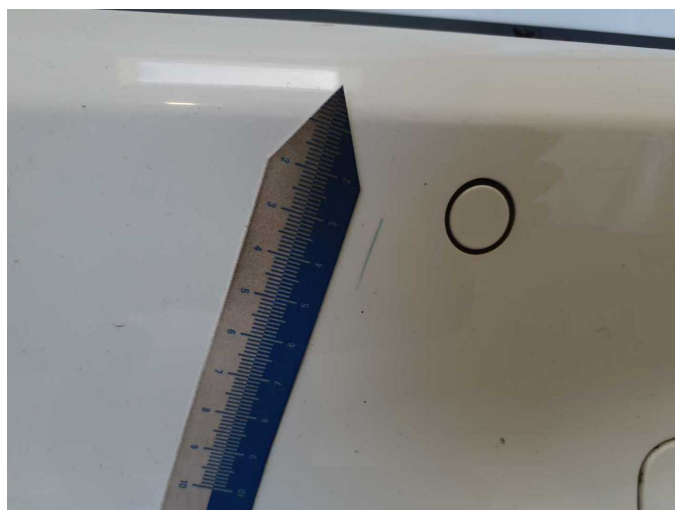
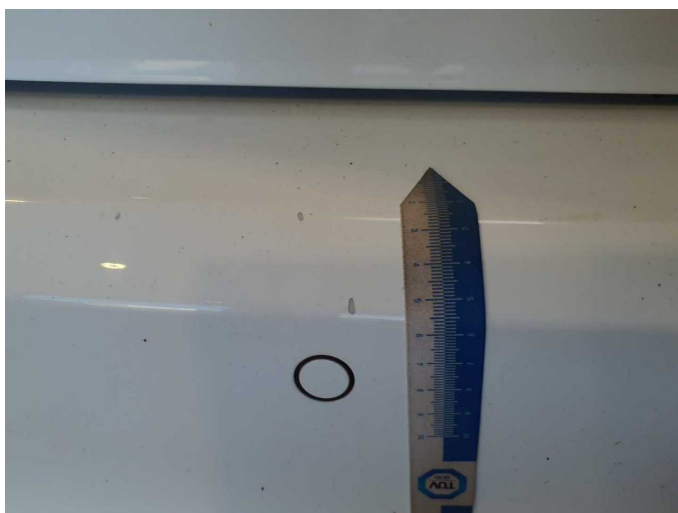
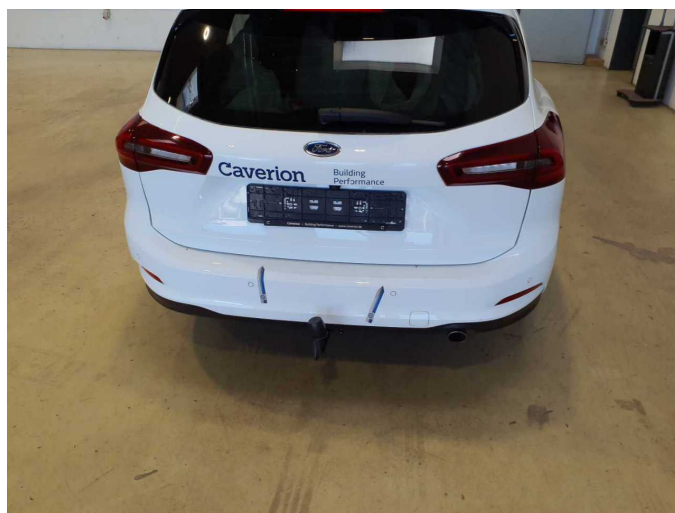
| No. | Component group | Description |
|---|---|---|
| 4 | Rear bumper | Rear bumper - Scratch(es) - Smart repair |

**Damage 4:** Rear bumper: Rear bumper - Scratch(es) - Smart repair

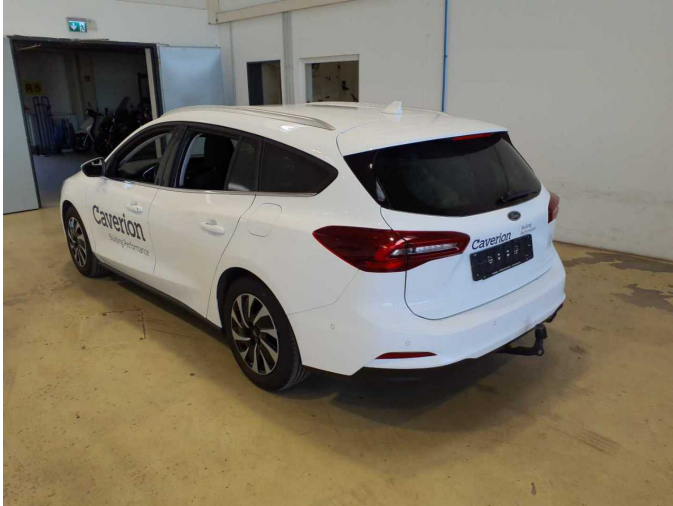
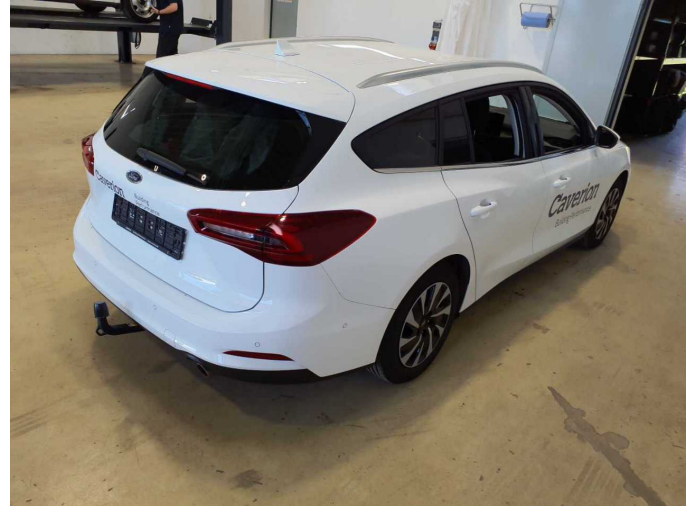
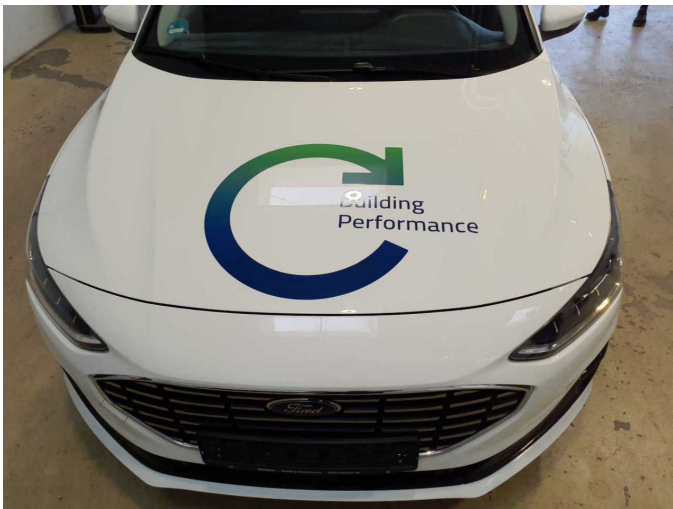
| No. | Component group | Description |
|---|---|---|
| 6 | Body | Body - Glued / labelled - De-glue / neutralise |

**Damage 6:** Body: Body - Glued / labelled - De-glue / neutralise
