Expertise

Protocol number: 46444422  
Order No. / Reference: 26479613-1  
Inspection date: 3 Jun 2026

| Manufacturer: Peugeot | Model: 5008 BlueHDi 180 EAT8 GT Pack |

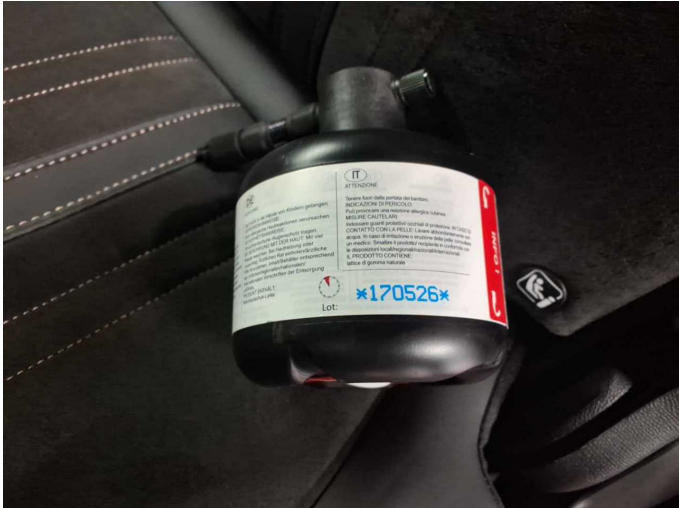
| No. | Component group | Description |
|---|---|---|
| 1 | Equipment | Tirefit filler - Expired - Replace |

Damage 1: Equipment: Tirefit filler - Expired - Replace

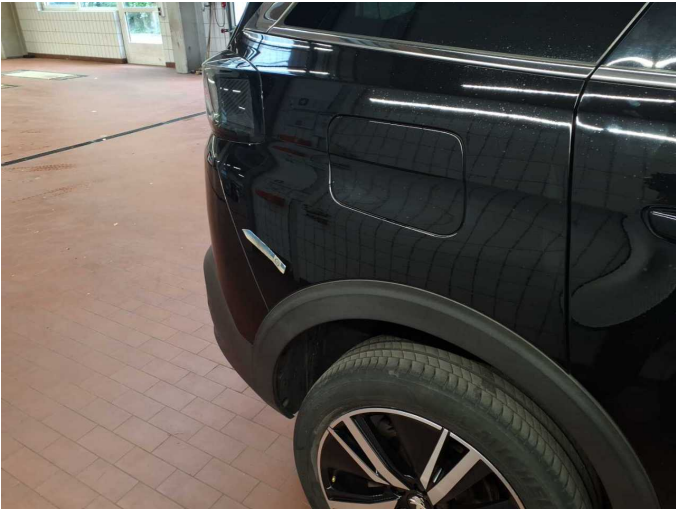
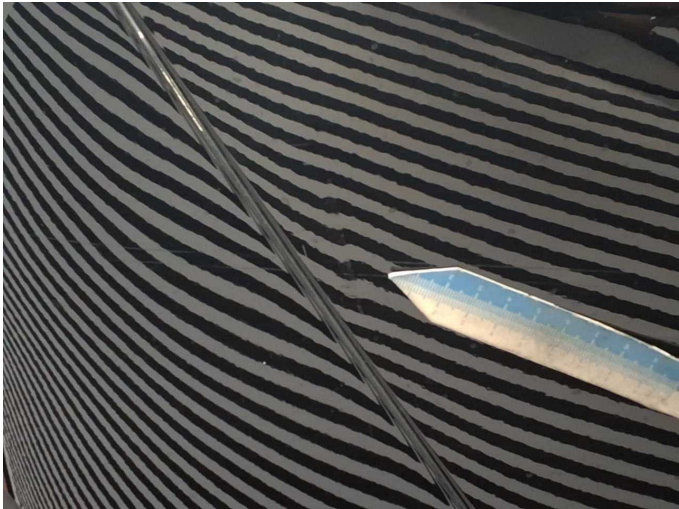
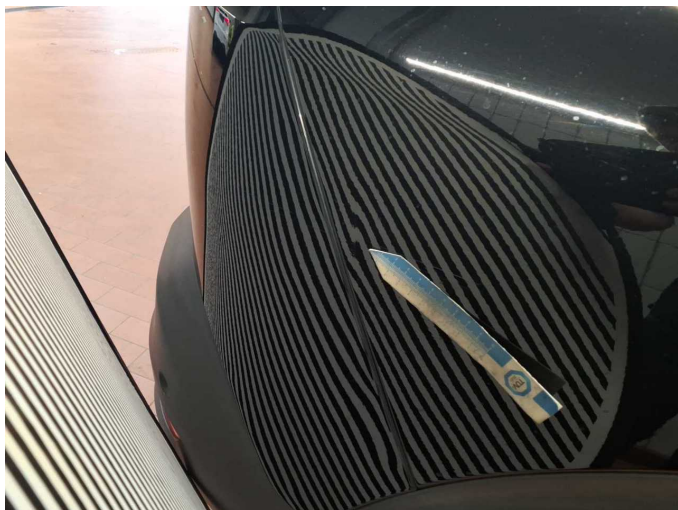
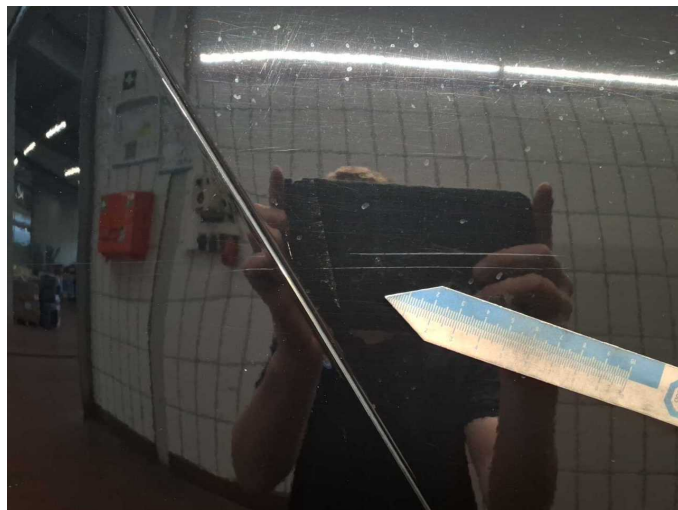
| No. | Component group | Description |
|---|---|---|
| 2 | Side panel - rear right side | Side panel - dent(s) - Smooth repair work |

Damage 2: Side panel - rear right side: Side panel - dent(s) - Smooth repair work

**Damage 2:** Side panel - rear right side: Side panel - dent(s) - Smooth repair work

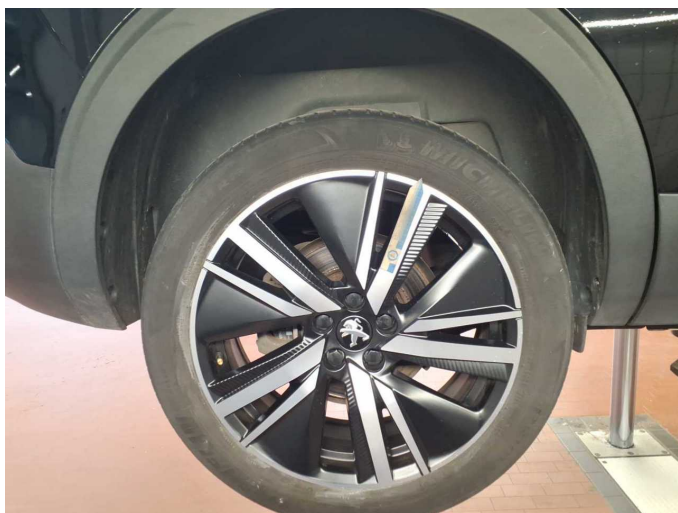
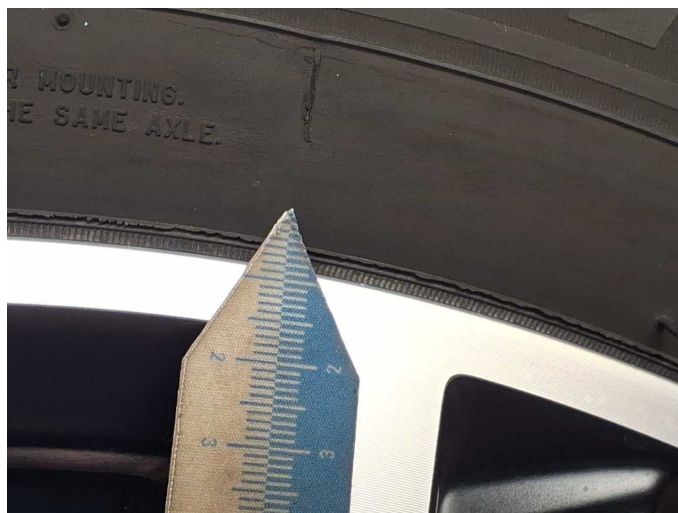
| No. | Component group | Description |
|---|---|---|
| 3 | Wheel / tyres | Tyre - rear right side - Broken / torn - Replace |

**Damage 3:** Wheel / tyres: Tyre - rear right side - Broken / torn - Replace

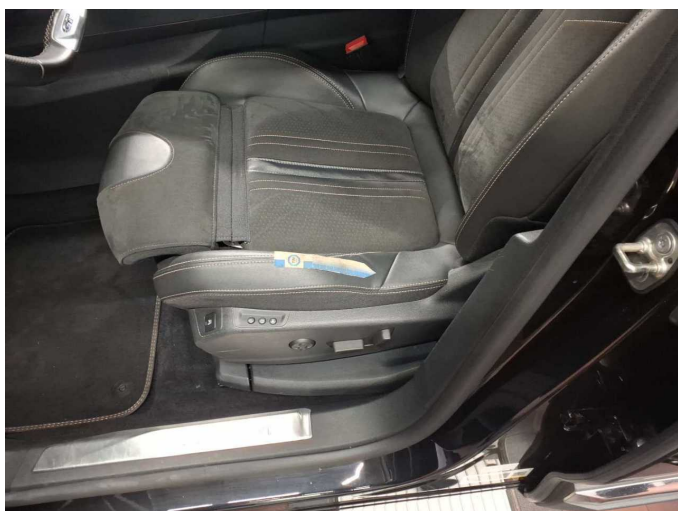
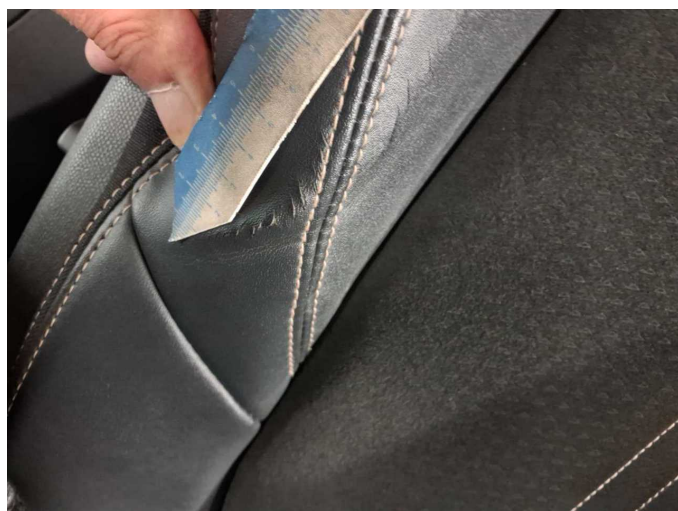
| No. | Component group | Description |
|---|---|---|
| 4 | Seat - front | Seat cover - left side - Porous / cracked - Smart repair |

**Damage 4:** Seat - front: Seat cover - left side - Porous / cracked - Smart repair

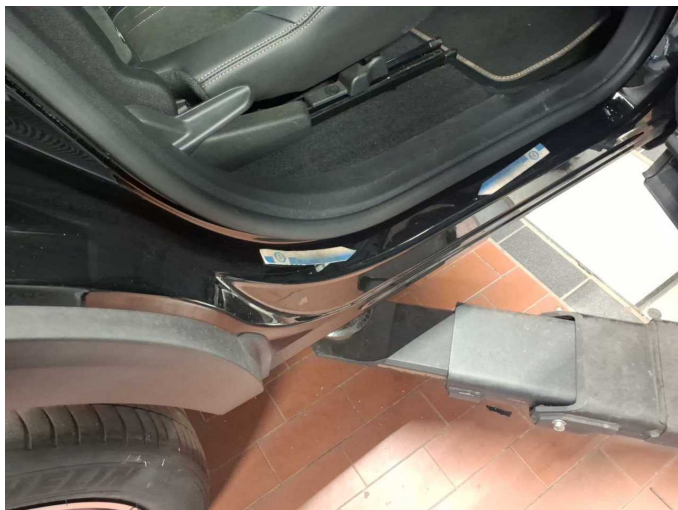
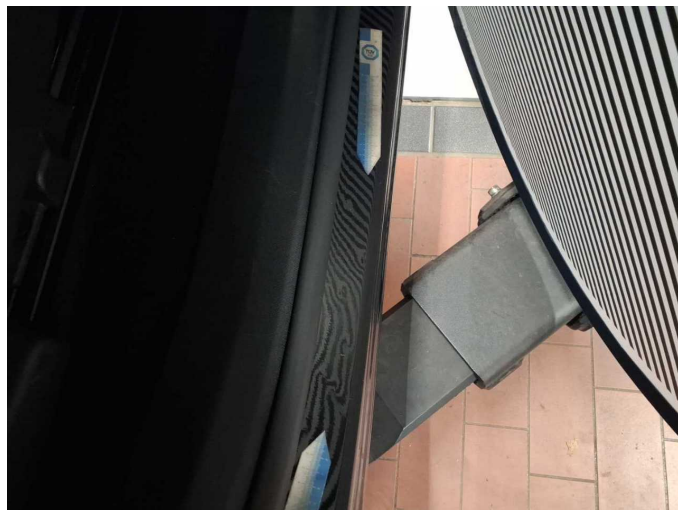
| No. | Component group | Description |
|---|---|---|
| 5 | Side panel - rear right side | Sill - dent(s) - Smooth repair work |

**Damage 5:** Side panel - rear right side: Sill - dent(s) - Smooth repair work

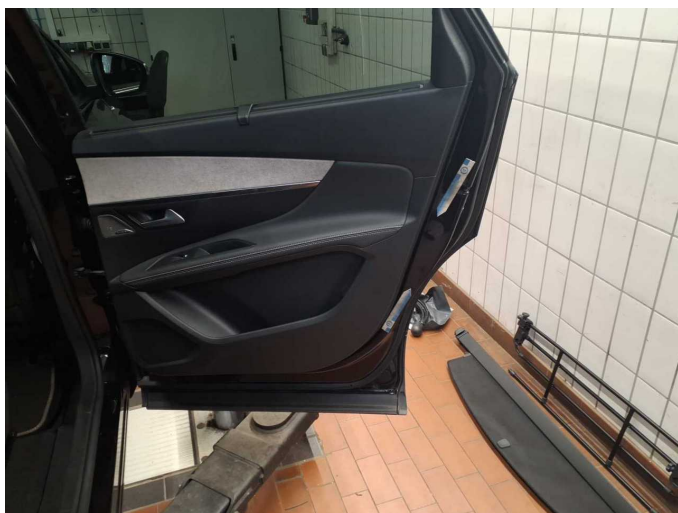
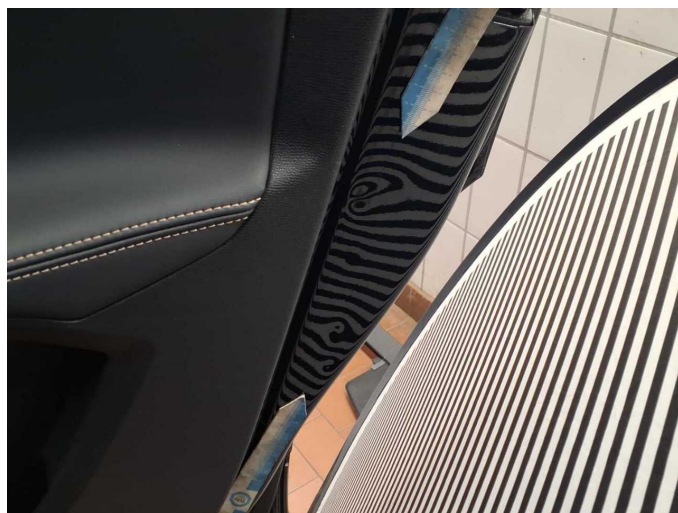
| No. | Component group | Description |
|---|---|---|
| 6 | Door - rear right side | Door - dent(s) - Smooth repair work |

**Damage 6:** Door - rear right side: Door - dent(s) - Smooth repair work

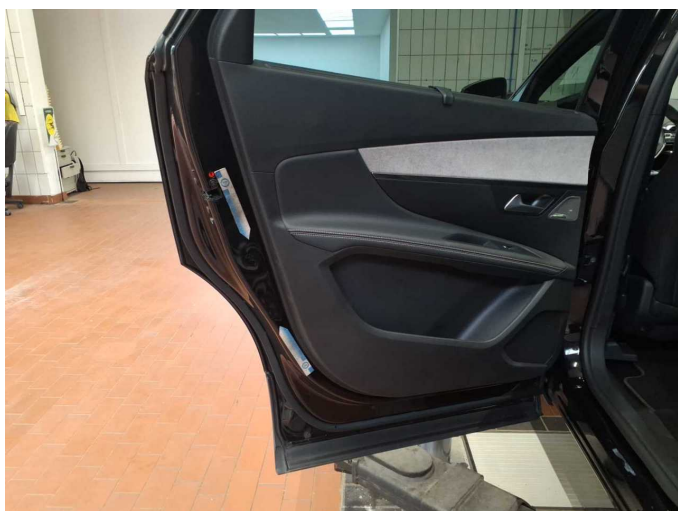
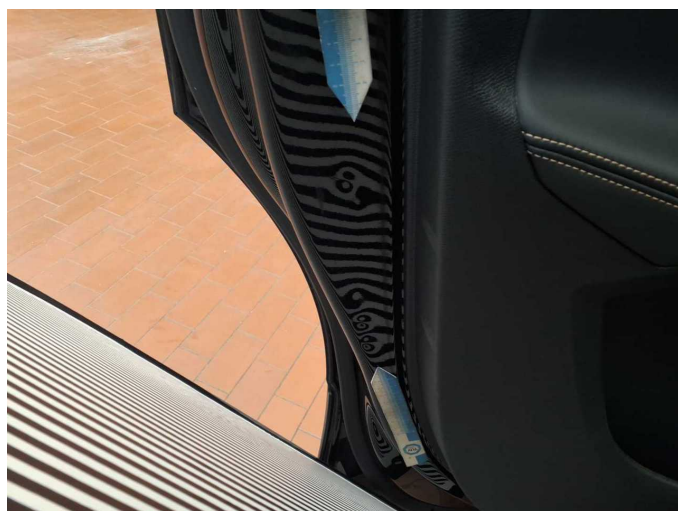
| No. | Component group | Description |
|---|---|---|
| 7 | Door - rear left side | Door - dent(s) - Smooth repair work |

**Damage 7:** Door - rear left side: Door - dent(s) - Smooth repair work

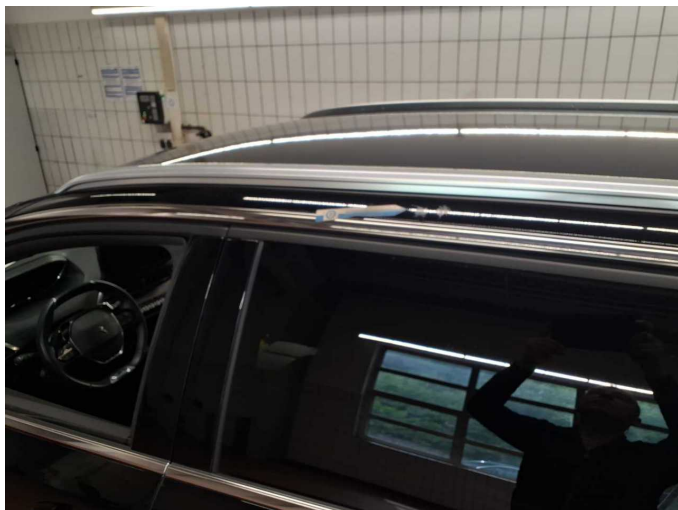
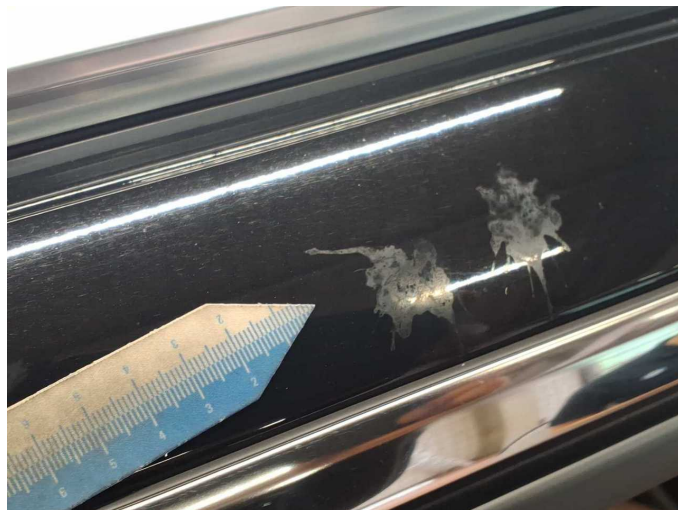
| No. | Component group | Description |
|---|---|---|
| 8 | Roof | Roof rail - left side (Verätzungen) - Paint defect - Paint |

**Damage 8:** Roof: Roof rail - left side (Verätzungen) - Paint defect - Paint

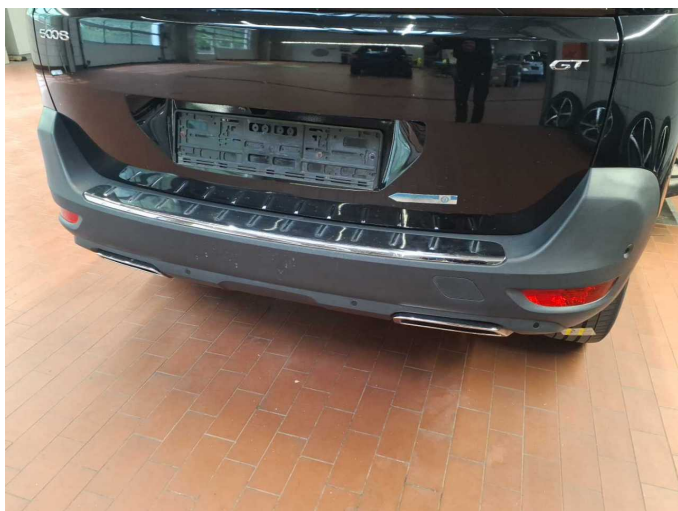
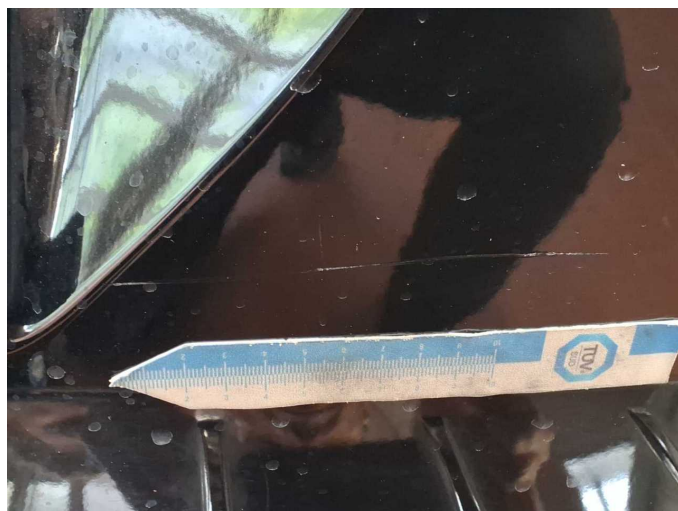
| No. | Component group | Description |
|---|---|---|
| 9 | Boot lid / rear door | Boot lid - Scratch(es) - Paint |

**Damage 9:** Boot lid / rear door: Boot lid - Scratch(es) - Paint

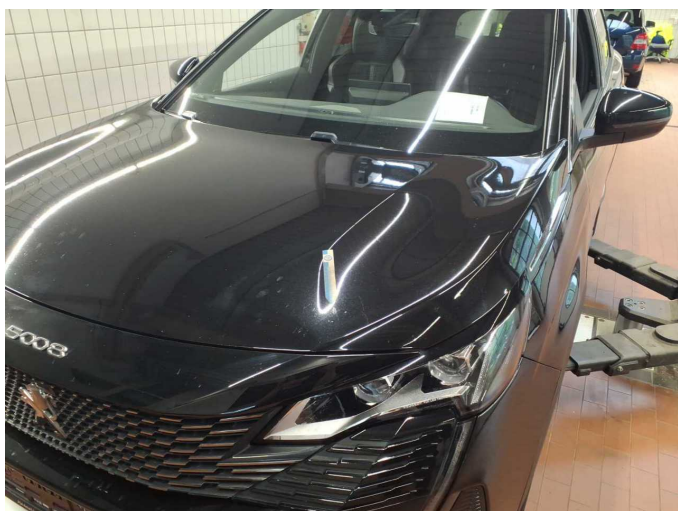
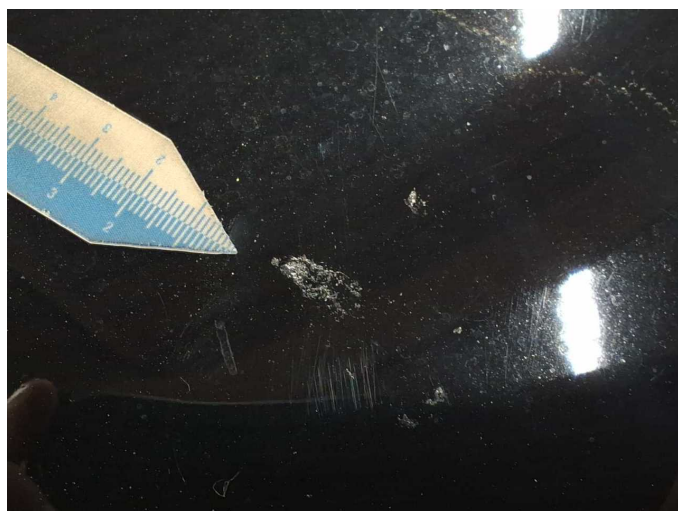
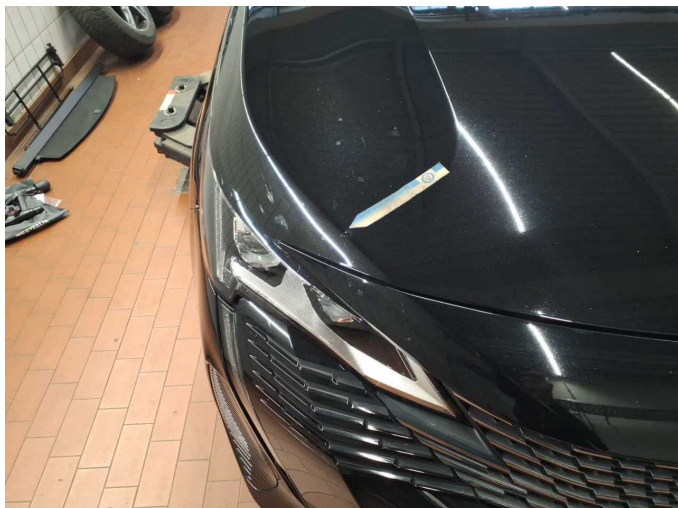
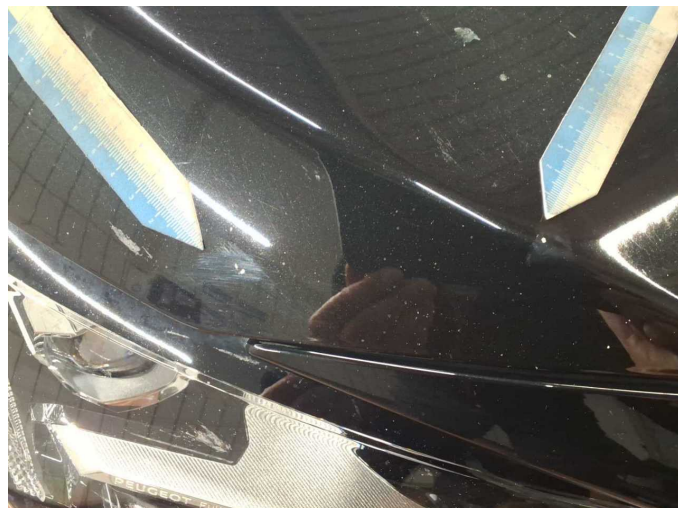
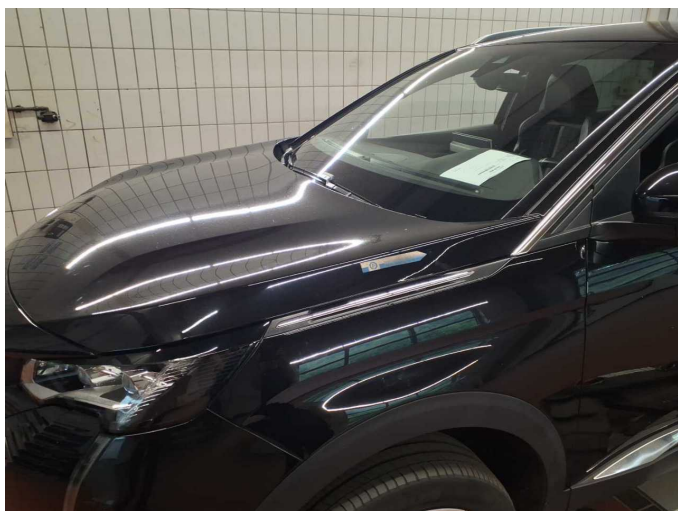
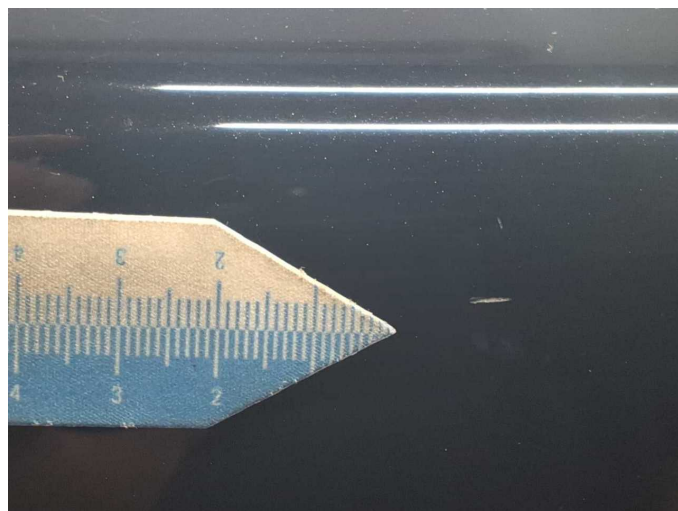
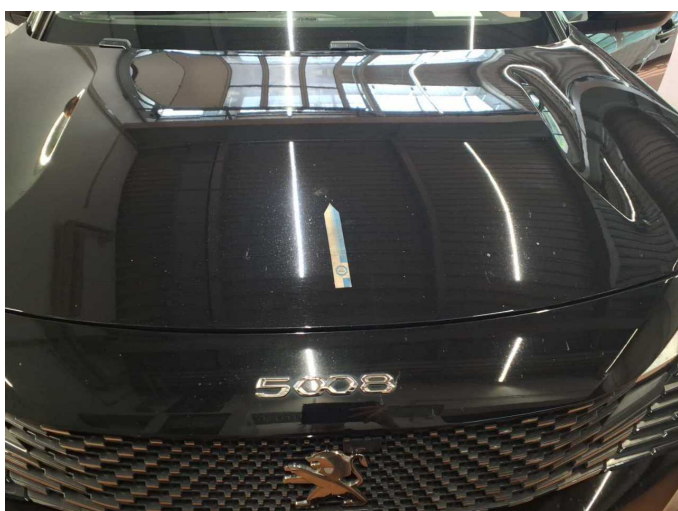
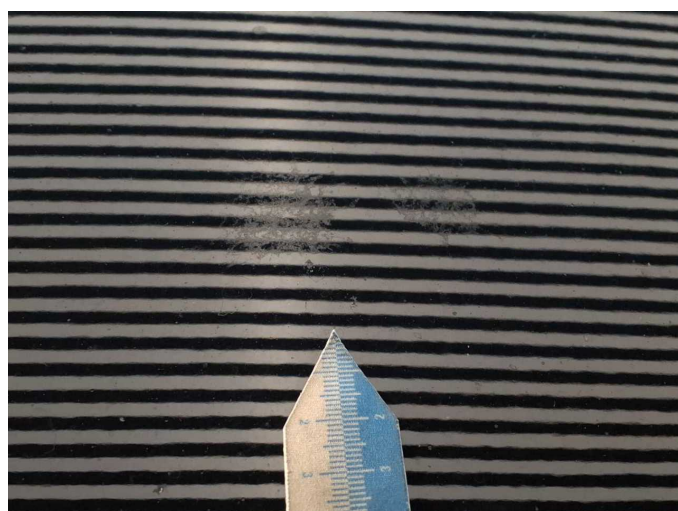
| No. | Component group | Description |
|---|---|---|
| 10 | Bonnet | Bonnet (Verätzung, + Steinschläge) - Paint defect - Paint |

**Damage 10:** Bonnet: Bonnet (Verätzung, + Steinschläge) - Paint defect - Paint

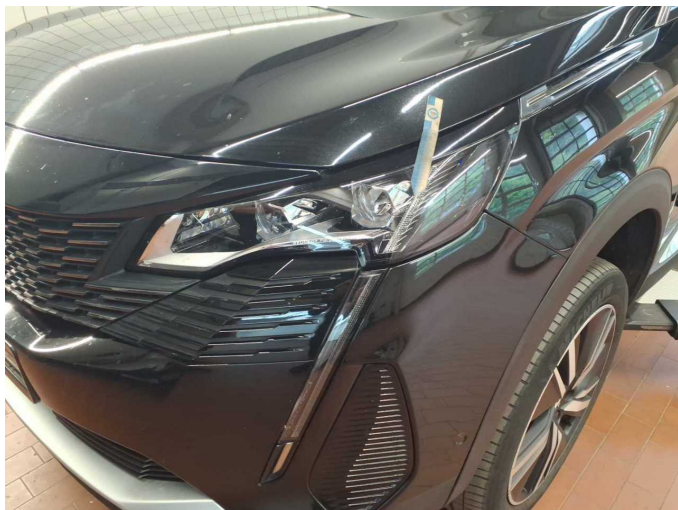
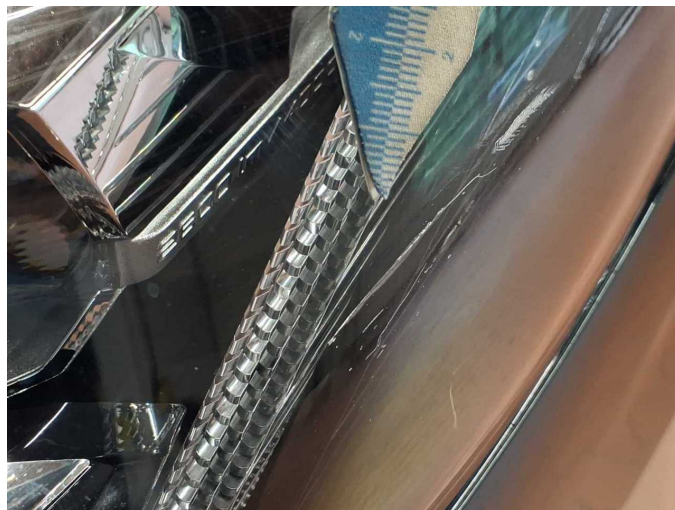
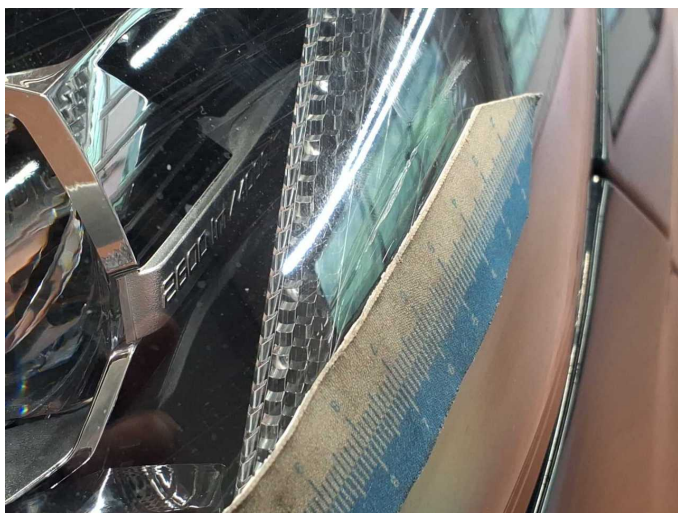
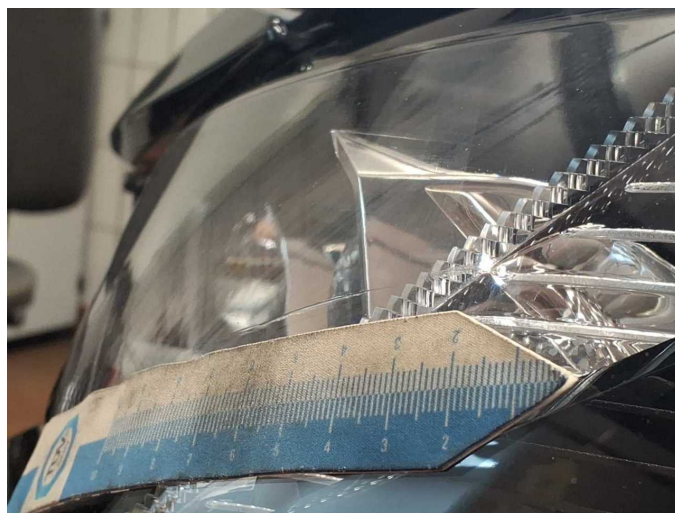
| No. | Component group | Description |
|---|---|---|
| 11 | Headlight | Headlight - left side - Broken / torn - Replace |

**Damage 11:** Headlight: Headlight - left side - Broken / torn - Replace

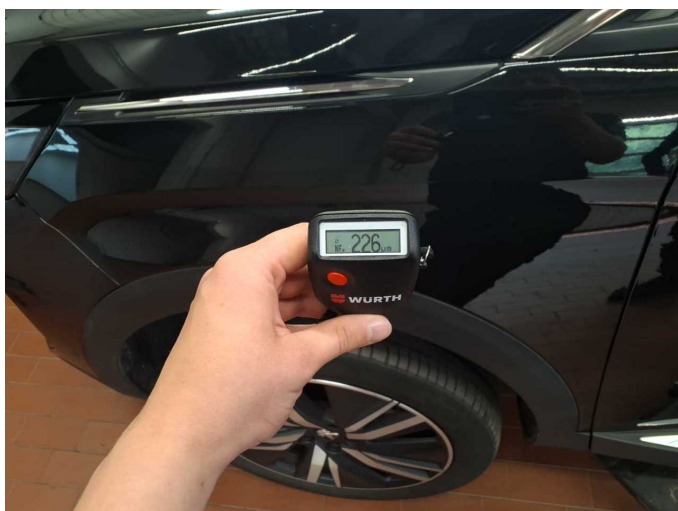
**Repainting 1:** Mudguard - left side

- 1 Mudguard - left side, Professionally carried out, Invoice of repair done Non-existent
- 2 Door - front left side, Professionally carried out, Invoice of repair done Non-existent

| Mudguard - left side | 226 µm | Door - front left side | 162 µm |
