Expertise

Protocol number: 46378562  
Order No. / Reference: 26462054  
Inspection date: 7 Jul 2026

Manufacturer: Mazda

Model: 2 SKYACTIV-G 90 M HYBRID Homura

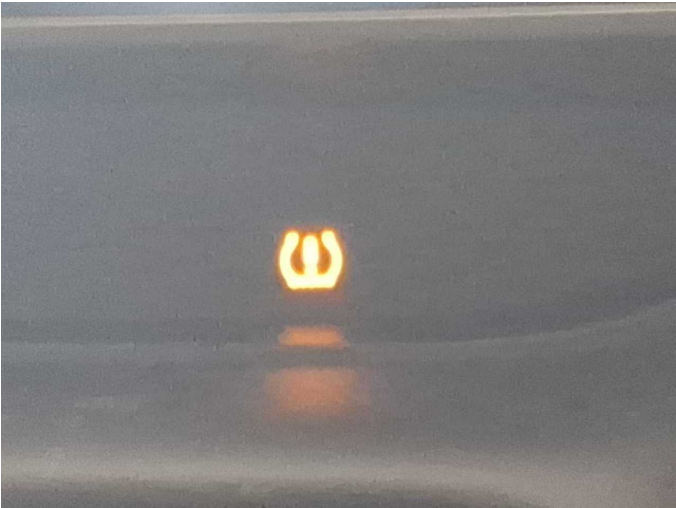
| No. | Component group | Description |
|---|---|---|
| 2 | Instrument panel | Indicator light (Reifendruckkontrolle) - on - Perform diagnosis |

Damage 2: Instrument panel: Indicator light (Reifendruckkontrolle) - on - Perform diagnosis

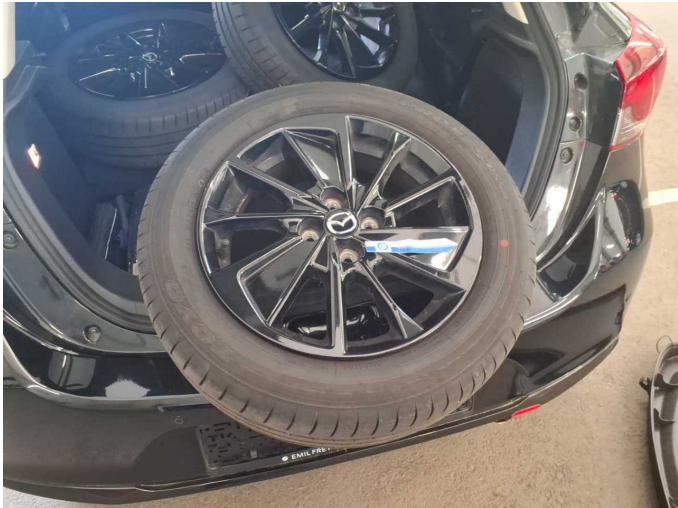
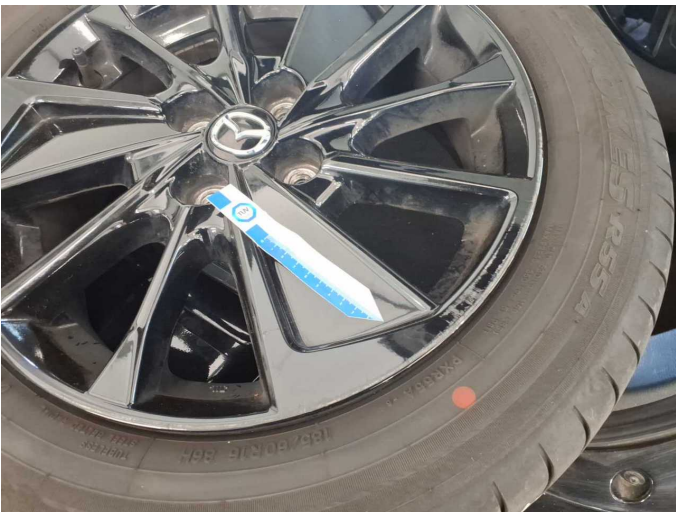
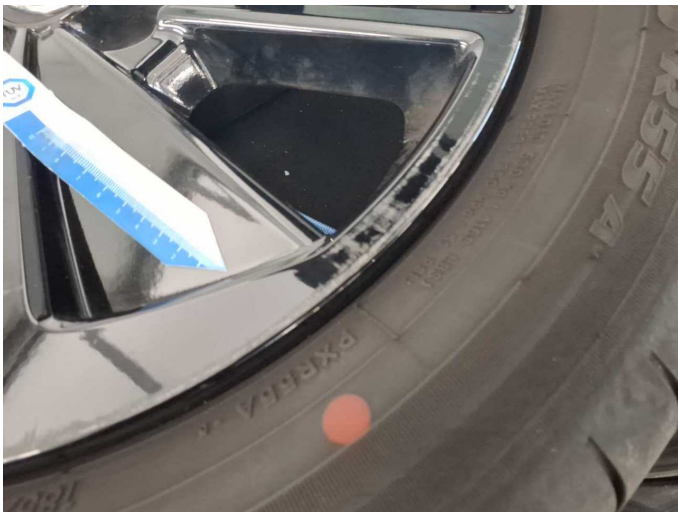
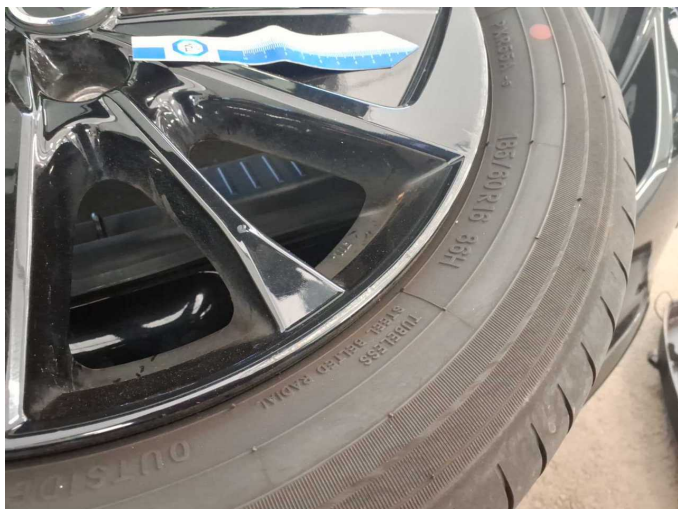
| No. | Component group | Description |
|---|---|---|
| 3 | 2nd wheel set | 1 alloy rim - Scratched - Loss in value |

Damage 3: 2nd wheel set: 1 alloy rim - Scratched - Loss in value

**Damage 3:** 2nd wheel set: 1 alloy rim - Scratched - Loss in value

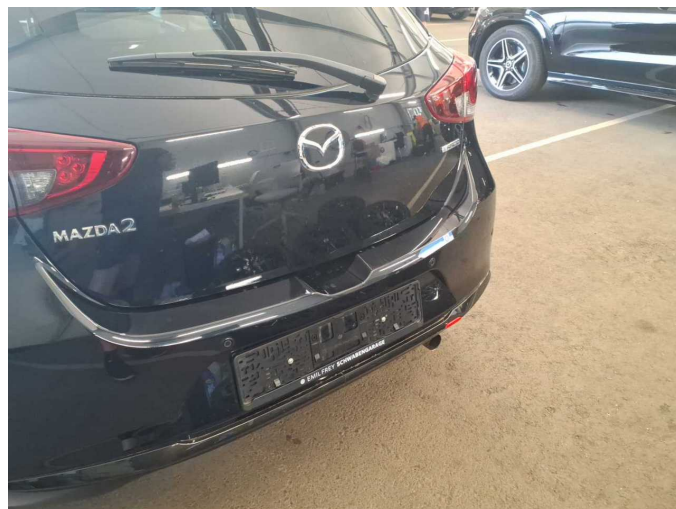
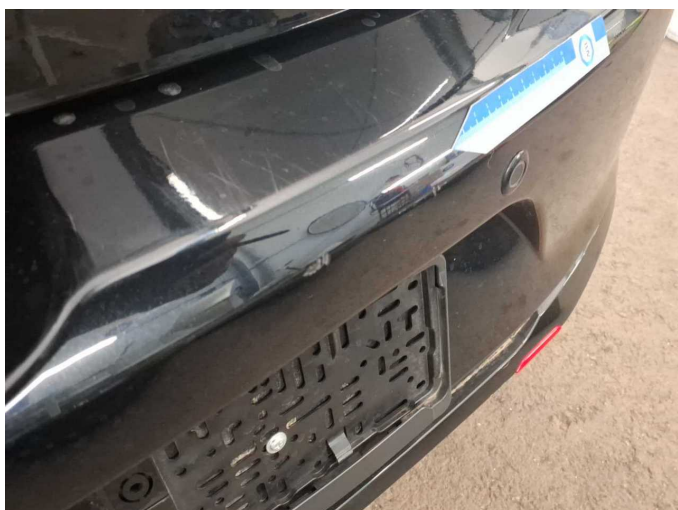
| No. | Component group | Description |
|---|---|---|
| 4 | Rear bumper | Rear bumper - Scratched - Smart repair |

**Damage 4:** Rear bumper: Rear bumper - Scratched - Smart repair

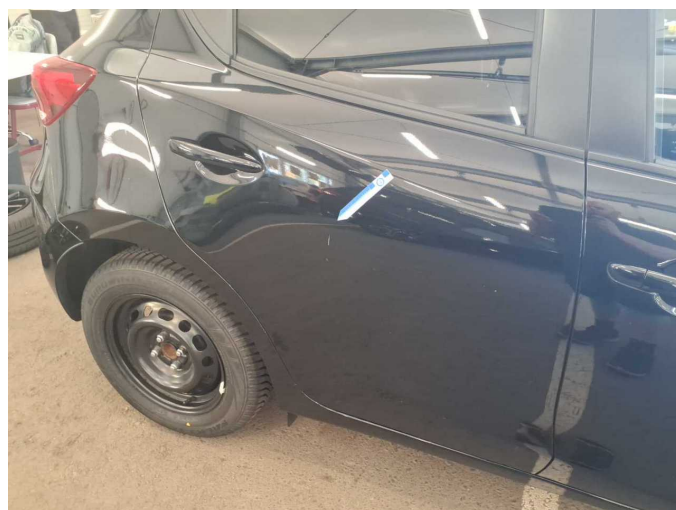
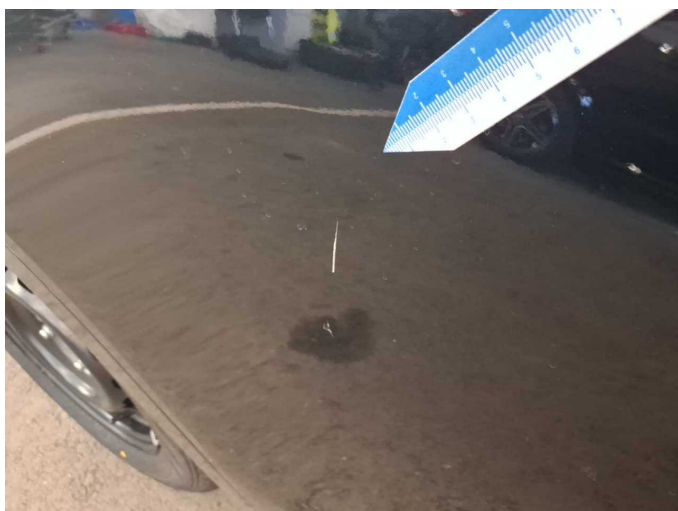
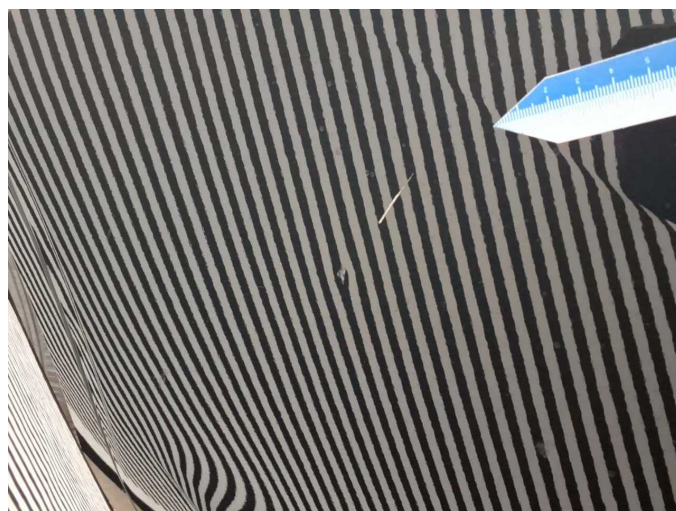
| No. | Component group | Description |
|---|---|---|
| 5 | Door - rear right side | Door - Dent / paintcoat damage - Repair and paint |

**Damage 5:** Door - rear right side: Door - Dent / paintcoat damage - Repair and paint
