Expertise

Protocol number: 46383567  
Order No. / Reference: 26482120  
Inspection date: 7 Jul 2026

Manufacturer: Ford

Model: Mondeo Turnier 2.0 EcoBlue Aut. Titanium

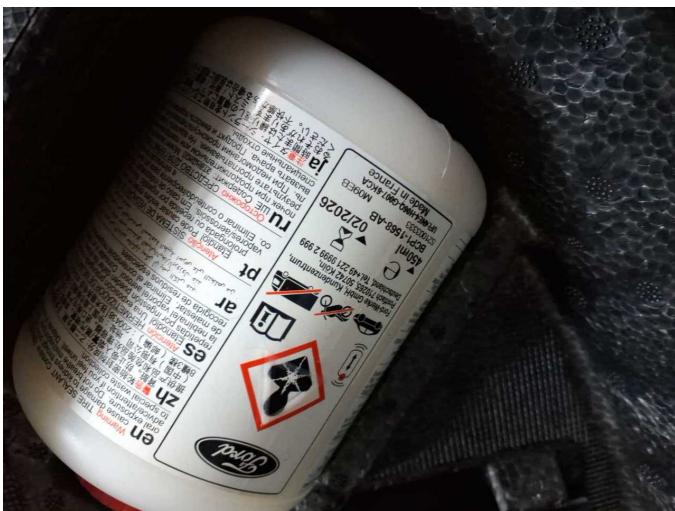
| No. | Component group | Description |
|---|---|---|
| 1 | Equipment | Tirefit filler - Expired - Replace |

Damage 1: Equipment: Tirefit filler - Expired - Replace

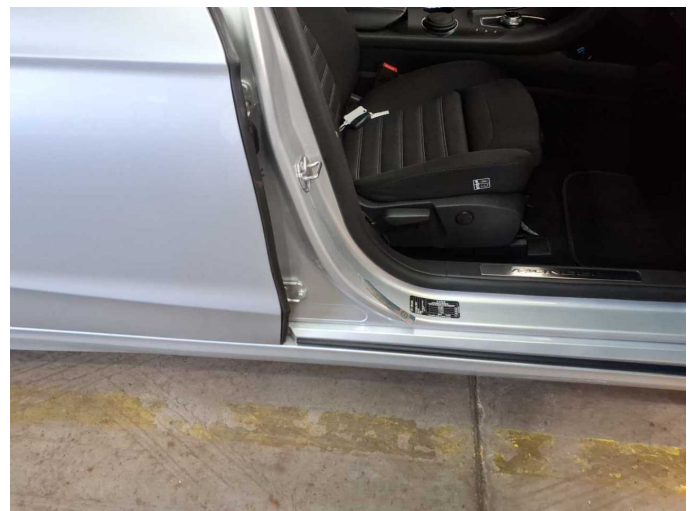
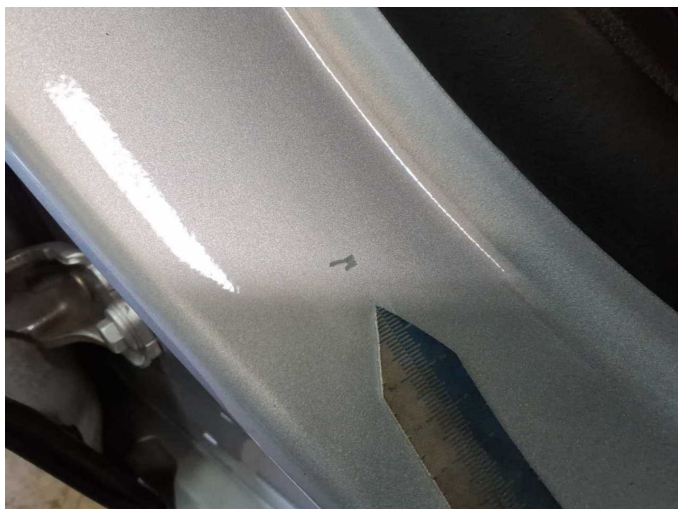
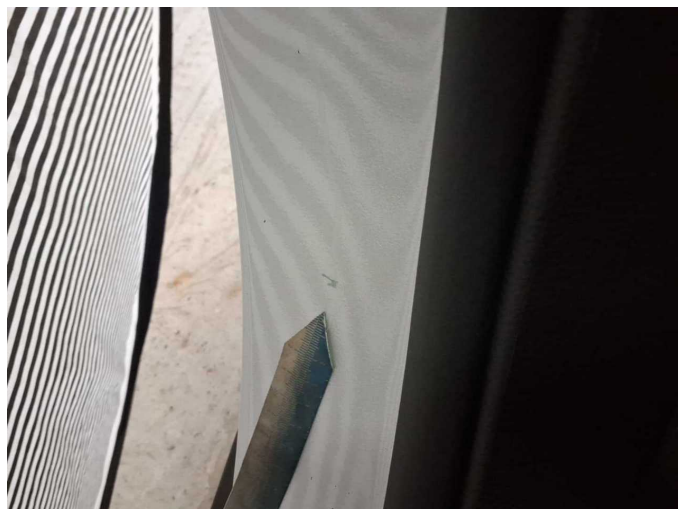
| No. | Component group | Description |
|---|---|---|
| 2 | Body | B-pillar - right side - Dent / paintcoat damage - Smart repair |

Damage 2: Body: B-pillar - right side - Dent / paintcoat damage - Smart repair

**Damage 2:** Body: B-pillar - right side - Dent / paintcoat damage - Smart repair

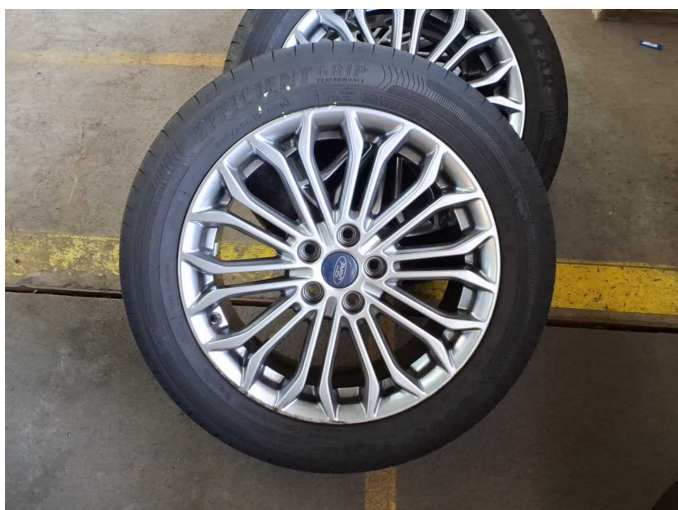
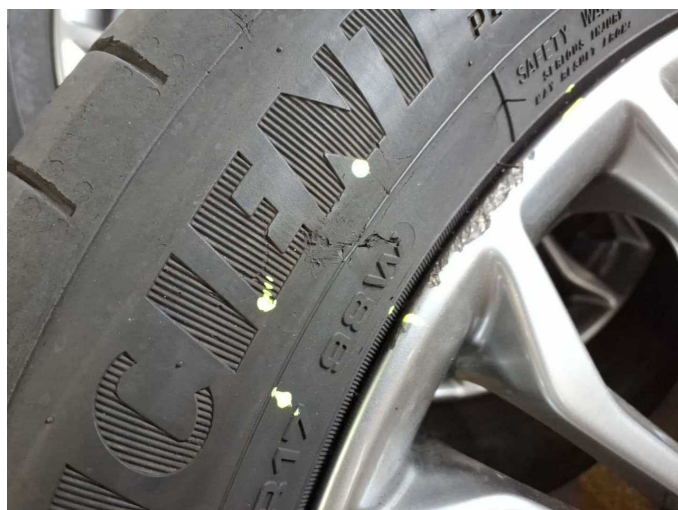
| No. | Component group | Description |
|---|---|---|
| 3 | 2nd wheel set | 1 tyre (Flanke) - Damaged - Replace |

**Damage 3:** 2nd wheel set: 1 tyre (Flanke) - Damaged - Replace

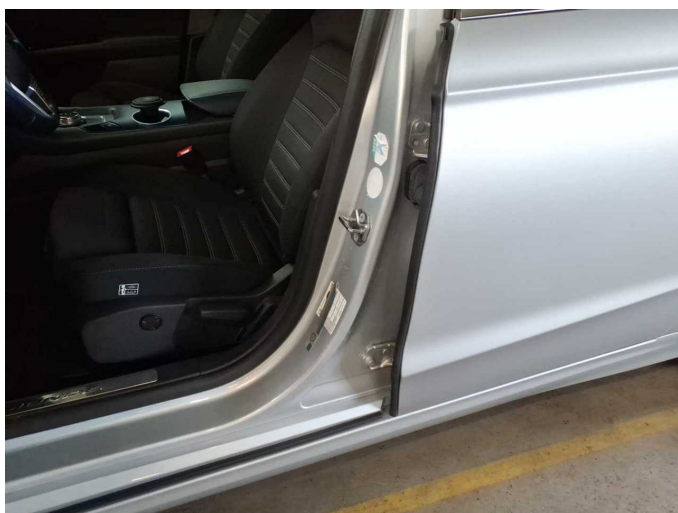
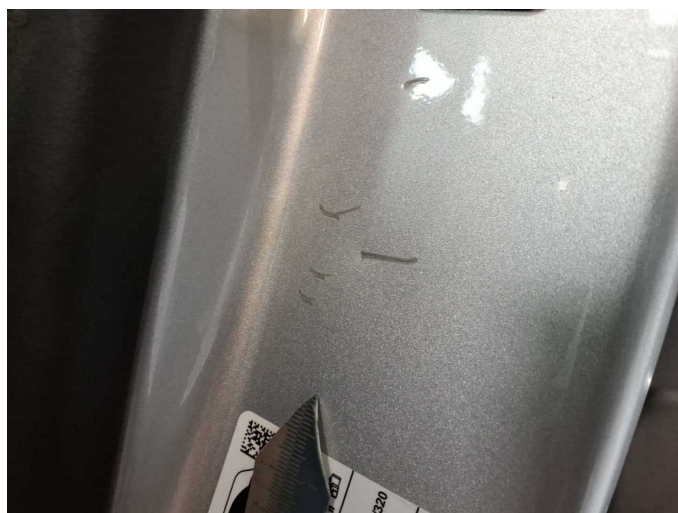
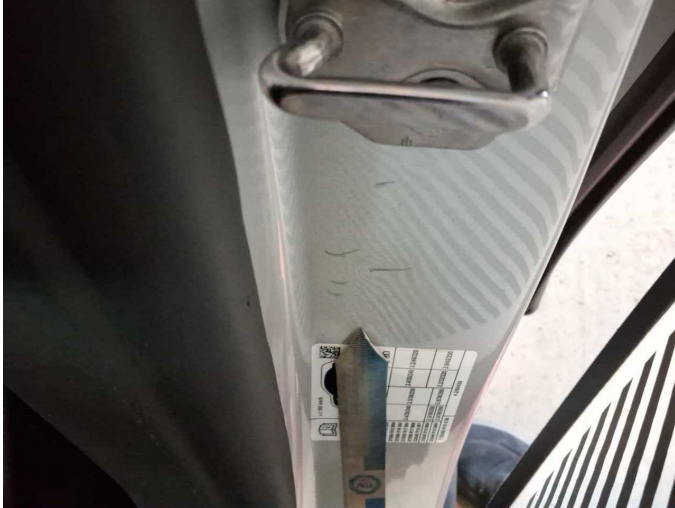
| No. | Component group | Description |
|---|---|---|
| 4 | Body | B-pillar - left side - Dent / paintcoat damage - Smart repair |

**Damage 4:** Body: B-pillar - left side - Dent / paintcoat damage - Smart repair

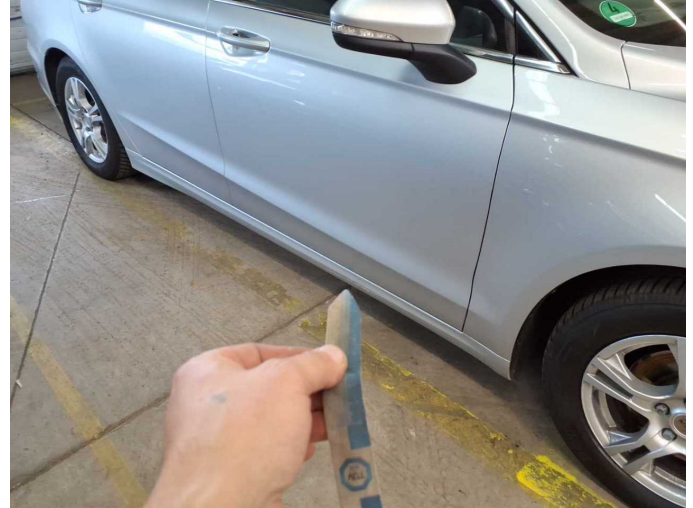
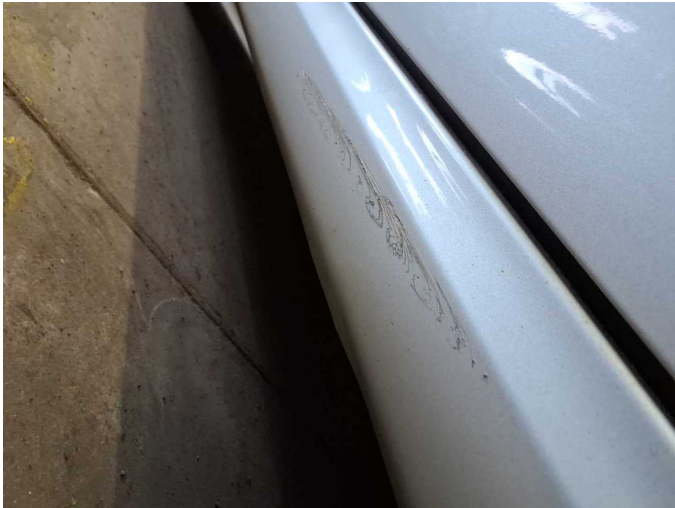
| No. | Component group | Description |
|---|---|---|
| 5 | Sill - right side | Trim - Scratch(es) - Smart repair |

**Damage 5:** Sill - right side: Trim - Scratch(es) - Smart repair

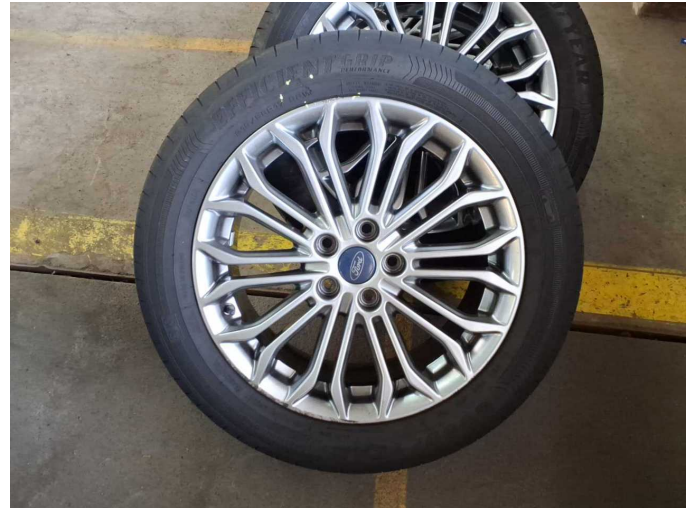
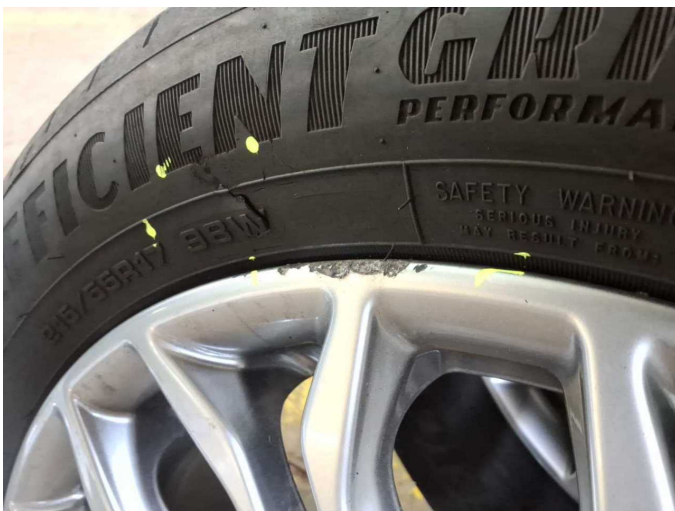
| No. | Component group | Description |
|---|---|---|
| 6 | 2nd wheel set | 1 alloy rim - Scratched - Loss in value |

**Damage 6:** 2nd wheel set: 1 alloy rim - Scratched - Loss in value

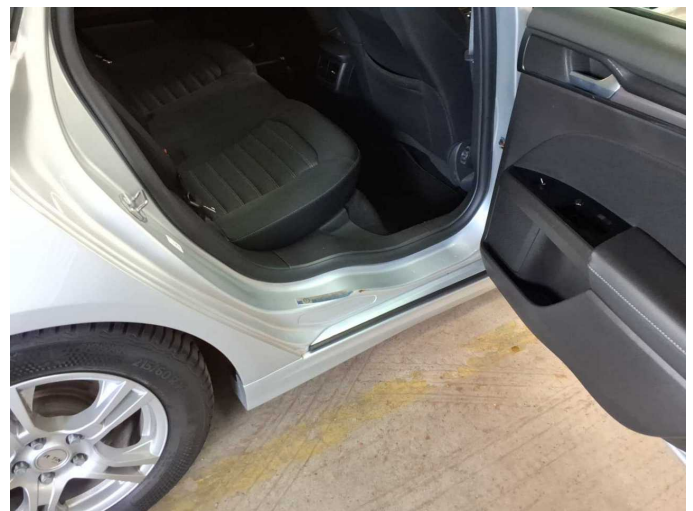
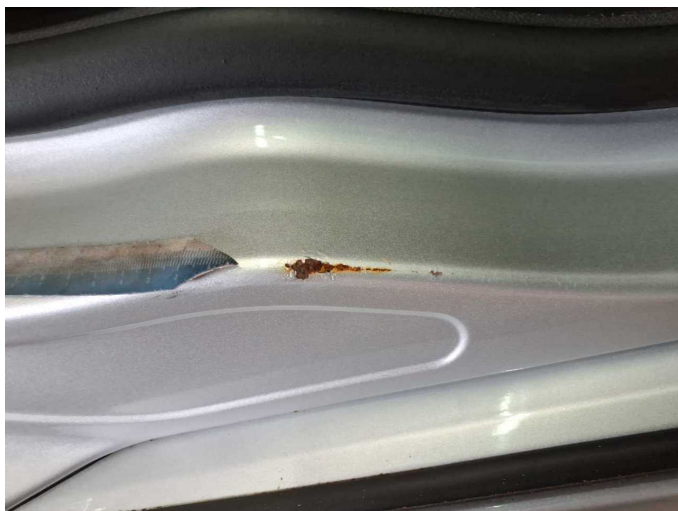
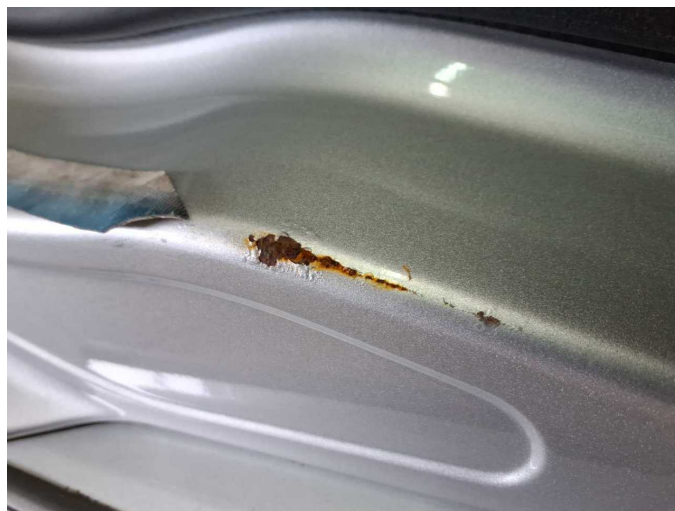
| No. | Component group | Description |
|---|---|---|
| 7 | Side panel - rear right side | Sill - Corrosion - Paint |

**Damage 7:** Side panel - rear right side: Sill - Corrosion - Paint

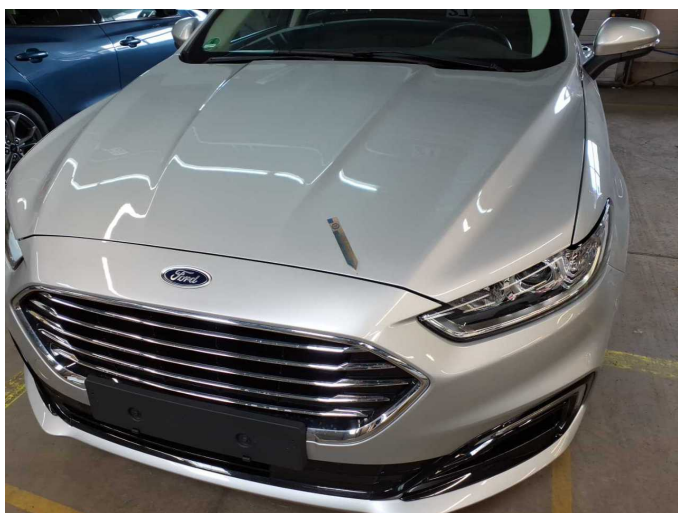
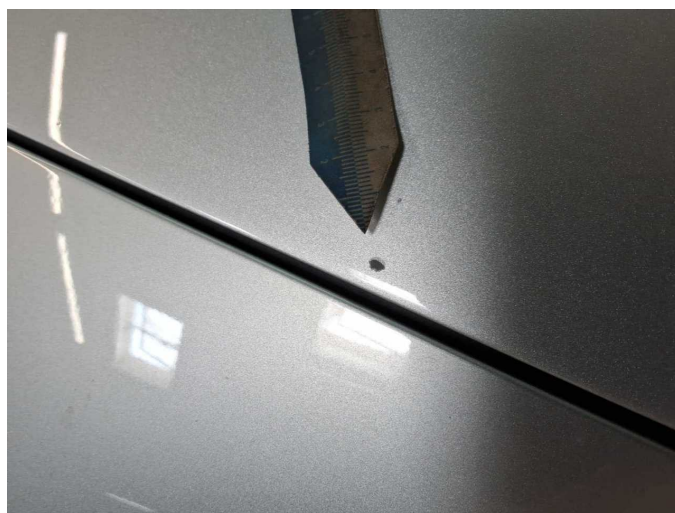
| No. | Component group | Description |
|---|---|---|
| 2 | Bonnet | Bonnet - Stone chips - No deduction |

**Wear and tear 2:** Bonnet: Bonnet - Stone chips - No deduction

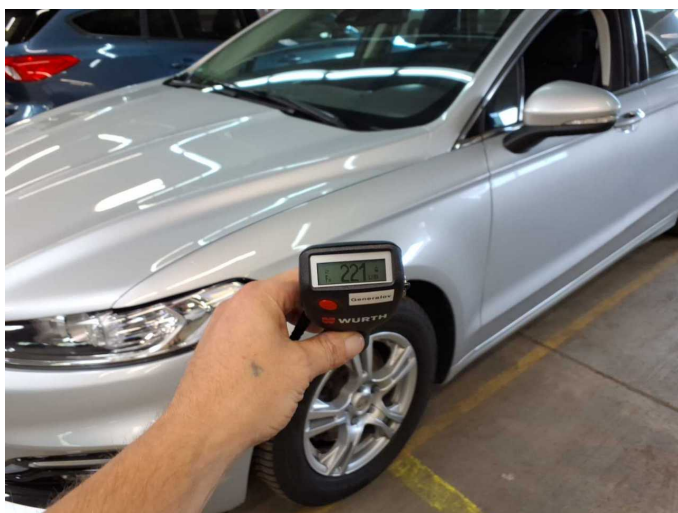
| Mudguard - left side | 221 µm | Mudguard - right side | 220 µm |

**Repainting 1:** Mudguard - left side

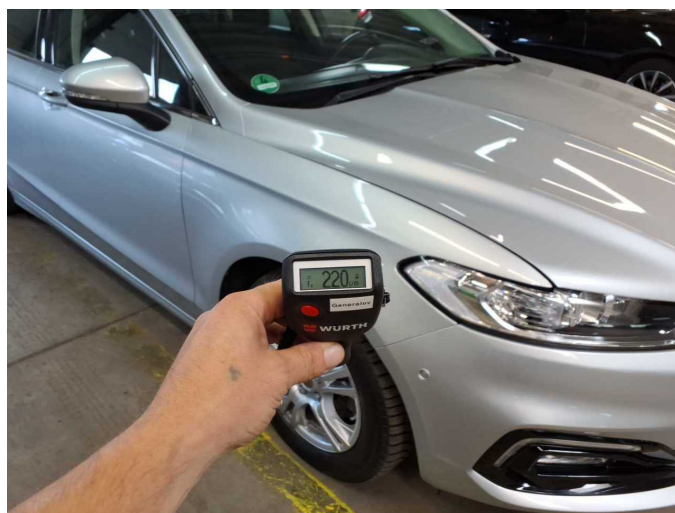
**Repainting 2:** Mudguard - right side

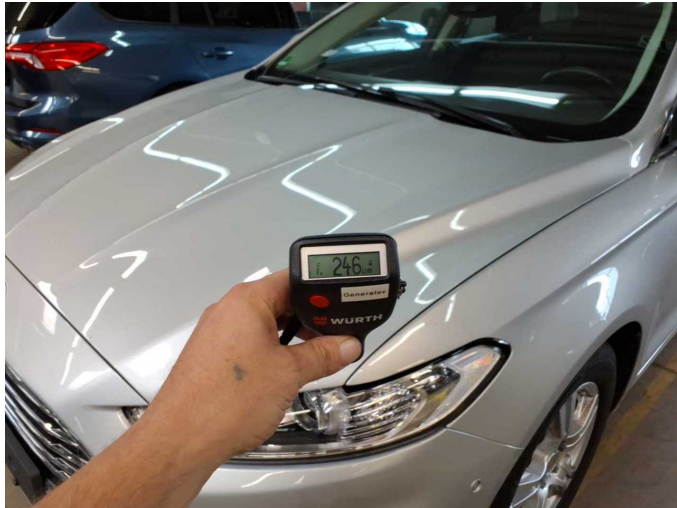
| Bonnet | 246 µm | | |

**Repainting 3: Bonnet**
