Expertise

Protocol number: 45790962
Order No. / Reference: 26153260
Inspection date: 2 Jun 2026

Manufacturer: Mercedes-Benz

Model: 317 CDI Sprinter Standard HA 9G-TRONIC PRO

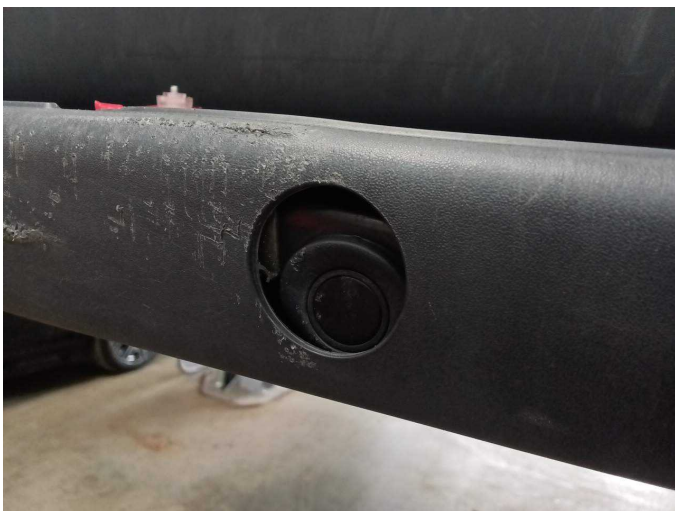
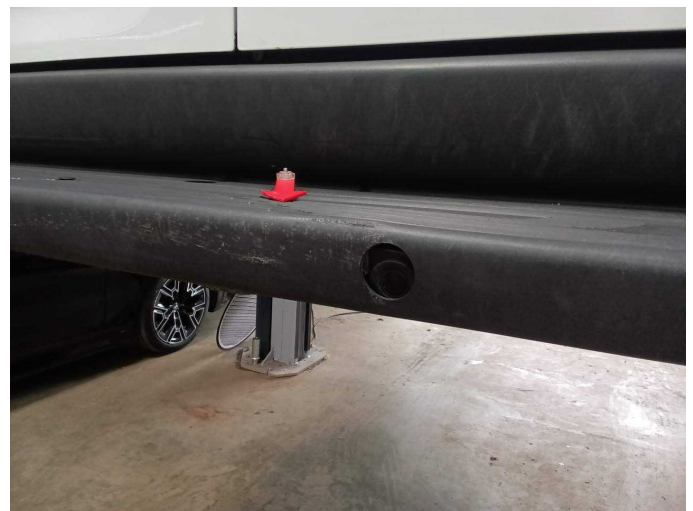
Damage 1: Rear bumper: Parking sensors - right side - Malposition - Replace

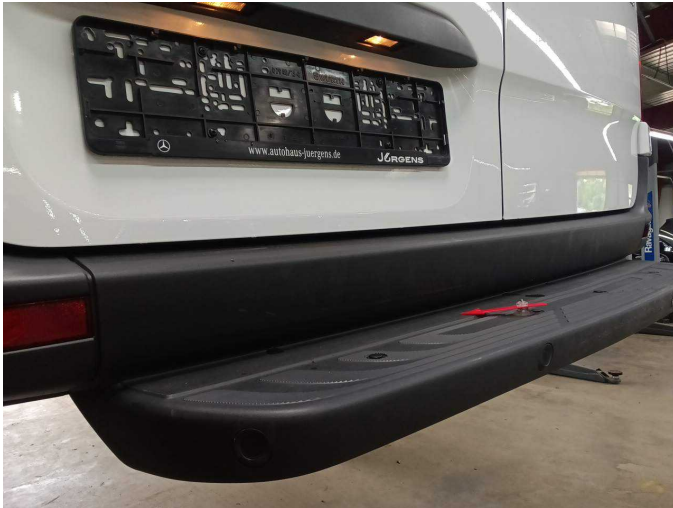
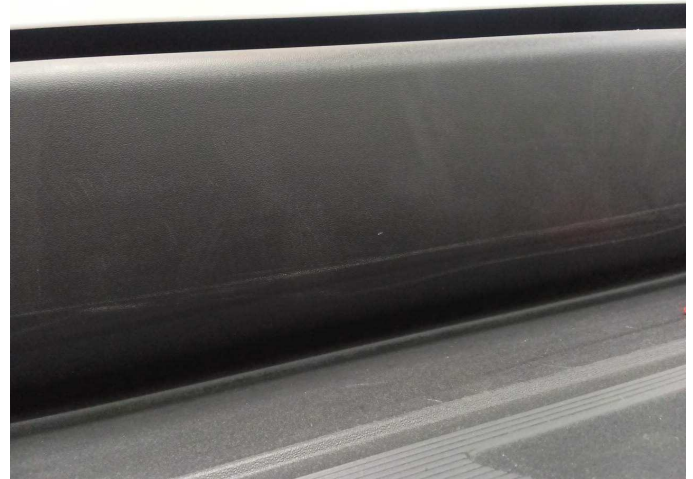
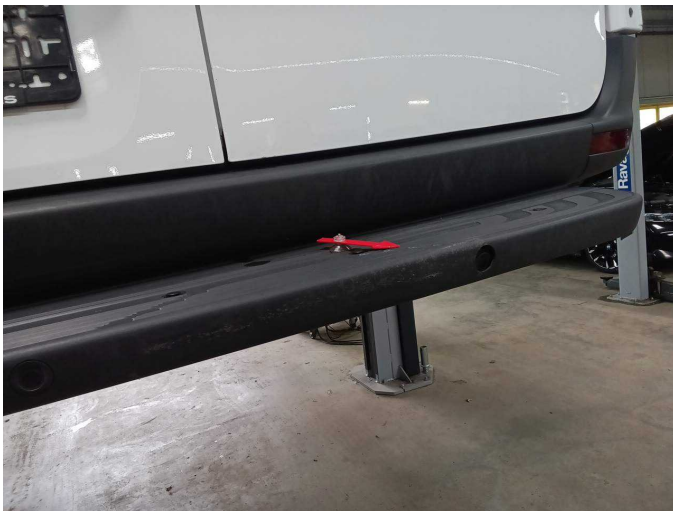
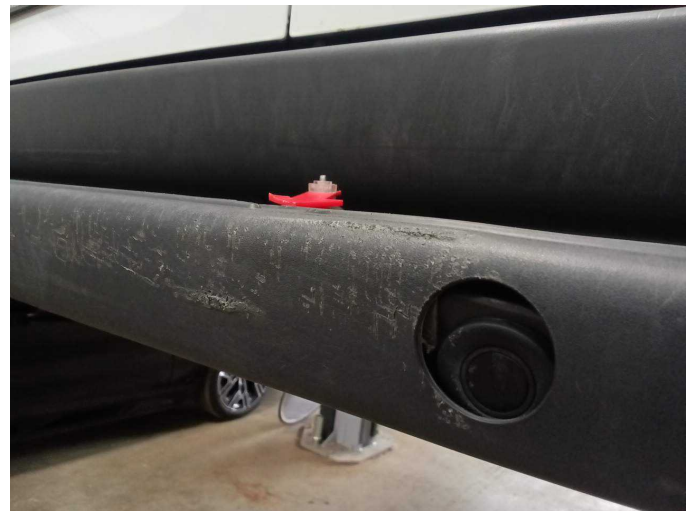
Damage 2: Rear of vehicle: Foot plate - Damaged - Replace

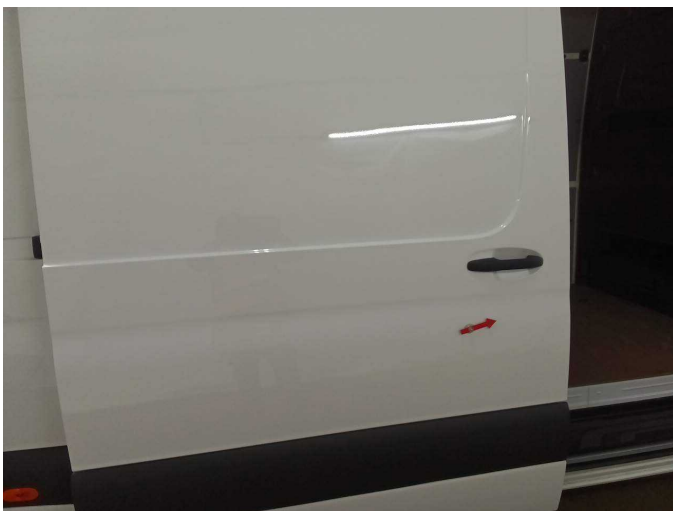
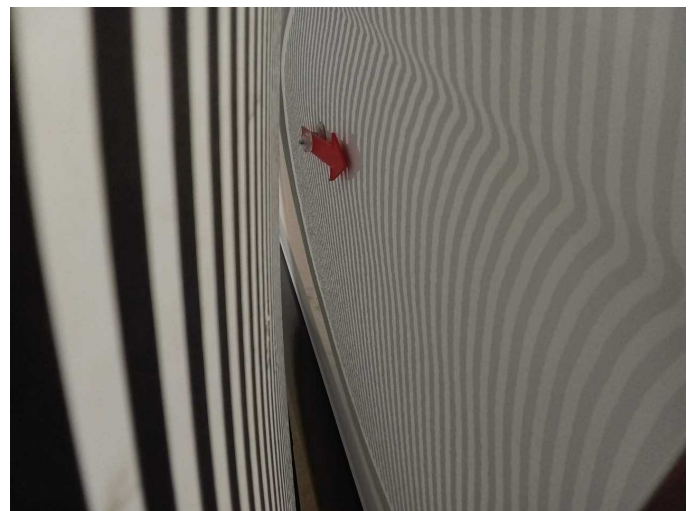
Wear and tear 6: Sliding door, right: Sliding door - dent(s) - No deduction

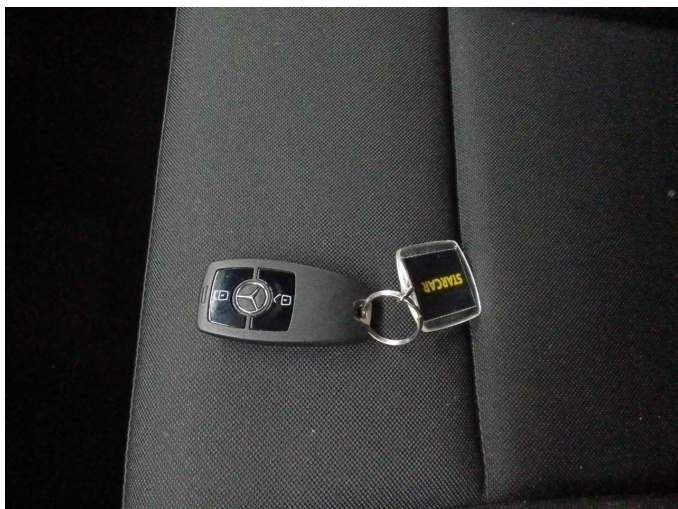
Missing part 1: Equipment: Vehicle key (1 Schlüssel vorhanden) -
Missing - Perform
