Expertise

Protocol number: 46919769  
Order No. / Reference: 26759094  
Inspection date: 6 Aug 2026

Manufacturer: Ford

Model: Focus Turnier 1.5 EcoBlue Start-Stopp-System  
COOL&CONNECT

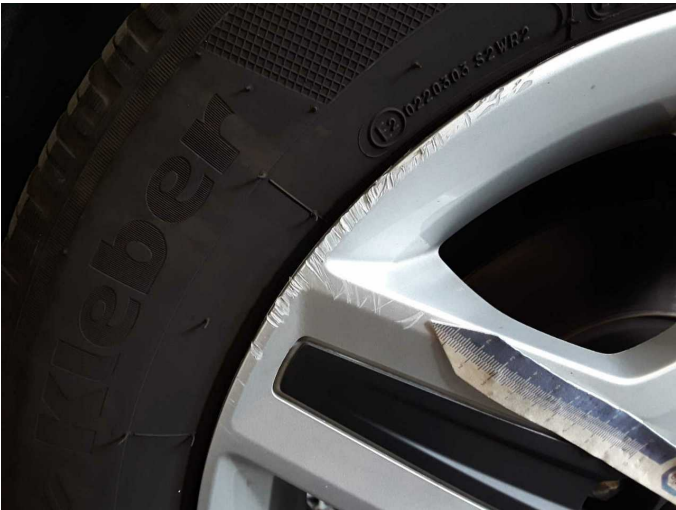
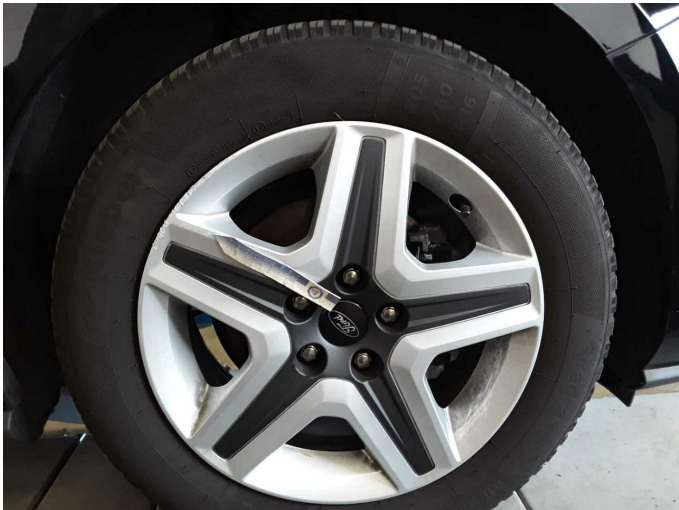
| No. | Component group | Description |
|---|---|---|
| 1 | Wheel / tyres | Wheel cover - front right side - Scratched - Replace |

Damage 1: Wheel / tyres: Wheel cover - front right side - Scratched - Replace

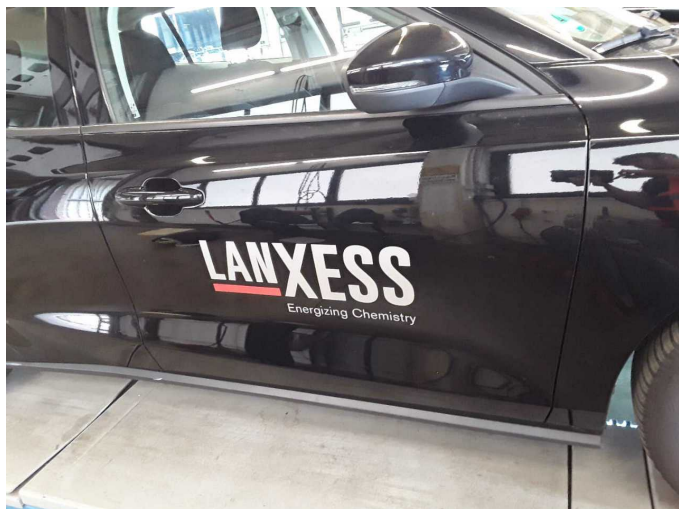
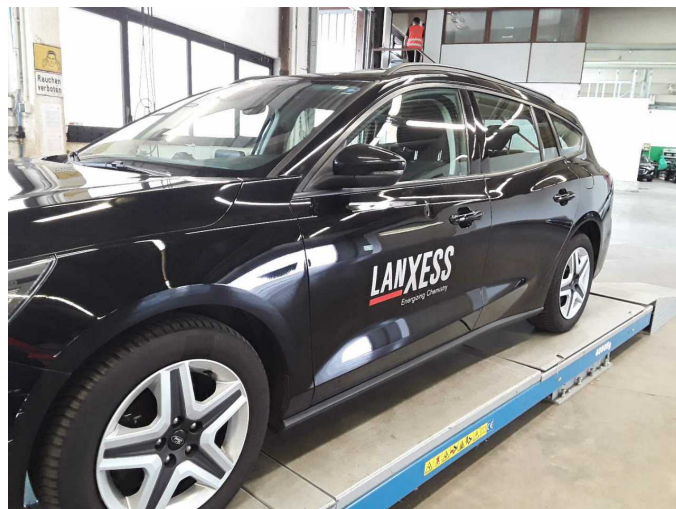
| No. | Component group | Description |
|---|---|---|
| 2 | Body | Body - Glued / labelled - De-glue / neutralise |

**Damage 2:** Body: Body - Glued / labelled - De-glue / neutralise

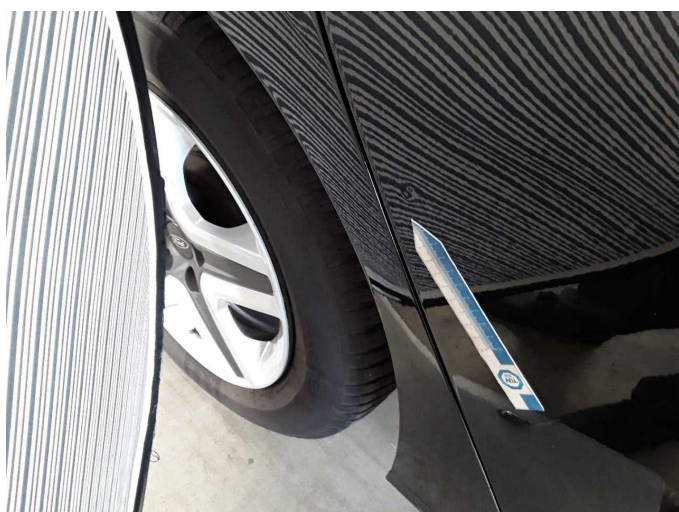
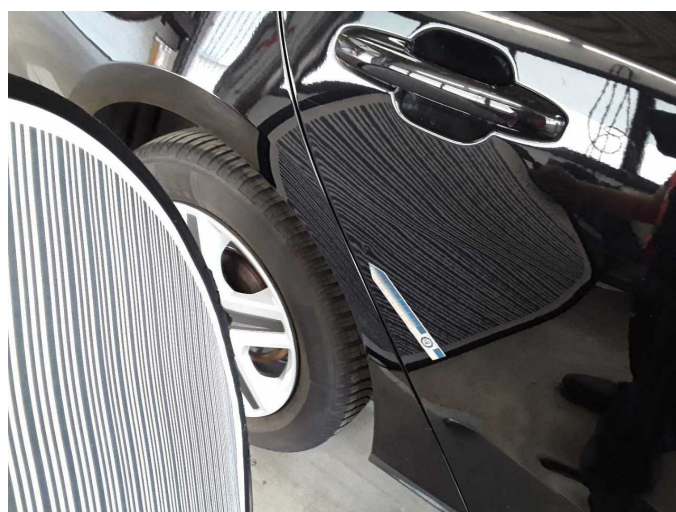
| No. | Component group | Description |
|---|---|---|
| 3 | Door - rear right side | Door - dent(s) - Smooth repair work |

**Damage 3:** Door - rear right side: Door - dent(s) - Smooth repair work

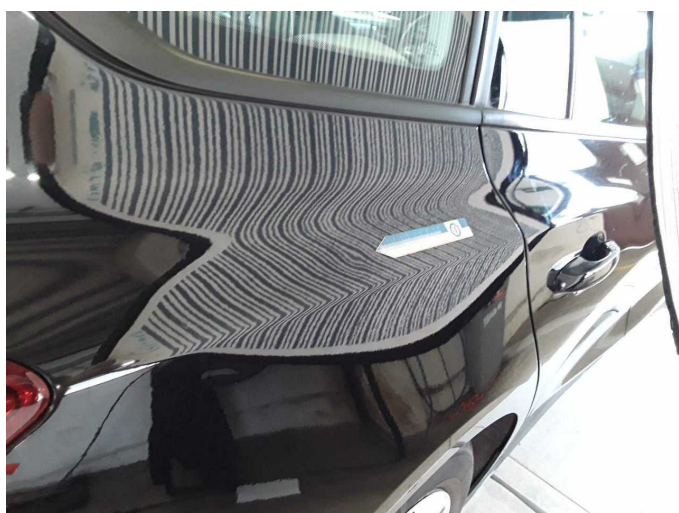
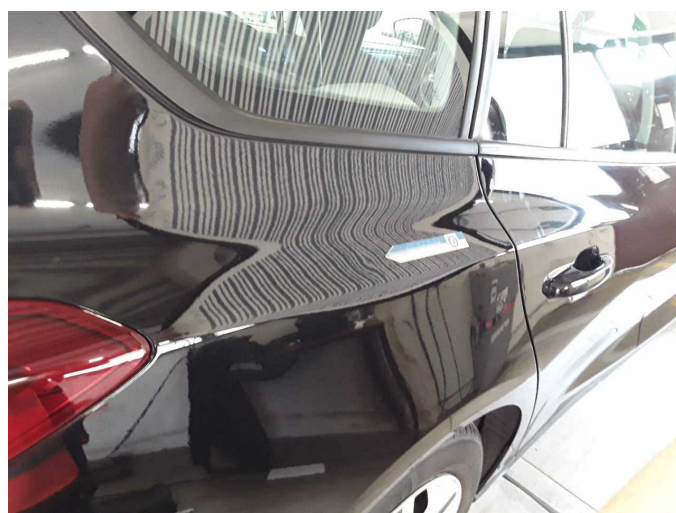
| No. | Component group | Description |
|---|---|---|
| 4 | Side panel - rear right side | Side panel - dent(s) - Smooth repair work |

**Damage 4:** Side panel - rear right side: Side panel - dent(s) - Smooth repair work

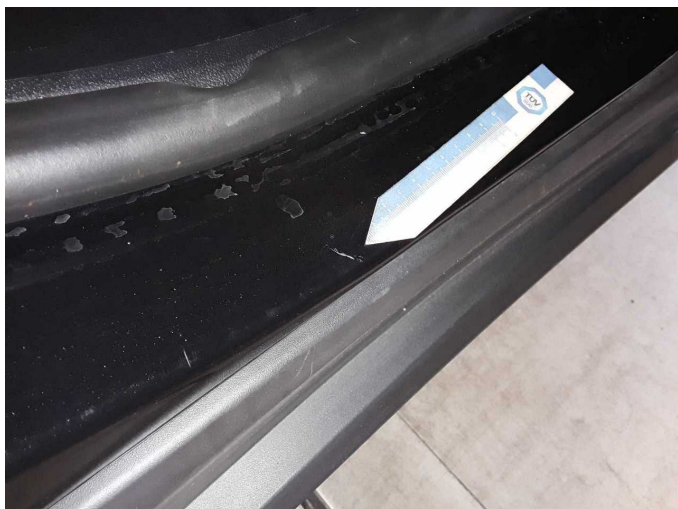
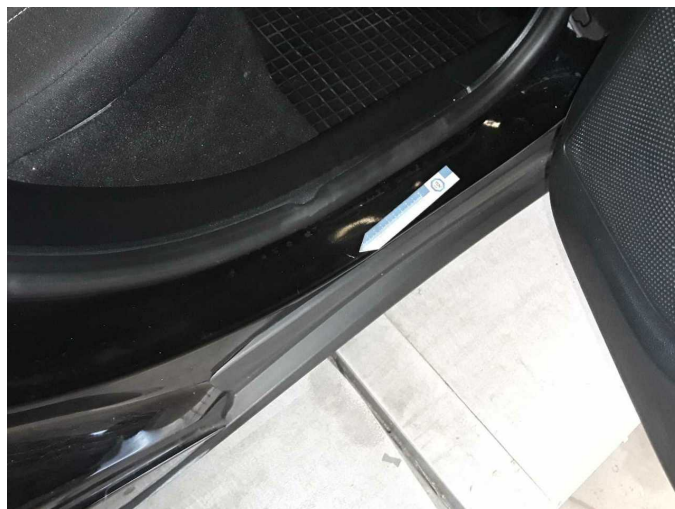
| No. | Component group | Description |
|---|---|---|
| 5 | Side panel - rear right side | Sill - Scratch(es) - Smart repair |

**Damage 5:** Side panel - rear right side: Sill - Scratch(es) - Smart repair

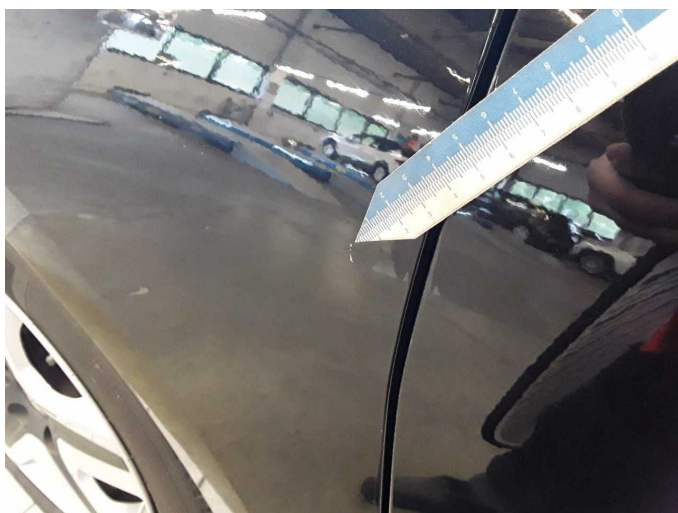
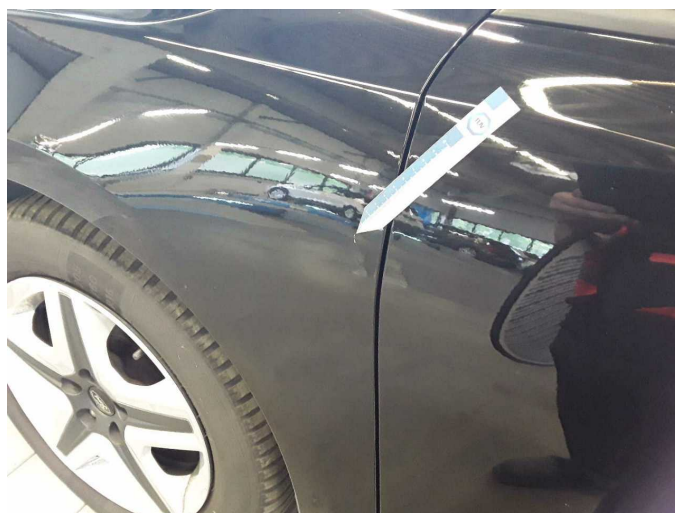
| No. | Component group | Description |
|---|---|---|
| 6 | Mudguard - left side | Mudguard - left side - Scratch(es) - Smart repair |

**Damage 6:** Mudguard - left side: Mudguard - left side - Scratch(es) - Smart repair

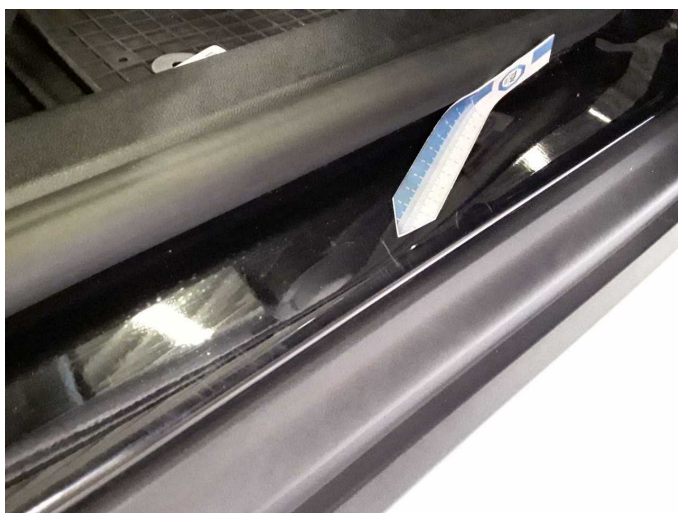
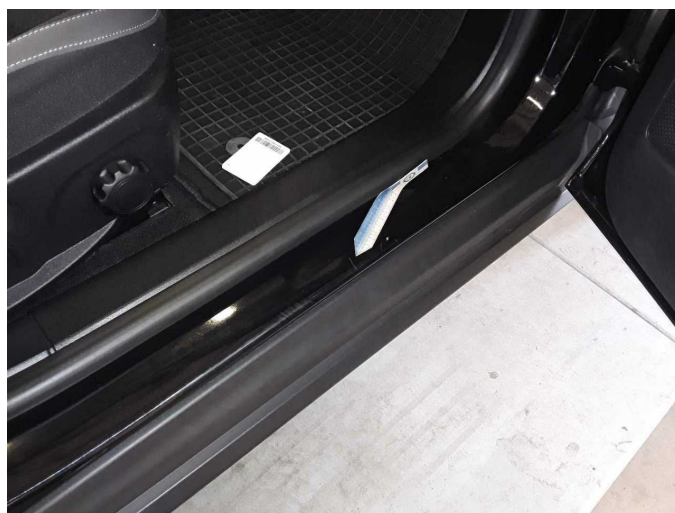
| No. | Component group | Description |
|---|---|---|
| 7 | Sill - right side | Sill - Scratch(es) - Smart repair |

**Damage 7:** Sill - right side: Sill - Scratch(es) - Smart repair

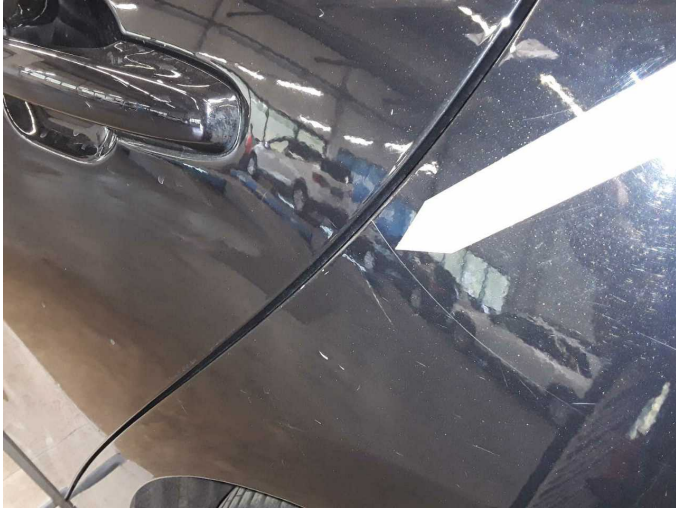
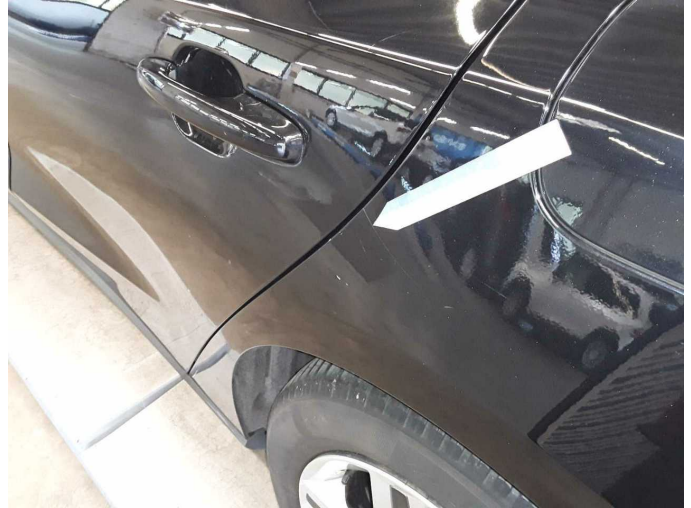
| No. | Component group | Description |
|---|---|---|
| 8 | Side panel - rear left side | Side panel - Scratch(es) - Smart repair |

**Damage 8:** Side panel - rear left side: Side panel - Scratch(es) - Smart repair

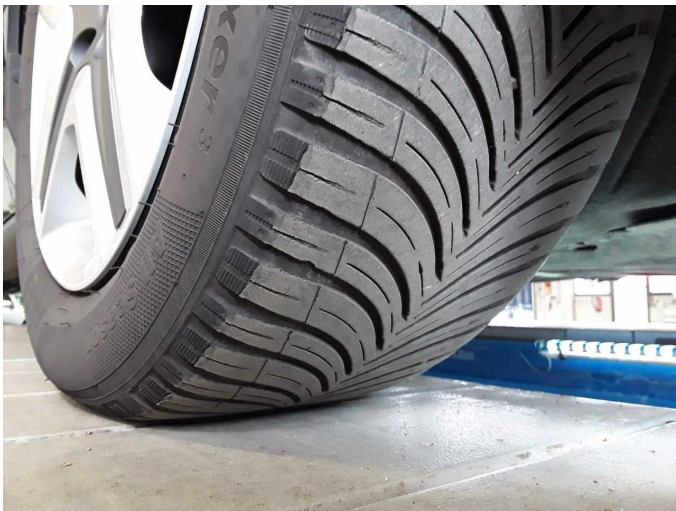
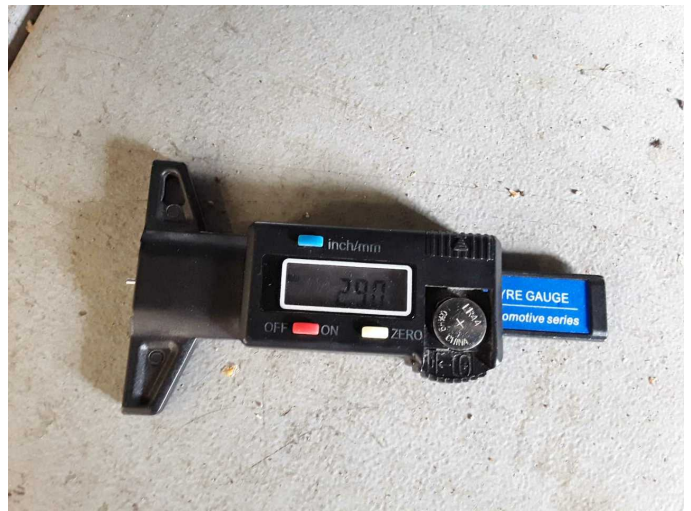
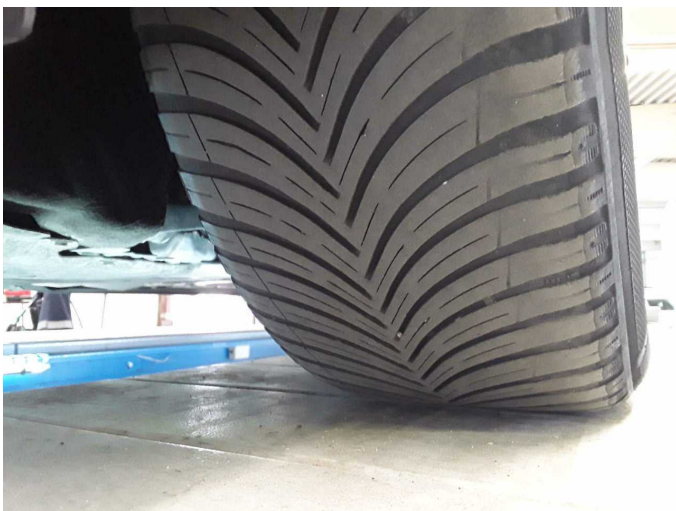
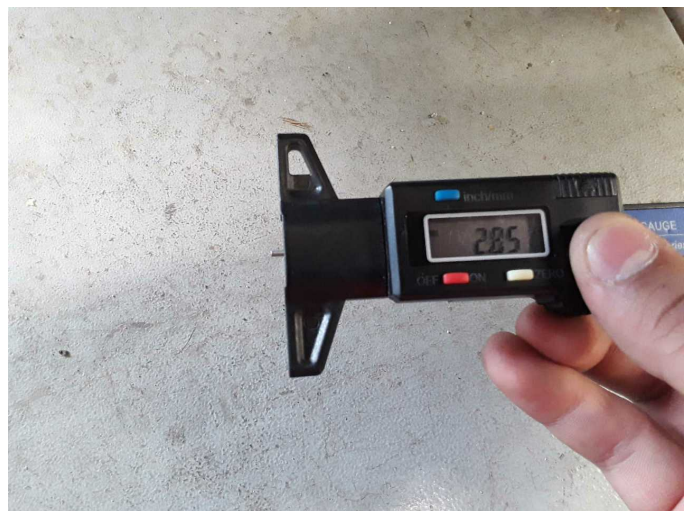
| Tyres | | | |
|---|---|---|---|
| 1) | 205/60 R16 96V | All-season tyres on Steel rim with wheel cover | 2mm / 2mm |

| No. | Component group | Description |
|---|---|---|
| 9 | Wheel / tyres | Tyre - front - Worn - Replace |

**Damage 9:** Wheel / tyres: Tyre - front - Worn - Replace

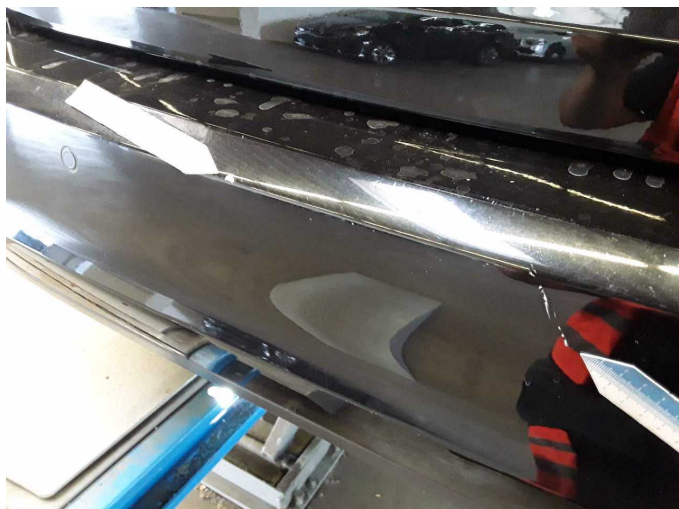
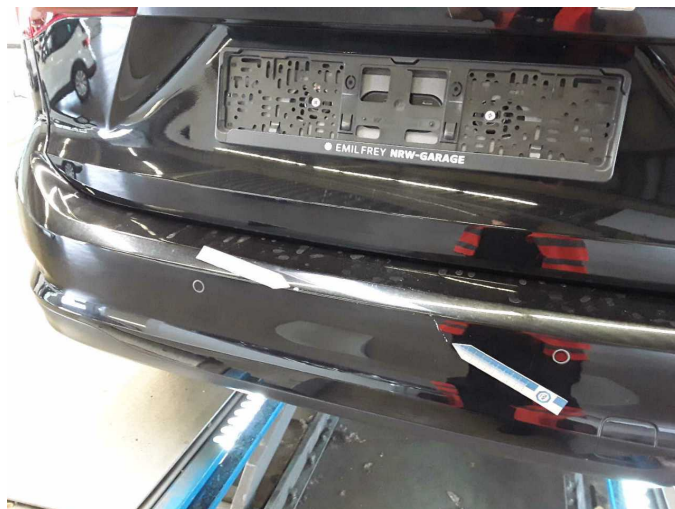
| No. | Component group | Description |
|---|---|---|
| 10 | Rear bumper | Rear bumper - Scratch(es) - Paint |

**Damage 10:** Rear bumper: Rear bumper - Scratch(es) - Paint

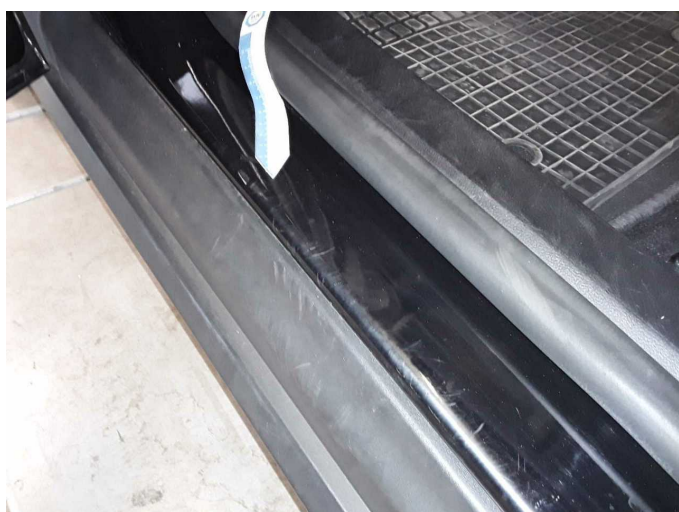
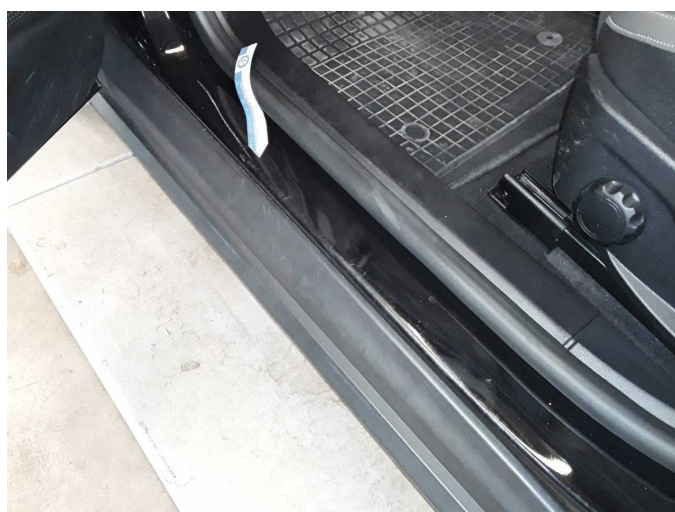
| No. | Component group | Description |
|---|---|---|
| 11 | Sill - left side | Sill - Scratch(es) - Paint |

**Damage 11:** Sill - left side: Sill - Scratch(es) - Paint

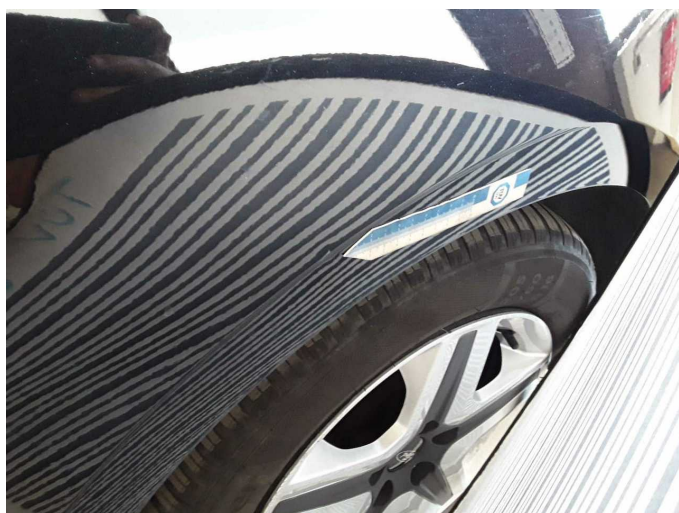
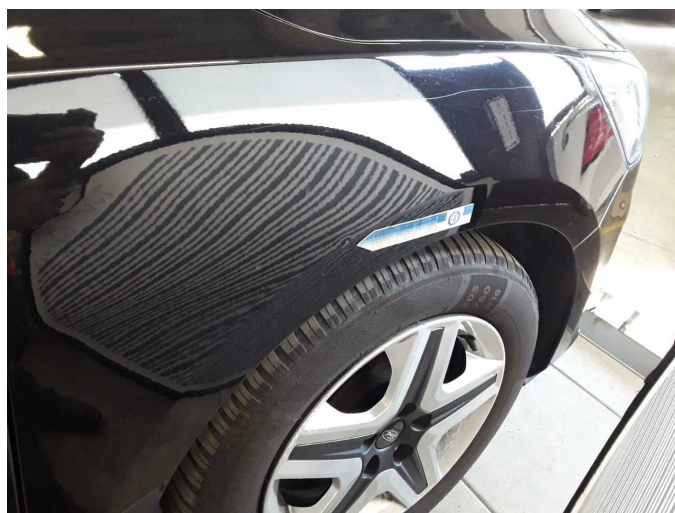
| No. | Component group | Description |
|---|---|---|
| 12 | Mudguard - right side | Mudguard - right side (Delle auf Kante) - Dent / paintcoat damage - Repair and paint |

**Damage 12:** Mudguard - right side: Mudguard - right side (Delle auf Kante) - Dent / paintcoat damage - Repair and paint

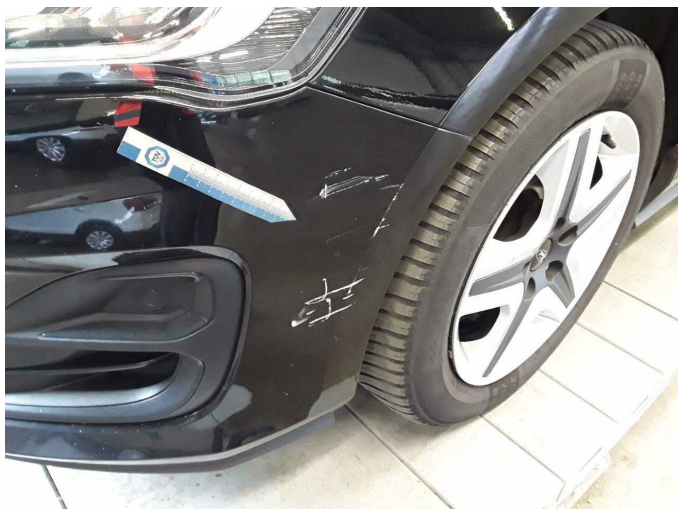
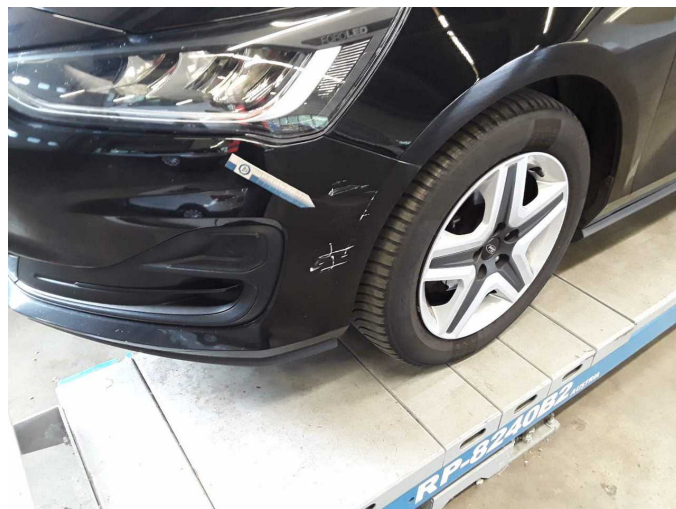
| No. | Component group | Description |
|---|---|---|
| 13 | Front bumper | Front bumper - Scratched - Paint |

**Damage 13:** Front bumper: Front bumper - Scratched - Paint

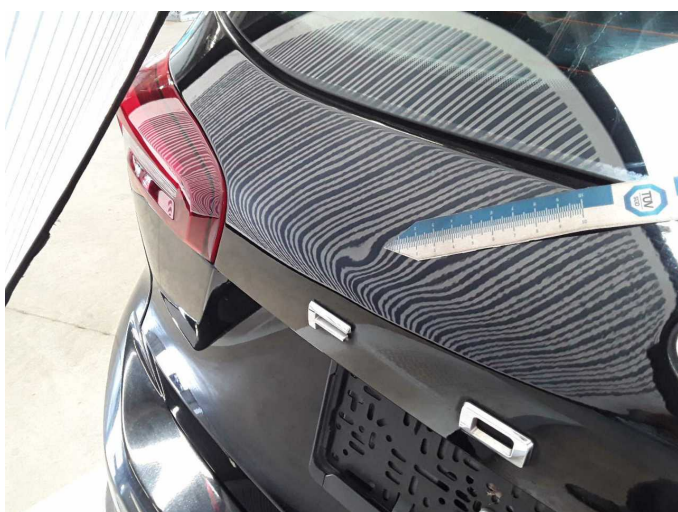
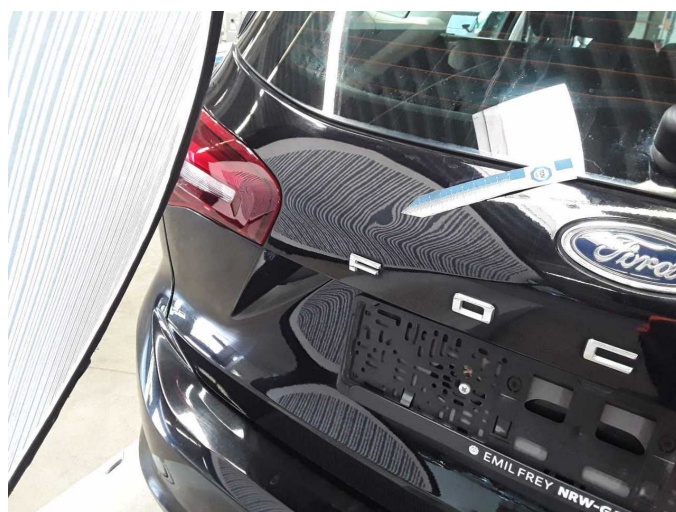
| No. | Component group | Description |
|---|---|---|
| 14 | Boot lid / rear door | Boot lid (Delle auf Kante) - dent(s) - Repair and paint |

**Damage 14:** Boot lid / rear door: Boot lid (Delle auf Kante) - dent(s) - Repair and paint

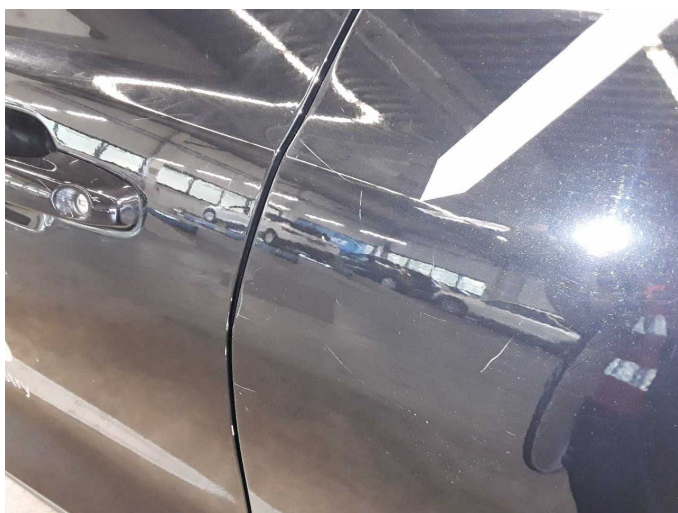
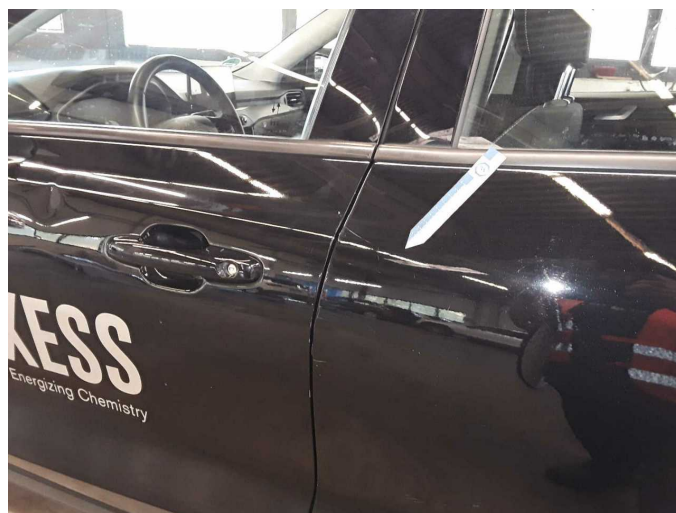
| No. | Component group | Description |
|---|---|---|
| 15 | Door - rear left side | Door - Scratch(es) - Paint |

**Damage 15:** Door - rear left side: Door - Scratch(es) - Paint

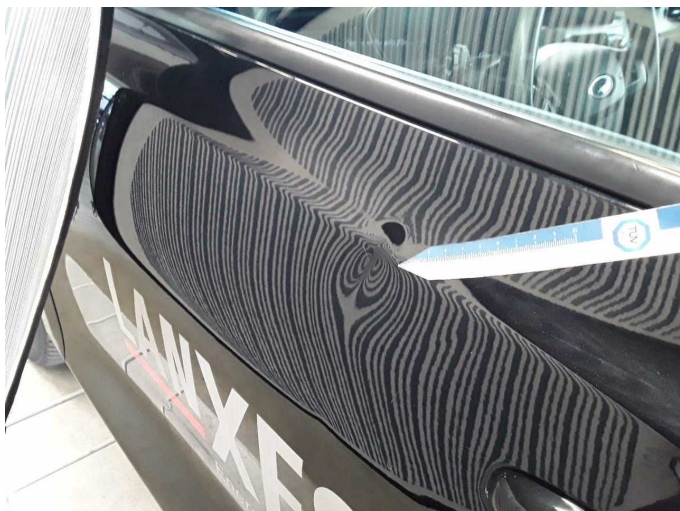
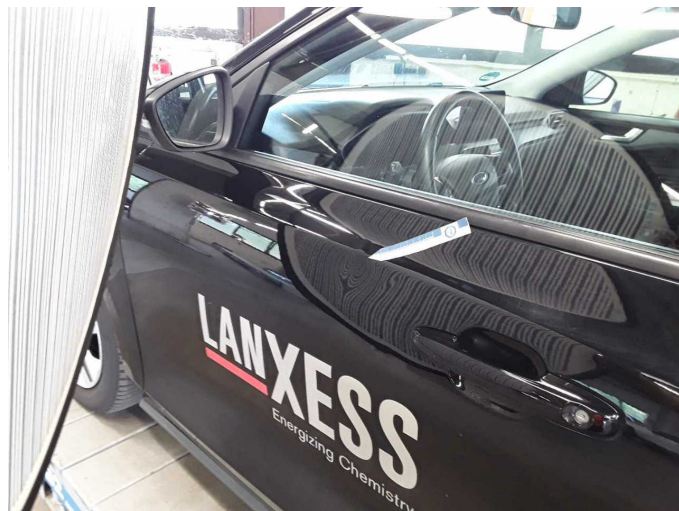
| No. | Component group | Description |
|---|---|---|
| 16 | Door - front left side | Door - Dent / paintcoat damage - Repair and paint |

**Damage 16:** Door - front left side: Door - Dent / paintcoat damage - Repair and paint

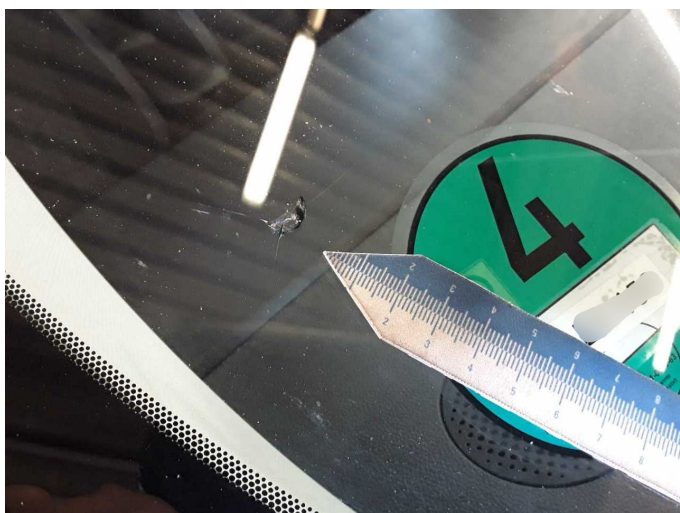
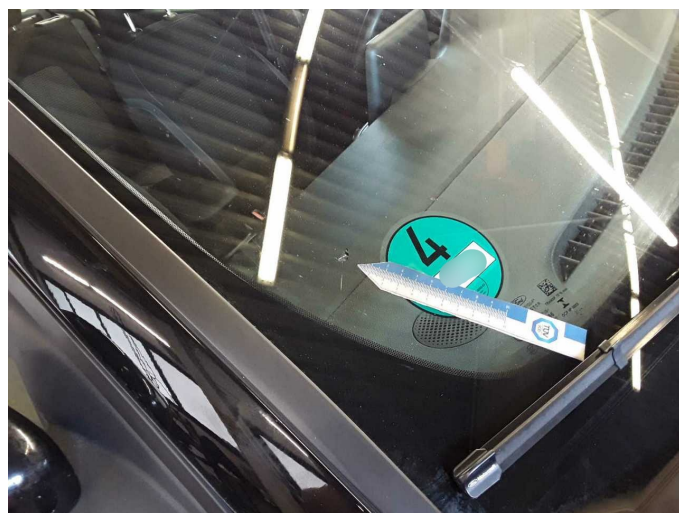
| No. | Component group | Description |
|---|---|---|
| 17 | Vehicle glazing | Windscreen - Stone chips - Replace |

**Damage 17:** Vehicle glazing: Windscreen - Stone chips - Replace
