Expertise

Protocol number: 46527558  
Order No. / Reference: 26733639  
Inspection date: 10 Jul 2026

Manufacturer: Opel

Model: Astra Sports Tourer 1.5 D Automatik GS

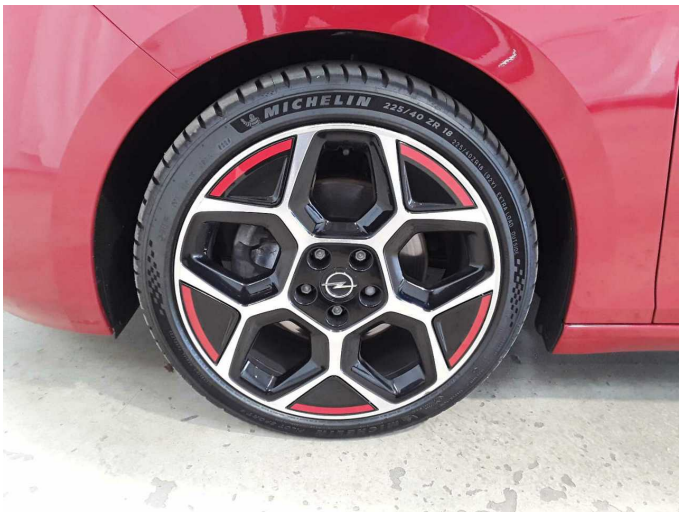
| No. | Component group | Description |
|---|---|---|
| 2 | Wheel / tyres | Alloy rim - front left side - Scratch(es) - Loss in value |

Damage 2: Wheel / tyres: Alloy rim - front left side - Scratch(es) - Loss in value

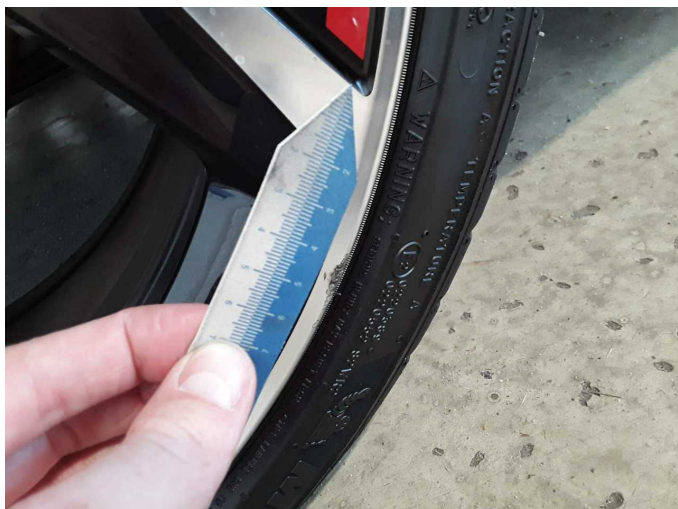
**Damage 2:** Wheel / tyres: Alloy rim - front left side - Scratch(es) - Loss in value

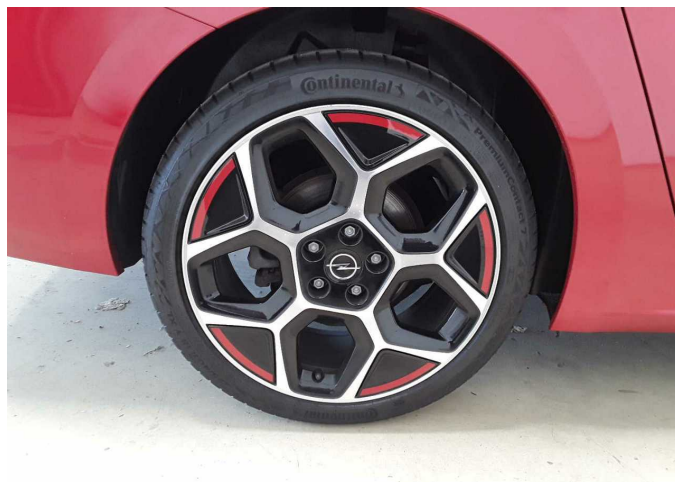
| No. | Component group | Description |
|---|---|---|
| 3 | Wheel / tyres | Alloy rim - rear right side - Scratch(es) - Loss in value |

**Damage 3:** Wheel / tyres: Alloy rim - rear right side - Scratch(es) - Loss in value

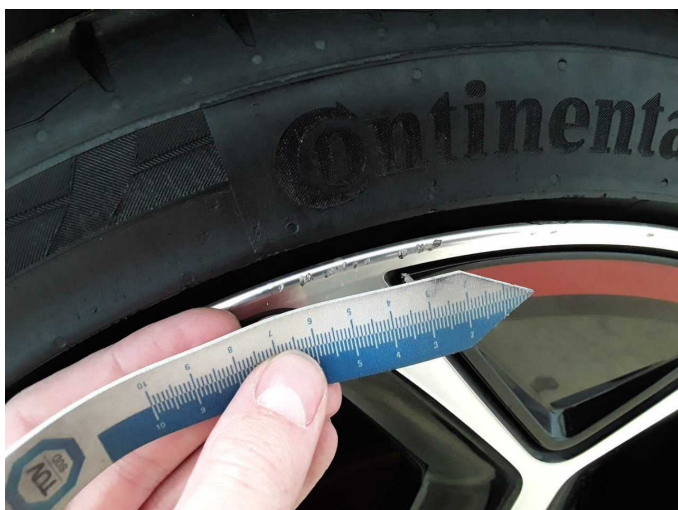
**Damage 3:** Wheel / tyres: Alloy rim - rear right side - Scratch(es) - Loss in value

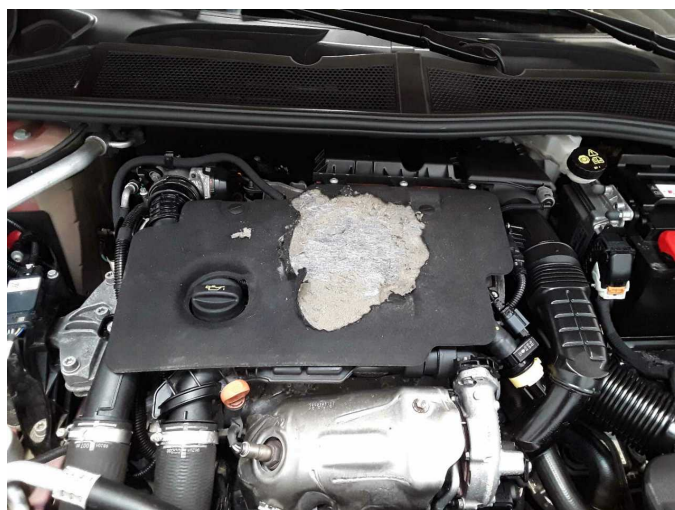
| No. | Component group | Description |
|---|---|---|
| 4 | Engine | Engine cover - top / cover - Damage caused by marten / rodent - Replace |

**Damage 4:** Engine: Engine cover - top / cover - Damage caused by marten / rodent - Replace

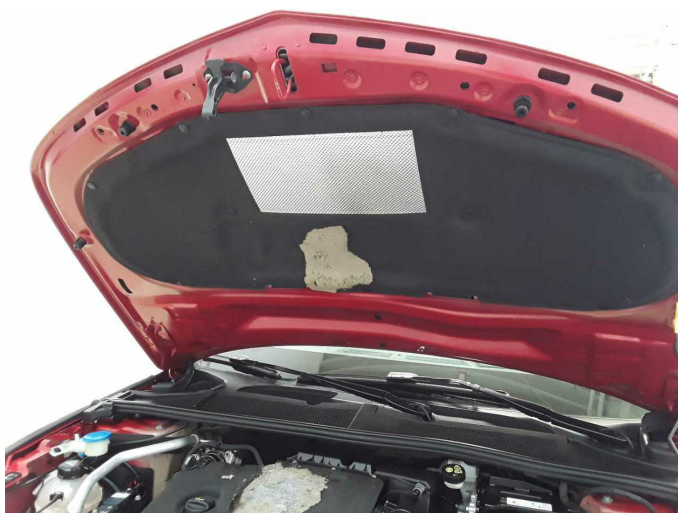
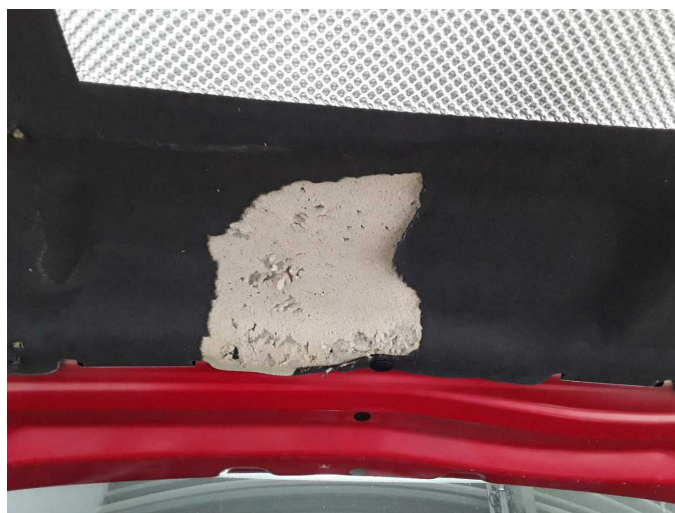
| No. | Component group | Description |
|---|---|---|
| 5 | Bonnet | Insulation lining - Damage caused by marten / rodent - Replace |

**Damage 5:** Bonnet: Insulation lining - Damage caused by marten / rodent - Replace

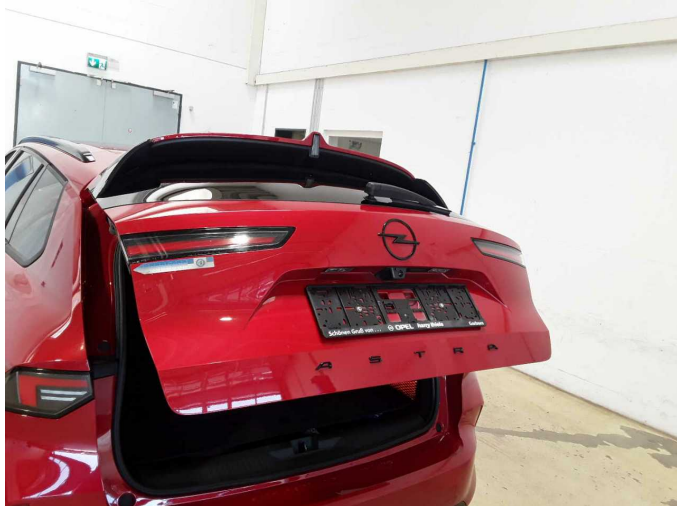
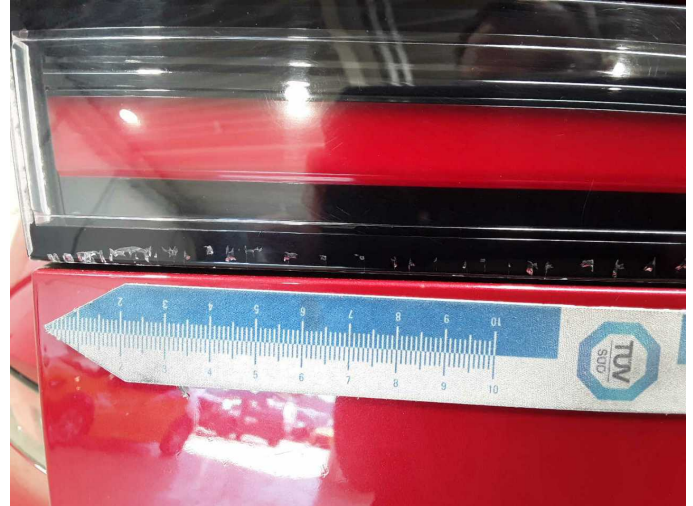
| No. | Component group | Description |
|---|---|---|
| 6 | Tail light | Tail lamp - left side (Innen) - Broken / torn - Replace |

**Damage 6:** Tail light: Tail lamp - left side (Innen) - Broken / torn - Replace

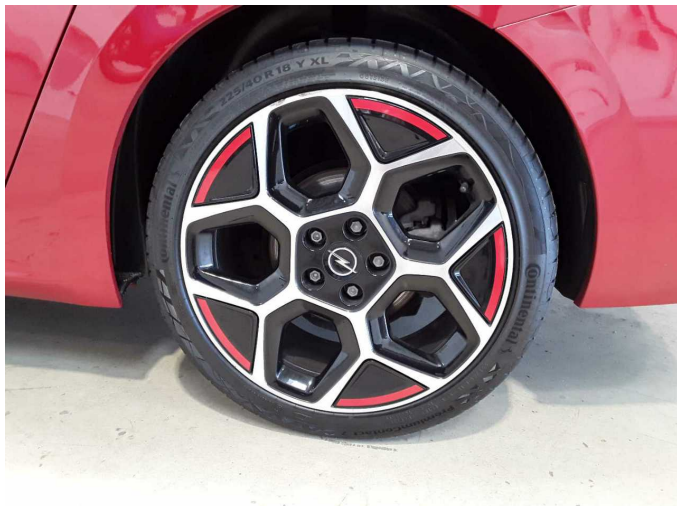
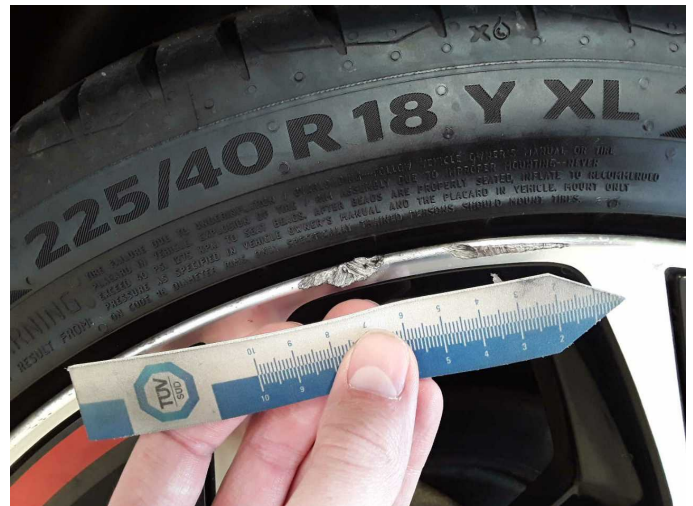
| No. | Component group | Description |
|---|---|---|
| 7 | Wheel / tyres | Alloy rim - rear left side - Scratched - Replace |

**Damage 7:** Wheel / tyres: Alloy rim - rear left side - Scratched - Replace

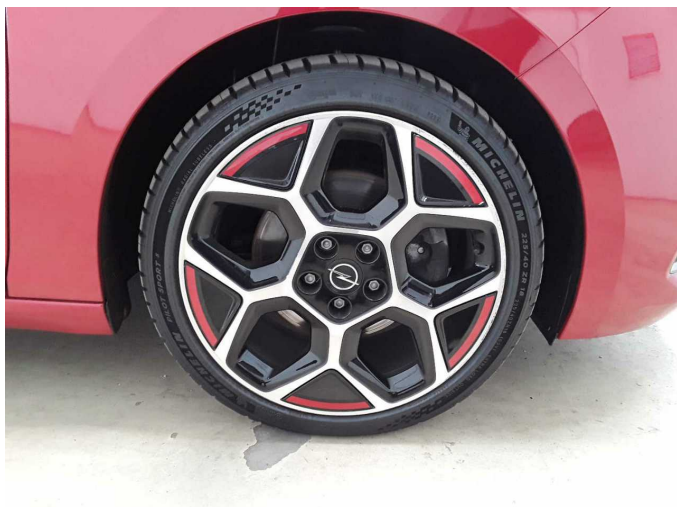
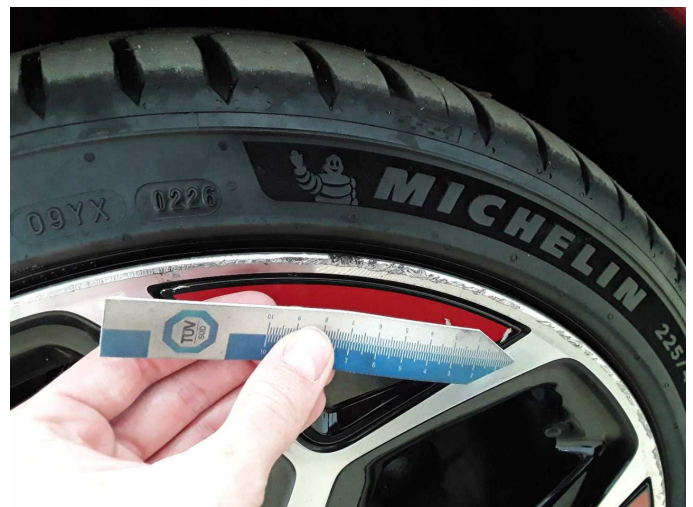
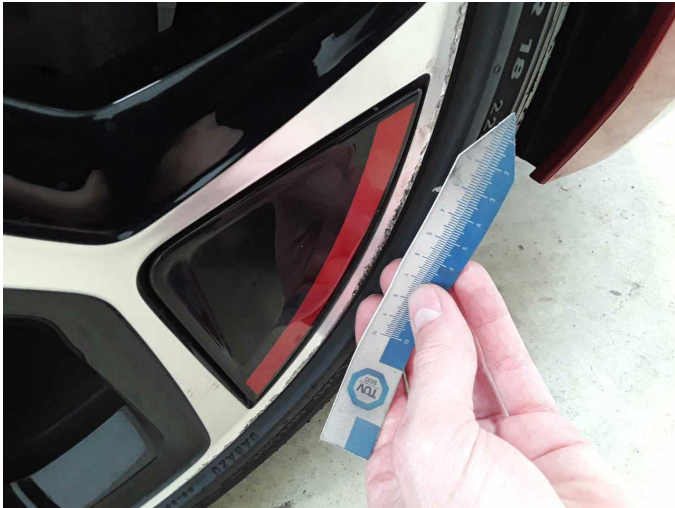
| No. | Component group | Description |
|---|---|---|
| 8 | Wheel / tyres | Alloy rim - front right side - Scratch(es) - Replace |

**Damage 8:** Wheel / tyres: Alloy rim - front right side - Scratch(es) - Replace

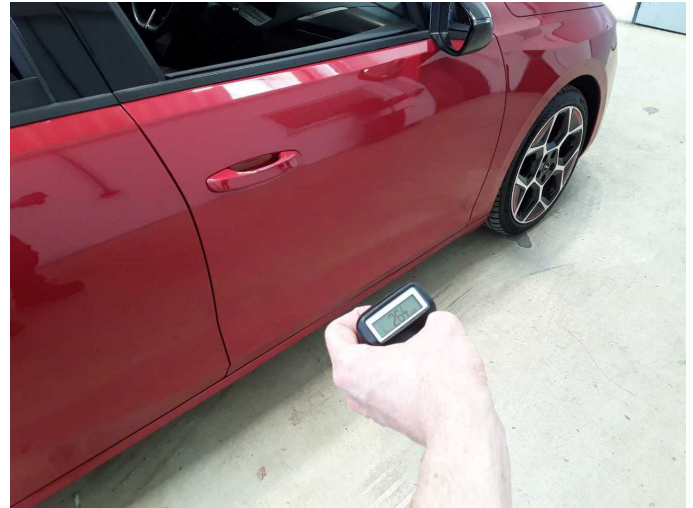
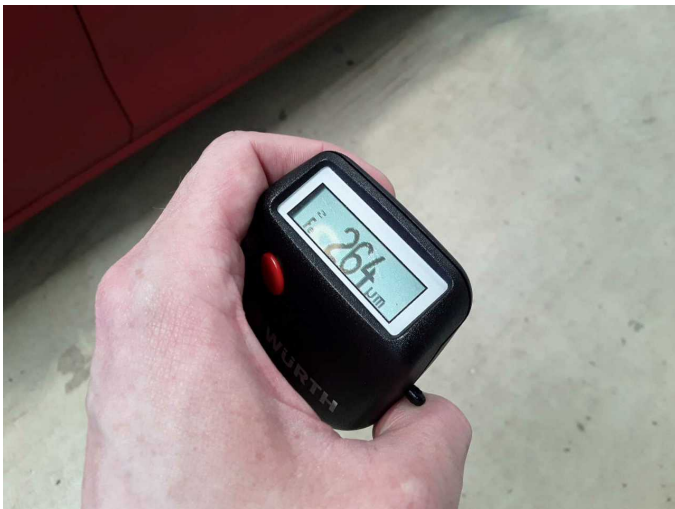
- 1 Door - front right side, Professionally carried out, Invoice of repair done Non-existent

264 µm

**Repainting 1:** Door - front right side
