Expertise

Protocol number: 45868620
Order No. / Reference: 26153198
Inspection date: 1 Jun 2026

Model: 317 CDI Sprinter Lang HA PRO

VIN: W1V3KCFZ7TP857760

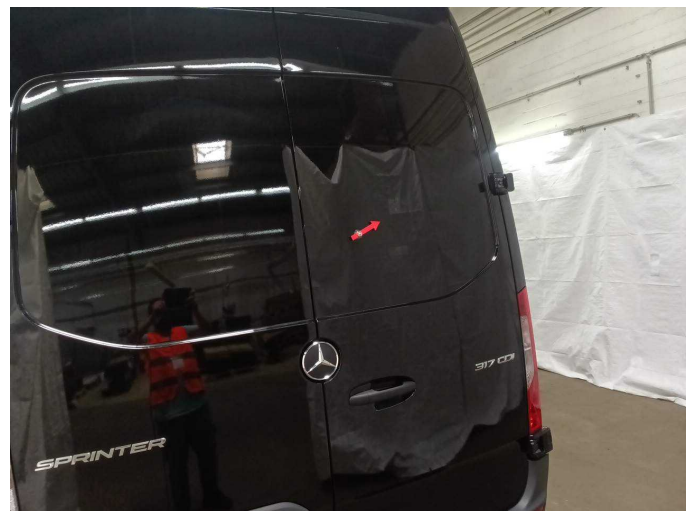
Damage 2: Boot lid / rear door: Boot lid - Glued / labelled - Remove

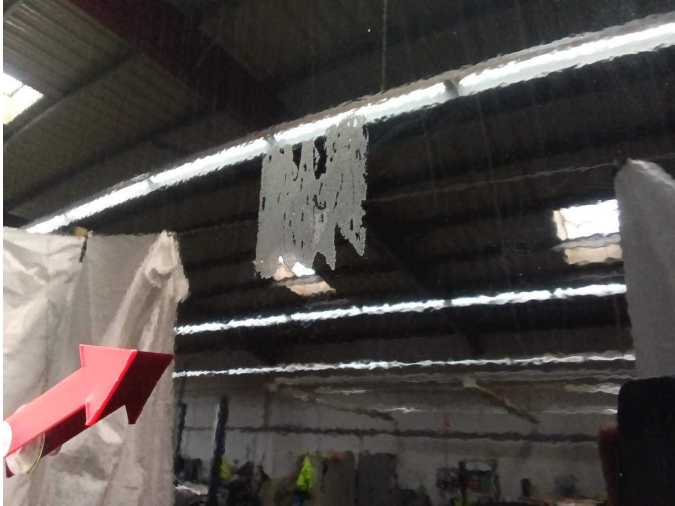
Damage 2: Boot lid / rear door: Boot lid - Glued / labelled - Remove

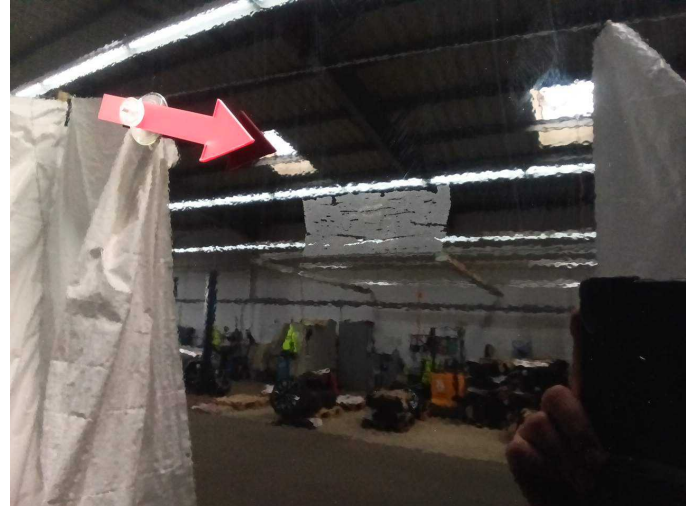
Damage 2: Boot lid / rear door: Boot lid - Glued / labelled - Remove

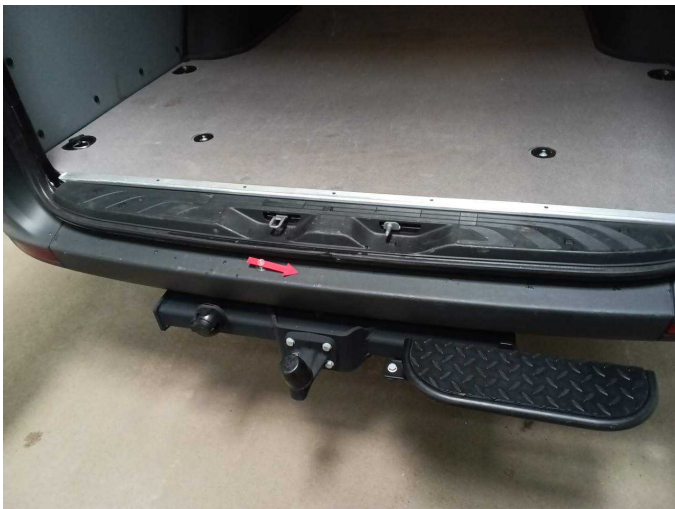
Damage 3: Rear bumper: Rear bumper - Scratched - Loss in value

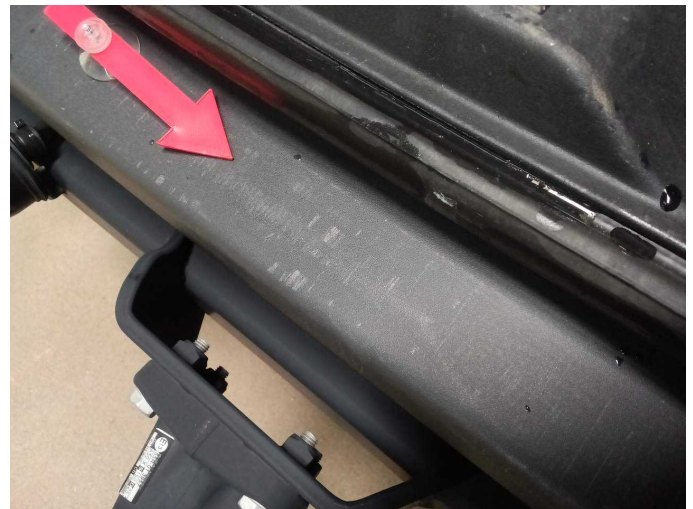
Damage 3: Rear bumper: Rear bumper - Scratched - Loss in value

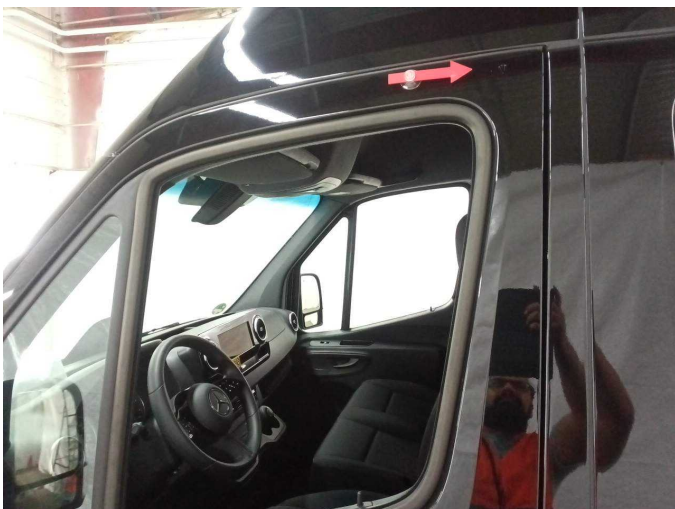
Damage 4: Door - front left side: Door - Scratch(es) - Smart repair

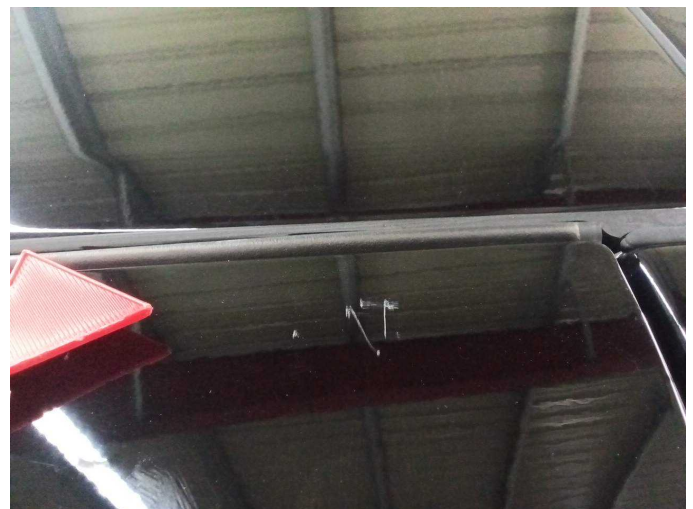
Damage 4: Door - front left side: Door - Scratch(es) - Smart repair

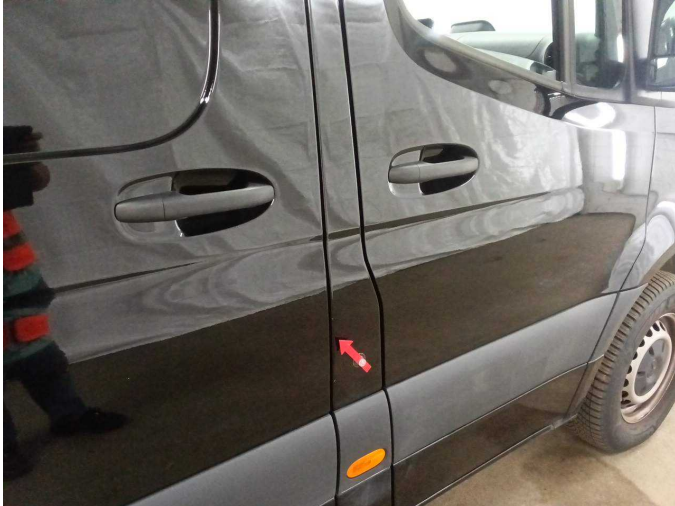
Damage 5: Body: B-pillar - right side - Scratch(es) - Smart repair

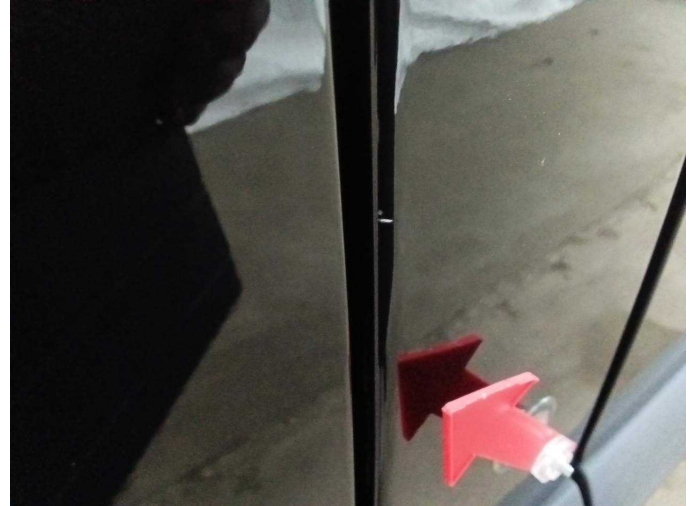
Damage 5: Body: B-pillar - right side - Scratch(es) - Smart repair

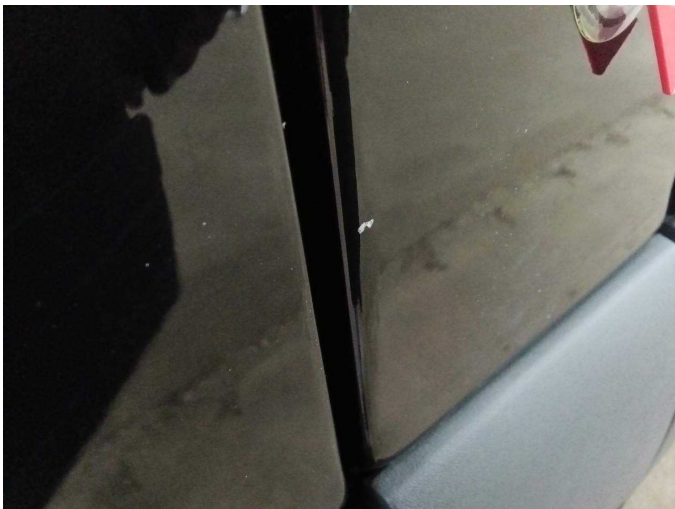
Damage 5: Body: B-pillar - right side - Scratch(es) - Smart repair

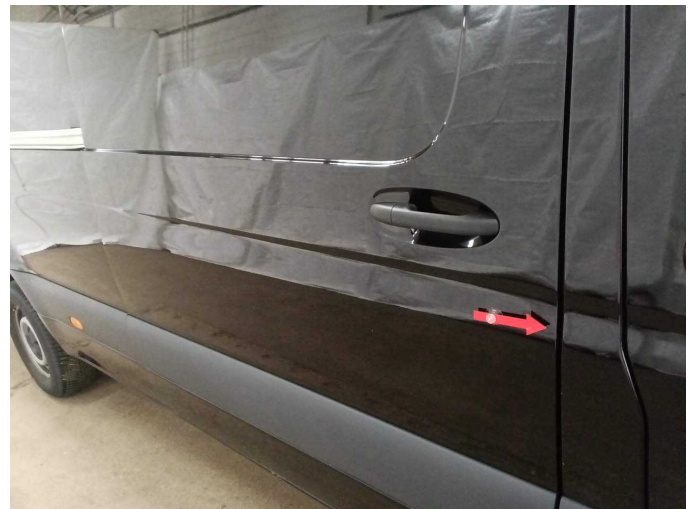
Damage 6: Door - front right side: Door edge - Scratch(es) - Smart repair

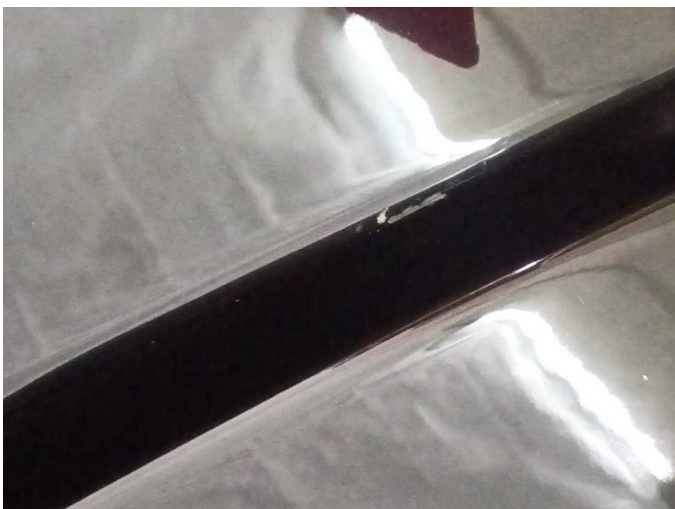
Damage 6: Door - front right side: Door edge - Scratch(es) - Smart repair

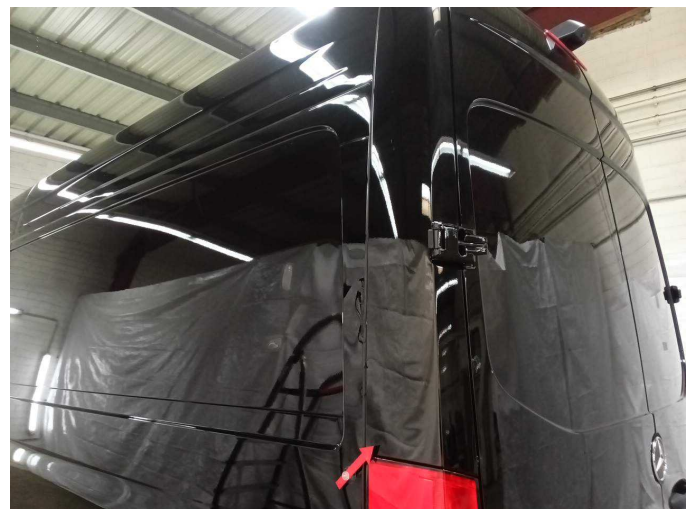
Damage 7: Body: D-pillar - left side - Dent / paintcoat damage - Smart repair

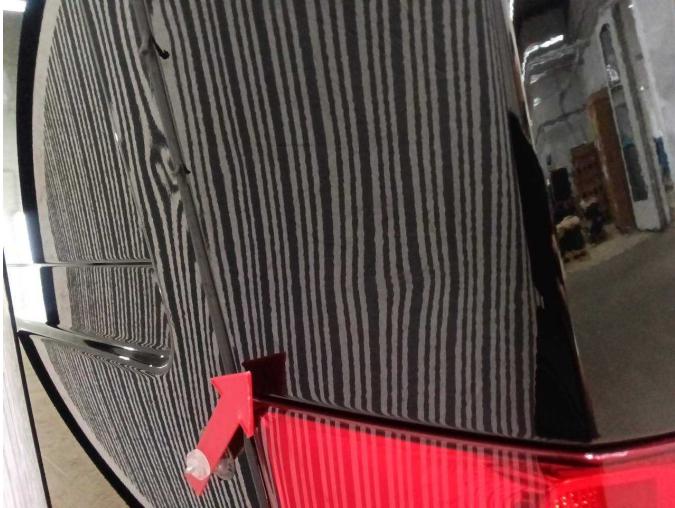
Damage 7: Body: D-pillar - left side - Dent / paintcoat damage - Smart repair

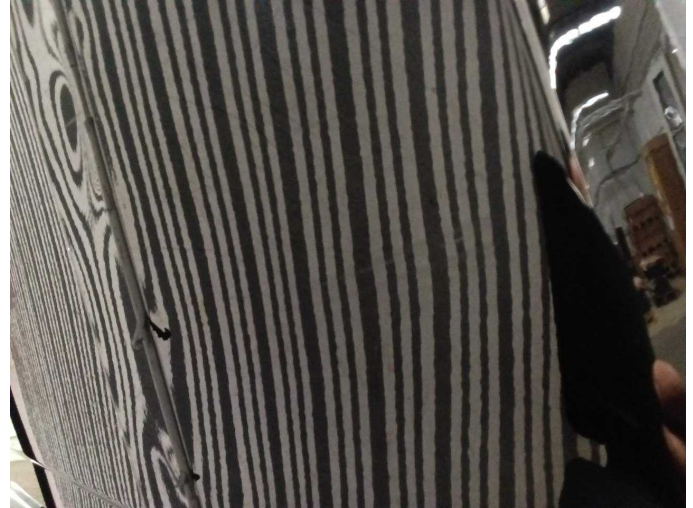
Damage 7: Body: D-pillar - left side - Dent / paintcoat damage - Smart repair

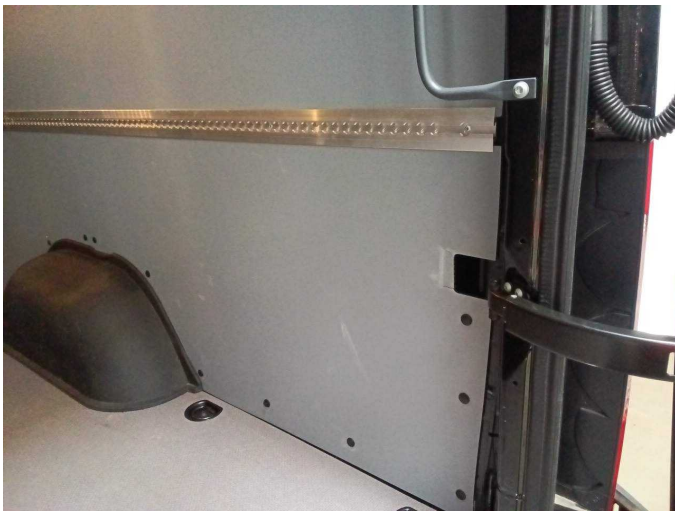
Damage 8: Side panel - rear right side: Interior trim - Broken / torn - Replace

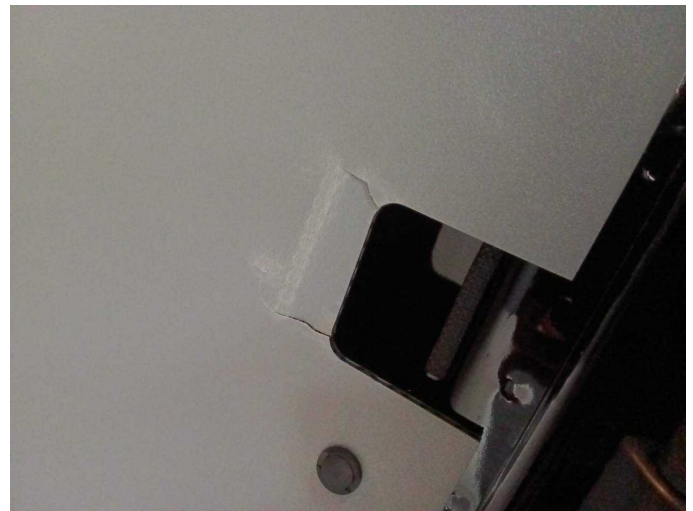
Damage 8: Side panel - rear right side: Interior trim - Broken / torn - Replace

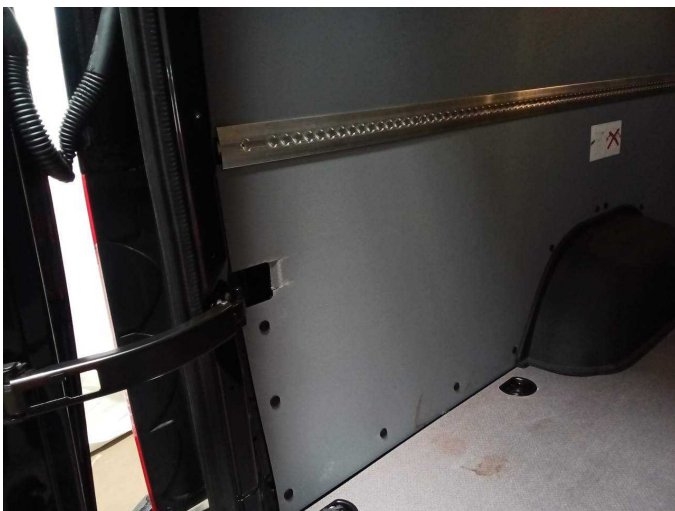
Damage 9: Side panel - rear left side: Interior trim - Broken / torn - Replace

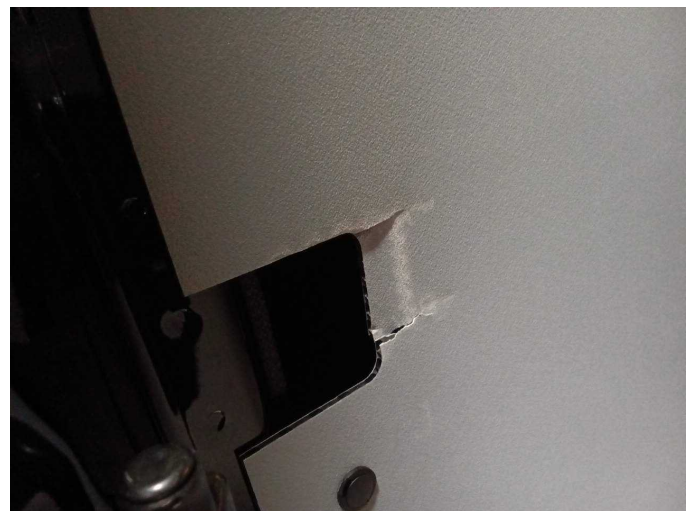
Damage 9: Side panel - rear left side: Interior trim - Broken / torn - Replace

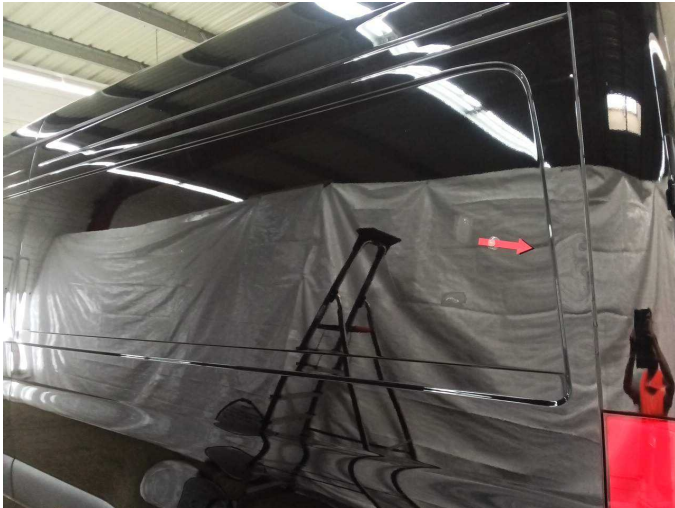
Damage 10: Side panel - rear left side: Side panel - Dent / paintcoat damage - repair according to calculation

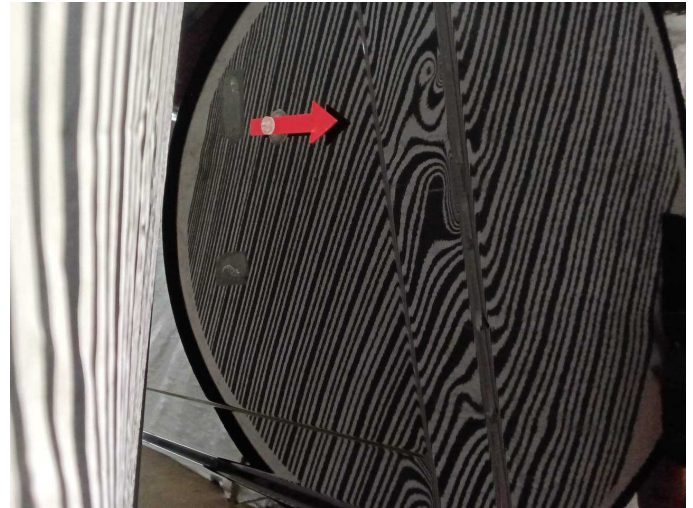
Damage 10: Side panel - rear left side: Side panel - Dent / paintcoat damage - repair according to calculation

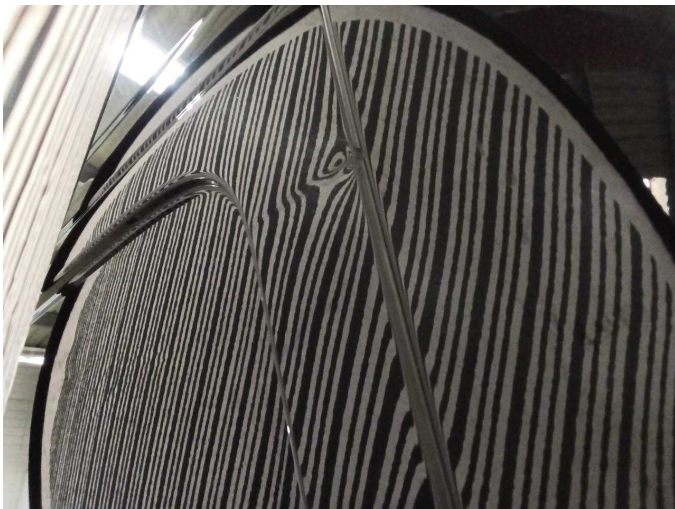
Damage 10: Side panel - rear left side: Side panel - Dent / paintcoat damage - repair according to calculation

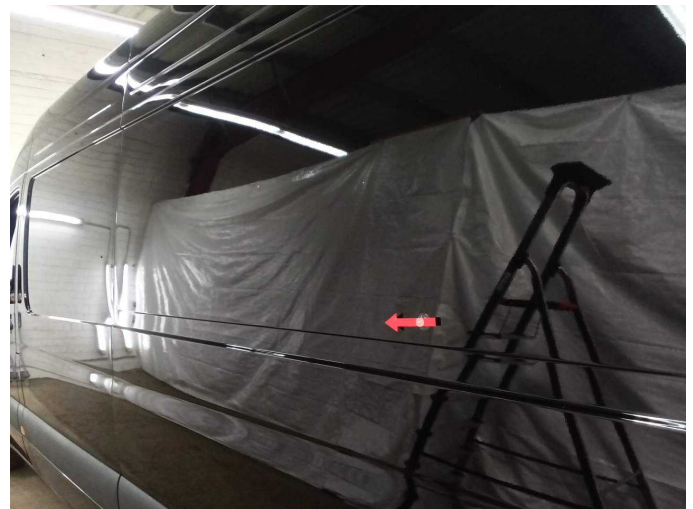
Damage 10: Side panel - rear left side: Side panel - Dent / paintcoat damage - repair according to calculation

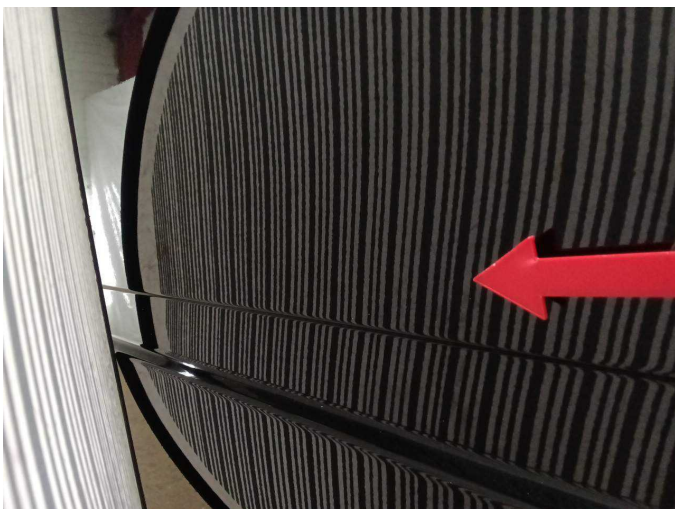
Damage 10: Side panel - rear left side: Side panel - Dent / paintcoat damage - repair according to calculation

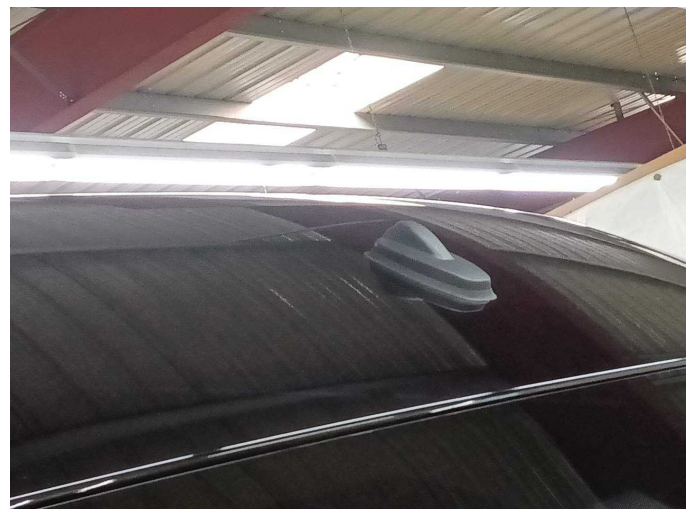
Missing part 1: Roof: Stub aerial - Missing - Perform

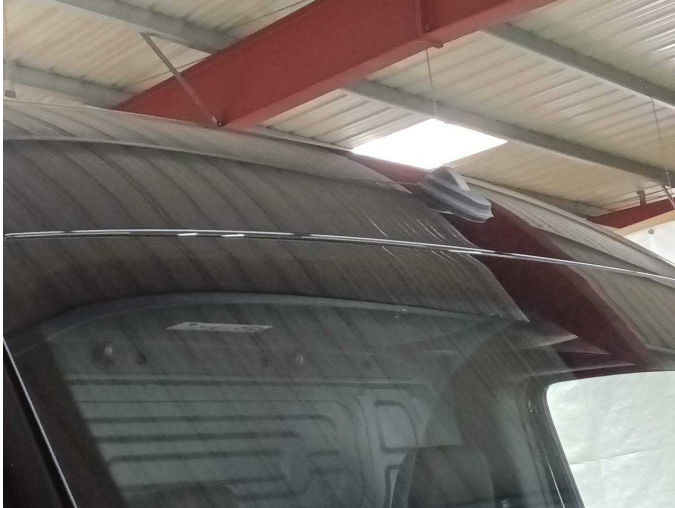
Missing part 1: Roof: Stub aerial - Missing - Perform
