Expertise

Protocol number: 46365685
Order No. / Reference: 26412190
Inspection date: 2 Jul 2026

Model: Focus Turnier 1.0 EcoBoost Start-Stopp-System TITANIUM

VIN: WF0PXXGCHPNG35446

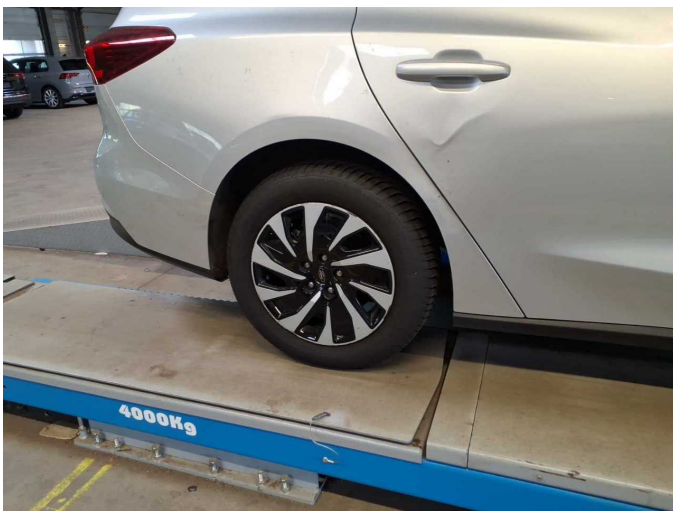
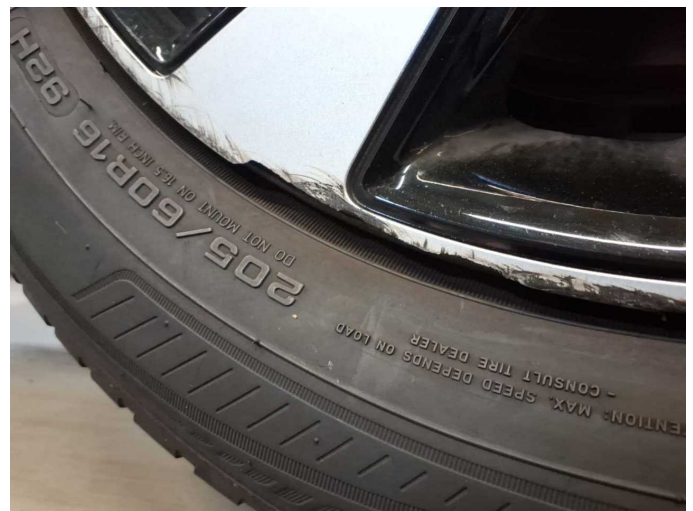
Damage 1: Wheel / tyres: Wheel cover - rear right side - Scratched - Replace

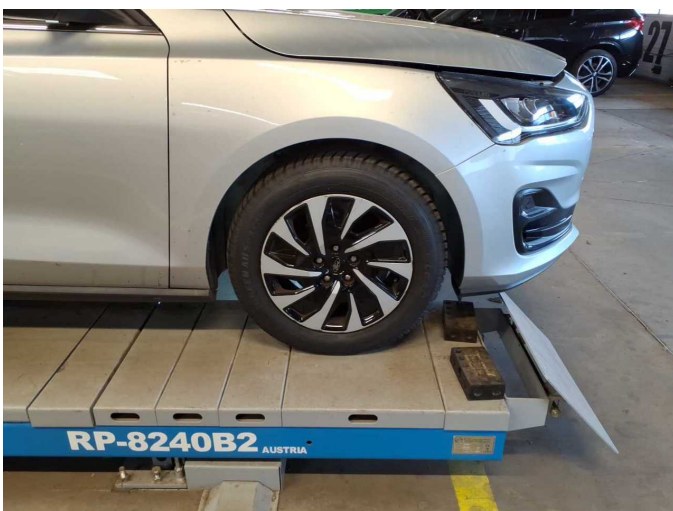
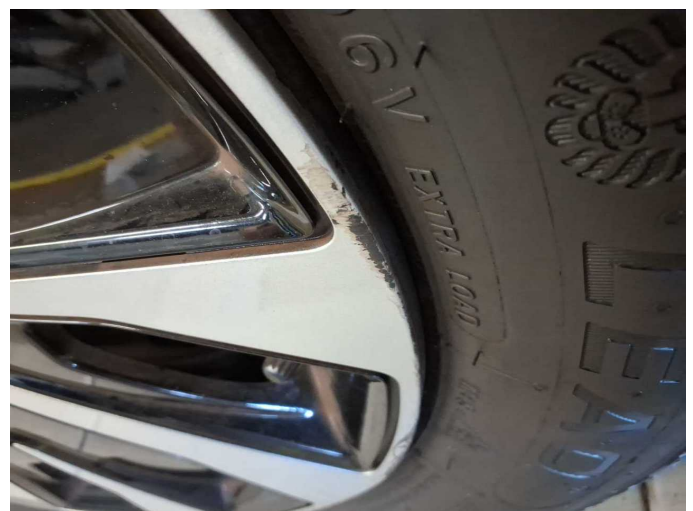
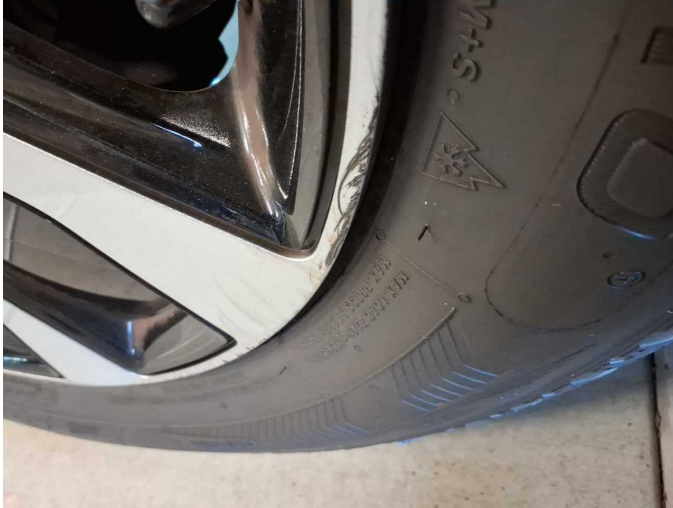
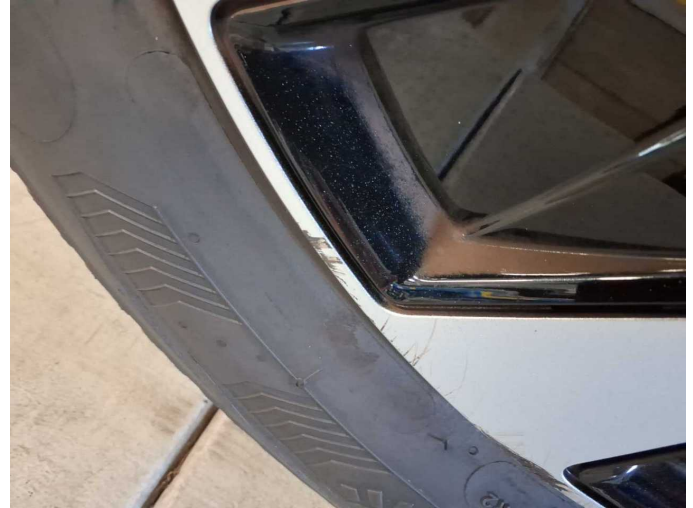
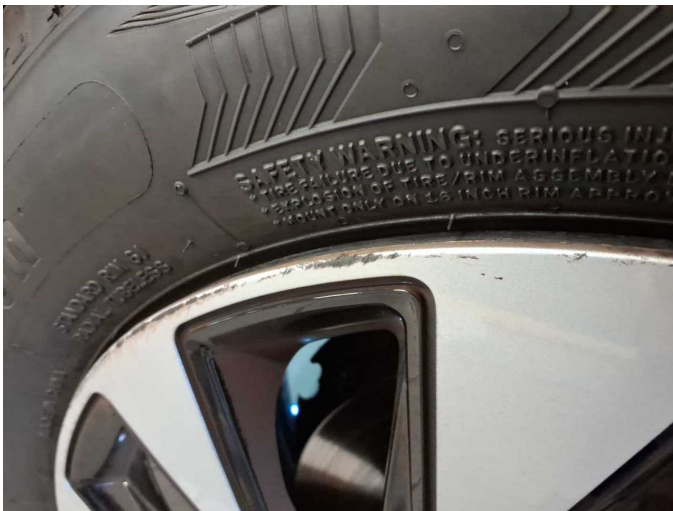
Damage 2: Wheel / tyres: Wheel cover - front right side - Scratched - Replace

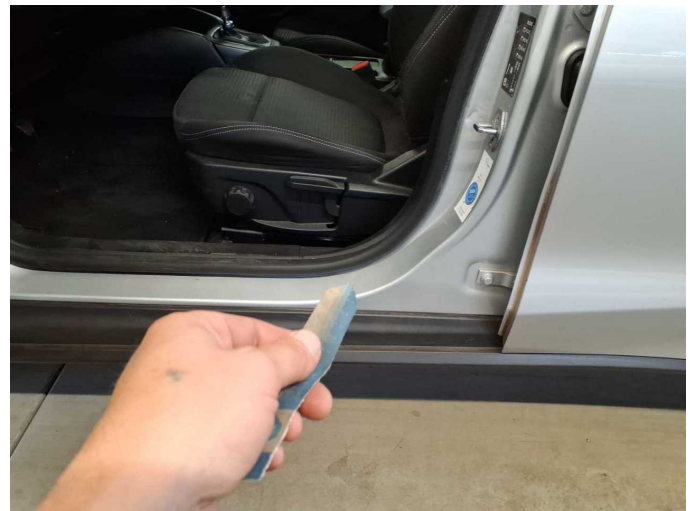
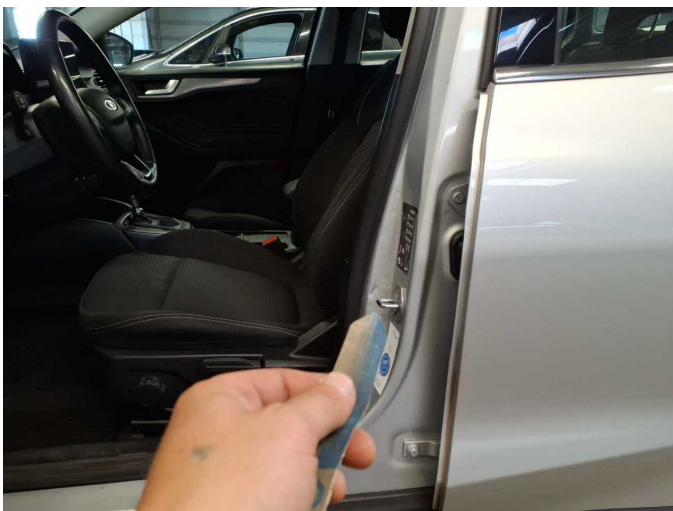
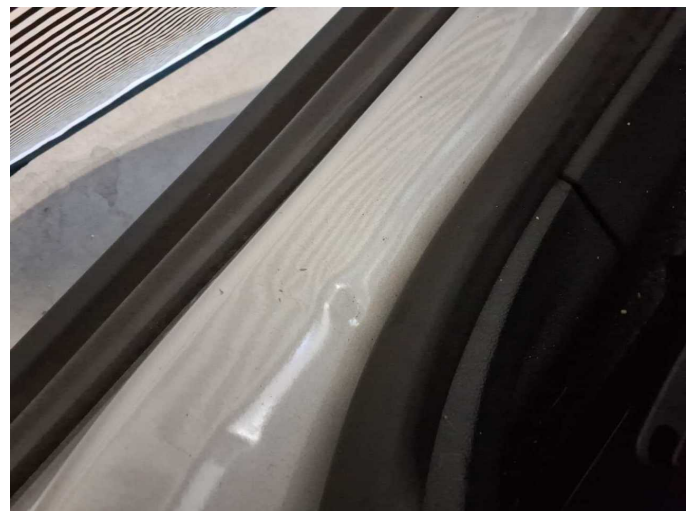
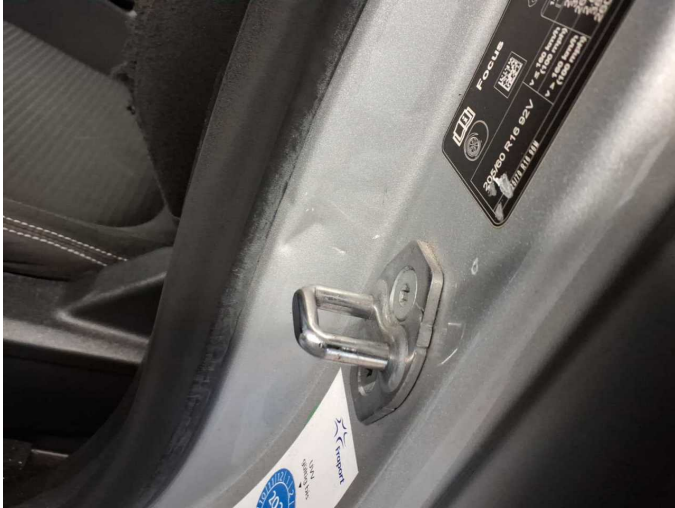
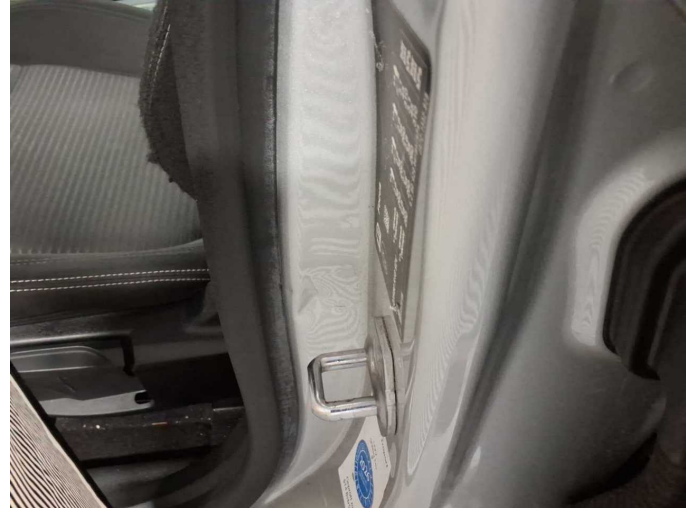
Damage 3: Body: B-pillar - left side - Dent / paintcoat damage - Smart repair

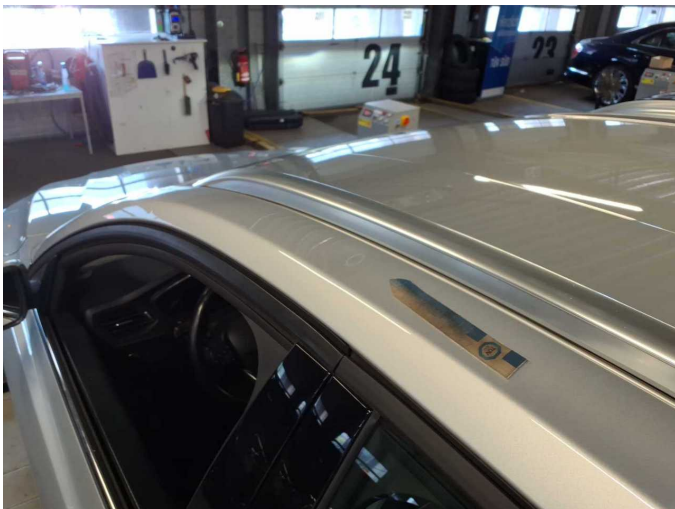
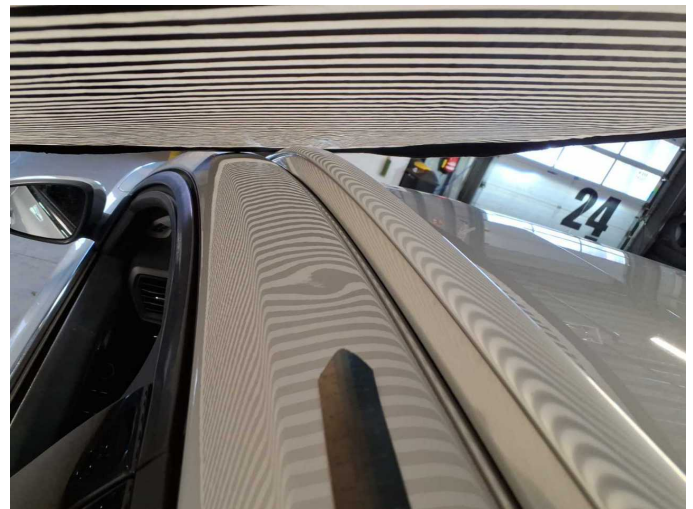
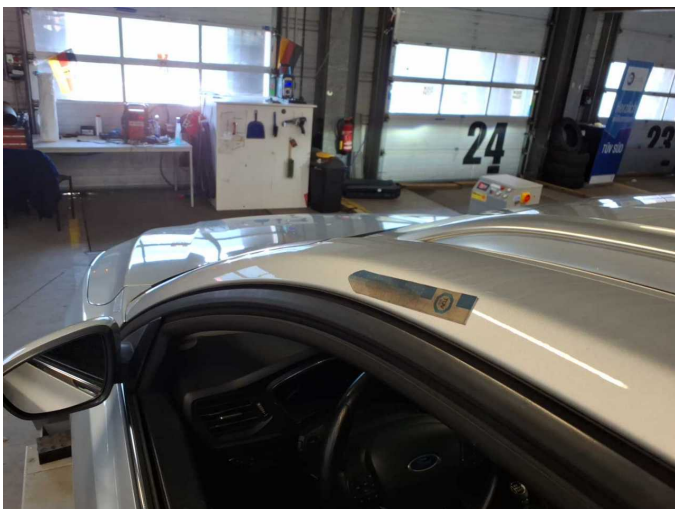
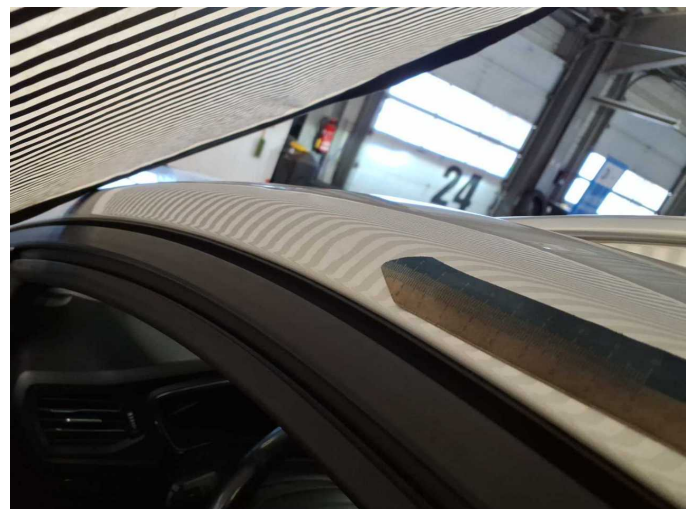
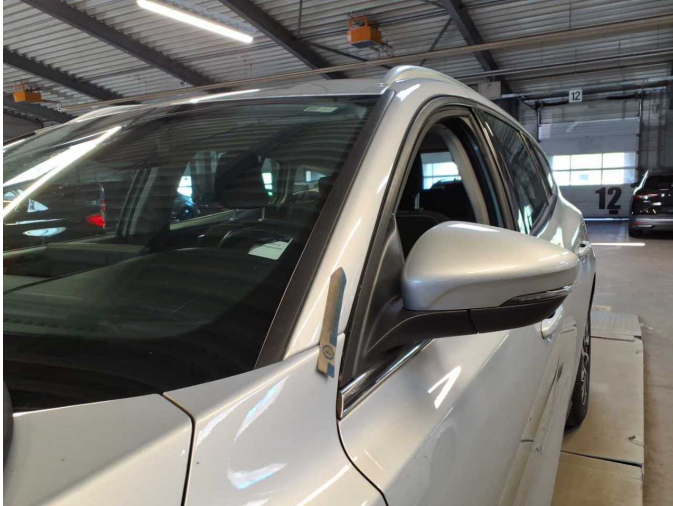
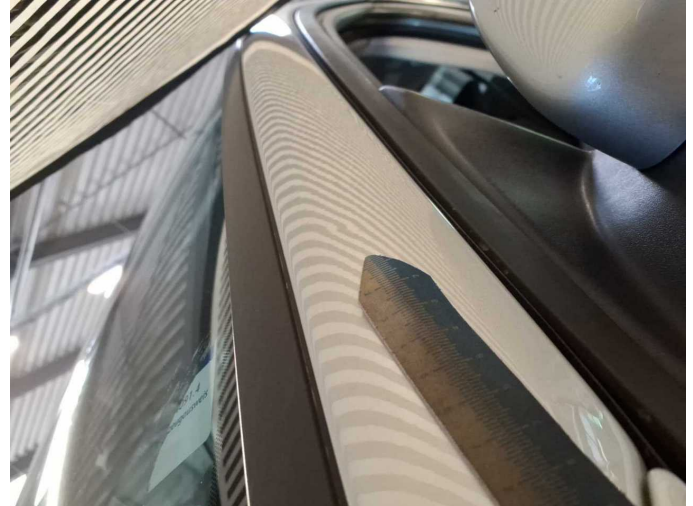
Damage 4: Body: A-pillar - left side (+Holm) - dent(s) - Smooth repair work

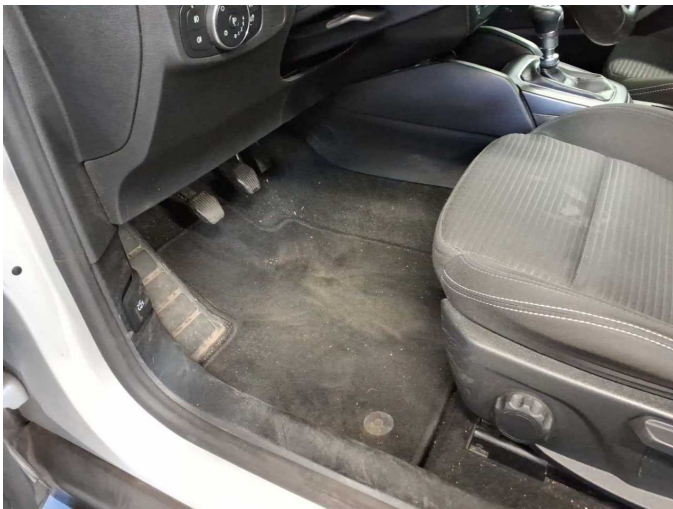
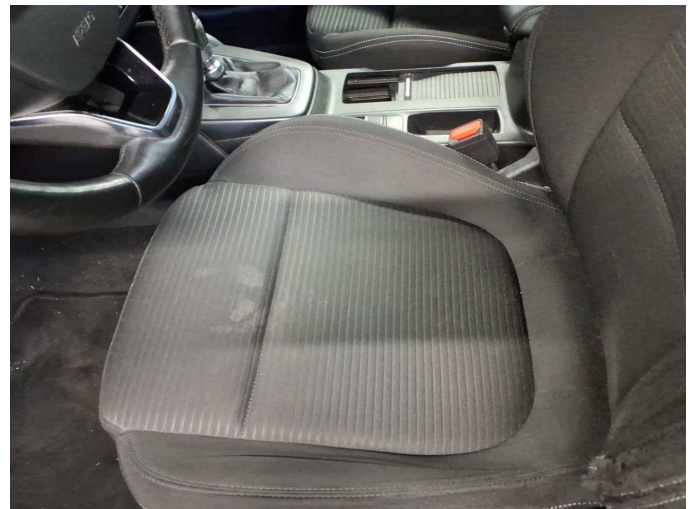
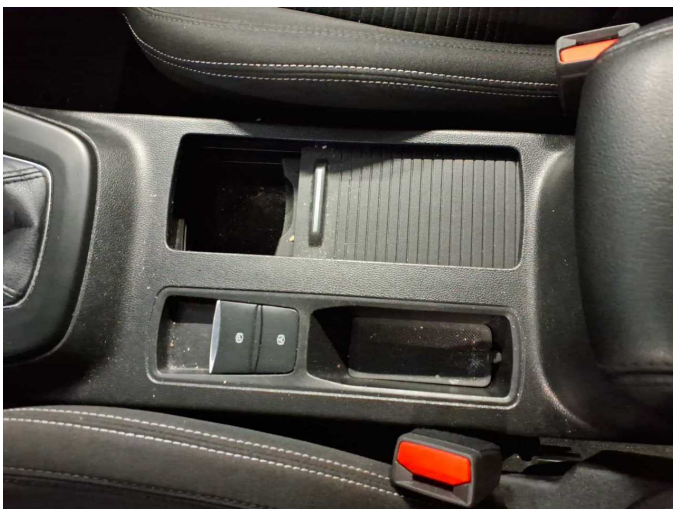
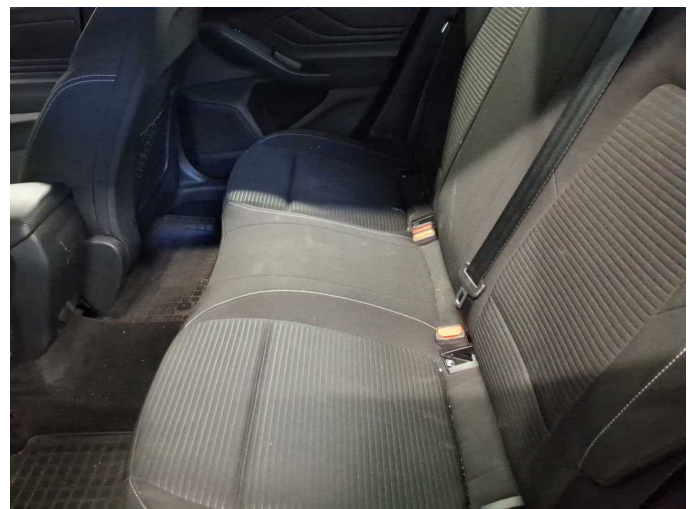
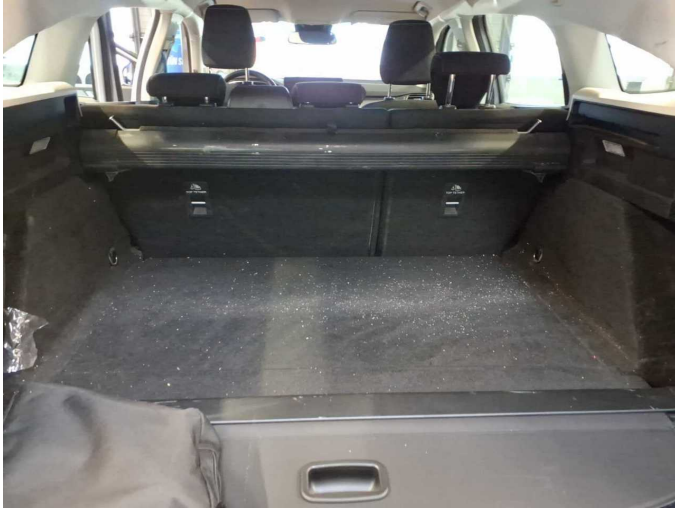
Damage 5: Interior: Interior - Soiled - Clean

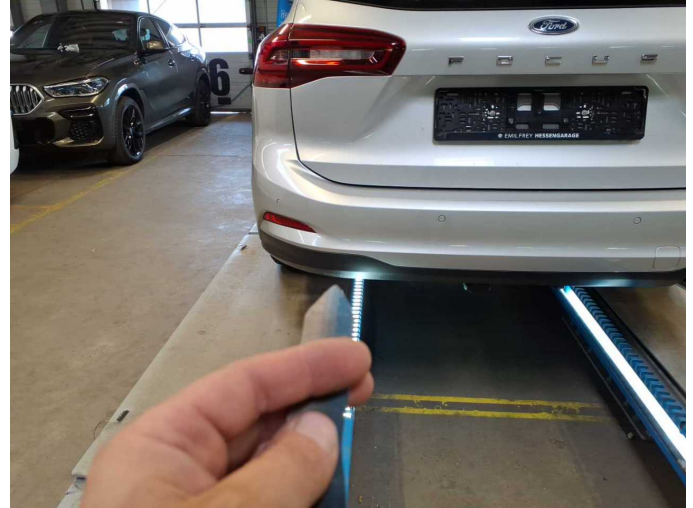
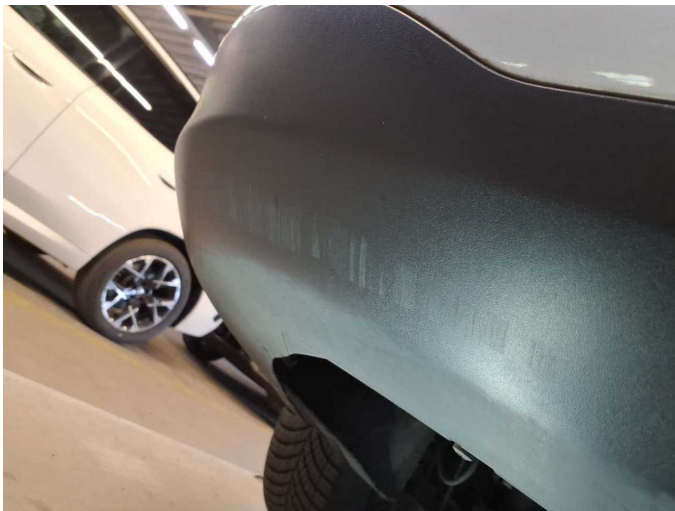
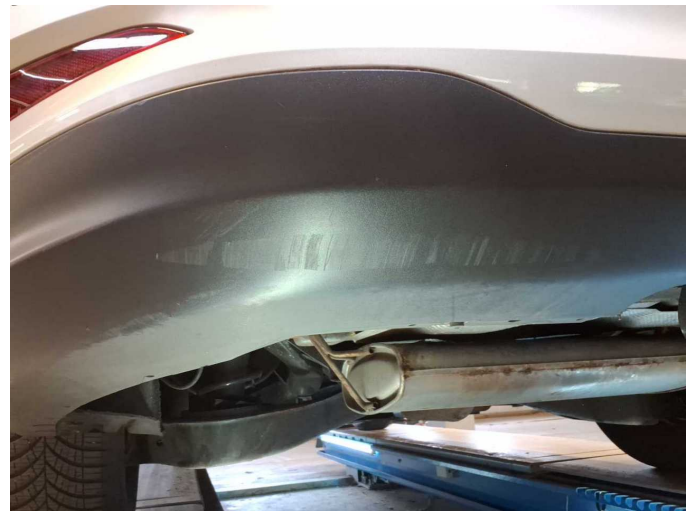
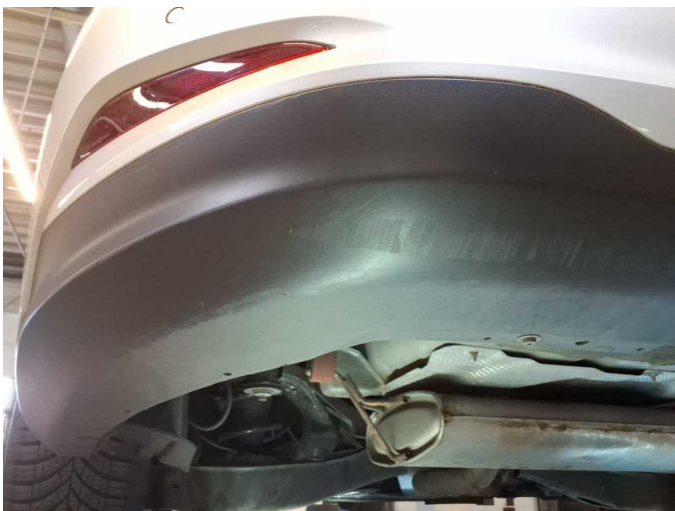
Damage 6: Rear bumper: Spoiler - Scratched - Replace

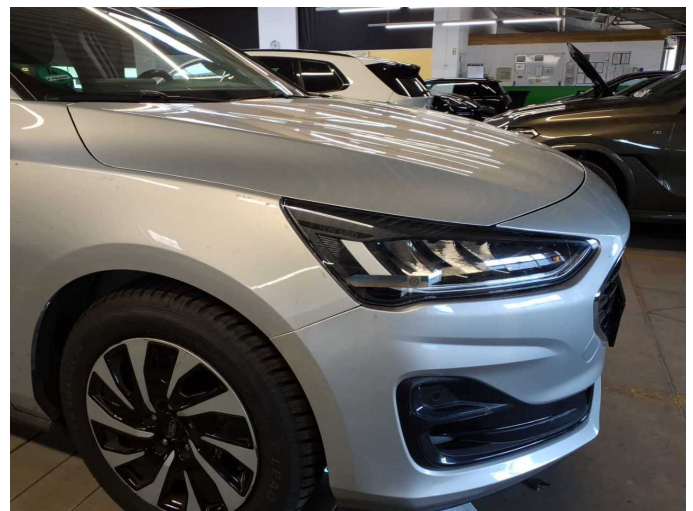
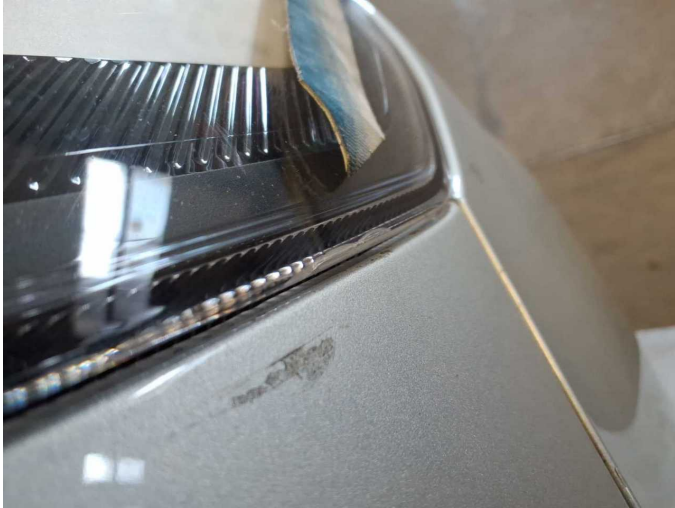
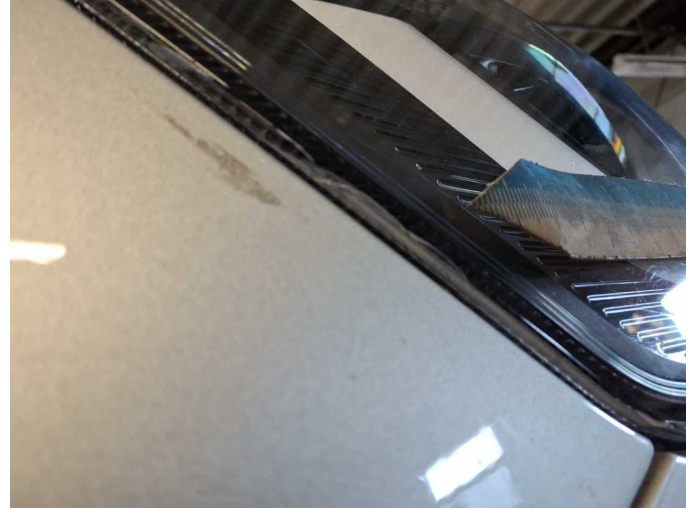
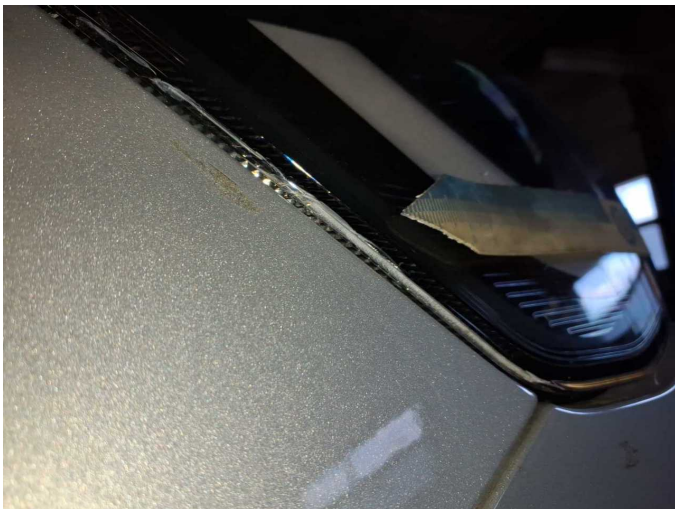
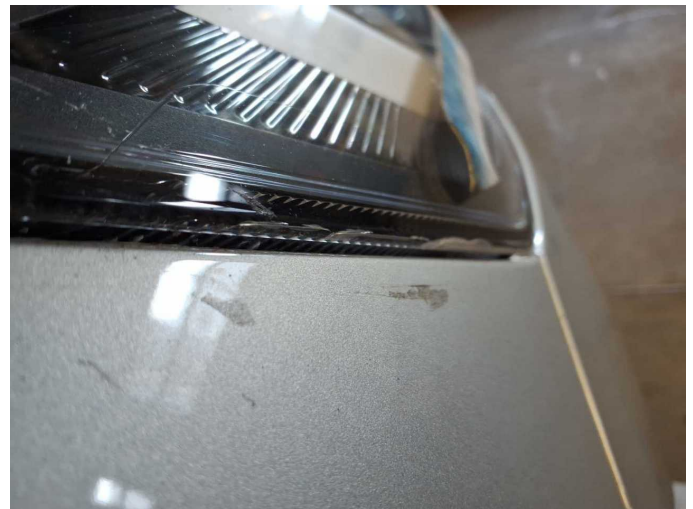
Damage 7: Headlight: Headlight - right side - Broken / torn - Replace

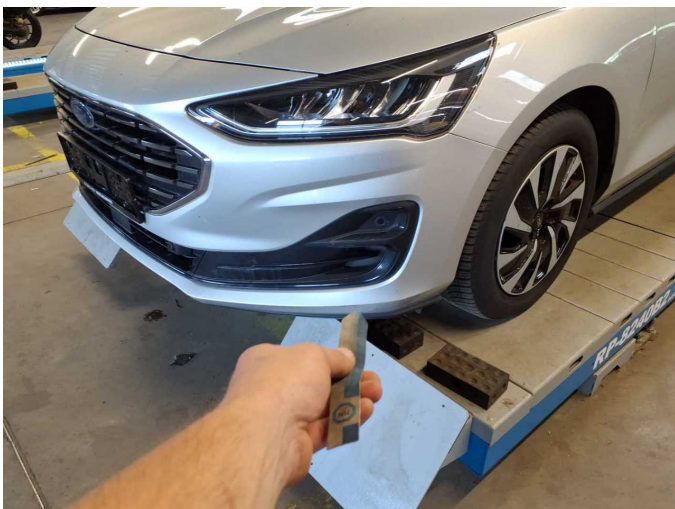
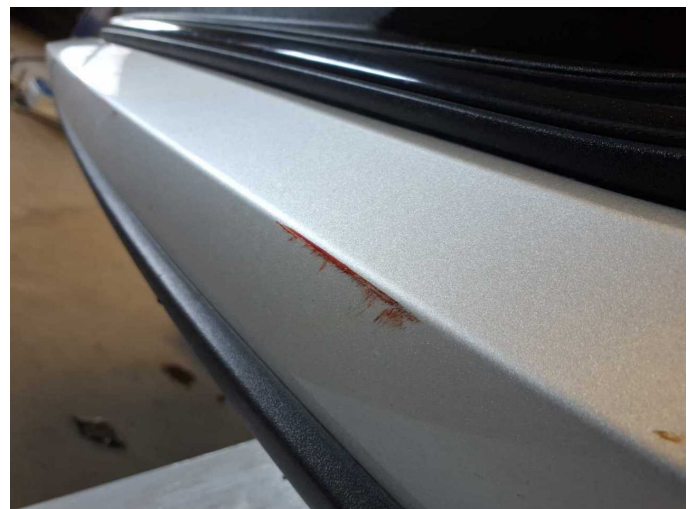
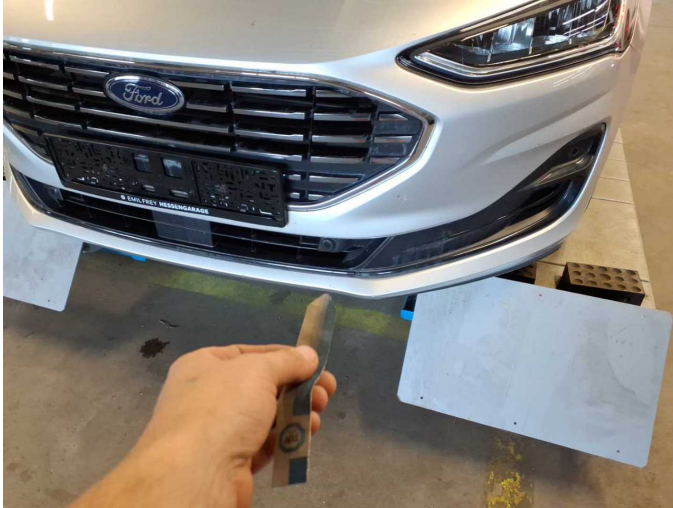
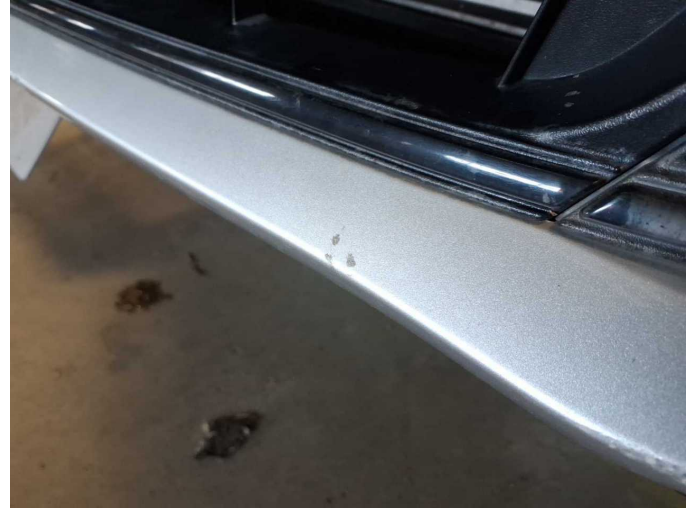
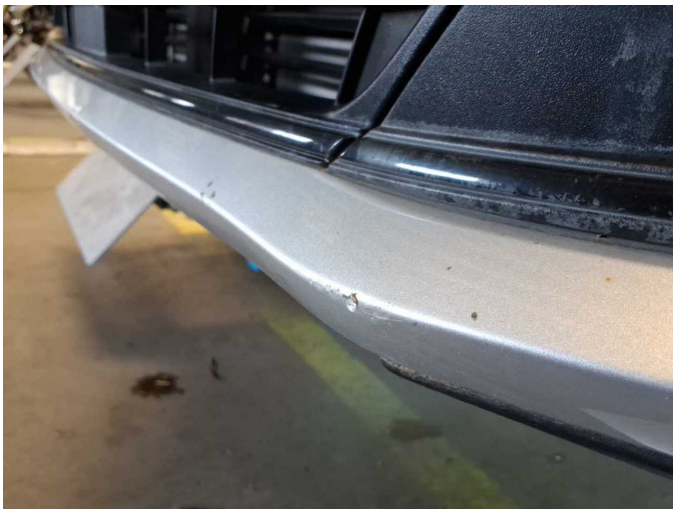
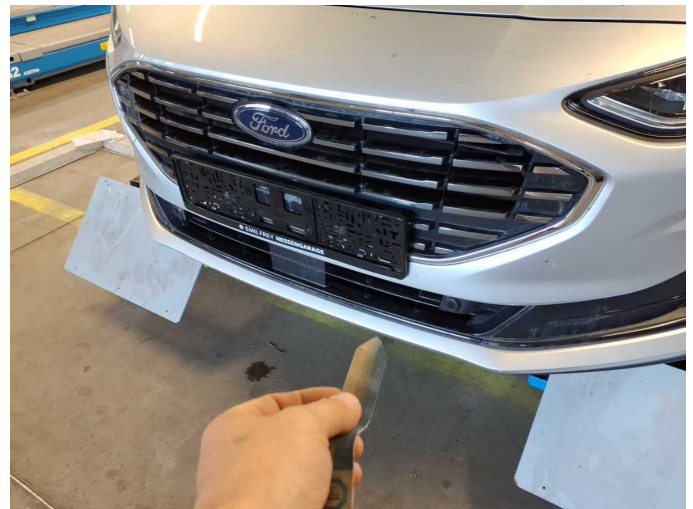
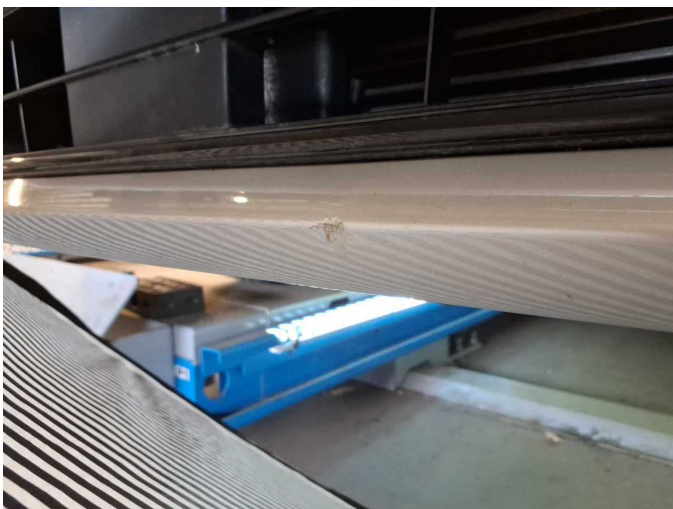
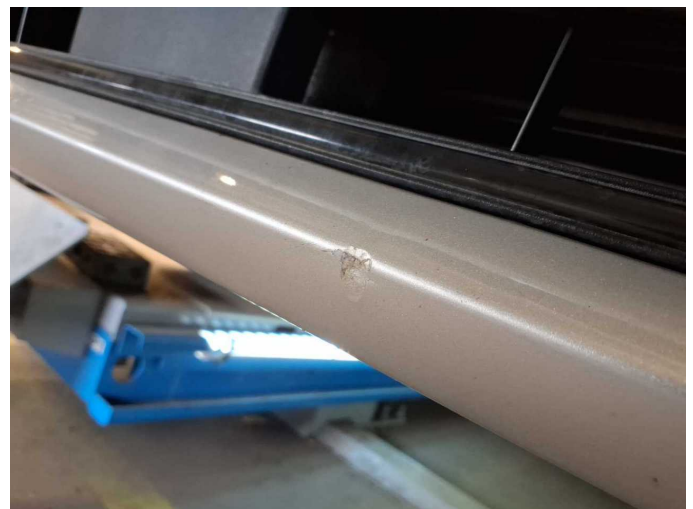
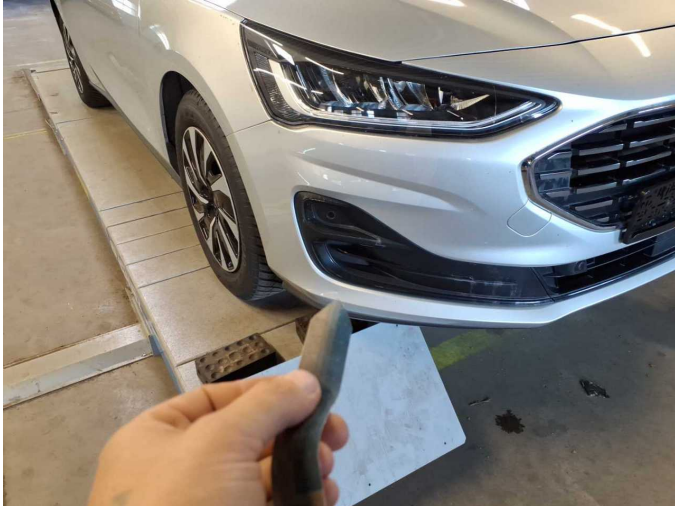
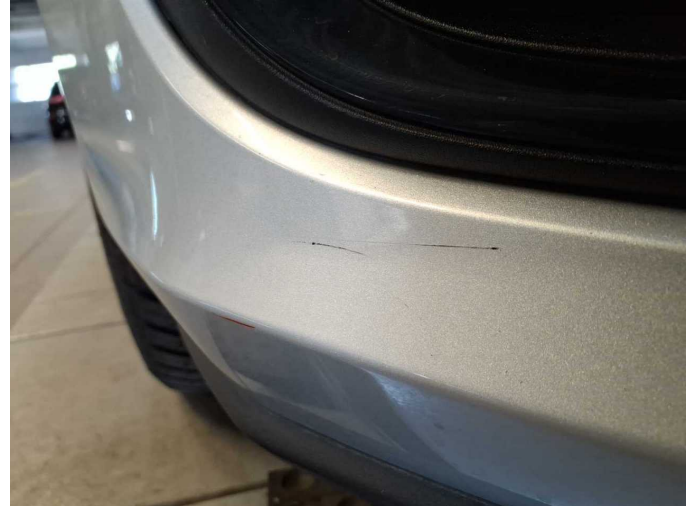
Damage 8: Front bumper: Front bumper - Scratched - Repair and paint

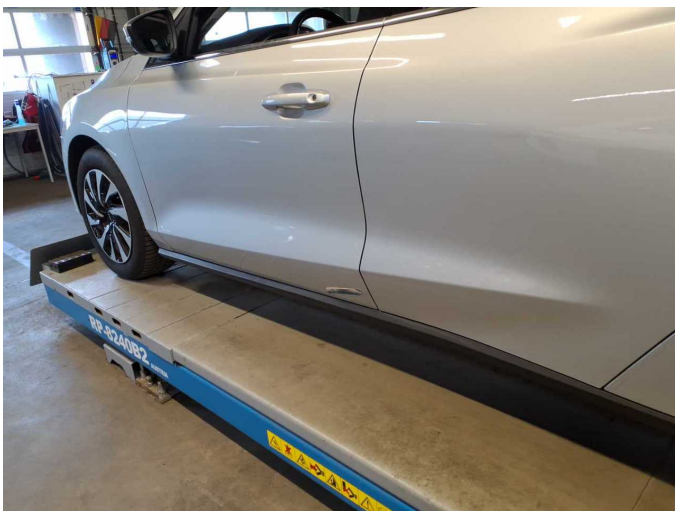
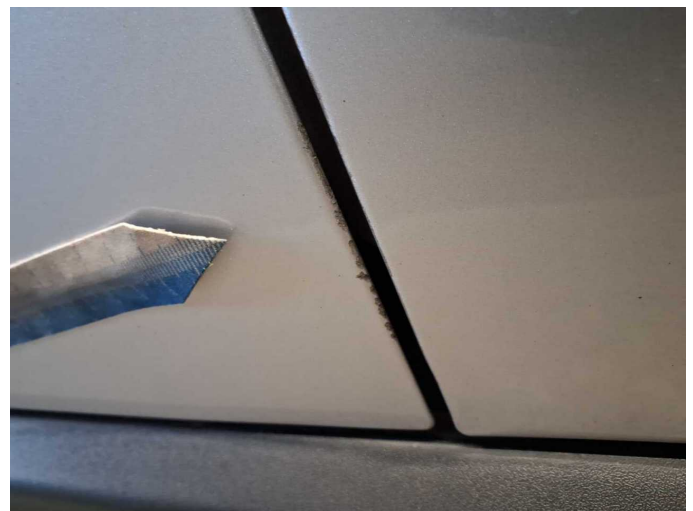
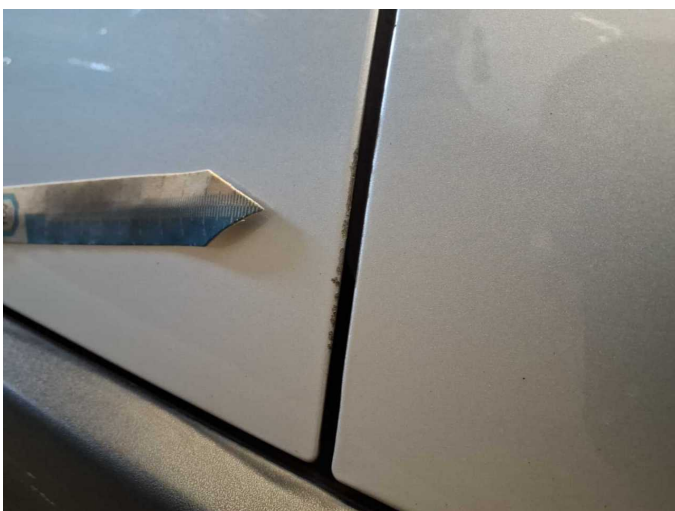
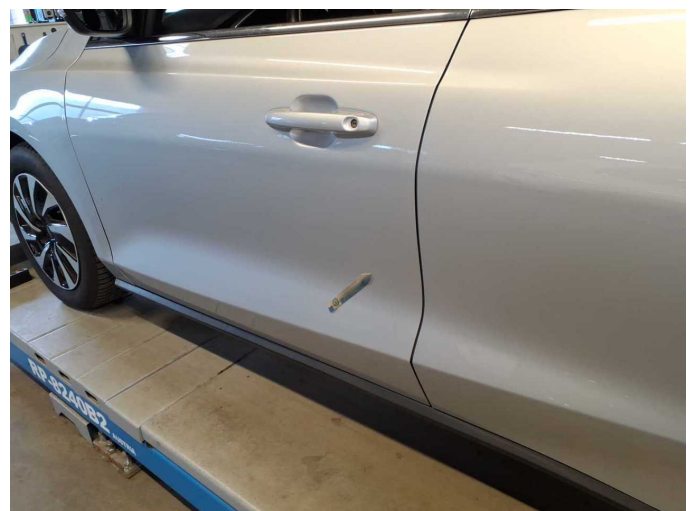
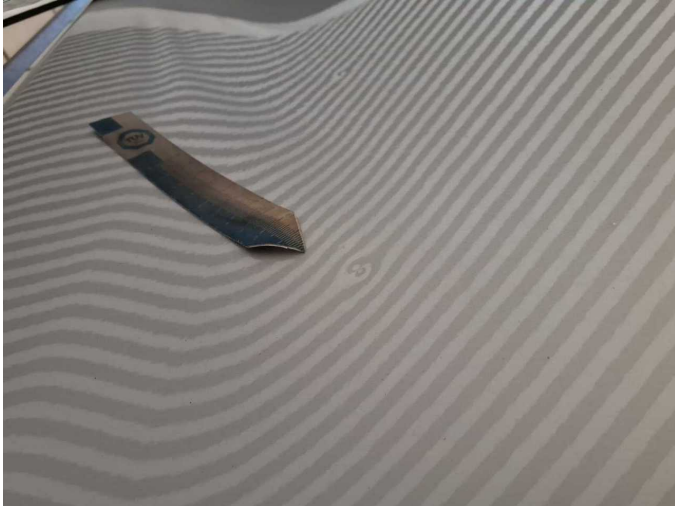
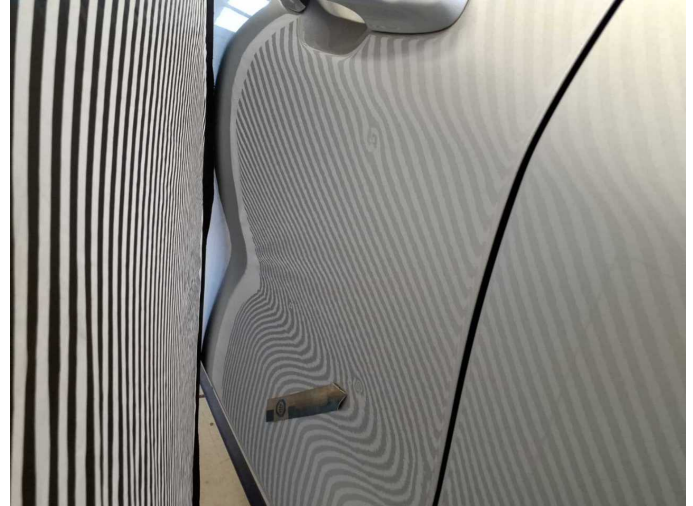
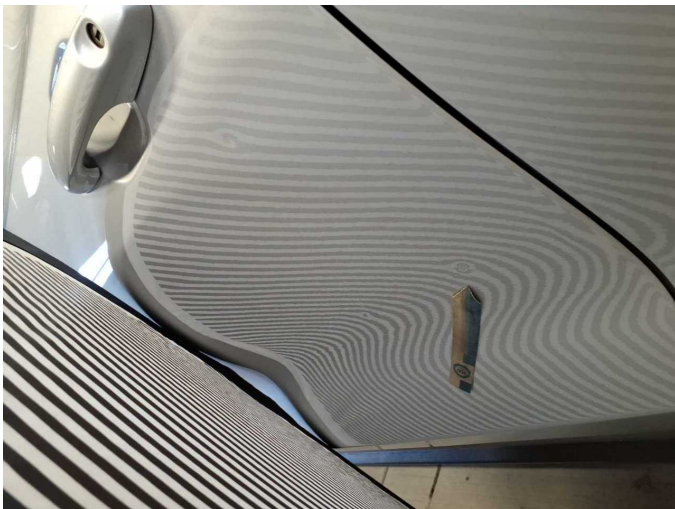
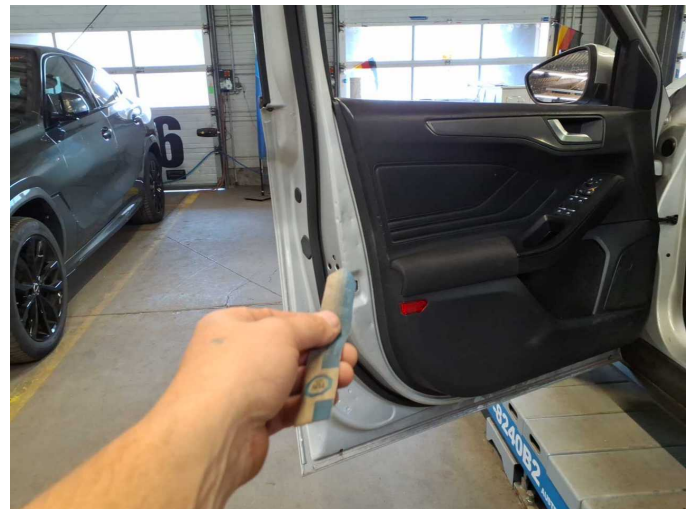
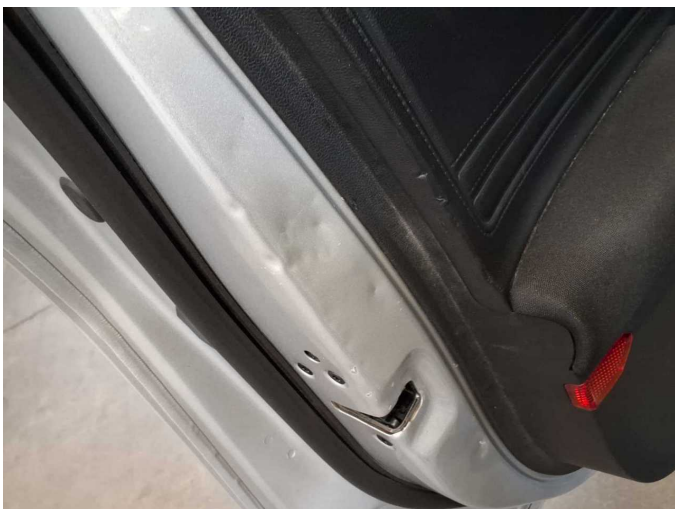
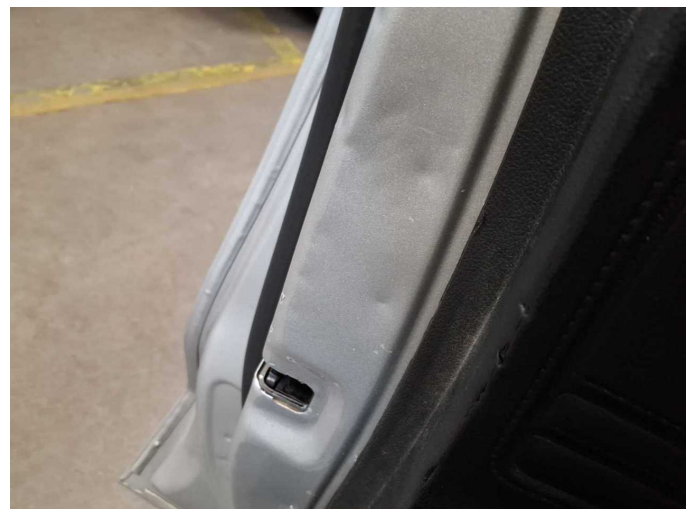
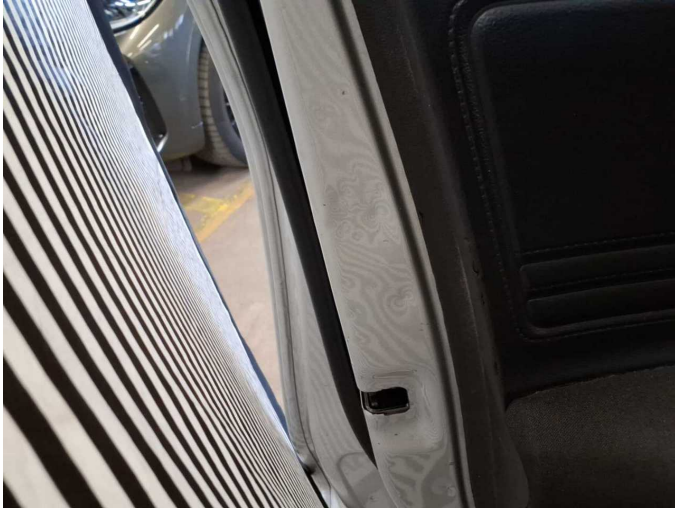
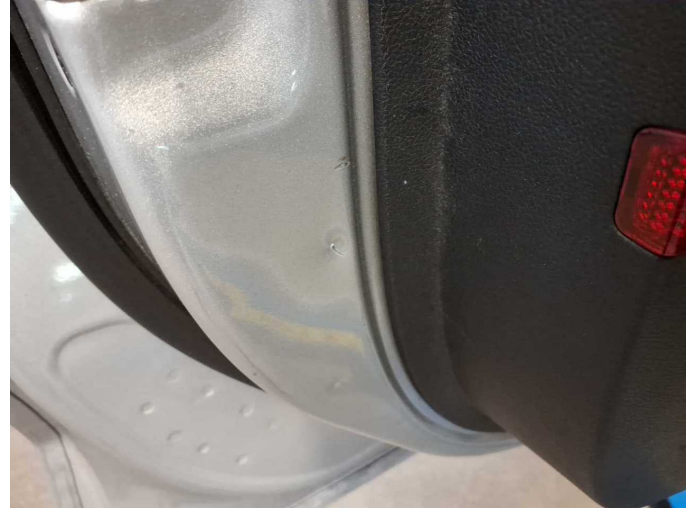
Damage 9: Door - front left side: Door (Verformt innen) - Dent / paintcoat damage - Repair and paint

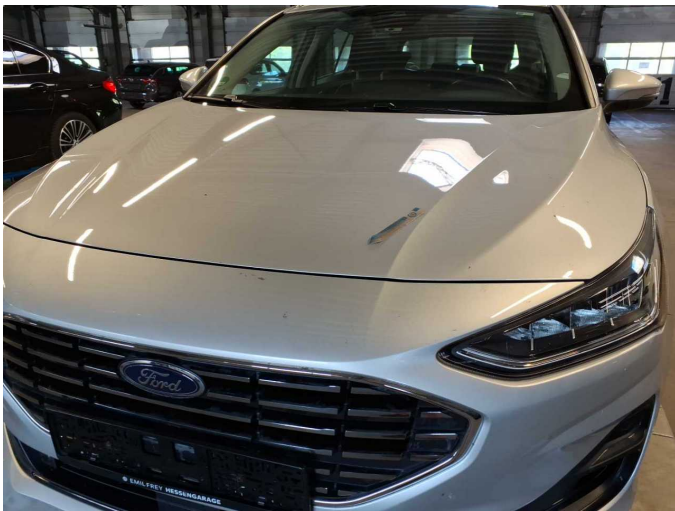
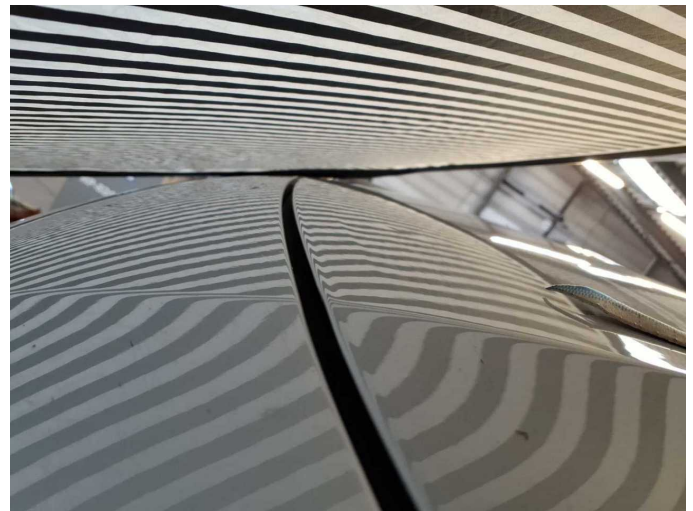
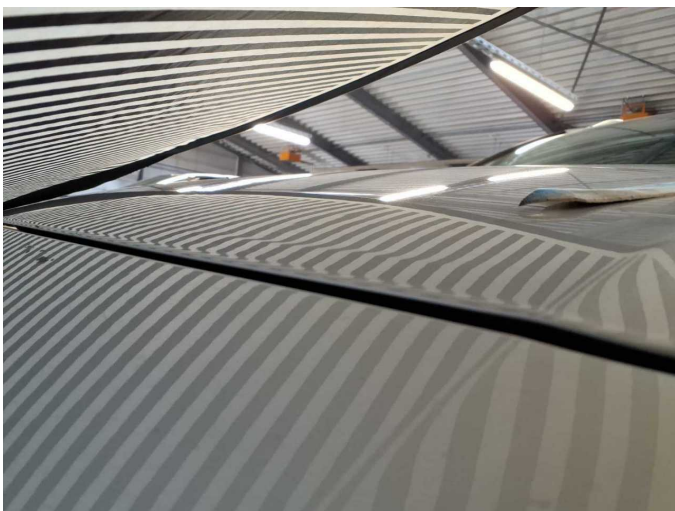
Damage 10: Bonnet: Bonnet - Deformed - Repair and paint

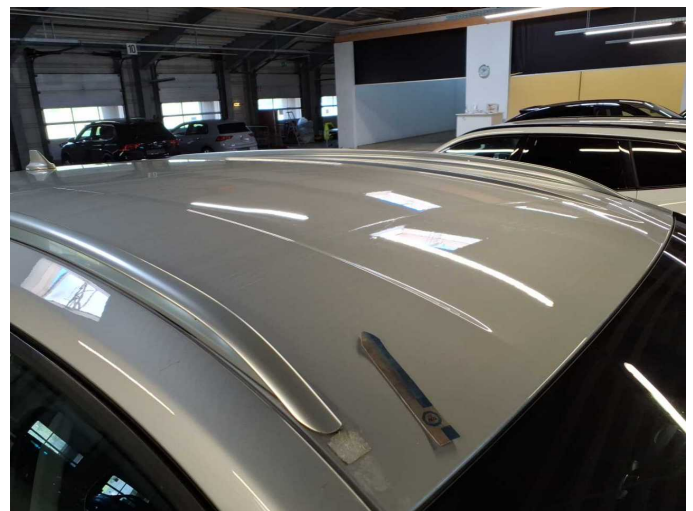
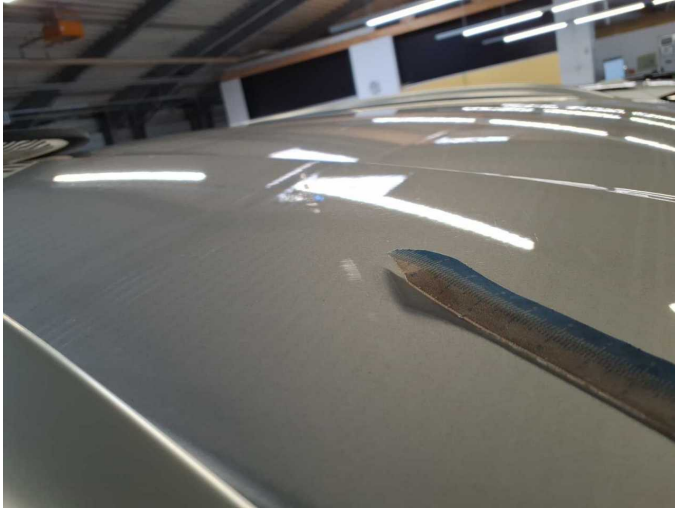
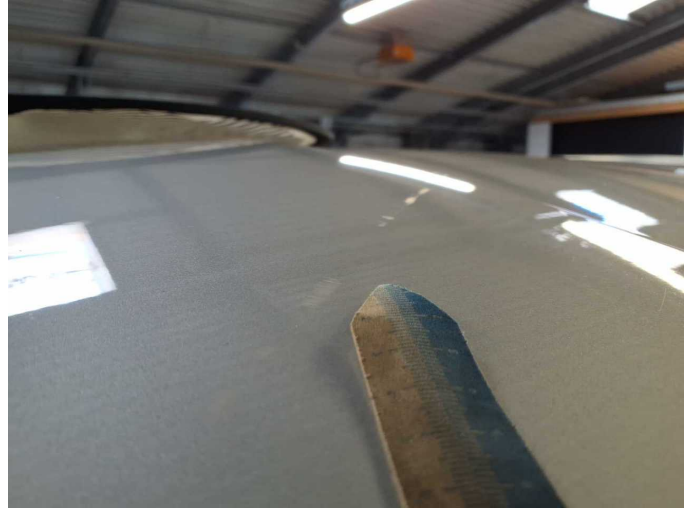
Damage 11: Roof: Roof - Scratch(es) - Paint

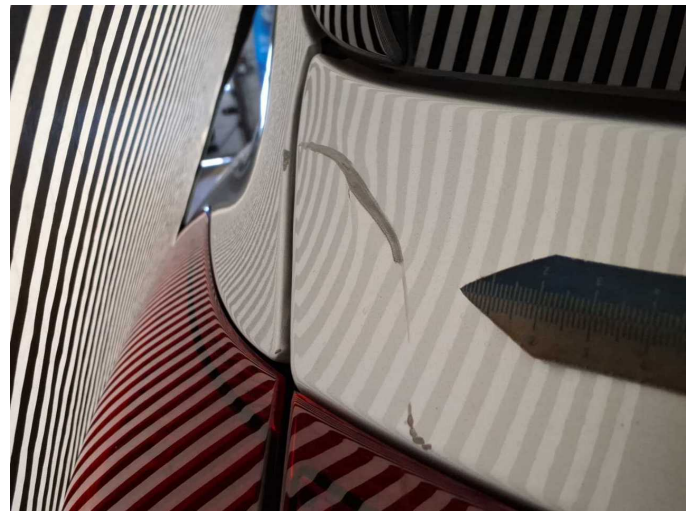
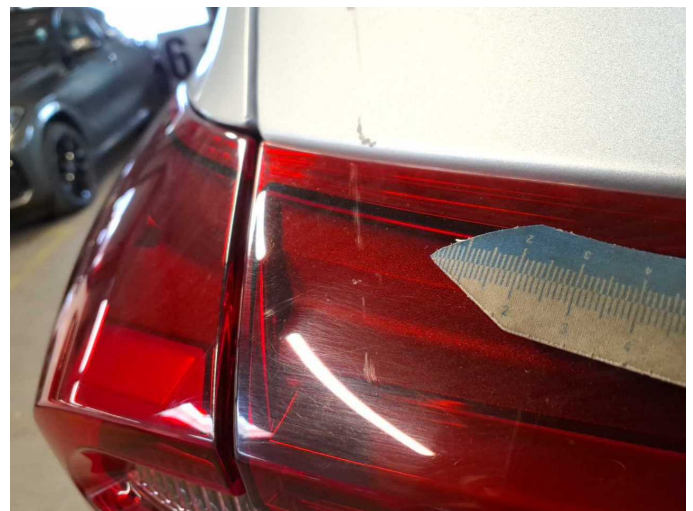
Accident 1: Rear, Side - left

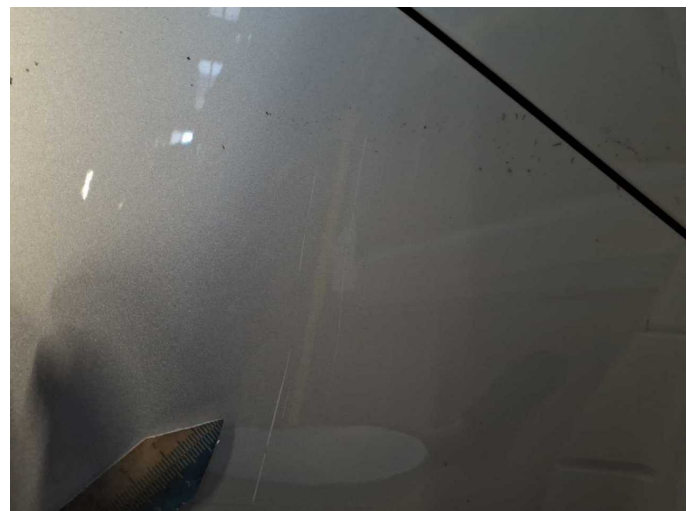
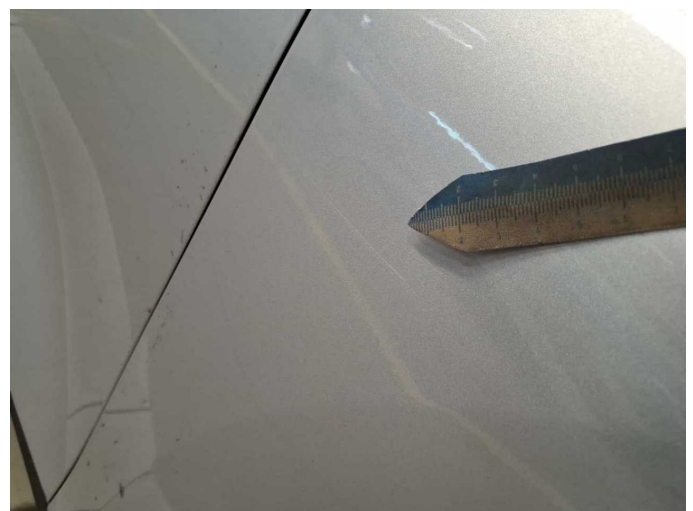
Accident 2: Side right
