## Expertise

Protocol number: 45384181  
 Order No. / Reference: 26243179  
 Inspection date: 11 May 2026

Manufacturer: Tesla

Model: Model 3 Langstreckenbatt. Allradantrieb Dual Motor

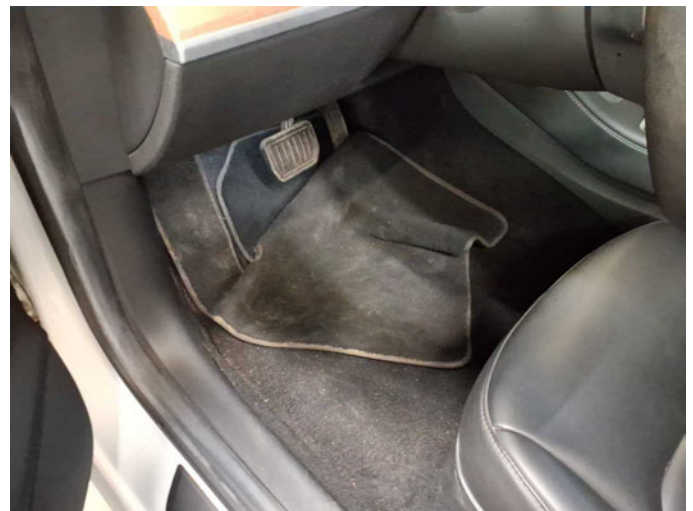
Damage 1: Trim / covers: Floor mats (VI) - Damaged - Replace

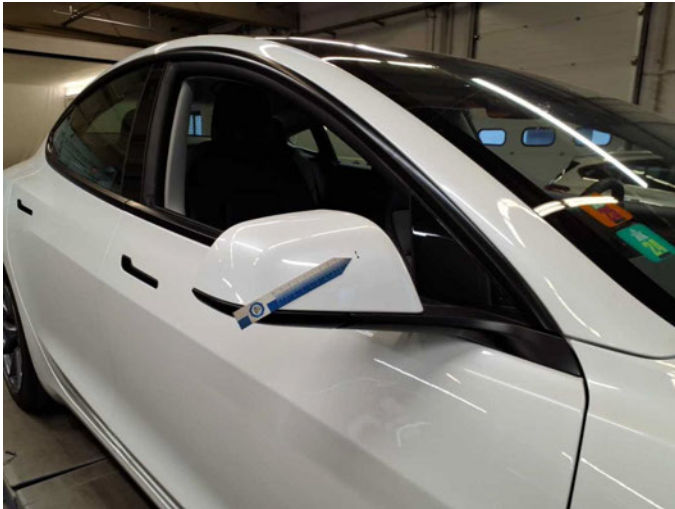
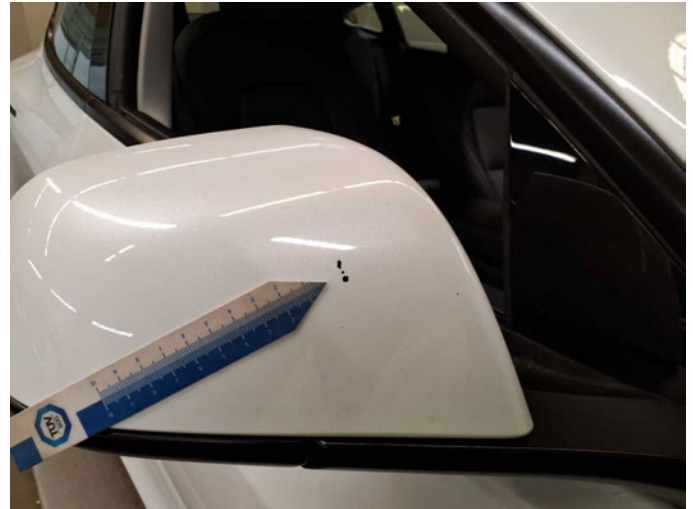
**Damage 2:** Wing mirror - right side: Cap - Scratch(es) - Smart repair

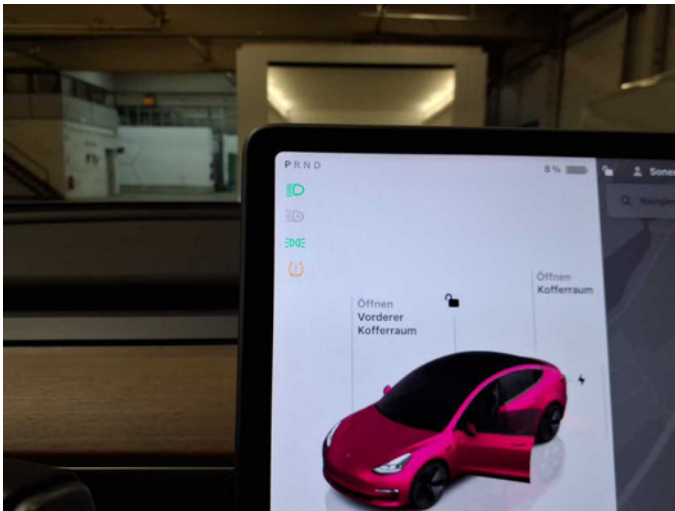
**Damage 3:** Instrument panel: Indicator light (RDKS) - on - Perform diagnosis

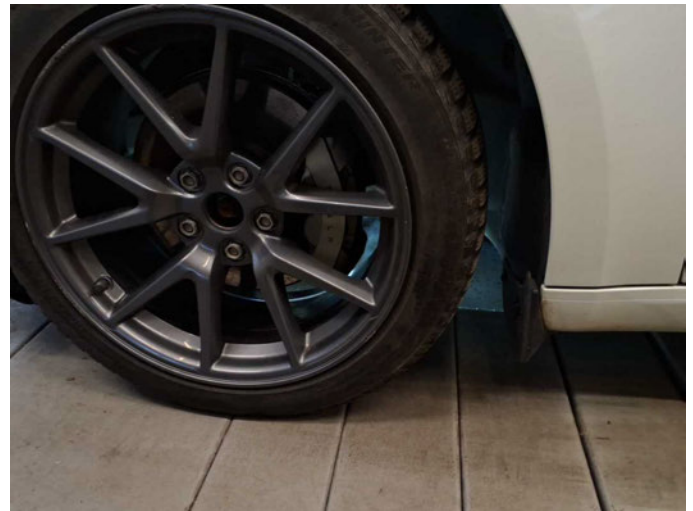
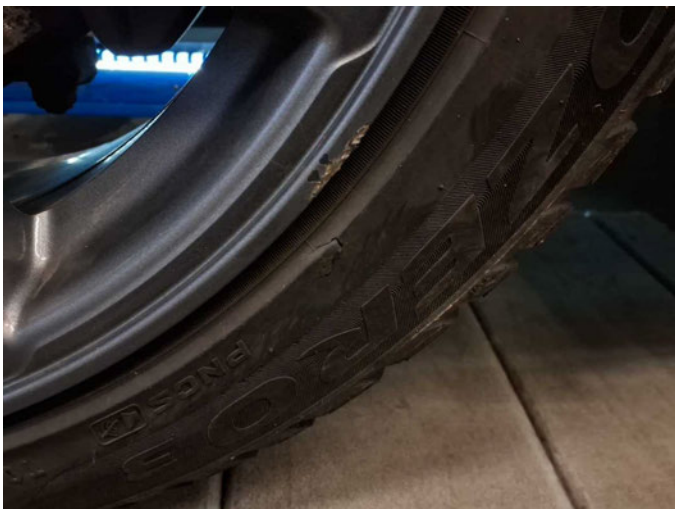
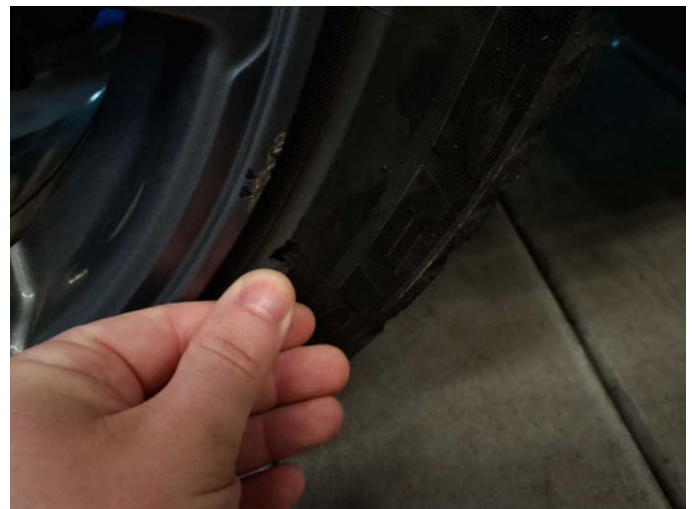
**Damage 4:** Wheel / tyres: Tyre - front left side - Broken / torn - Replace

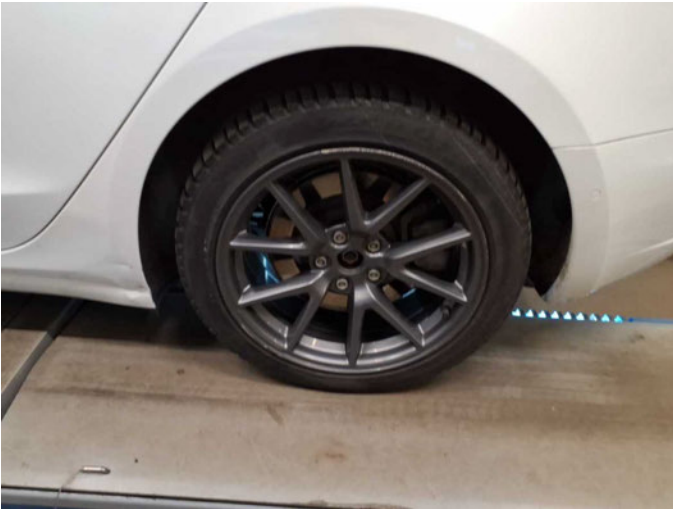
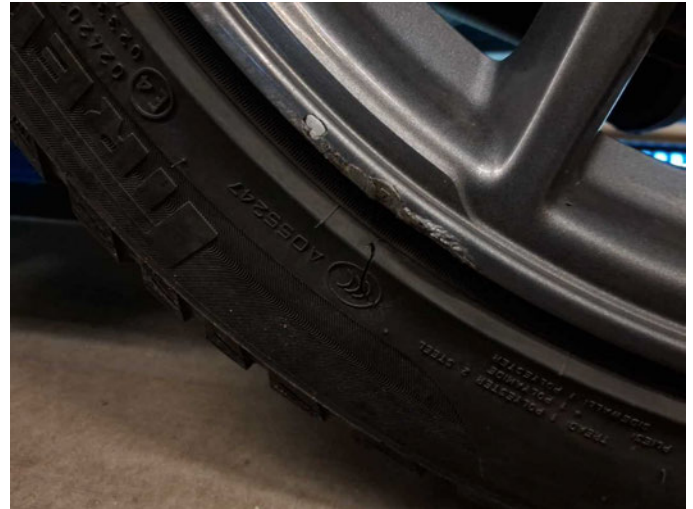
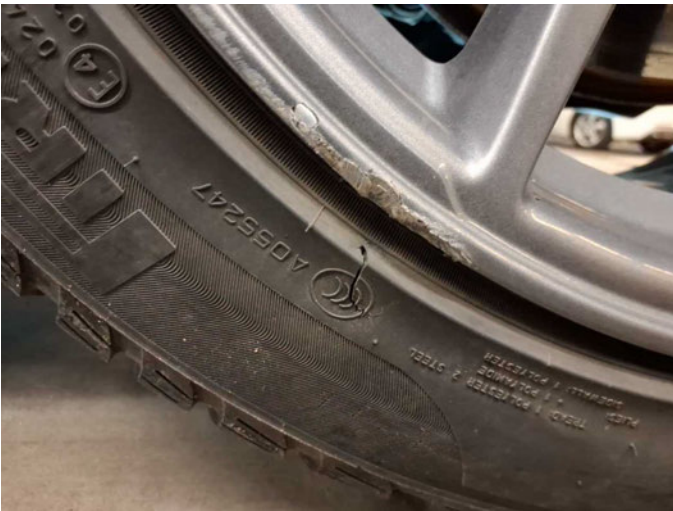
**Damage 5:** Wheel / tyres: Tyre - rear left side - Broken / torn - Replace

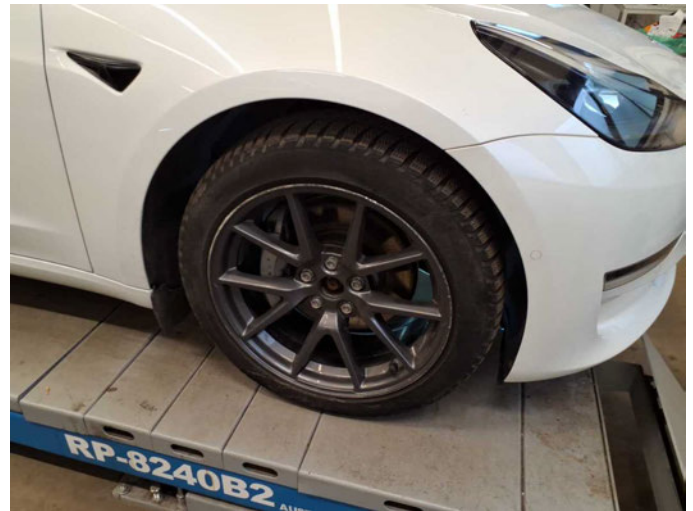
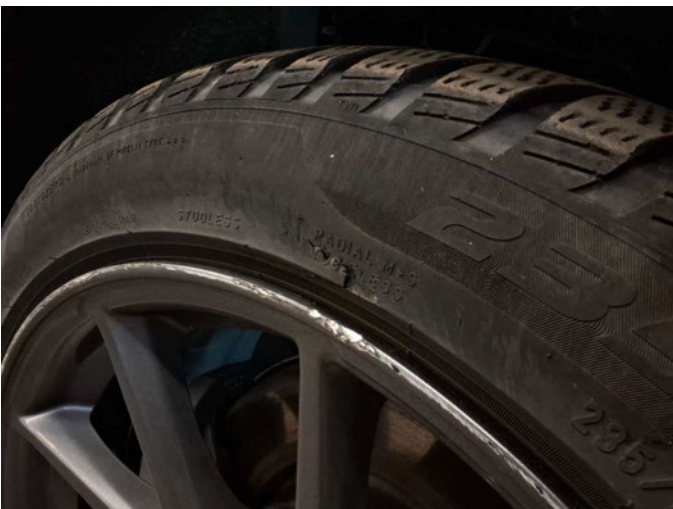
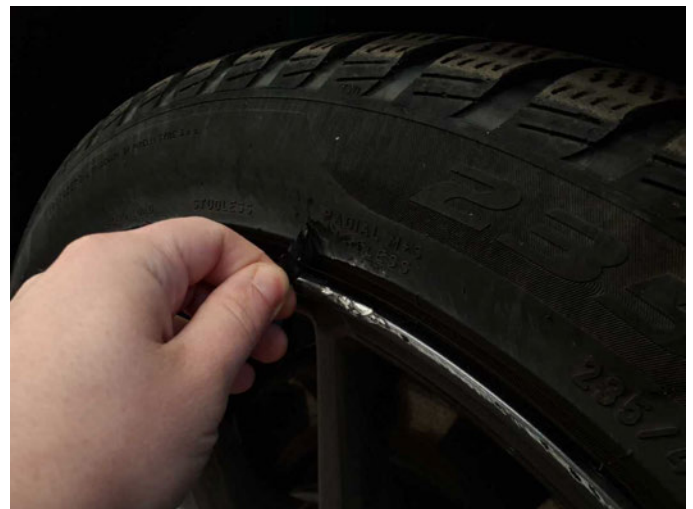
**Damage 6:** Wheel / tyres: Tyre - front right side - Broken / torn - Replace

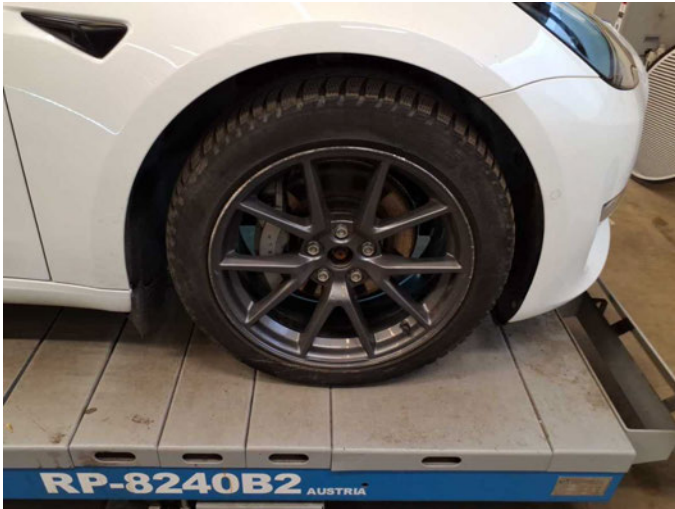
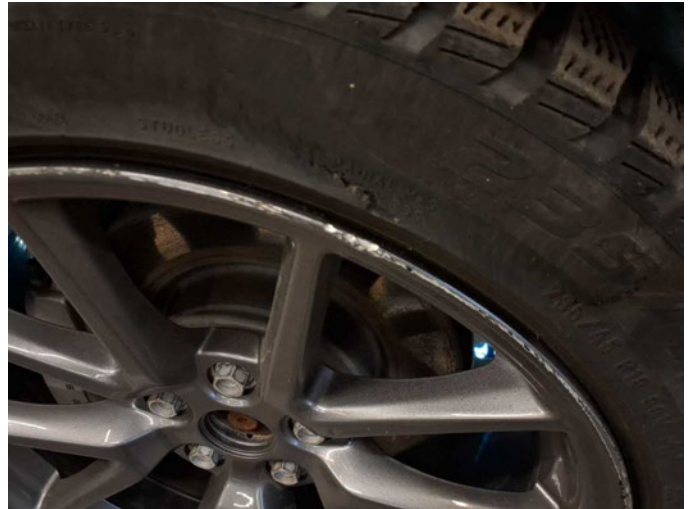
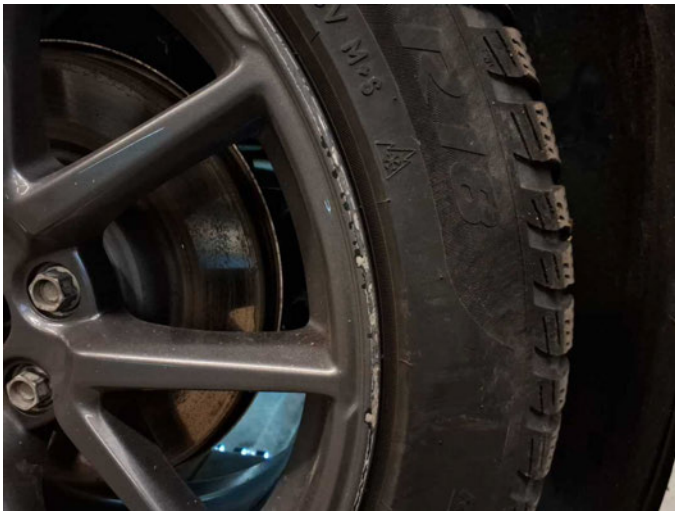
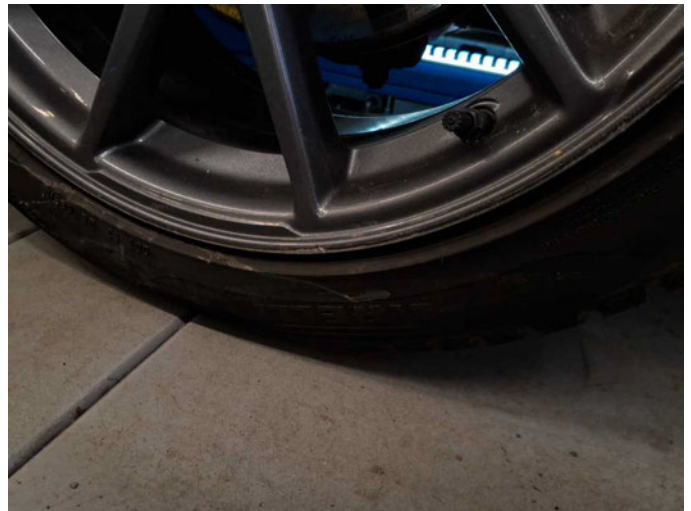
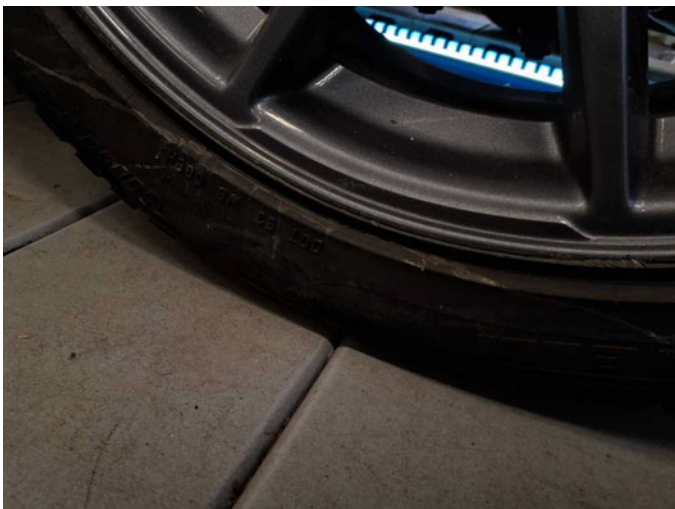
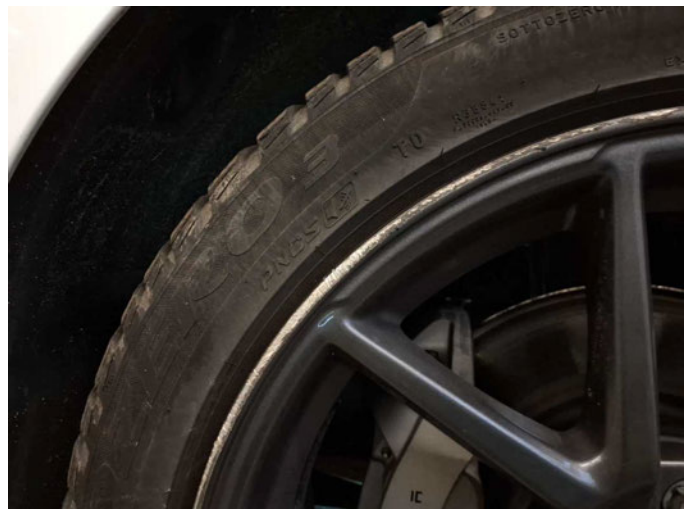
**Damage 7:** Wheel / tyres: Alloy rim - front right side - Scratched - Replace

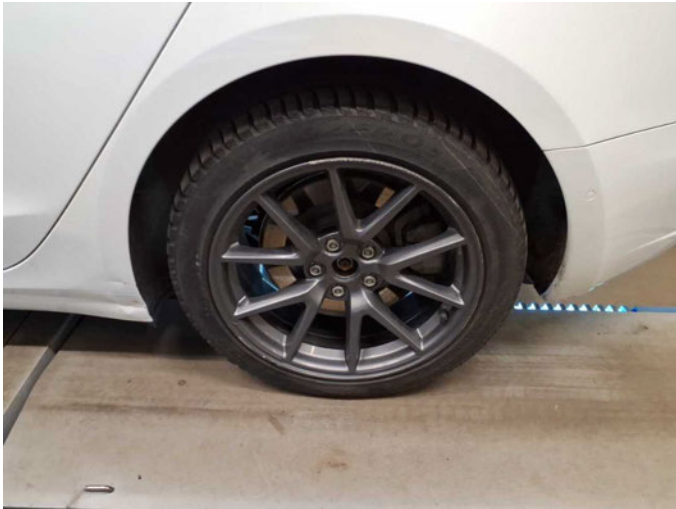
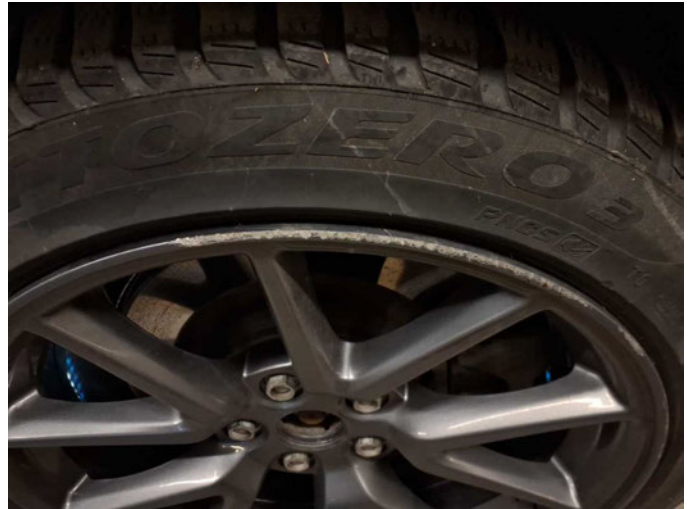
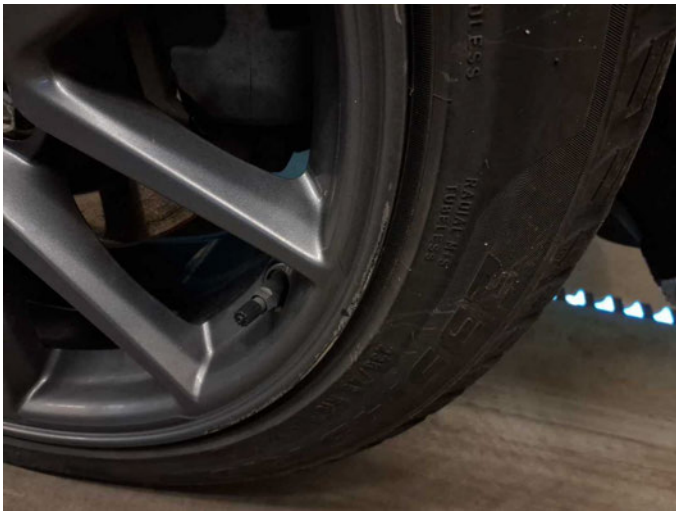
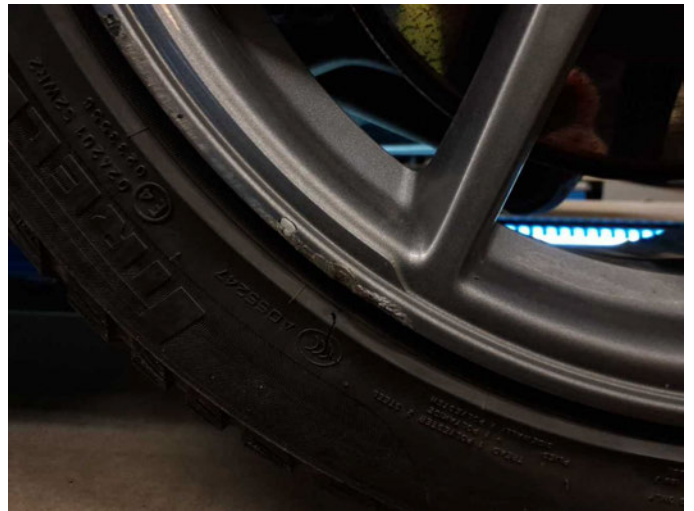
**Damage 8:** Wheel / tyres: Alloy rim - rear left side - Scratched - Replace

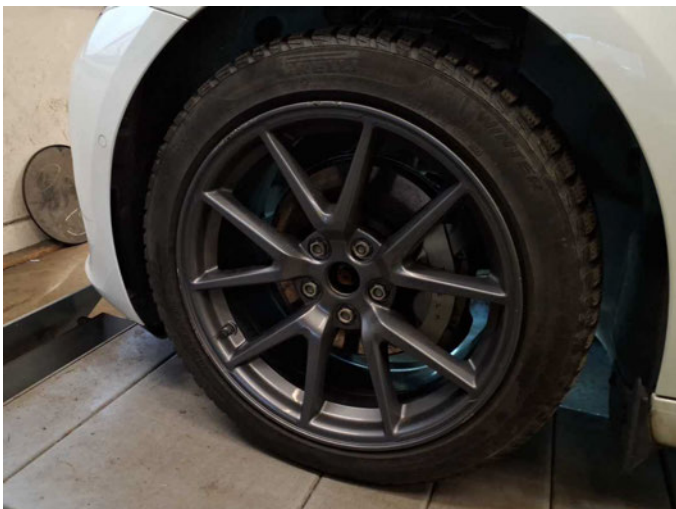
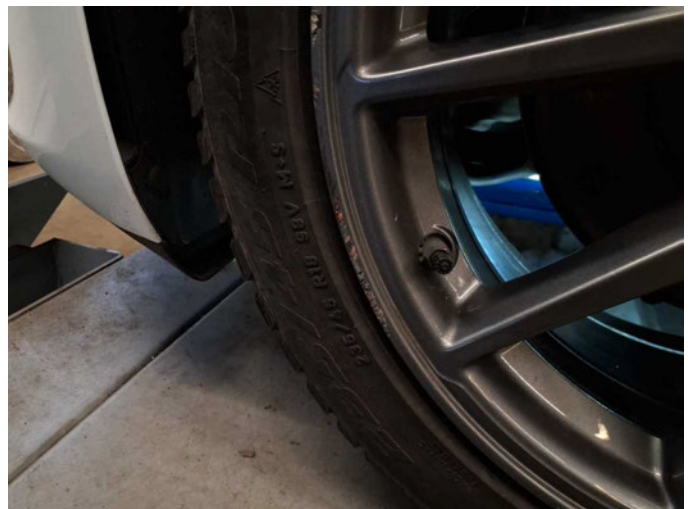
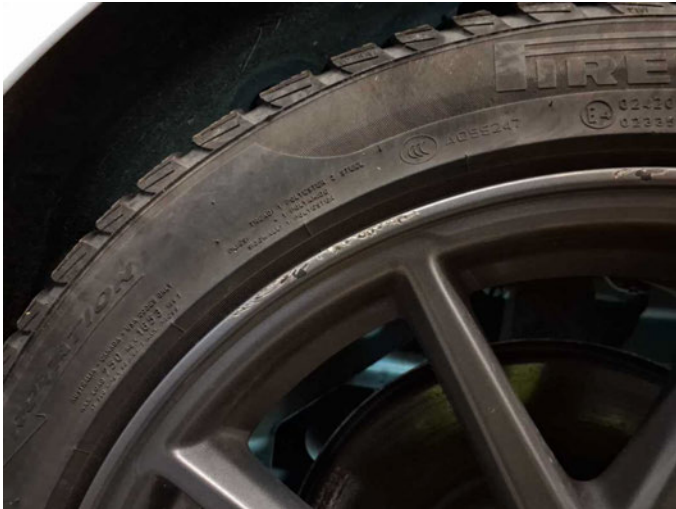
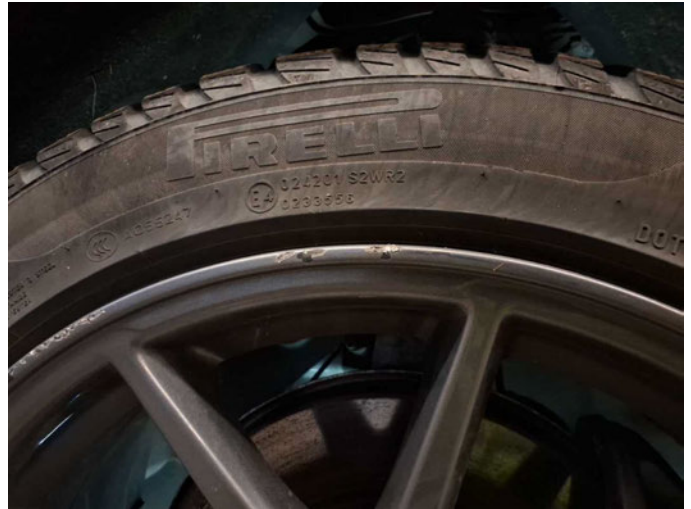
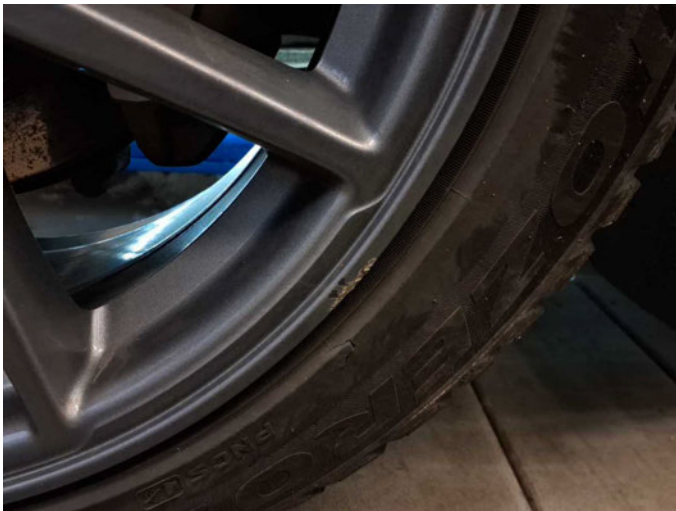
**Damage 9:** Wheel / tyres: Alloy rim - front left side - Scratched - Replace

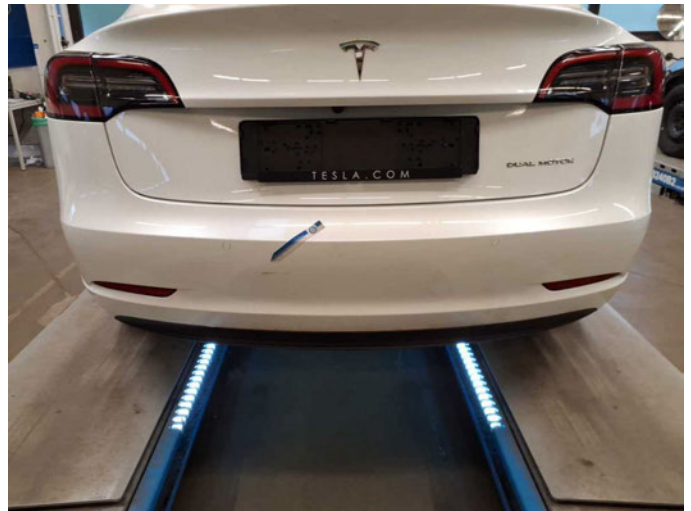
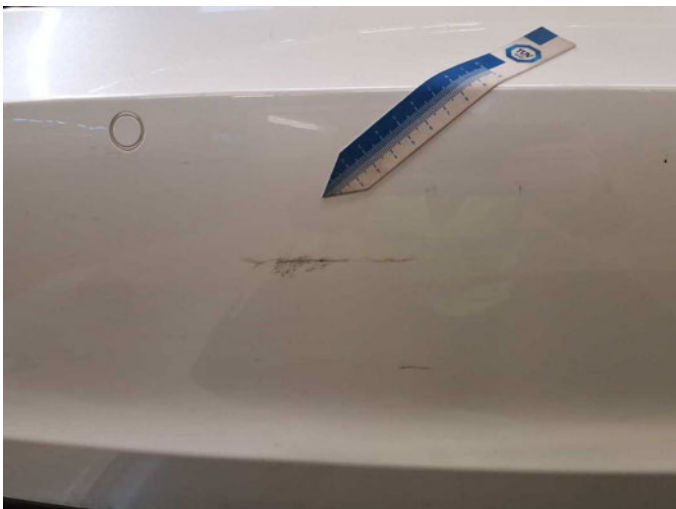
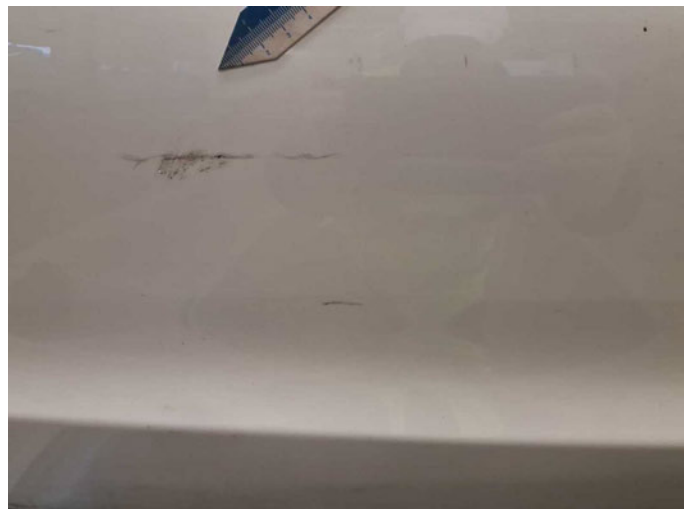
**Damage 10:** Rear bumper: Rear bumper - Scratch(es) - Paint

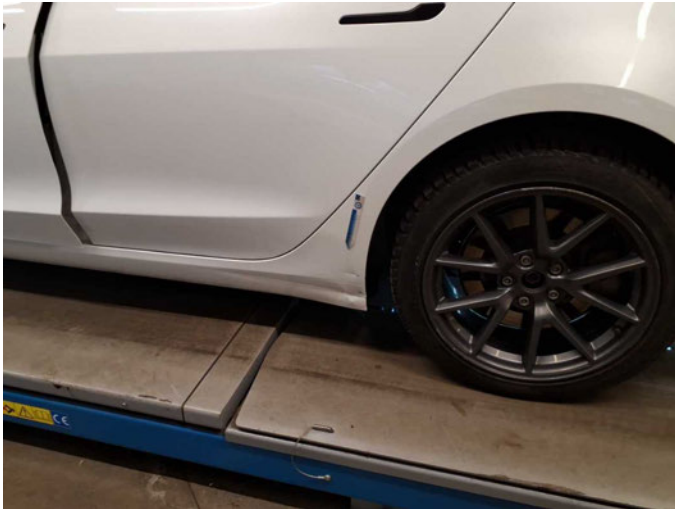
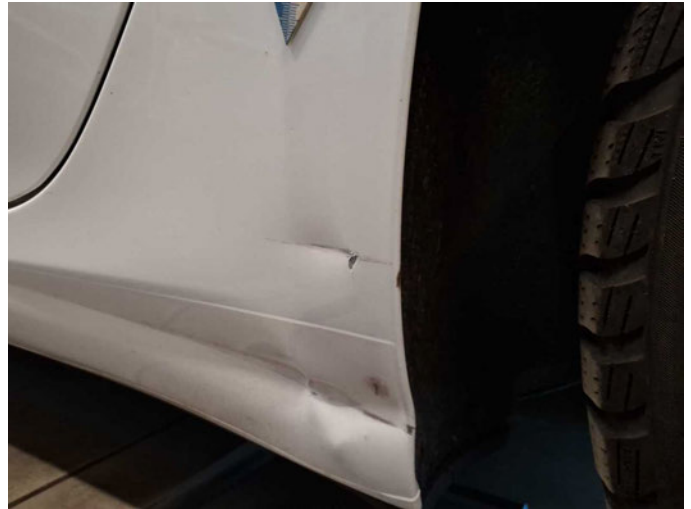
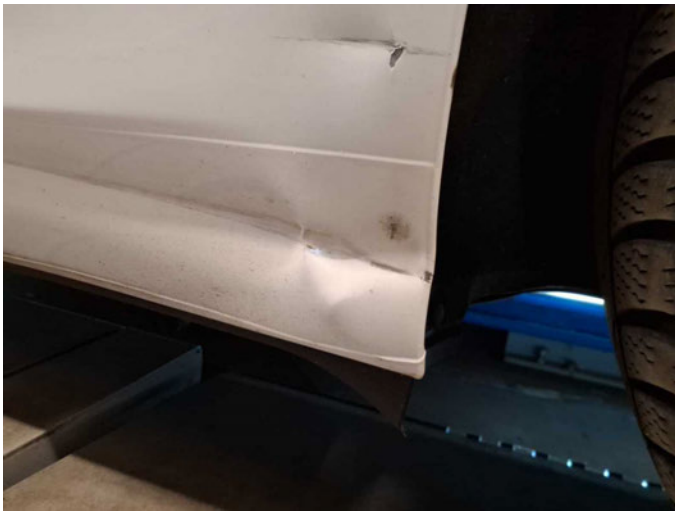
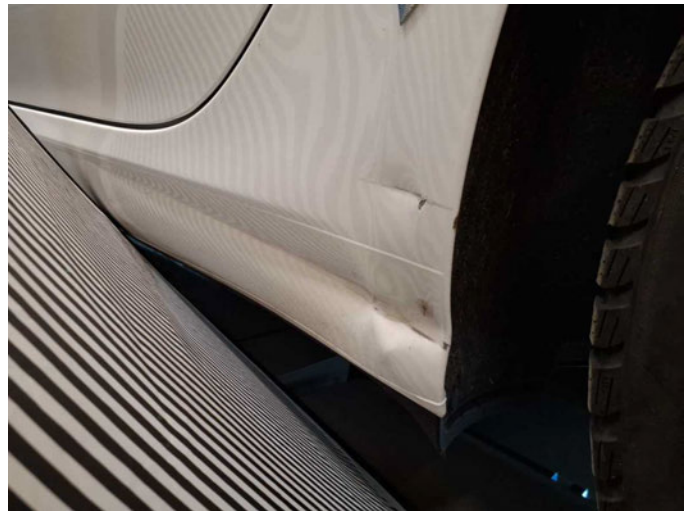
**Damage 11:** Sill - left side: Sill - Deformed - Repair and paint

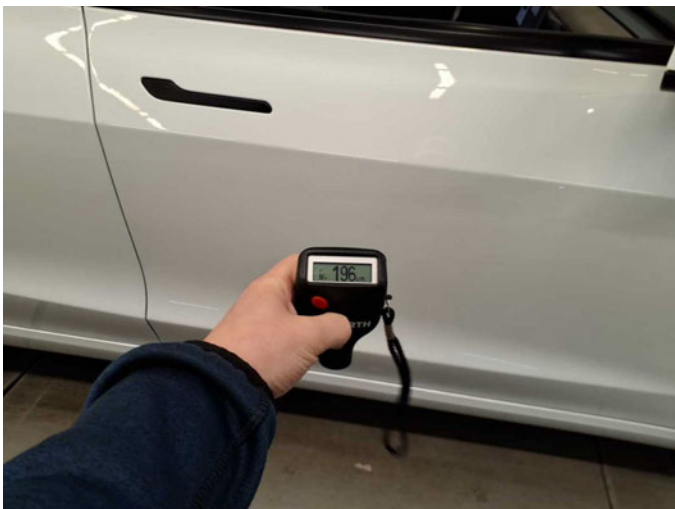
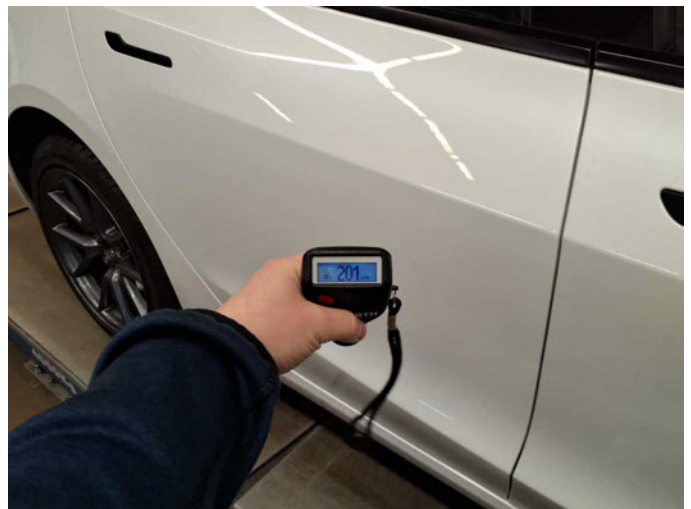
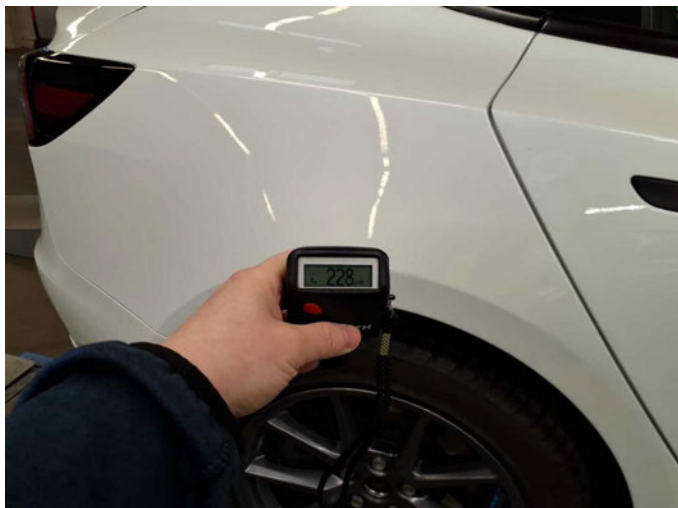
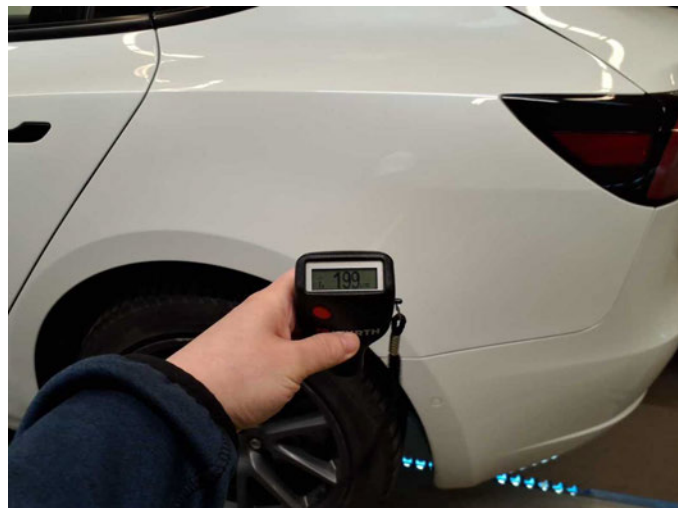
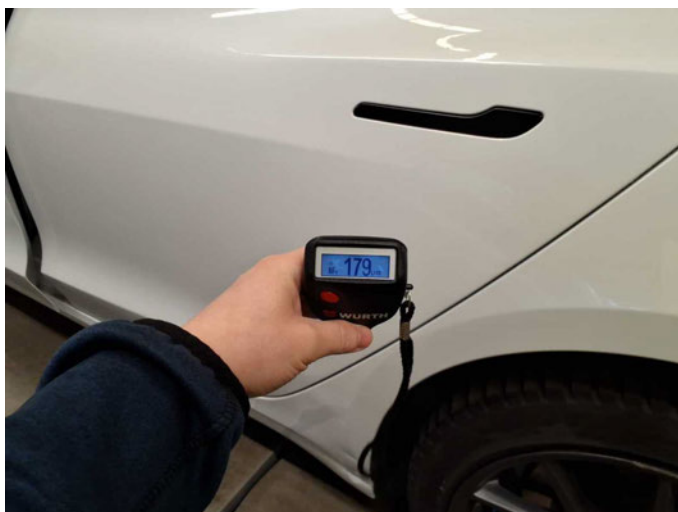
Side panel - rear left side	199 µm	Side panel - rear right side	228 µm
Door - rear left side	179 µm	Door - rear right side	201 µm
Door - front right side	196 µm

**Repainting 1:** Side panel - rear left side, Side panel - rear right side, Door - rear left side, Door - rear right side, Door - front right side
