Expertise

Protocol number: 46536047  
Order No. / Reference: 26501140  
Inspection date: 13 Apr 2026

Manufacturer: Mercedes-Benz  
VIN: W1KEG1BB5PF023793

Model: EQE 300 Electric Art

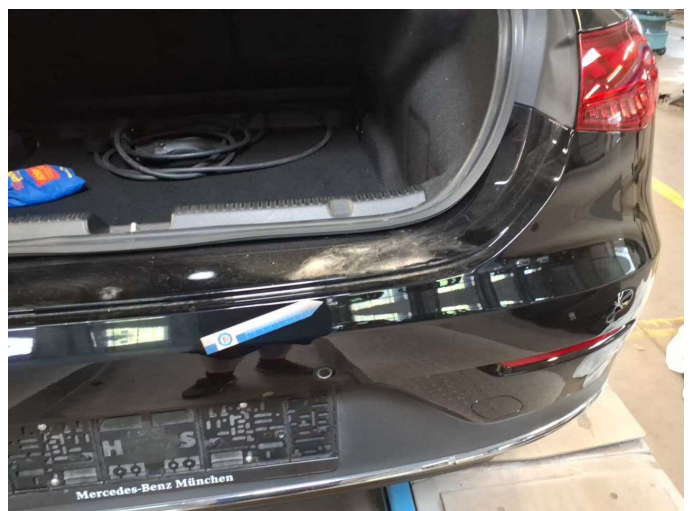
| No. | Component group | Description |
|---|---|---|
| 2 | Box | Load sill - Scratched - Smart repair |

Damage 2: Box: Load sill - Scratched - Smart repair

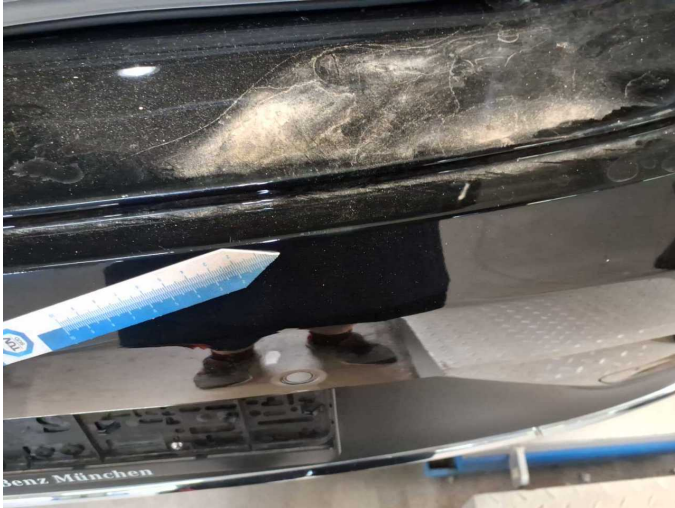
**Damage 2:** Box: Load sill - Scratched - Smart repair

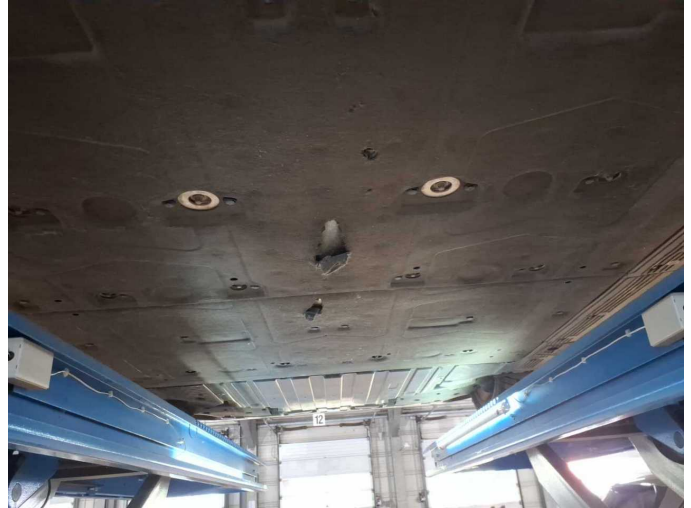
| No. | Component group | Description |
|---|---|---|
| 3 | Body | Underbody panelling - Damaged - Replace |

**Damage 3:** Body: Underbody panelling - Damaged - Replace

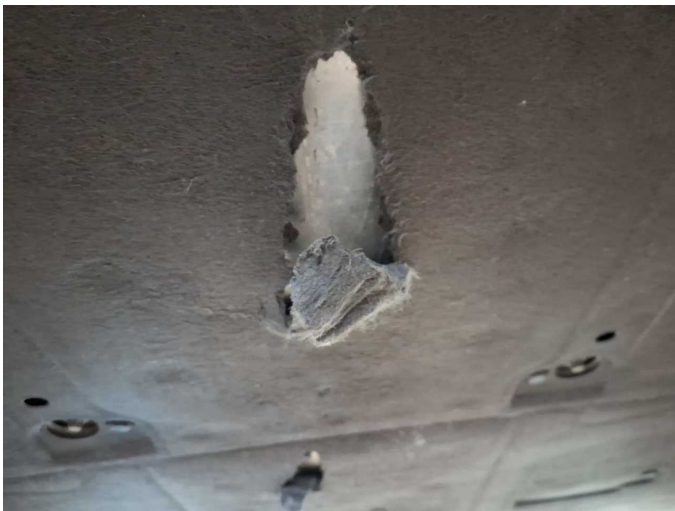
**Damage 3:** Body: Underbody panelling - Damaged - Replace

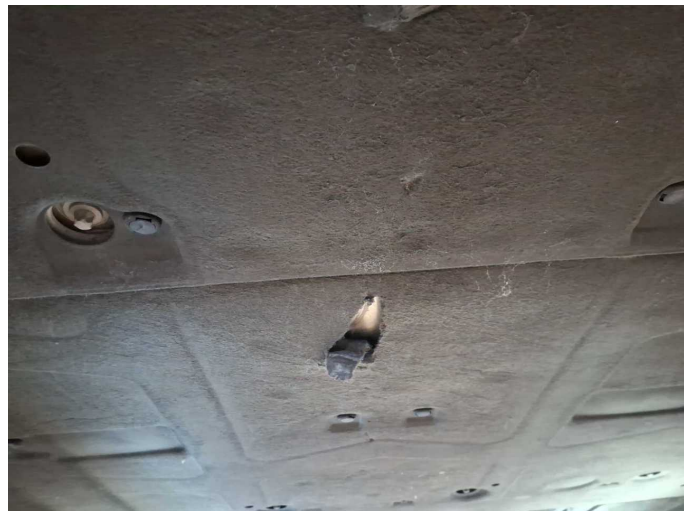
**Damage 3:** Body: Underbody panelling - Damaged - Replace

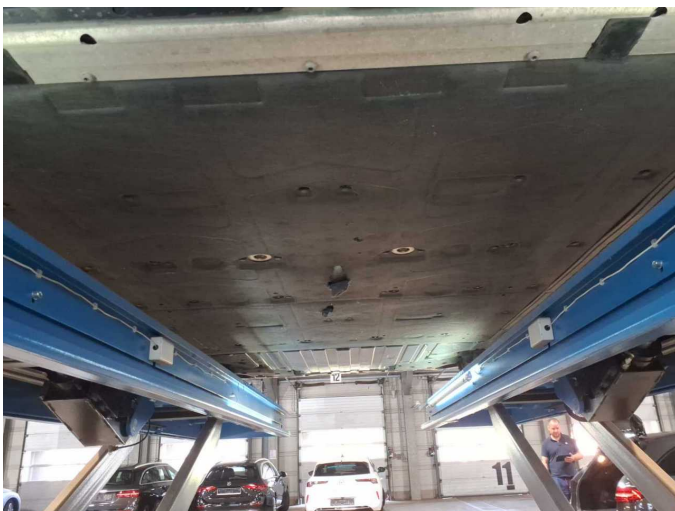
**Damage 3:** Body: Underbody panelling - Damaged - Replace

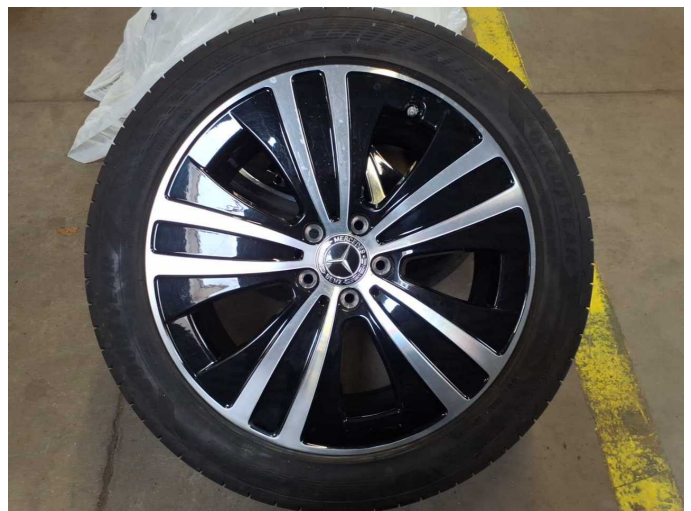
| No. | Component group | Description |
|---|---|---|
| 4 | 2nd wheel set | 1 alloy rim - Scratched - Loss in value |

**Damage 4:** 2nd wheel set: 1 alloy rim - Scratched - Loss in value

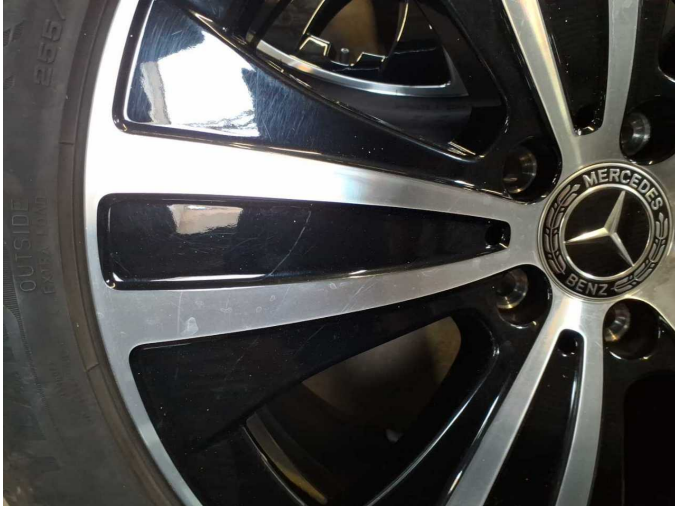
**Damage 4:** 2nd wheel set: 1 alloy rim - Scratched - Loss in value

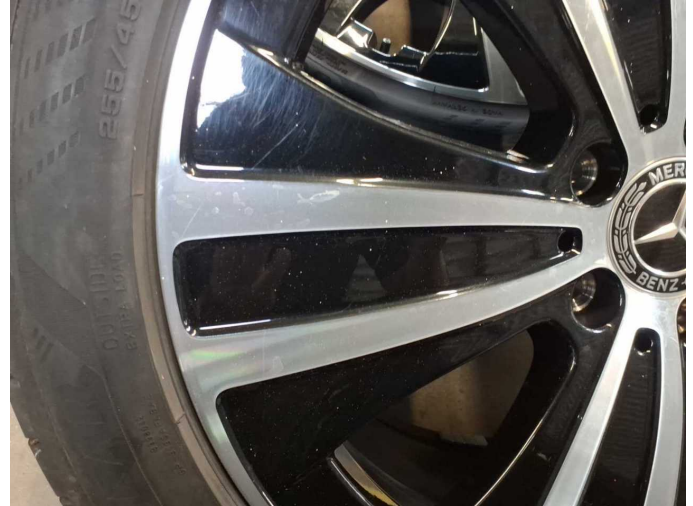
**Damage 4:** 2nd wheel set: 1 alloy rim - Scratched - Loss in value

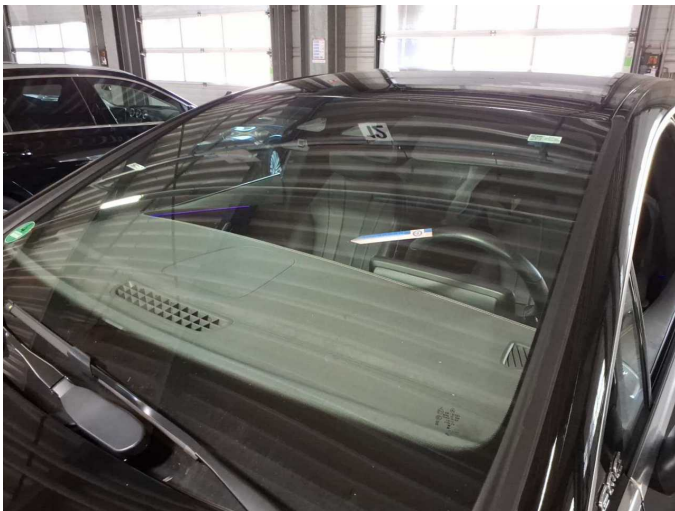
| No. | Component group | Description |
|---|---|---|
| 3 | Vehicle glazing | Windscreen - Stone chips - No deduction |

**Wear and tear 3:** Vehicle glazing: Windscreen - Stone chips - No deduction

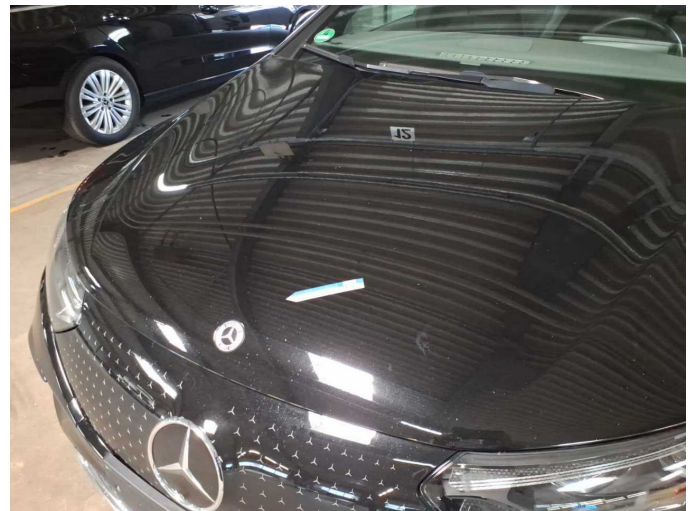
| No. | Component group | Description |
|---|---|---|
| 4 | Bonnet | Bonnet - Stone chips - No deduction |

**Wear and tear 4:** Bonnet: Bonnet - Stone chips - No deduction

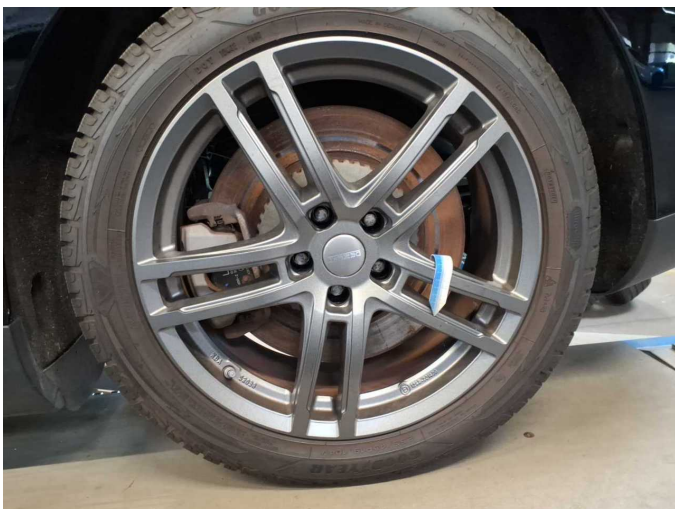
| No. | Component group | Description |
|---|---|---|
| 5 | Wheel / tyres | Alloy rim - rear left side (Gehört nicht zur Ausstattung) - Scratched - No deduction |

**Wear and tear 5:** Wheel / tyres: Alloy rim - rear left side (Gehört nicht zur Ausstattung) - Scratched - No deduction

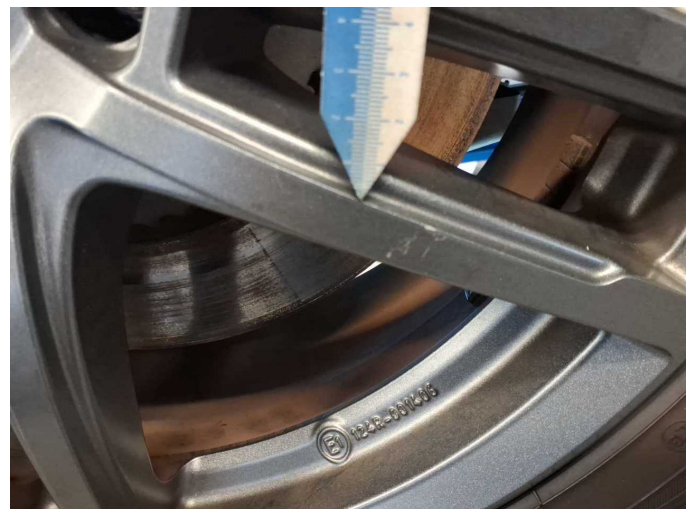
**Wear and tear 5:** Wheel / tyres: Alloy rim - rear left side (Gehört nicht zur Ausstattung) - Scratched - No deduction

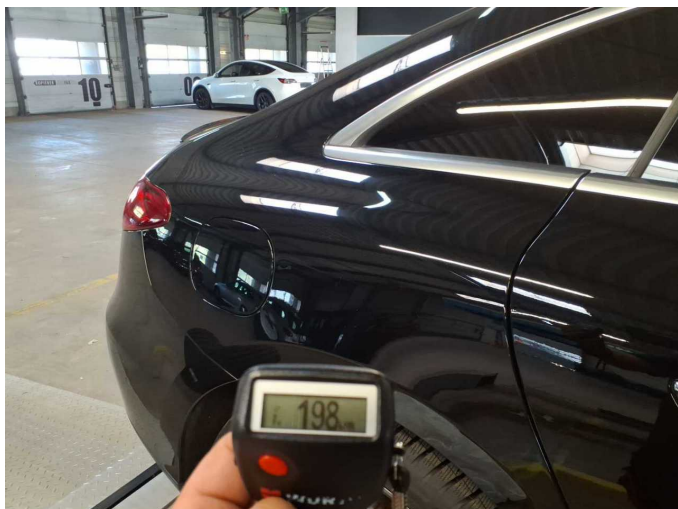
Side panel - rear right side 198 µm

**Repainting 1:** Side panel - rear right side
