Expertise

Protocol number: 46369045
Order No. / Reference: 26461215
Inspection date: 7 Jul 2026

Model: Focus Turnier 1.5 EcoBlue Start-Stopp-System Aut. ST-LINE X

VIN: WF0PXXGCHPPD75023

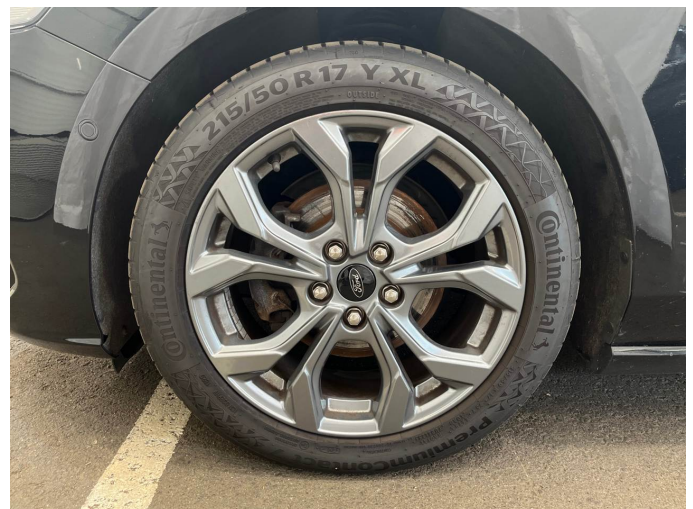
Mounted tyres				
#	Tyre size	Type of tyre	Manufacturer	Tread depth
1)	215/50 R17 95Y	Summer tyres on Light alloy	Continental	6mm / 6mm
2)	215/50 R17 95Y	Summer tyres on Light alloy	Continental	5mm / 5mm
Additional tyres				
#	Tyre size	Type of tyre	Manufacturer	Tread depth
1)	215/50 R17 95V	Winter tyres on Light alloy	Dunlop	6mm / 6mm
2)	215/50 R17 95V	Winter tyres on Light alloy	Dunlop	6mm / 6mm
Replacement				
Typ	Tyre size	Type of tyre	Manufacturer	Tread depth
	Tirefit	Expiration date 04/2027

Figure 12: Mounted tyres

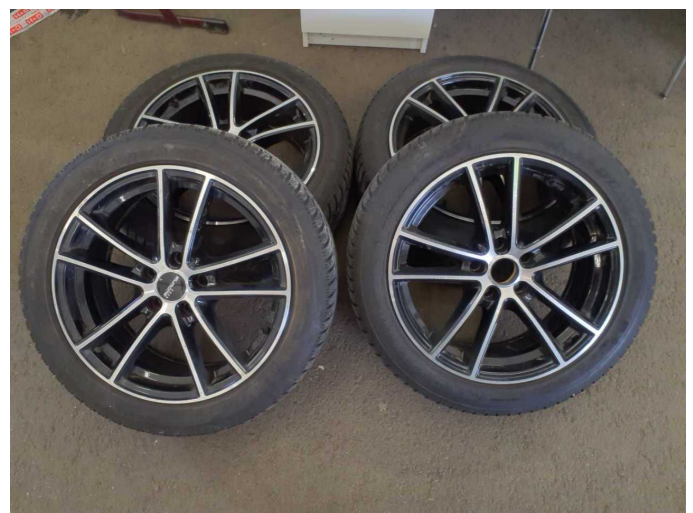
Figure 18: Additional tyres

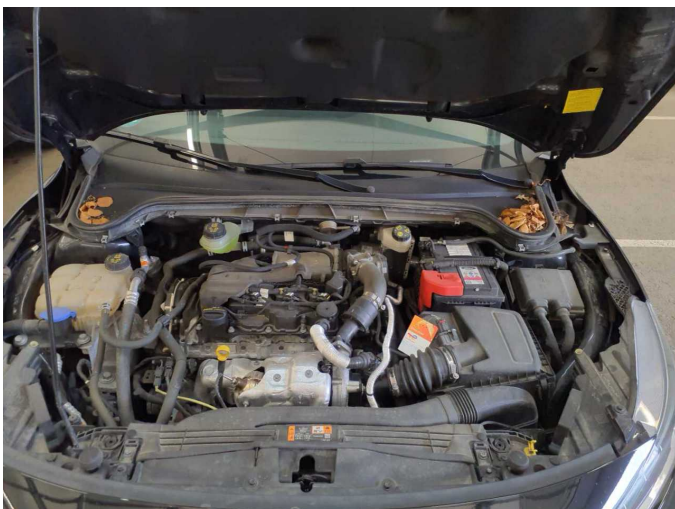
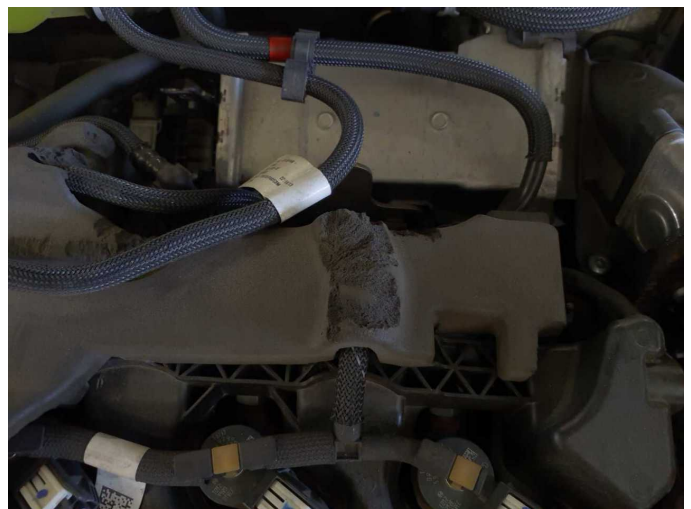
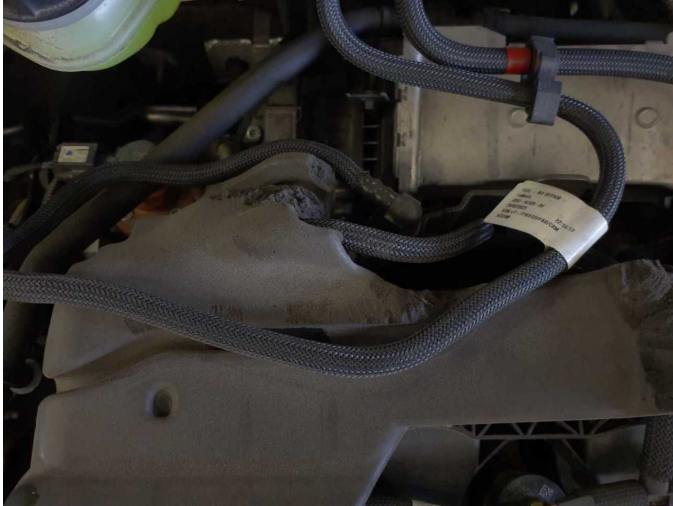
No.	Component group	Description
1	Engine	Engine cover - Damage caused by marten / rodent - Replace
2	Door - front right side	Door - Dent / paintcoat damage - Smart repair
3	Misc.	Main inspection - Due - Perform

Damage 1: Engine: Engine cover - Damage caused by marten / rodent - Replace

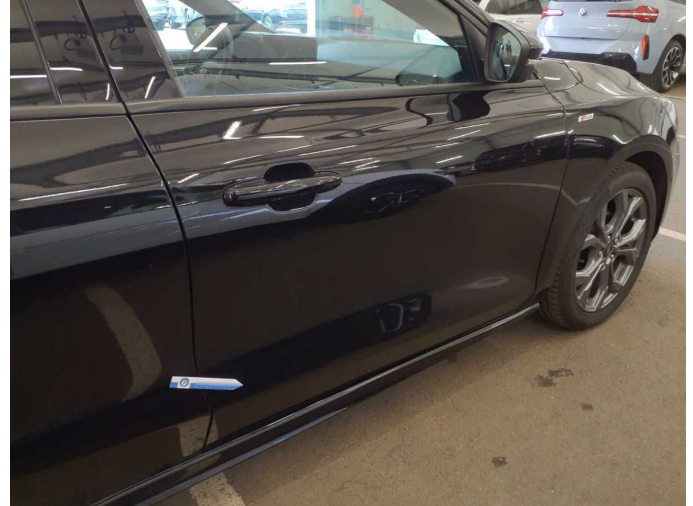
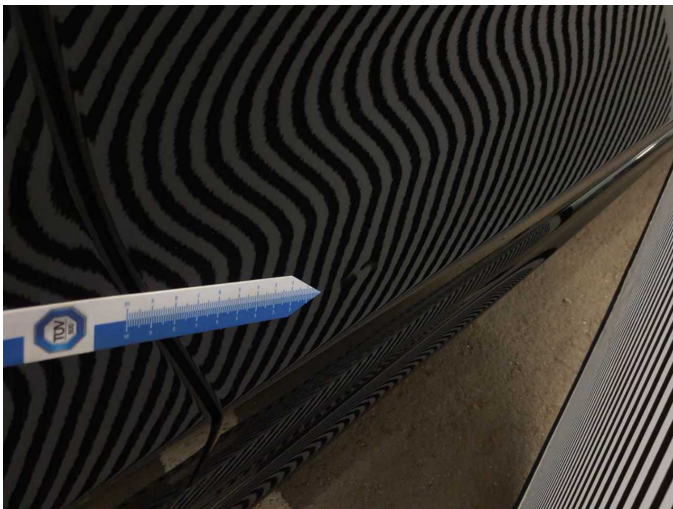
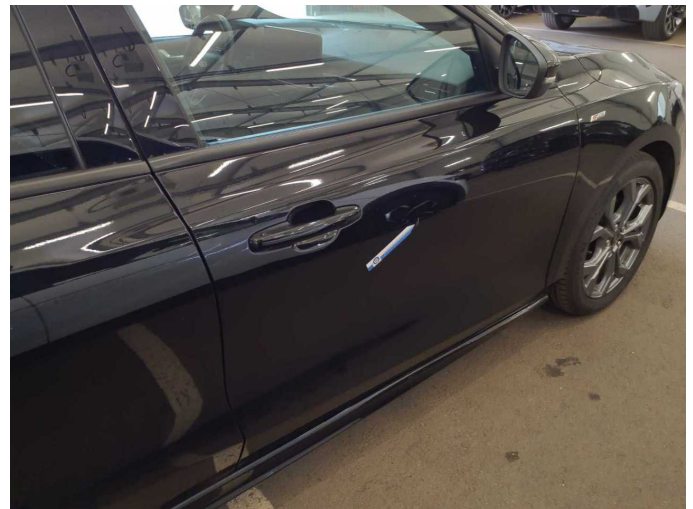
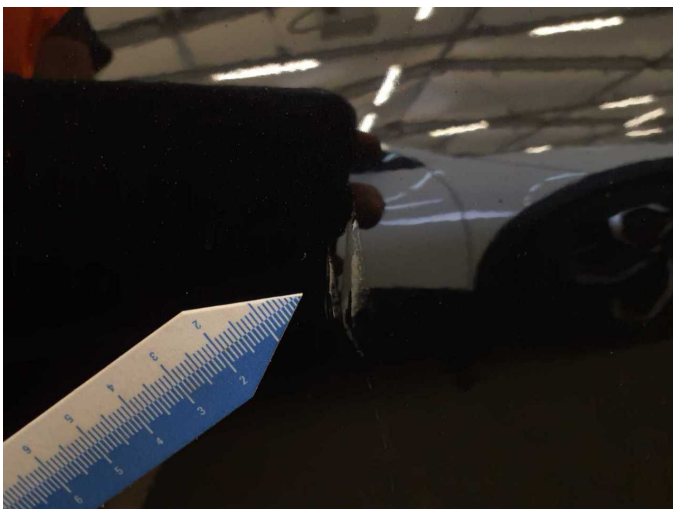
Damage 2: Door - front right side: Door - Dent / paintcoat damage - Smart repair

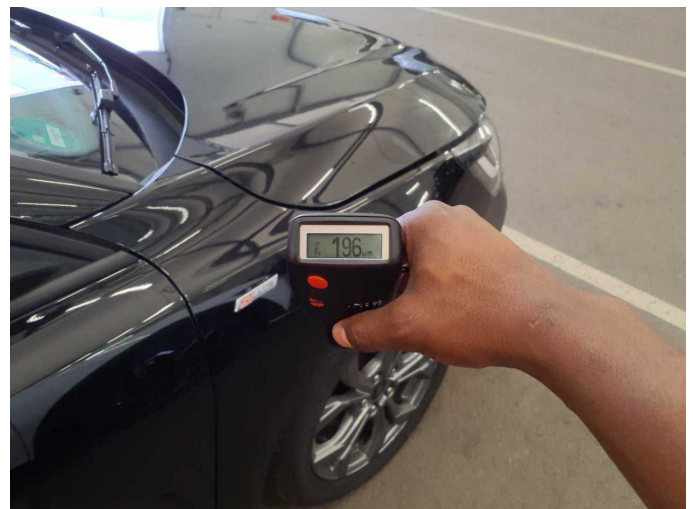
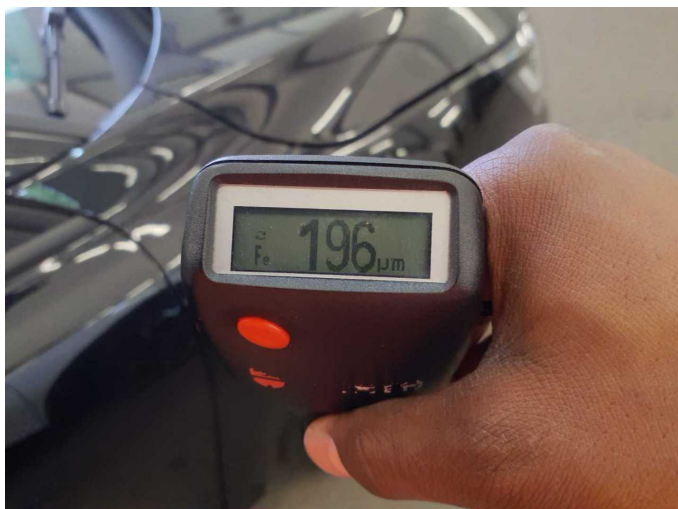
No.	Repainting
1	Mudguard - right side, Professionally carried out, Invoice of repair done Non-existent
2	Bonnet, Professionally carried out, Invoice of repair done Non-existent

Mudguard - right side	196 µm	Bonnet	253 µm
-----------------------	--------	--------	--------

Repainting 1: Mudguard - right side

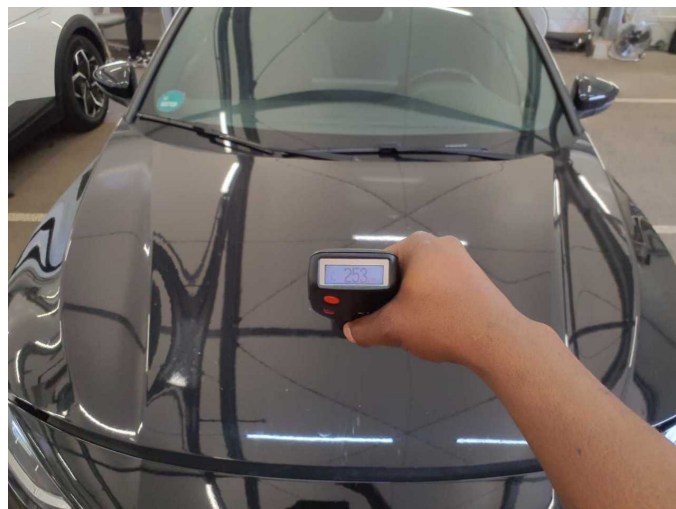
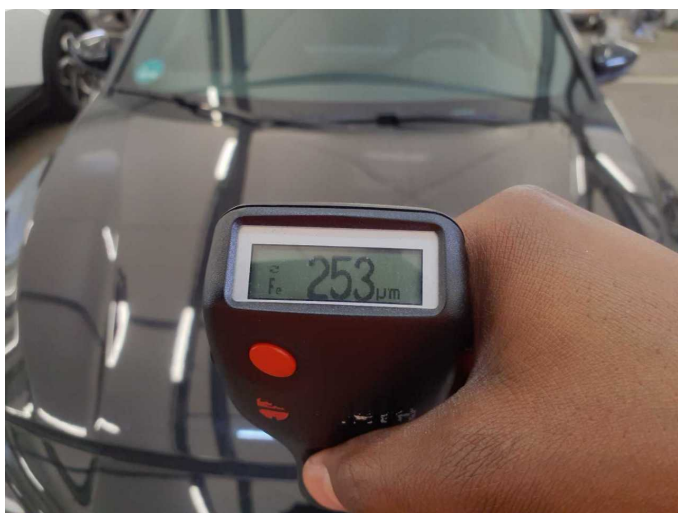
Repainting 2: Bonnet
