Expertise

Protocol number: 46791165  
Order No. / Reference: 26739595  
Inspection date: 27 Jul 2026

| Manufacturer: Opel | Model: Astra 1.5 D Start/Stop Sports Tourer Automatik Business Edition |

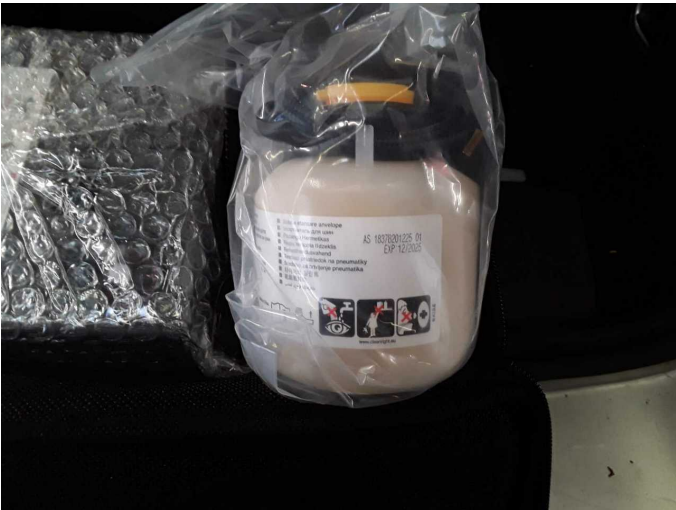
| No. | Component group | Description |
|---|---|---|
| 1 | Equipment | Tirefit filler - Expired - Replace |

Damage 1: Equipment: Tirefit filler - Expired - Replace

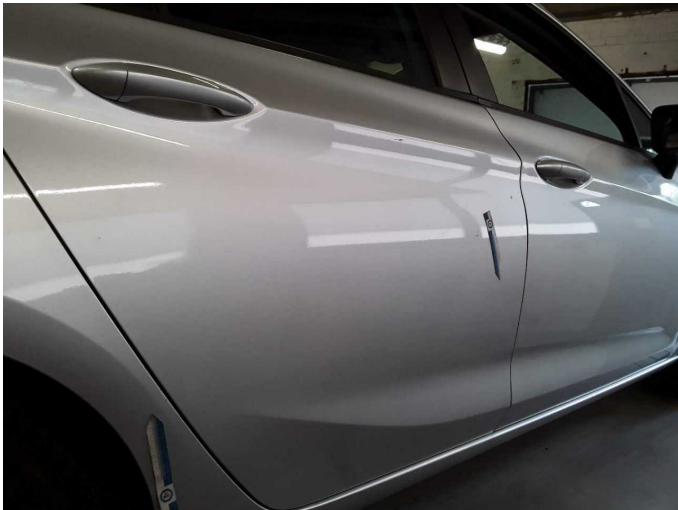
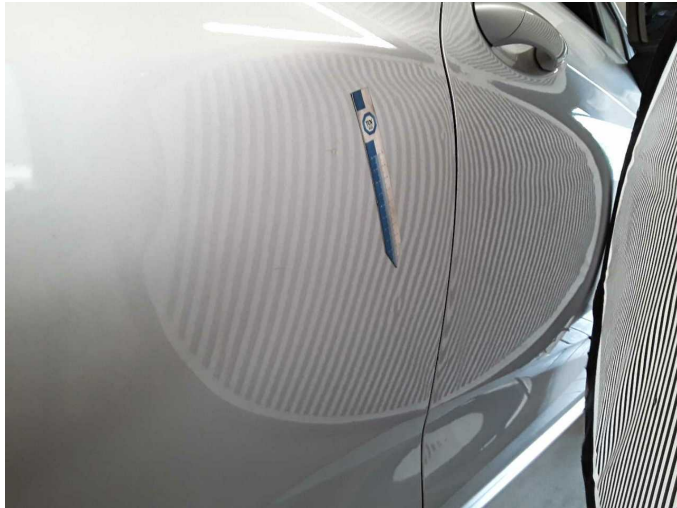
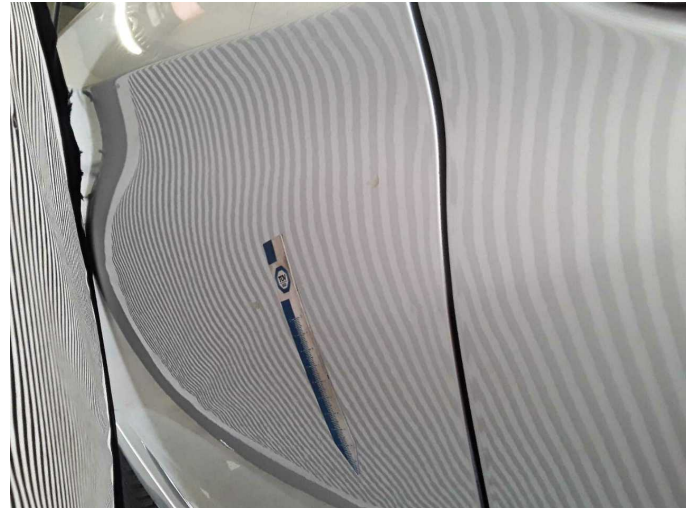
| No. | Component group | Description |
|---|---|---|
| 2 | Door - rear right side | Door - dent(s) - Smooth repair work |

Damage 2: Door - rear right side: Door - dent(s) - Smooth repair work

**Damage 2:** Door - rear right side: Door - dent(s) - Smooth repair work

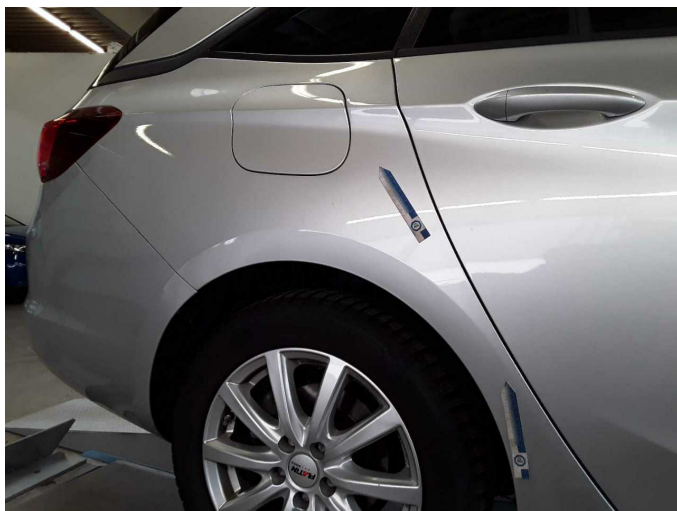
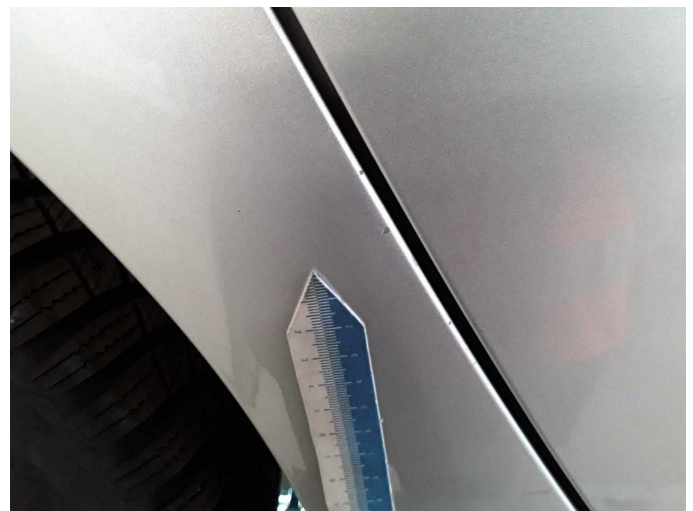
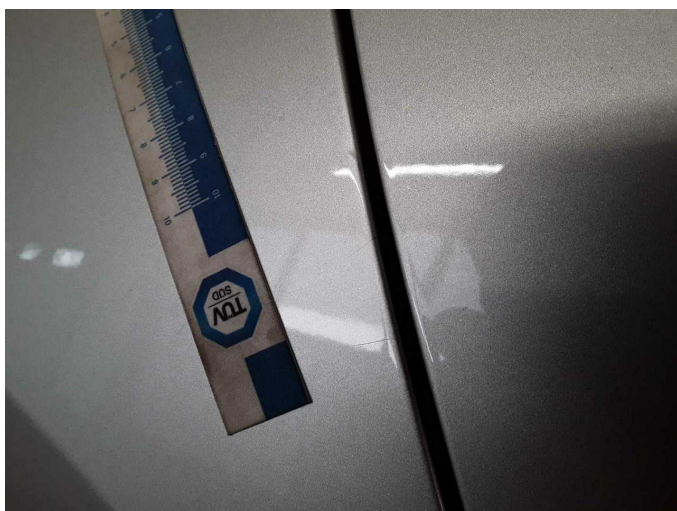
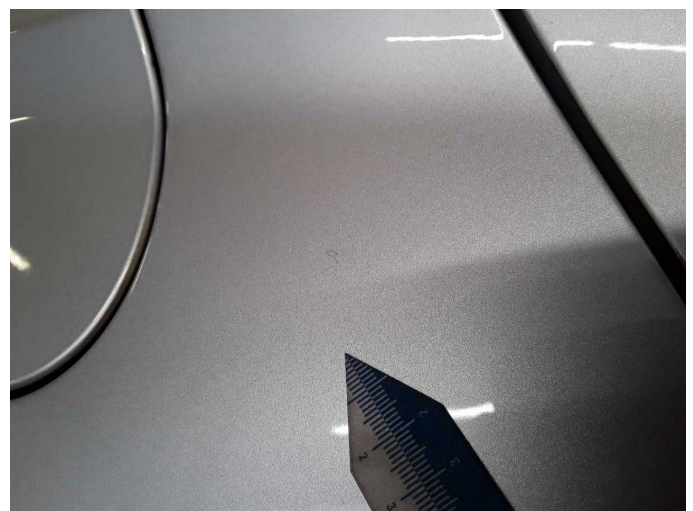
| No. | Component group | Description |
|---|---|---|
| 4 | Side panel - rear right side | Side panel - Scratched - Paint |

**Damage 4:** Side panel - rear right side: Side panel - Scratched - Paint

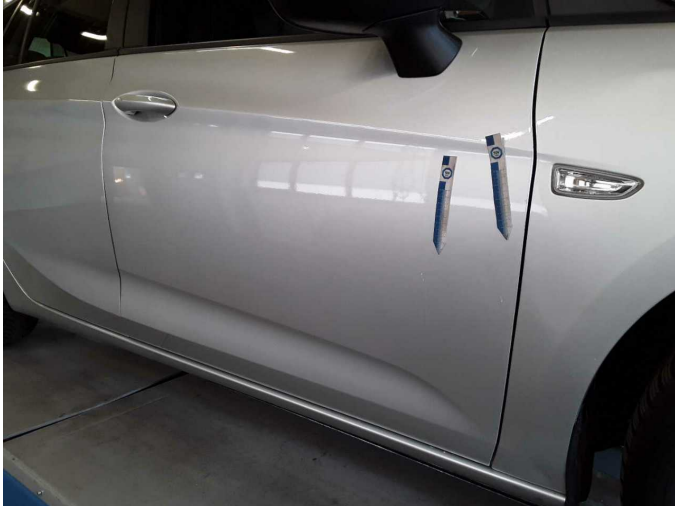
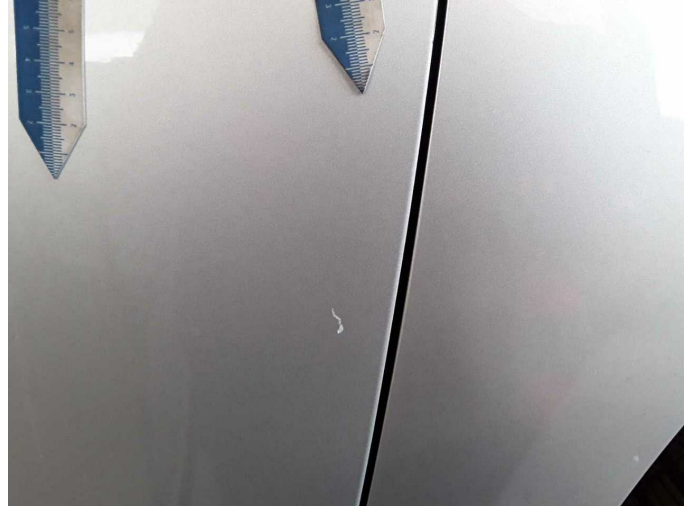
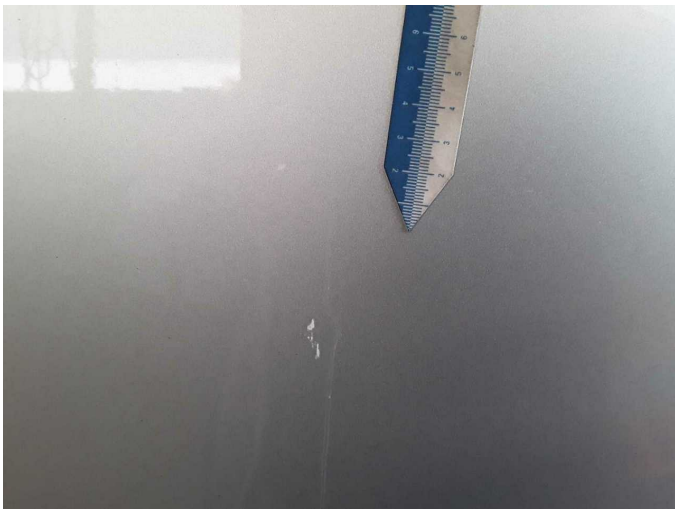
| No. | Component group | Description |
|---|---|---|
| 5 | Door - front right side | Door - Scratched - Paint |

**Damage 5:** Door - front right side: Door - Scratched - Paint

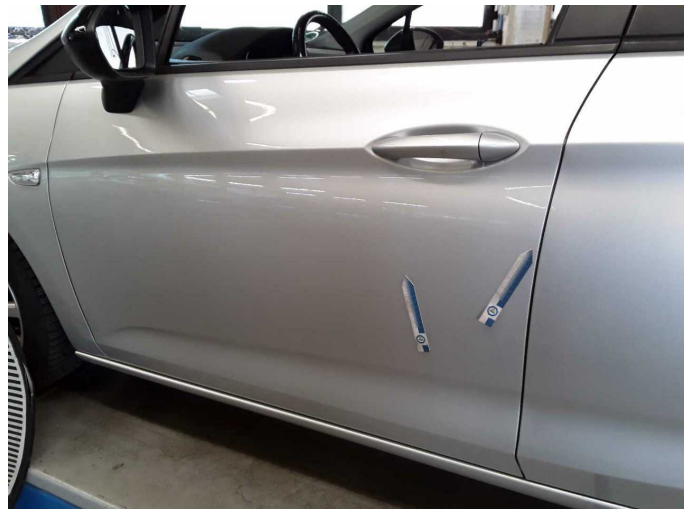
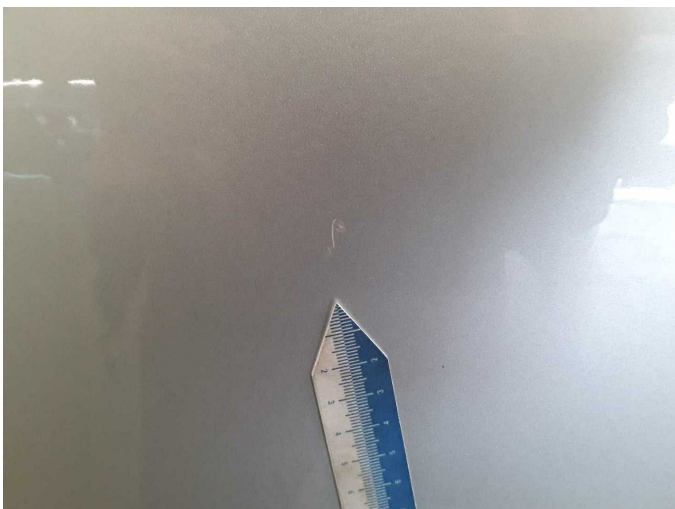
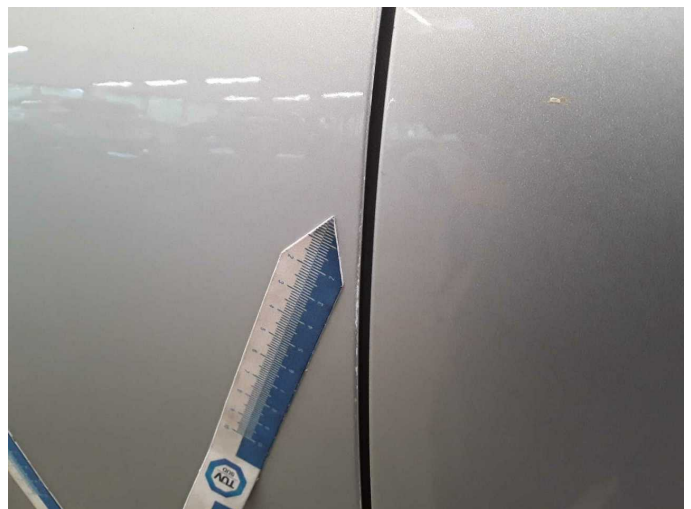
| No. | Component group | Description |
|---|---|---|
| 6 | Door - front left side | Door - Scratched - Paint |

**Damage 6:** Door - front left side: Door - Scratched - Paint

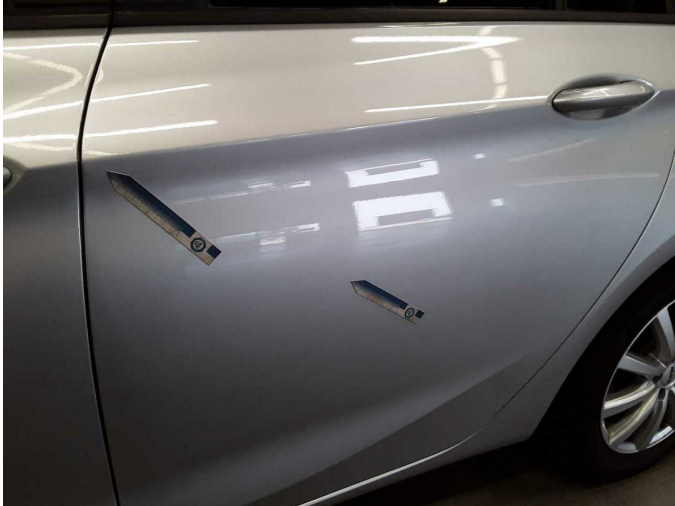
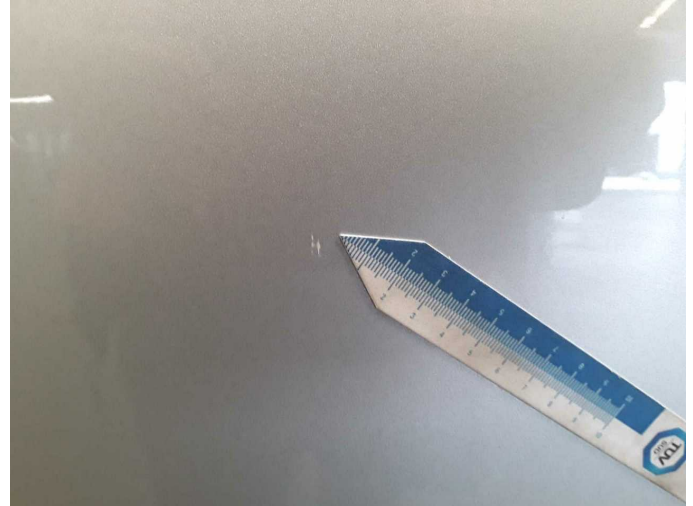
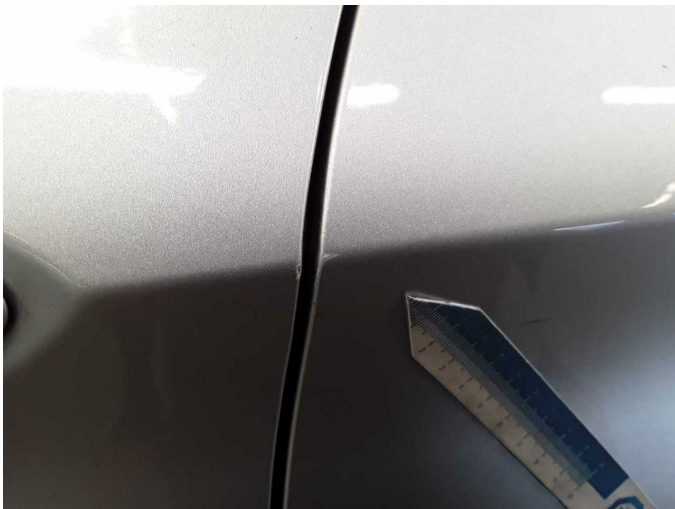
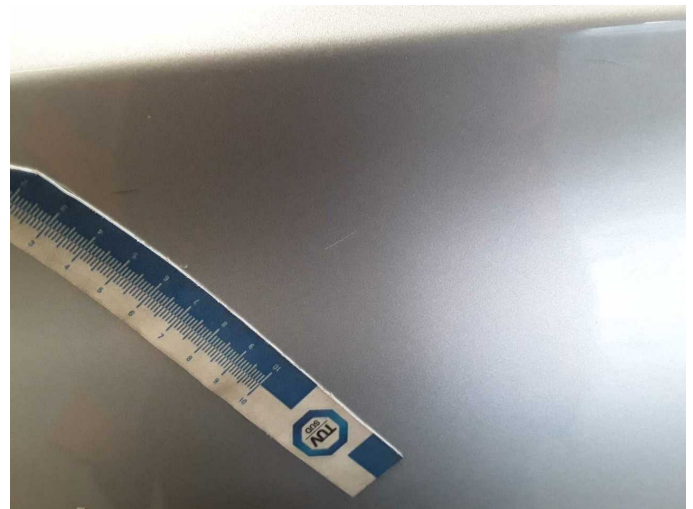
| No. | Component group | Description |
|---|---|---|
| 7 | Door - rear left side | Door - Scratched - Paint |

**Damage 7:** Door - rear left side: Door - Scratched - Paint

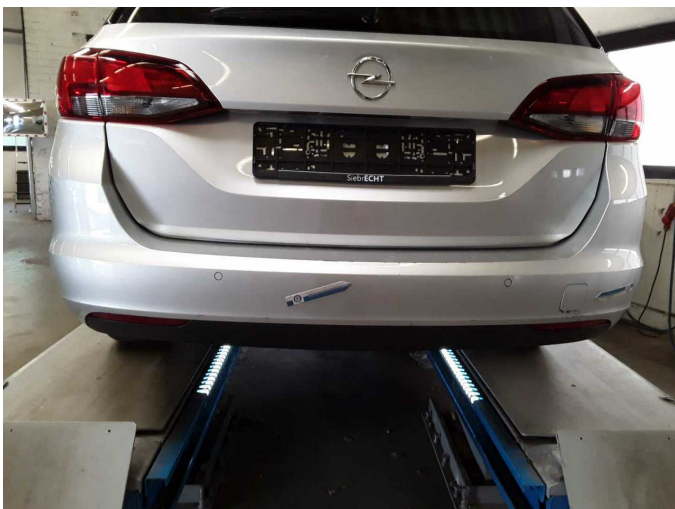
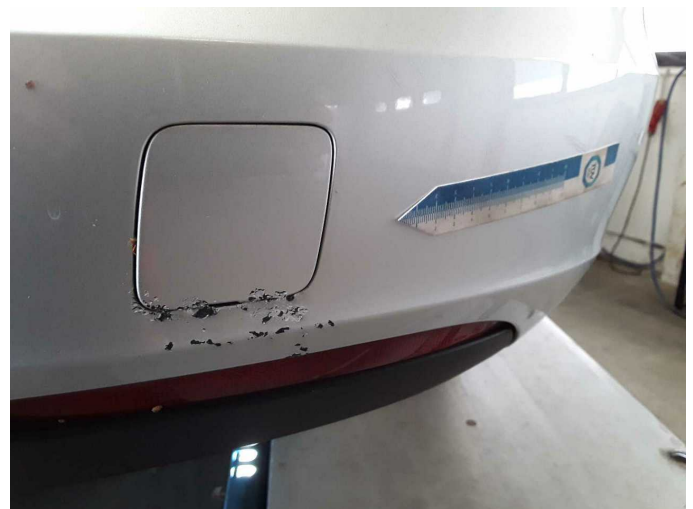
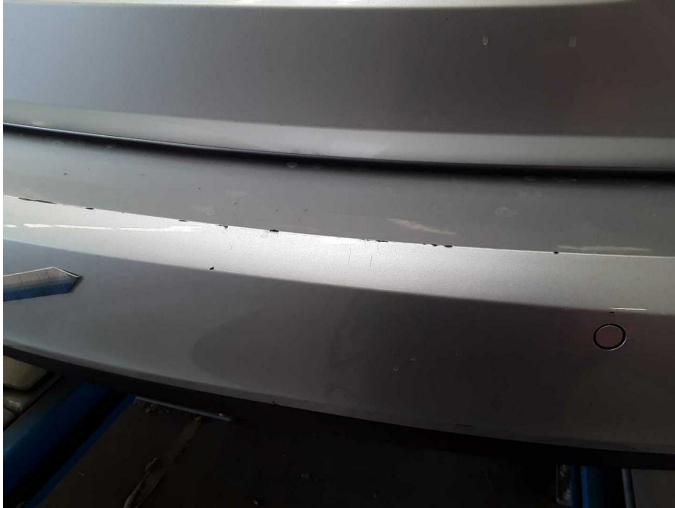
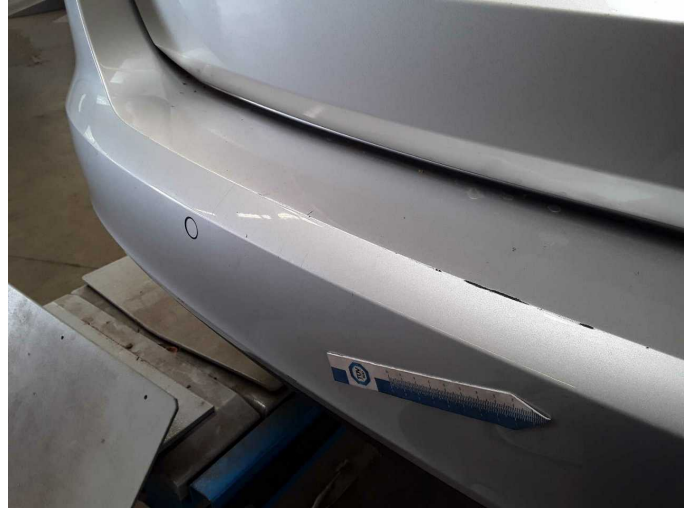
| No. | Component group | Description |
|---|---|---|
| 8 | Rear bumper | Rear bumper - Scratched - Paint |

**Damage 8:** Rear bumper: Rear bumper - Scratched - Paint

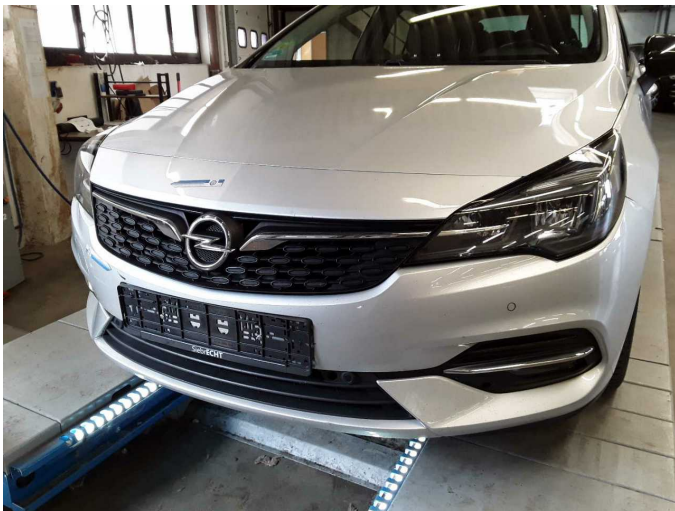
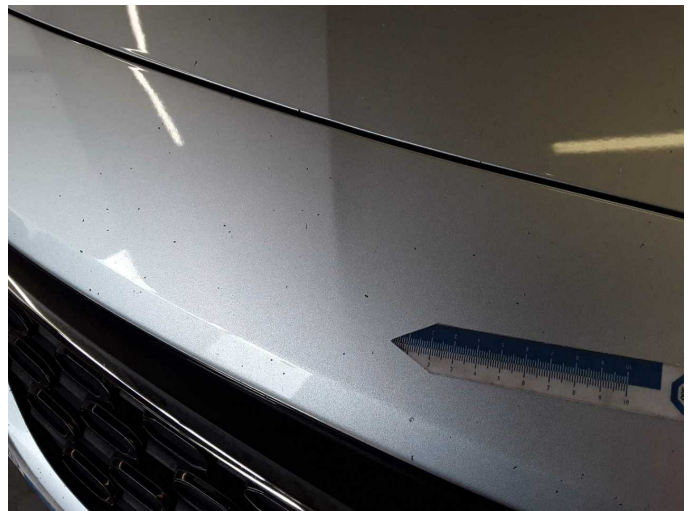
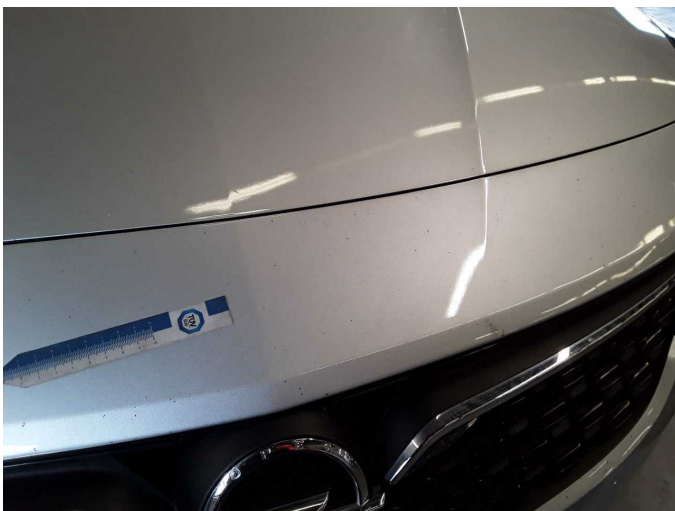
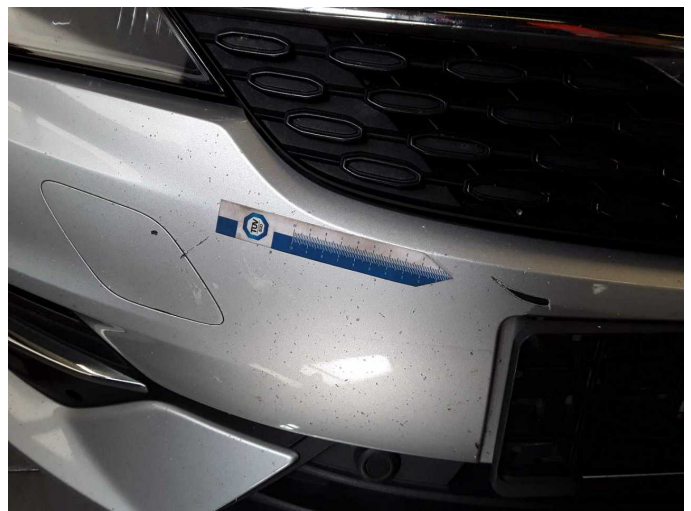
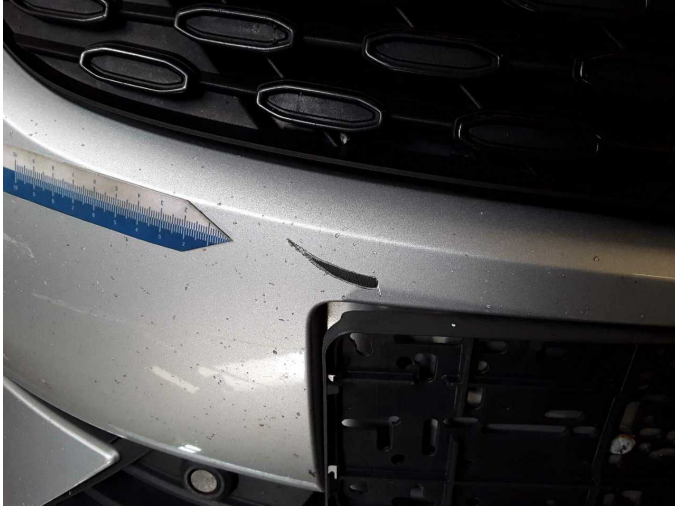
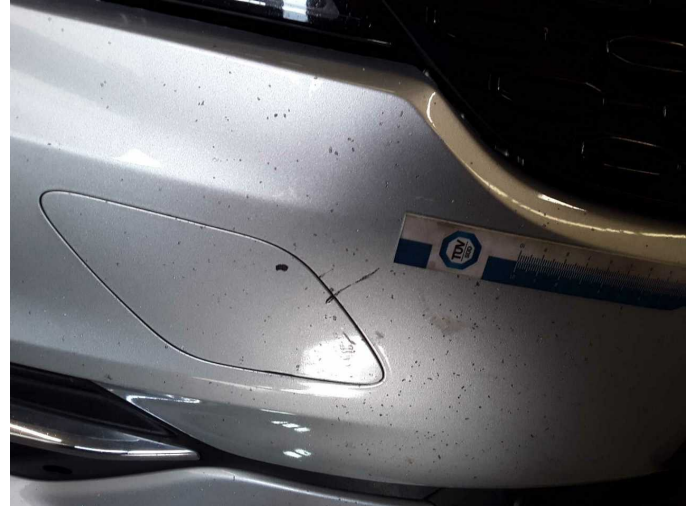
| No. | Component group | Description |
|---|---|---|
| 9 | Front bumper | Front bumper - Scratched - Paint |

**Damage 9:** Front bumper: Front bumper - Scratched - Paint

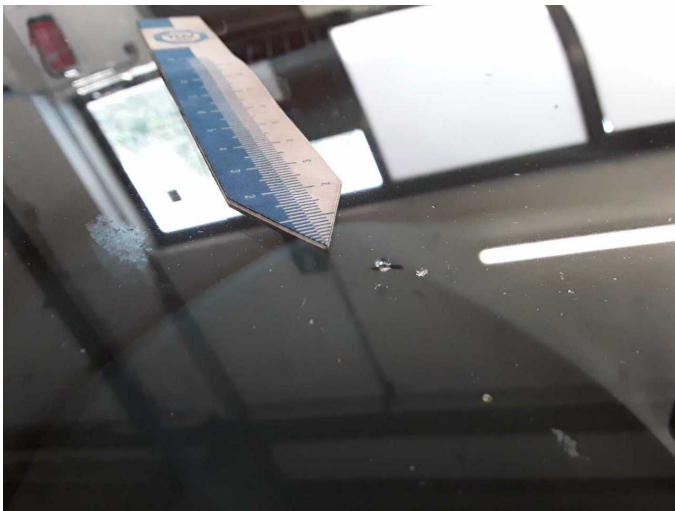
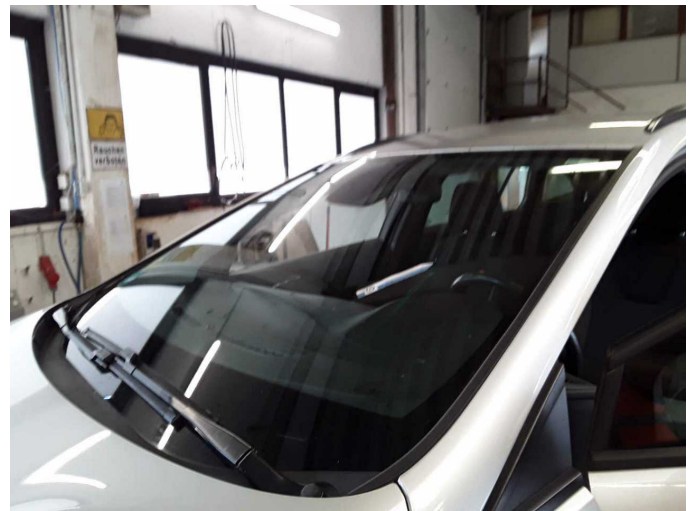
| No. | Component group | Description |
|---|---|---|
| 10 | Vehicle glazing | Windscreen - Stone chips - Replace |

**Damage 10:** Vehicle glazing: Windscreen - Stone chips - Replace

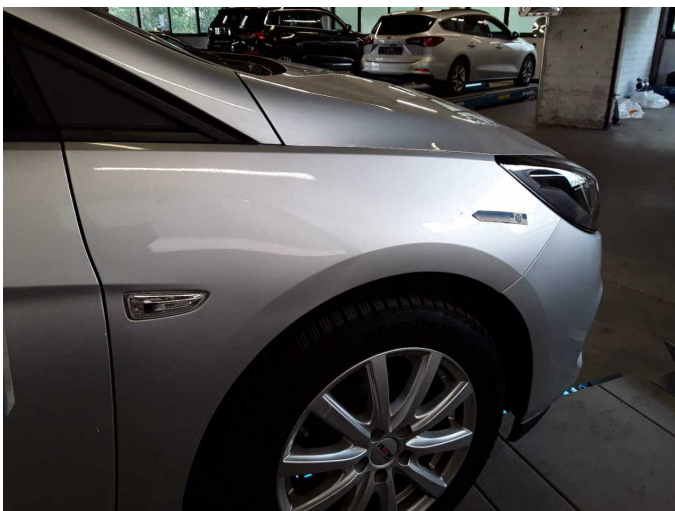
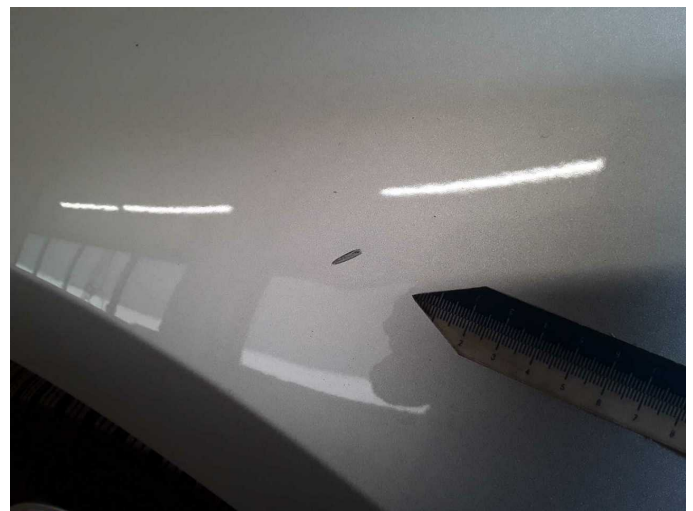
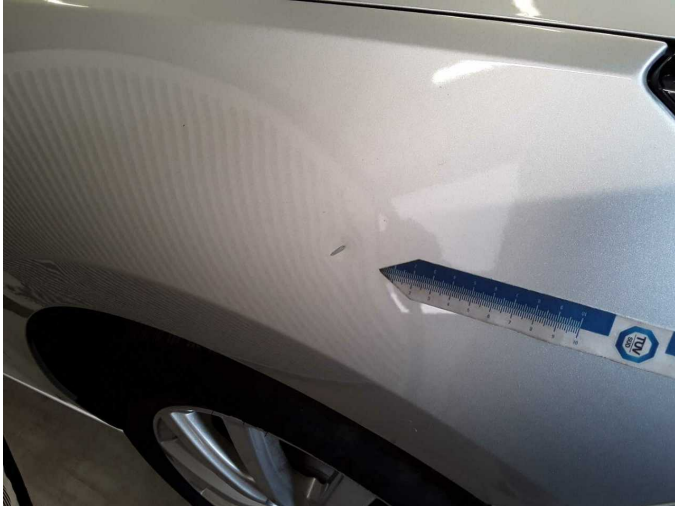
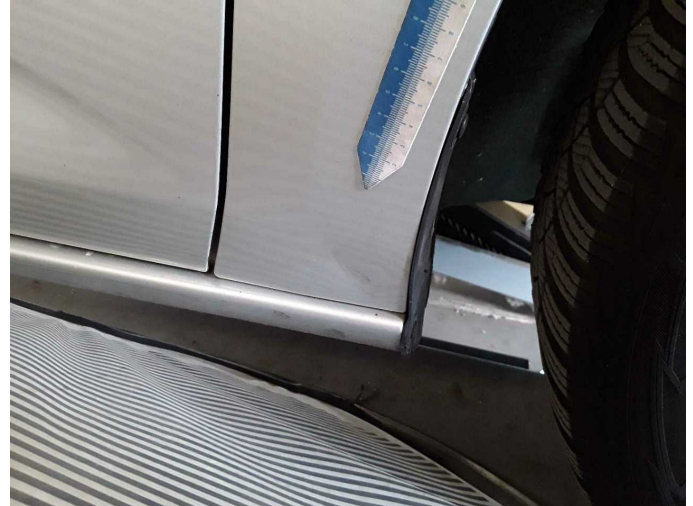
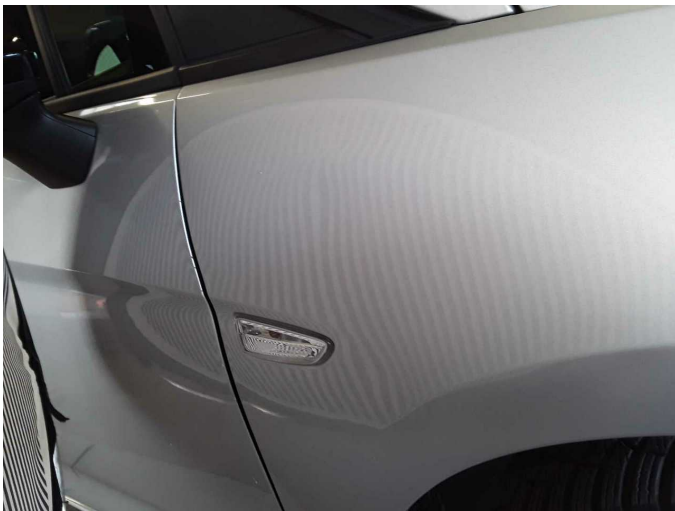
| No. | Component group | Description |
|---|---|---|
| 11 | Mudguard - right side | Mudguard - right side - Dent / paintcoat damage - Repair and paint |

**Damage 11:** Mudguard - right side: Mudguard - right side - Dent / paintcoat damage - Repair and paint

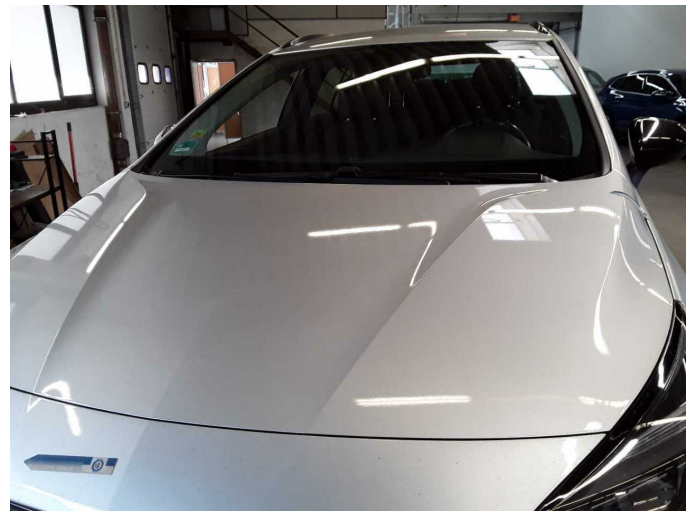
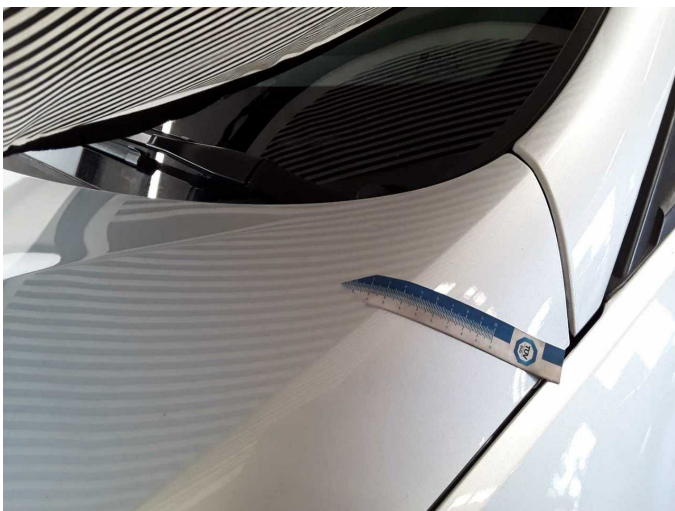
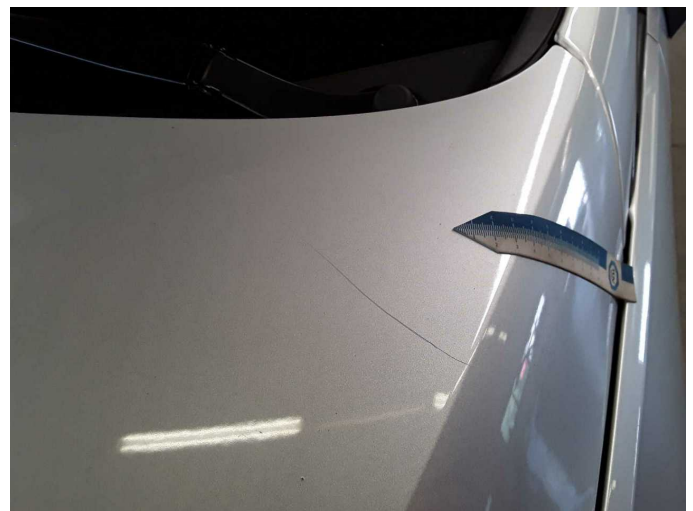
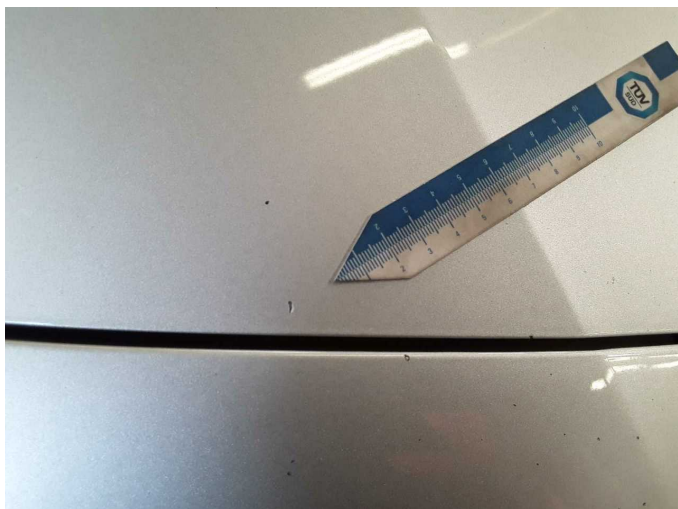
| No. | Component group | Description |
|---|---|---|
| 12 | Bonnet | Bonnet - Dent / paintcoat damage - Paint |

**Damage 12:** Bonnet: Bonnet - Dent / paintcoat damage - Paint

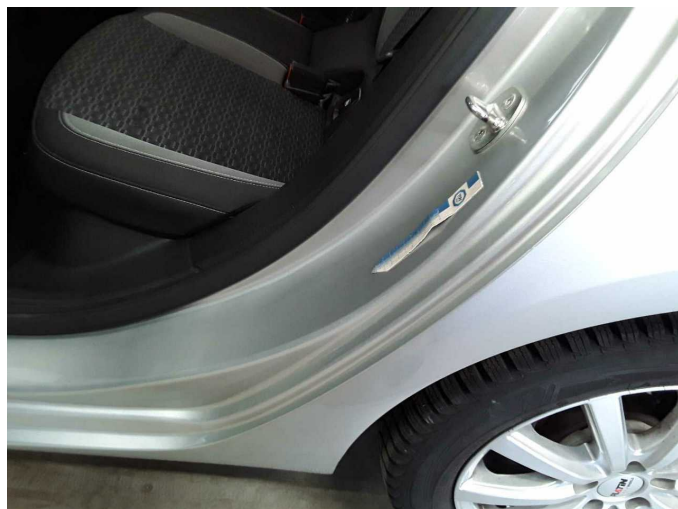
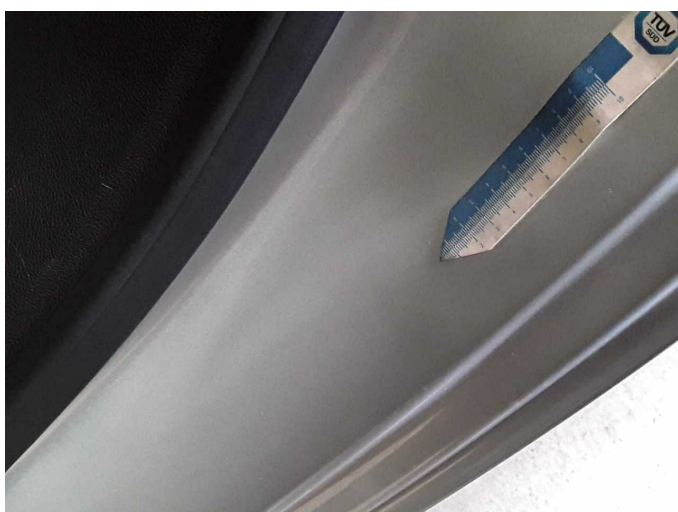
| No. | Component group | Description |
|---|---|---|
| 1 | Side panel - rear left side | Sill - Scratch(es) - No deduction |

**Wear and tear 1:** Side panel - rear left side: Sill - Scratch(es) - No deduction

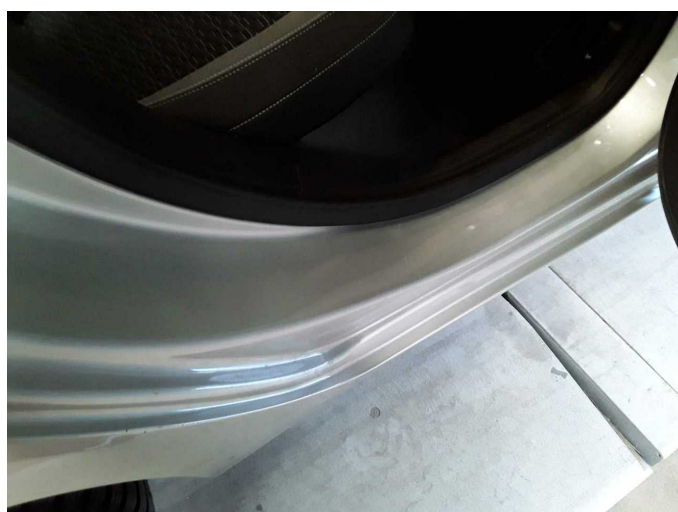
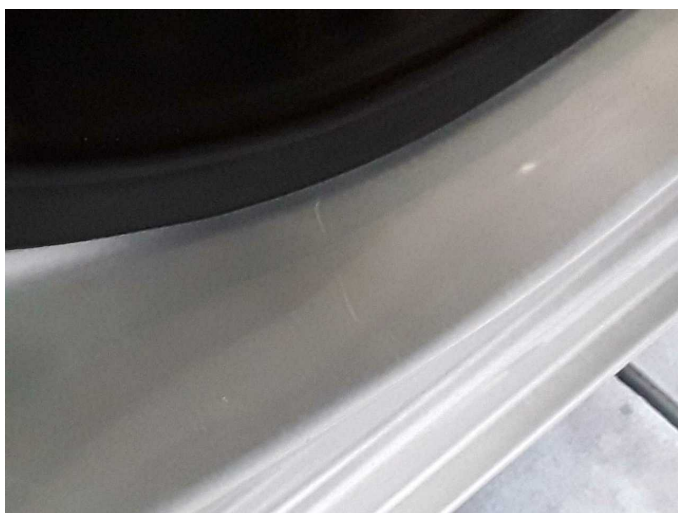
| No. | Component group | Description |
|---|---|---|
| 3 | Side panel - rear right side | Sill - Scratch(es) - No deduction |

**Wear and tear 3:** Side panel - rear right side: Sill - Scratch(es) - No deduction

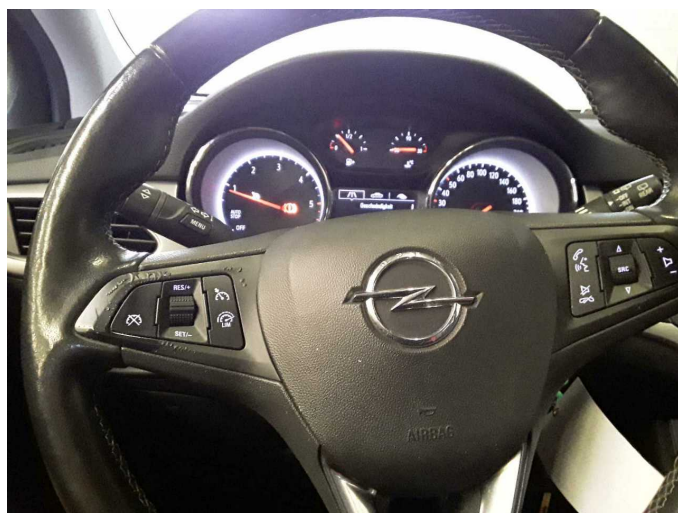
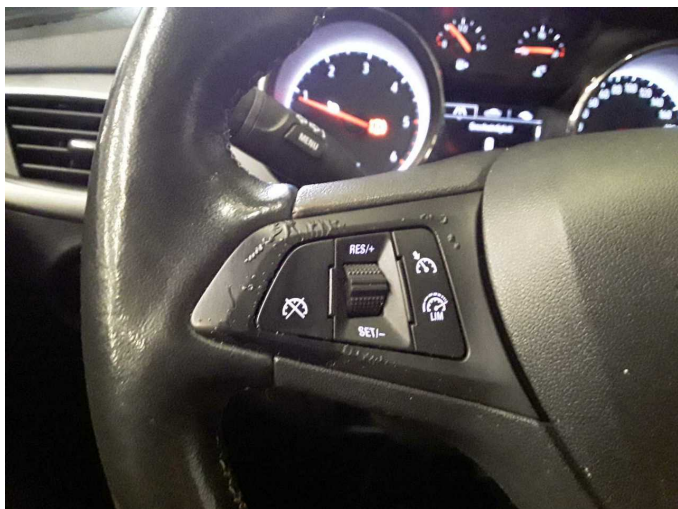
| No. | Component group | Description |
|---|---|---|
| 4 | Steering system | Steering wheel button - Scratch(es) - No deduction |

**Wear and tear 4:** Steering system: Steering wheel button - Scratch(es) - No deduction

**Wear and tear 4:** Steering system: Steering wheel button - Scratch(es) -  
No deduction
