## Expertise

Protocol number: 45946055  
Order No. / Reference: 26433494  
Inspection date: 10 Jun 2026

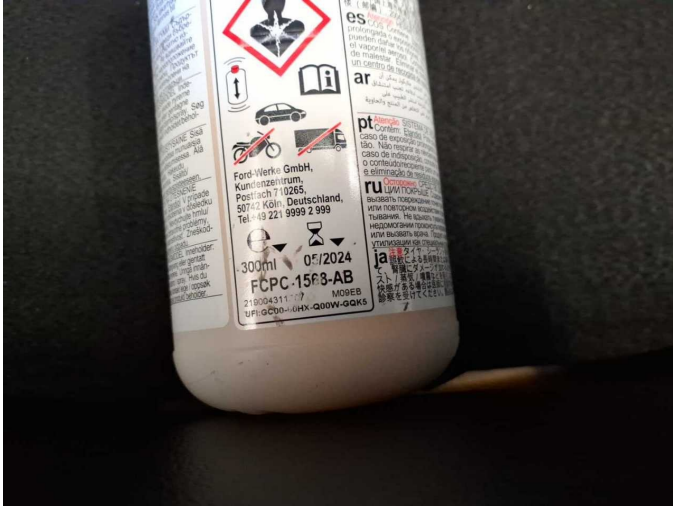
**Damage 3:** Equipment: Tirefit filler - Expired - Replace

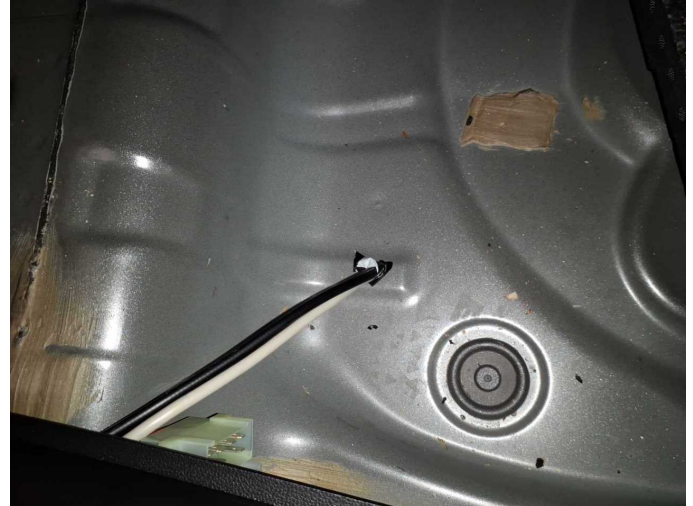
**Damage 4:** Electrical system: Cable strand (Kabelführung von Frontbereich in Laderaum) - Differs from the original configuration - Un-/install

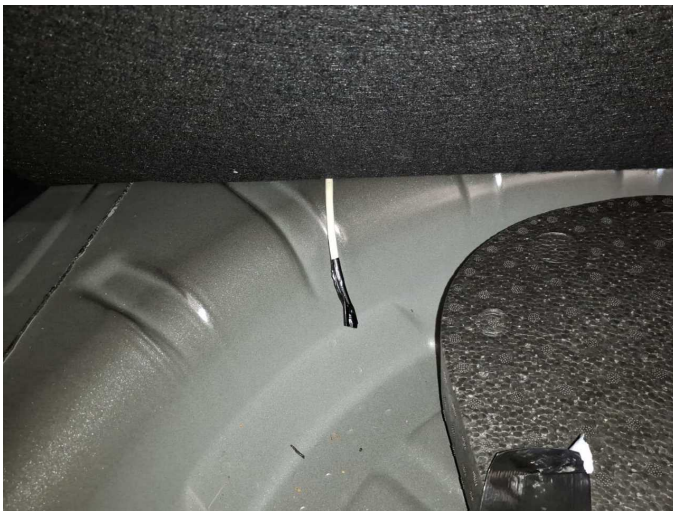
**Damage 4:** Electrical system: Cable strand (Kabelführung von Frontbereich in Laderaum) - Differs from the original configuration - Un-/install

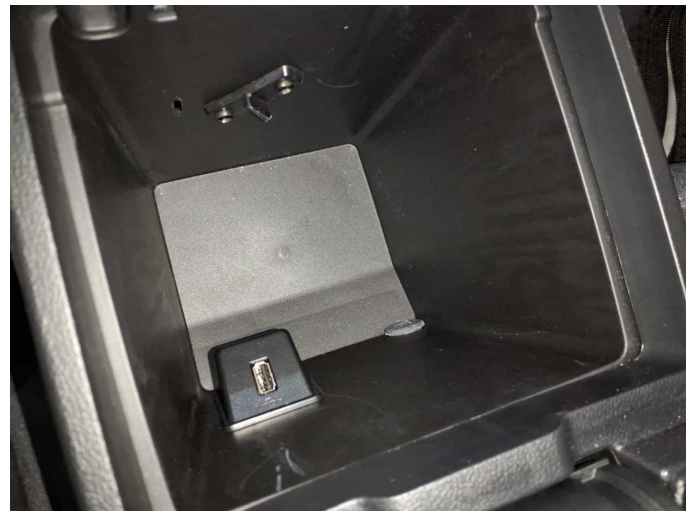
**Damage 5:** Interior: Arm rest, front (Deckel hinten) - Differs from the original configuration - Replace

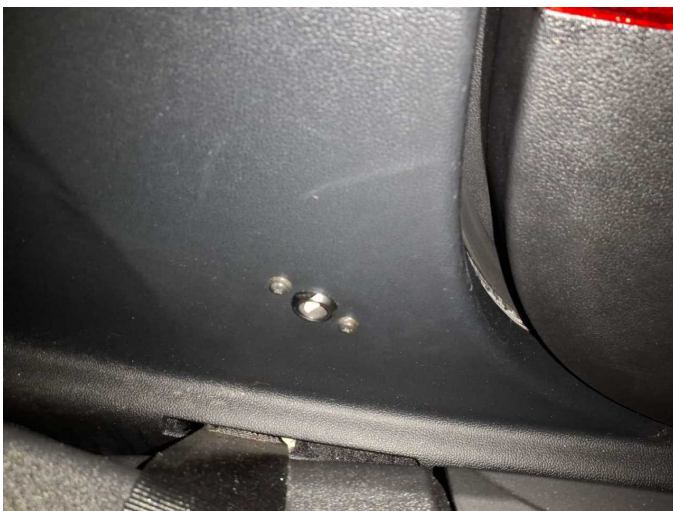
**Damage 6:** Trim / covers: B-pillar - trim - interior, left side (Fehlbohrungen) - Differs from the original configuration - Replace

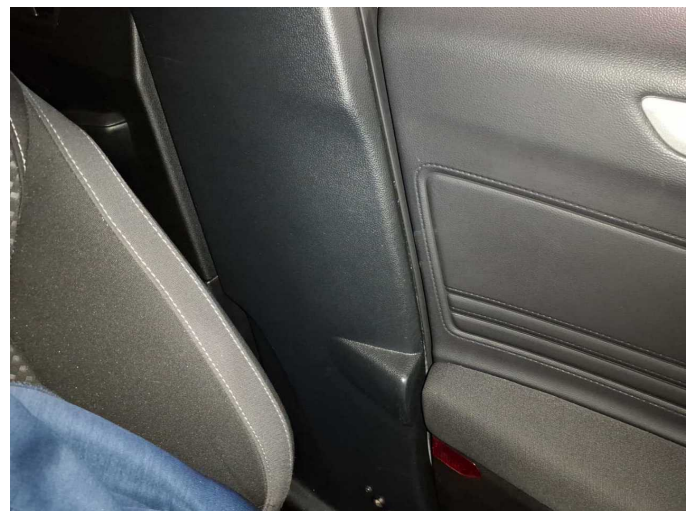
**Damage 6:** Trim / covers: B-pillar - trim - interior, left side (Fehlbohrungen) - Differs from the original configuration - Replace

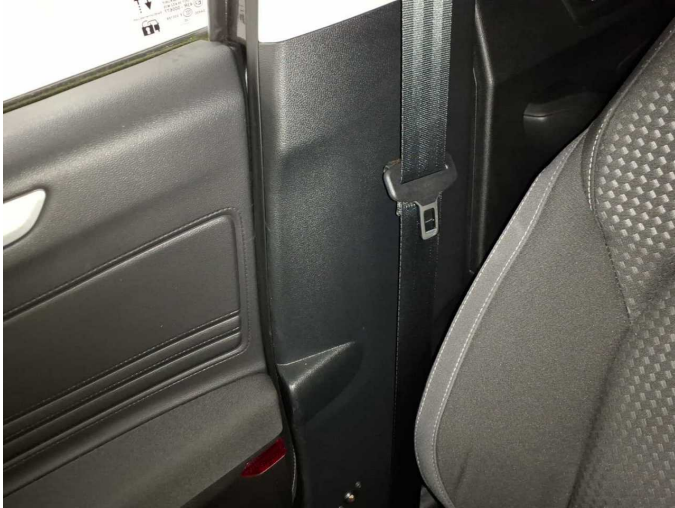
**Damage 7:** Trim / covers: B-pillar - trim - interior, right side (Fehlbohrungen) - Differs from the original configuration - Replace

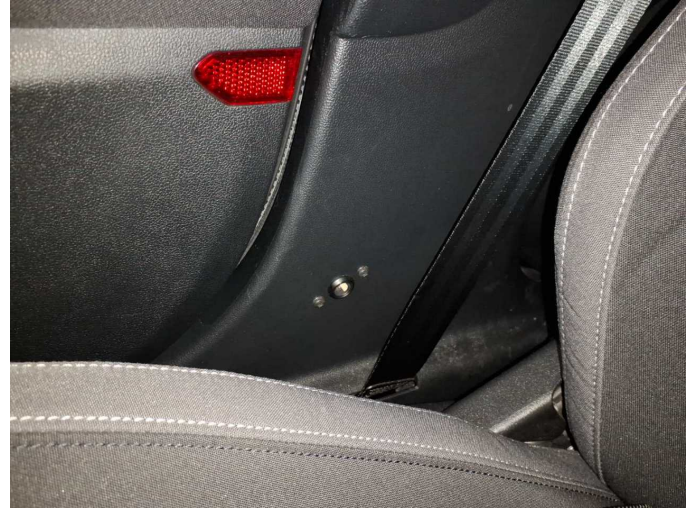
**Damage 7:** Trim / covers: B-pillar - trim - interior, right side (Fehlbohrungen) - Differs from the original configuration - Replace

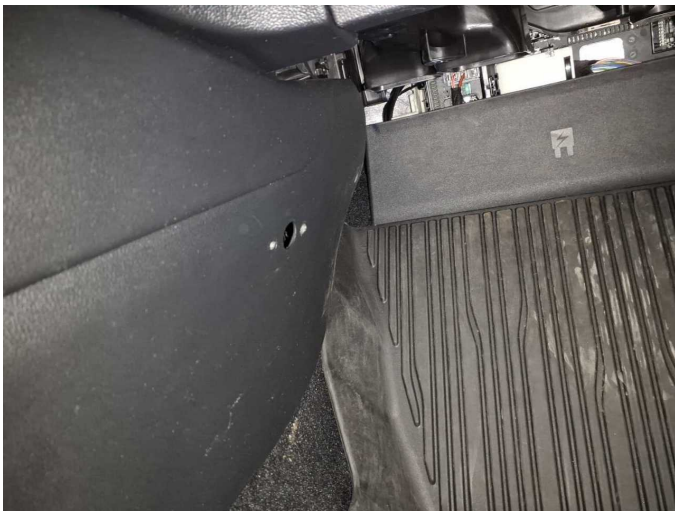
**Damage 8:** Instrument panel: Centre console - front (Blende rechts, Fehlbohrungen) - Differs from the original configuration - Replace

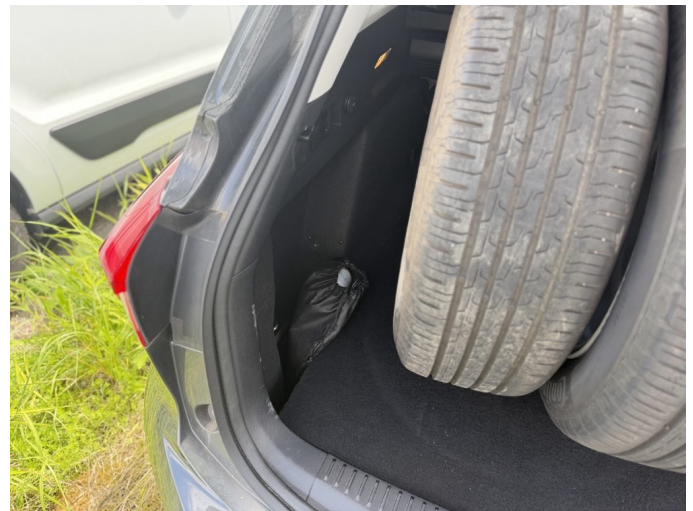
**Damage 9:** Trim / covers: Cargo area - lining -left side - Differs from the original configuration - Replace

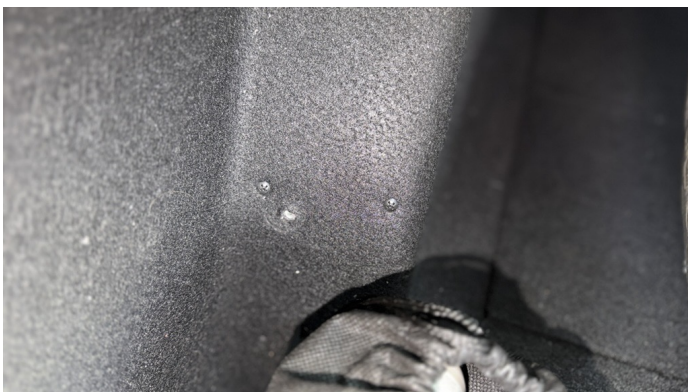
**Damage 9:** Trim / covers: Cargo area - lining -left side - Differs from the original configuration - Replace

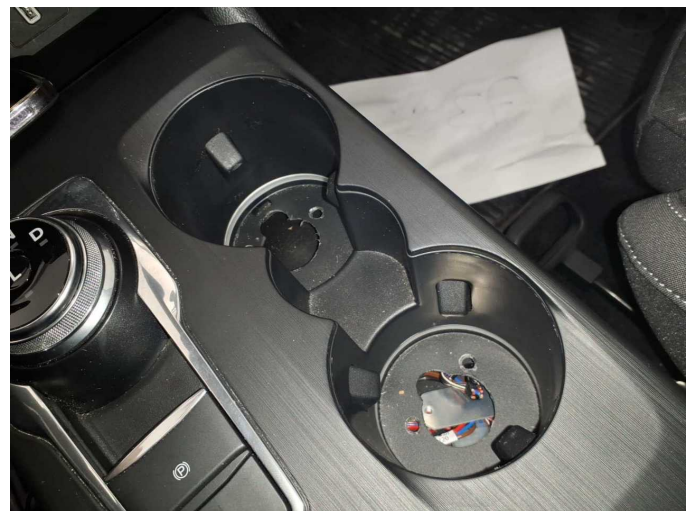
**Damage 10:** Instrument panel: Centre console - front (Getränkehalter, Fehlbohrungen) - Differs from the original configuration - Replace

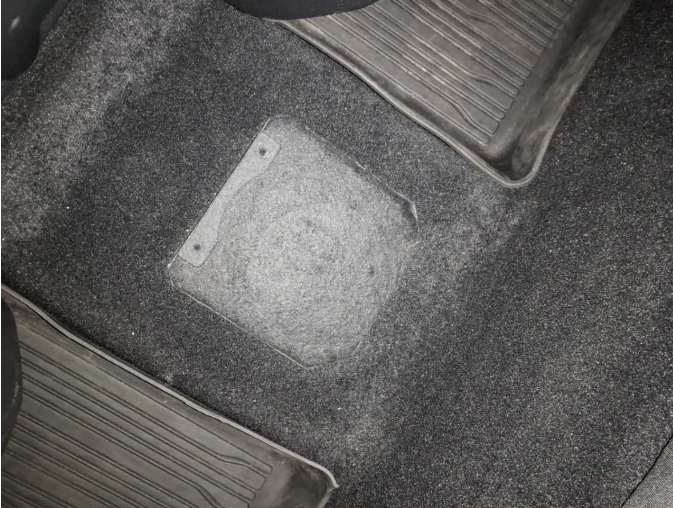
**Damage 11:** Trim / covers: Carpet - Differs from the original configuration  
- Replace
