# MACDAM

## Volkswagen ID.4 '21 BEV

### Damage summary

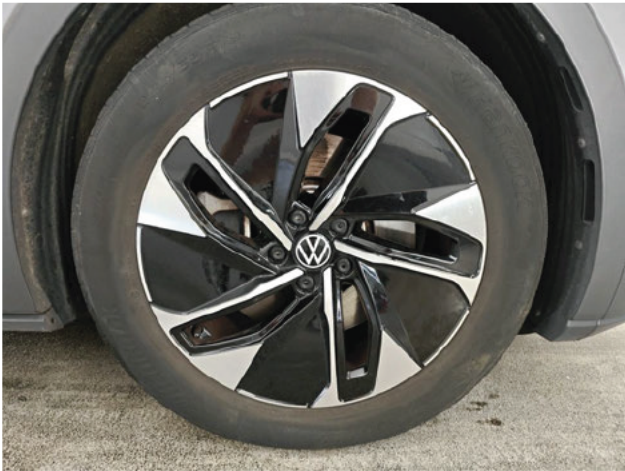
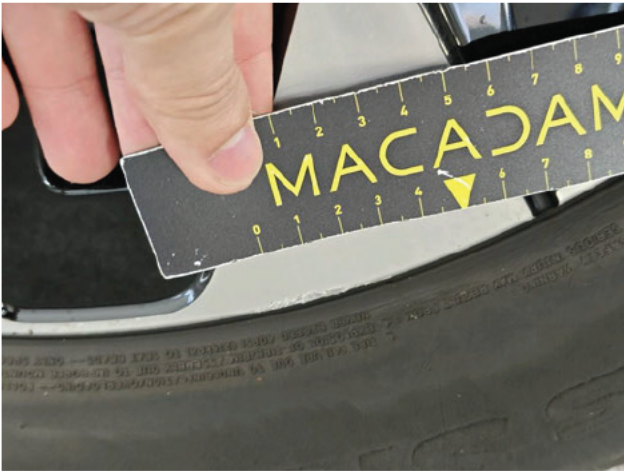
Alloy rim FR

Scratch(es)

Repair and paint (complete)

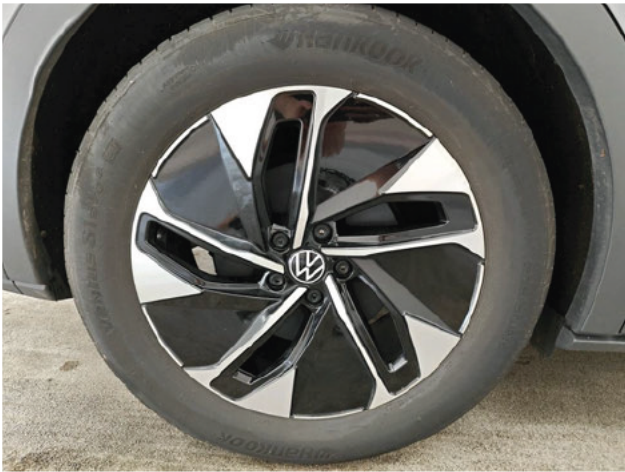
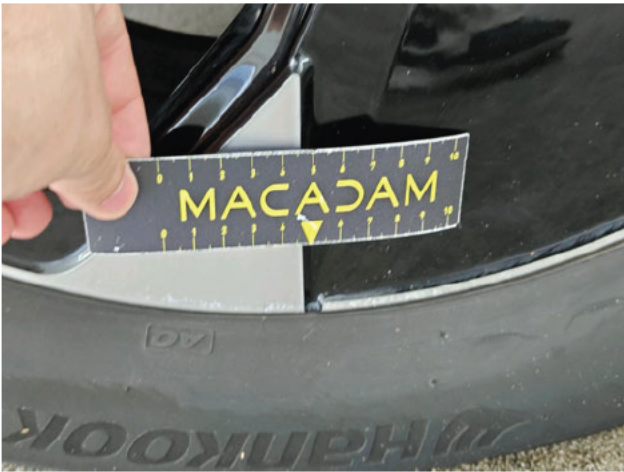
Alloy rim RR

Scratch(es)

Repair and paint (complete)

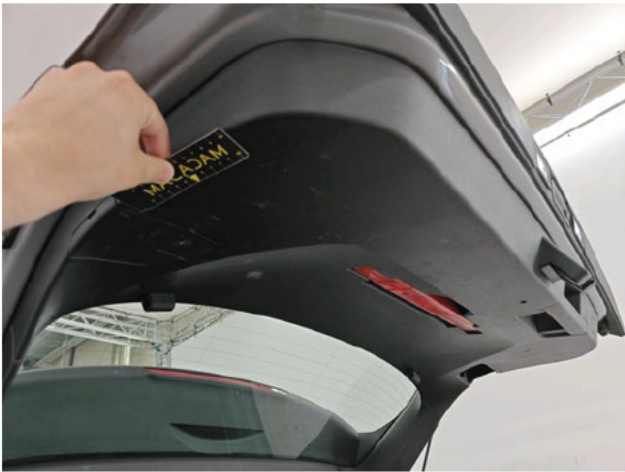
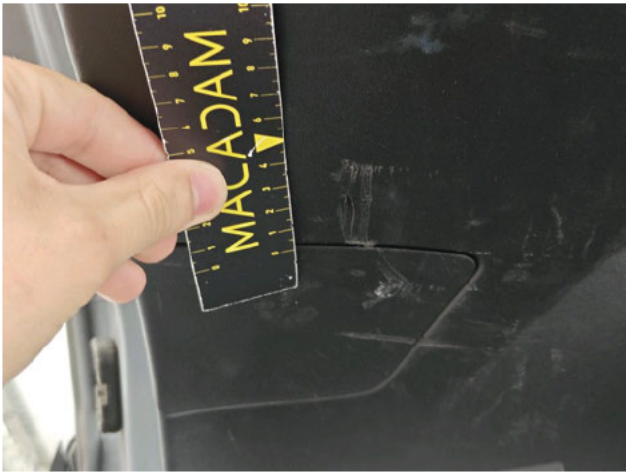
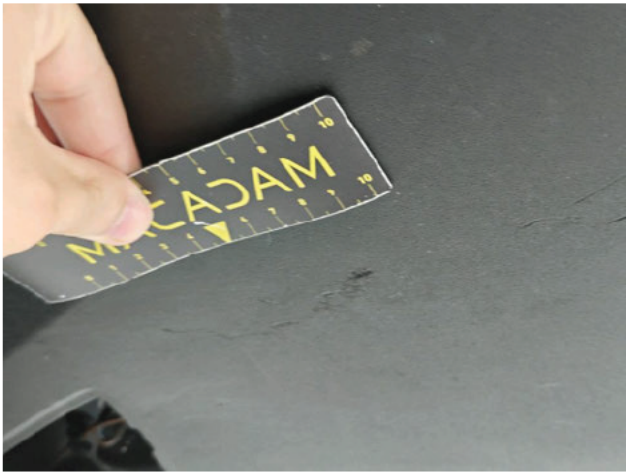
Boot lid covering R

Scratch(es)

Smart repair

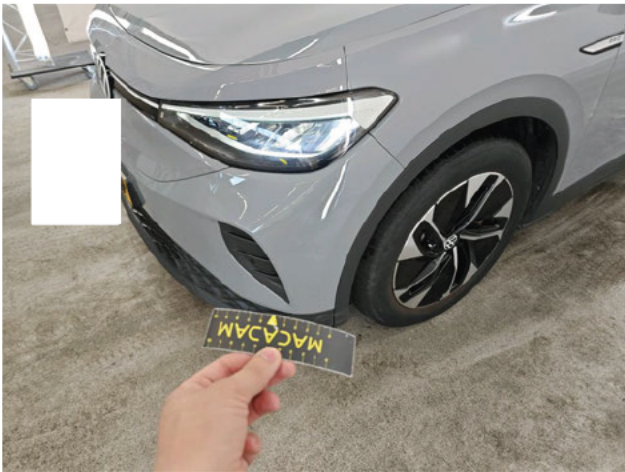
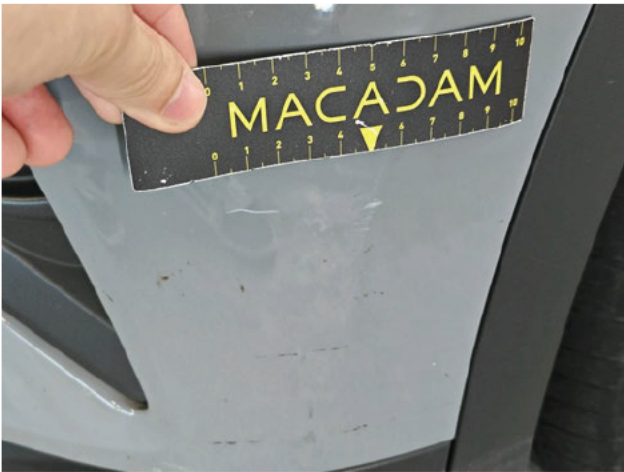
Bumper F

Scratch(es)

Repair and paint (complete)

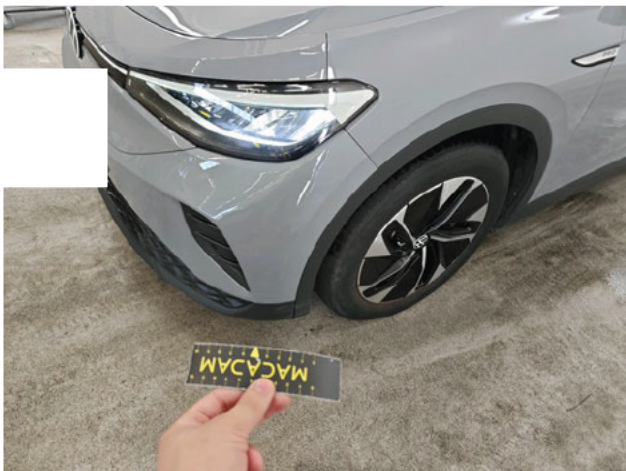
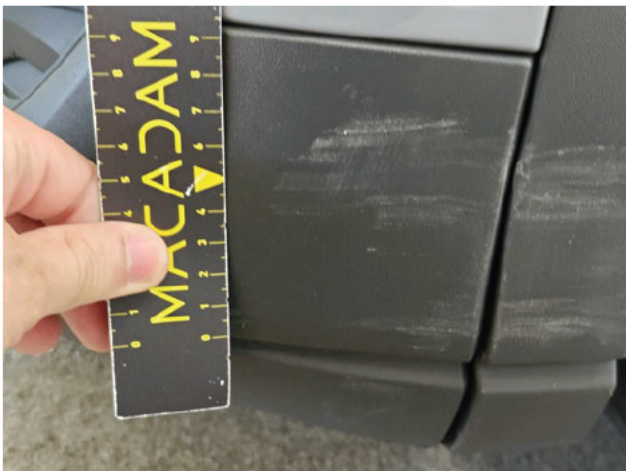
Bumper trim F

Scratch(es)

Replace

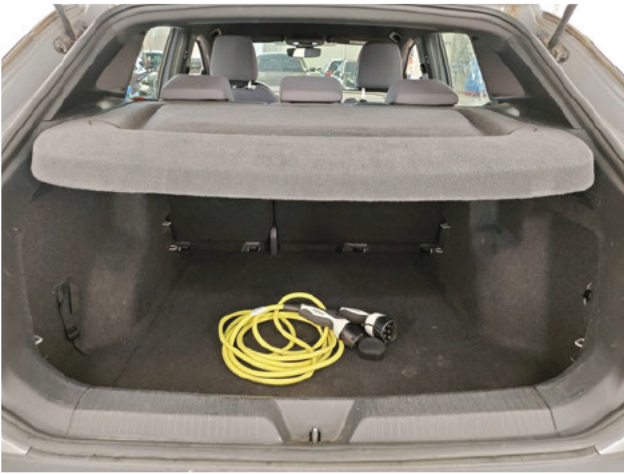
Charging cable (normal)

Missing  
Replace  
Rear

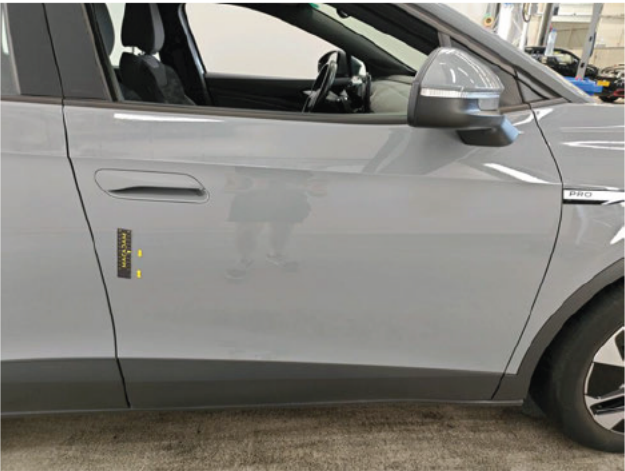
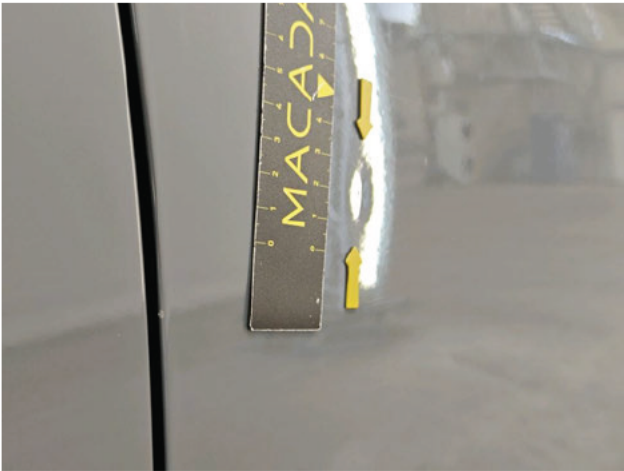
Door FR

Dent(s) and scratch(es)  
Repair and paint (complete)  
Right

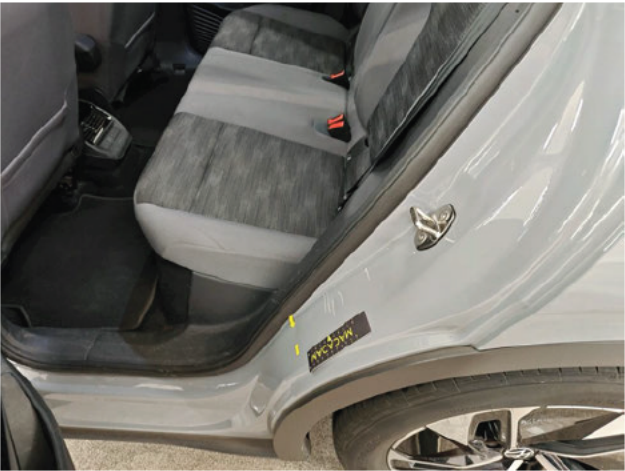
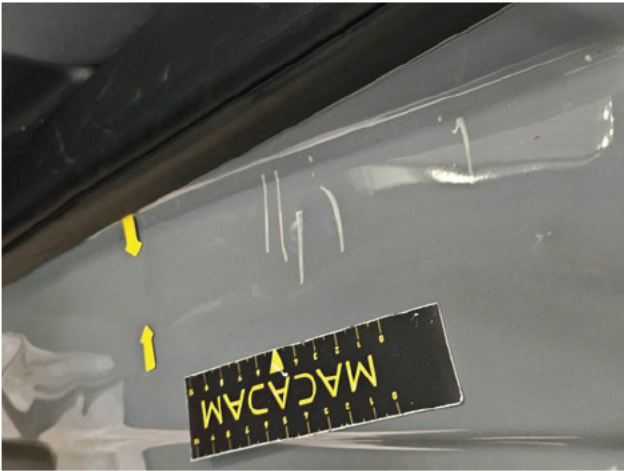
Door frame RL

Dent(s) and scratch(es)  
Repair and paint (complete)  
Left

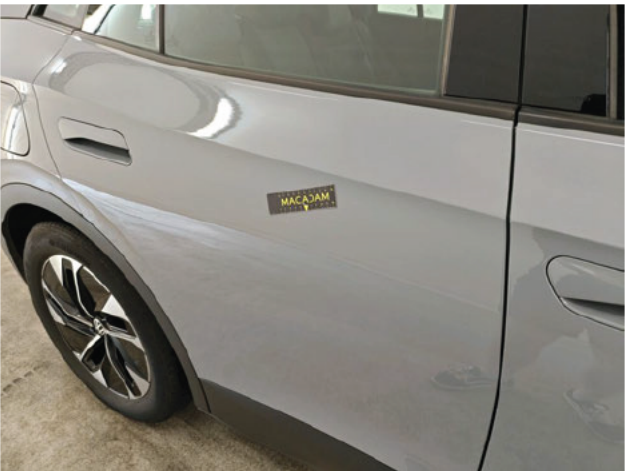
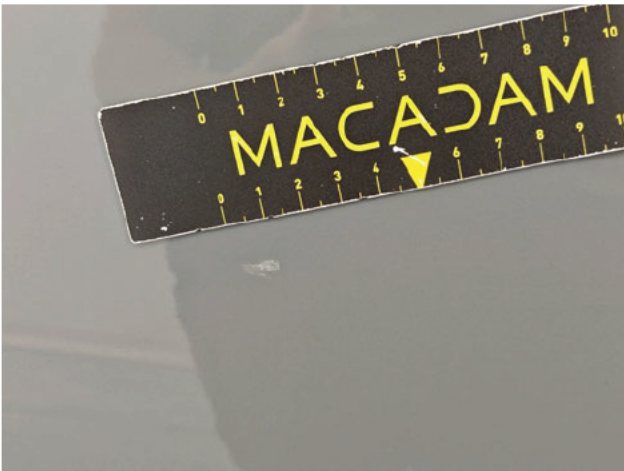
Door RR

Scratch(es)  
Repair and paint (complete)  
Right

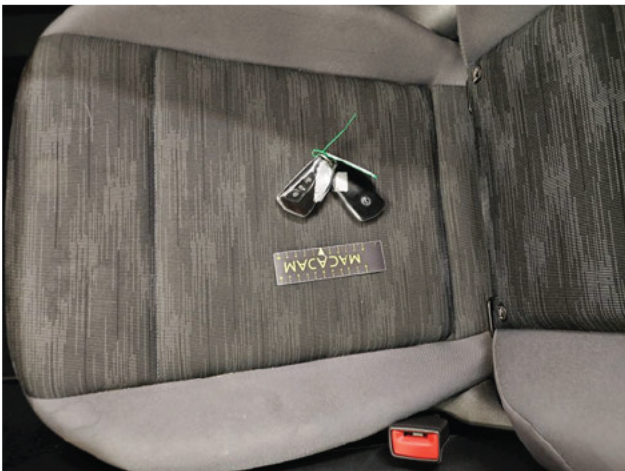
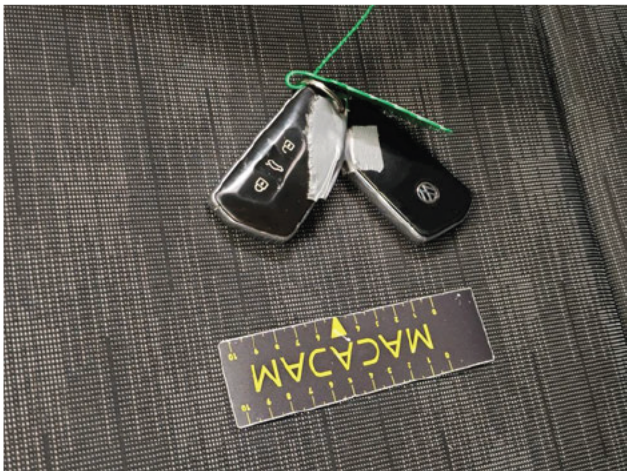
Ignition key

Worn  
Replace  
Interior

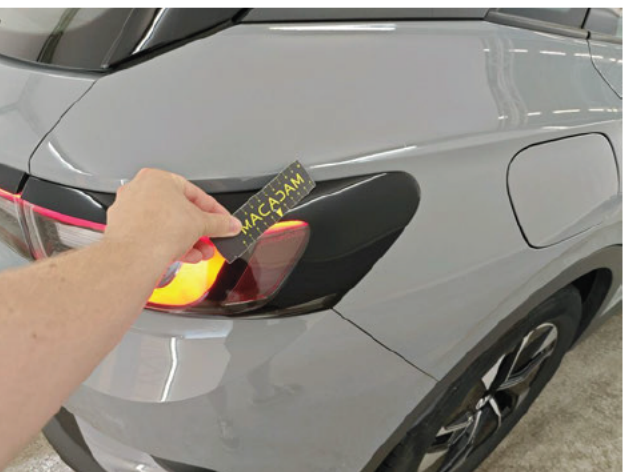
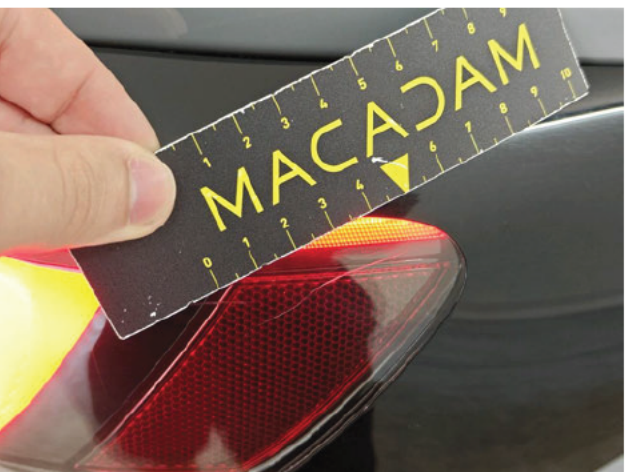
Rear light R

Scratch(es)  
Replace  
Rear

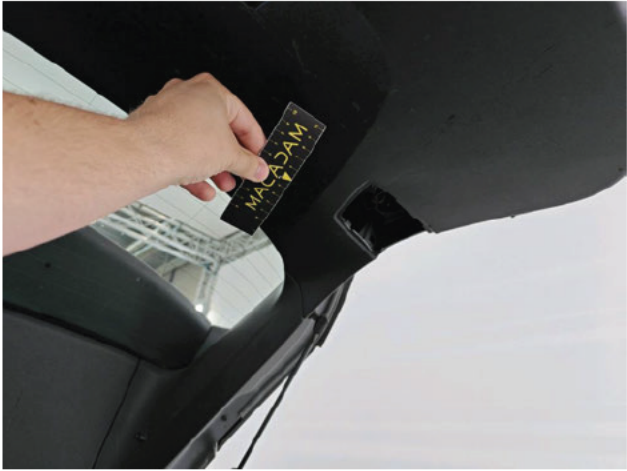
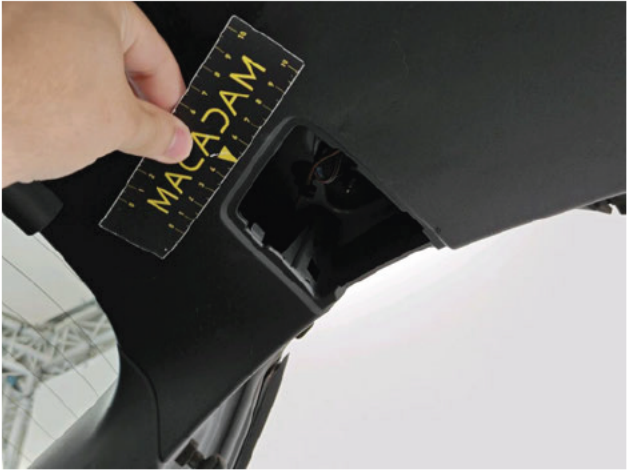
**Shutter / cover**  
Missing  
Replace  
Interior

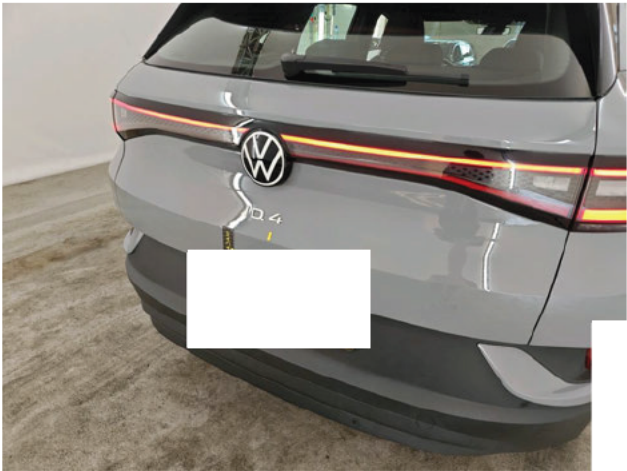
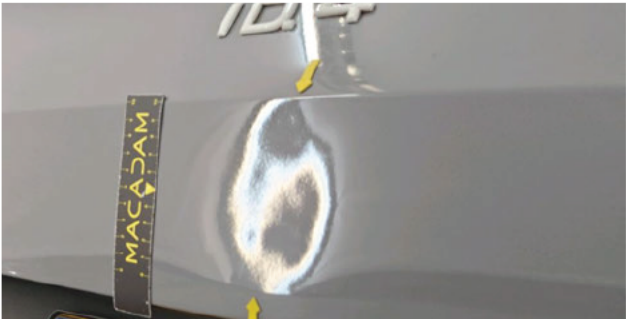
**Tailgate / Boot**  
Dent(s)  
Repair and paint (complete)  
Rear

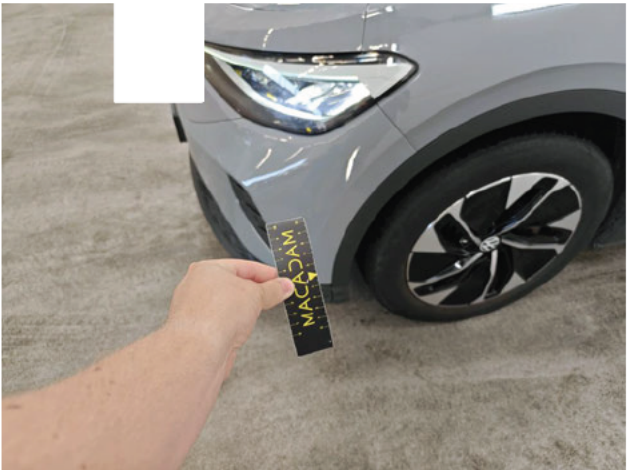
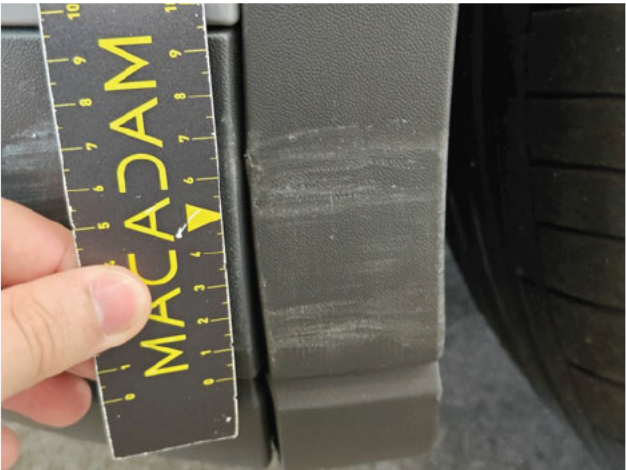
**Wheel arch cover FL**  
Scratch(es)  
Replace  
Left

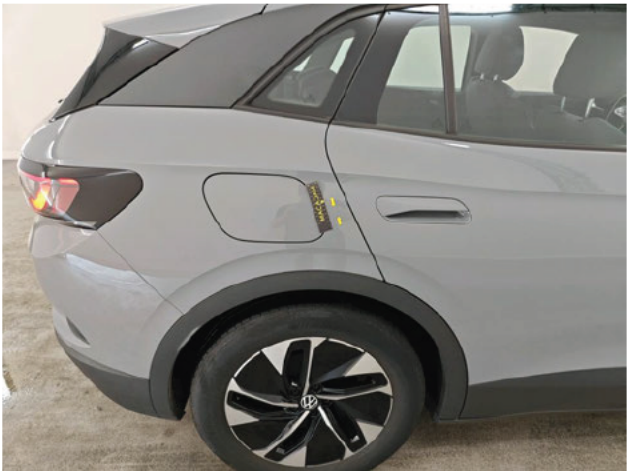
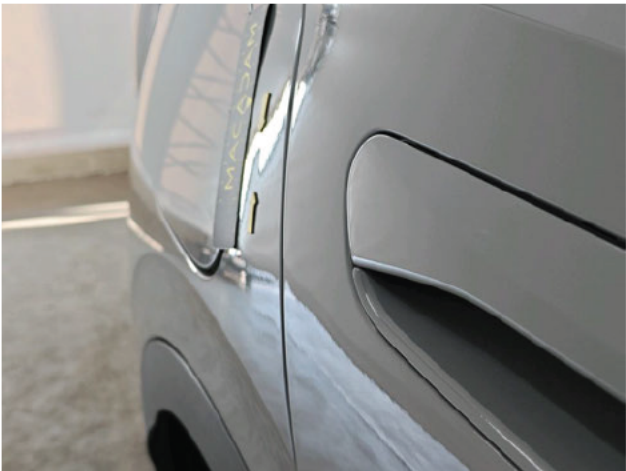
**Wing RR**  
Dent(s)  
Repair and paint (complete)  
Right
