# Ford Mustang '19 BEV

Vehicle information

| Model: | <b>Mustang '19 BEV</b> | VIN: | <b>WF0TK1EM9MMA14521</b> |

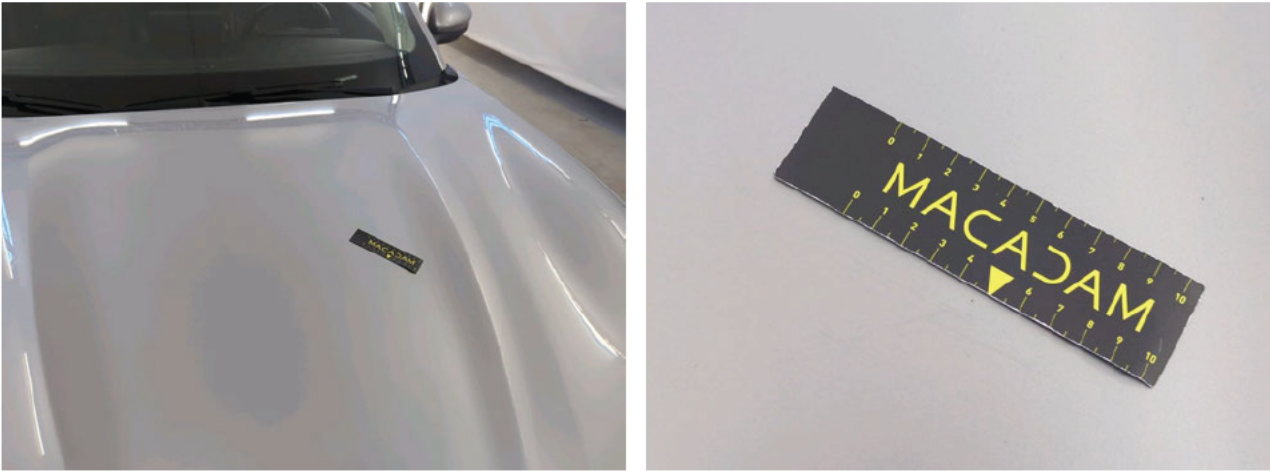
| Options according to the inspector | | | |
|---|---|---|---|
| <b>Bonnet</b><br>Scratch(es)<br>Repair and paint (complete)<br>Front | | | |

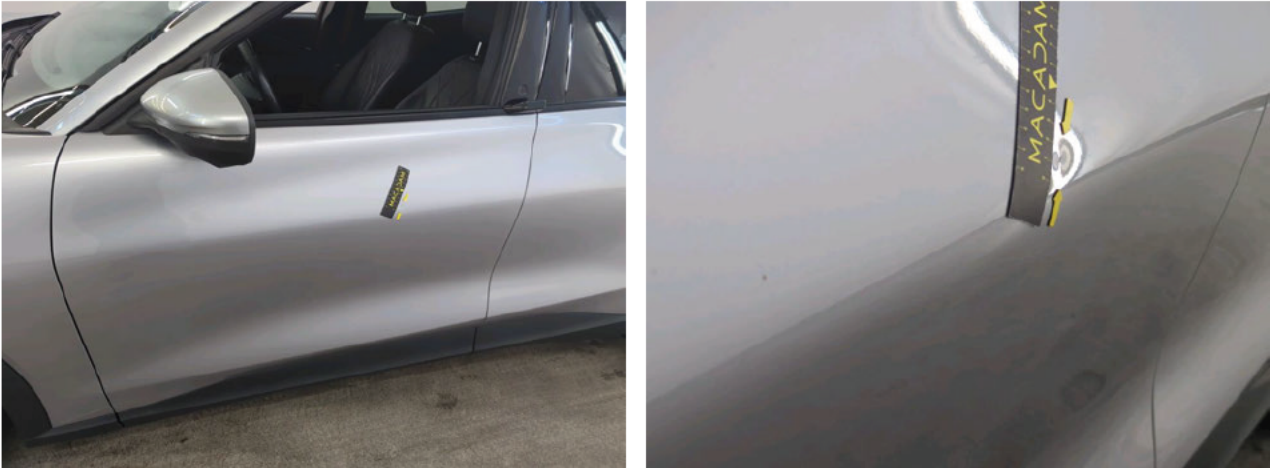
| Options according to the inspector | | | |
|---|---|---|---|
| <b>Door FL</b><br>Dent(s) and scratch(es)<br>Repair and paint (complete)<br>Left | | | |

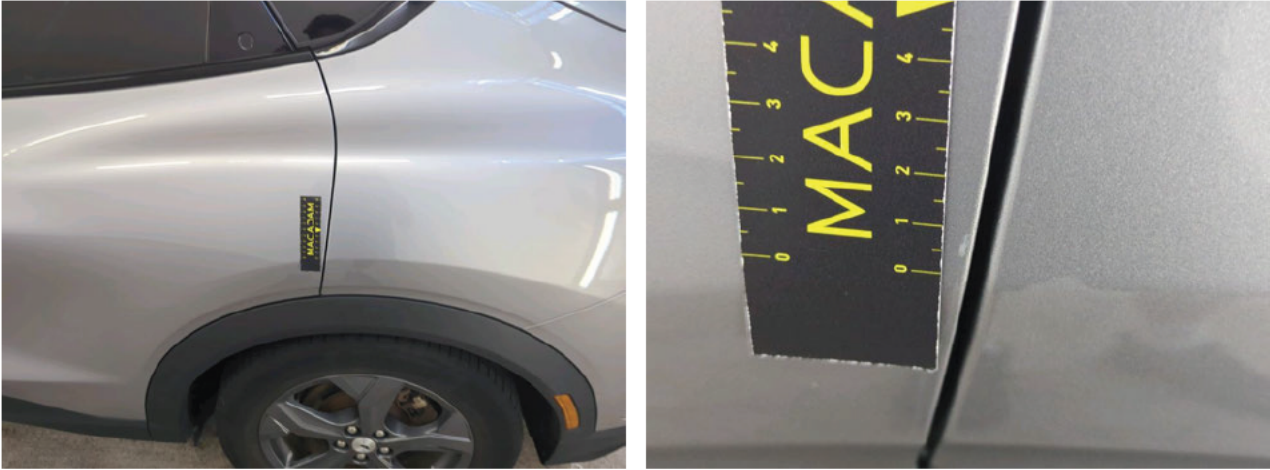
| Options according to the inspector | | | |
|---|---|---|---|
| <b>Wing RL</b><br>Scratch(es)<br>Repair and paint (complete)<br>Left | | | |

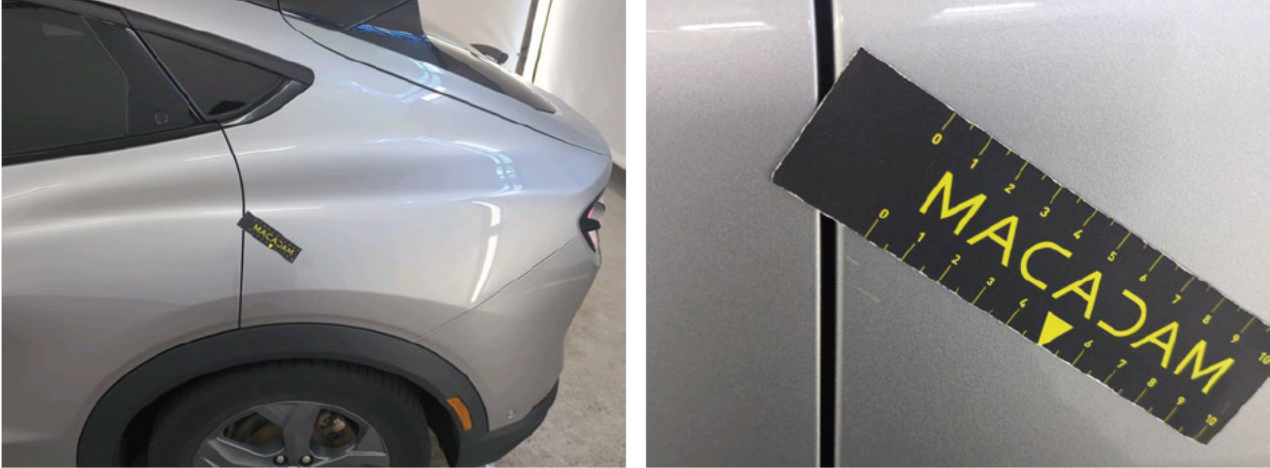
| Options according to the inspector | | | |
|---|---|---|---|
| <b>Wing RL</b><br>Scratch(es)<br>Repair and paint (complete)<br>Left | | | |

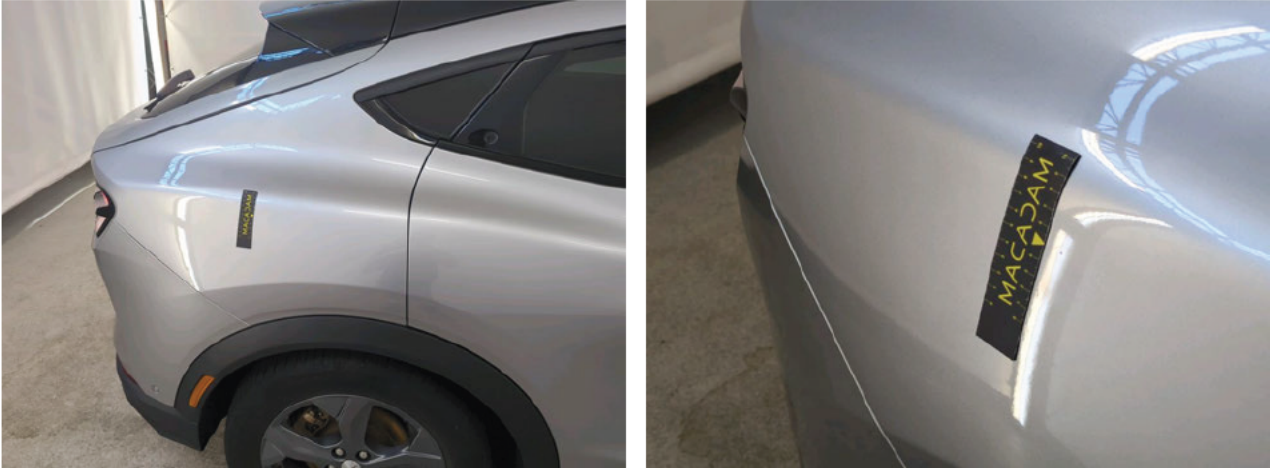
| Options according to the inspector | | | |
|---|---|---|---|
| <b>Wing RR</b><br>Bad repair<br>Repair and paint (complete)<br>Right | | | |
