Expertise

Protocol number: 46309856
Order No. / Reference: 26566047
Inspection date: 29 Jun 2026

Model: Astra 1.5 D Start/Stop Sports Tourer Automatik Elegance

VIN: W0VBE8EV6N8044225

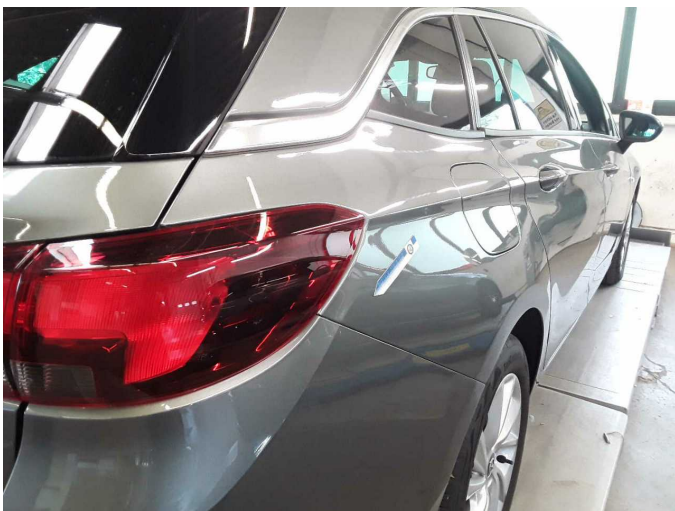
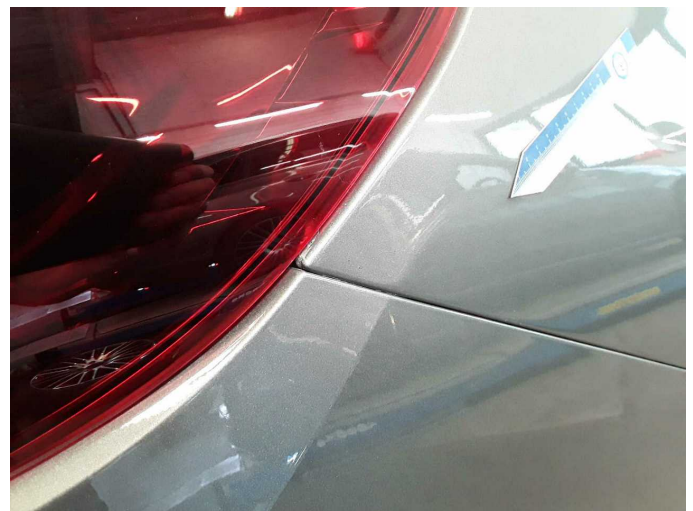
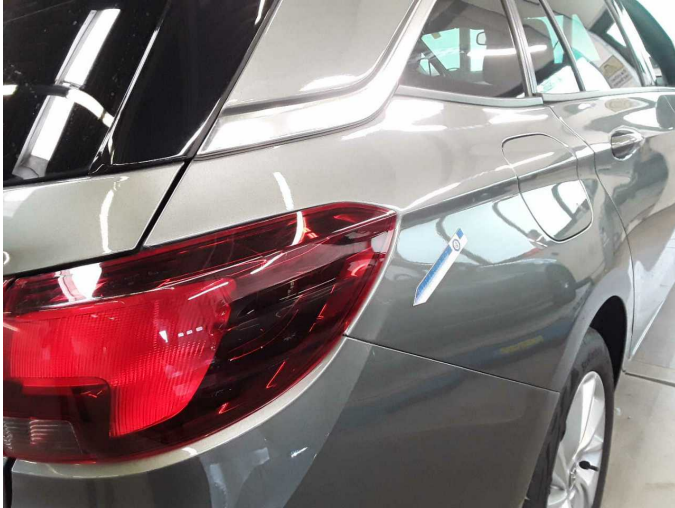
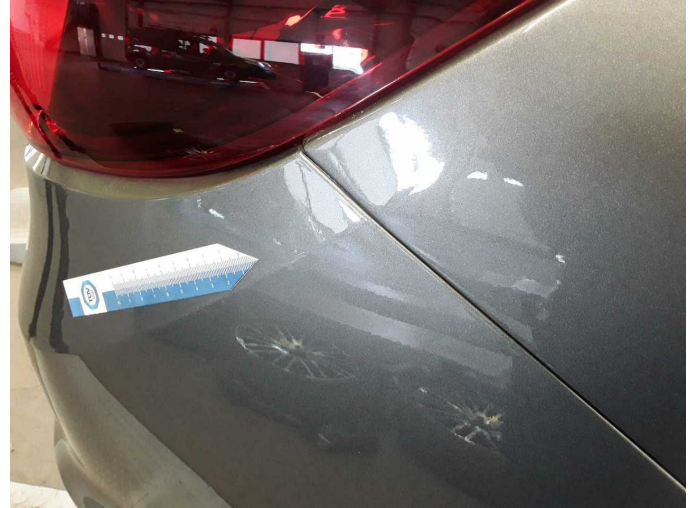
Side panel - rear right side	464 µm	Door - rear right side	243 µm
Door - front left side	157 µm	Door - front right side	171 µm

Damage 1: Side panel - rear right side: Side panel (Schleifspuren) - Unprofessionally repaired - Smart repair

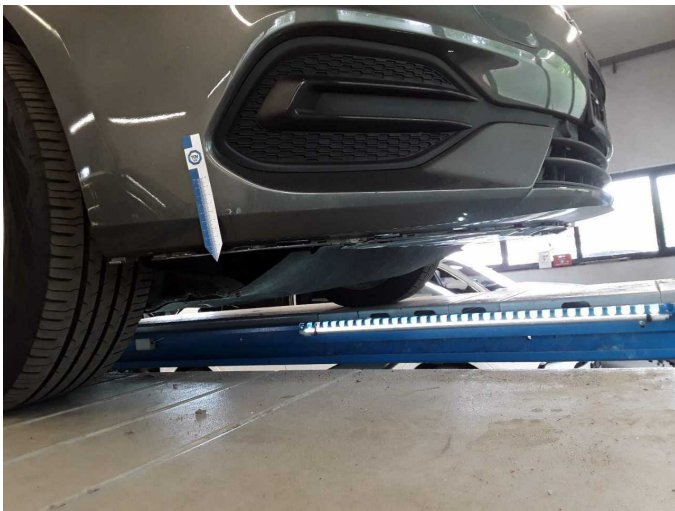
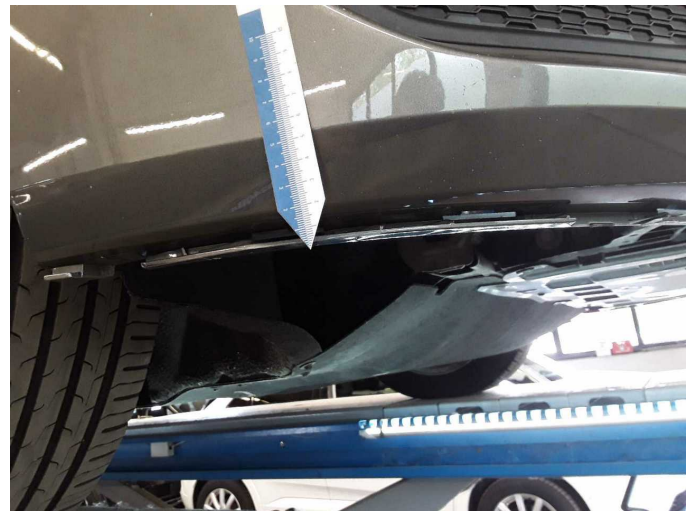
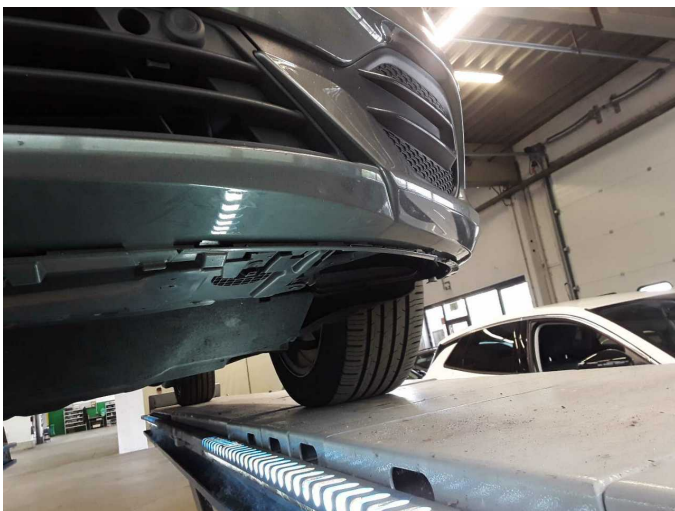
Damage 2: Front bumper: Spoiler - Missing - Replace

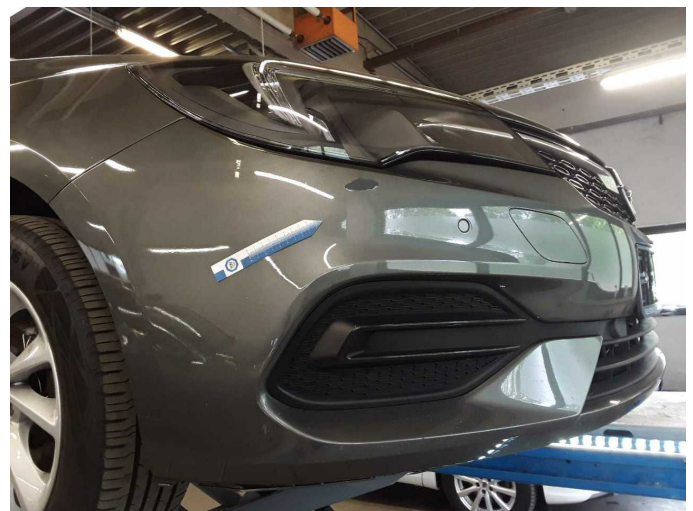
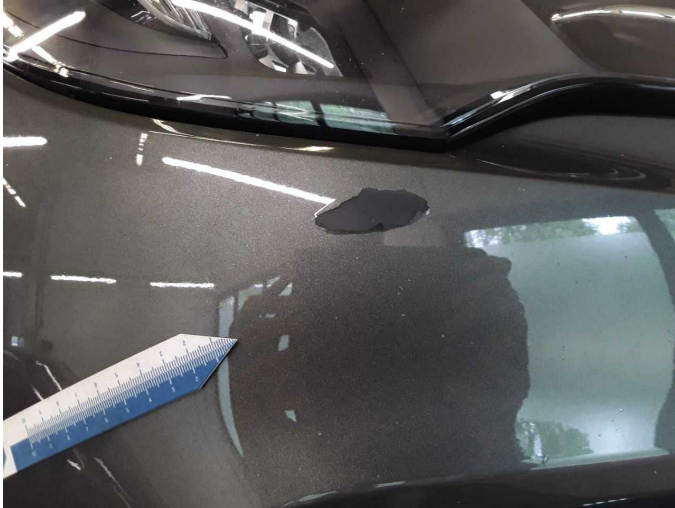
Damage 4: Front bumper: Front bumper - Paint defect - Paint

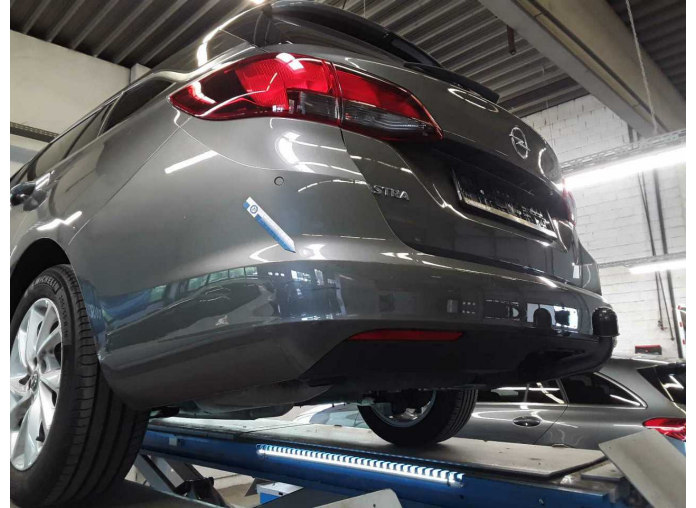
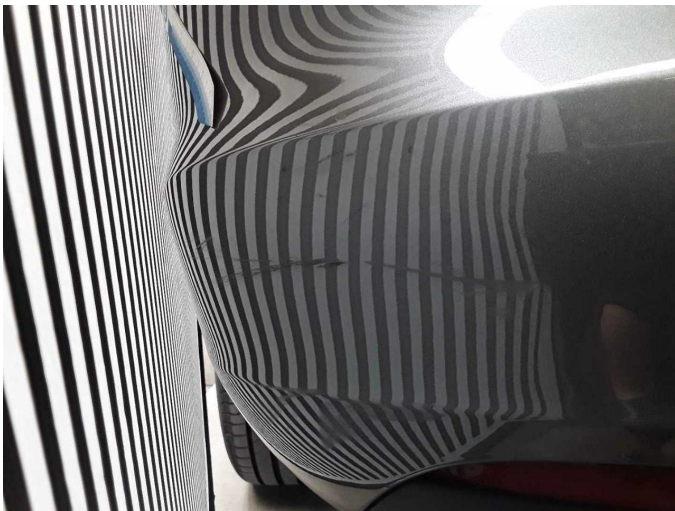
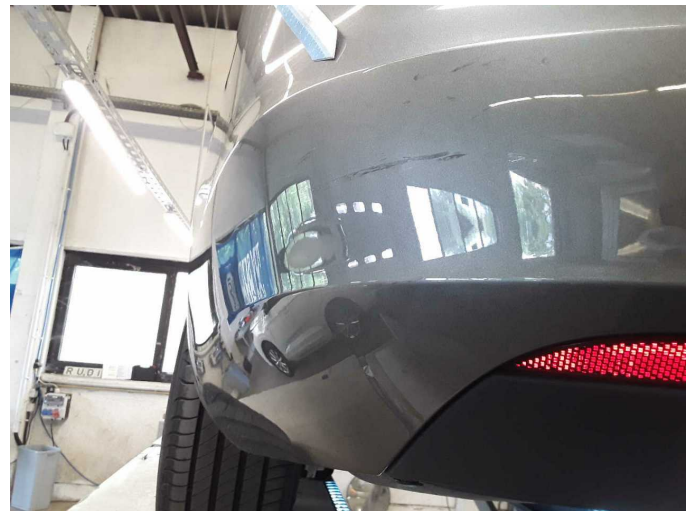
Damage 5: Rear bumper: Rear bumper - Scratch(es) - Paint

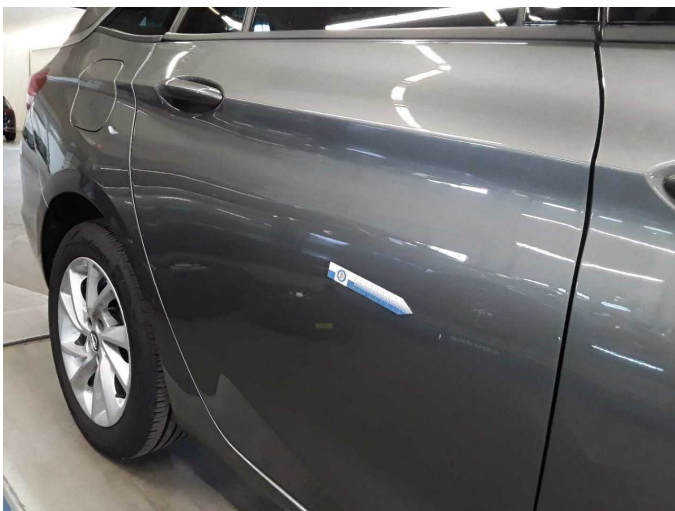
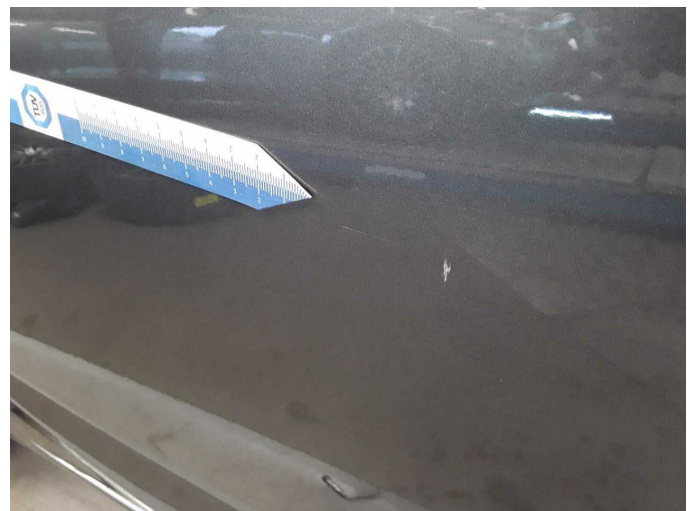
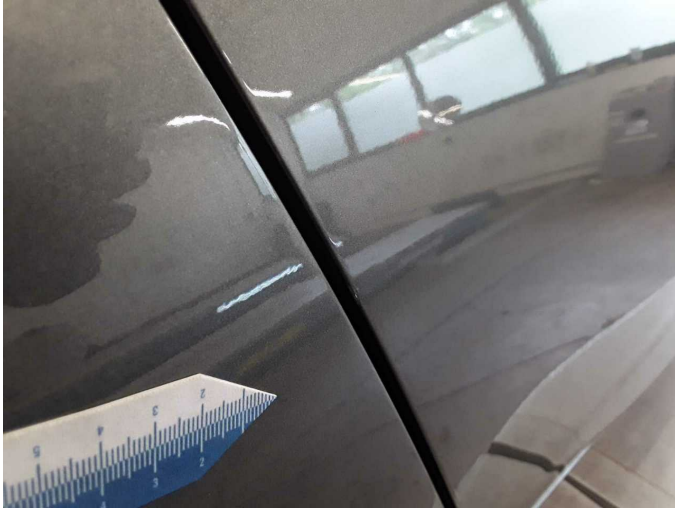
Damage 6: Door - rear right side: Door - Scratch(es) - Paint

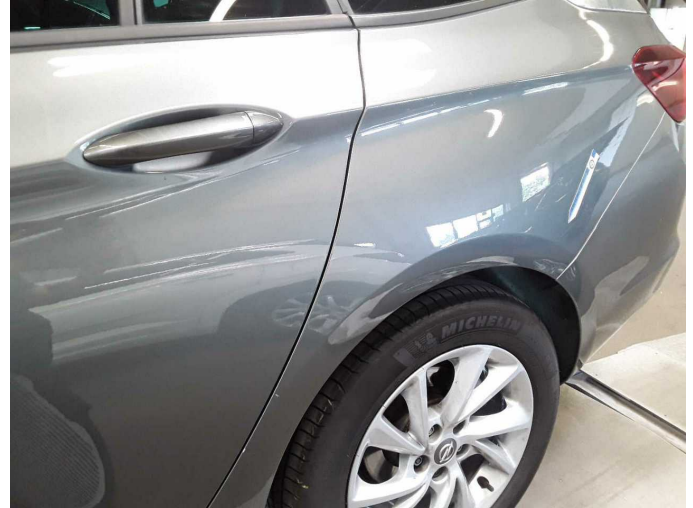
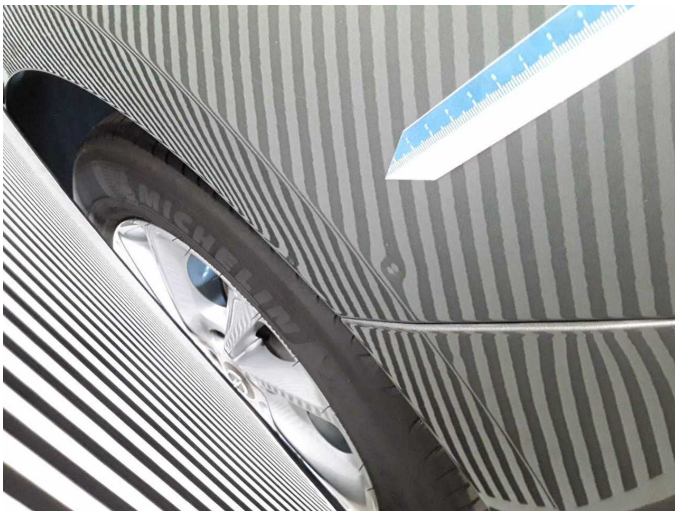
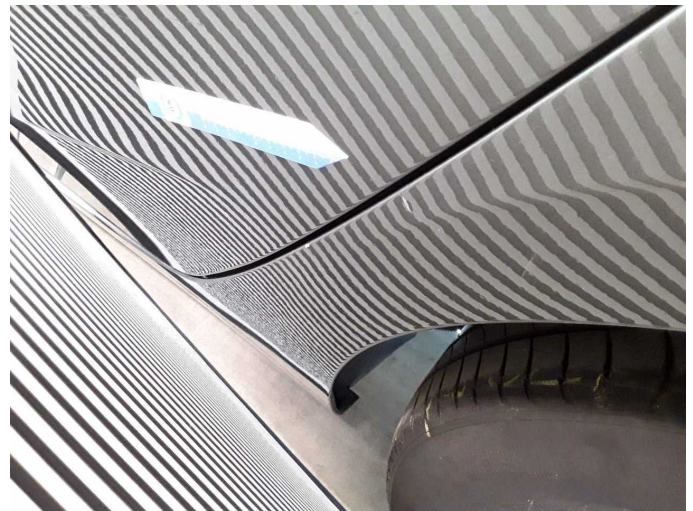
Damage 7: Side panel - rear left side: Side panel - Dent / paintcoat damage - Repair and paint

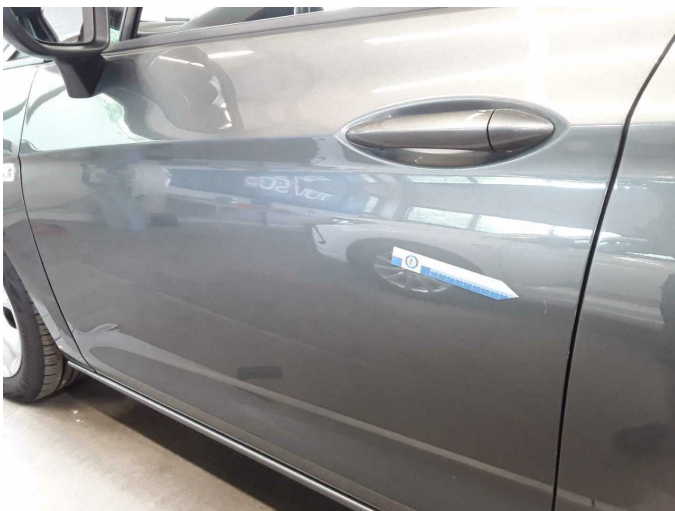
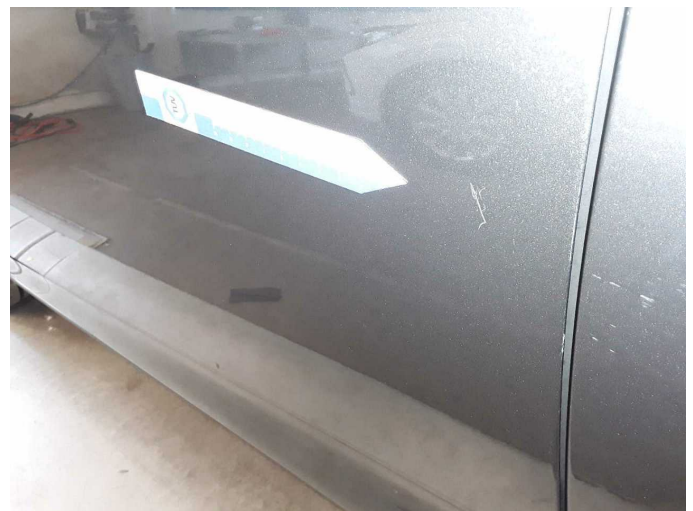
Damage 8: Door - front left side: Door - Scratch(es) - Paint

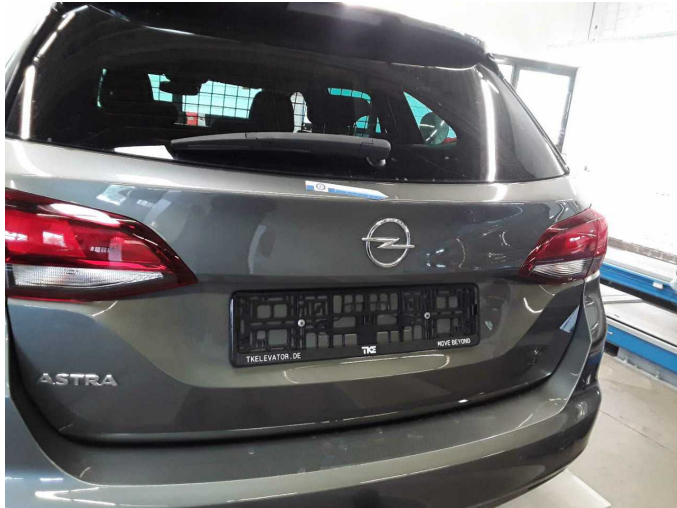
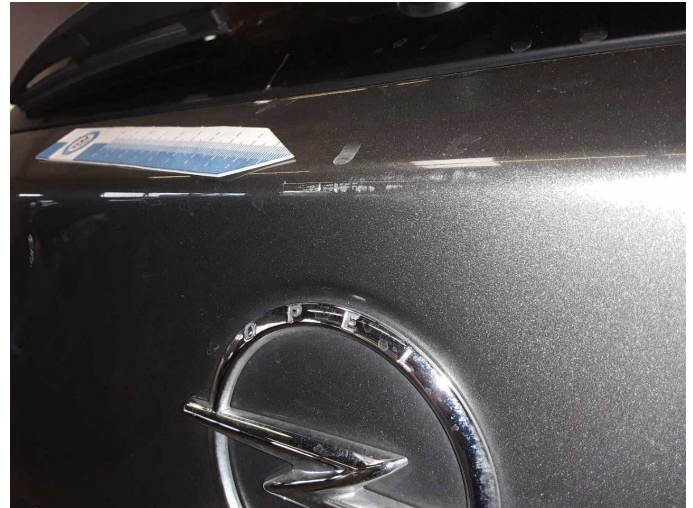
Damage 9: Boot lid / rear door: Boot lid - Scratch(es) - Paint

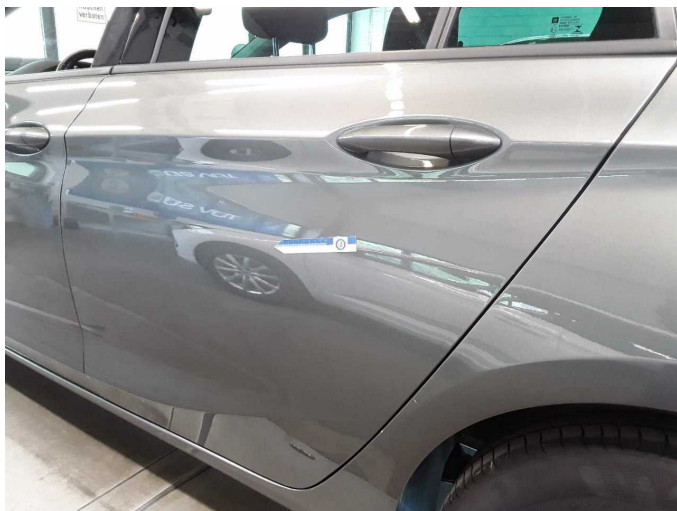
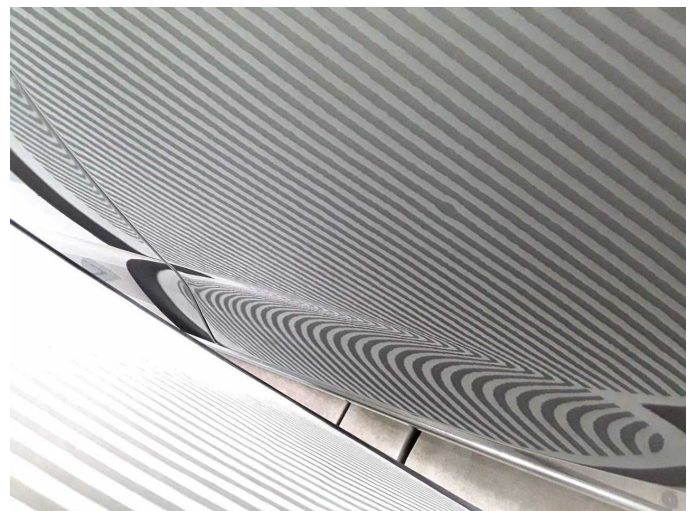
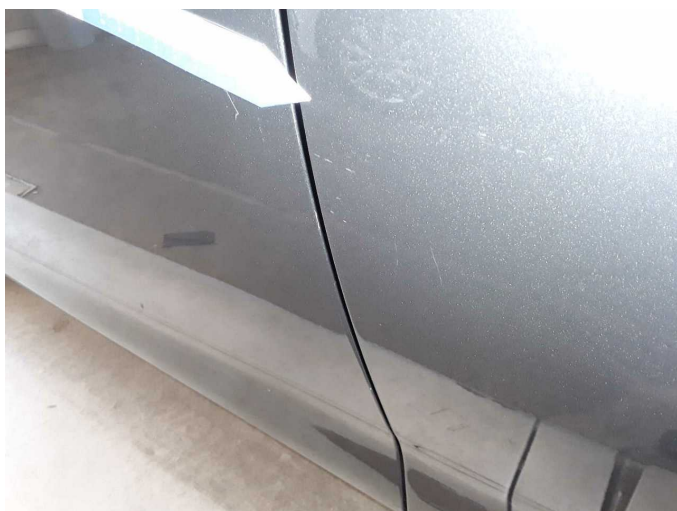
Damage 10: Door - rear left side: Door - Dent / paintcoat damage - Repair and paint

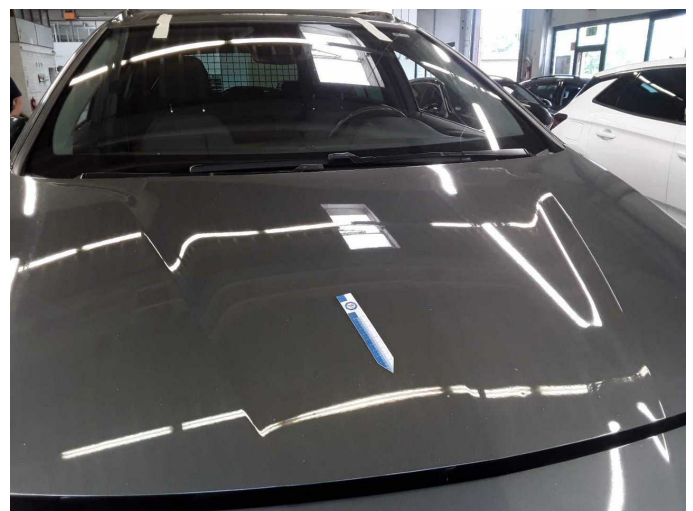
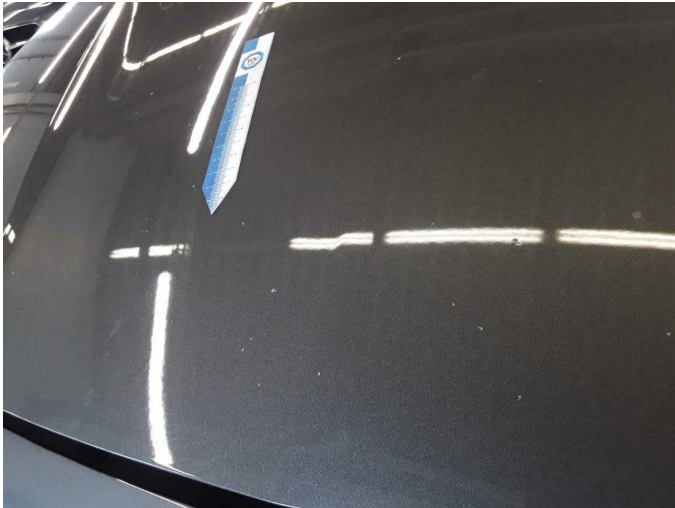
Wear and tear 1: Bonnet: Bonnet - Stone chips - No deduction

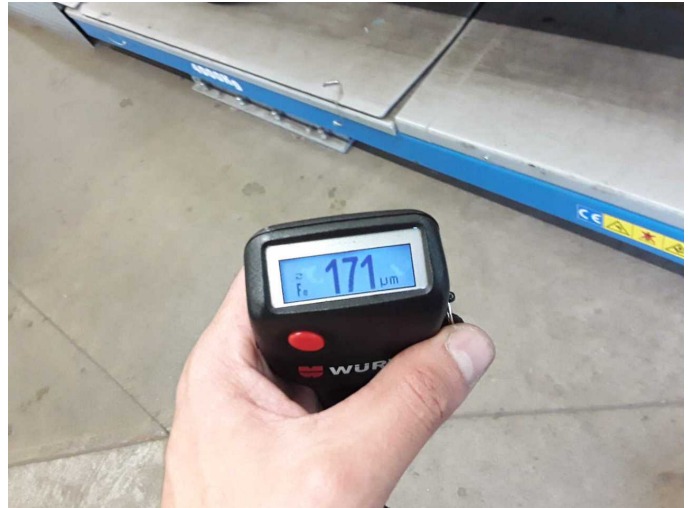
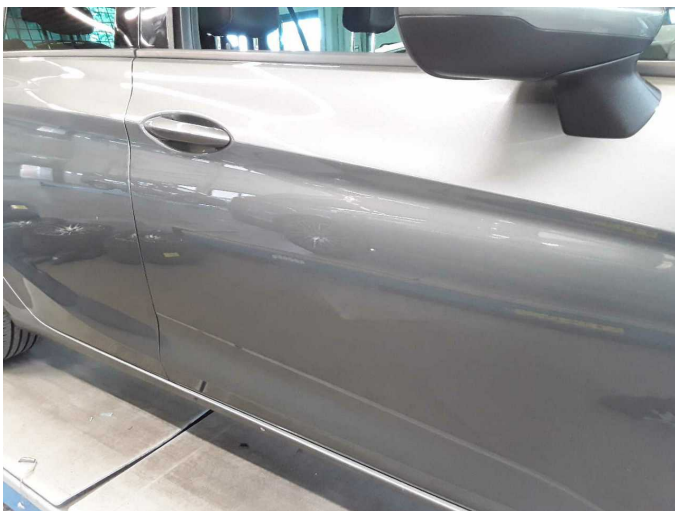
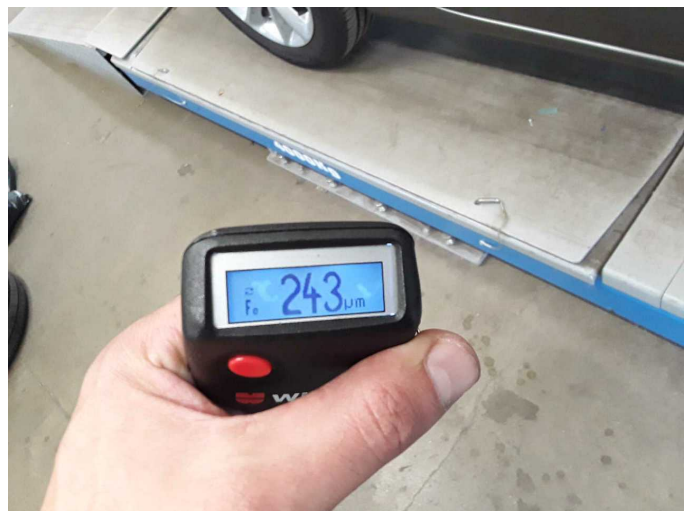
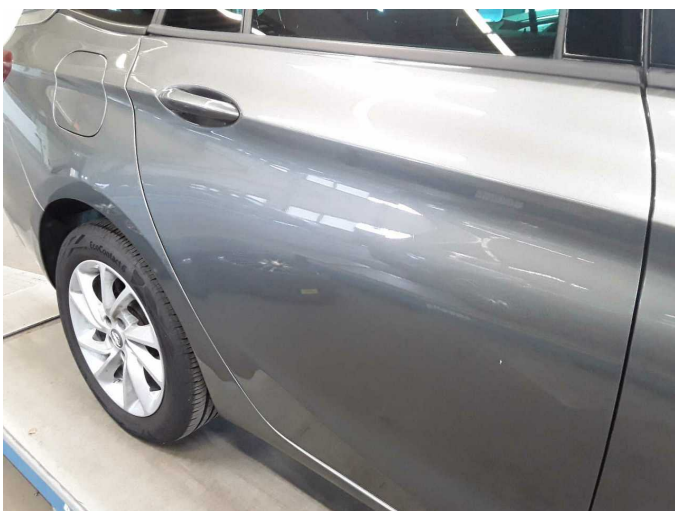
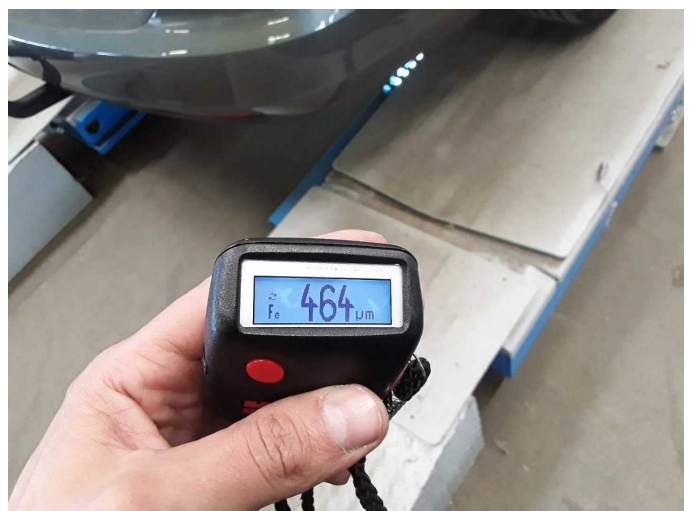
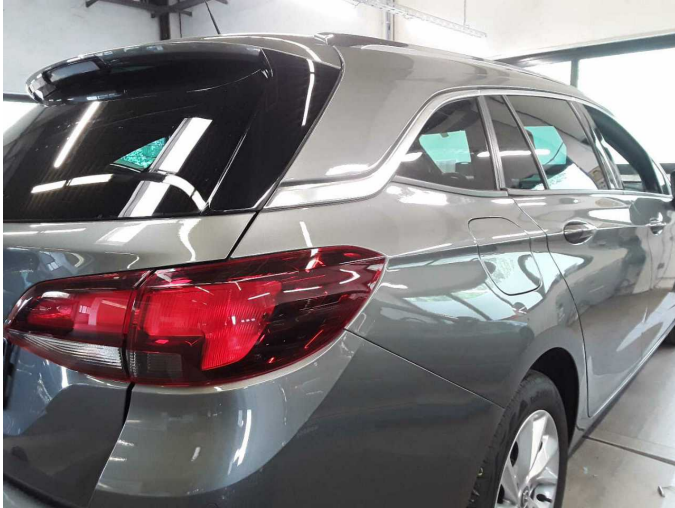
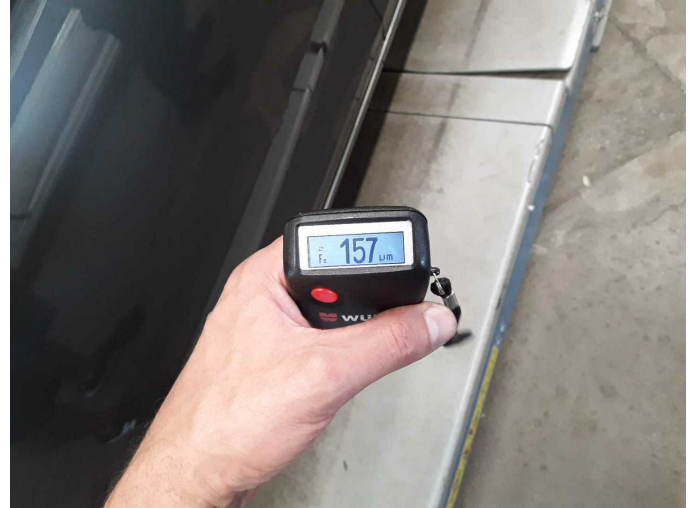
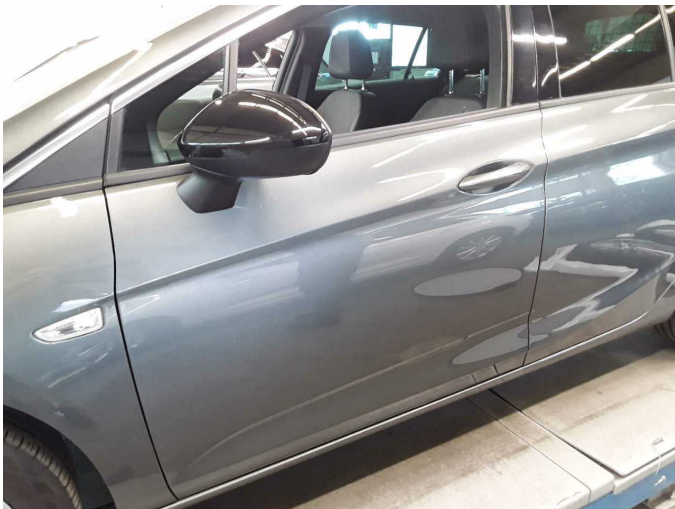
Repainting 1: Door - rear right side, Door - front left side, Door - front right side
