## Expertise

Protocol number: 45990412  
Order No. / Reference: 26451713  
Inspection date: 15 Jun 2026

Model: Vivaro 2.0 D Cargo L EHZ Autm. Elegance

VIN: VXEVFEHZ7N7039844

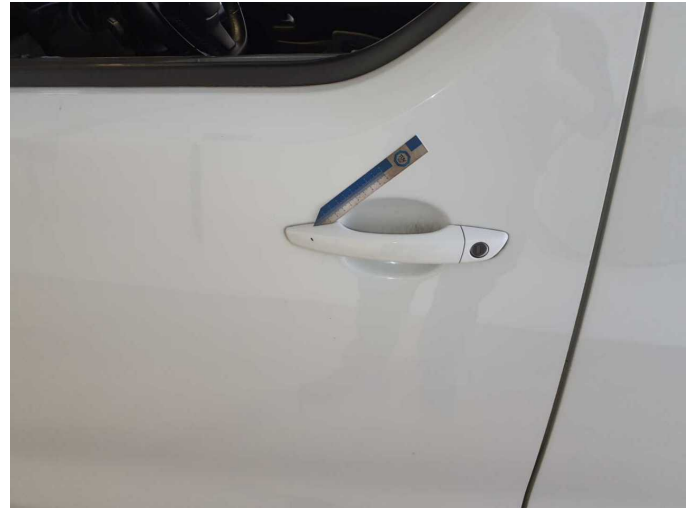
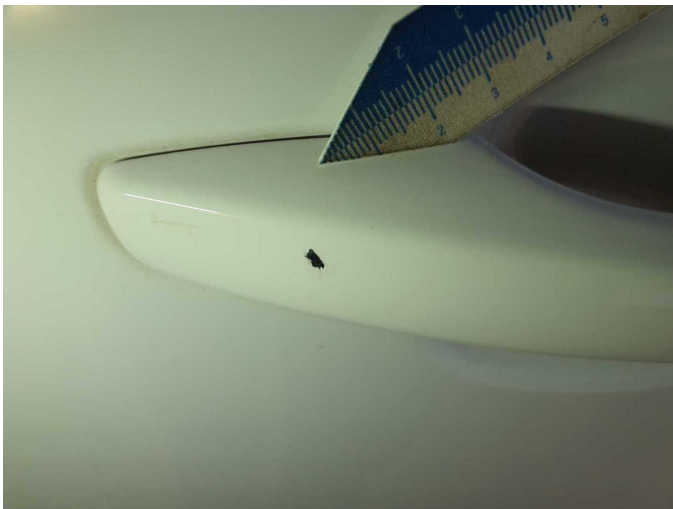
Damage 1: Door - front left side: Door handle - outside - Scratch(es) - Smart repair

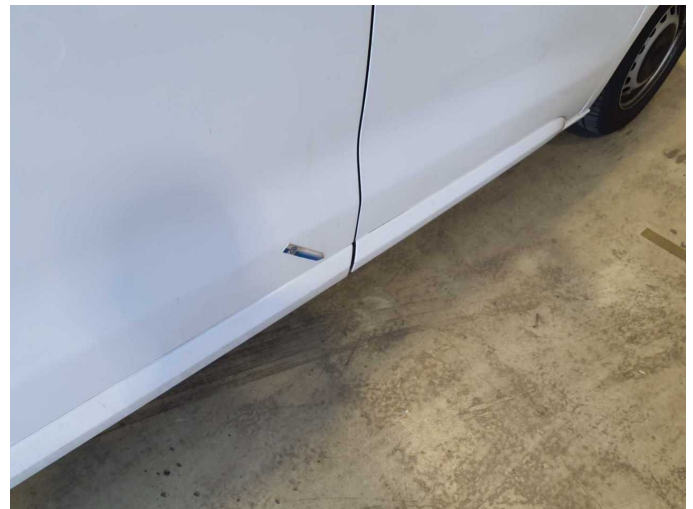
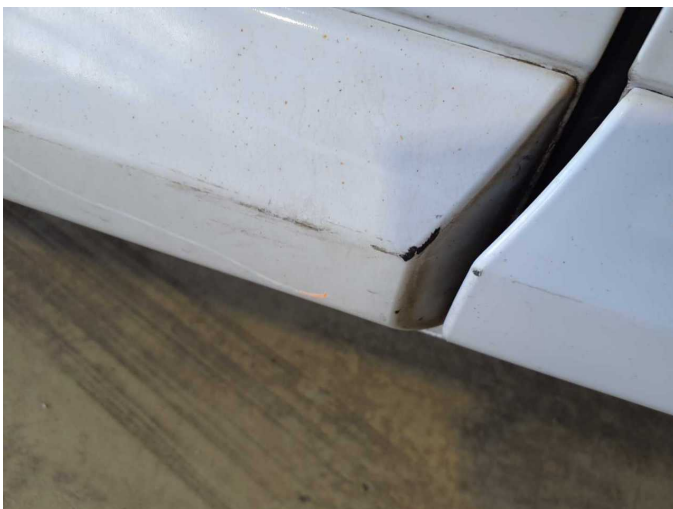
Damage 2: Door - rear right side: Brightware - lower - Scratch(es) - Smart repair

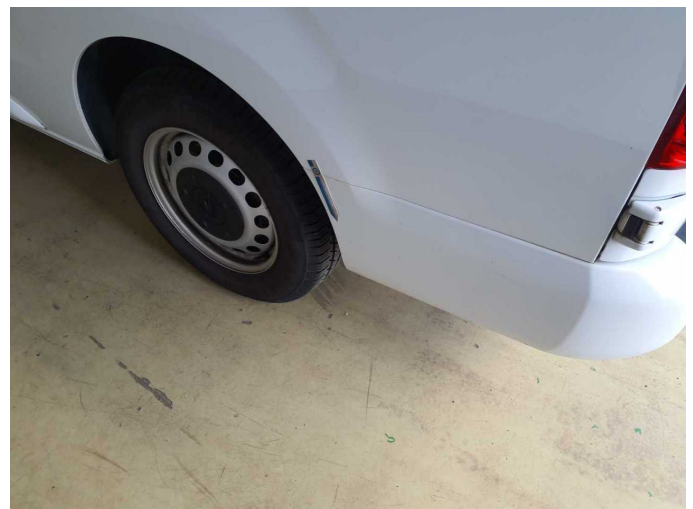
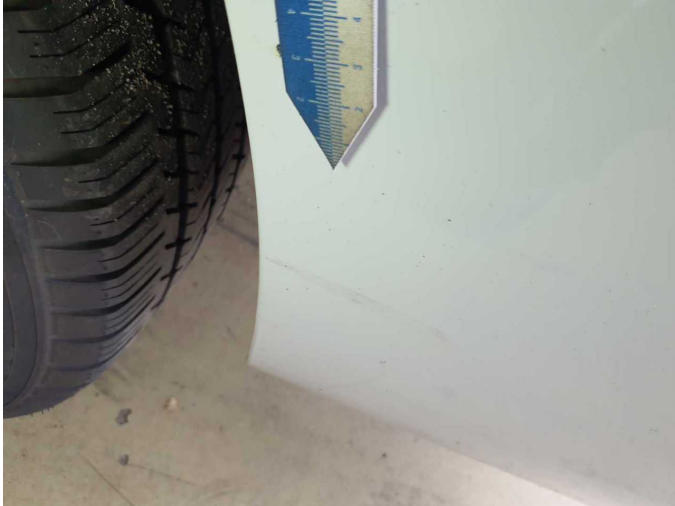
Damage 3: Rear bumper: Rear bumper - Scratch(es) - Smart repair

**Damage 3:** Rear bumper: Rear bumper - Scratch(es) - Smart repair

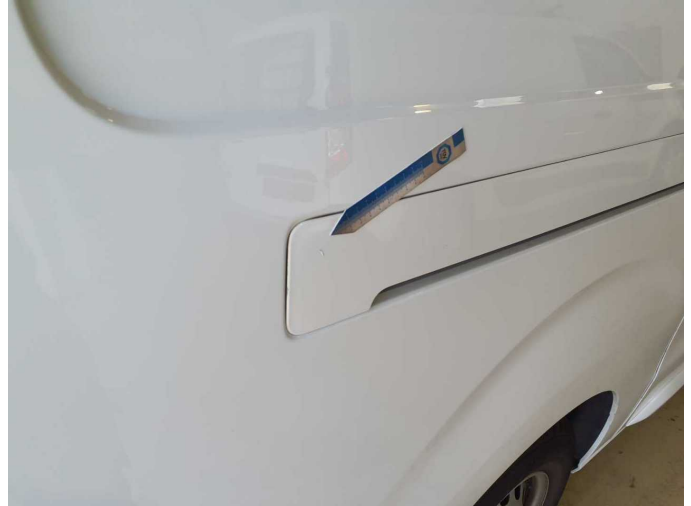
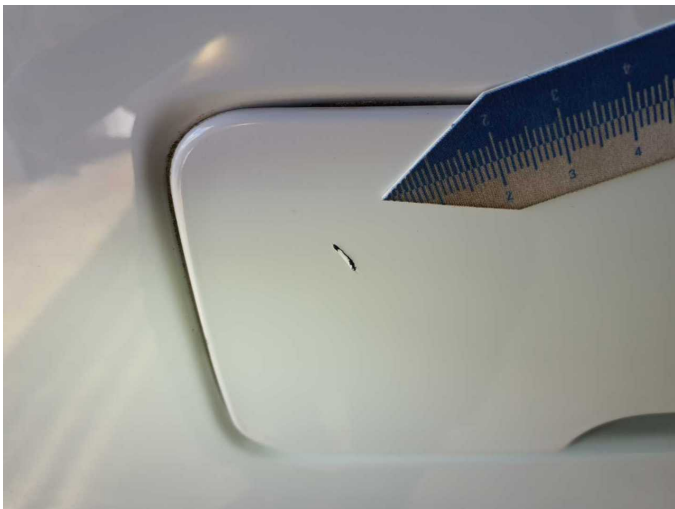
**Damage 4:** Trim / covers: Trim / covers - Scratch(es) - Smart repair

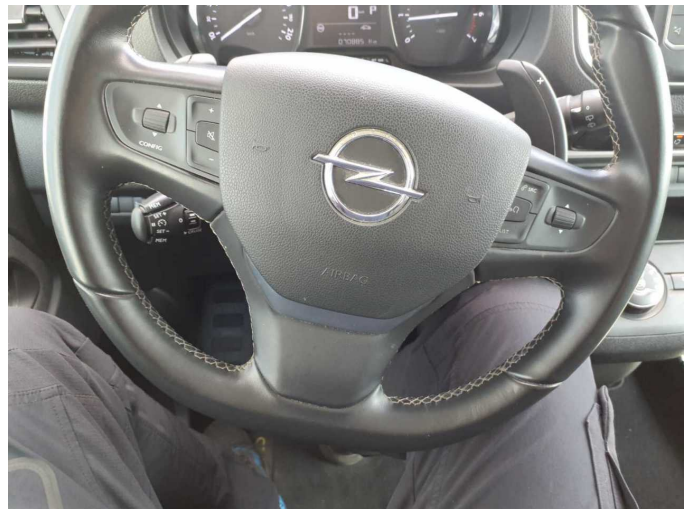
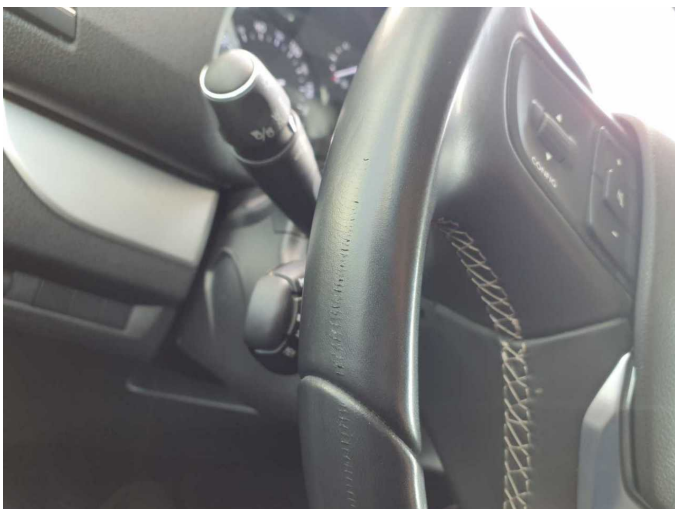
**Damage 5:** Steering system: Steering wheel - Scratch(es) - Smart repair

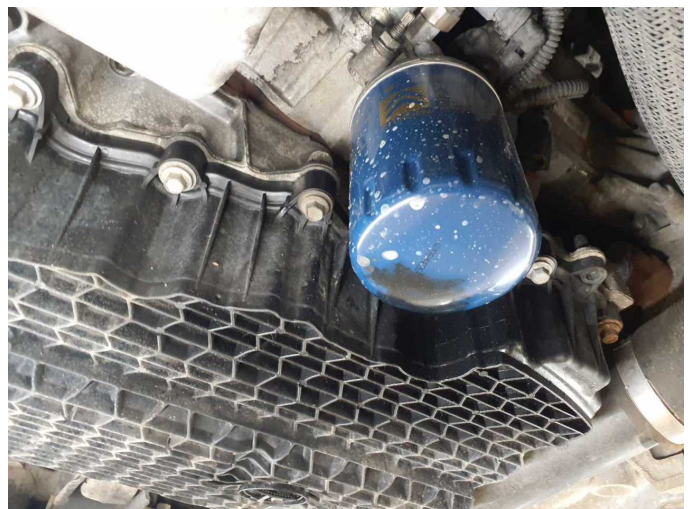
**Damage 6:** Engine: Engine - Leaking - Perform diagnosis

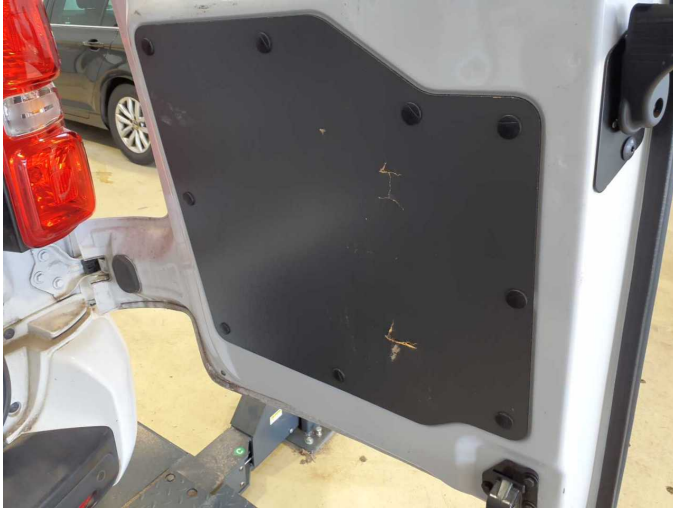
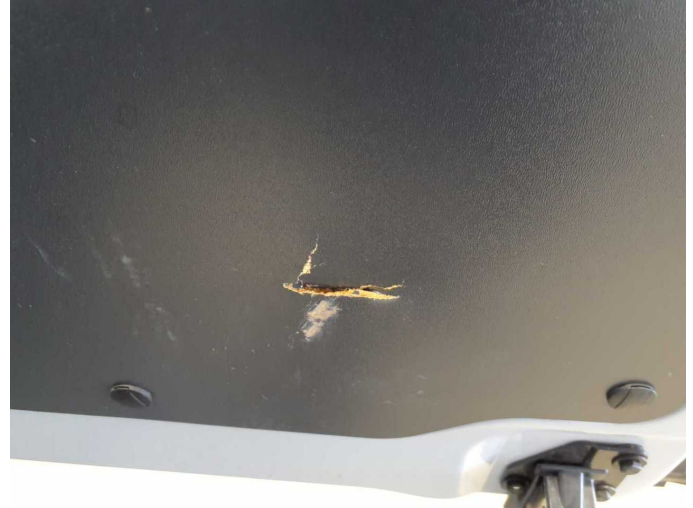
**Damage 7:** Boot lid / rear door: Trim rear door - plywood - lower - Broken / torn - Replace

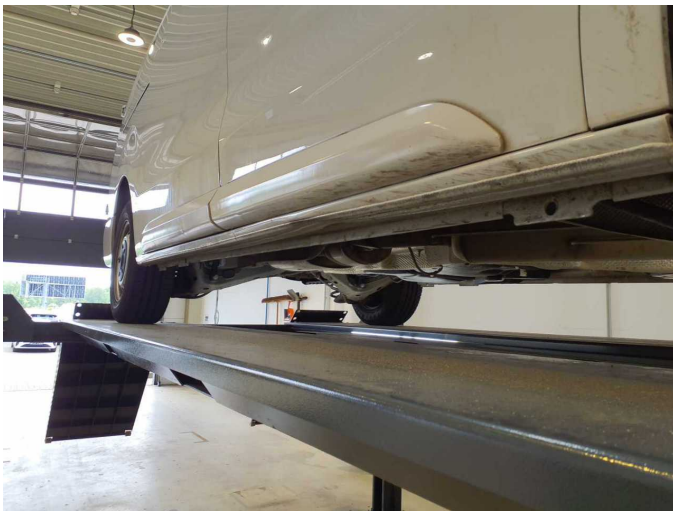
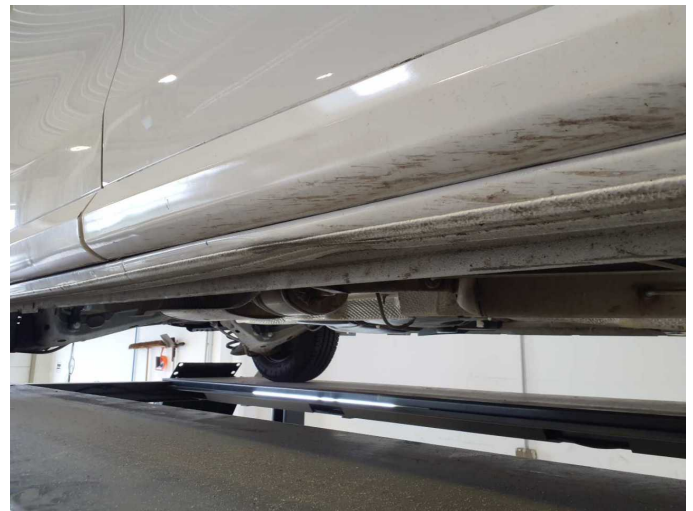
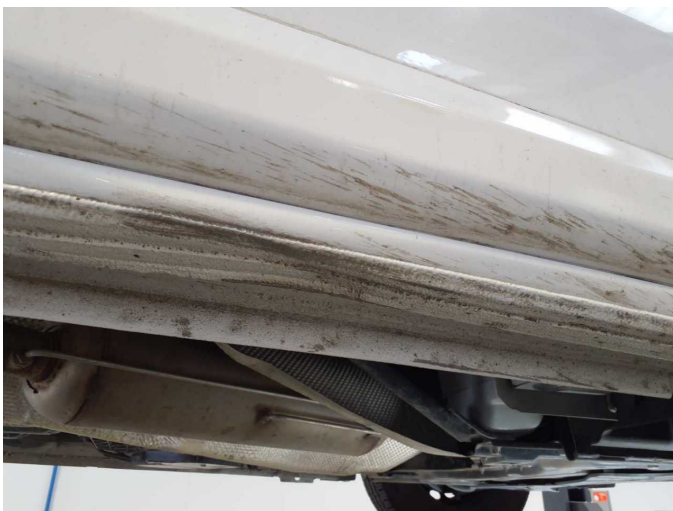
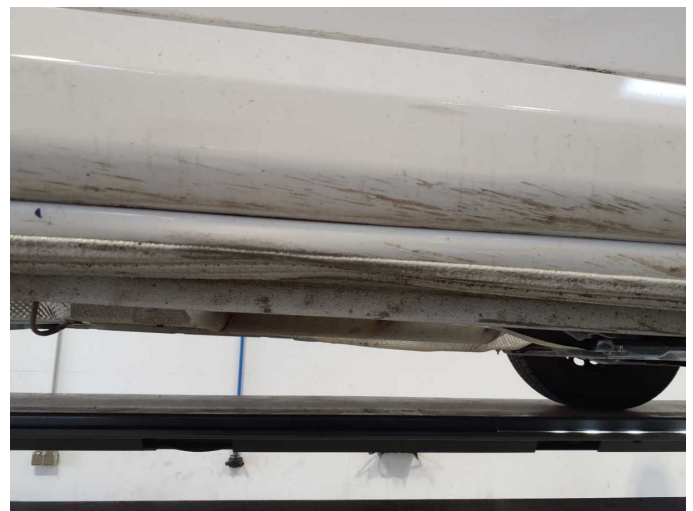
**Damage 8:** Sill - right side: Sill - Deformed - Repair and paint

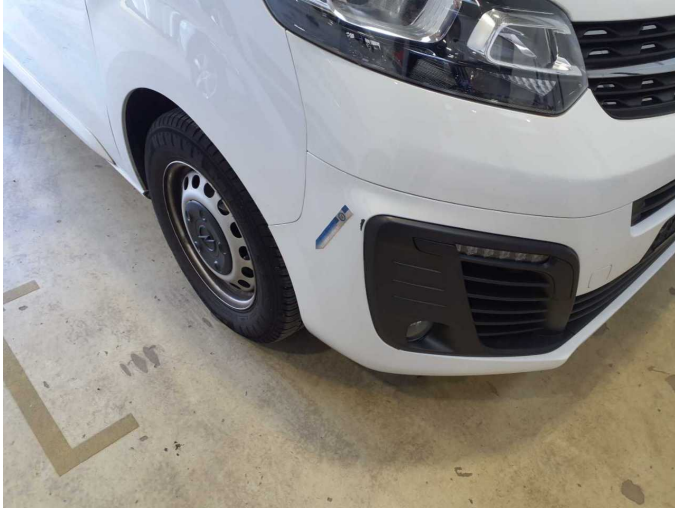
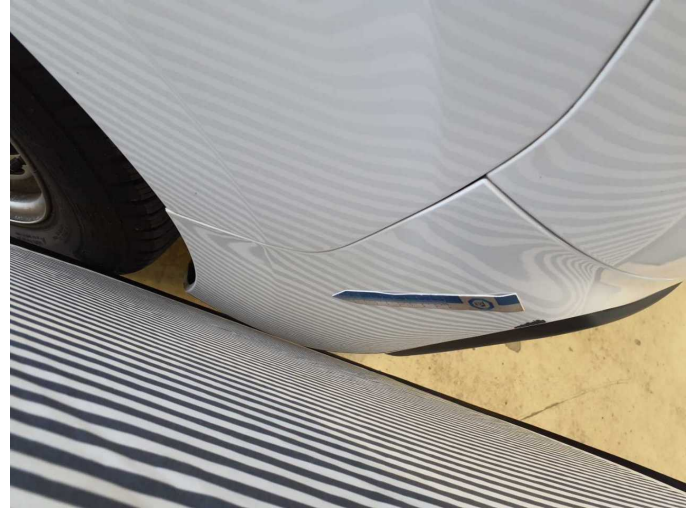
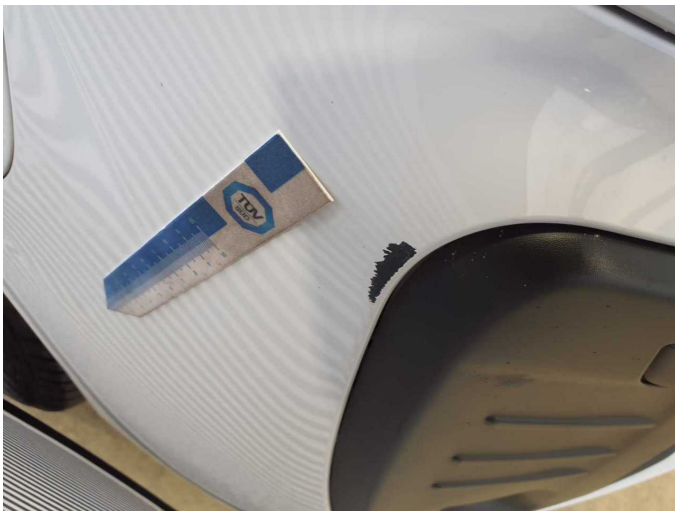
**Damage 9:** Front bumper: Front bumper - Dent / paintcoat damage - Paint

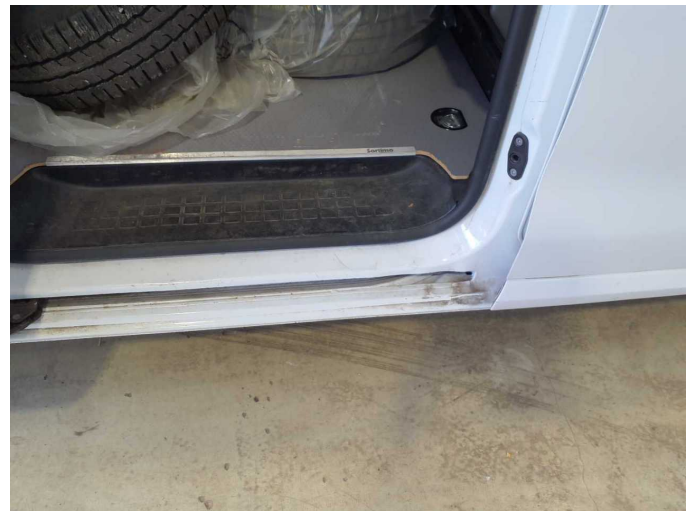
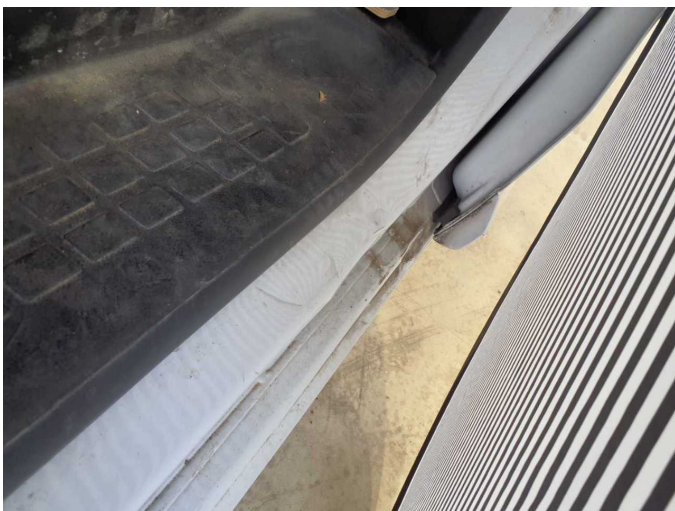
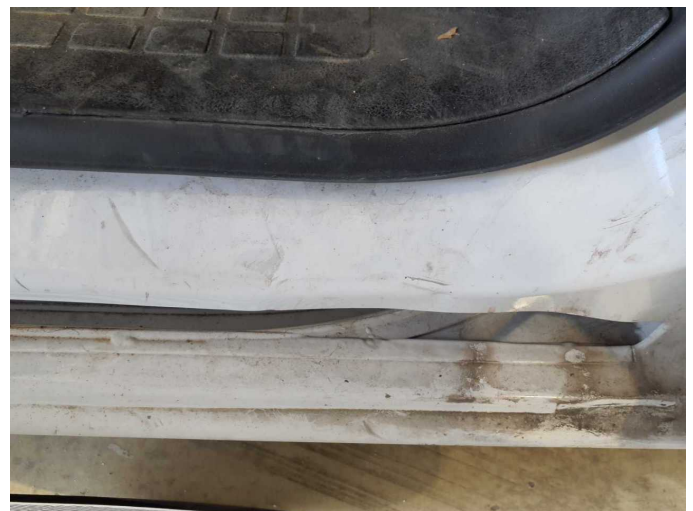
**Damage 10:** Side panel - rear right side: Sill - Dent / paintcoat damage - Repair and paint

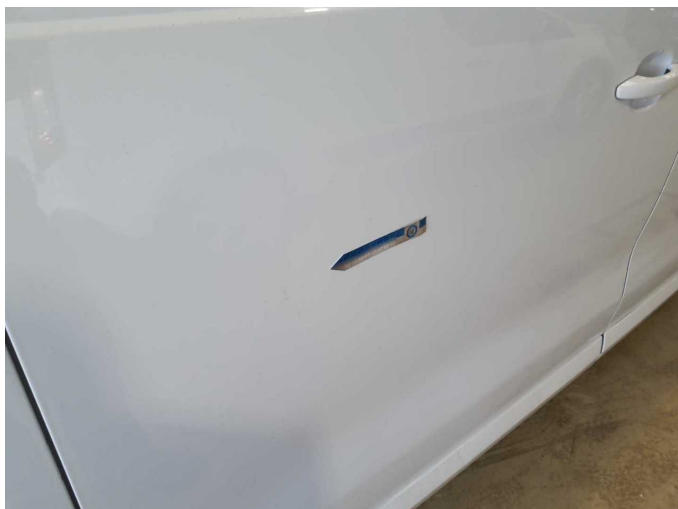
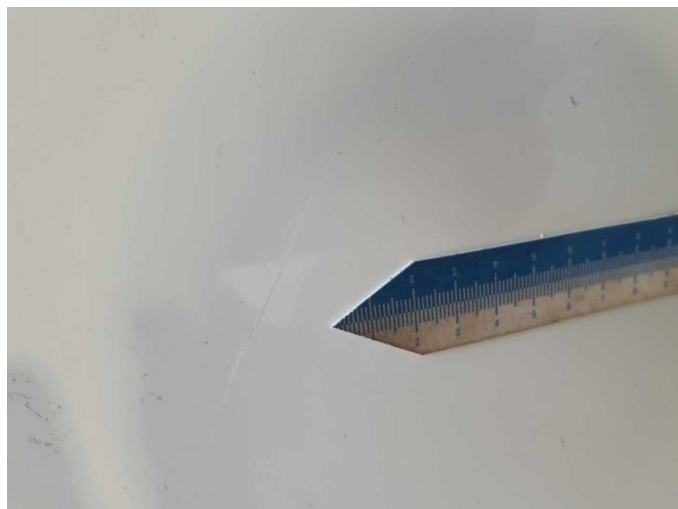
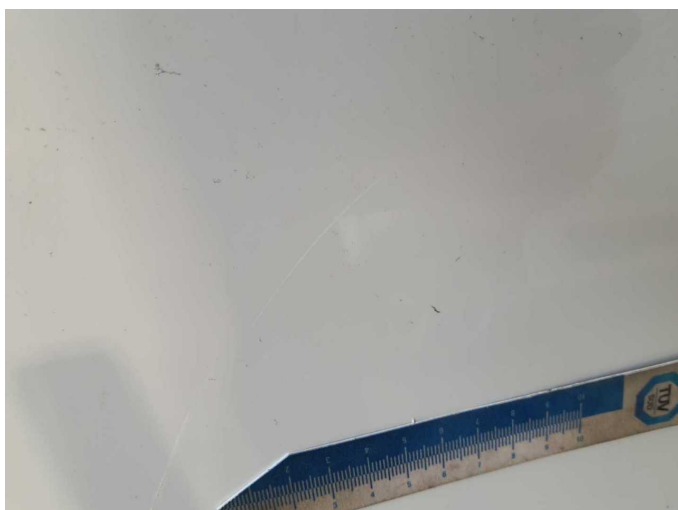
**Damage 11:** Sliding door, right: Sliding door - Scratch(es) - Paint
