Expertise

Protocol number: 46343883
Order No. / Reference: 26664144
Inspection date: 2 Jul 2026

Model: Caddy Cargo 2.0 TDI BMT Maxi

VIN: WV1ZZZSK7PX078508

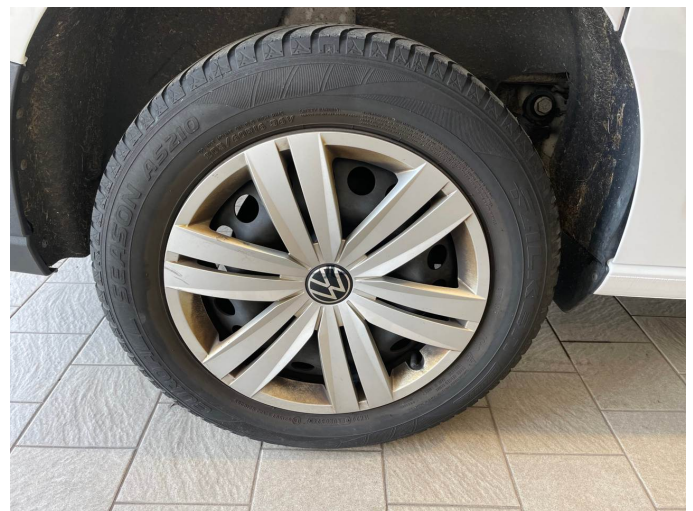
Figure 12: Mounted tyres

#	Tyre size	Type of tyre	Manufacturer	Tread depth
1)	205/60 R16 96V	All-season tyres on Steel rim with wheel cover	Falken	3mm / 3mm
2)	205/60 R16 96V	All-season tyres on Steel rim with wheel cover	Falken	4mm / 4mm

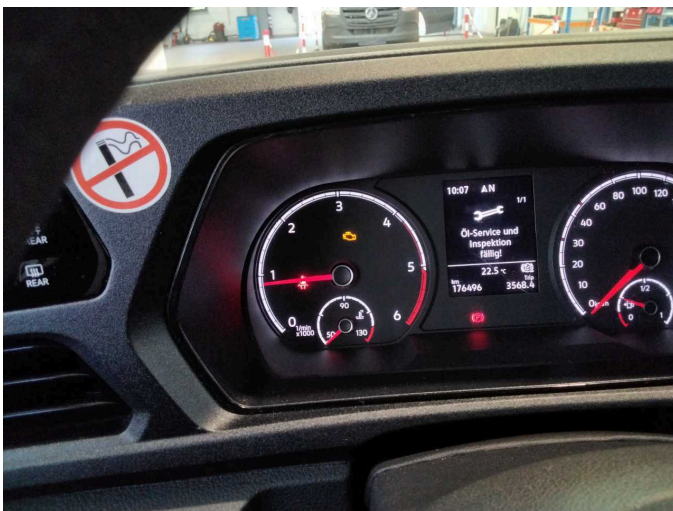
Damage 1: Engine: Engine (MKL) - on - Perform diagnosis

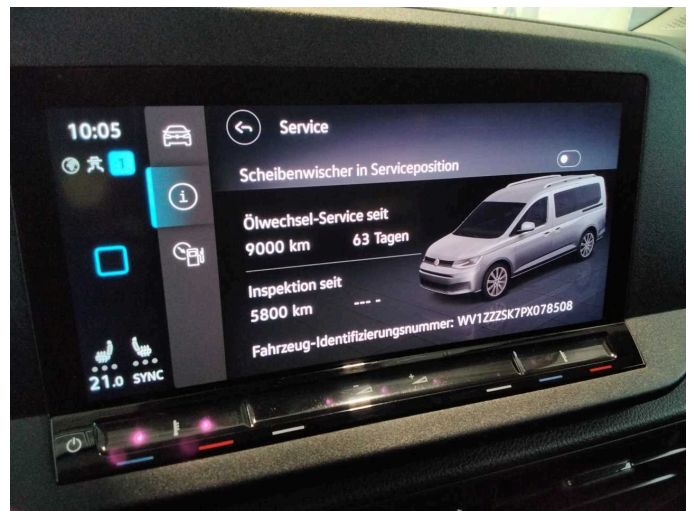
Damage 2: Misc.: Inspection / maintenance - Due - Perform

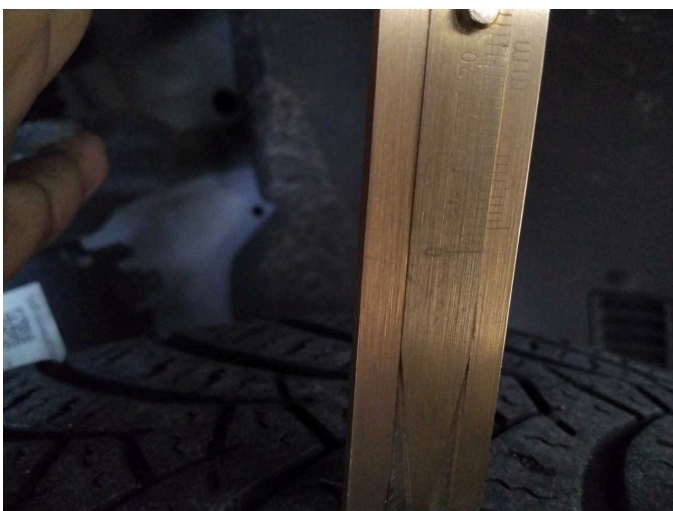
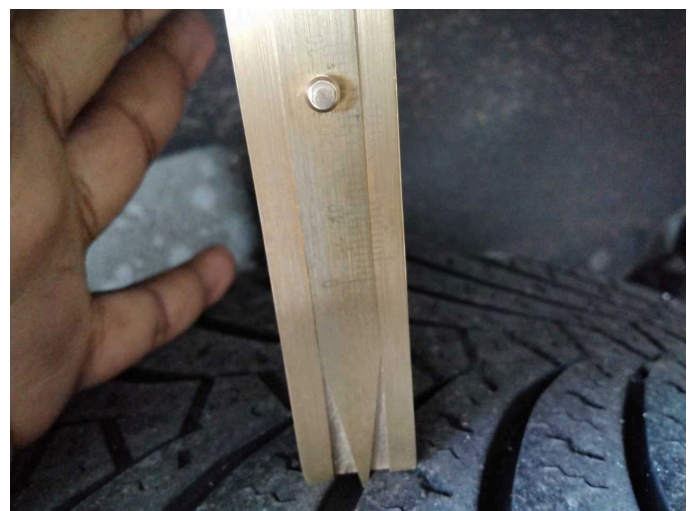
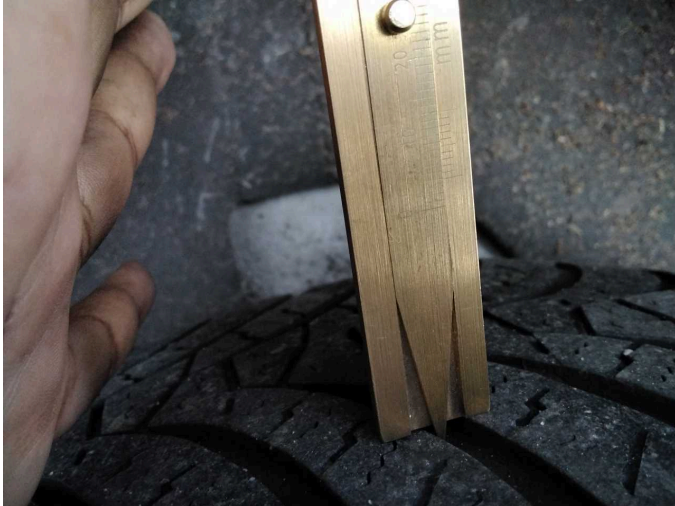
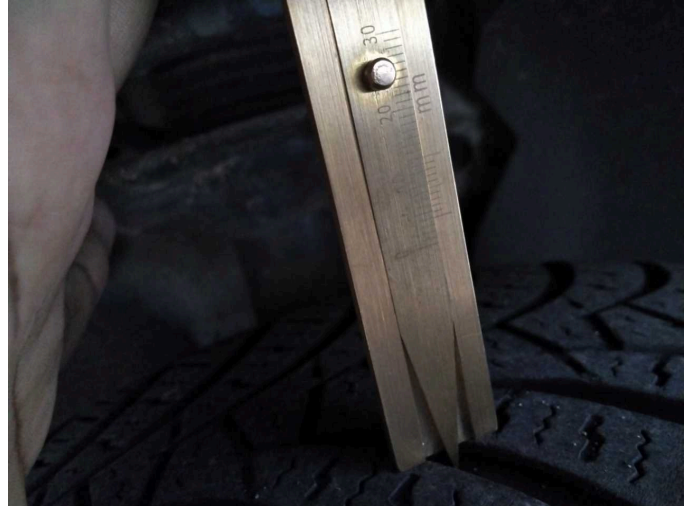
Damage 3: Wheel / tyres: Wheelset - complete (3mm) - does not meet manufacturer specifications - Replace

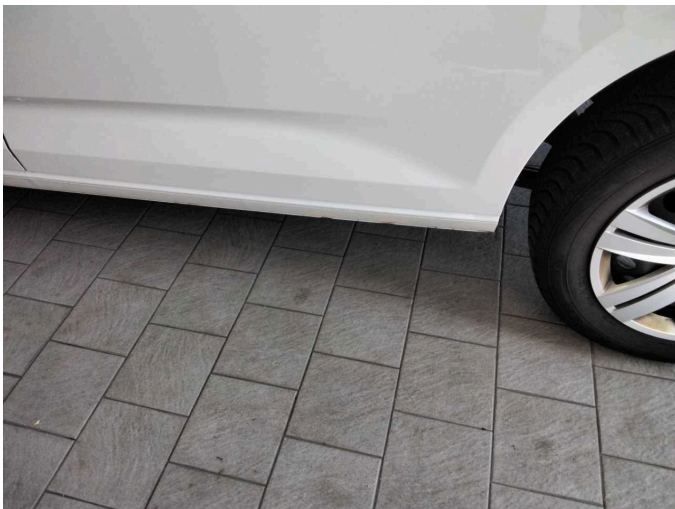
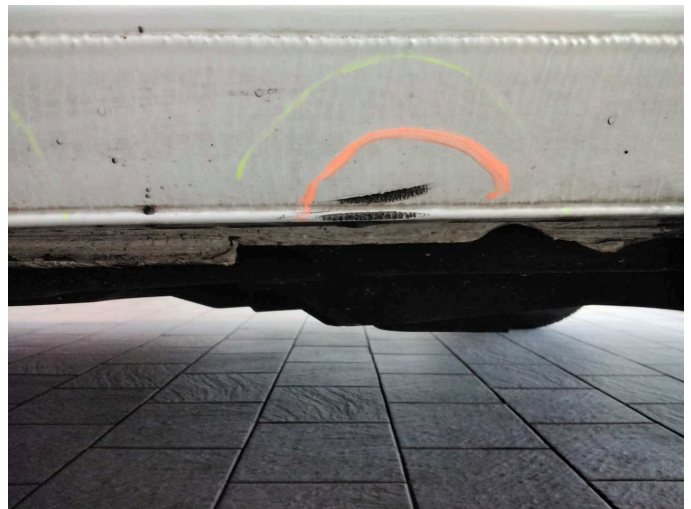
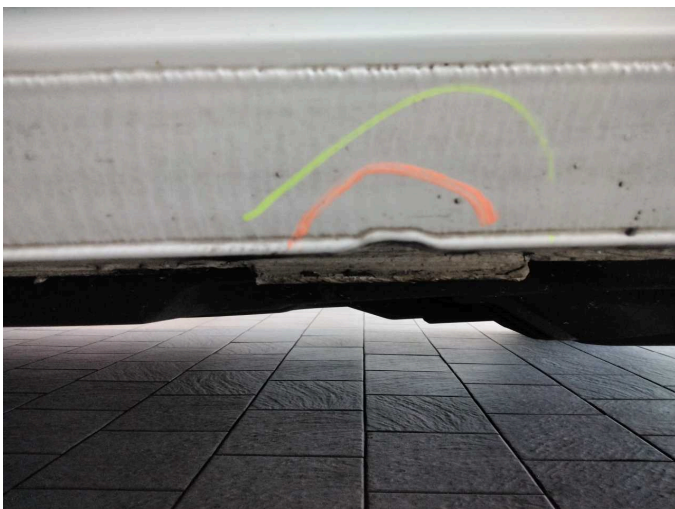
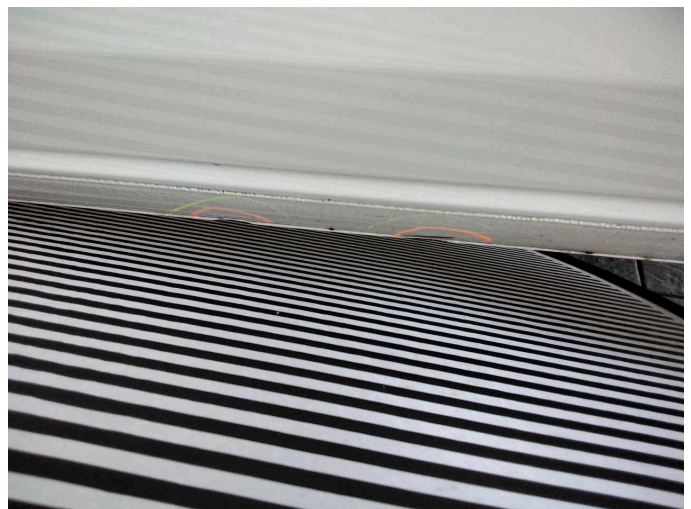
Damage 4: Sill - left side: Sill - Dent / paintcoat damage - Repair and paint

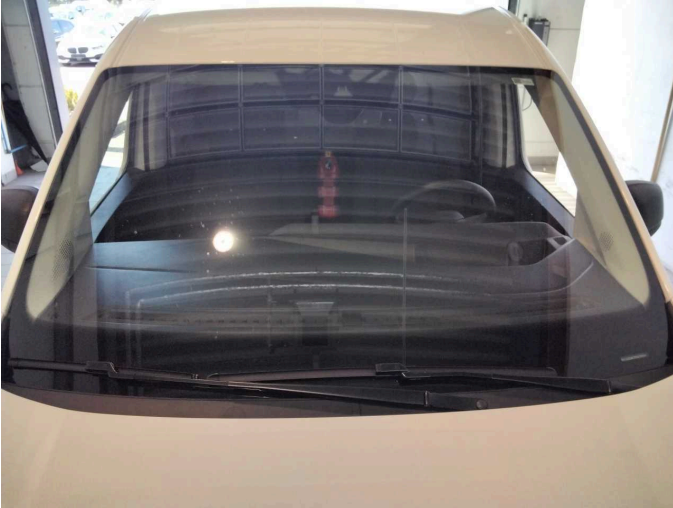
Wear and tear 1: Vehicle glazing: Windscreen - Stone chips - No deduction

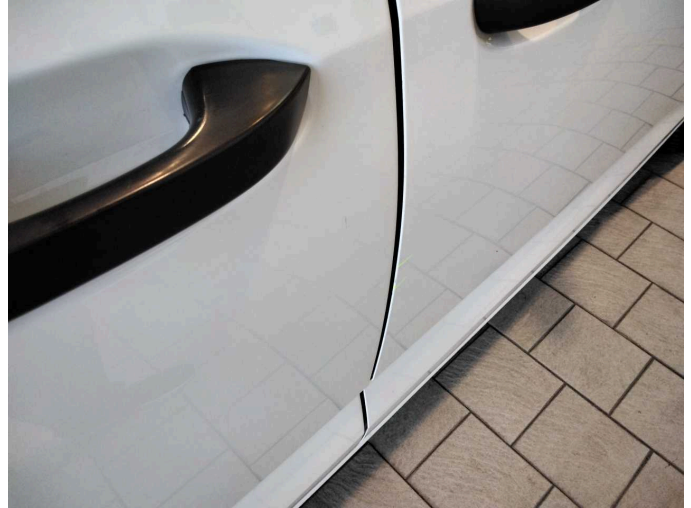
Wear and tear 5: Door - front right side: Door edge - Scratch(es) - No deduction

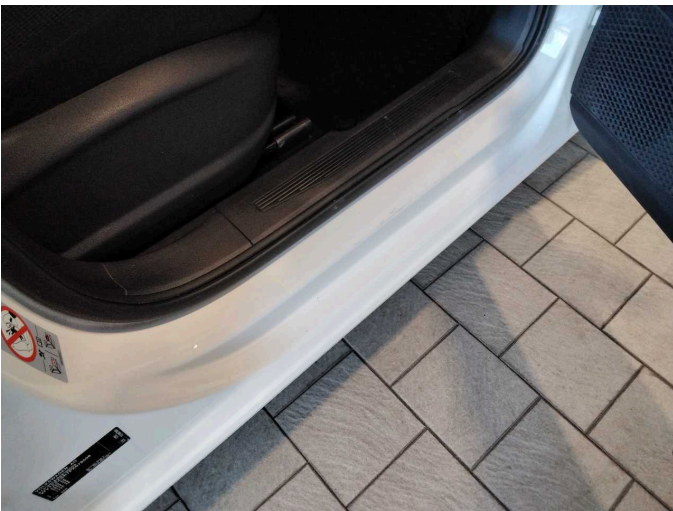
Wear and tear 6: Sill - right side: Sill - Scratch(es) - No deduction

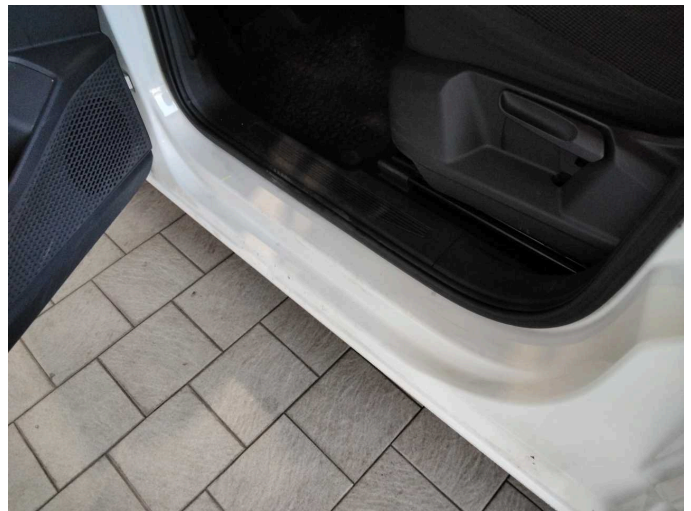
Wear and tear 7: Sill - left side: Sill - Scratch(es) - No deduction

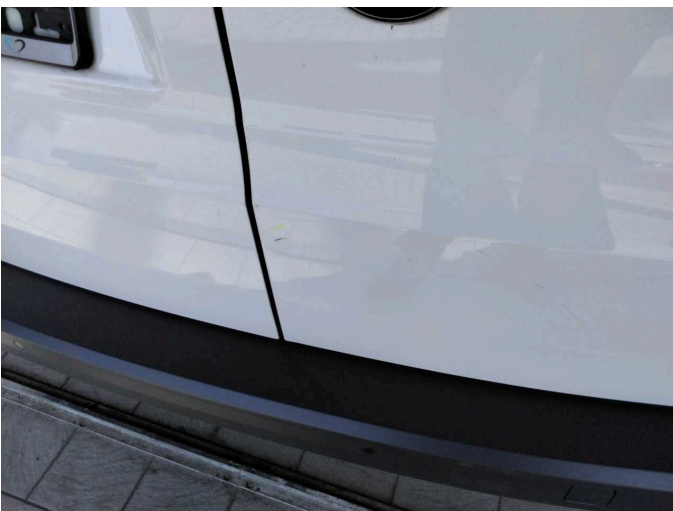
Wear and tear 8: Boot lid / rear door: Rear door - right side - Scratch(es) - No deduction

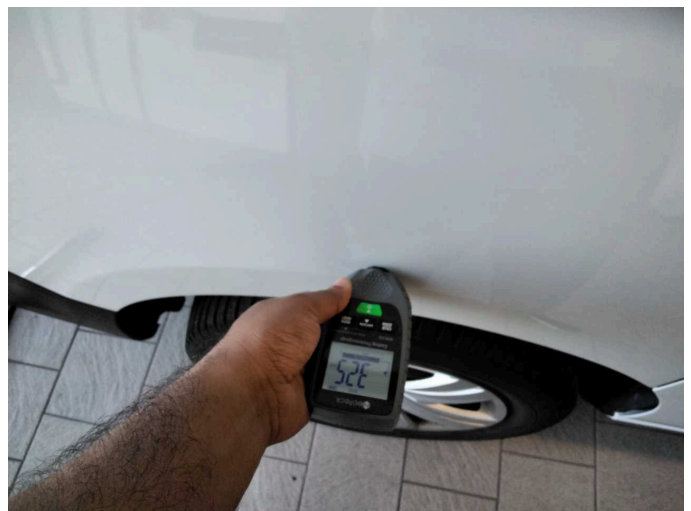
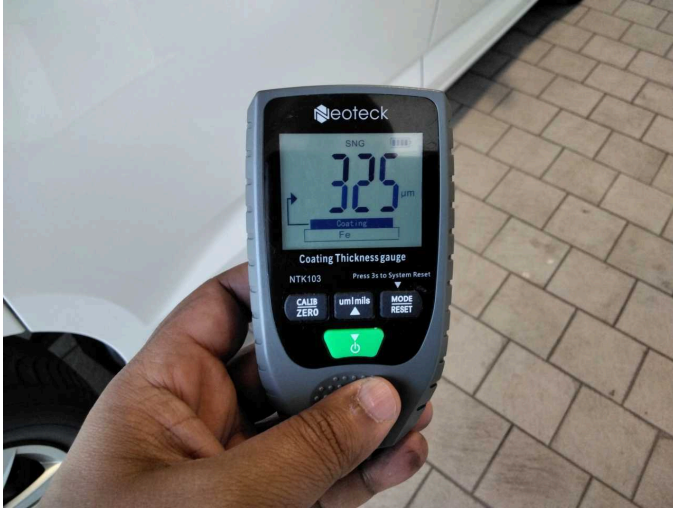
Side panel - rear right side: 325 µm

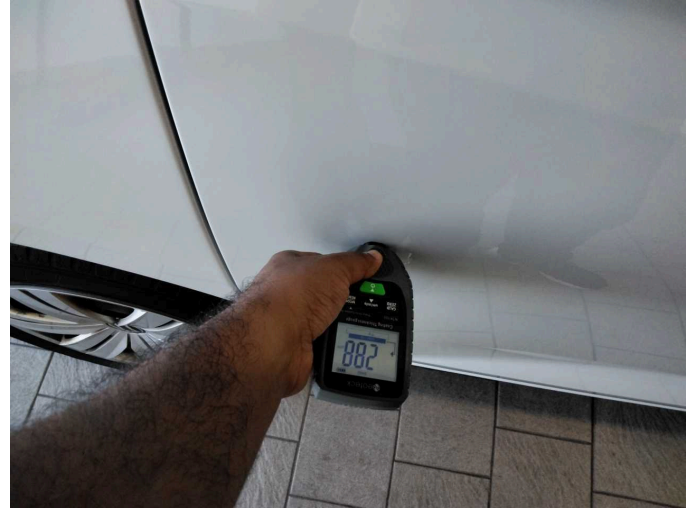
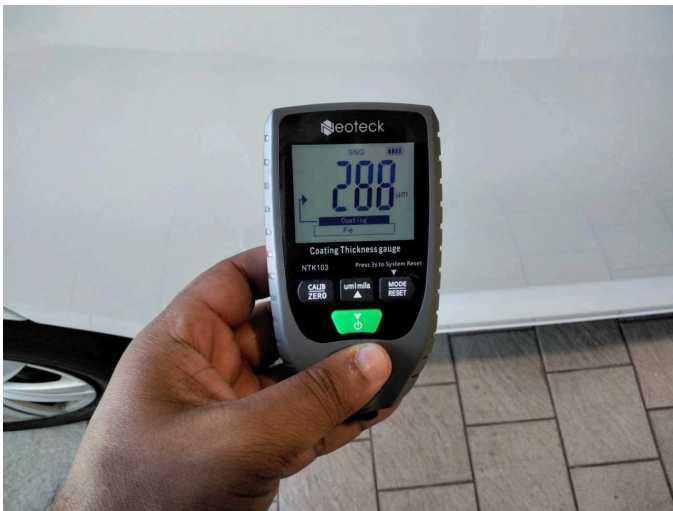
Door - rear right side: 288 µm
