Expertise

Protocol number: 43750475
Order number / reference: 25919472
Inspection date: 6 Feb 2026

Model: 317 CDI Sprinter Standard HA 9G-TRONIC PRO

VIN: W1V3KBFZ2TP864576

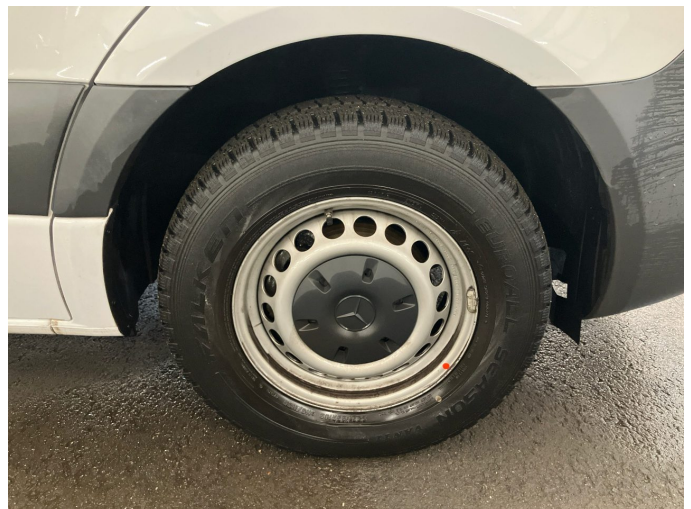
Figure 12: Mounted tyres

#	Tyre size	Type of tyre	Manufacturer	Tread depth
1)	235/65 R16 115R	All-season tyres on Steel rim with wheel cover	Falken	6mm / 6mm
2)	235/65 R16 115R	All-season tyres on Steel rim with wheel cover	Falken	6mm / 6mm

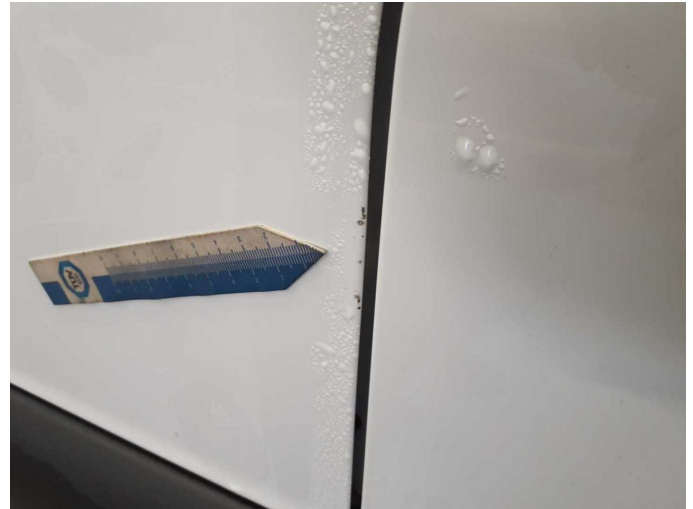
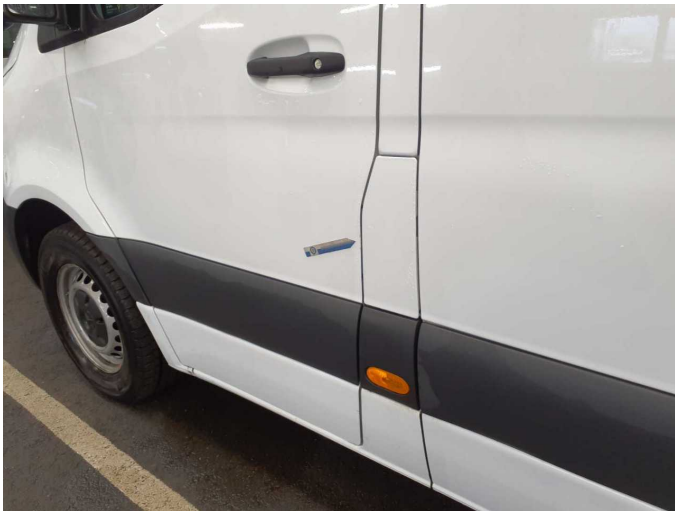
No.	Component group	Description
1	Door - front left side	Door edge - Scratch(es) - Smart repair

Damage 1: Door - front left side: Door edge - Scratch(es) - Smart repair

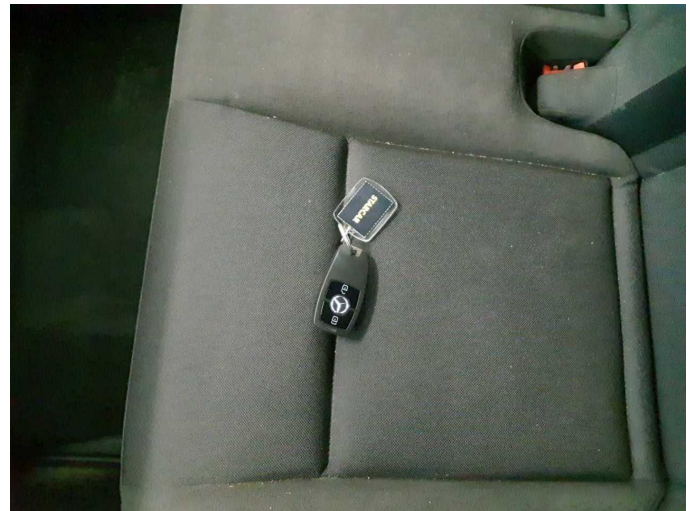
Equipment - Vehicle key

Missing part 1: Equipment: Vehicle key - Missing - Replace
