Expertise

Protocol number: 46226164
Order No. / Reference: 26562715
Inspection date: 29 Jun 2026

Manufacturer: Opel

Model: Corsa-e Edition

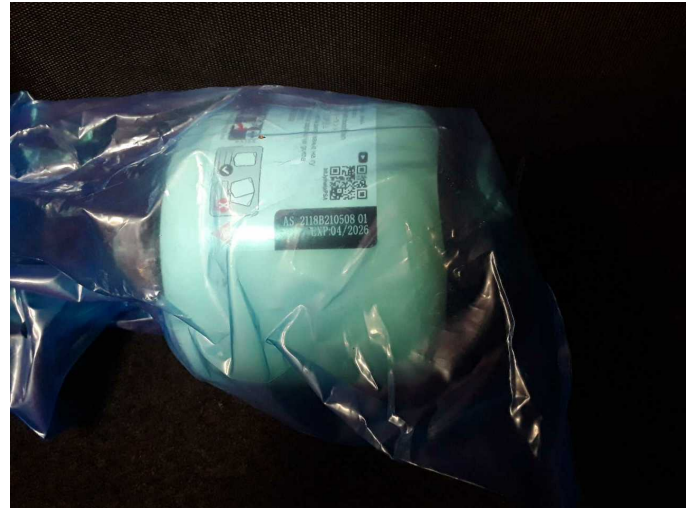
Damage 1: Equipment: Tirefit filler - Expired - Replace

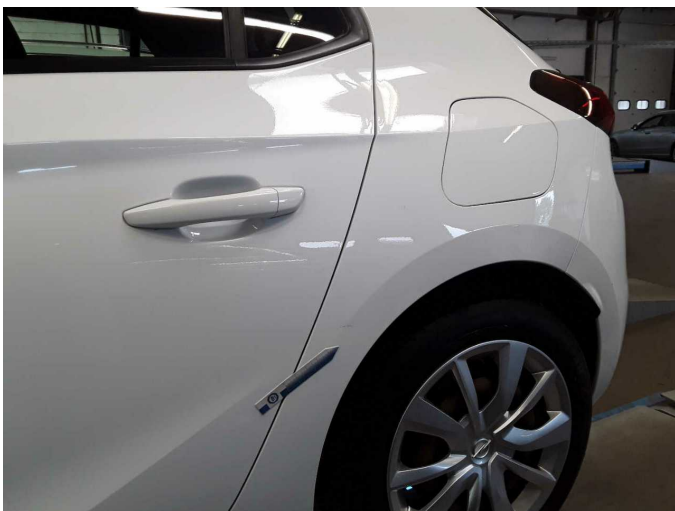
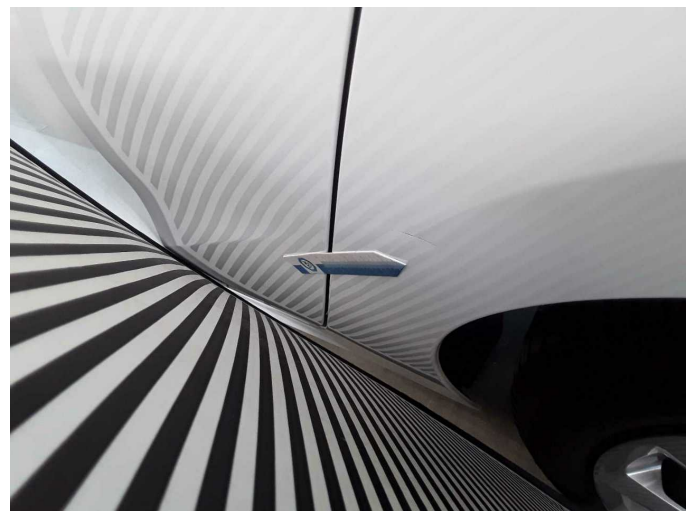
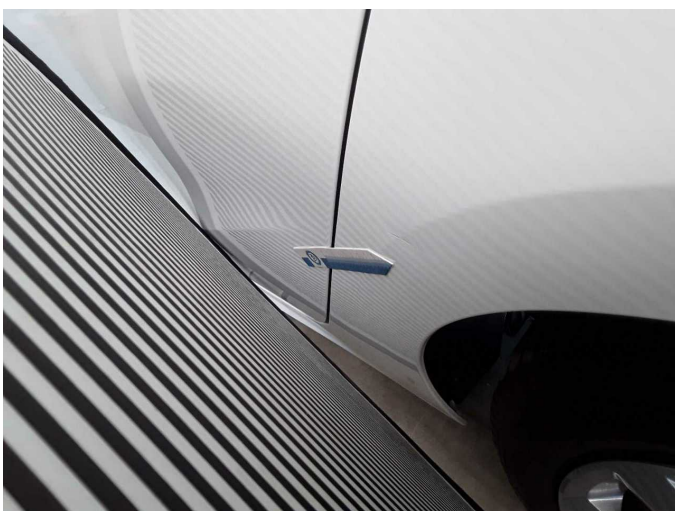
Damage 2: Side panel - rear left side: Side panel - Dent / paintcoat damage - Repair and paint

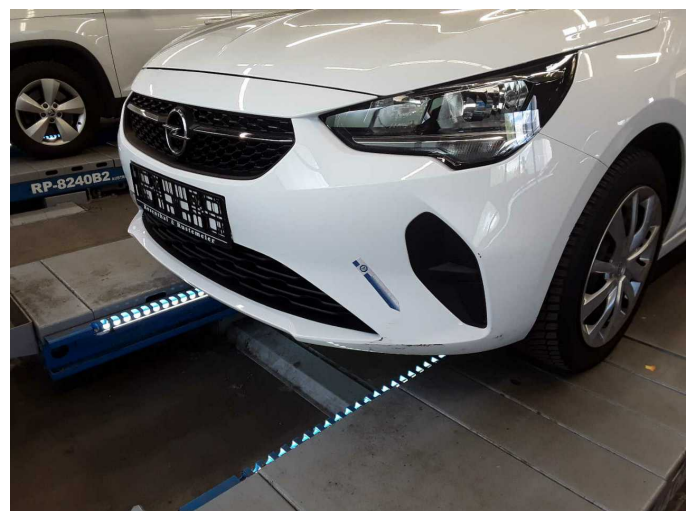
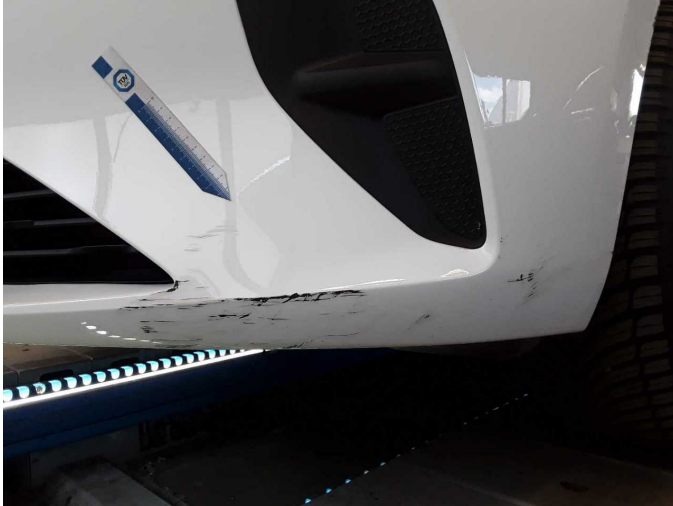
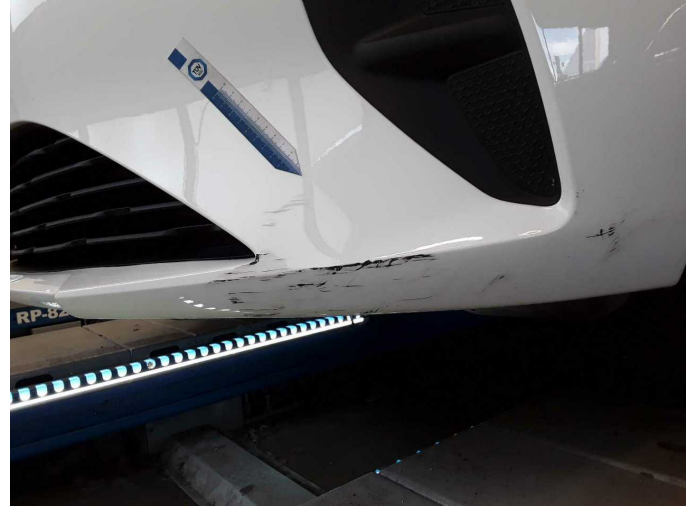
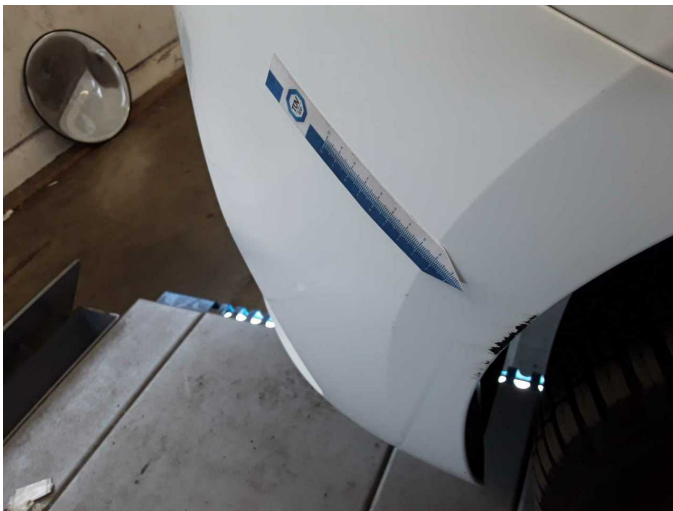
Damage 3: Front bumper: Front bumper - Scratched - Paint

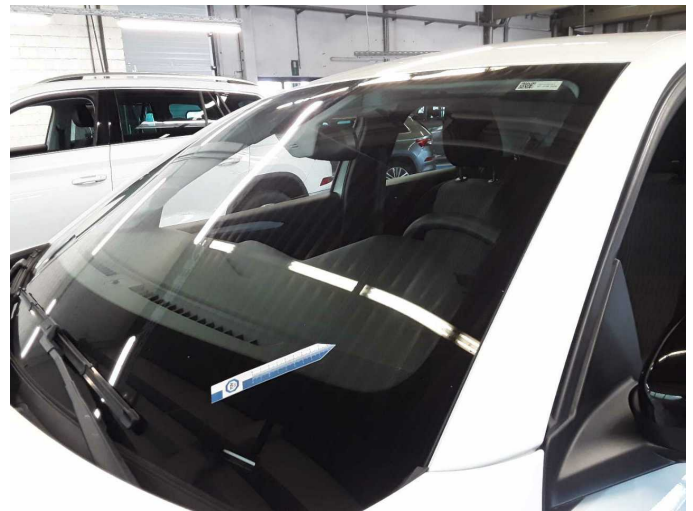
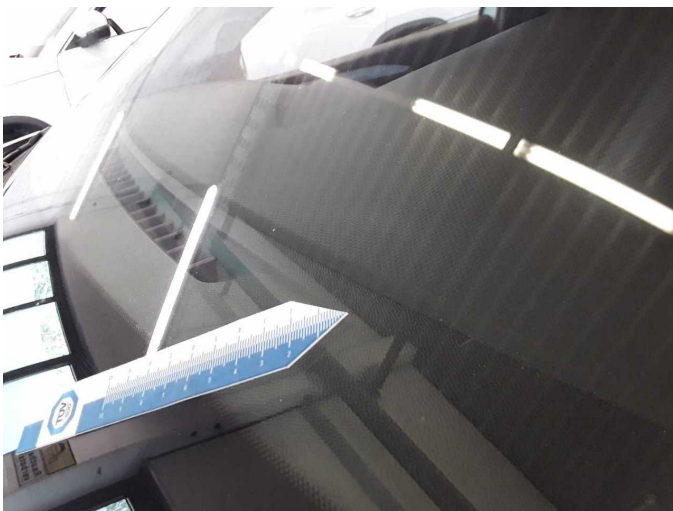
Wear and tear 1: Vehicle glazing: Windscreen - Stone chips - No deduction
