Expertise

Protocol number: 46328933  
Order No. / Reference: 26685439  
Inspection date: 6 Jul 2026

| Manufacturer: Opel | Model: Insignia Sports Tourer 2.0 Diesel Aut. Business Elegance |

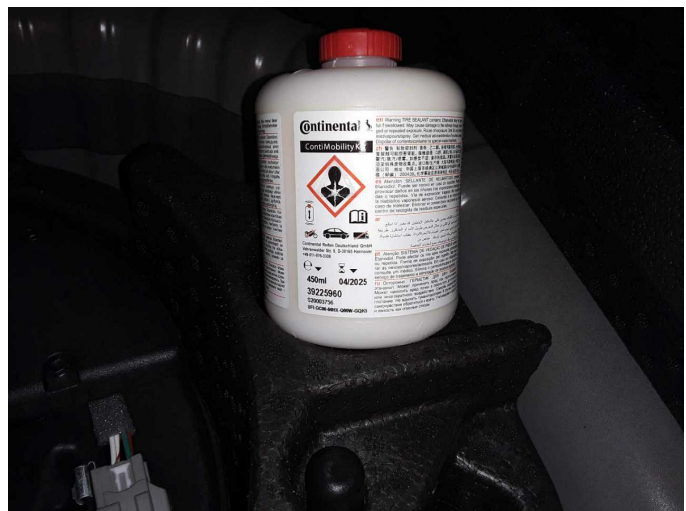
| No. | Component group | Description |
|---|---|---|
| 1 | Equipment | Tirefit filler - Due - Replace |

Damage 1: Equipment: Tirefit filler - Due - Replace

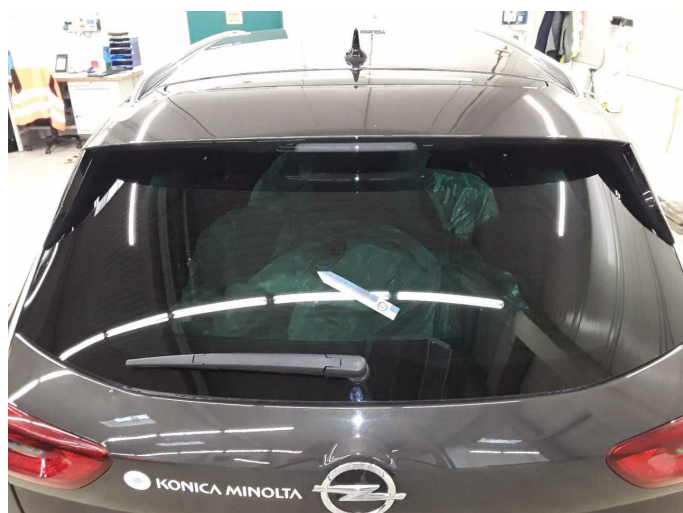
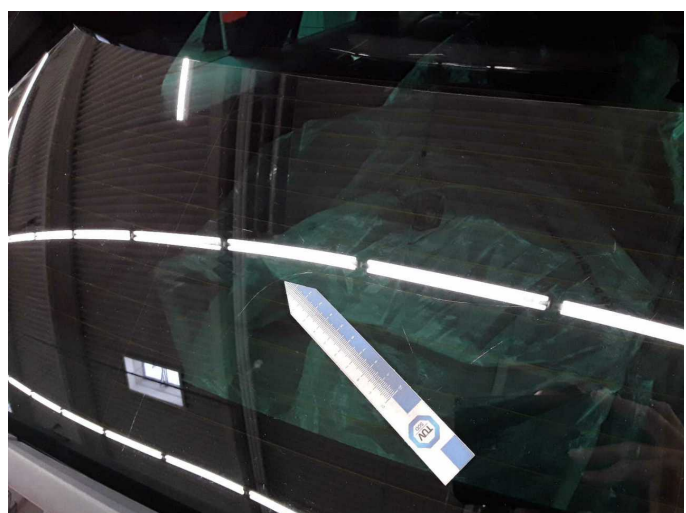
| No. | Component group | Description |
|---|---|---|
| 2 | Vehicle glazing | Rear window - Scratch(es) - Loss in value |

Damage 2: Vehicle glazing: Rear window - Scratch(es) - Loss in value

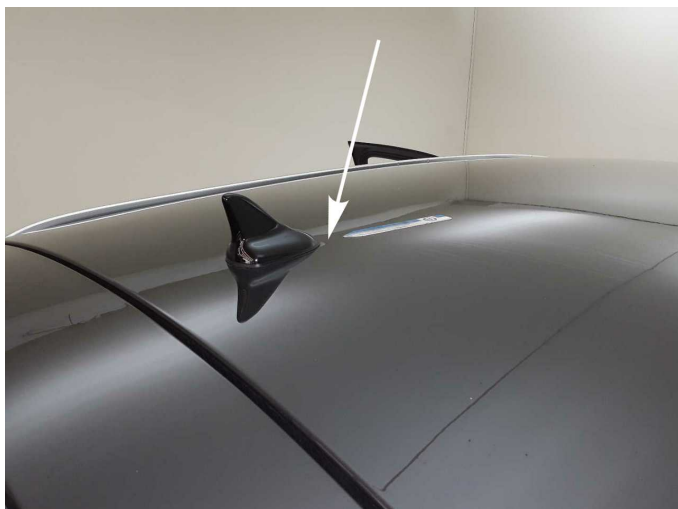
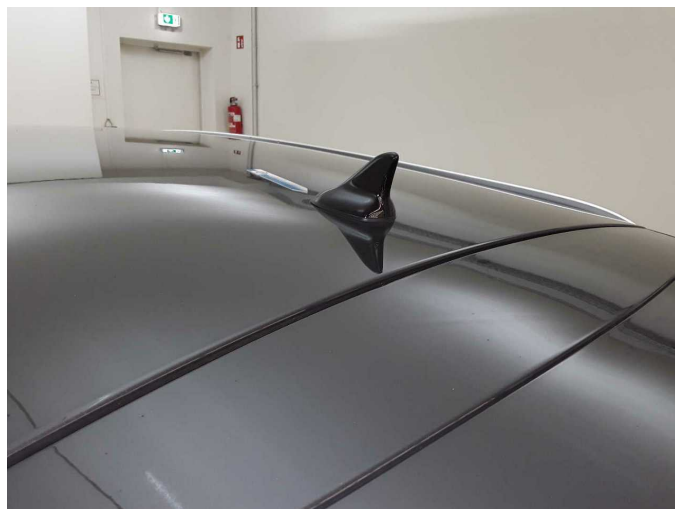
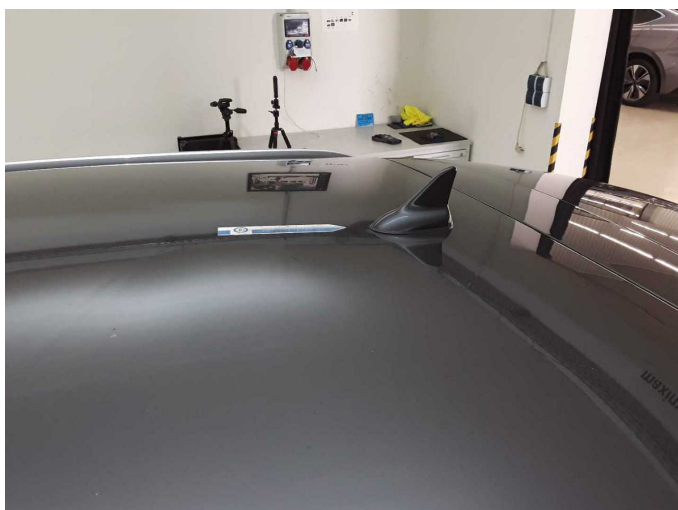
| No. | Component group | Description |
|---|---|---|
| 3 | Roof | Roof - dent(s) - Smart repair |

**Damage 3:** Roof: Roof - dent(s) - Smart repair

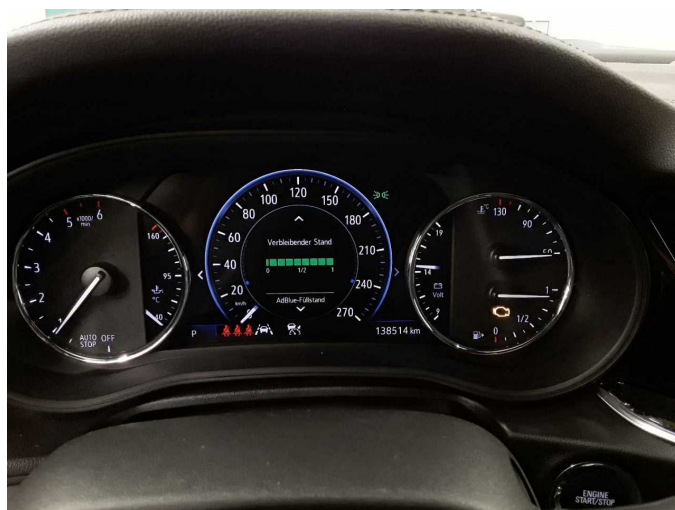
| Engine function test | An engine test run was performed, problem has been detected<br>This is due to the following reason.:<br>Motorkontrolle Leuchtet |

| No. | Component group | Description |
|---|---|---|
| 4 | Instrument panel | Indicator light (Motorkontrolle) - on - Perform diagnosis |

**Damage 4:** Instrument panel: Indicator light (Motorkontrolle) - on - Perform diagnosis

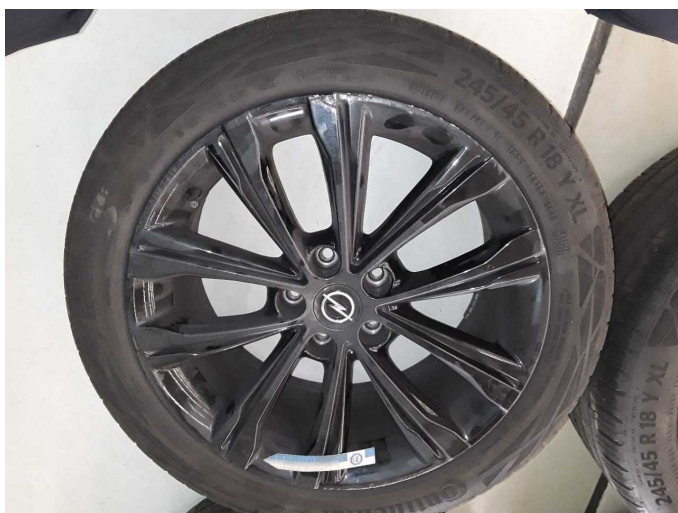
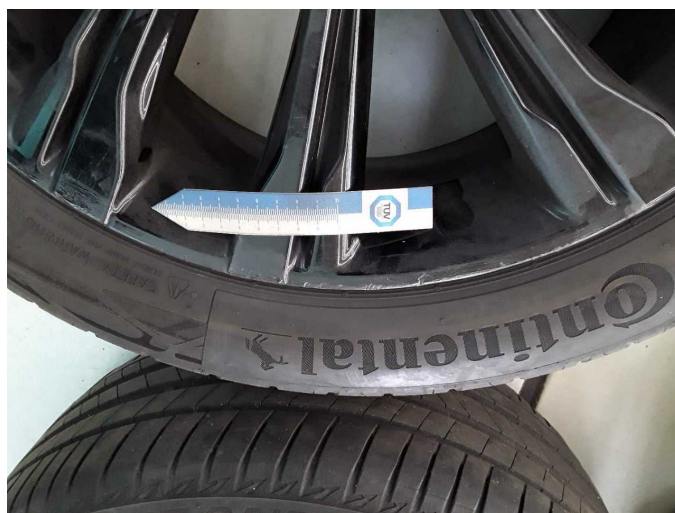
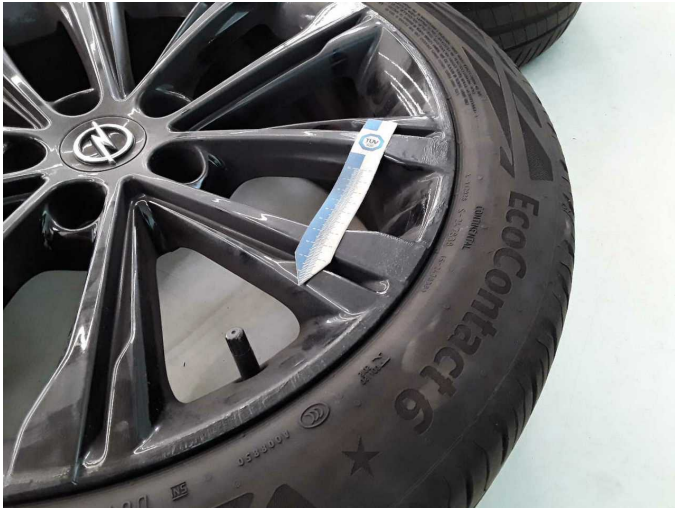
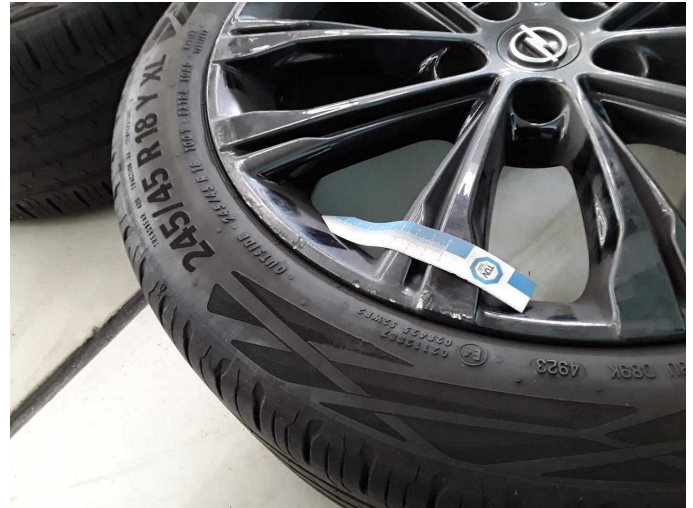
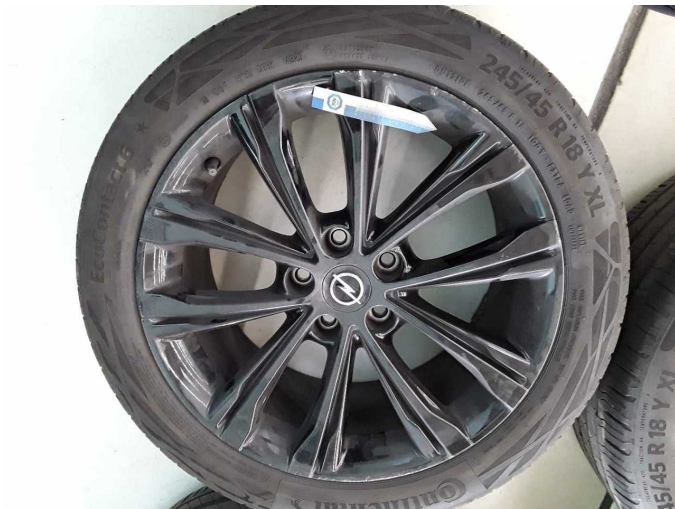
| No. | Component group | Description |
|---|---|---|
| 5 | 2nd wheel set | 1 alloy rim (Wurde bearbeitet, verschürft) - Unprofessionally repaired - Replace |

**Damage 5:** 2nd wheel set: 1 alloy rim (Wurde bearbeitet, verschürt) - Unprofessionally repaired - Replace

**Damage 5:** 2nd wheel set: 1 alloy rim (Wurde bearbeitet, verschürft) - Unprofessionally repaired - Replace

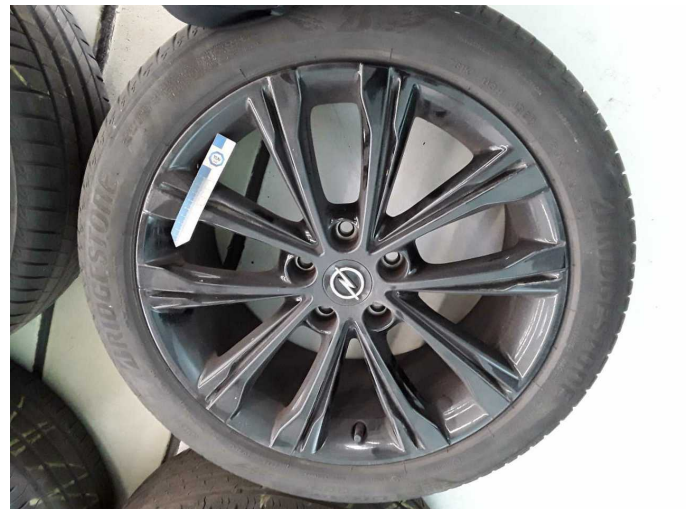
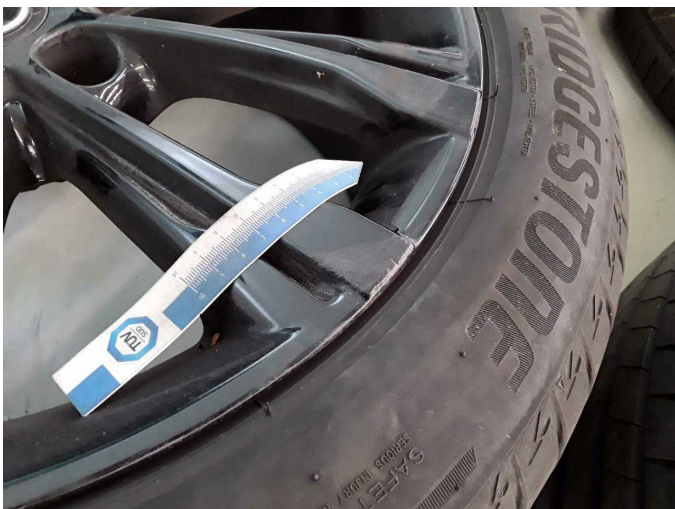
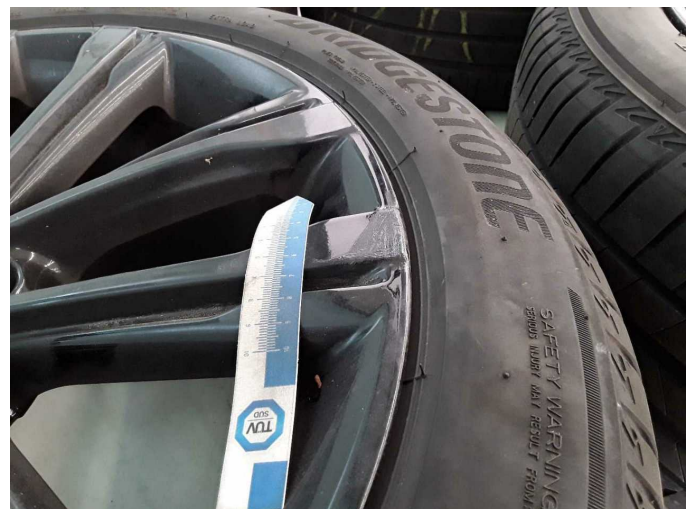
| No. | Component group | Description |
|---|---|---|
| 6 | 2nd wheel set | 1 alloy rim (Wurde bearbeitet) - Unprofessionally repaired - Replace |

**Damage 6:** 2nd wheel set: 1 alloy rim (Wurde bearbeitet) - Unprofessionally repaired - Replace

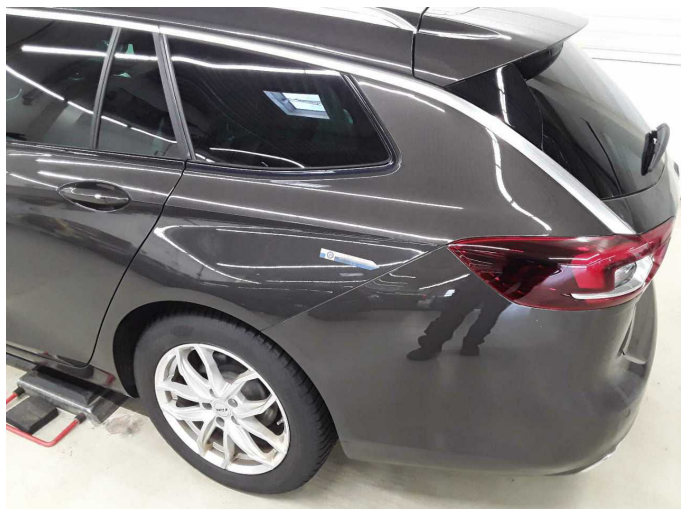
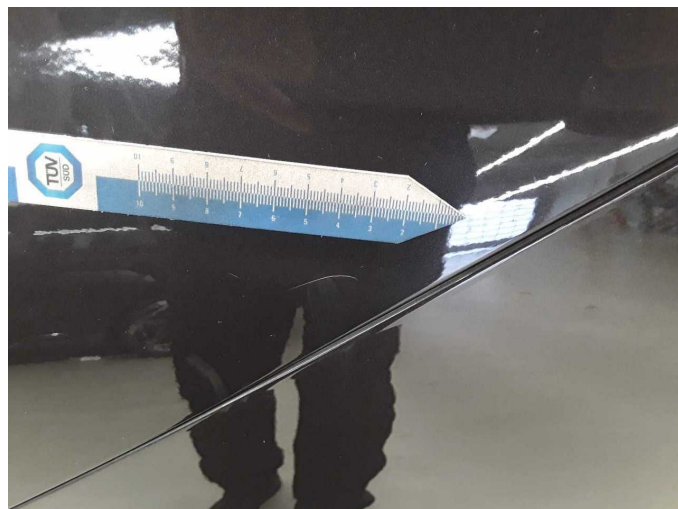
| No. | Component group | Description |
|---|---|---|
| 7 | Side panel - rear left side | Side panel - Scratch(es) - Repair and paint |

**Damage 7:** Side panel - rear left side: Side panel - Scratch(es) - Repair and paint

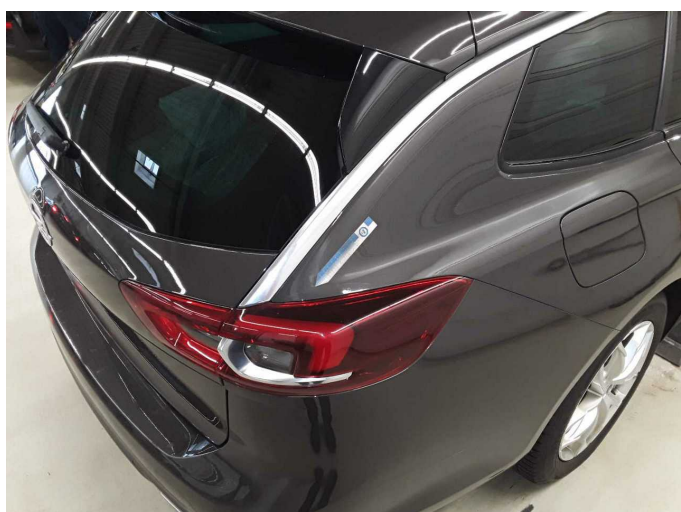
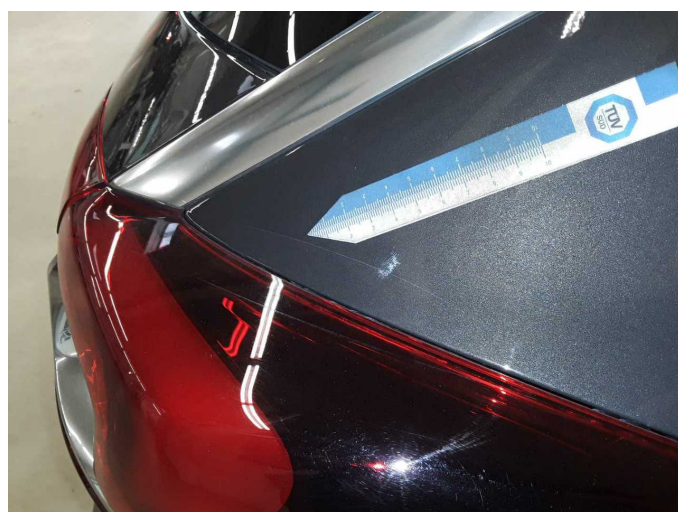
| No. | Component group | Description |
|---|---|---|
| 8 | Side panel - rear right side | Side panel - Scratch(es) - Repair and paint |

**Damage 8:** Side panel - rear right side: Side panel - Scratch(es) - Repair and paint

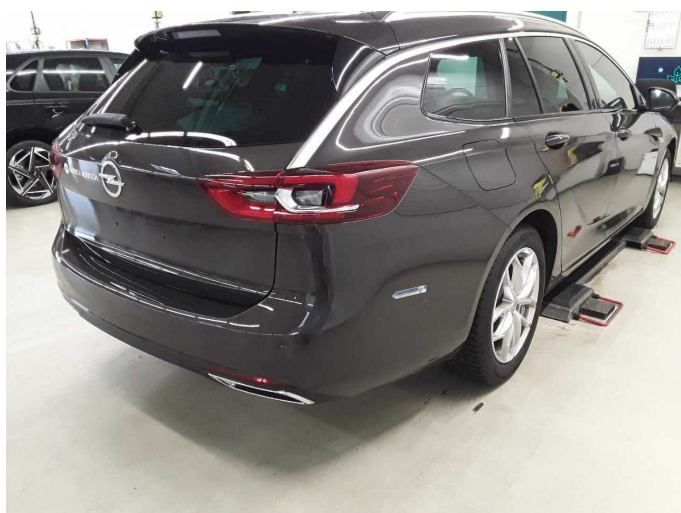
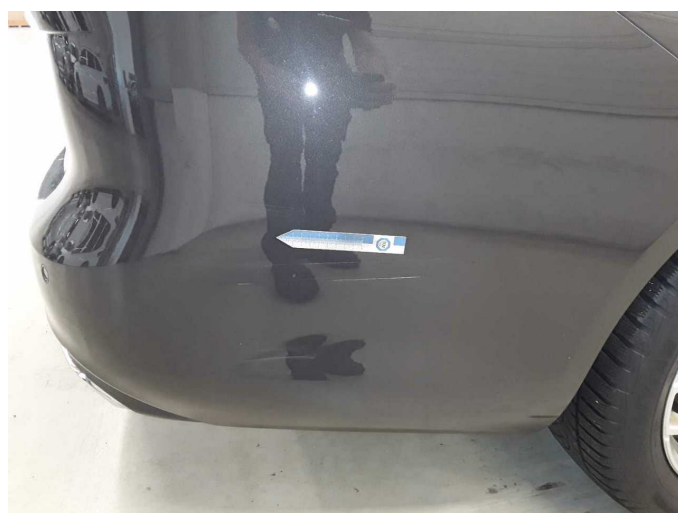
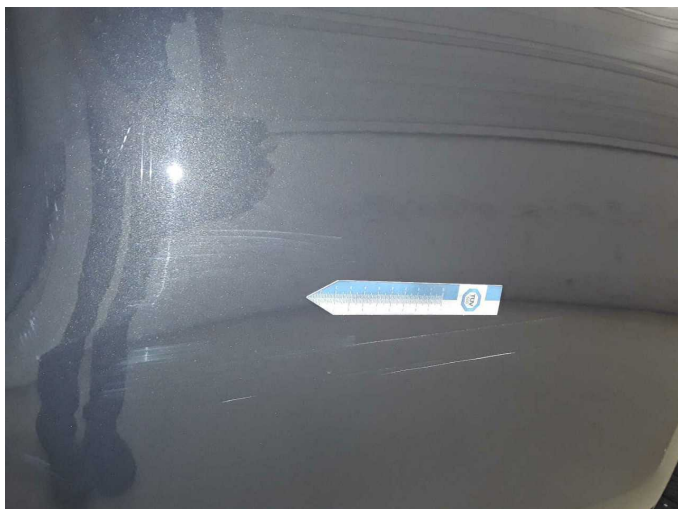
| No. | Component group | Description |
|---|---|---|
| 9 | Rear bumper | Rear bumper - Scratched - Repair and paint |

**Damage 9:** Rear bumper: Rear bumper - Scratched - Repair and paint

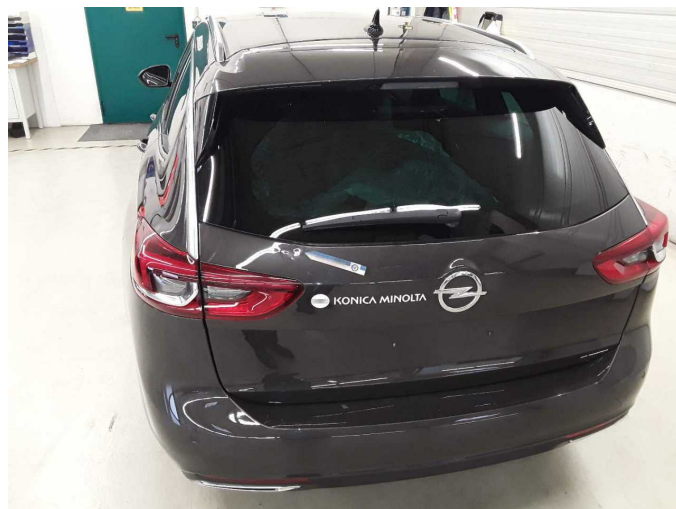
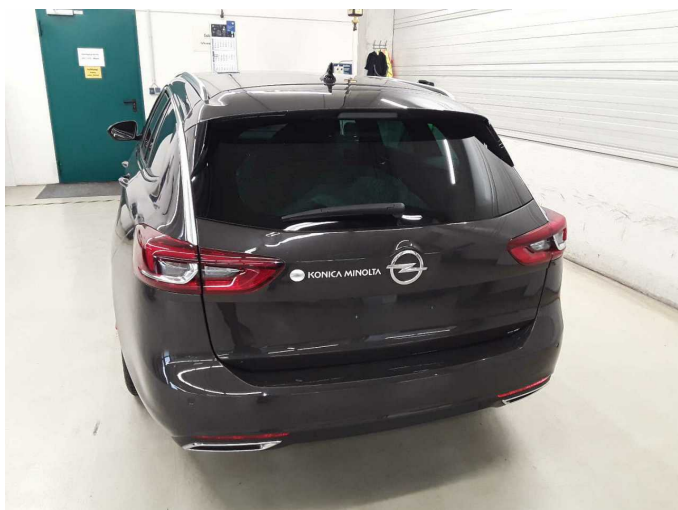
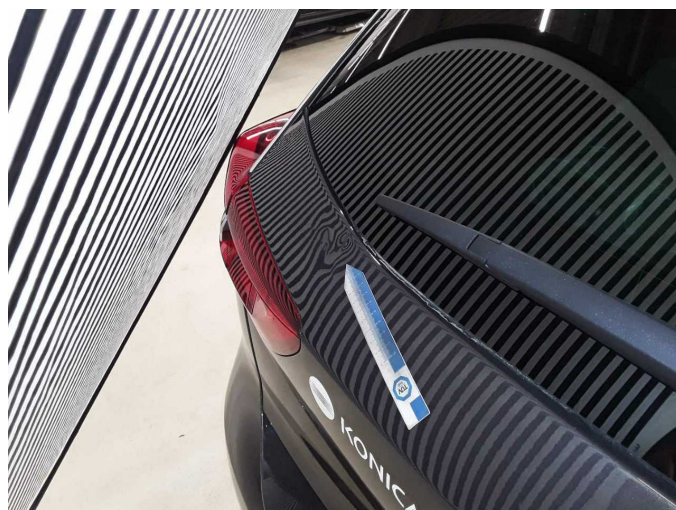
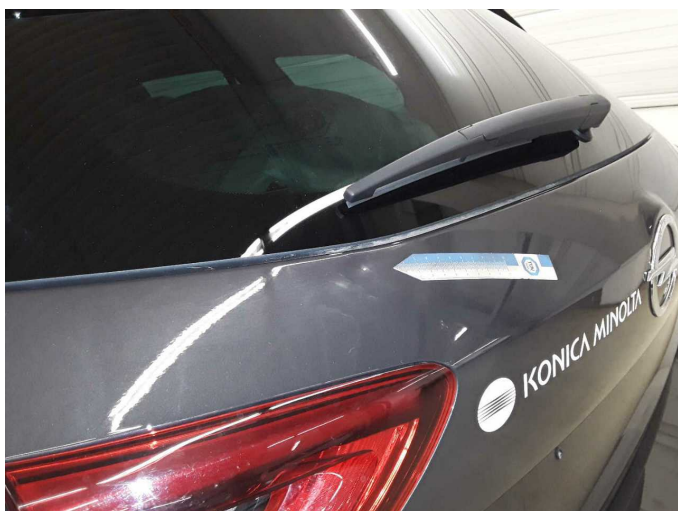
| No. | Component group | Description |
|---|---|---|
| 10 | Boot lid / rear door | Boot lid (mit Entkleben) - Dent / paintcoat damage - Repair and paint |

**Damage 10:** Boot lid / rear door: Boot lid (mit Entkleben) - Dent / paintcoat damage - Repair and paint

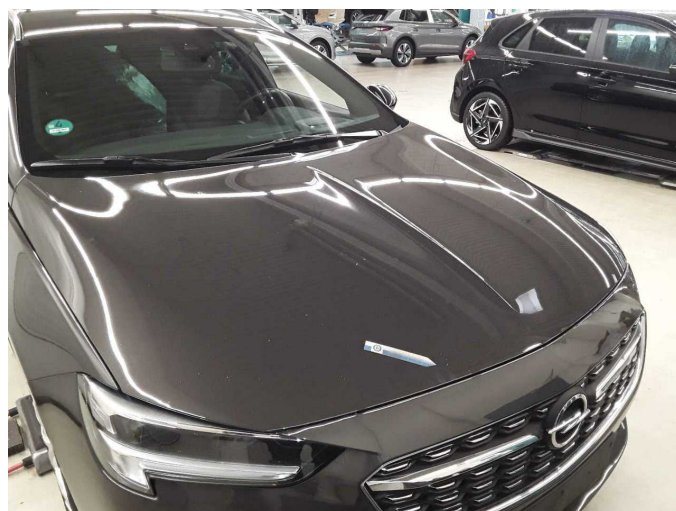
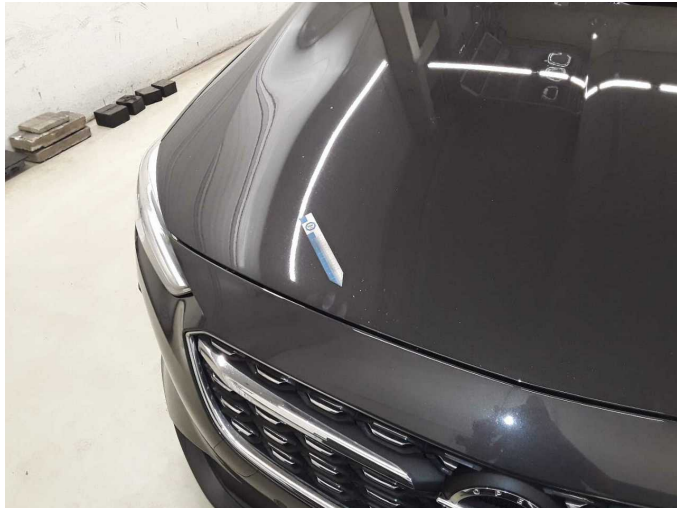
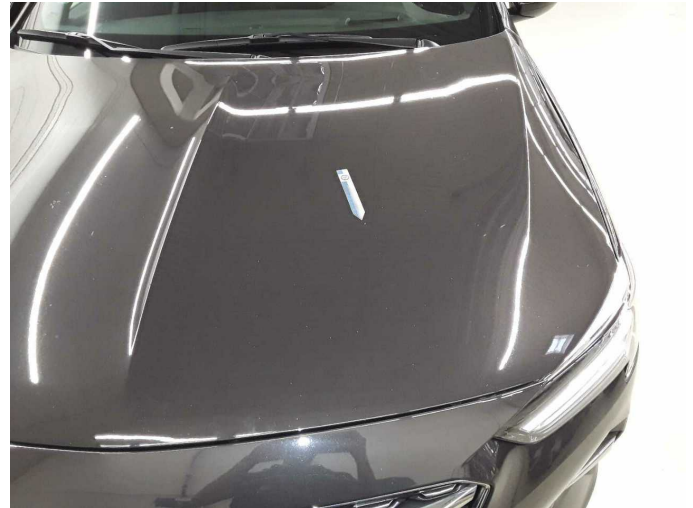
| No. | Component group | Description |
|---|---|---|
| 1 | Bonnet | Bonnet - Stone chips - No deduction |

**Wear and tear 1:** Bonnet: Bonnet - Stone chips - No deduction

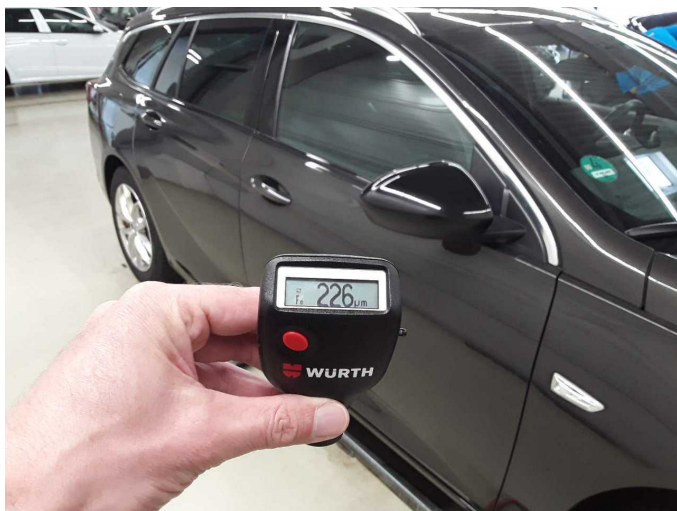
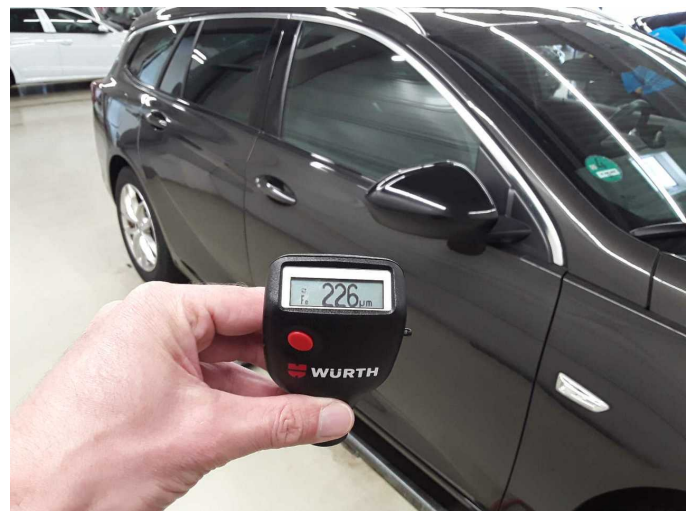
**Repainting 1:** Door - front right side

| No. | Repainting |
|---|---|
| 1 | Door - front right side, Professionally carried out, Invoice of repair done Non-existent |

| Door - front right side | 226 µm |

**Door - front right side:** 226 µm
