Expertise

Protocol number: 46506567  
Order No. / Reference: 26660610  
Inspection date: 14 Jul 2026

Manufacturer: Opel

Model: Grandland 1.5 D Automatik Elegance

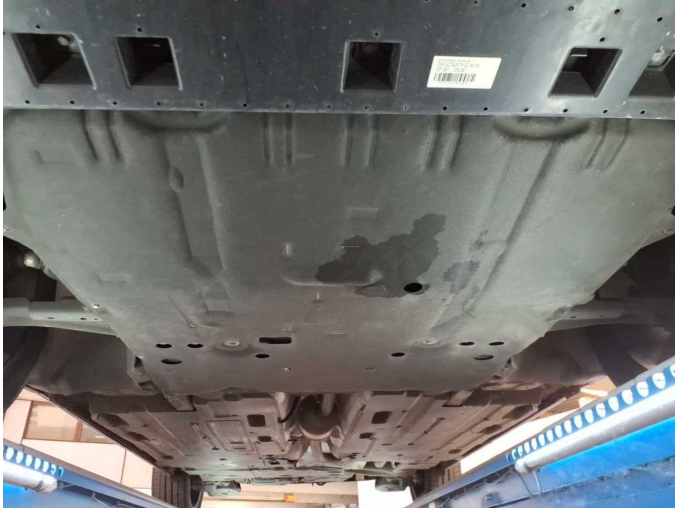
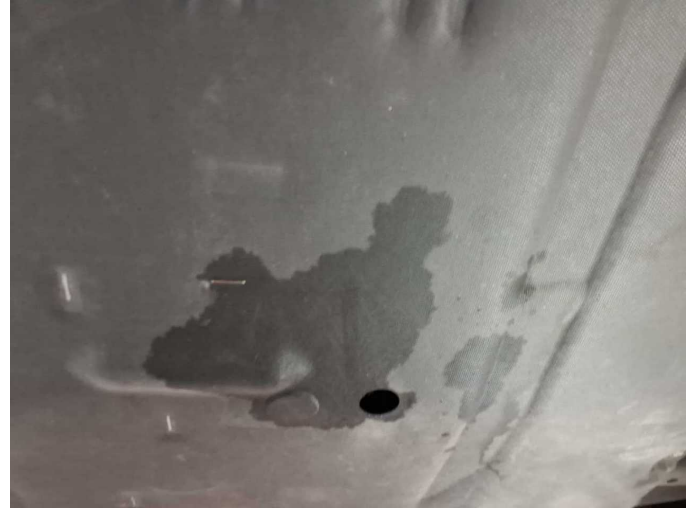
| No. | Component group | Description |
|---|---|---|
| 1 | Engine | Engine - Leaking - Perform diagnosis |

**Damage 1:** Engine: Engine - Leaking - Perform diagnosis

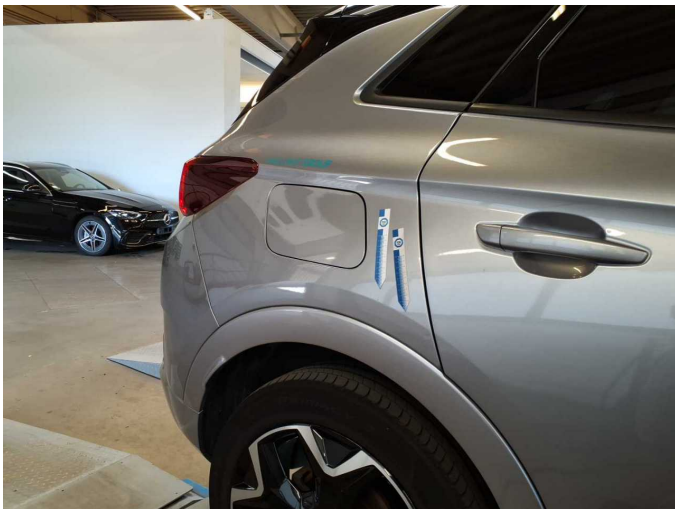
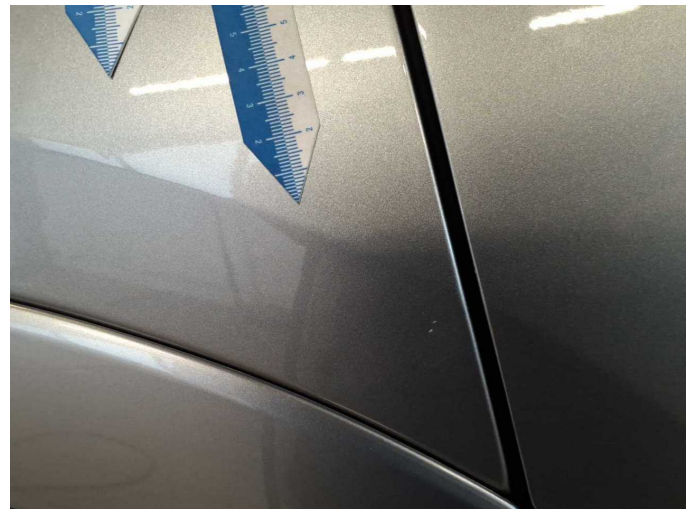
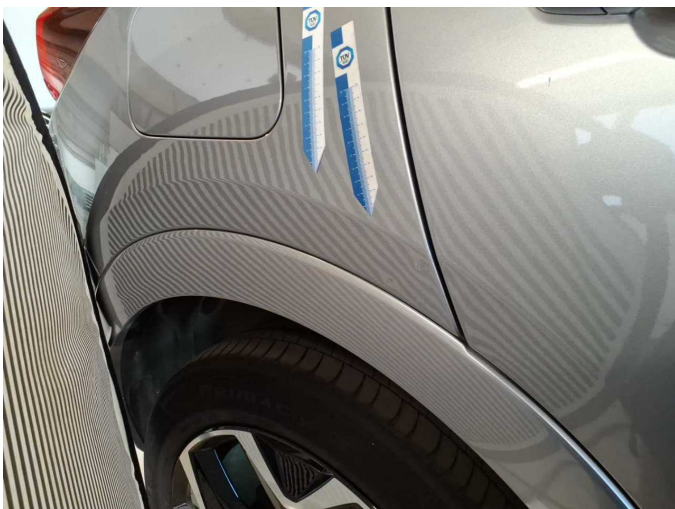
| No. | Component group | Description |
|---|---|---|
| 2 | Side panel - rear right side | Side panel - Dent / paintcoat damage - Repair and paint |

**Damage 2:** Side panel - rear right side: Side panel - Dent / paintcoat damage - Repair and paint

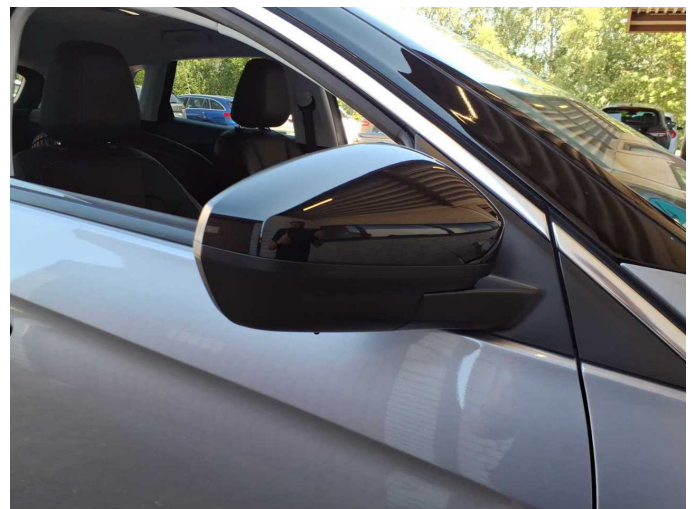
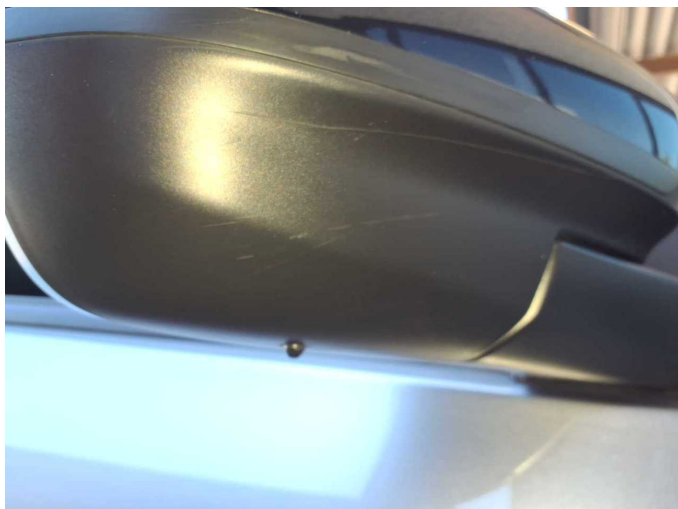
| No. | Component group | Description |
|---|---|---|
| 1 | Wing mirror - right side | Mirror housing - Soiled - No deduction |

**Wear and tear 1:** Wing mirror - right side: Mirror housing - Soiled - No deduction

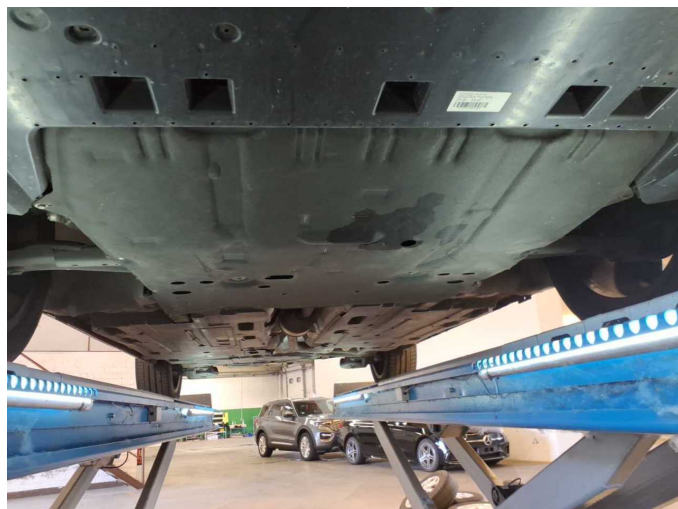
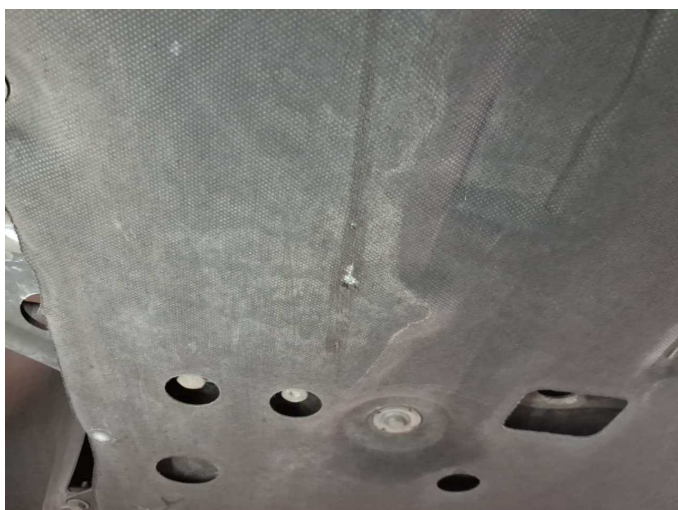
| No. | Component group | Description |
|---|---|---|
| 2 | Body | Underbody panelling - Scratched - No deduction |

**Wear and tear 2:** Body: Underbody panelling - Scratched - No deduction

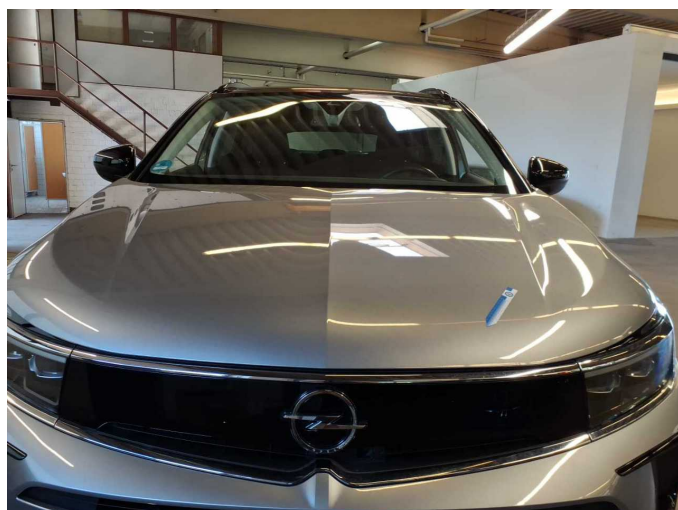
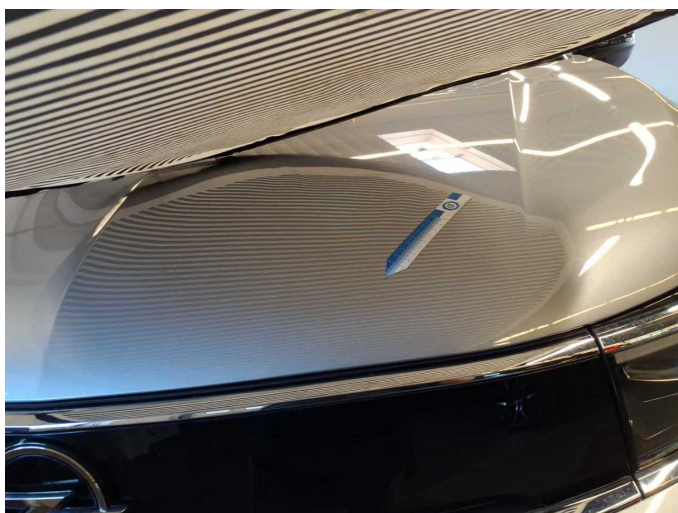
| No. | Component group | Description |
|---|---|---|
| 3 | Bonnet | Bonnet - dent(s) - No deduction |

**Wear and tear 3:** Bonnet: Bonnet - dent(s) - No deduction

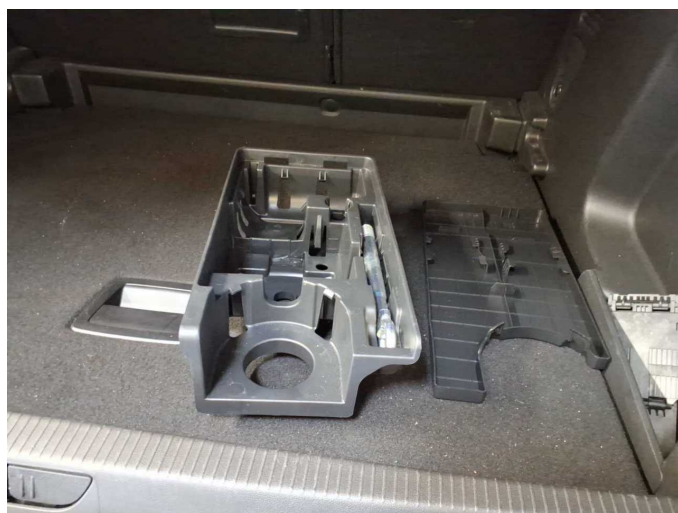
Equipment - Tirefit complete

**Missing part 1:** Equipment: Tirefit complete - Missing - Replace
