**TMAK381GFNJ038837**

## Zustandsbericht

Besichtigungsdatum: 16.06.2026  
**Protokollnummer: 46029047**  
Erstellt durch: Paula Kube  
Besichtigt durch: Baumgartner

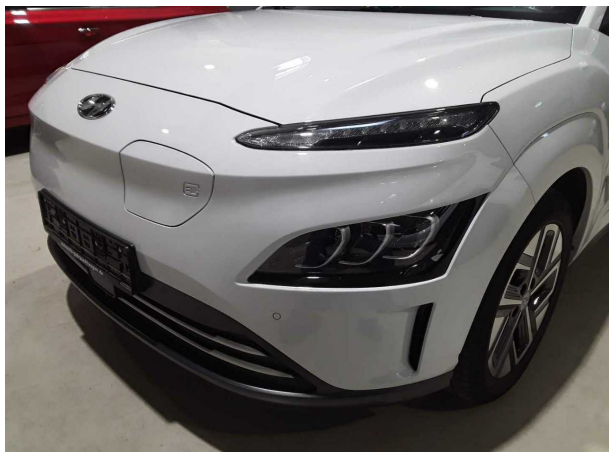
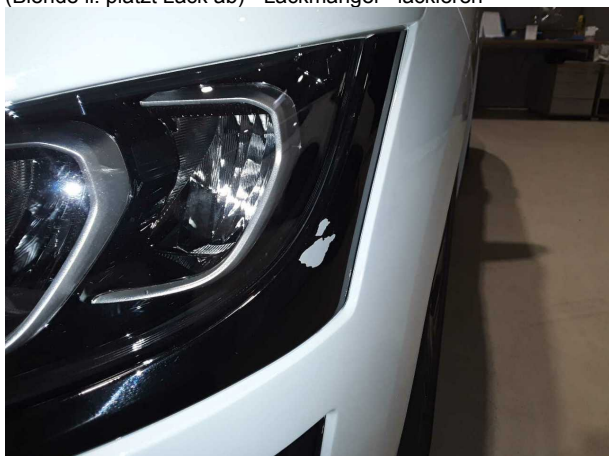
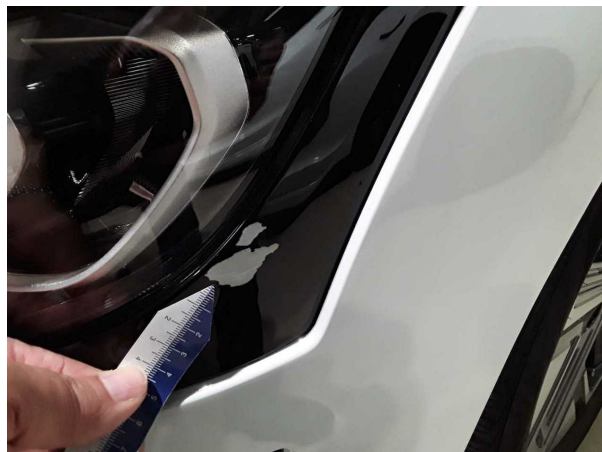
| Nr. | Bauteilgruppe | Beschreibung |
|---|---|---|
| 1 | Stoßfänger vorn | Blende unter Scheinwerfer (Blende li. platzt Lack ab) - Lackmangel - lackieren |

**Beschädigung #1:** Stossfänger vorn: Blende unter Scheinwerfer (Blende li. platzt Lack ab) - Lackmangel - lackieren

**Beschädigung #1:** Stossfänger vorn: Blende unter Scheinwerfer (Blende li. platzt Lack ab) - Lackmangel -

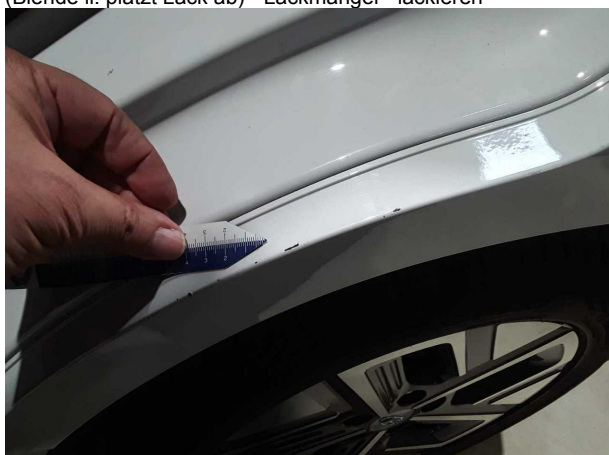
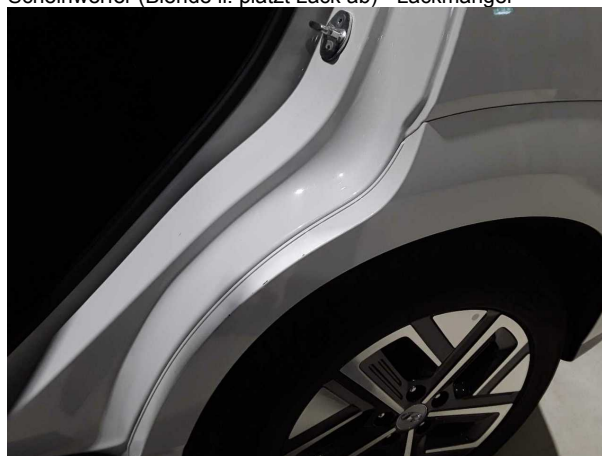
| Nr. | Bauteilgruppe | Beschreibung |
|---|---|---|
| 2 | Seitenwand links | Radlauf (Radlaufblende) - Kratzer - Smart Repair |

**Beschädigung #2:** Seitenwand links: Radlauf (Radlaufblende) - Kratzer - Smart Repair

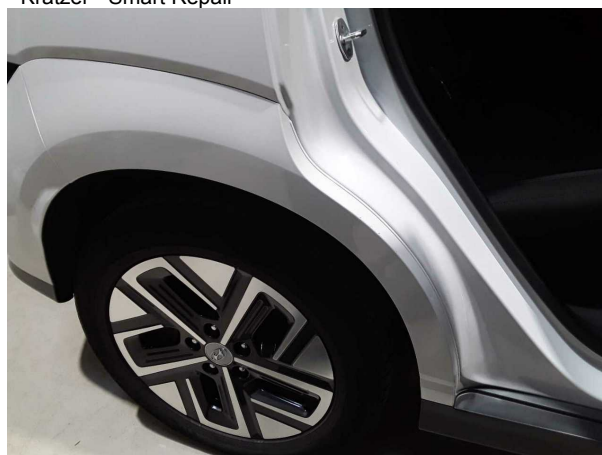
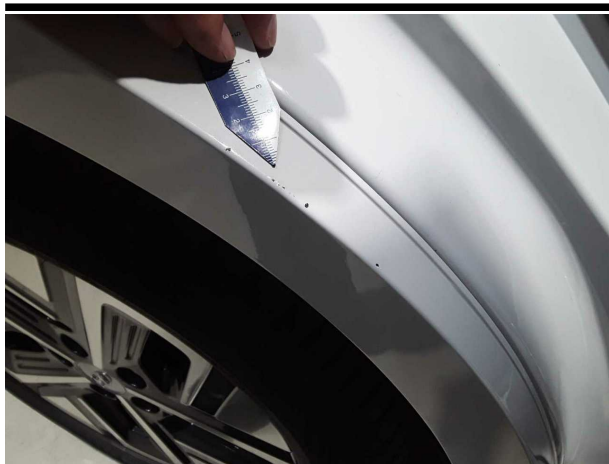
| Nr. | Bauteilgruppe | Beschreibung |
|---|---|---|
| 3 | Seitenwand rechts | Radlauf (Radlaufblende) - Kratzer - Smart Repair |

**Beschädigung #3:** Seitenwand rechts: Radlauf (Radlaufblende) - Kratzer - Smart Repair

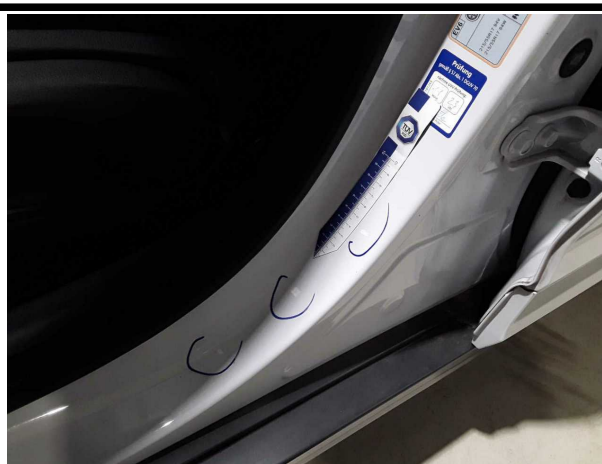
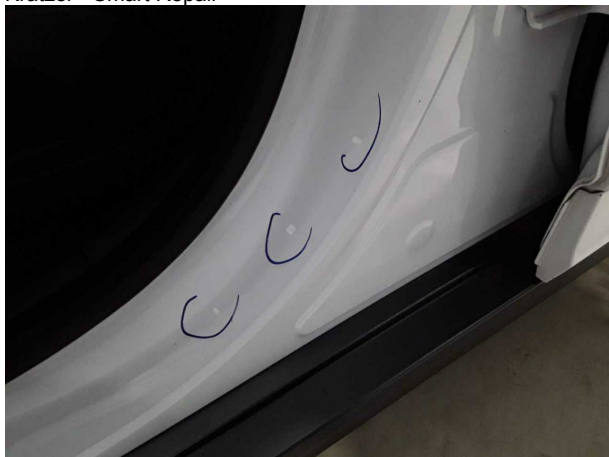
| Nr. | Bauteilgruppe | Beschreibung |
|---|---|---|
| 4 | Schweller links | Einstieg - Delle / Lackschaden - sanft instandsetzen |

**Beschädigung #4:** Schweller links: Einstieg - Delle / Lackschaden - sanft instandsetzen

**Beschädigung #4:** Schweller links: Einstieg - Delle / Lackschaden... sanft instandsetzen

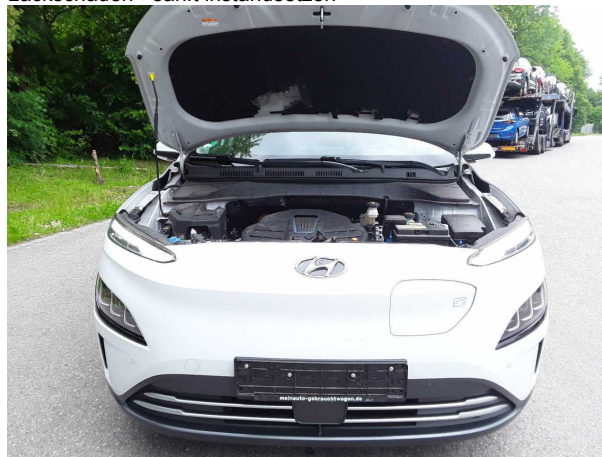
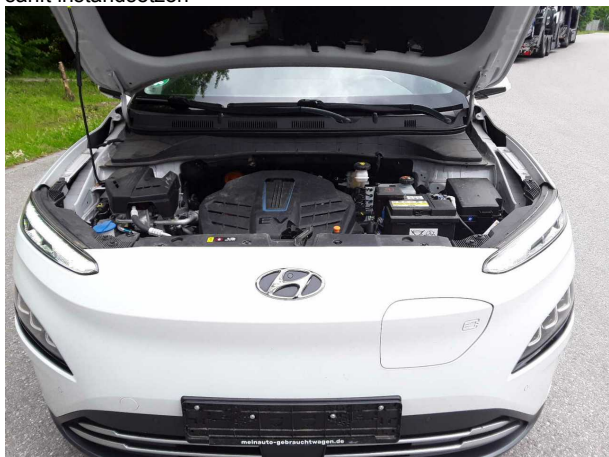
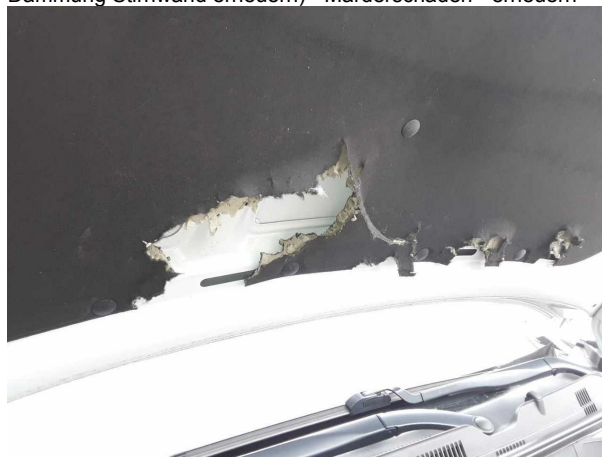
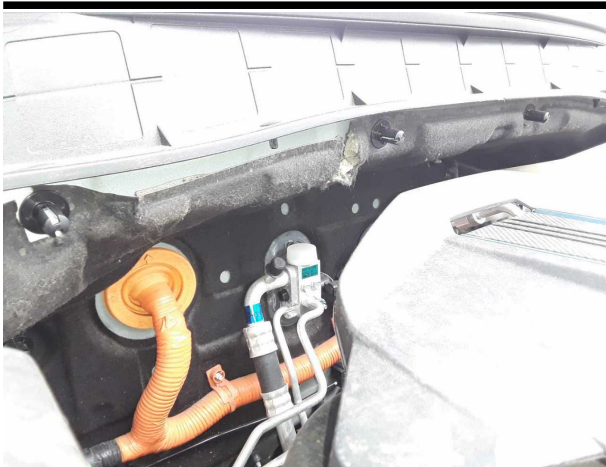
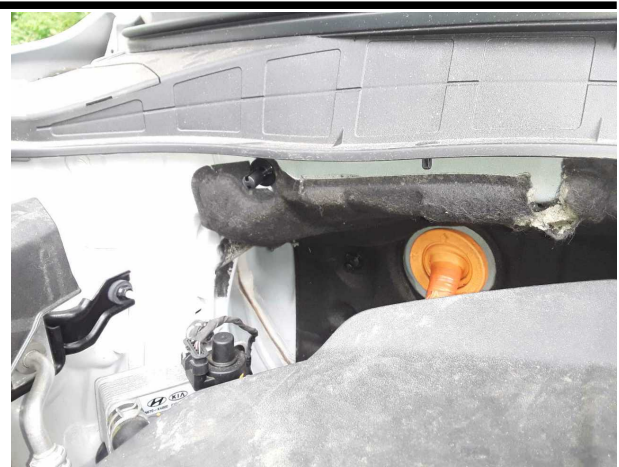
| Nr. | Bauteilgruppe | Beschreibung |
|---|---|---|
| 6 | Motorhaube | Dämmmatte (inklusive Dämmung Stirnwand erneuern) - Marderschaden - erneuern |

**Beschädigung #6:** Motorhaube: Dämmmatte (inklusive Dämmung Stirnwand erneuern) - Marderschaden - erneuern
