Expertise

Protocol number: 46444093  
Order No. / Reference: 26510333-1  
Inspection date: 2 Jun 2026

Manufacturer: Volkswagen

Model: Crafter 35 TDI MR HA

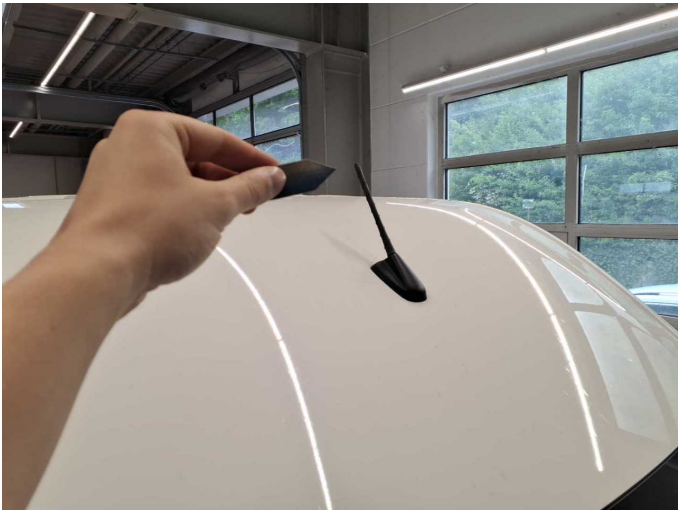
| No. | Component group | Description |
|---|---|---|
| 1 | Roof | Stub aerial - Damage caused by marten / rodent - Replace |

Damage 1: Roof: Stub aerial - Damage caused by marten / rodent - Replace

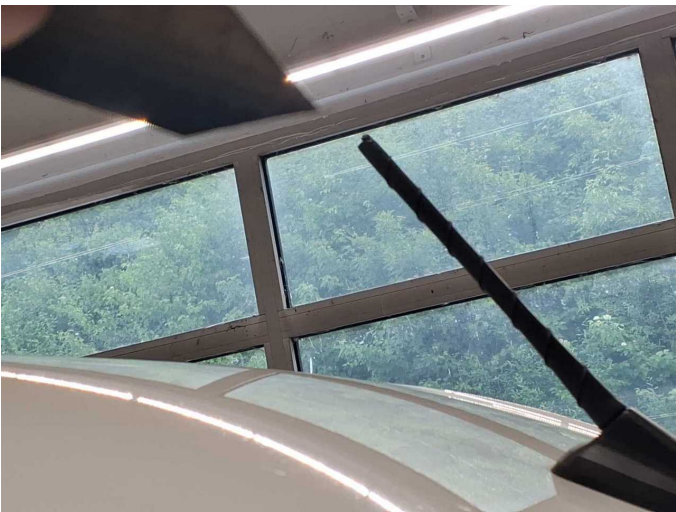
Damage 1: Roof: Stub aerial - Damage caused by marten / rodent - Replace

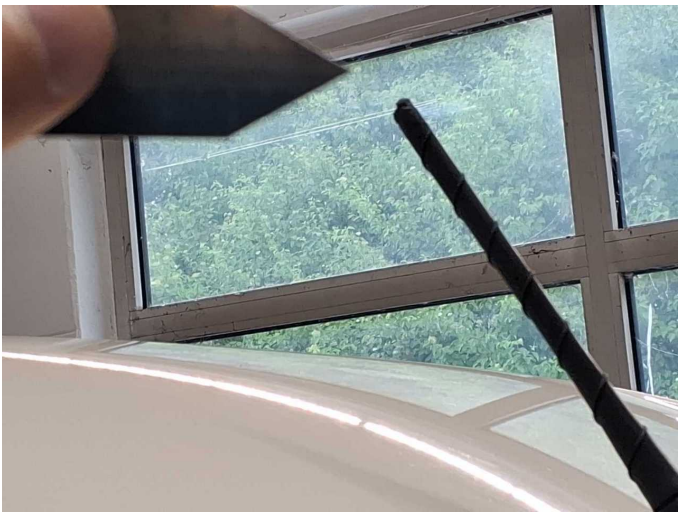
Damage 1: Roof: Stub aerial - Damage caused by marten / rodent - Replace

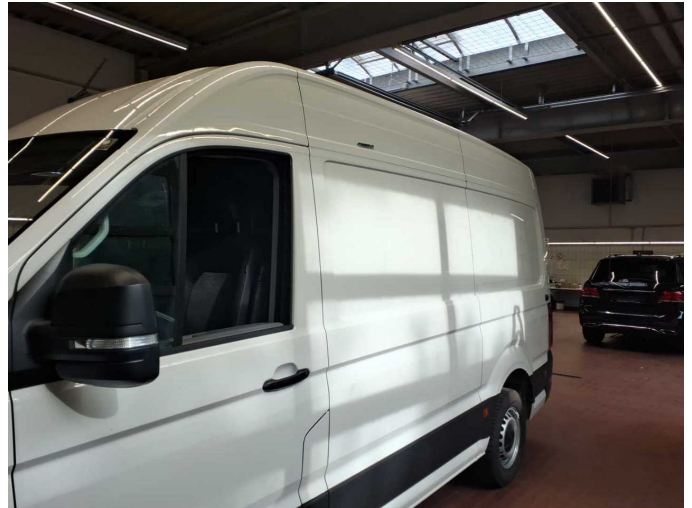
| No. | Component group | Description |
|---|---|---|
| 3 | Side panel - rear left side | Side panel - dent(s) - Smart repair |

**Damage 3:** Side panel - rear left side: Side panel - dent(s) - Smart repair

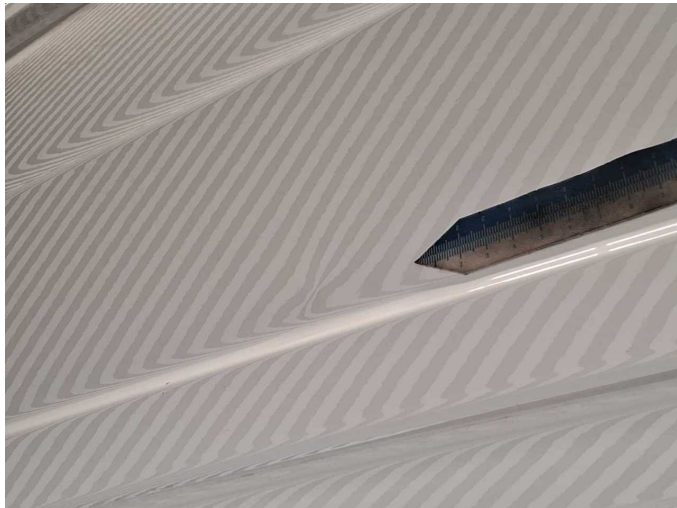
**Damage 3:** Side panel - rear left side: Side panel - dent(s) - Smart repair

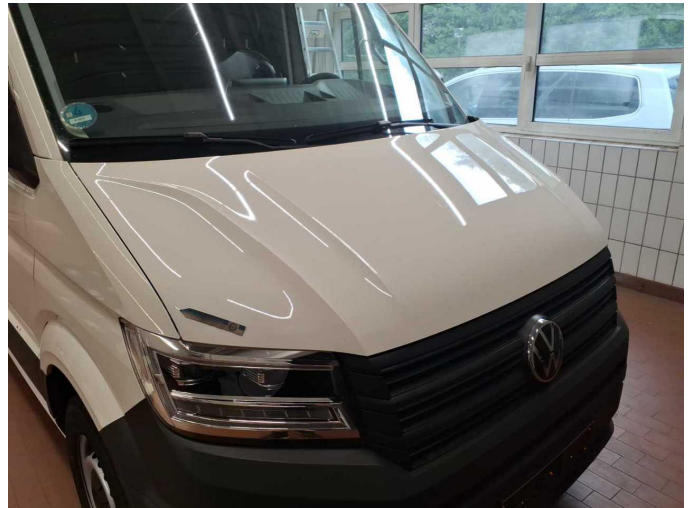
| No. | Component group | Description |
|---|---|---|
| 4 | Bonnet | Bonnet - Stone chips - Repair and paint |

**Damage 4:** Bonnet: Bonnet - Stone chips - Repair and paint

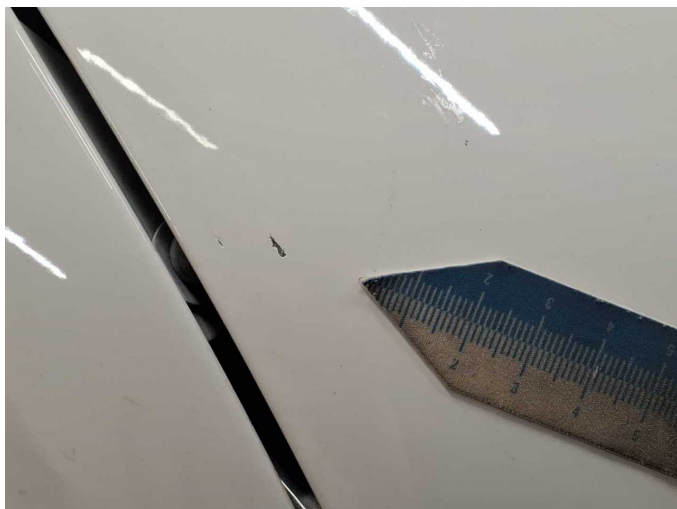
**Damage 4:** Bonnet: Bonnet - Stone chips - Repair and paint

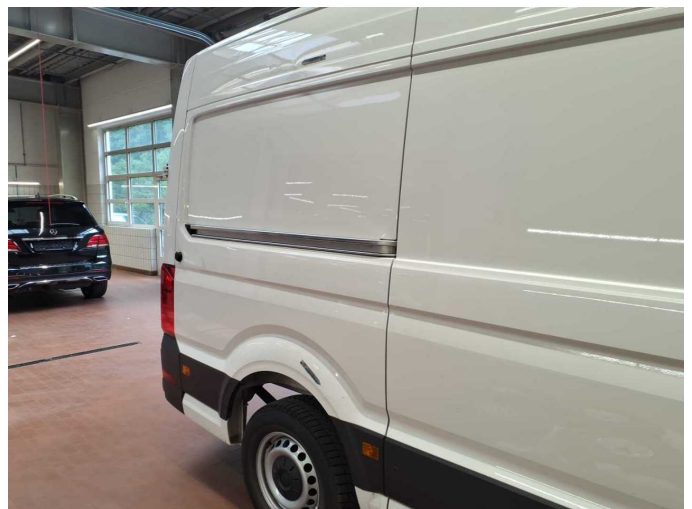
| No. | Component group | Description |
|---|---|---|
| 5 | Side panel - rear right side | Side panel - dent(s) - Repair and paint |

**Damage 5:** Side panel - rear right side: Side panel - dent(s) - Repair and paint

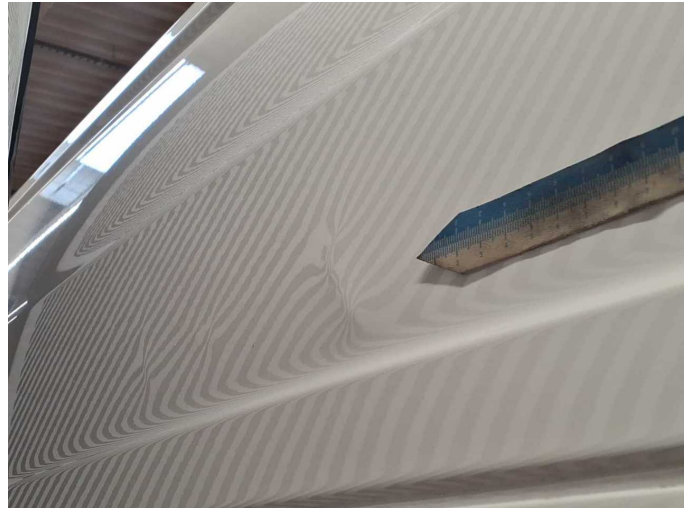
**Damage 5:** Side panel - rear right side: Side panel - dent(s) - Repair and paint

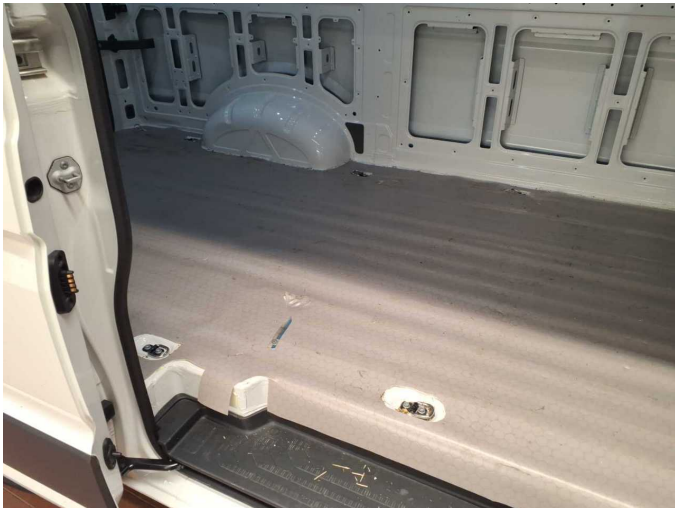
| No. | Component group | Description |
|---|---|---|
| 1 | Interior | Cargo area floor - Broken / torn - No deduction |

**Wear and tear 1:** Interior: Cargo area floor - Broken / torn - No deduction

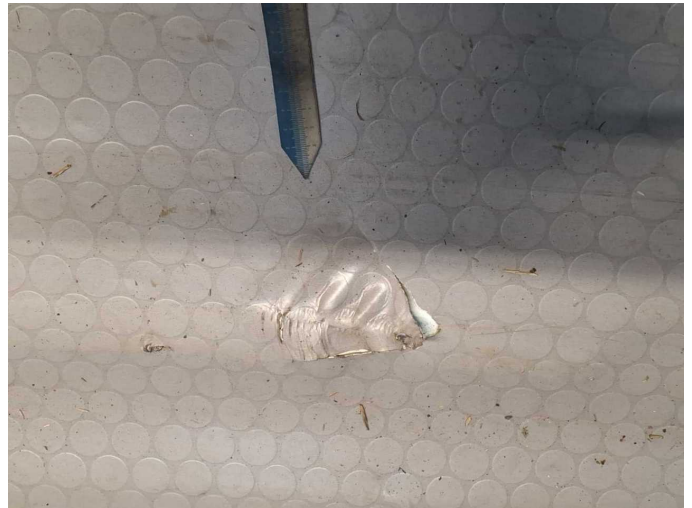
**Wear and tear 1:** Interior: Cargo area floor - Broken / torn - No deduction

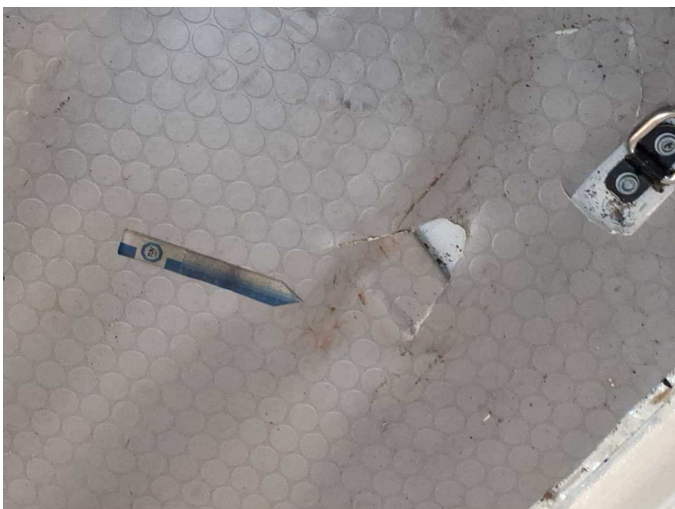
**Wear and tear 1:** Interior: Cargo area floor - Broken / torn - No deduction

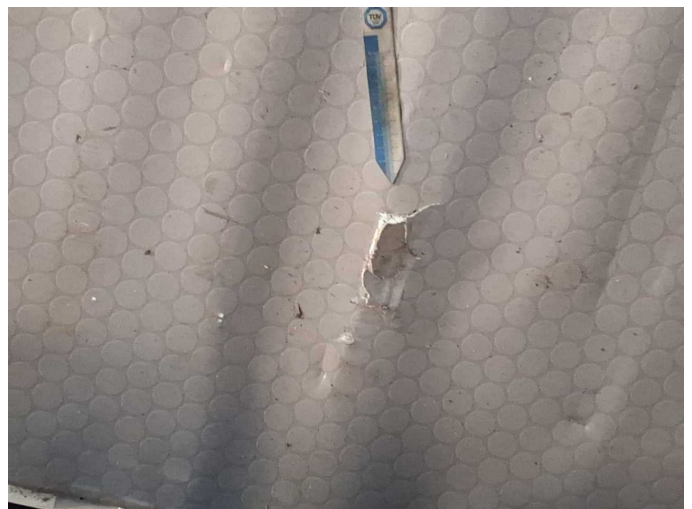
**Wear and tear 1:** Interior: Cargo area floor - Broken / torn - No deduction
