Expertise

Protocol number: 46417159  
Order No. / Reference: 26583899  
Inspection date: 9 Jul 2026

Manufacturer: Opel

Model: Movano 2.3 D (CDTI) L2H2 DPF 2WD VA

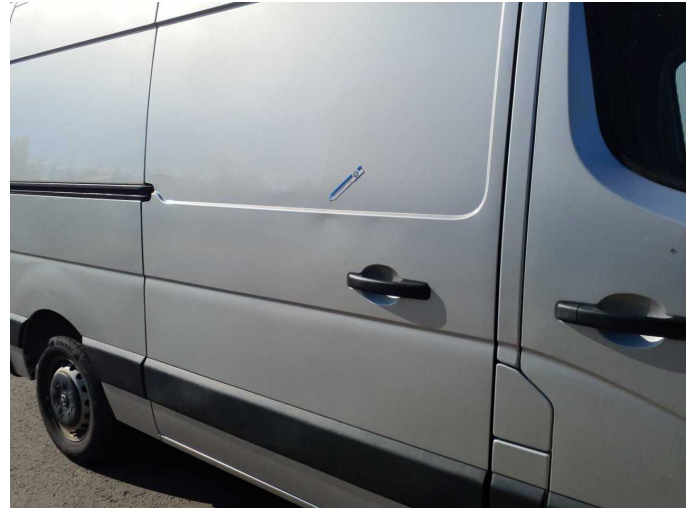
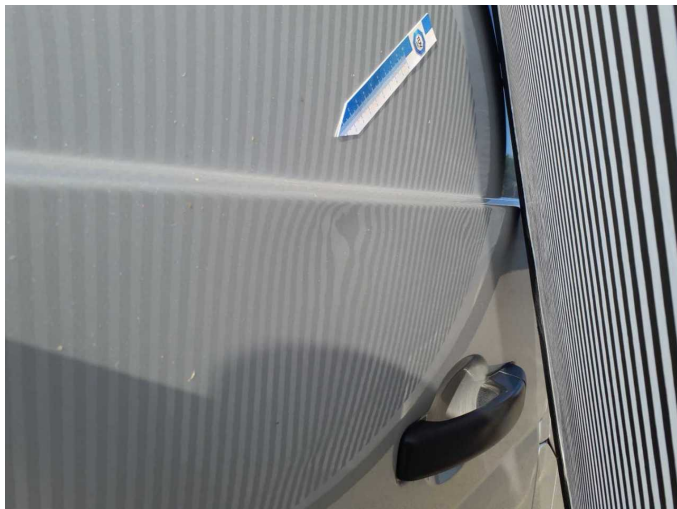
| No. | Component group | Description |
|---|---|---|
| 1 | Sliding door, right | Sliding door - dent(s) - Smart repair |

**Damage 1:** Sliding door, right: Sliding door - dent(s) - Smart repair

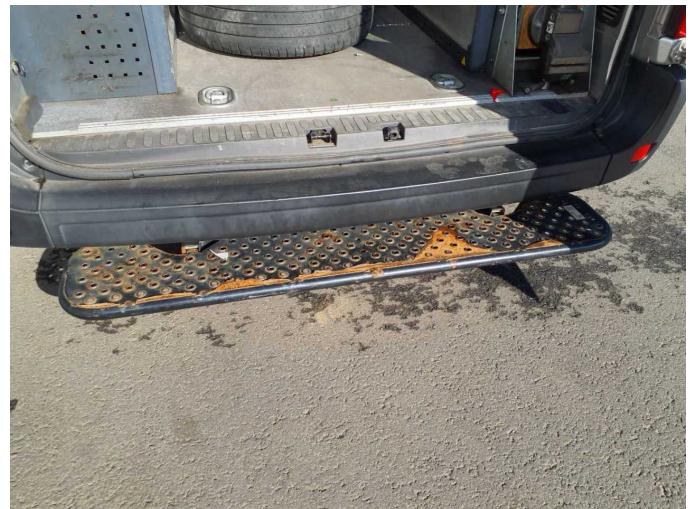
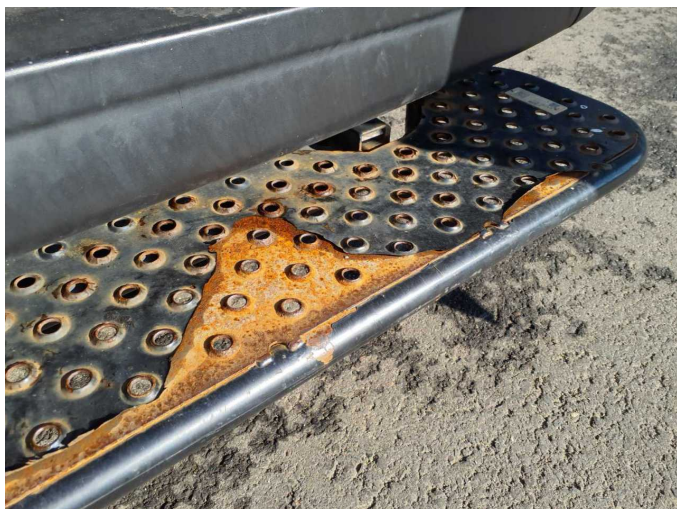
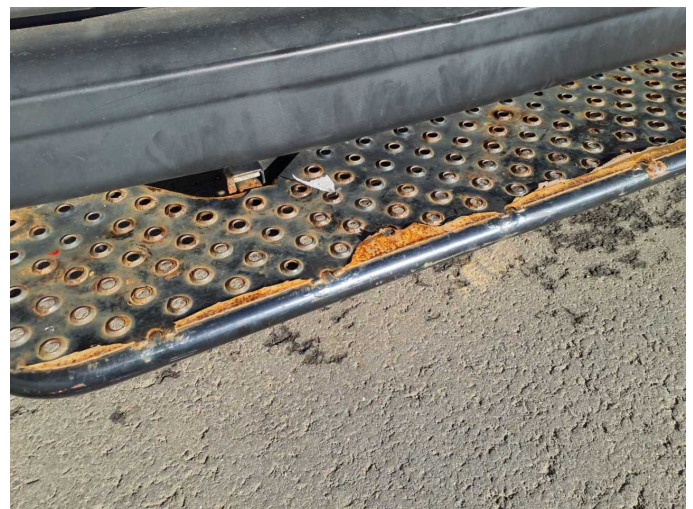
| No. | Component group | Description |
|---|---|---|
| 2 | Rear of vehicle | Foot plate (Korrosion) - Paint defect - Loss in value |

**Damage 2:** Rear of vehicle: Foot plate (Korrosion) - Paint defect - Loss in value

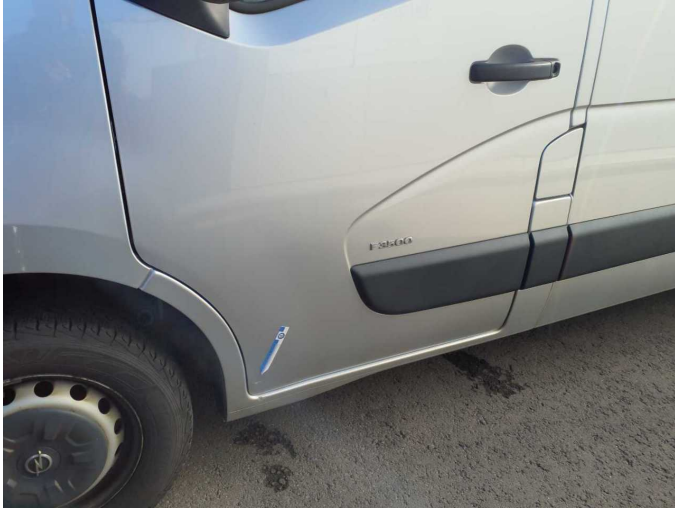
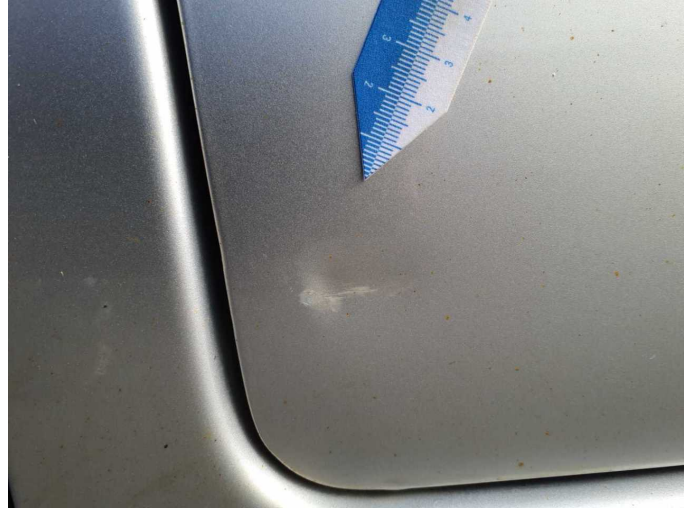
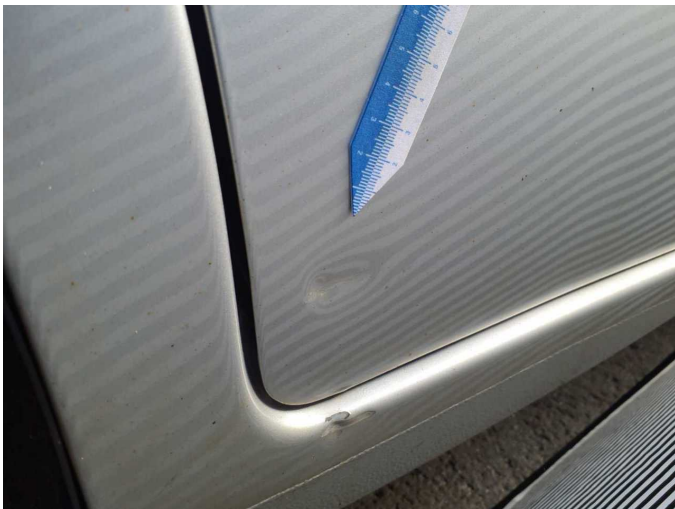
| No. | Component group | Description |
|---|---|---|
| 3 | Door - front left side | Door - Dent / paintcoat damage - Repair and paint |

**Damage 3:** Door - front left side: Door - Dent / paintcoat damage - Repair and paint

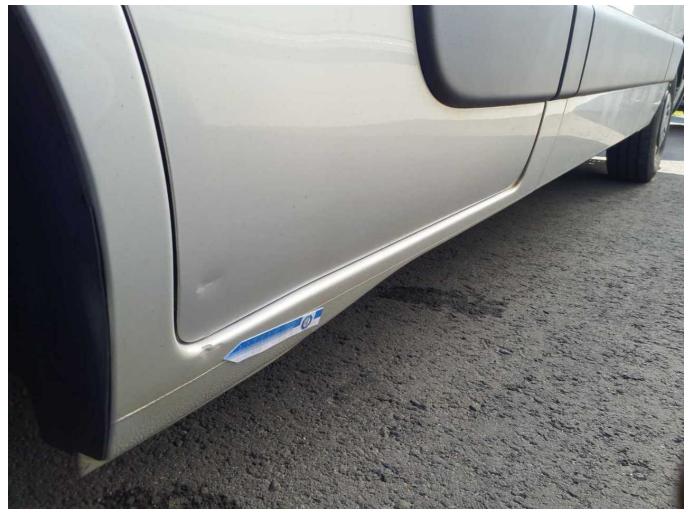
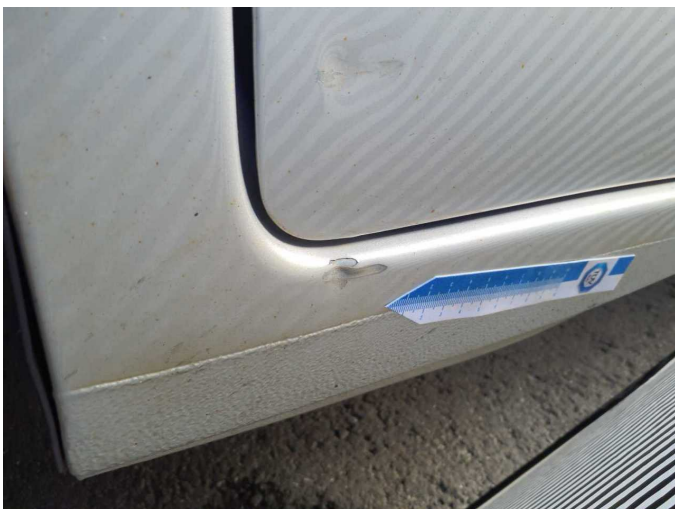
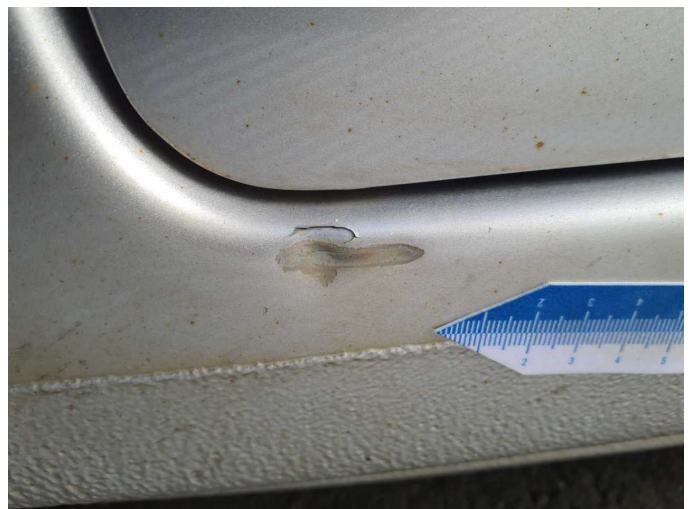
| No. | Component group | Description |
|---|---|---|
| 4 | Sill - left side | Sill - Dent / paintcoat damage - Repair and paint |

**Damage 4:** Sill - left side: Sill - Dent / paintcoat damage - Repair and paint
