Protocol number: 45445299
Order No. / Reference: 26146297
Inspection date: 4 May 2026

Manufacturer: Mercedes-Benz

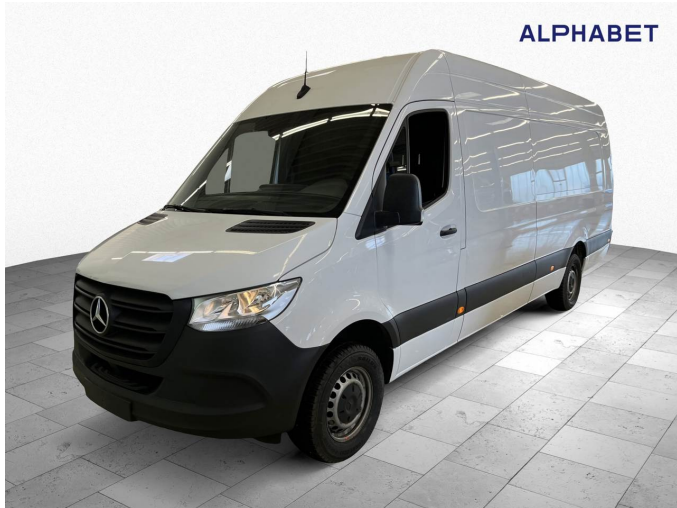
Figure 1: Diagonal front (left)

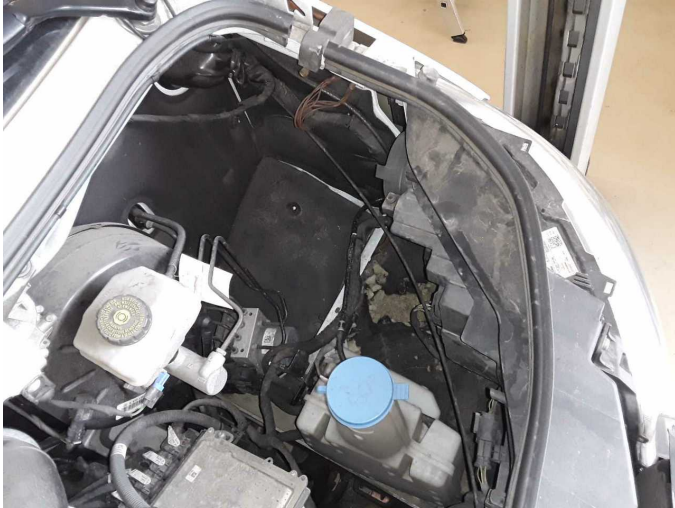
Damage 1: Cab: Insulation lining (Im Motorraum) - Broken / torn - Replace

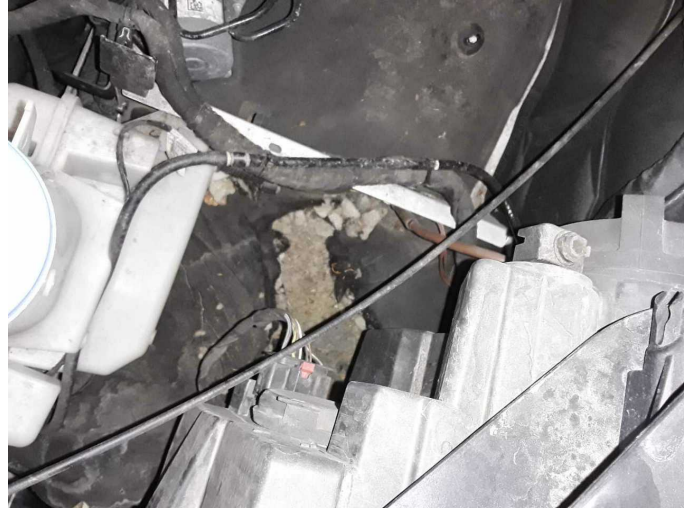
Damage 1: Cab: Insulation lining (Im Motorraum) - Broken / torn - Replace

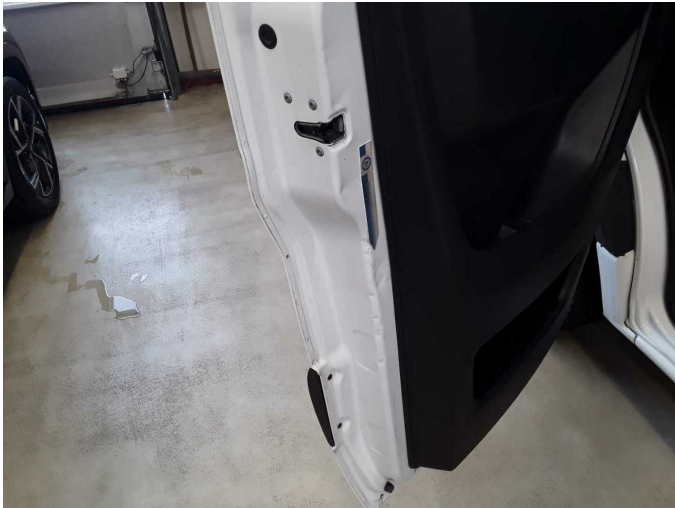
Damage 2: Door - front left side: Door (Innen) - dent(s) - Repair and paint

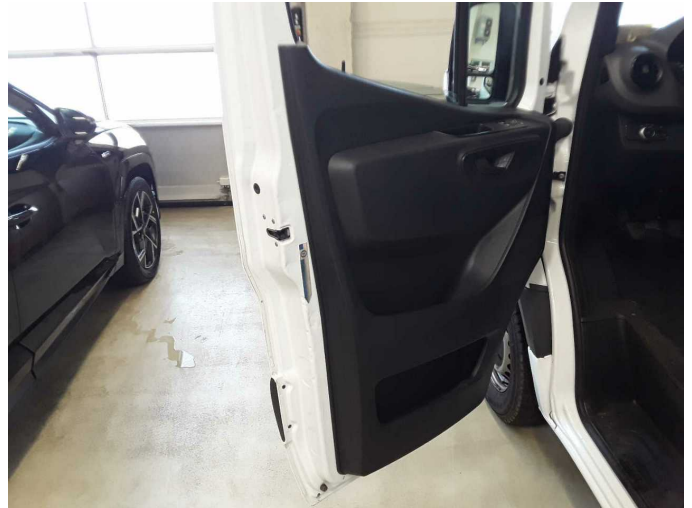
Damage 2: Door - front left side: Door (Innen) - dent(s) - Repair and paint

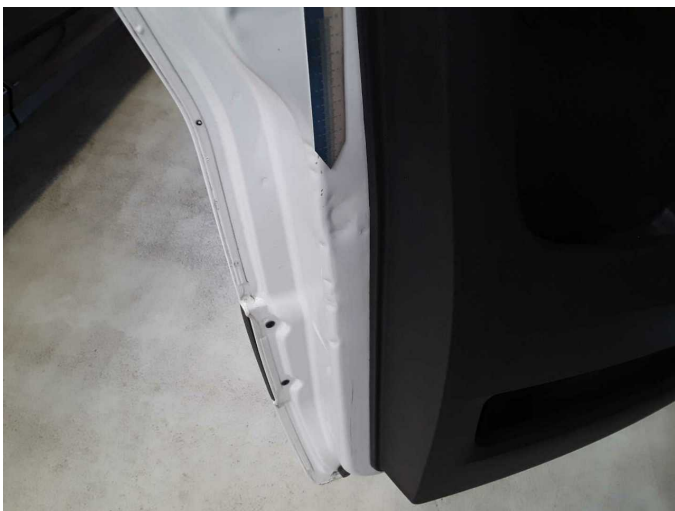
Damage 2: Door - front left side: Door (Innen) - dent(s) - Repair and paint

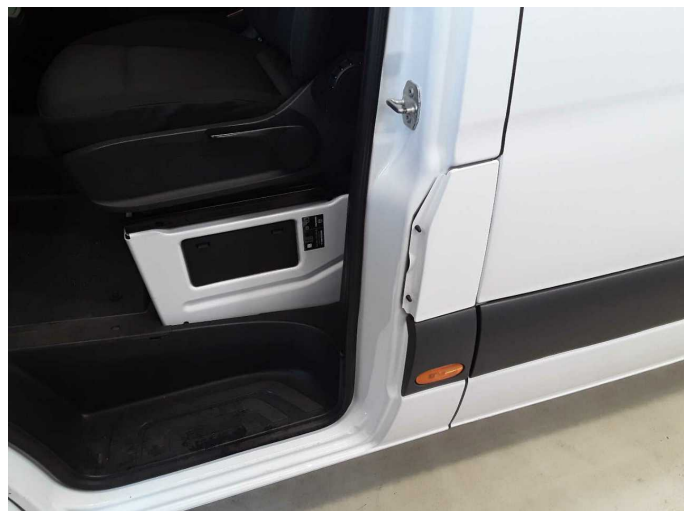
Damage 2: Door - front left side: Door (Innen) - dent(s) - Repair and paint

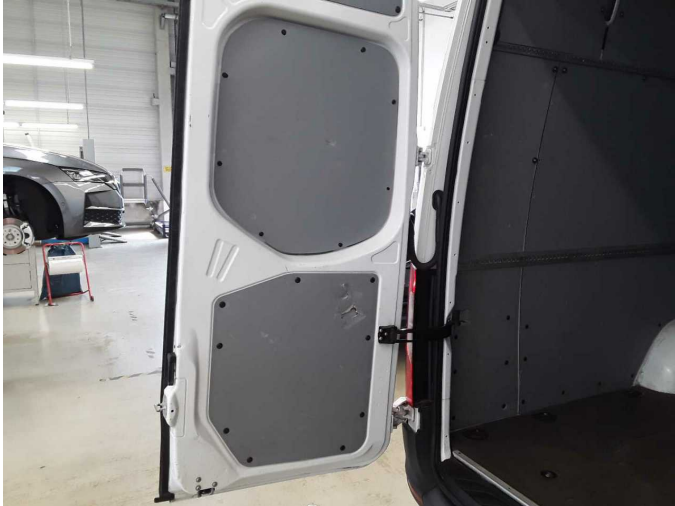
Damage 3: Trim / covers: Cargo area - lining - right side (Rechts und links und Hecktür links) - Broken / torn - Replace

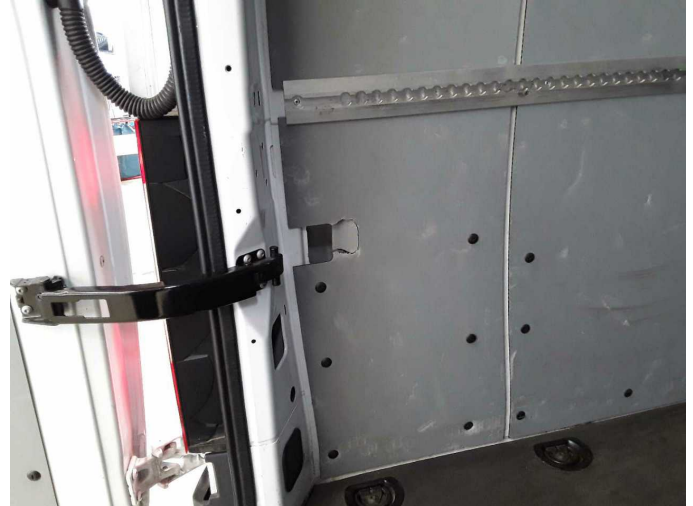
Damage 3: Trim / covers: Cargo area - lining - right side (Rechts und links und Hecktür links) - Broken / torn - Replace

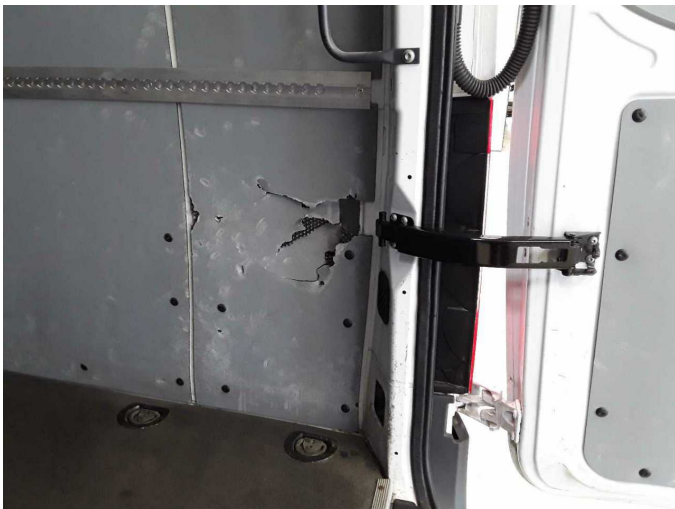
Damage 3: Trim / covers: Cargo area - lining - right side (Rechts und links und Hecktür links) - Broken / torn - Replace

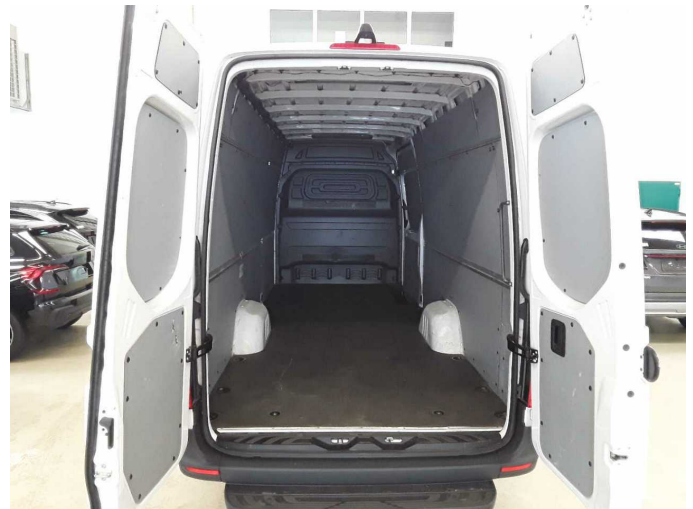
Damage 3: Trim / covers: Cargo area - lining - right side (Rechts und links und Hecktür links) - Broken / torn - Replace

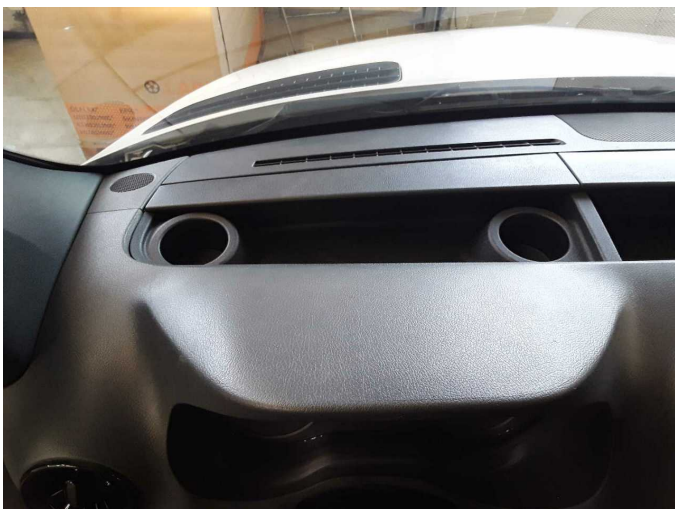
Missing part 1: Interior: Ashtray - front - Missing - Replace

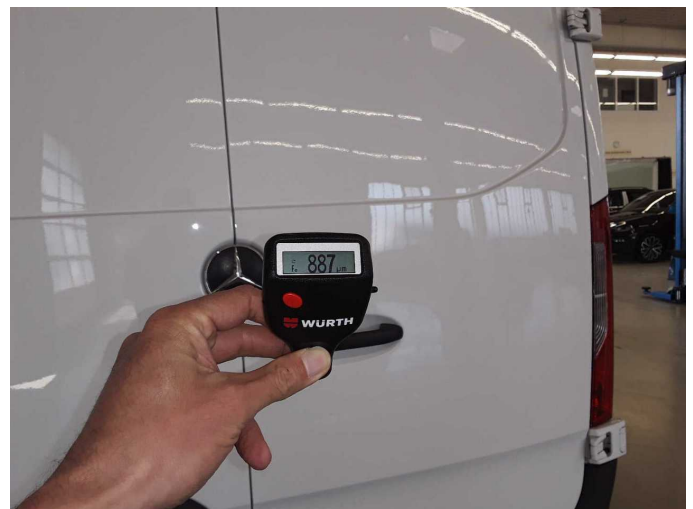
Boot lid / rear door: 887 µm
