Expertise

Protocol number: 46454328  
Order No. / Reference: 26691915  
Inspection date: 9 Jul 2026

Manufacturer: Ford

Model: Mondeo Turnier 2.0 EcoBlue Aut. Titanium

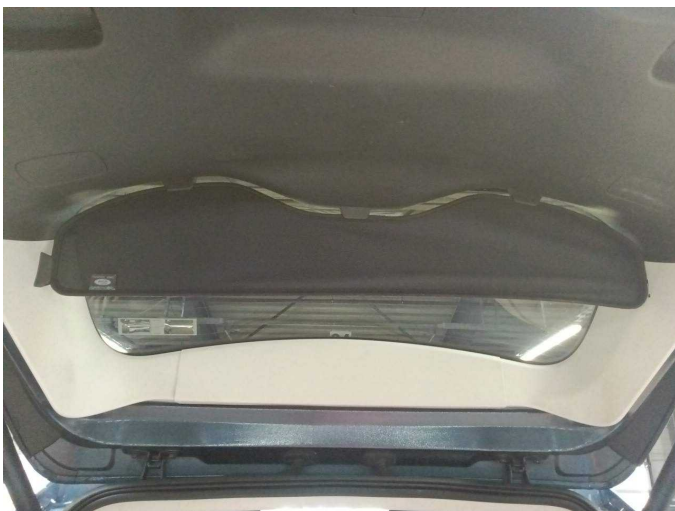
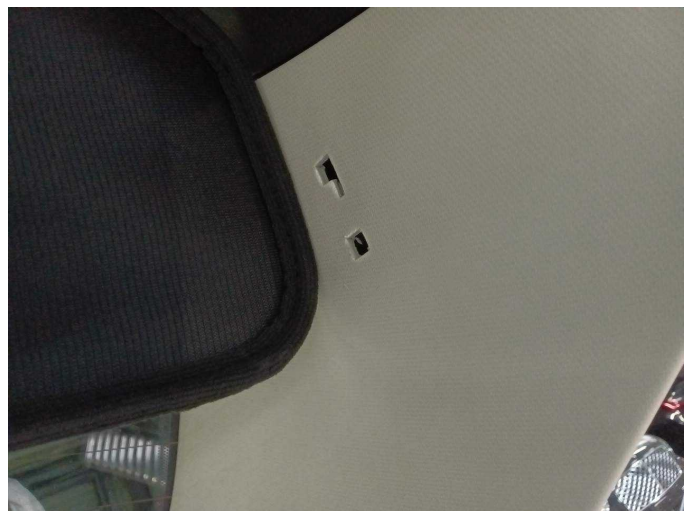
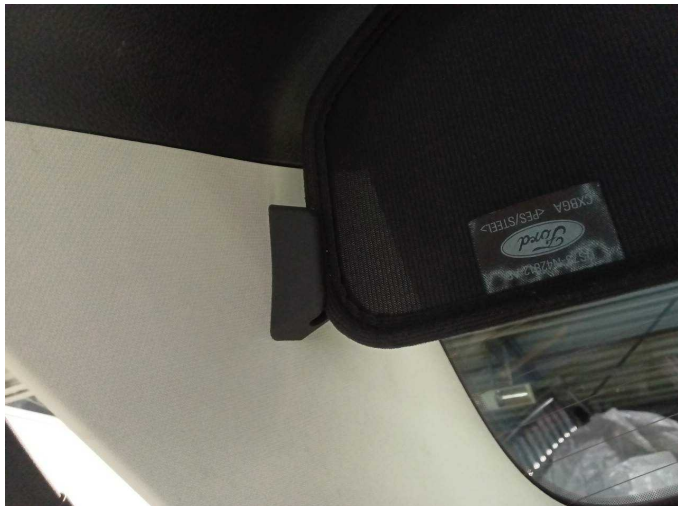
| No. | Component group | Description |
|---|---|---|
| 1 | Misc. | Misc. (Sonnenblende befestigung) - Missing - Replace |

Damage 1: Misc.: Misc. (Sonnenblende befestigung) - Missing - Replace

**Damage 1:** Misc.: Misc. (Sonnenblende befestigung) - Missing - Replace

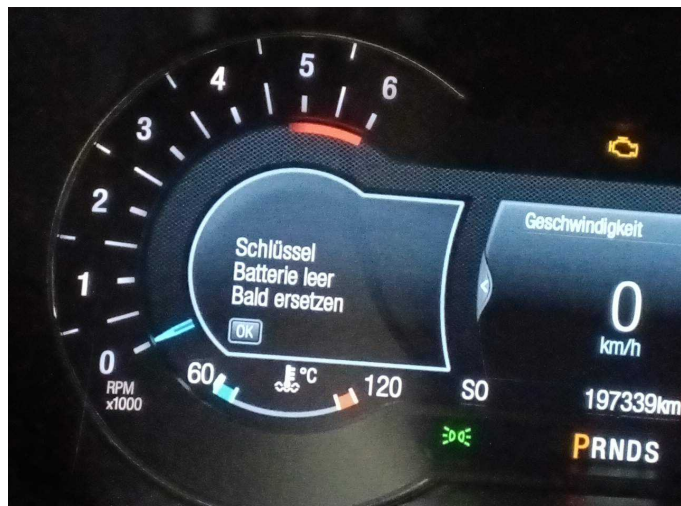
| No. | Component group | Description |
|---|---|---|
| 2 | Equipment | Vehicle key (Schlüsselbatterie wechseln) - Non-operational - Replace |

**Damage 2:** Equipment: Vehicle key (Schlüsselbatterie wechseln) - Non-operational - Replace

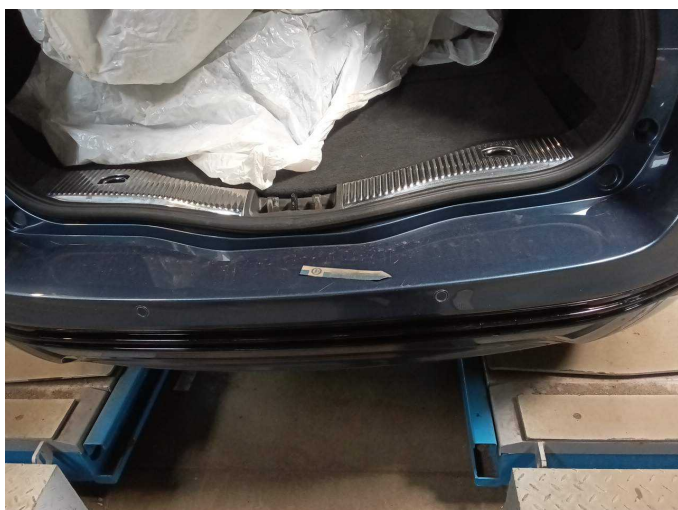
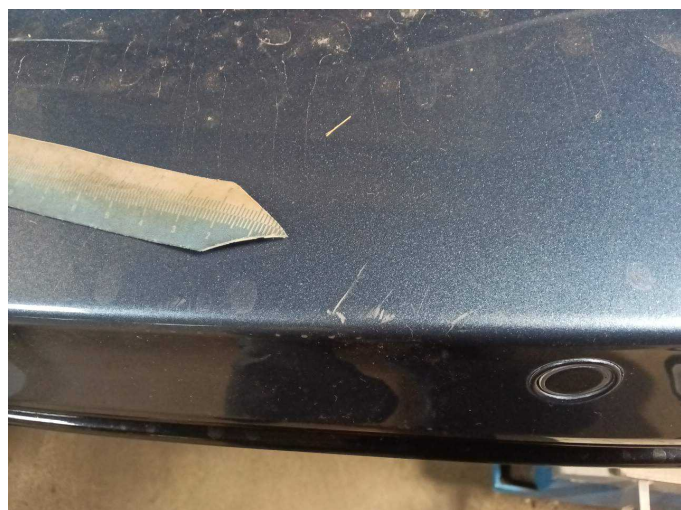
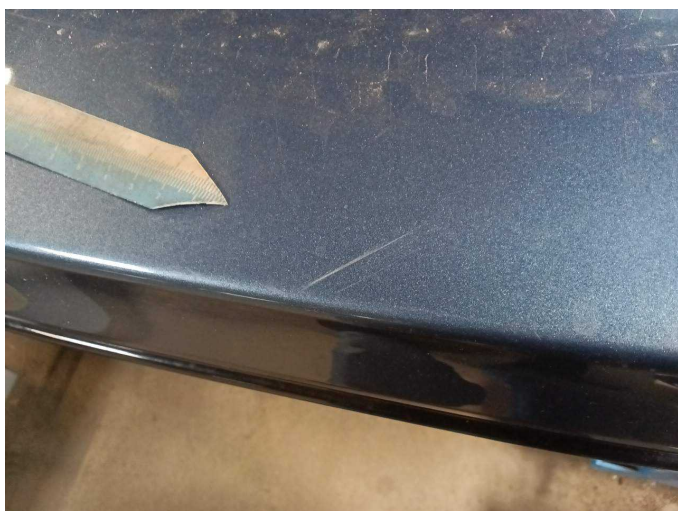
| No. | Component group | Description |
|---|---|---|
| 3 | Rear bumper | Rear bumper - Scratch(es) - Smart repair |

**Damage 3:** Rear bumper: Rear bumper - Scratch(es) - Smart repair

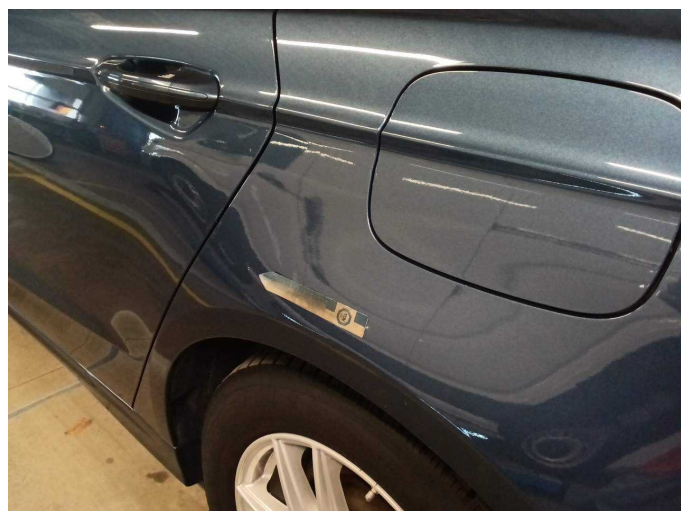
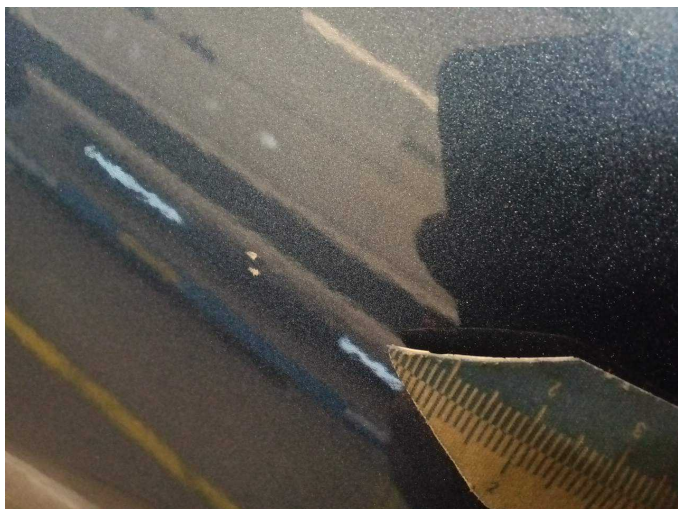
| No. | Component group | Description |
|---|---|---|
| 4 | Side panel - rear left side | Side panel - Scratch(es) - Smart repair |

**Damage 4:** Side panel - rear left side: Side panel - Scratch(es) - Smart repair

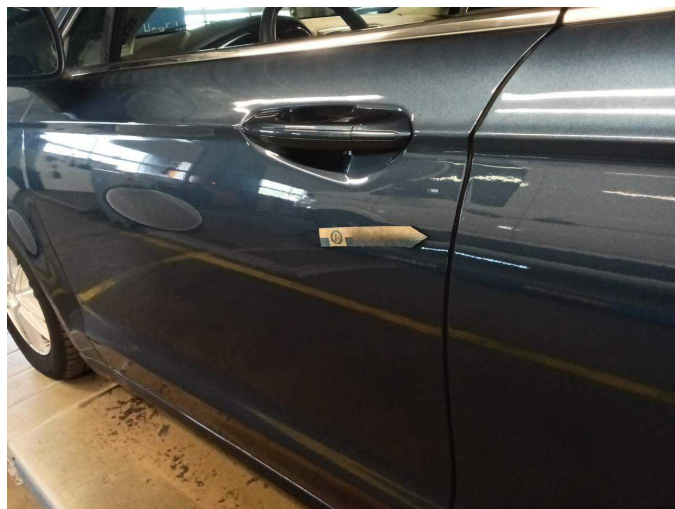
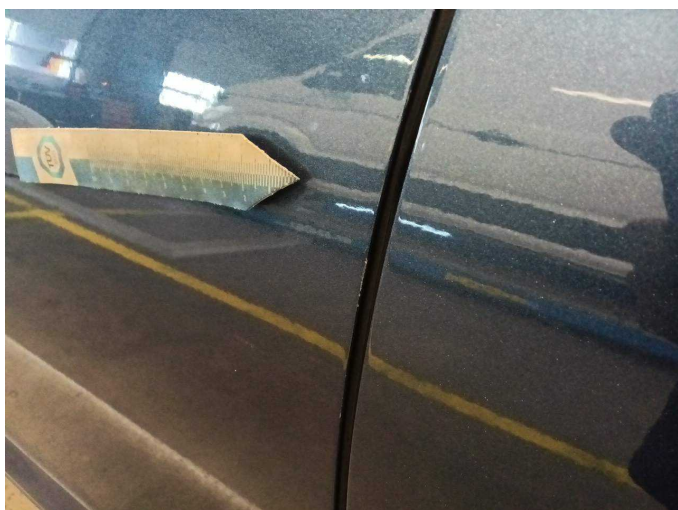
| No. | Component group | Description |
|---|---|---|
| 5 | Door - front left side | Door edge - Scratch(es) - Smart repair |

**Damage 5:** Door - front left side: Door edge - Scratch(es) - Smart repair

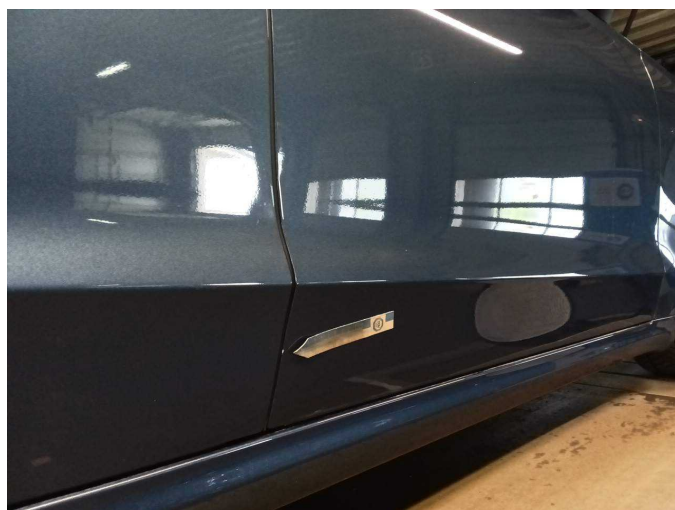
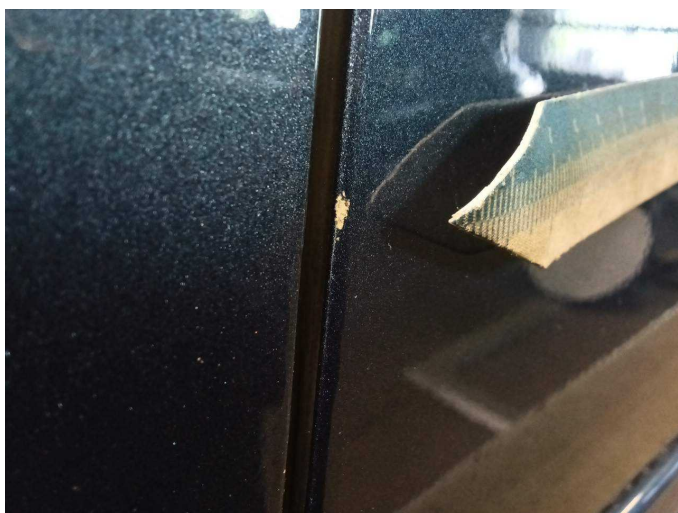
| No. | Component group | Description |
|---|---|---|
| 6 | Door - front right side | Door edge - Scratch(es) - Smart repair |

**Damage 6:** Door - front right side: Door edge - Scratch(es) - Smart repair

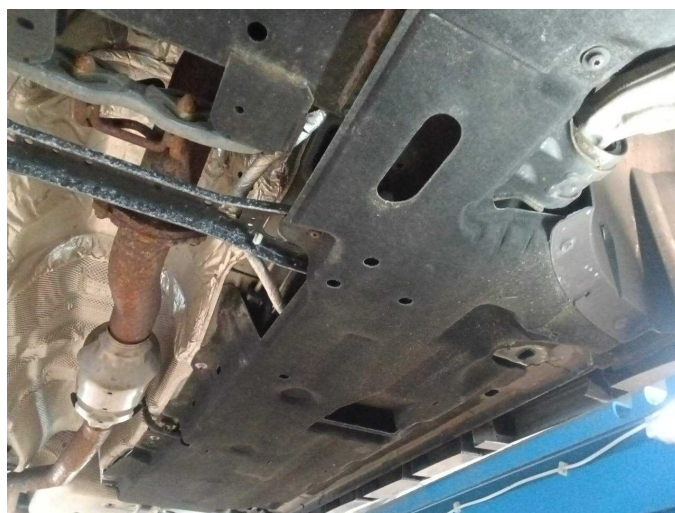
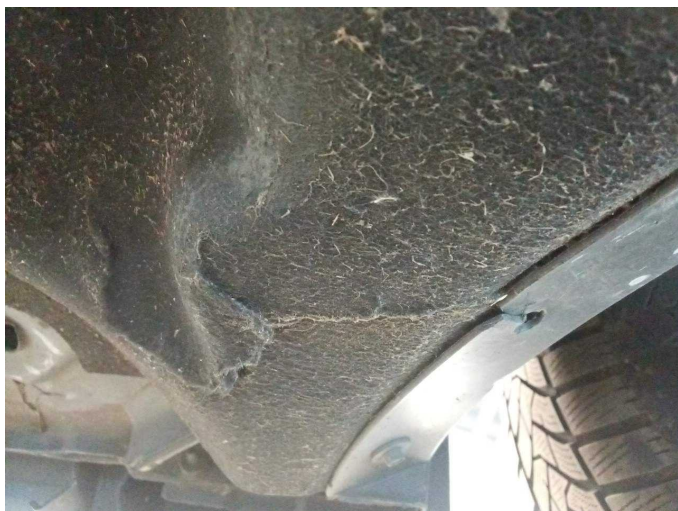
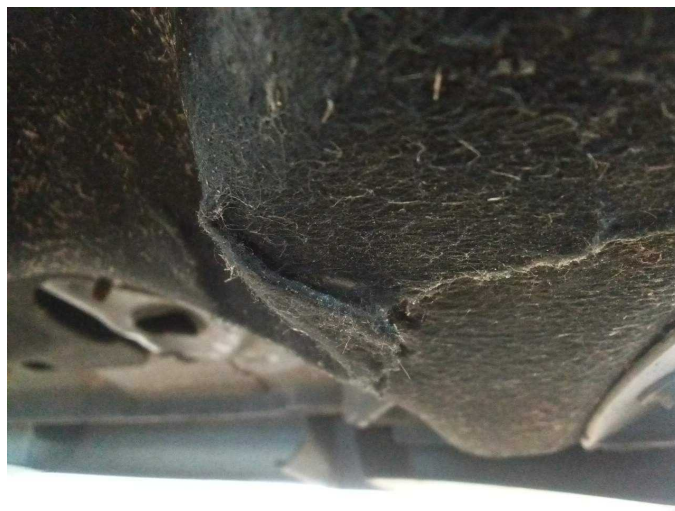
| No. | Component group | Description |
|---|---|---|
| 1 | Body | Underbody panelling - Holes - No deduction |

**Wear and tear 1:** Body: Underbody panelling - Holes - No deduction

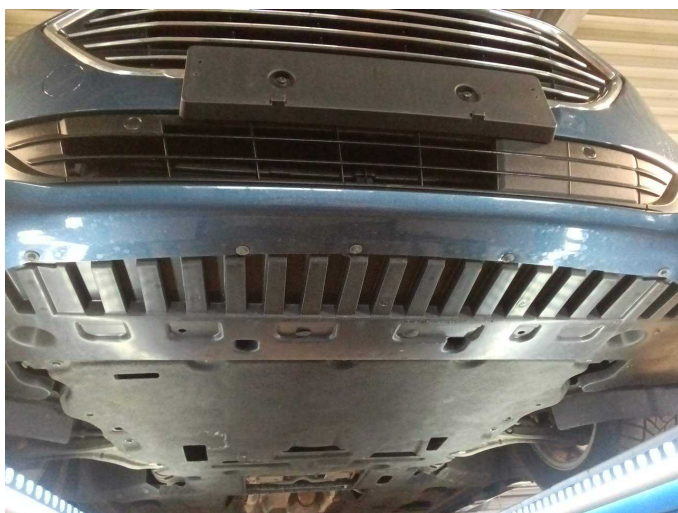
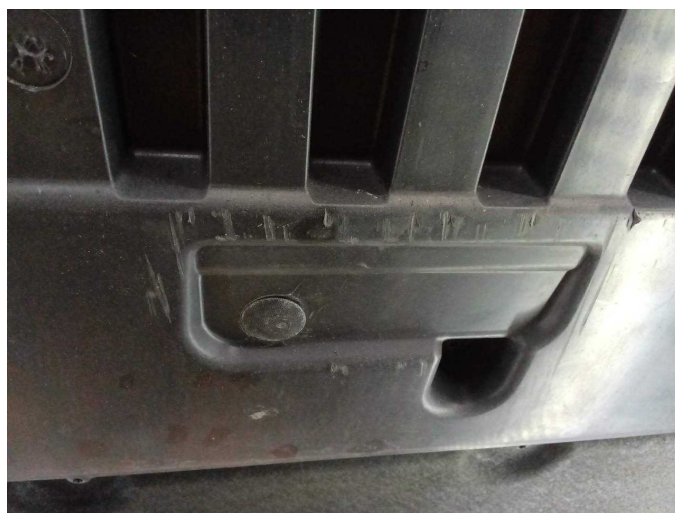
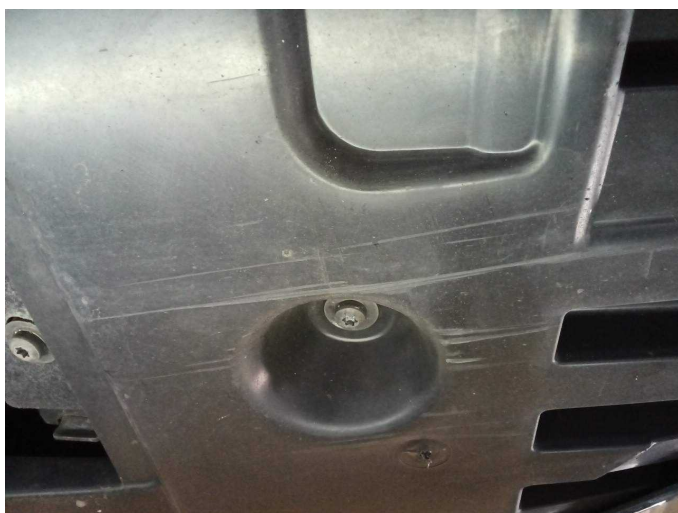
| No. | Component group | Description |
|---|---|---|
| 2 | Body | Underbody panelling - Scratched - No deduction |

**Wear and tear 2:** Body: Underbody panelling - Scratched - No deduction

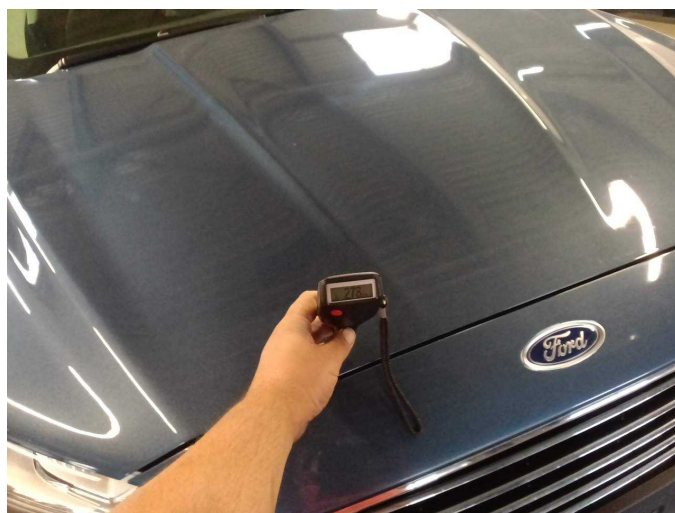
| Bonnet | 278 µm | Door - rear left side | 162 µm |

**Bonnet:** 278 µm

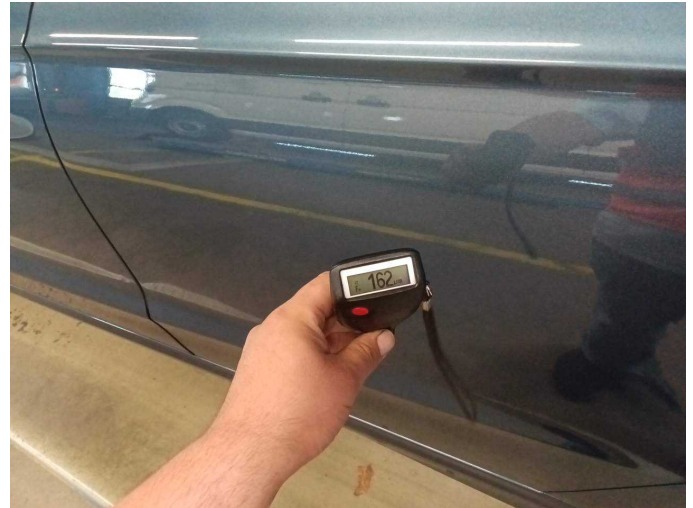
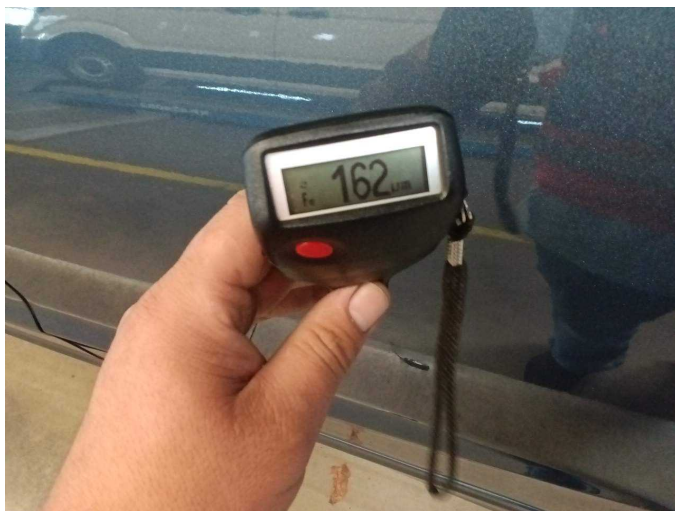
**Door - rear left side:** 162  $\mu\text{m}$
