Expertise

Protocol number: 46324629  
Order No. / Reference: 26628768  
Inspection date: 3 Jul 2026

Model: Combo Cargo 1.5 D Edition

VIN: W0VEFYHT2MJ910137

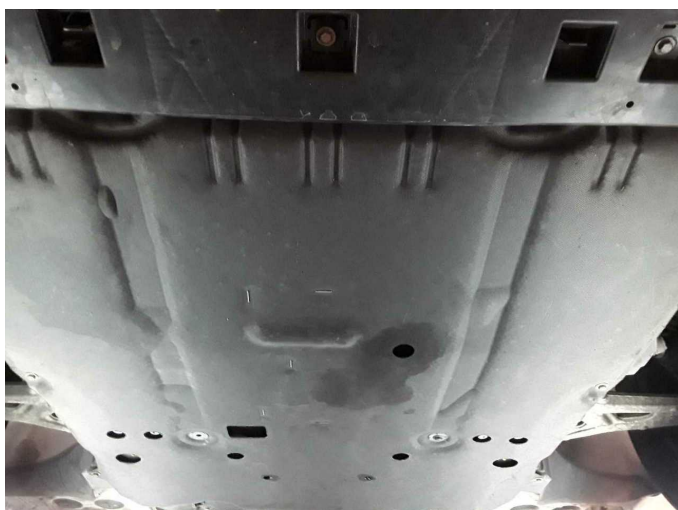
| No. | Component group | Description |
|---|---|---|
| 1 | Engine | Engine - Leaking - Diagnosed and repair if necessary |

**Damage 1:** Engine: Engine - Leaking - Diagnosed and repair if necessary

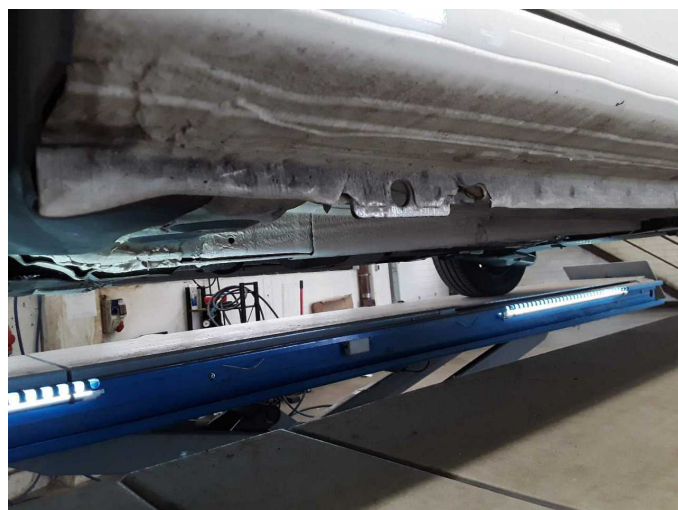
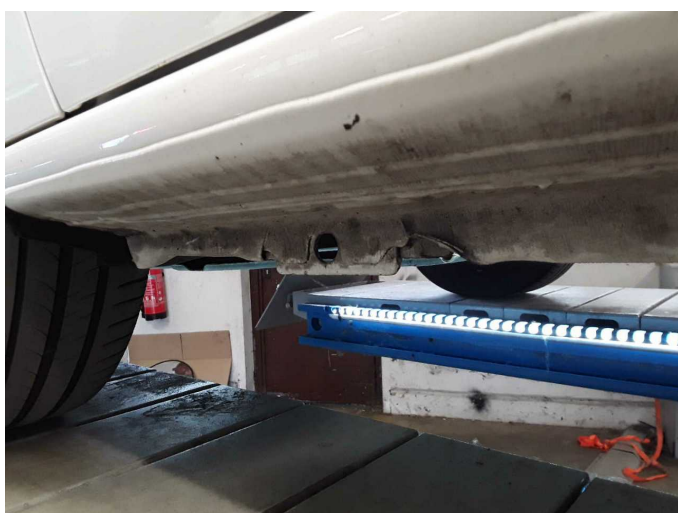
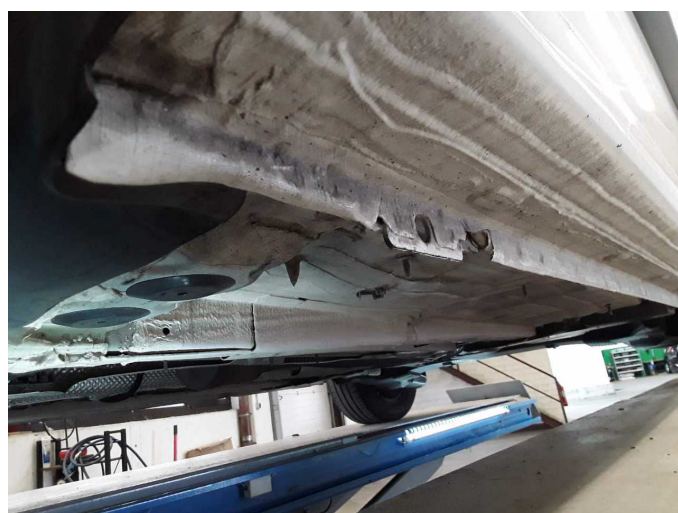
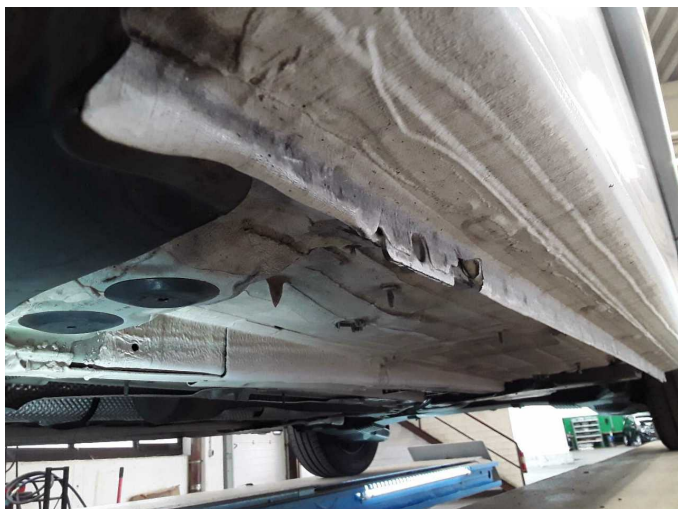
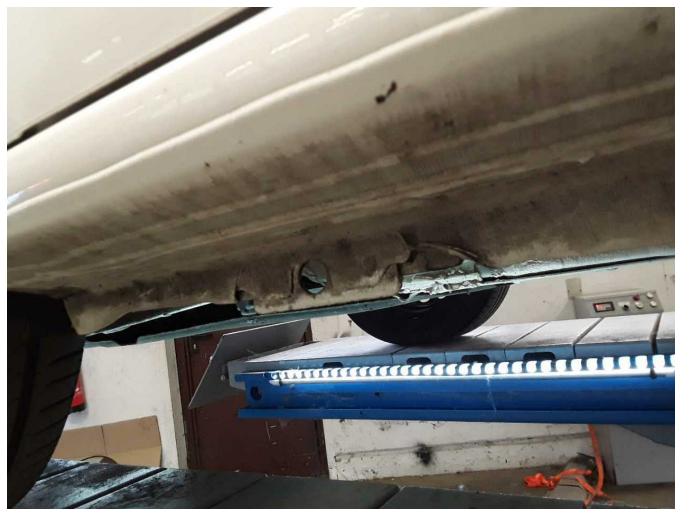
| No. | Component group | Description |
|---|---|---|
| 2 | Sill - left side | Sill - Deformed - Repair and paint |

**Damage 2:** Sill - left side: Sill - Deformed - Repair and paint

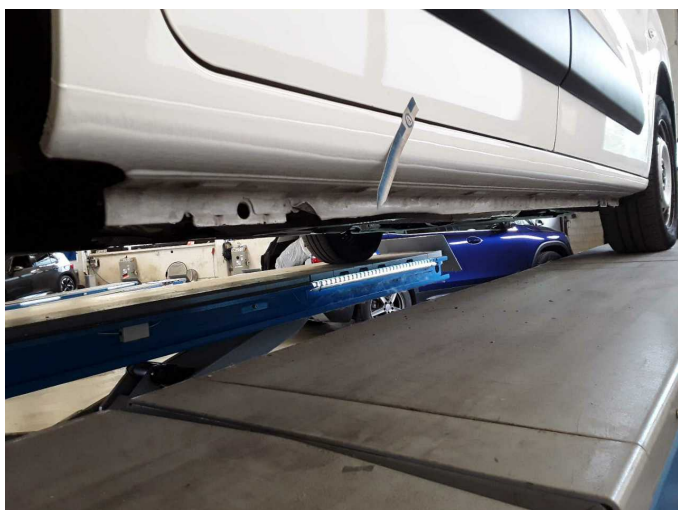
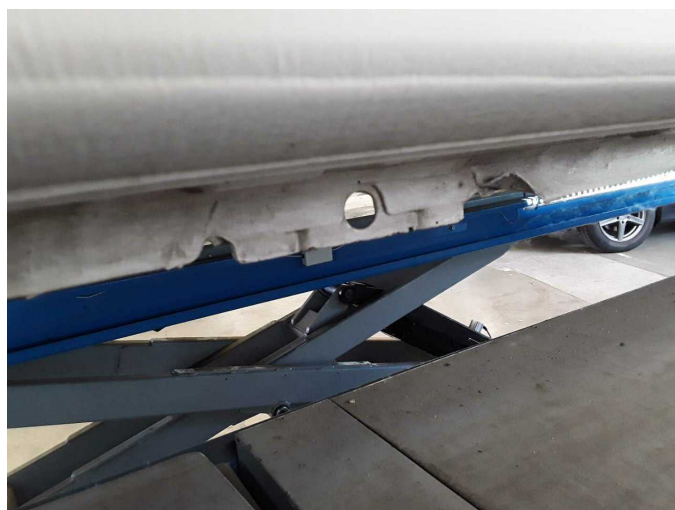
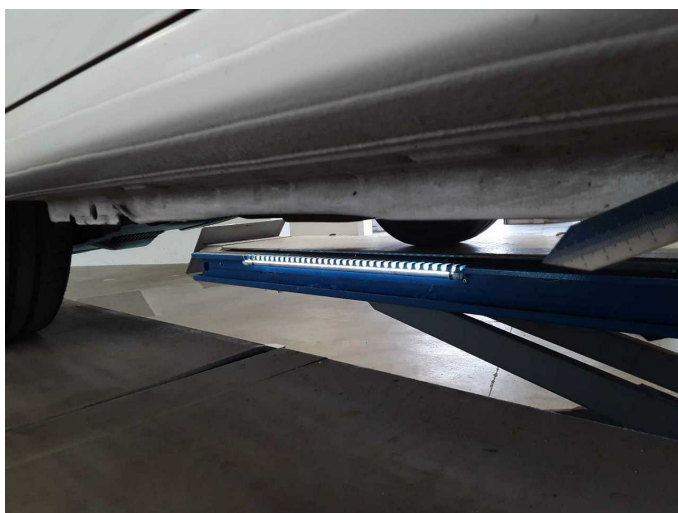
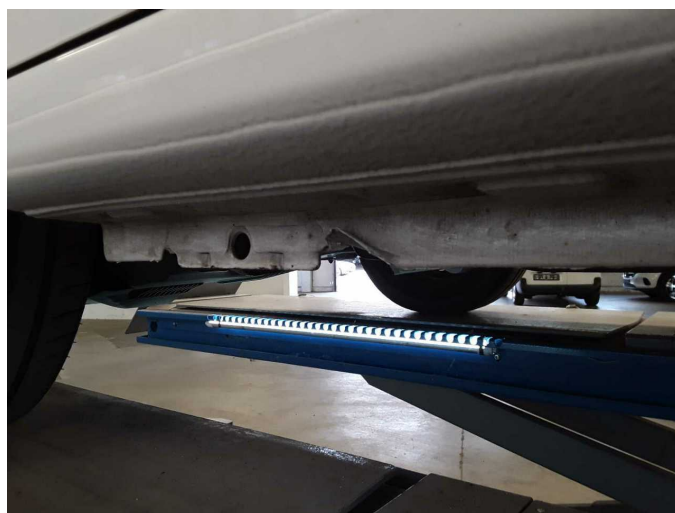
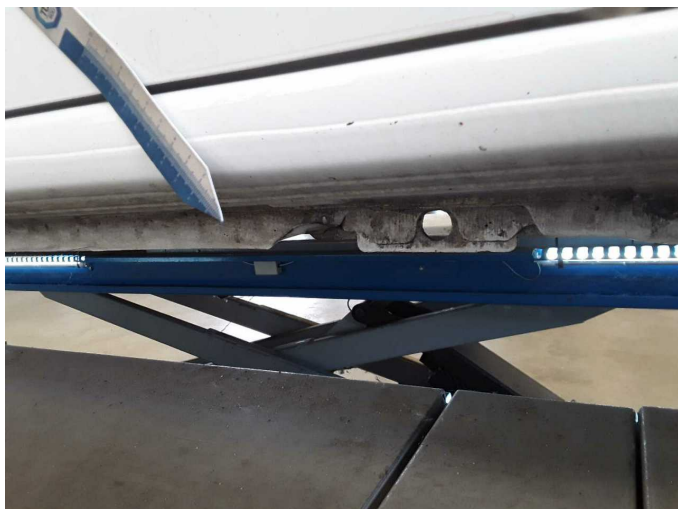
| No. | Component group | Description |
|---|---|---|
| 3 | Sill - right side | Sill - Deformed - Repair and paint |

**Damage 3:** Sill - right side: Sill - Deformed - Repair and paint

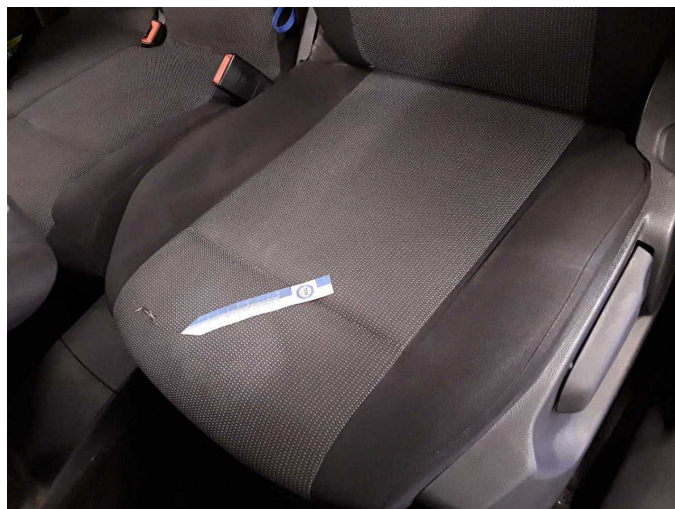
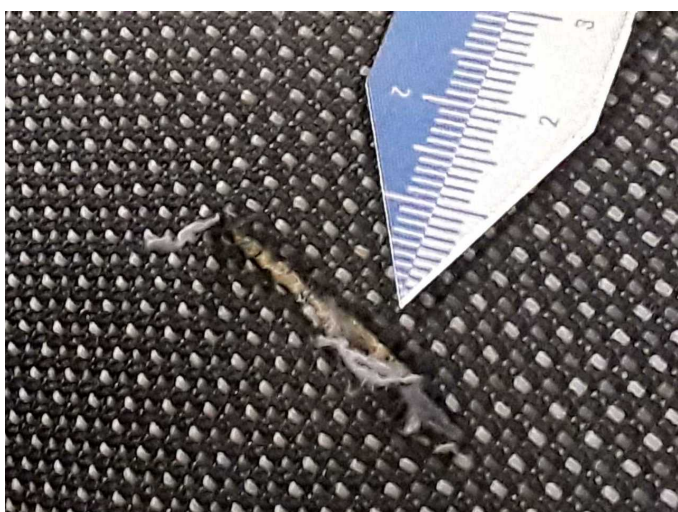
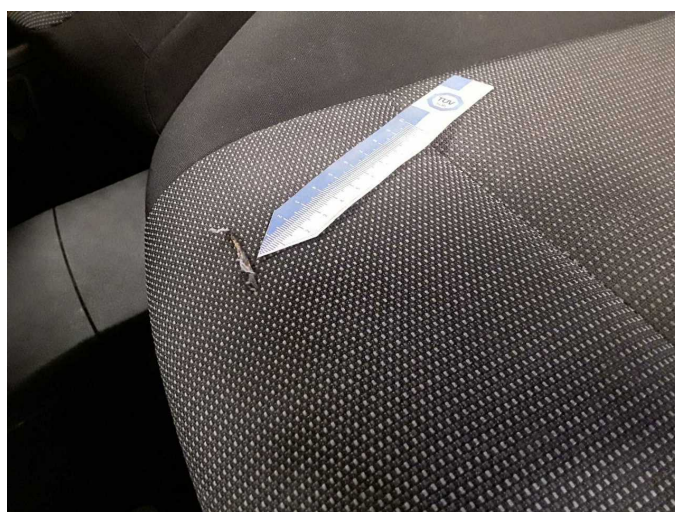
| No. | Component group | Description |
|---|---|---|
| 4 | Seat - front | Seat cover - left side - Porous / cracked - Replace |

**Damage 4:** Seat - front: Seat cover - left side - Porous / cracked - Replace

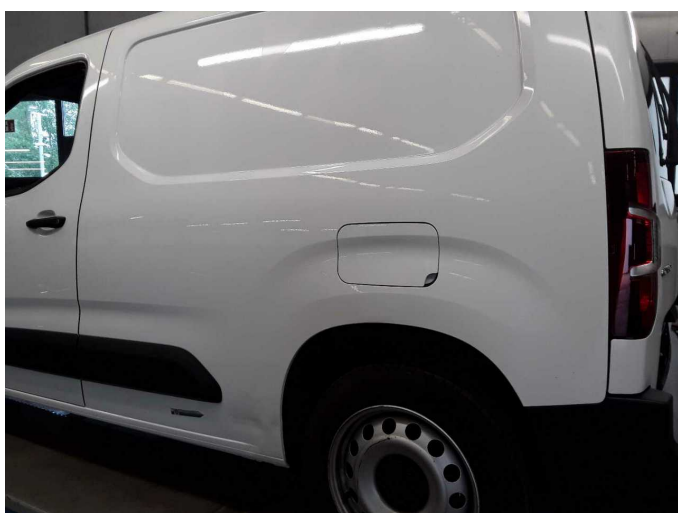
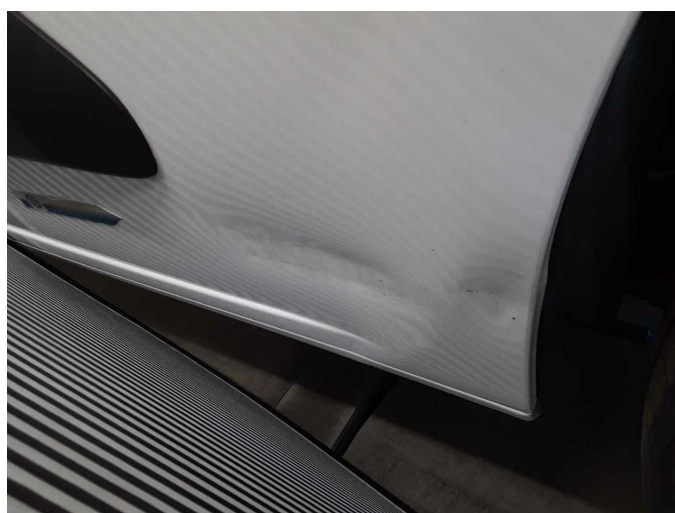
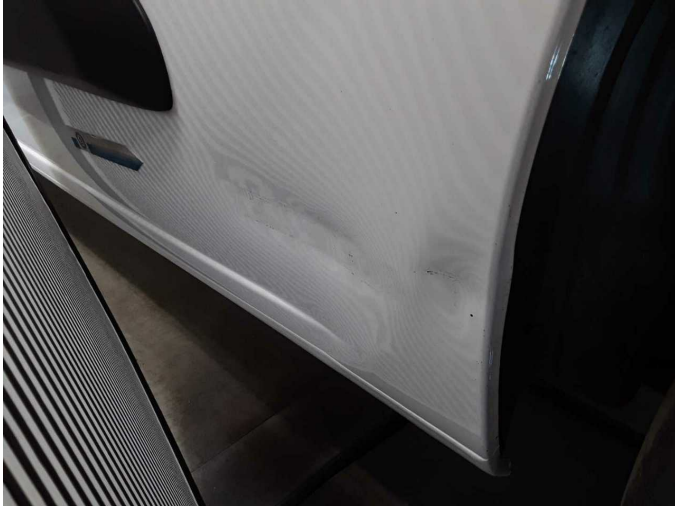
| No. | Component group | Description |
|---|---|---|
| 5 | Side panel - rear left side | Side panel - Dent / paintcoat damage - Repair and paint |

**Damage 5:** Side panel - rear left side: Side panel - Dent / paintcoat damage - Repair and paint

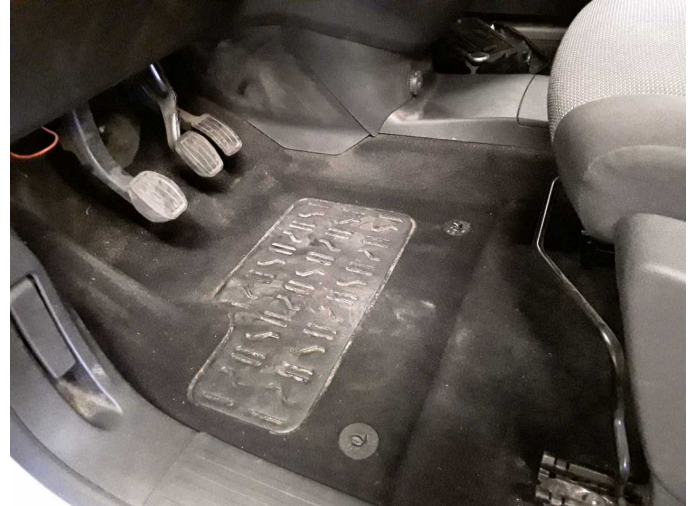
Trim / covers - Floor mats

**Missing part 1:** Trim / covers: Floor mats - Missing - Replace
