## Expertise

Protocol number: 45894795  
Order No. / Reference: 26433469  
Inspection date: 8 Jun 2026

Manufacturer: Ford

Model: Focus Turnier 2.0 EcoBlue Start-Stopp-System Aut.  
COOL&CONNECT

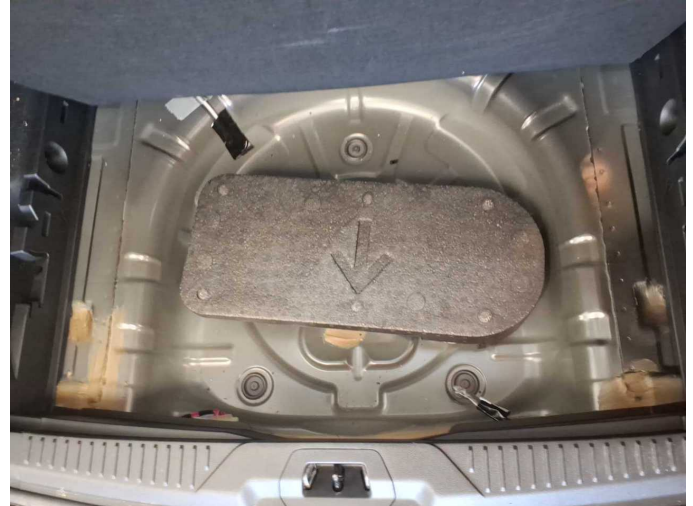
Damage 1: Electrical system: Cable strand ((Kabelführung für Frontbereich im Laderaum)) - Specify findings - Remove

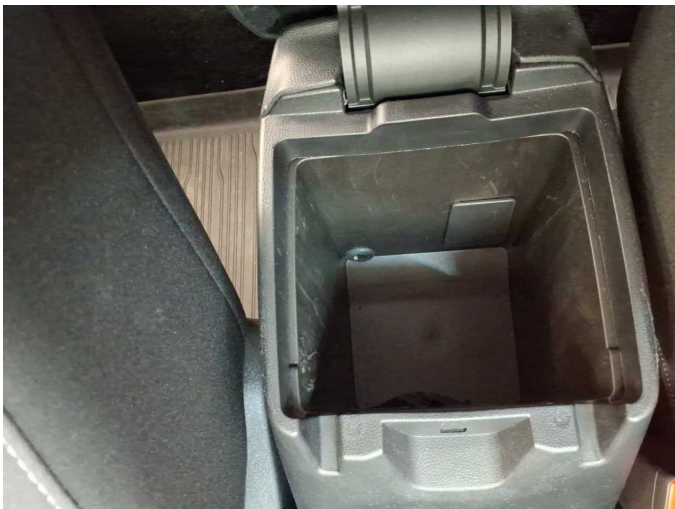
Damage 2: Interior: Arm rest, front (Deckel Hinten) - Differs from the original configuration - Replace

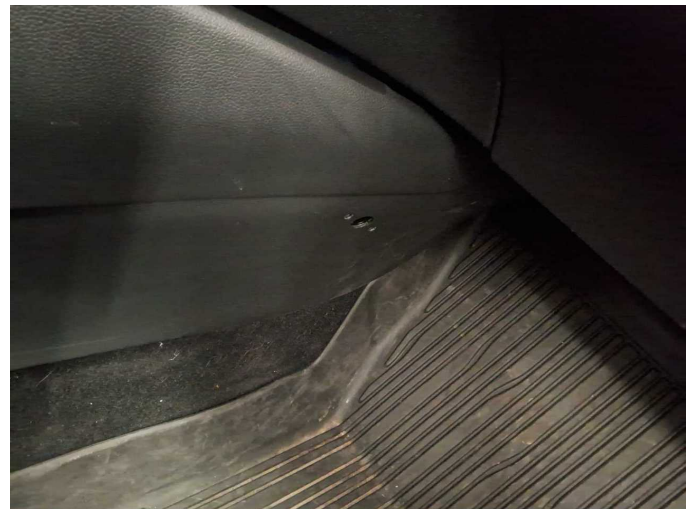
Damage 3: Instrument panel: Centre console - front (Blende vorne rechts) - Differs from the original configuration - Replace

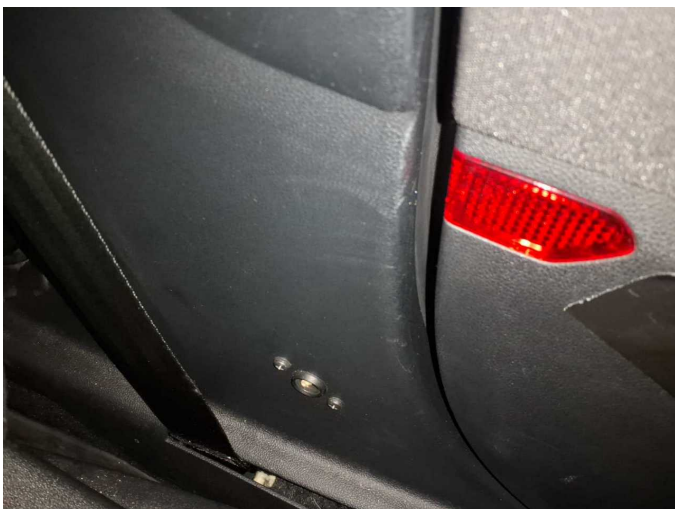
Damage 4: Trim / covers: B-pillar - trim - interior, left side - Differs from the original configuration - Replace

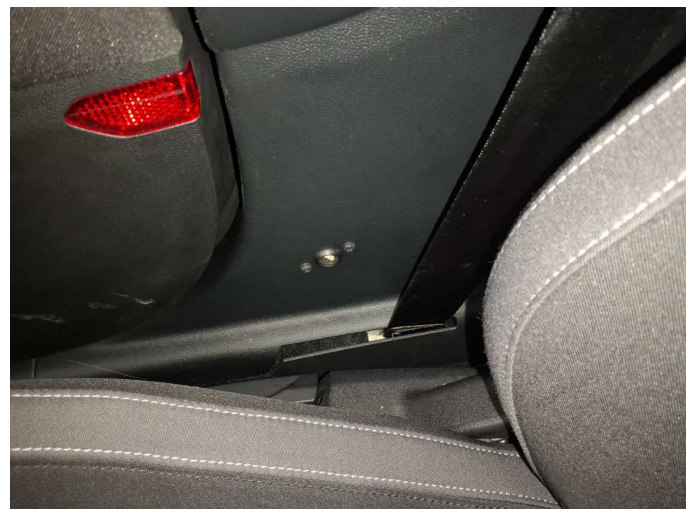
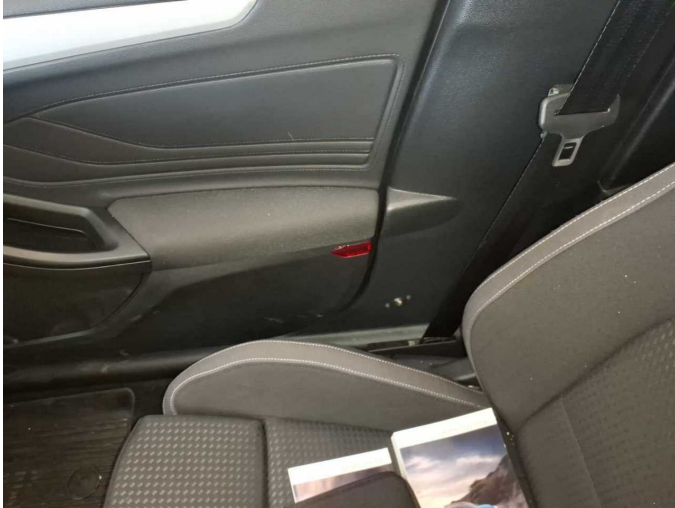
Damage 5: Trim / covers: B-pillar - trim - interior, right side - Differs from the original configuration - Replace

**Damage 5:** Trim / covers: B-pillar - trim - interior, right side - Differs from the original configuration - Replace

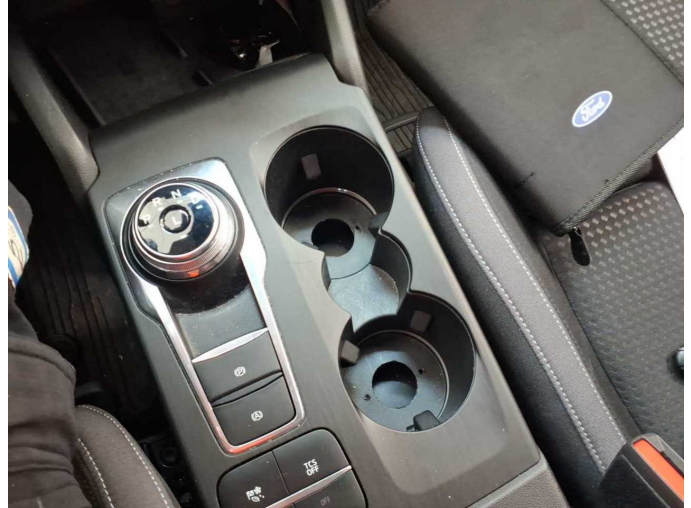
**Damage 6:** Instrument panel: Centre console - front ((Fehlbohrung)) - Differs from the original configuration - Replace

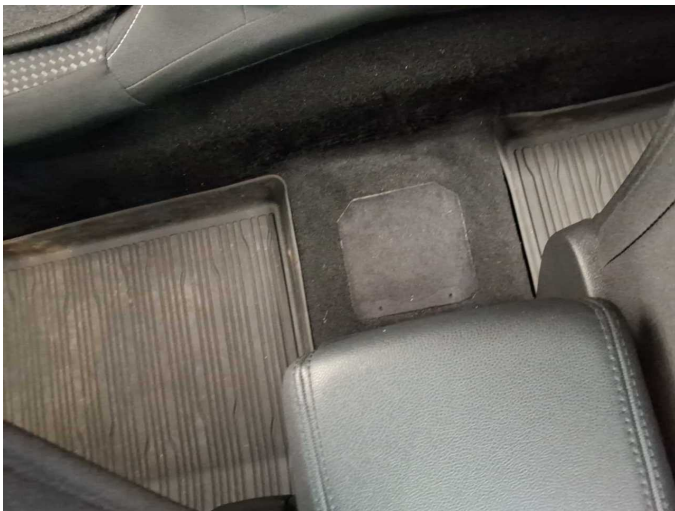
**Damage 7:** Trim / covers: Carpet - Differs from the original configuration - Replace

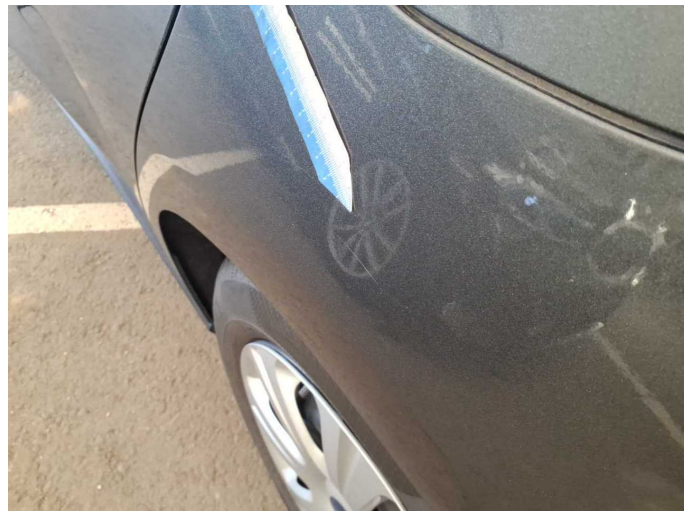
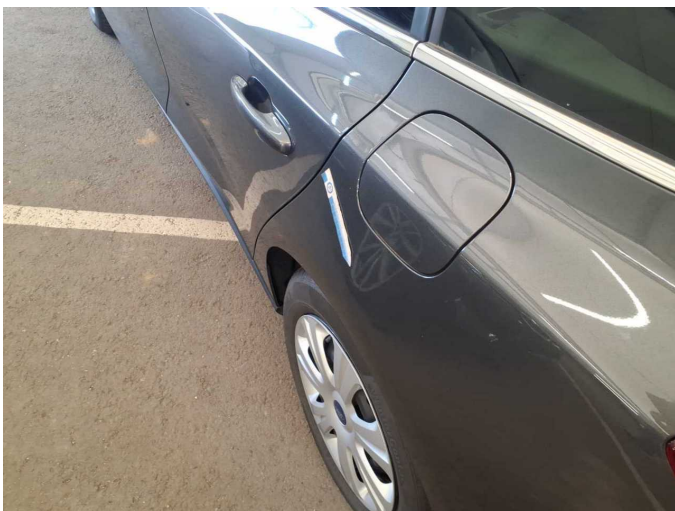
**Damage 8:** Side panel - rear left side: Side panel - Scratch(es) - Paint

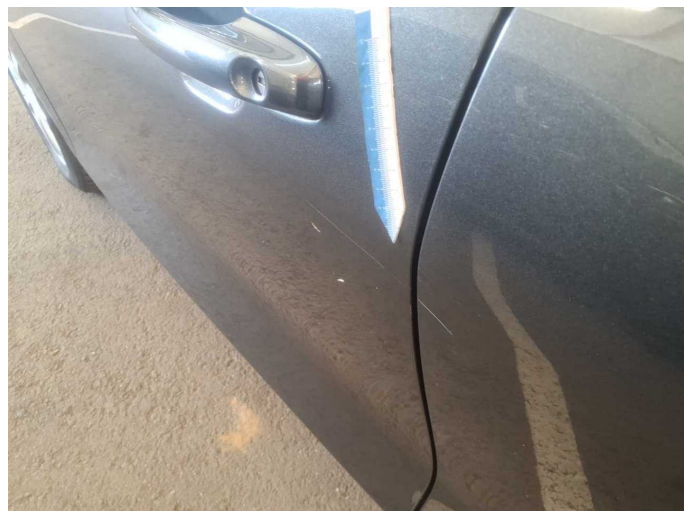
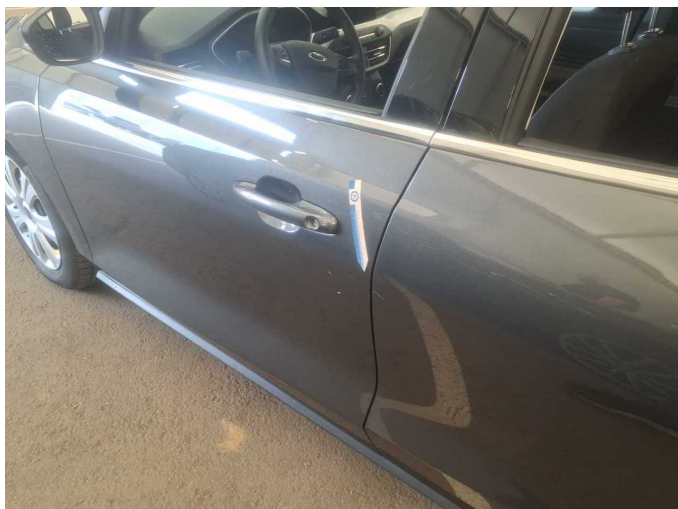
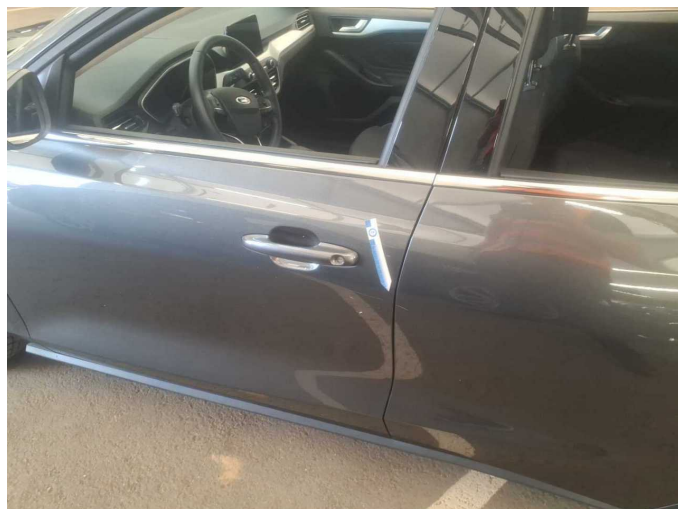
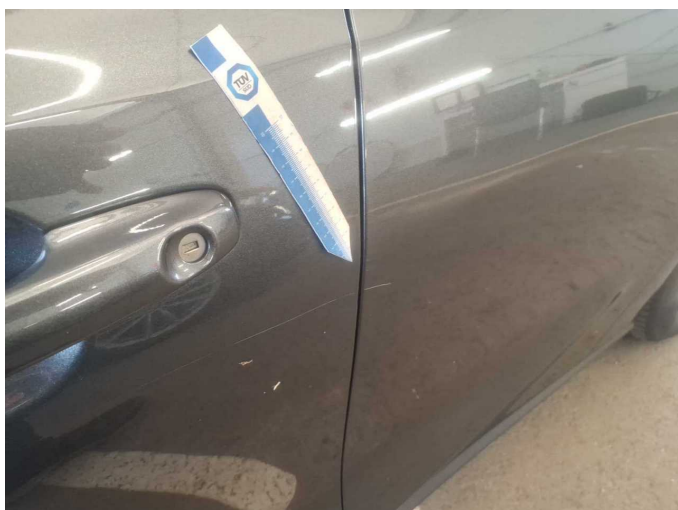
**Accident 1:** Side - left

**Accident 1: Side - left**
