Expertise

Protocol number: 46930835  
Order No. / Reference: 26852162  
Inspection date: 5 Aug 2026

| Manufacturer: Opel | Model: Crossland 1.5 Diesel Automatik Ultimate |
| VIN: W0V7H9EJ2M4379584 | |

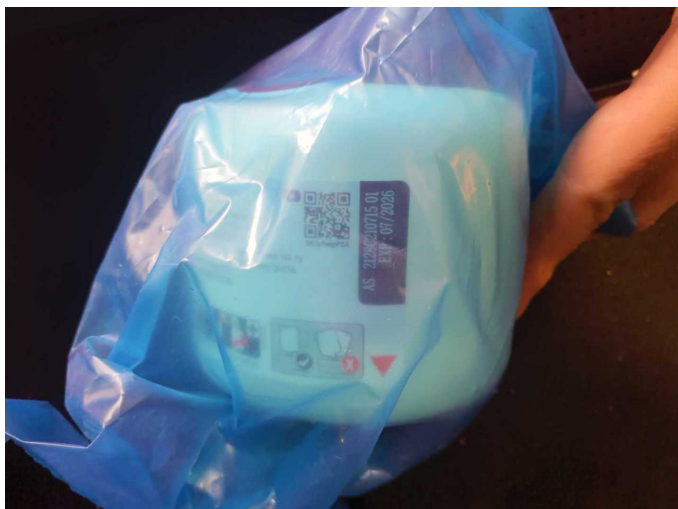
| No. | Component group | Description |
|---|---|---|
| 1 | Equipment | Tirefit filler - Expired - Replace |

**Damage 1:** Equipment: Tirefit filler - Expired - Replace

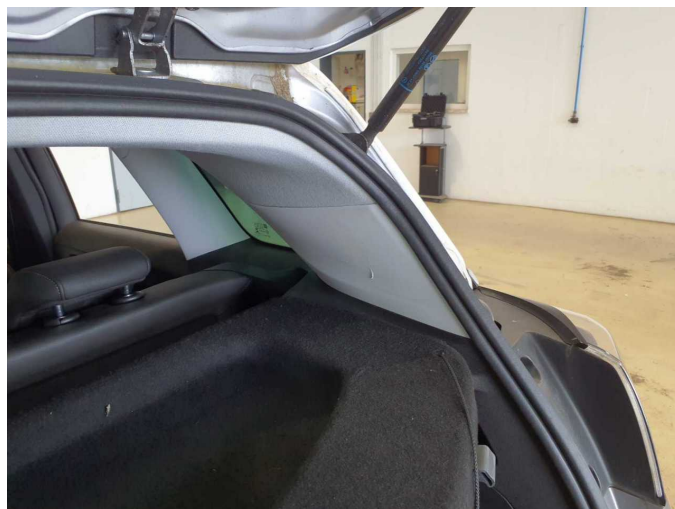
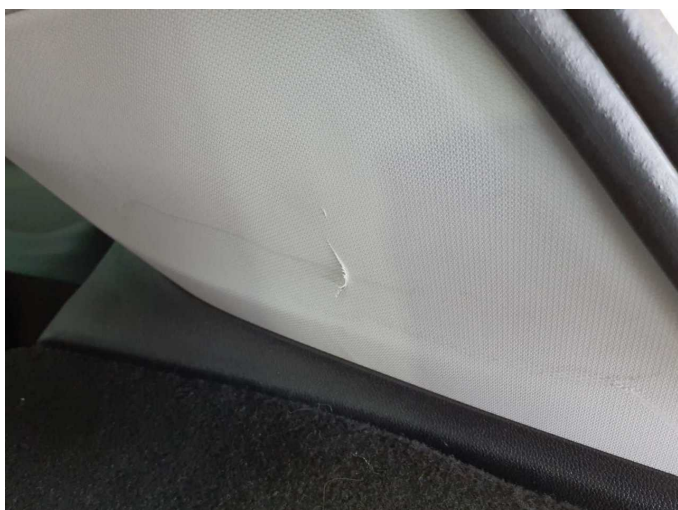
| No. | Component group | Description |
|---|---|---|
| 2 | Trim / covers | Cargo area - lining - right side - Scratch(es) - Loss in value |

**Damage 2:** Trim / covers: Cargo area - lining - right side - Scratch(es) - Loss in value

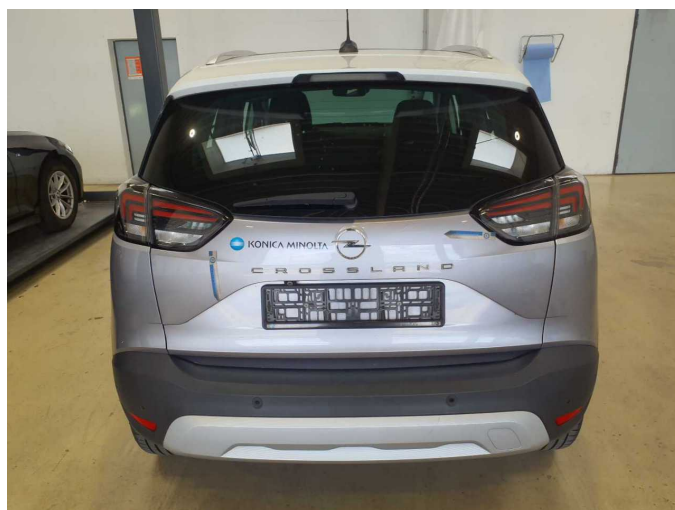
| No. | Component group | Description |
|---|---|---|
| 3 | Body | Body - Glued / labelled - De-glue / neutralise |

**Damage 3:** Body: Body - Glued / labelled - De-glue / neutralise

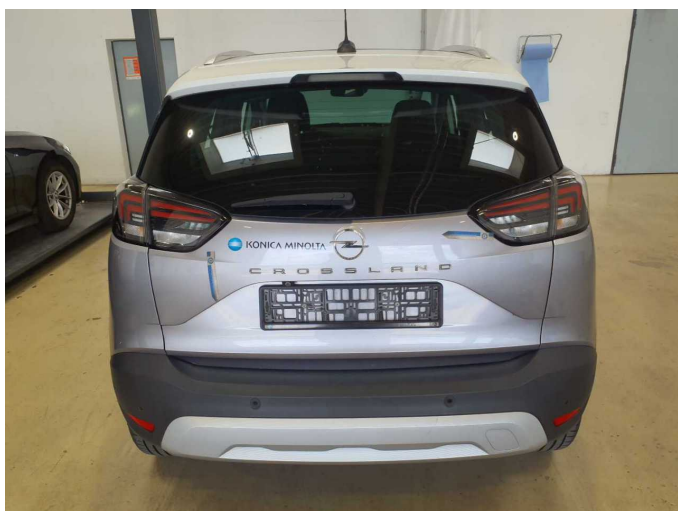
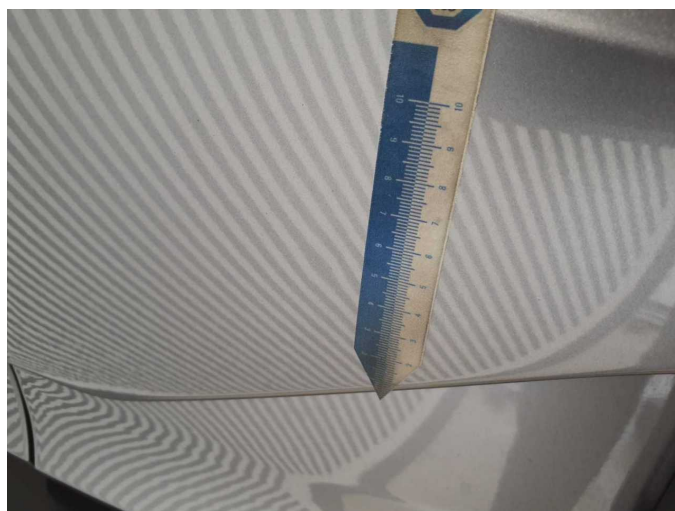
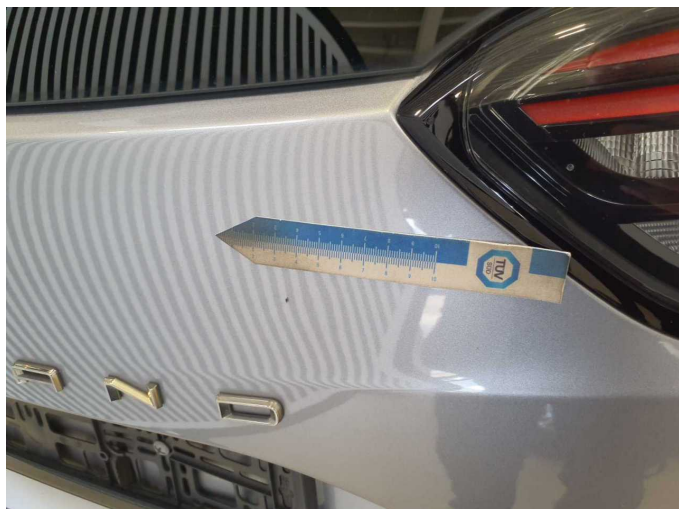
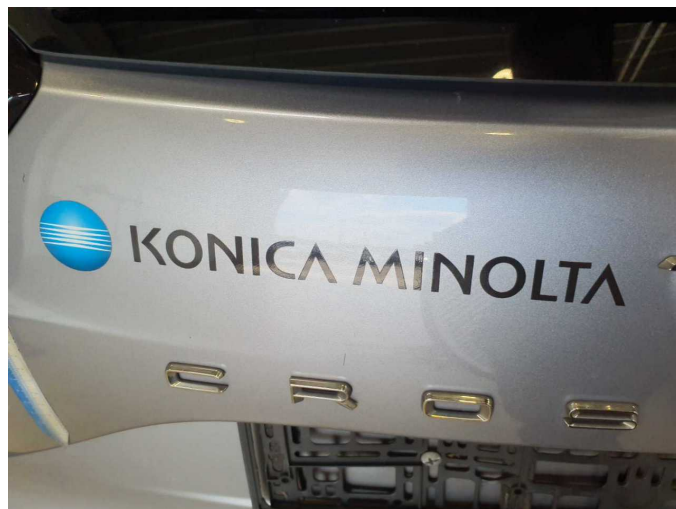
| No. | Component group | Description |
|---|---|---|
| 4 | Boot lid / rear door | Boot lid - dent(s) - Smooth repair work |

**Damage 4:** Boot lid / rear door: Boot lid - dent(s) - Smooth repair work

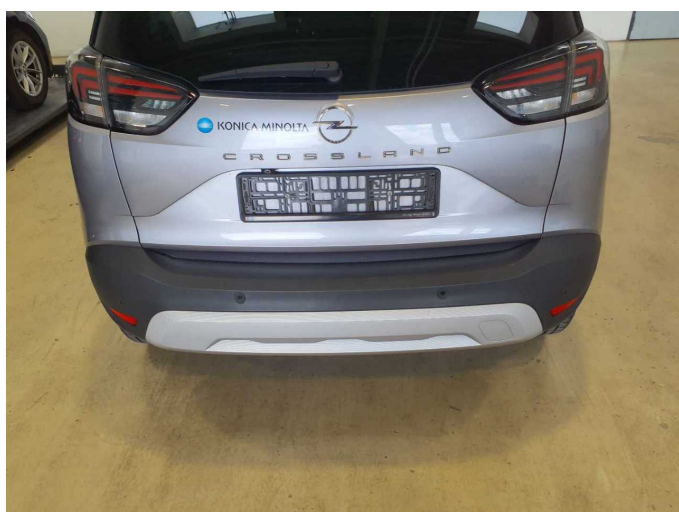
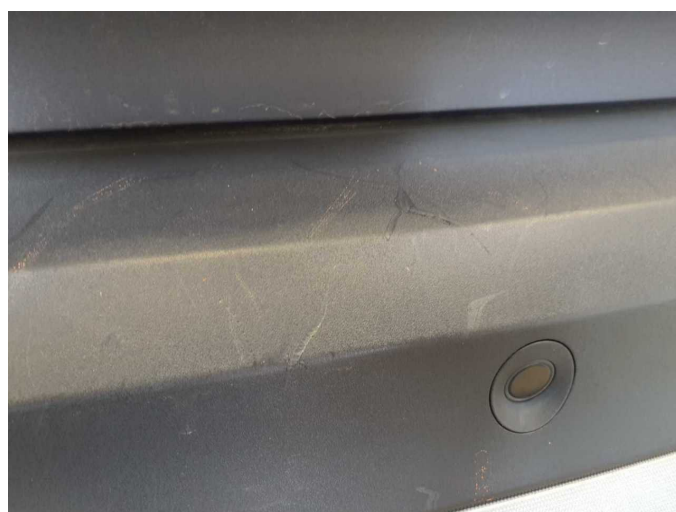
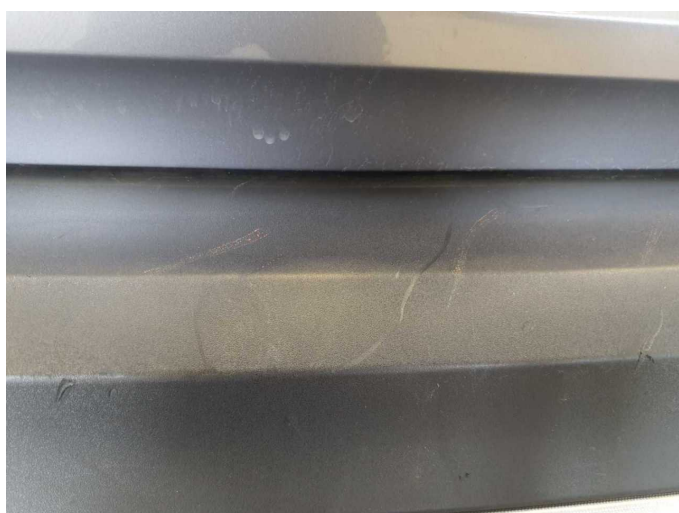
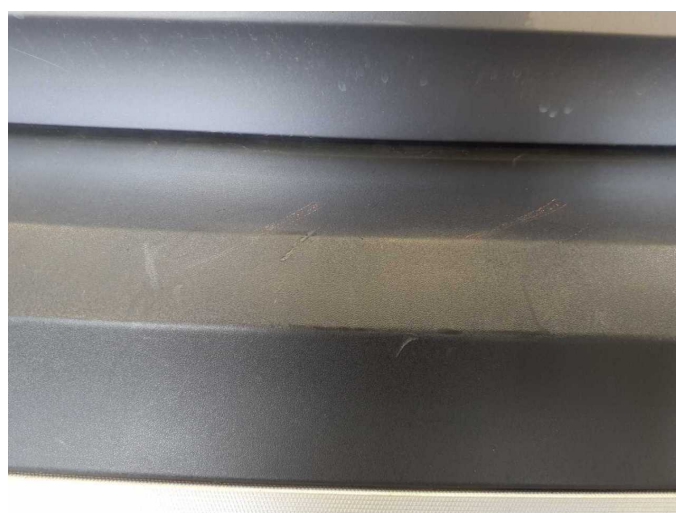
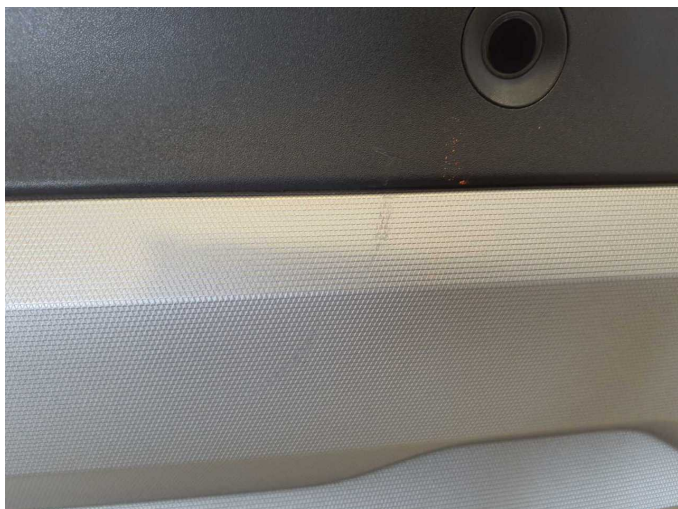
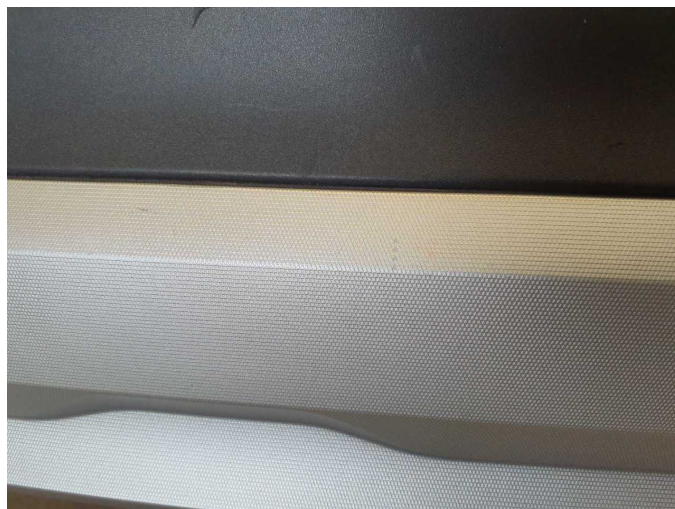
| No. | Component group | Description |
|---|---|---|
| 5 | Rear bumper | Rear bumper (Zusätzlich Spoiler Kratzer) - Scratch(es) - Loss in value |

**Damage 5:** Rear bumper: Rear bumper (Zusätzlich Spoiler Kratzer) - Scratch(es) - Loss in value

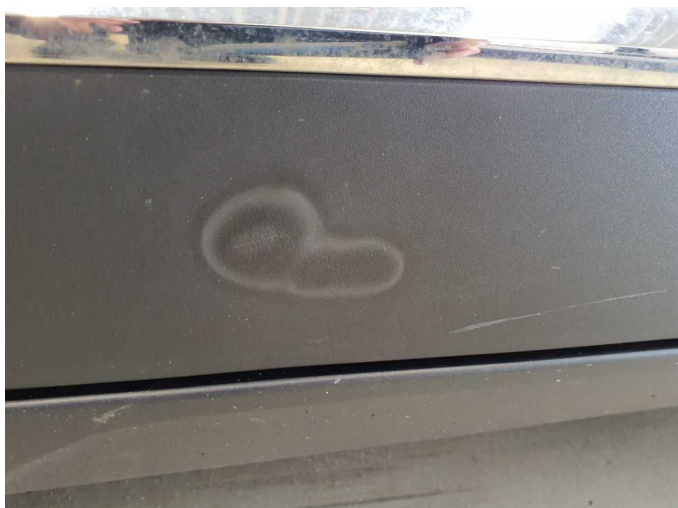
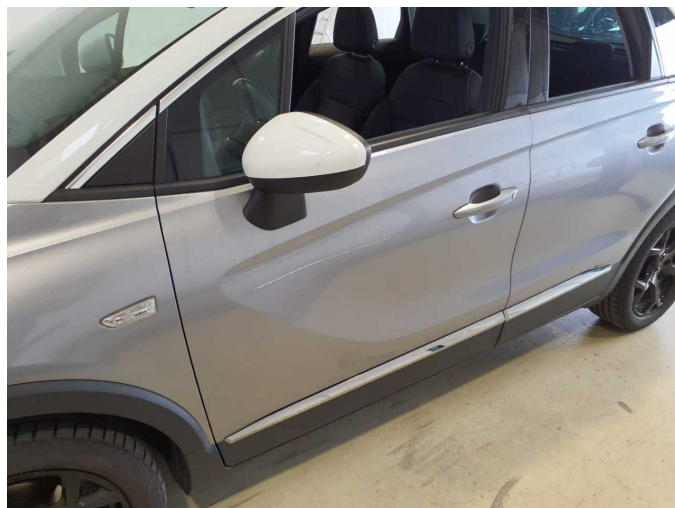
| No. | Component group | Description |
|---|---|---|
| 6 | Door - front left side | Door (Zierleiste unten, verfärbt) - Paint defect - Replace |

**Damage 6:** Door - front left side: Door (Zierleiste unten, verfärbt) - Paint defect - Replace

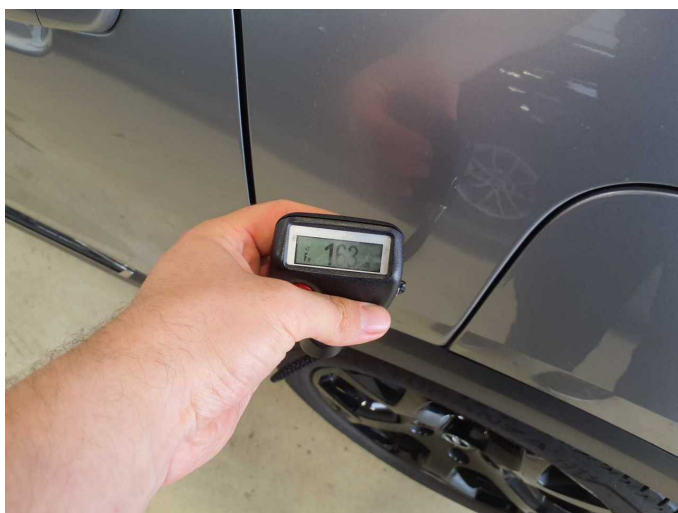
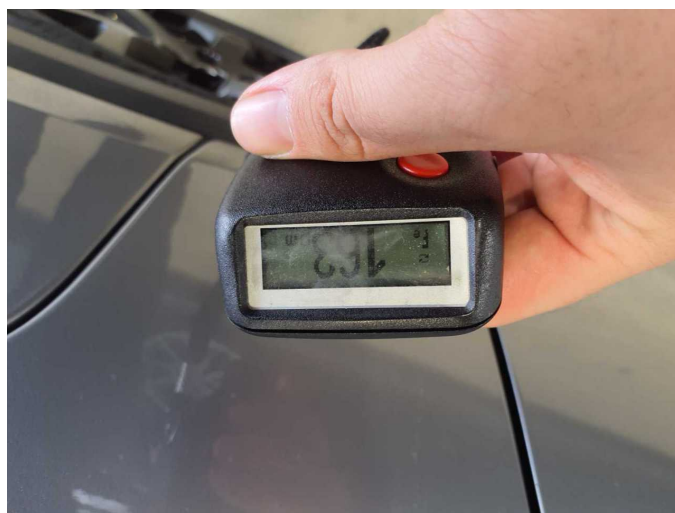
| No. | Repainting |
|---|---|
| 1 | Side panel - rear left side, Professionally carried out |

| Side panel - rear left side | 163 µm | Door - rear left side | 168 µm |

**Repainting 1:** Side panel - rear left side

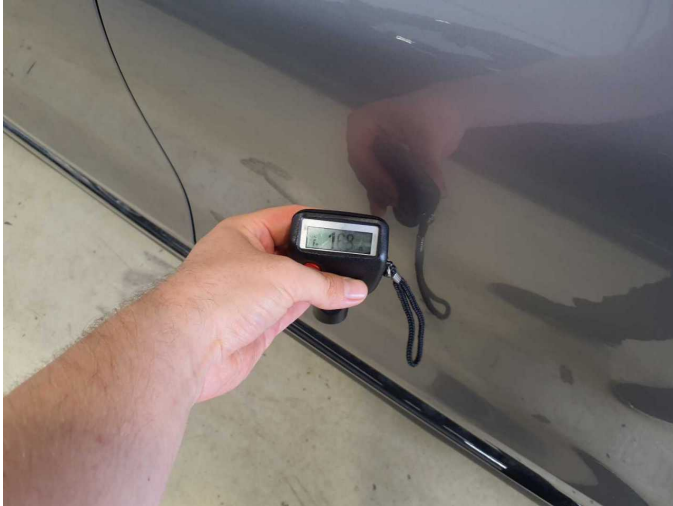
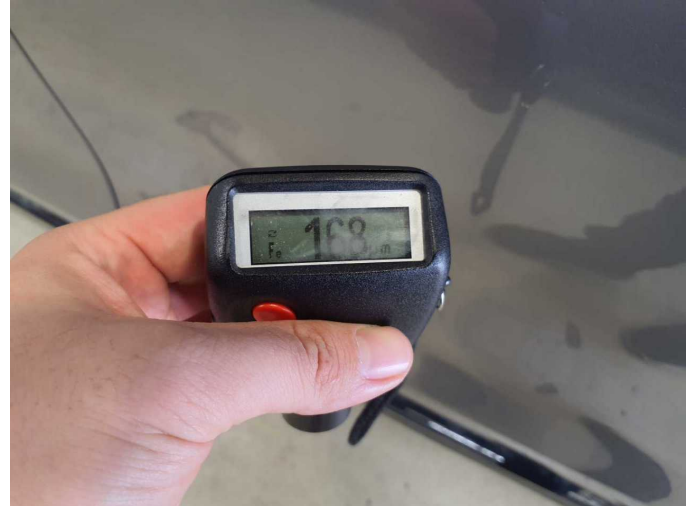
| No. | Repainting |
|---|---|
| 2 | Door - rear left side, Professionally carried out |

**Repainting 2:** Door - rear left side

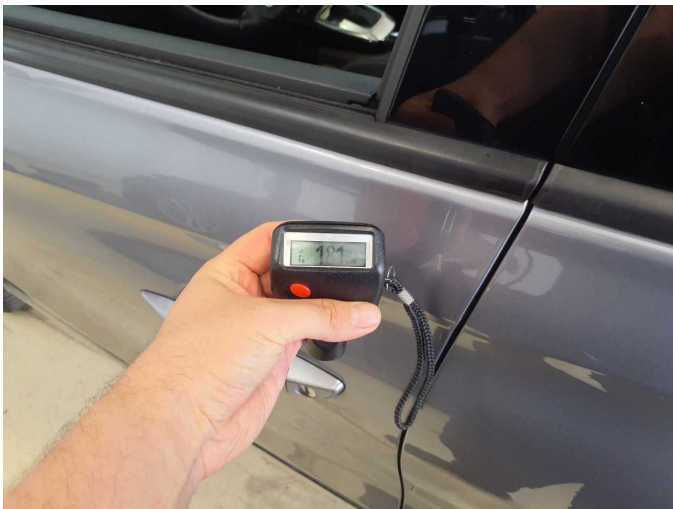
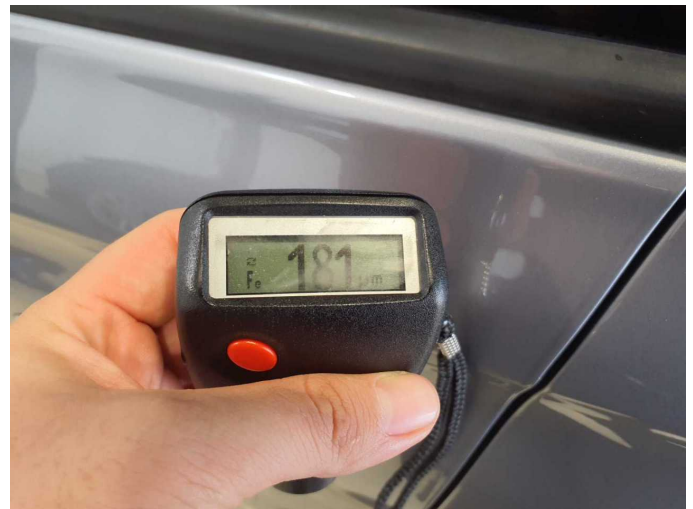
| No. | Repainting |
|---|---|
| 3 | Door - front left side, Professionally carried out |

| Door - front left side | 181 µm | | |

**Repainting 3:** Door - front left side
