Expertise

Protocol number: 46494078  
Order No. / Reference: 26488445  
Inspection date: 10 Jul 2026

| Manufacturer: Opel | Model: Astra 1.2 Turbo Start/Stop Sports Tourer Edition |

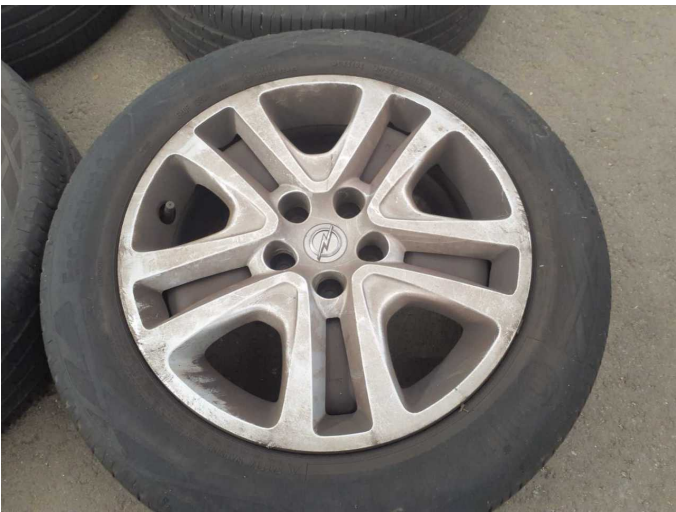
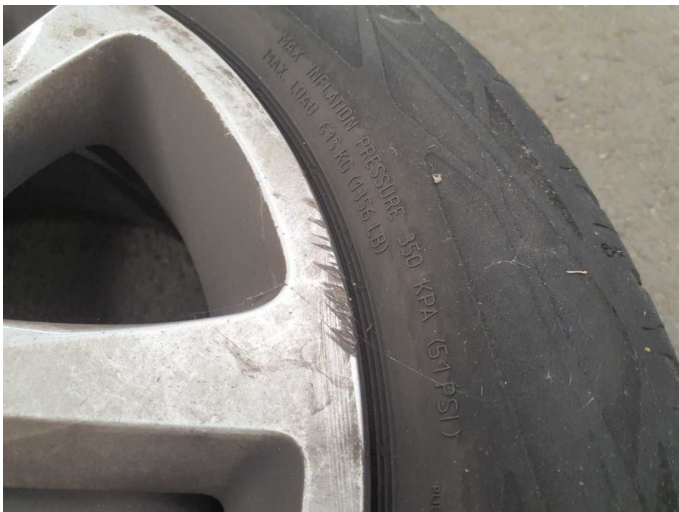
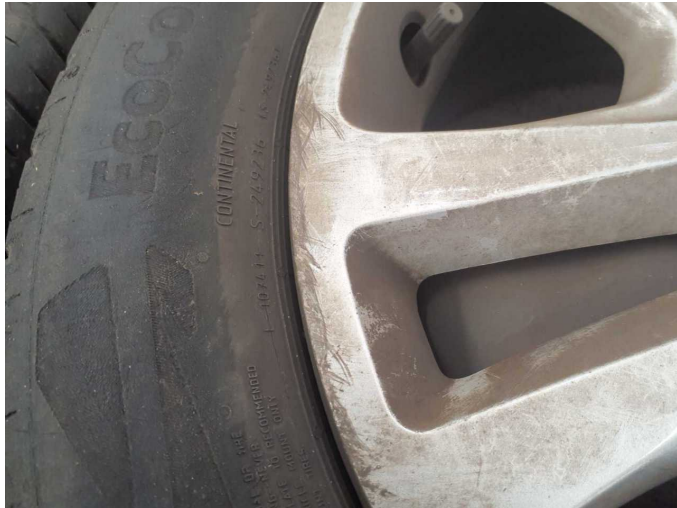
| No. | Component group | Description |
|---|---|---|
| 1 | 2nd wheel set | 1 wheel cover - Scratched - Replace |

Damage 1: 2nd wheel set: 1 wheel cover - Scratched - Replace

**Damage 1:** 2nd wheel set: 1 wheel cover - Scratched - Replace

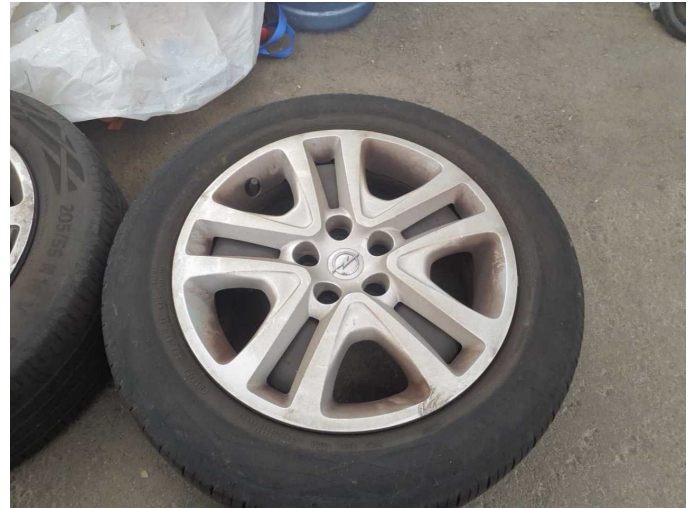
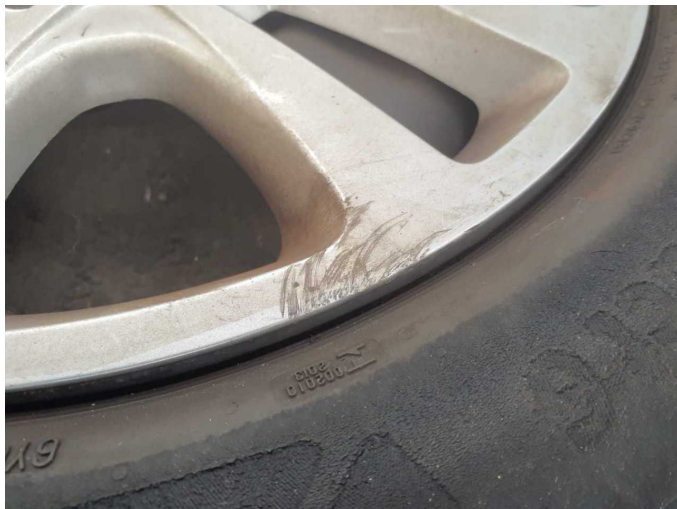
| No. | Component group | Description |
|---|---|---|
| 2 | 2nd wheel set | 1 wheel cover - Scratched - Replace |

**Damage 2:** 2nd wheel set: 1 wheel cover - Scratched - Replace

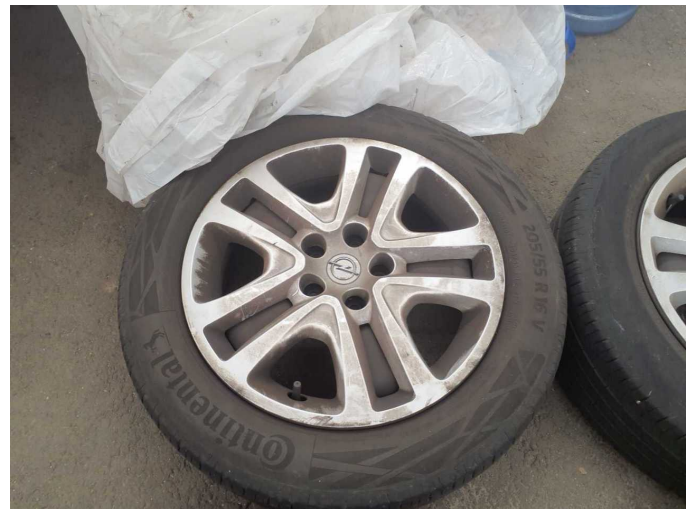
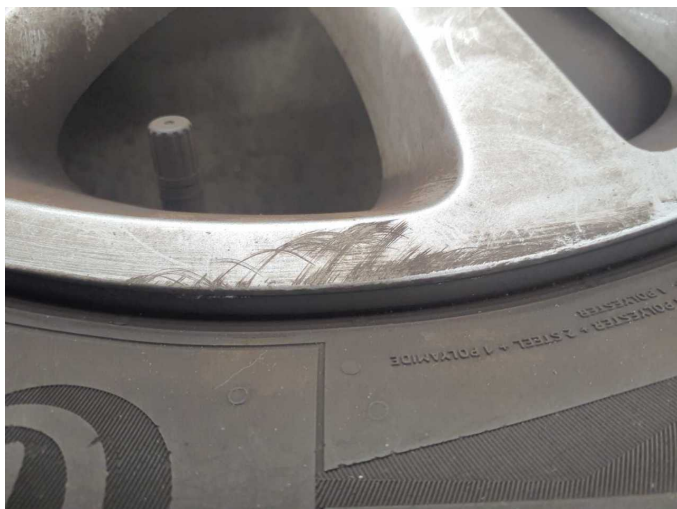
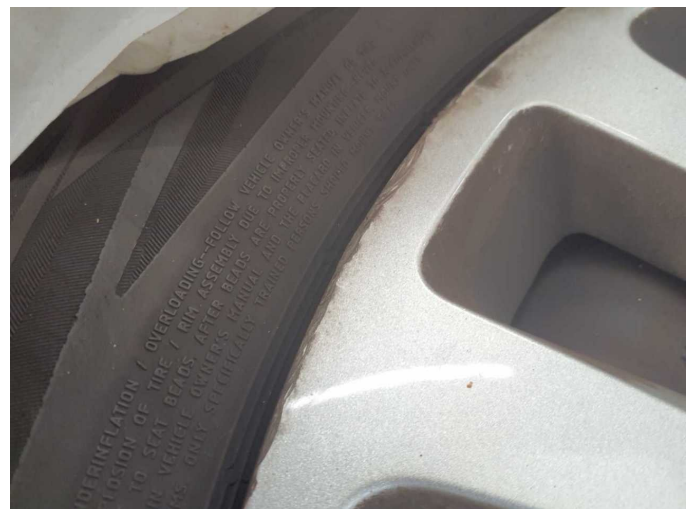
| No. | Component group | Description |
|---|---|---|
| 3 | 2nd wheel set | 1 wheel cover - Scratched - Replace |

**Damage 3:** 2nd wheel set: 1 wheel cover - Scratched - Replace

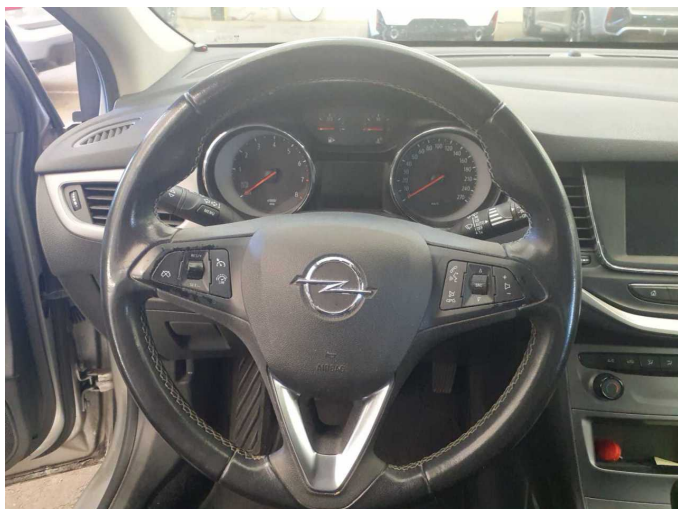
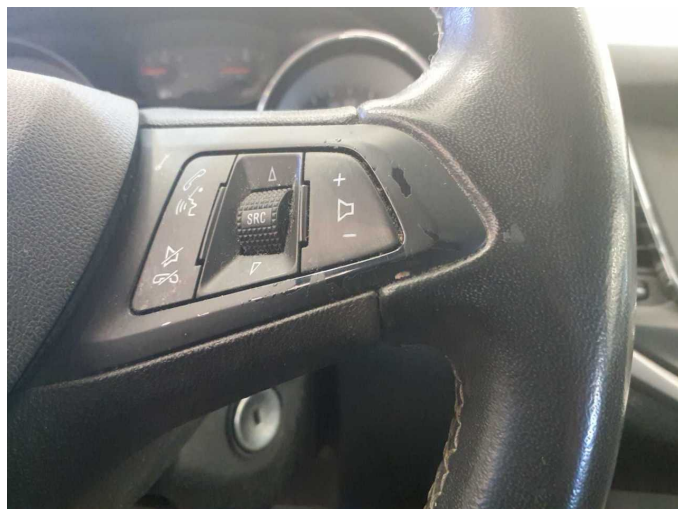
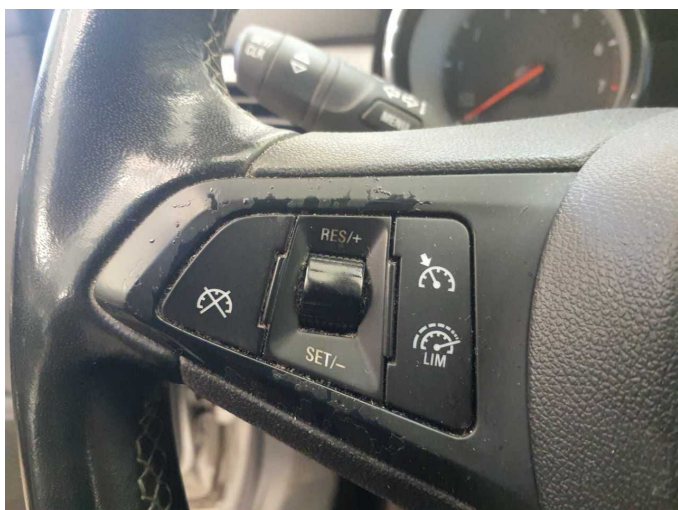
| No. | Component group | Description |
|---|---|---|
| 4 | Steering system | Steering wheel (Knöpfe abgenutzt) - Paint defect - Loss in value |

**Damage 4:** Steering system: Steering wheel (Knöpfe abgenutzt) - Paint defect - Loss in value

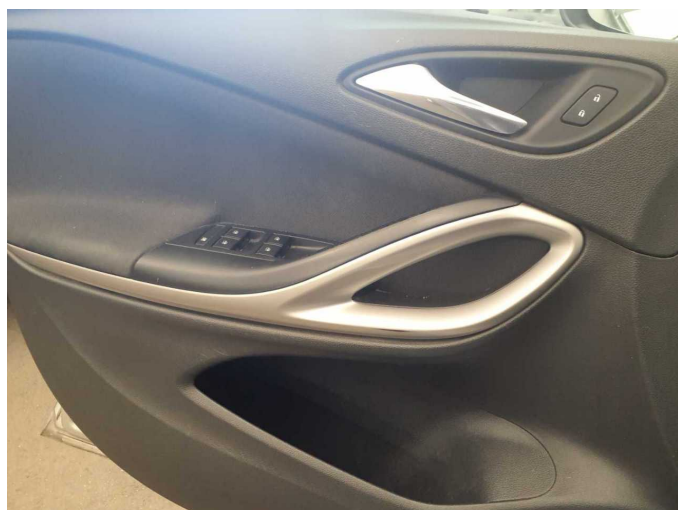
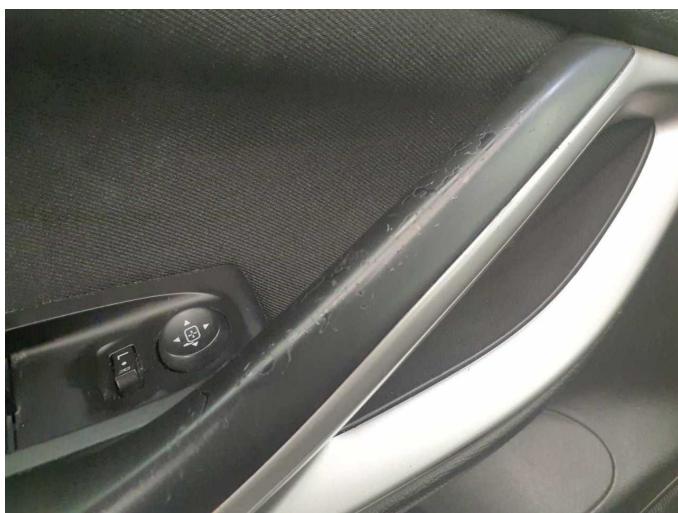
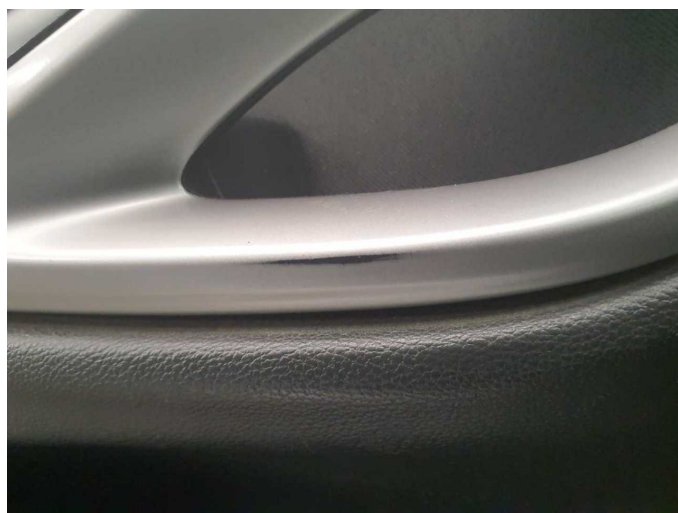
| No. | Component group | Description |
|---|---|---|
| 5 | Door - front left side | Door handle - inside - Paint defect - Loss in value |

**Damage 5:** Door - front left side: Door handle - inside - Paint defect - Loss in value

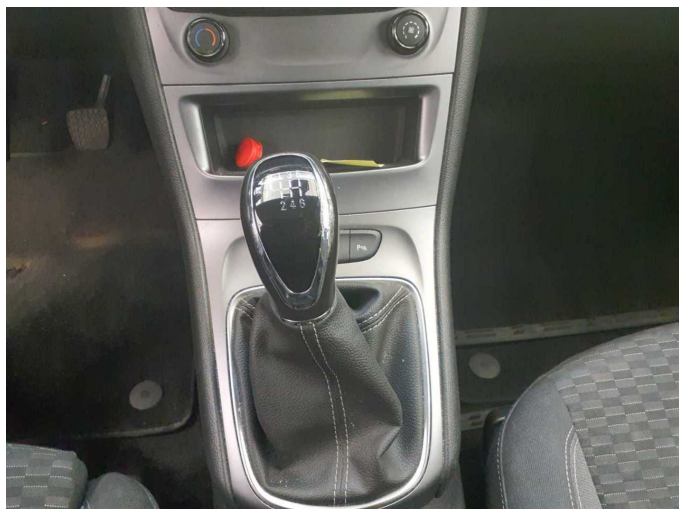
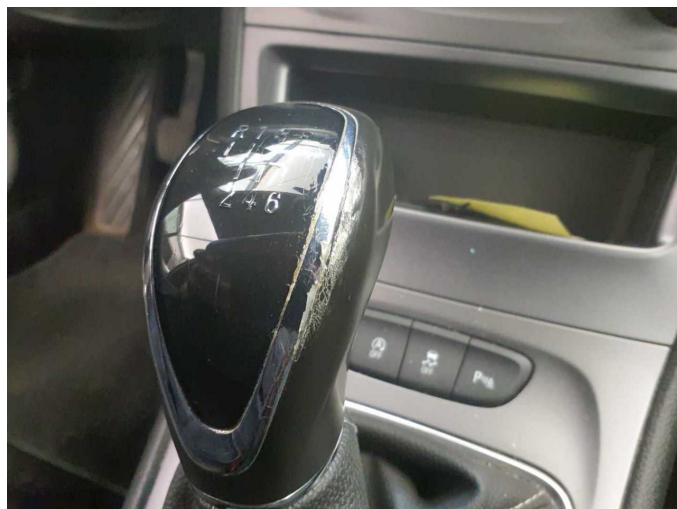
| No. | Component group | Description |
|---|---|---|
| 6 | Gearbox | Gear knob - Abrasion - Loss in value |

**Damage 6:** Gearbox: Gear knob - Abrasion - Loss in value

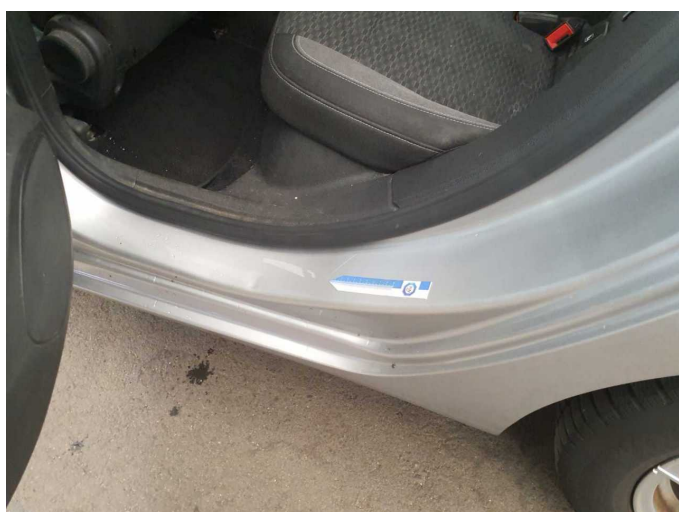
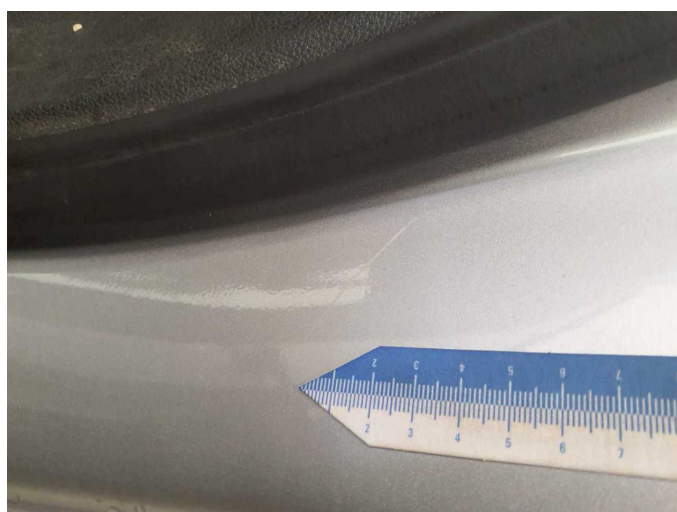
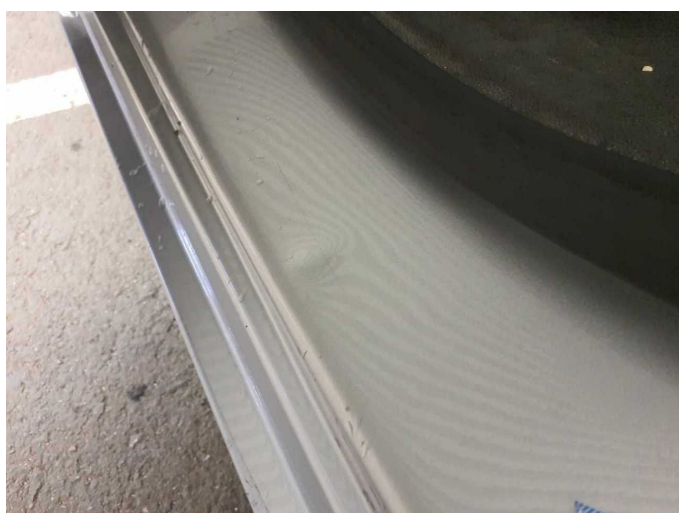
| No. | Component group | Description |
|---|---|---|
| 7 | Side panel - rear left side | Sill - Dent / paintcoat damage - Smart repair |

**Damage 7:** Side panel - rear left side: Sill - Dent / paintcoat damage - Smart repair

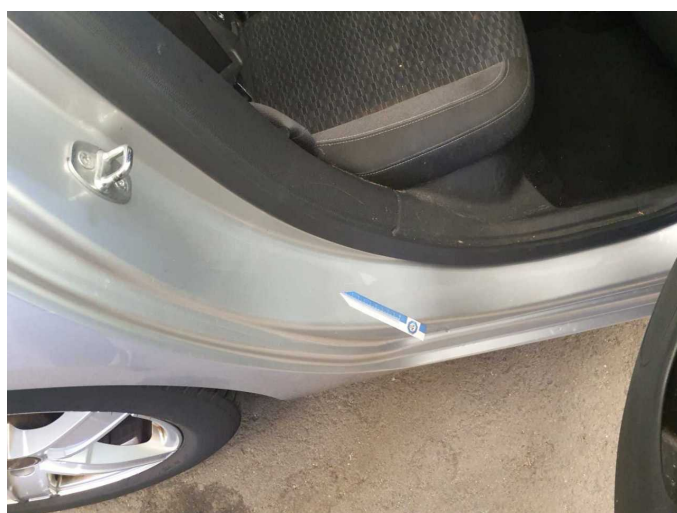
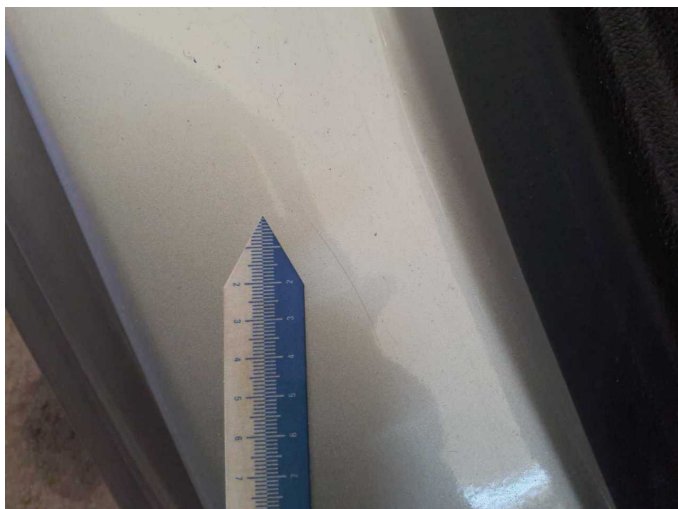
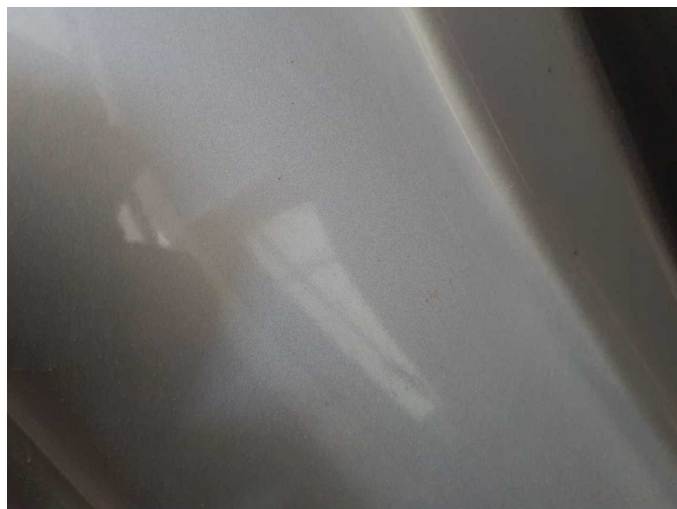
| No. | Component group | Description |
|---|---|---|
| 8 | Side panel - rear right side | Sill - Scratch(es) - Smart repair |

**Damage 8:** Side panel - rear right side: Sill - Scratch(es) - Smart repair

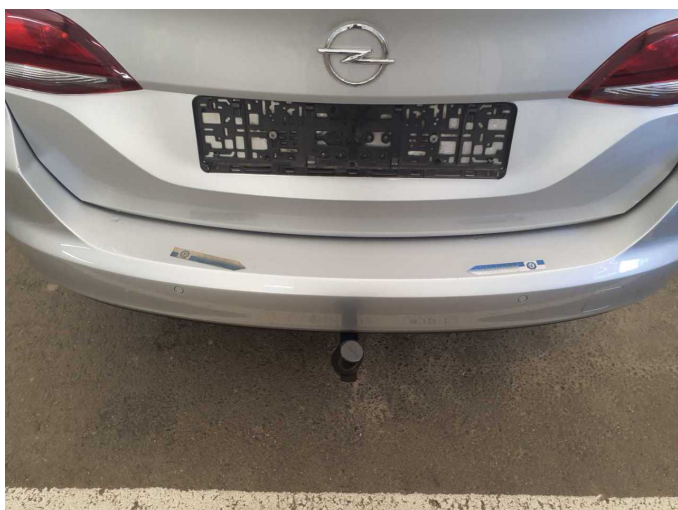
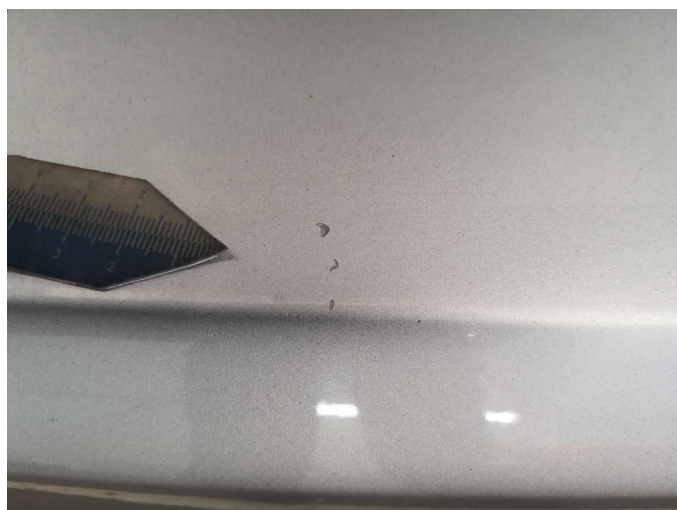
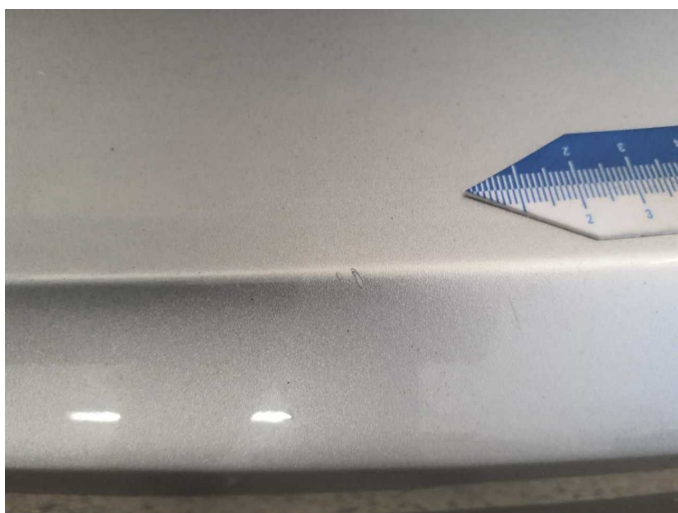
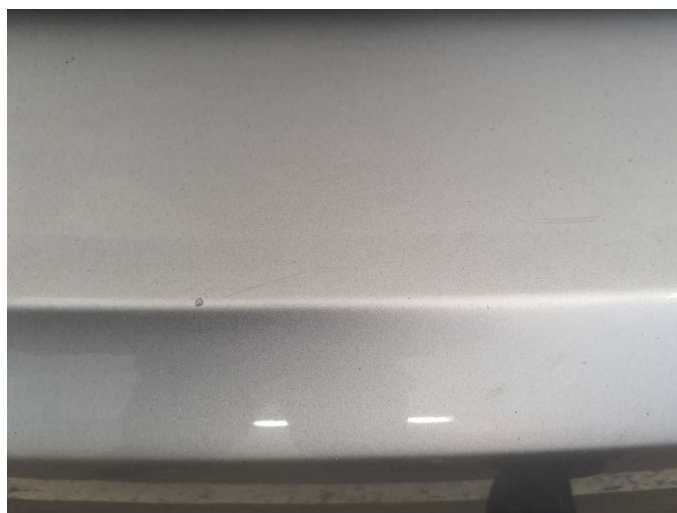
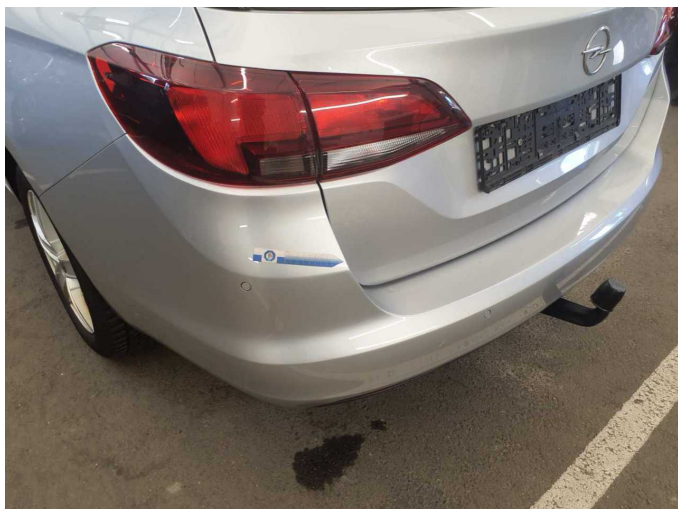
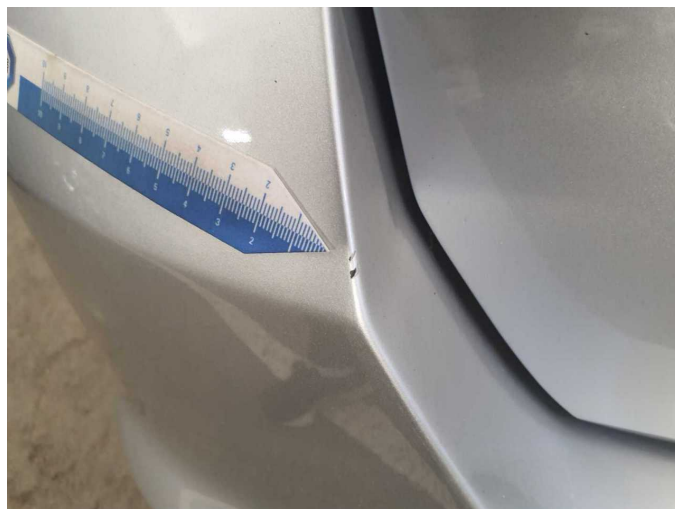
| No. | Component group | Description |
|---|---|---|
| 9 | Rear bumper | Rear bumper - Scratch(es) - Smart repair |

**Damage 9:** Rear bumper: Rear bumper - Scratch(es) - Smart repair

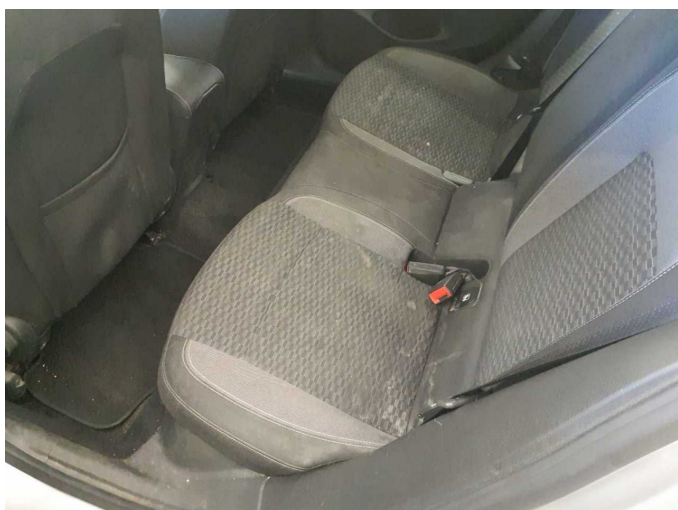
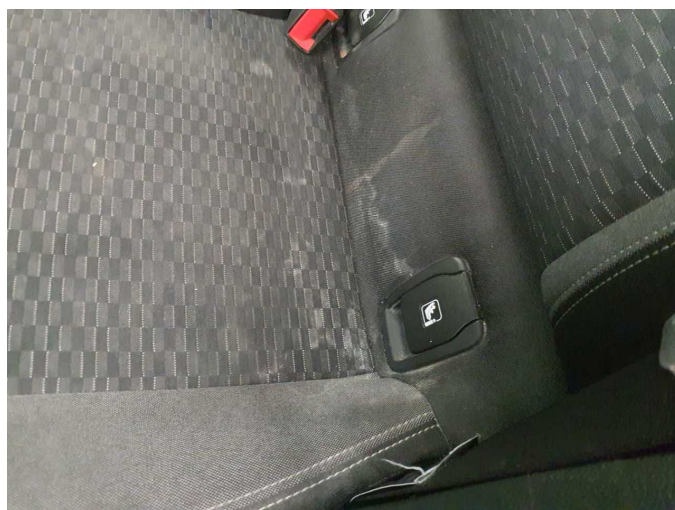
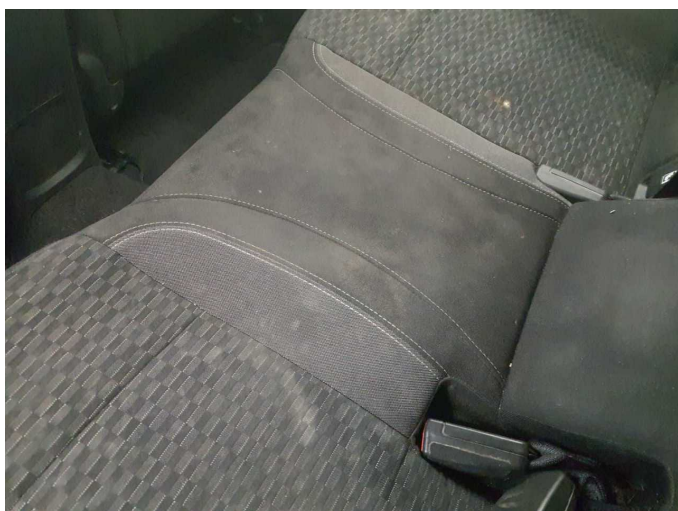
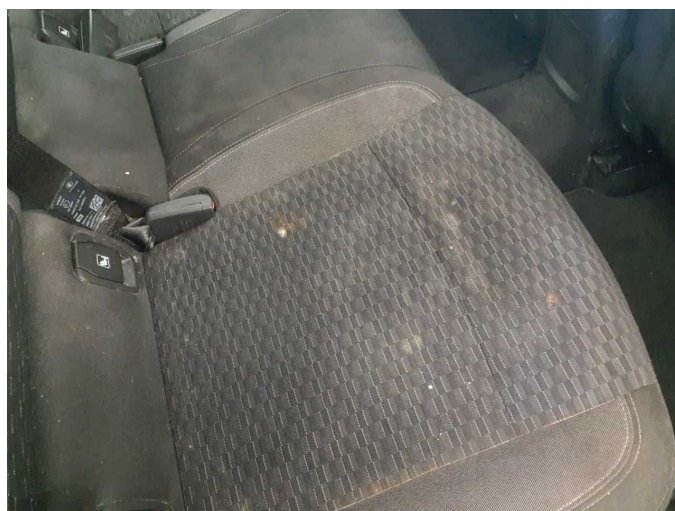
| No. | Component group | Description |
|---|---|---|
| 10 | Seat - rear | Seat upholstery - 3 seater bench - Soiled - Clean |

**Damage 10:** Seat - rear: Seat upholstery - 3 seater bench - Soiled - Clean

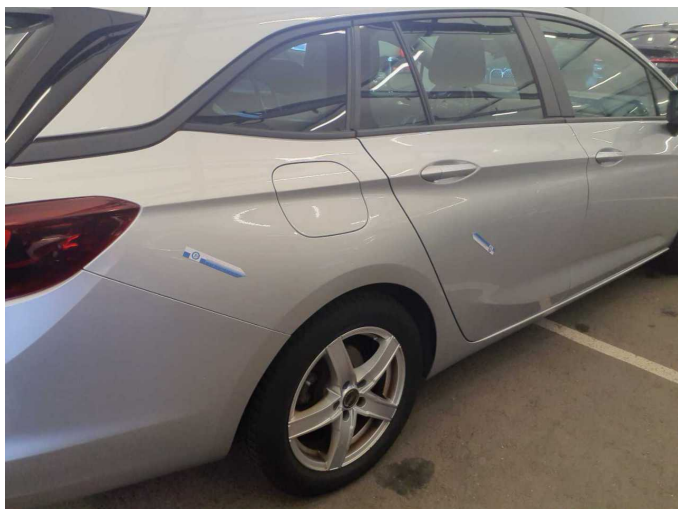
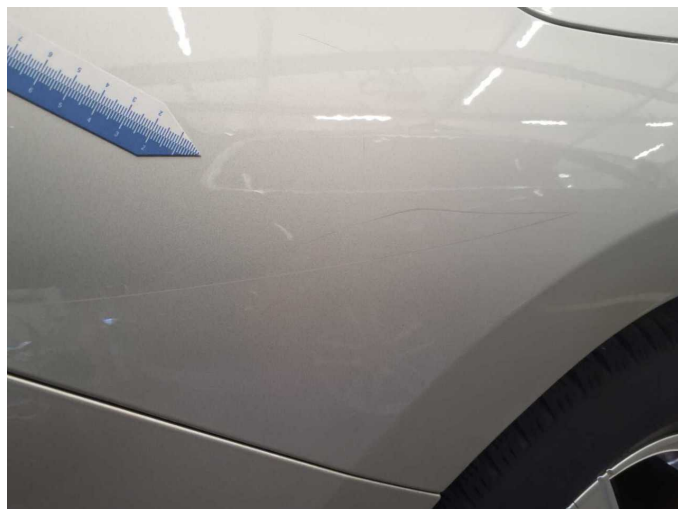
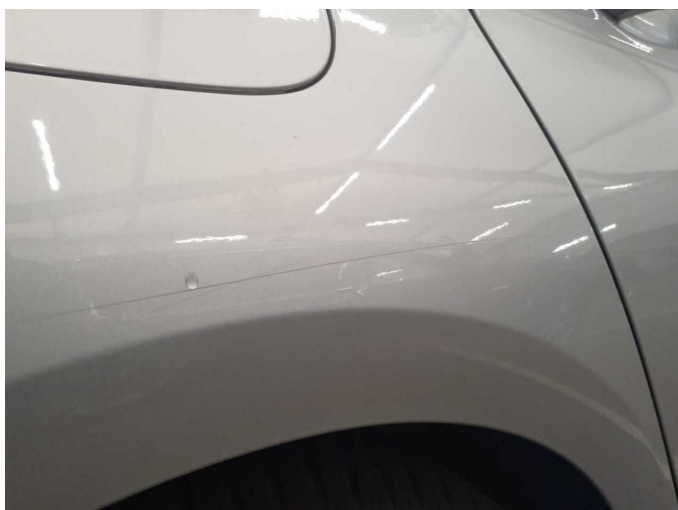
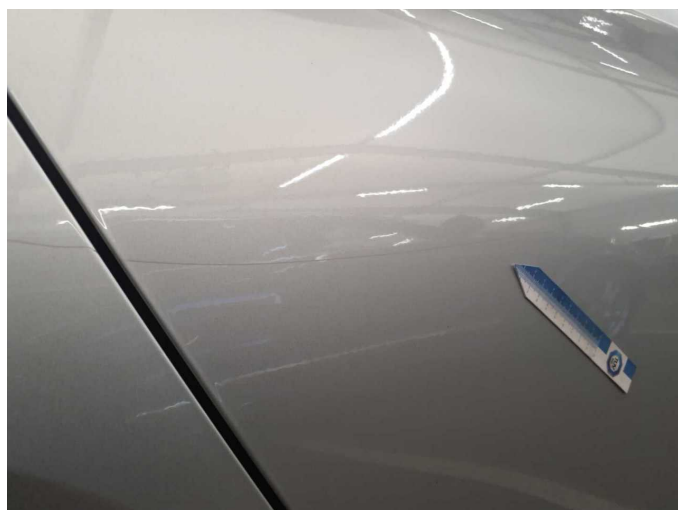
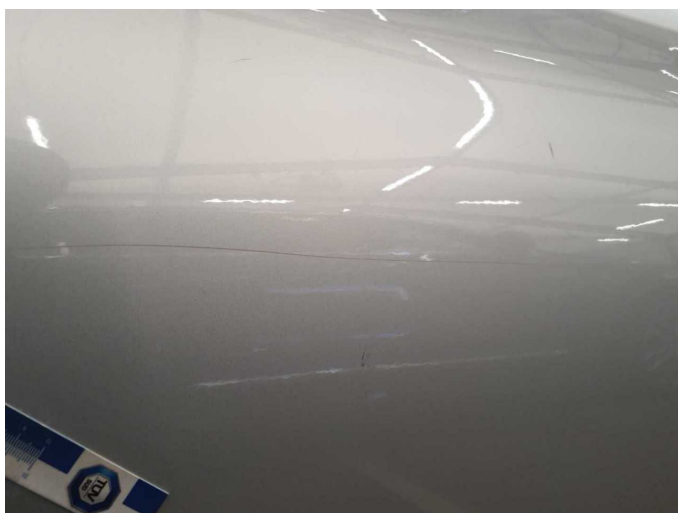
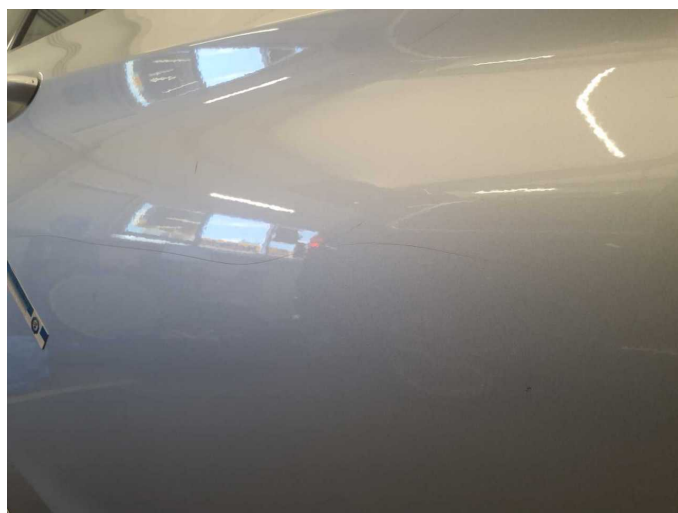
| No. | Component group | Description |
|---|---|---|
| 11 | Body | Body (Gewaltschaden Seite rechts) - Scratch(es) - Paint |

**Damage 11:** Body: Body (Gewaltschaden Seite rechts) - Scratch(es) - Paint

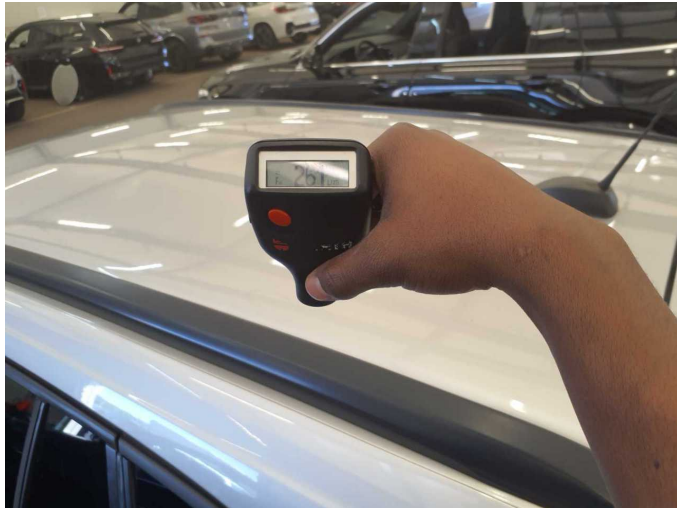
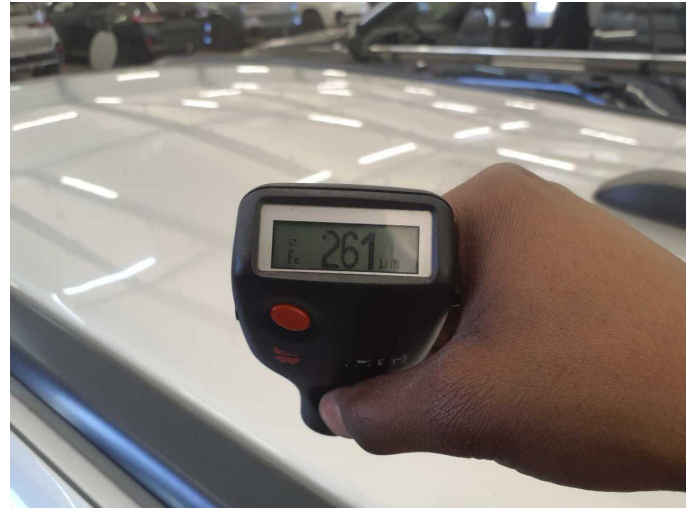
**Repainting 1: Roof**

- 1 Roof, Professionally carried out, Invoice of repair done Non-existent
- 2 Roof rail - left side, Professionally carried out, Invoice of repair done Non-existent

| Roof | 261 µm | Roof rail - left side | 270 µm |

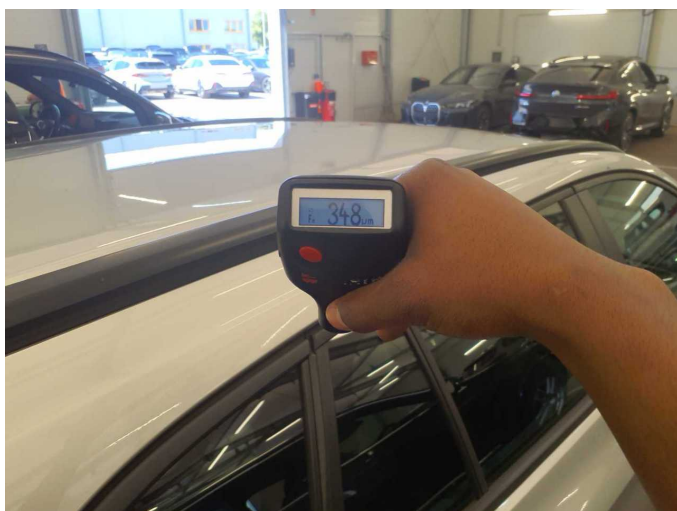
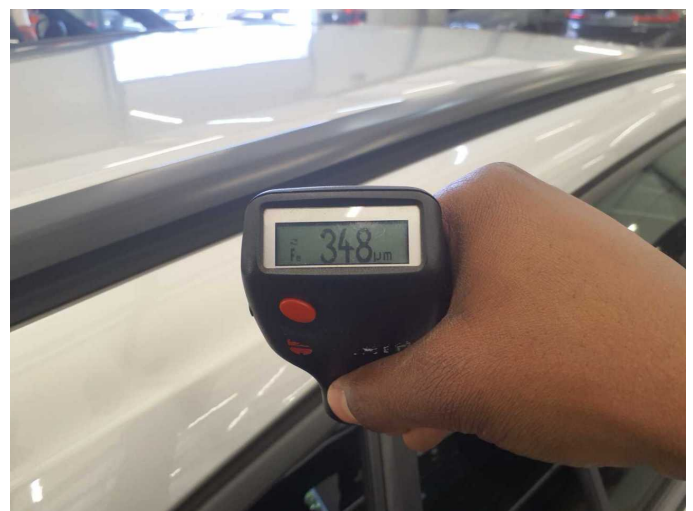
**Repainting 3: Roof rail - right side**

| Roof rail - right side | 348 µm | Mudguard - left side | 280 µm |

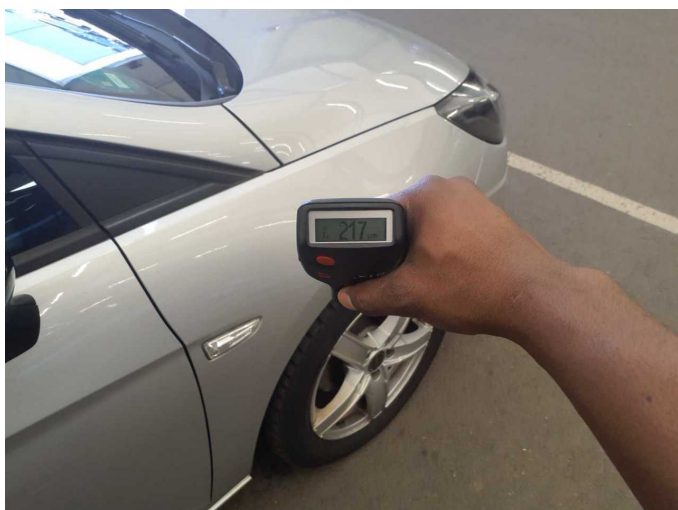
**Repainting 5:** Mudguard - right side

| Mudguard - right side | 217 µm | Bonnet | 222 µm |

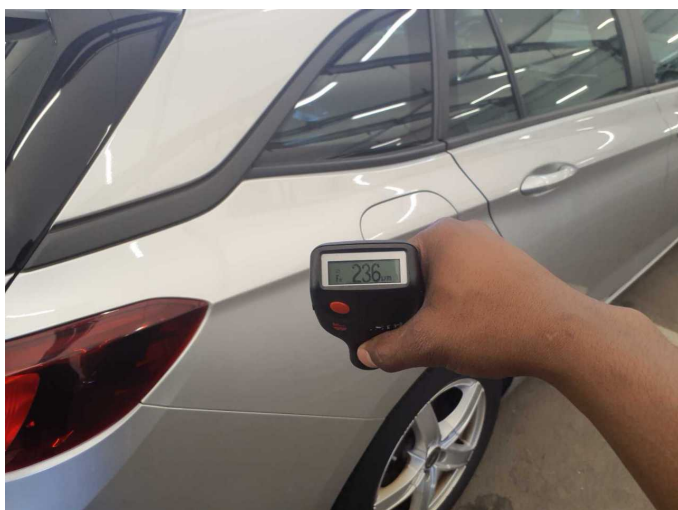
**Repainting 8:** Side panel - rear right side

| Side panel - rear left side | 289 µm | Side panel - rear right side | 236 µm |

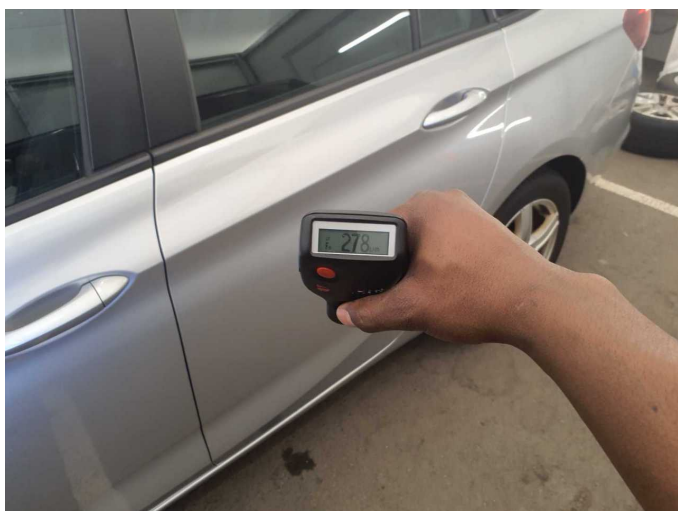
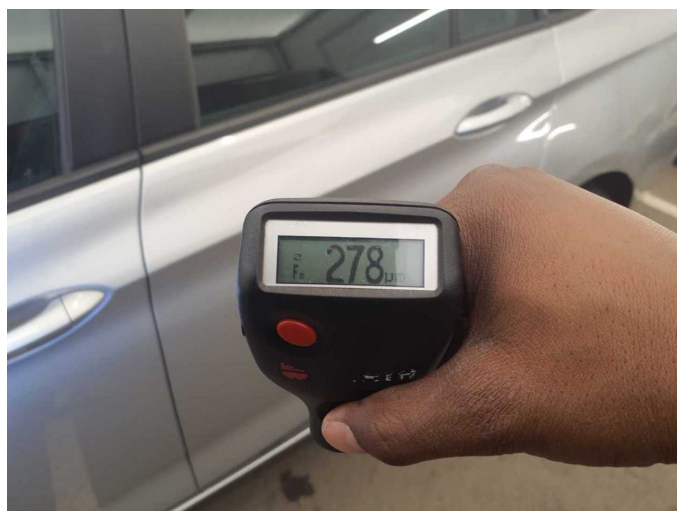
**Repainting 9:** Door - rear left side

| Door - rear left side | 278 µm | Door - rear right side | 230 µm |

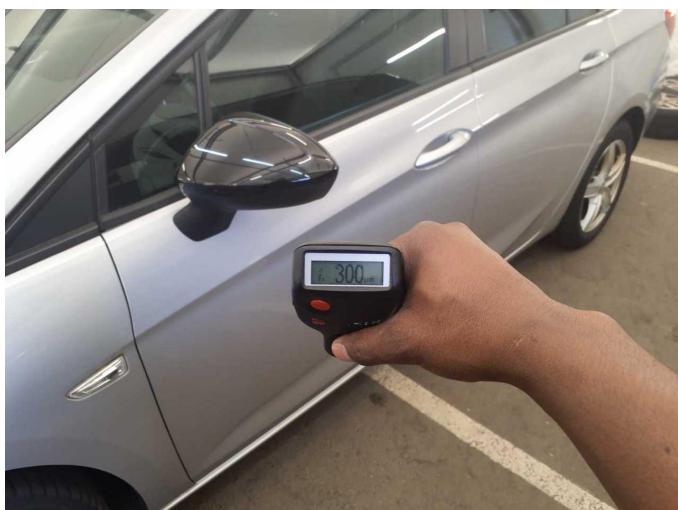
**Repainting 11:** Door - front left side

| Door - front left side | 300 µm | Door - front right side | 234 µm |
