Expertise

Protocol number: 46462749  
Order No. / Reference: 26442284  
Inspection date: 10 Jul 2026

Manufacturer: Mercedes-Benz  
VIN: W1VVLCEZ8T4564491

Model: Vito 116 CDI Extralang HA Aut. PRO

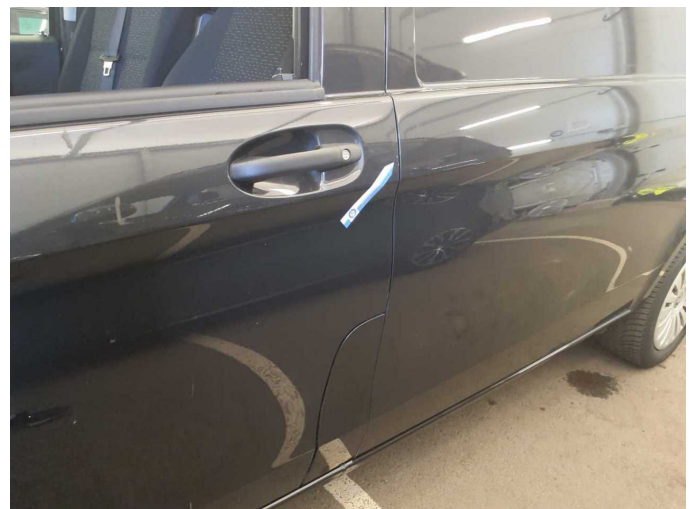
| No. | Component group | Description |
|---|---|---|
| 1 | Door - front left side | Door - Dent / paintcoat damage - Smart repair |

Damage 1: Door - front left side: Door - Dent / paintcoat damage - Smart repair

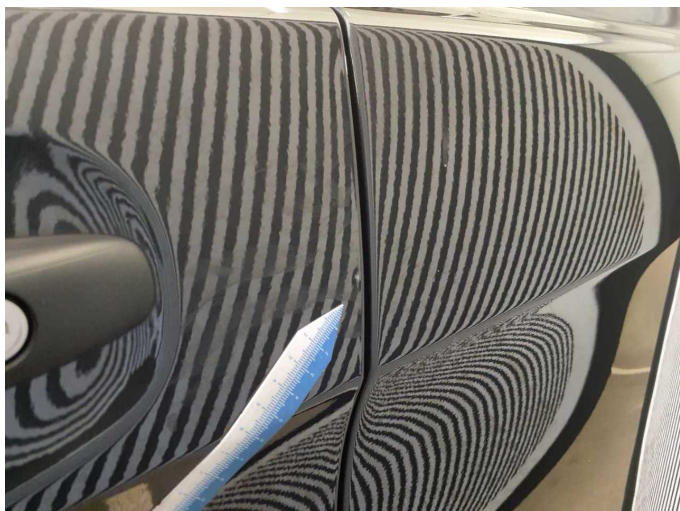
**Damage 1:** Door - front left side: Door - Dent / paintcoat damage - Smart repair

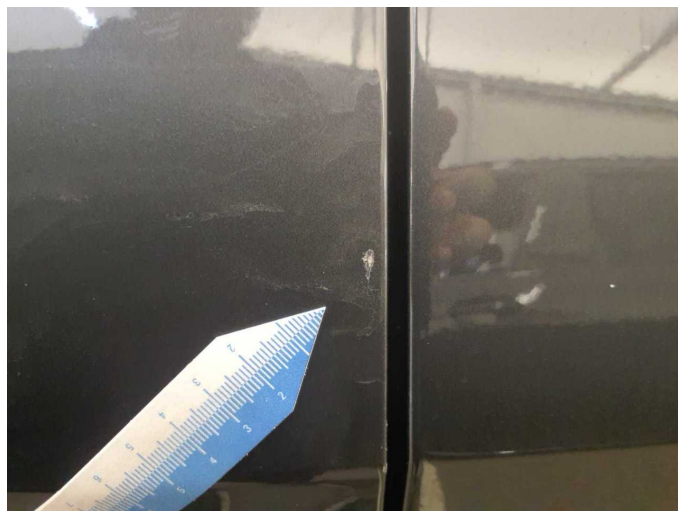
**Damage 1:** Door - front left side: Door - Dent / paintcoat damage - Smart repair

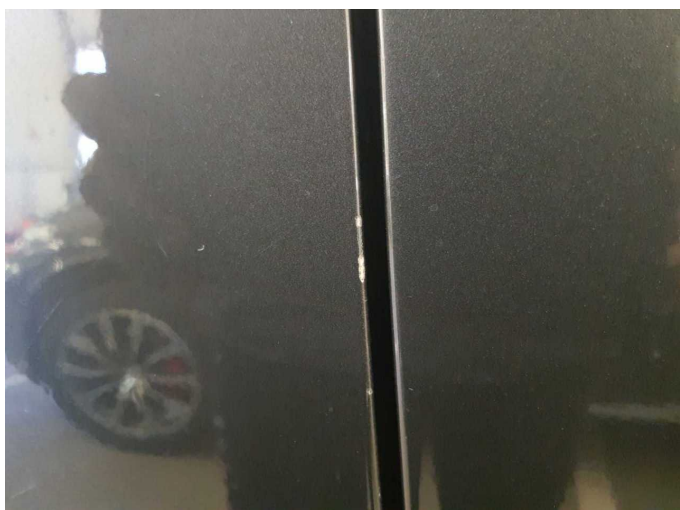
**Damage 1:** Door - front left side: Door - Dent / paintcoat damage - Smart repair

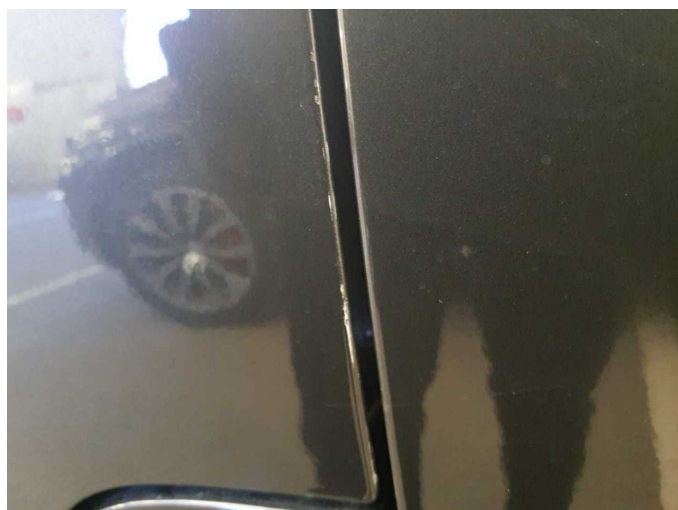
**Damage 1:** Door - front left side: Door - Dent / paintcoat damage - Smart repair

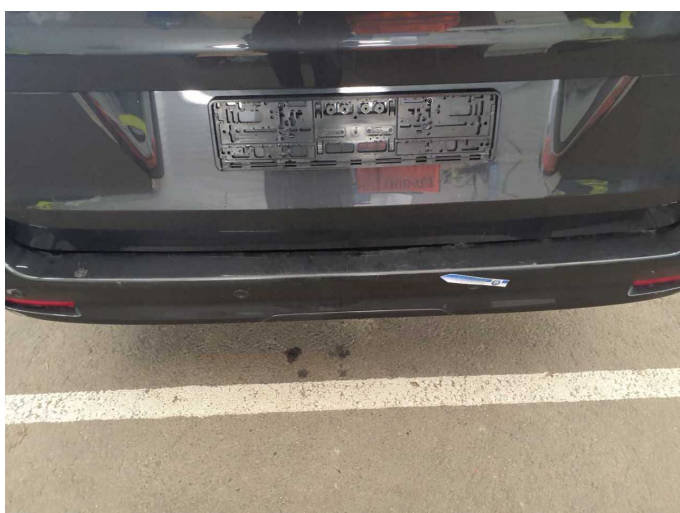
| No. | Component group | Description |
|---|---|---|
| 2 | Rear bumper | Rear bumper - Scratch(es) - Smart repair |

**Damage 2:** Rear bumper: Rear bumper - Scratch(es) - Smart repair

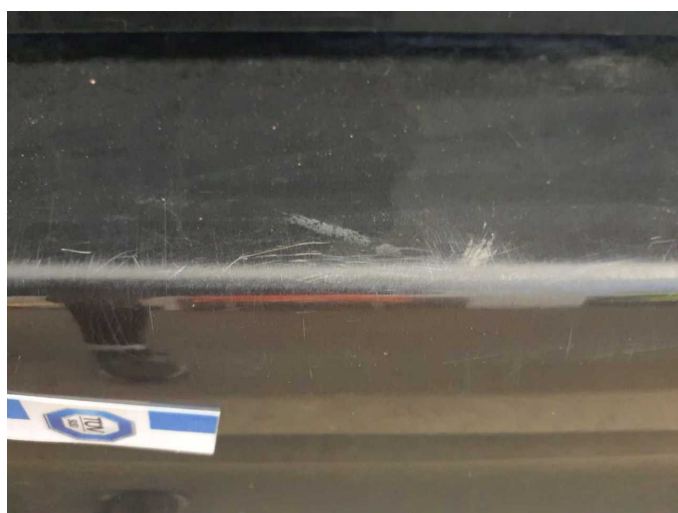
**Damage 2:** Rear bumper: Rear bumper - Scratch(es) - Smart repair

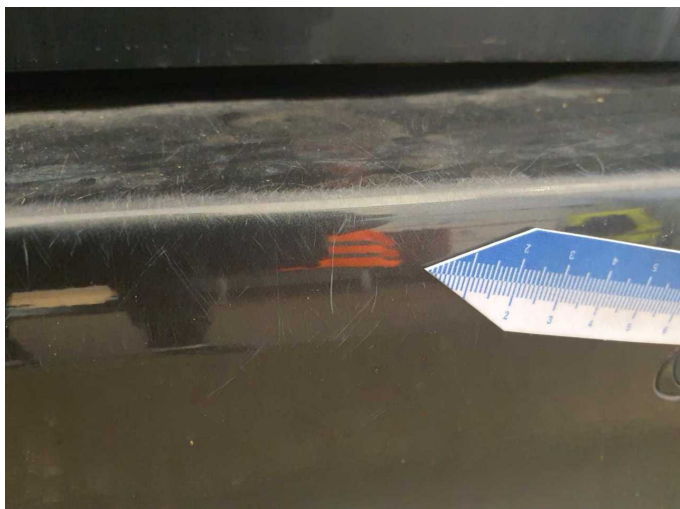
**Damage 2:** Rear bumper: Rear bumper - Scratch(es) - Smart repair

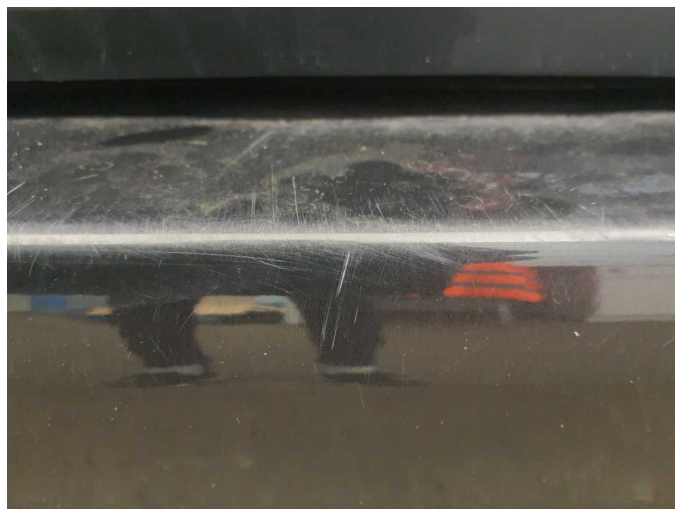
**Damage 2:** Rear bumper: Rear bumper - Scratch(es) - Smart repair

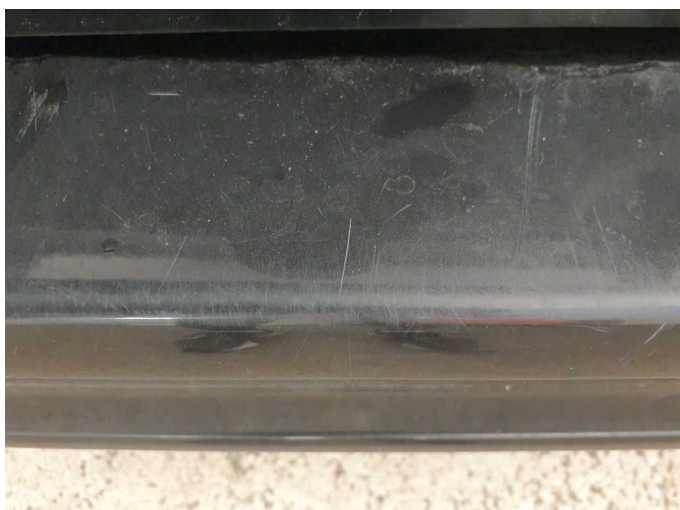
**Damage 2:** Rear bumper: Rear bumper - Scratch(es) - Smart repair

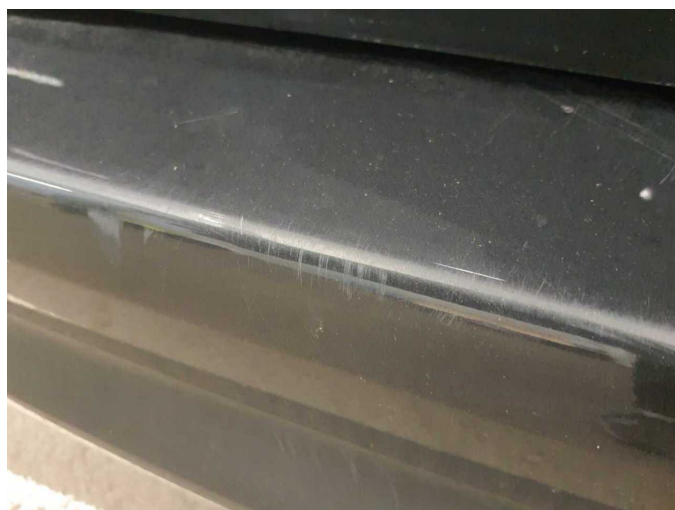
**Damage 2:** Rear bumper: Rear bumper - Scratch(es) - Smart repair

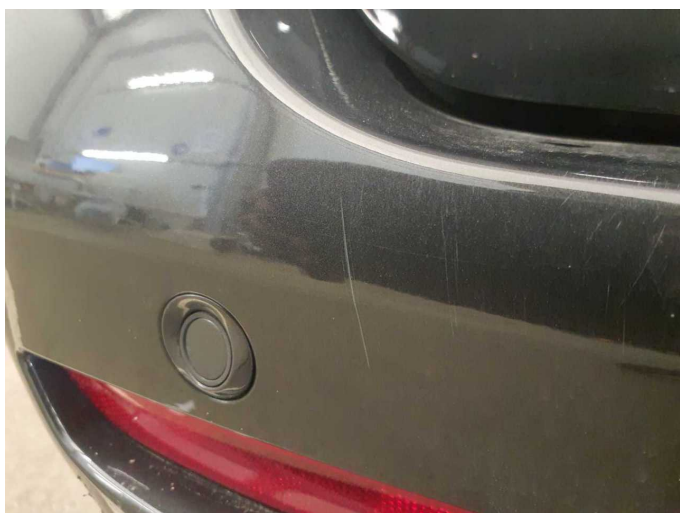
**Damage 2:** Rear bumper: Rear bumper - Scratch(es) - Smart repair

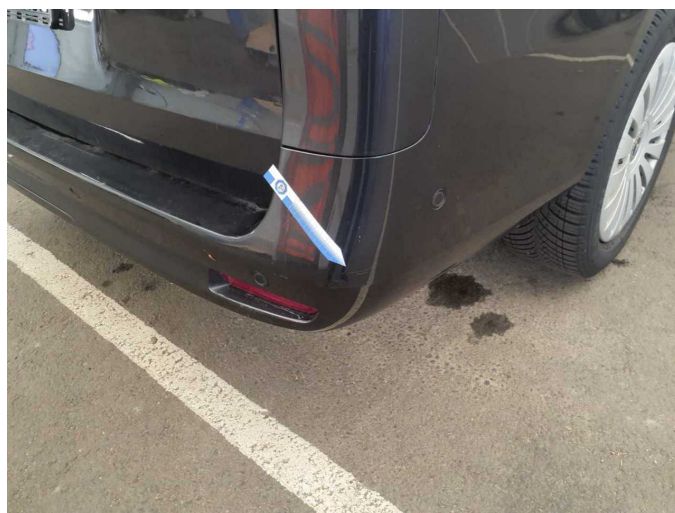
**Damage 2:** Rear bumper: Rear bumper - Scratch(es) - Smart repair

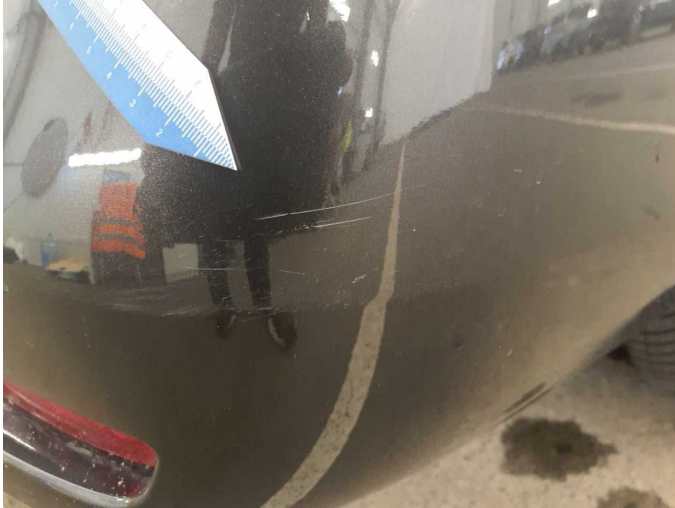
**Damage 2:** Rear bumper: Rear bumper - Scratch(es) - Smart repair

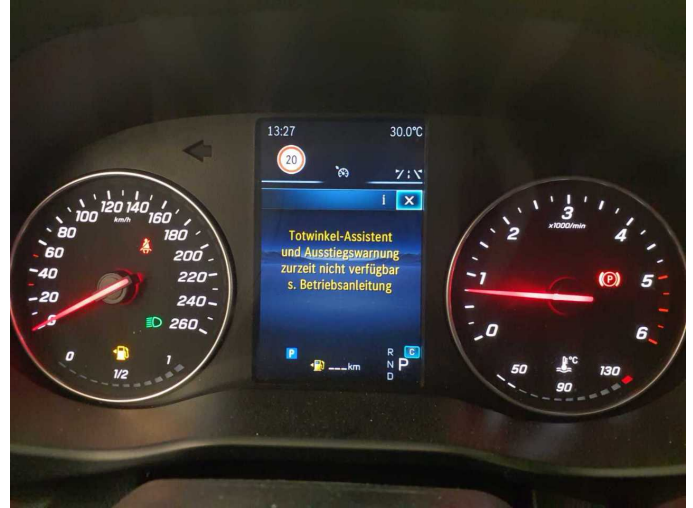
| No. | Component group | Description |
|---|---|---|
| 3 | Instrument panel | Indicator light (Totwinkel Assistent) - Non-operational - Perform diagnosis |

**Damage 3:** Instrument panel: Indicator light (Totwinkel Assistent) - Non-operational - Perform diagnosis

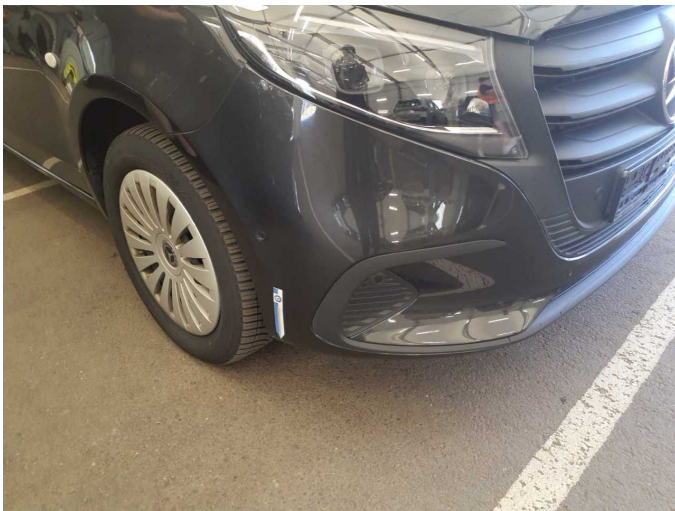
| No. | Component group | Description |
|---|---|---|
| 4 | Front bumper | Front bumper - Scratch(es) - Smart repair |

**Damage 4:** Front bumper: Front bumper - Scratch(es) - Smart repair

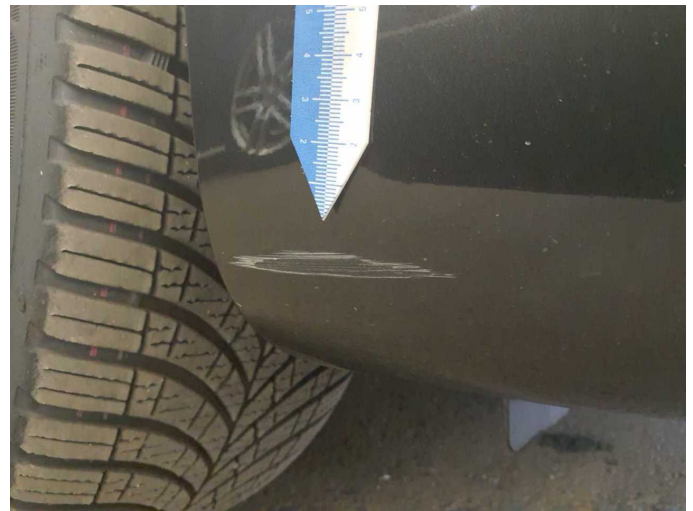
**Damage 4:** Front bumper: Front bumper - Scratch(es) - Smart repair

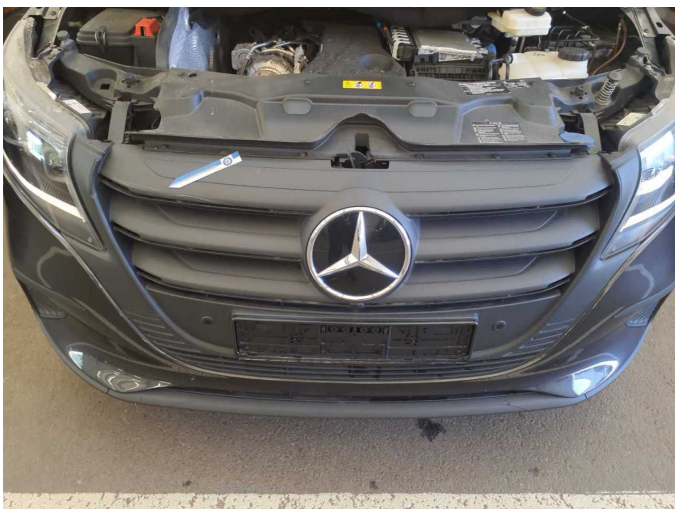
| No. | Component group | Description |
|---|---|---|
| 5 | Bonnet | Radiator grille (+ verformt) - Scratched - Replace |

**Damage 5:** Bonnet: Radiator grille (+ verformt) - Scratched - Replace

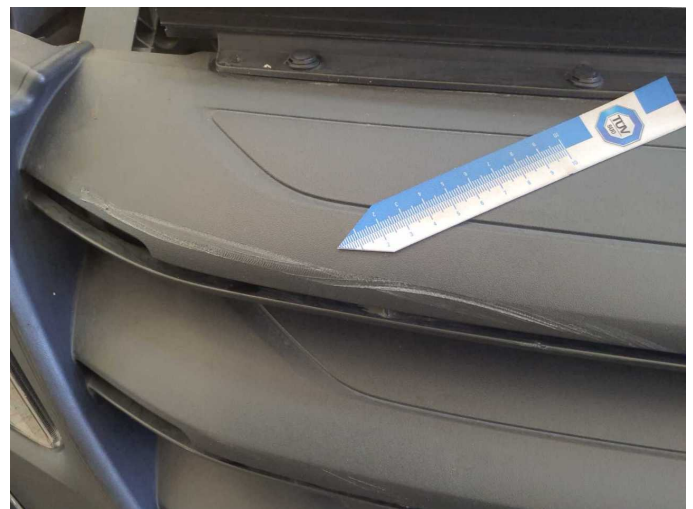
**Damage 5:** Bonnet: Radiator grille (+ verformt) - Scratched - Replace

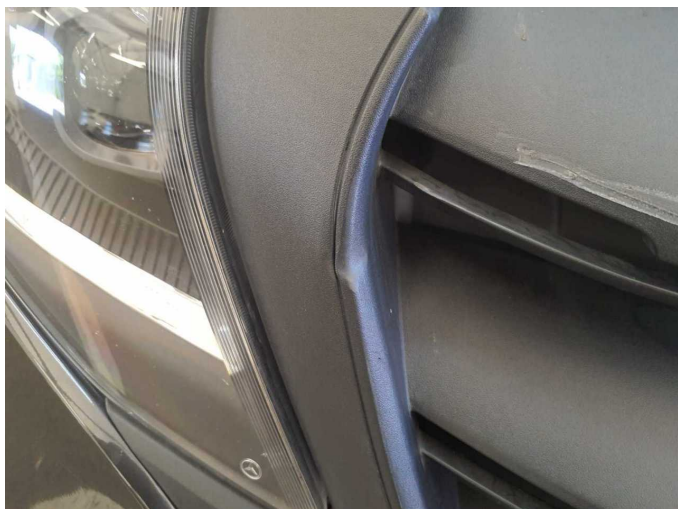
**Damage 5:** Bonnet: Radiator grille (+ verformt) - Scratched - Replace

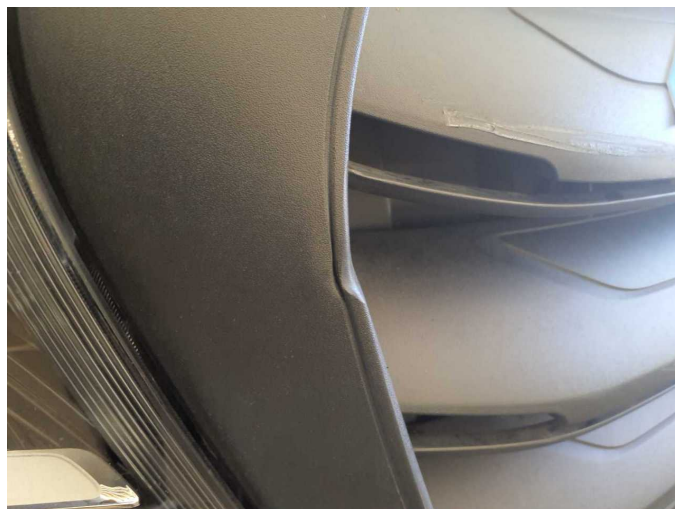
**Damage 5:** Bonnet: Radiator grille (+ verformt) - Scratched - Replace

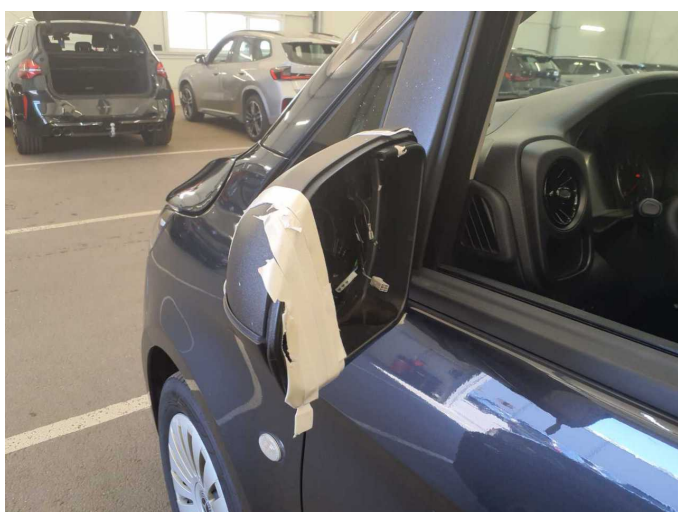
| No. | Component group | Description |
|---|---|---|
| 6 | Wing mirror - left side | Wing mirror - Broken / torn - Replace |

**Damage 6:** Wing mirror - left side: Wing mirror - Broken / torn - Replace

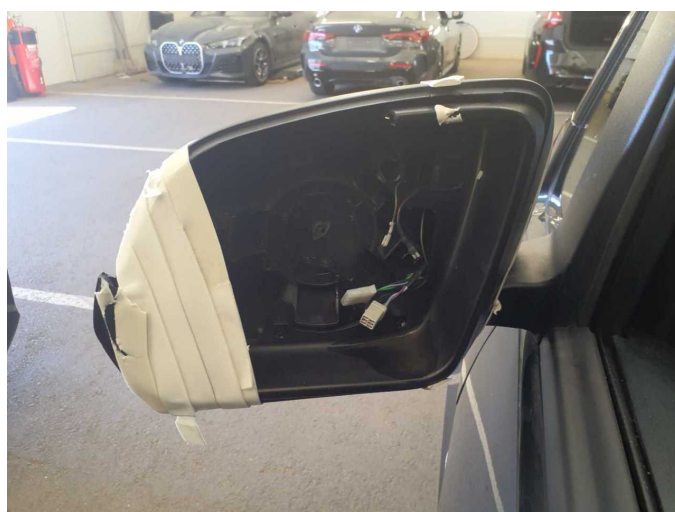
**Damage 6:** Wing mirror - left side: Wing mirror - Broken / torn - Replace

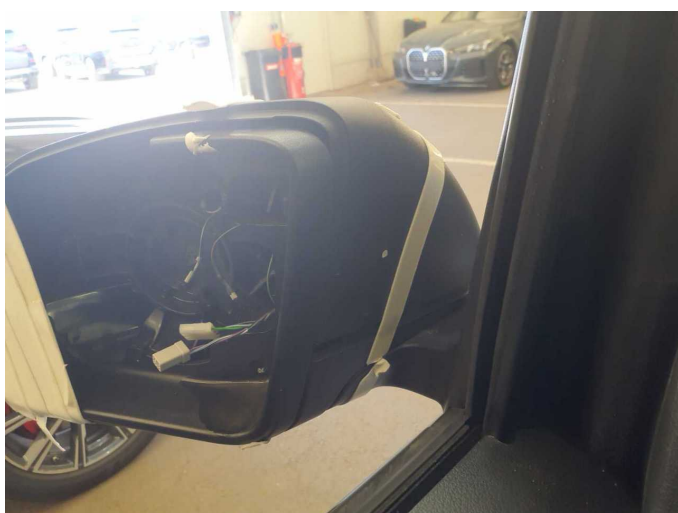
**Damage 6:** Wing mirror - left side: Wing mirror - Broken / torn - Replace

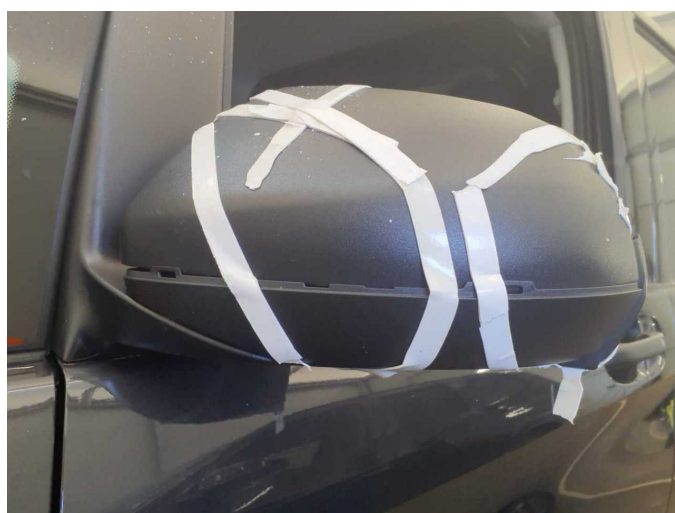
**Damage 6:** Wing mirror - left side: Wing mirror - Broken / torn - Replace

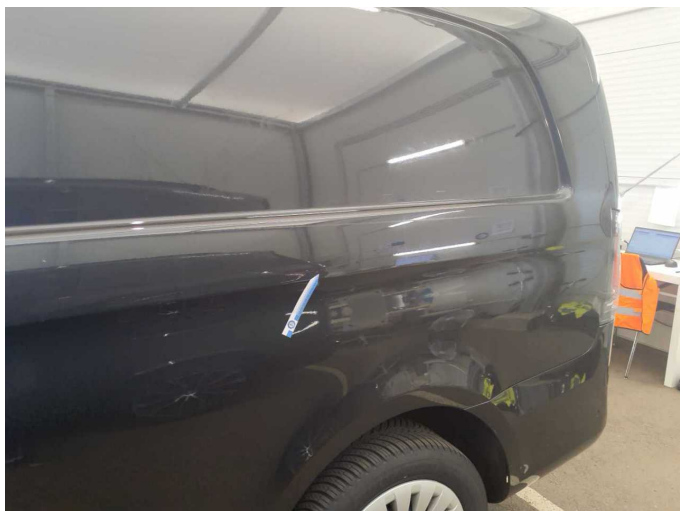
| No. | Component group | Description |
|---|---|---|
| 7 | Side panel - rear left side | Side panel - Scratch(es) - Paint |

**Damage 7:** Side panel - rear left side: Side panel - Scratch(es) - Paint

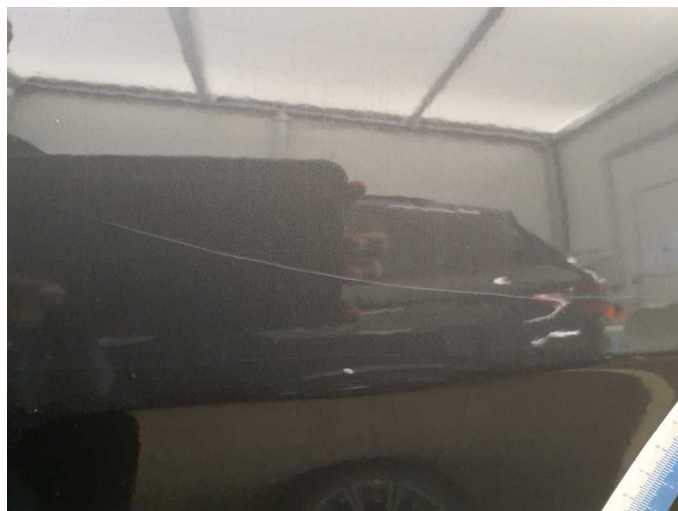
**Damage 7:** Side panel - rear left side: Side panel - Scratch(es) - Paint

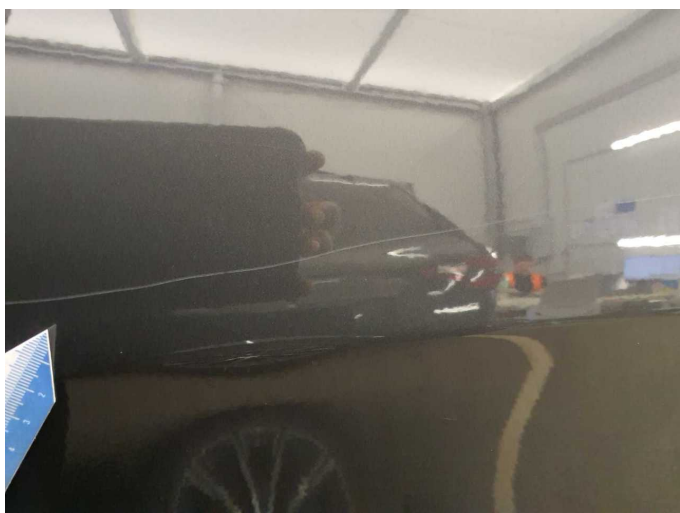
**Damage 7:** Side panel - rear left side: Side panel - Scratch(es) - Paint

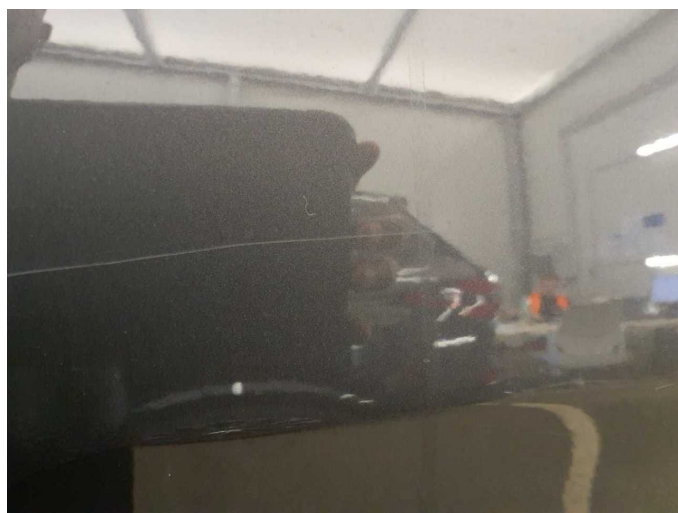
**Damage 7:** Side panel - rear left side: Side panel - Scratch(es) - Paint
