Expertise

Protocol number: 46478901  
Order No. / Reference: 26565413  
Inspection date: 13 Jul 2026

Manufacturer: Ford

Model: Galaxy 2.5 Duratec FHEV TITANIUM

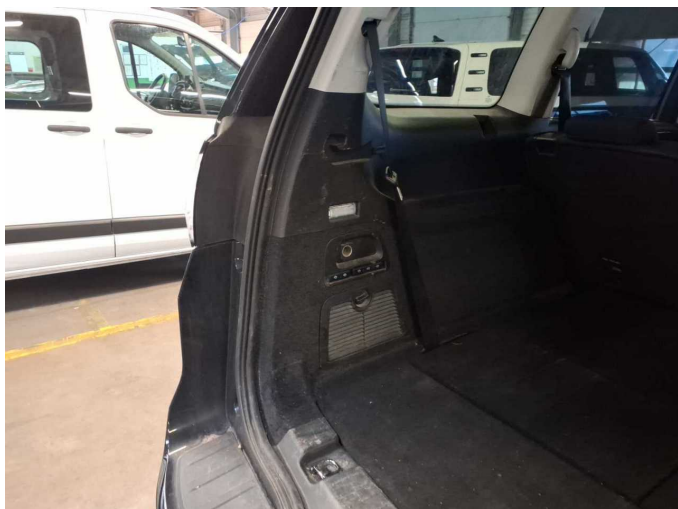
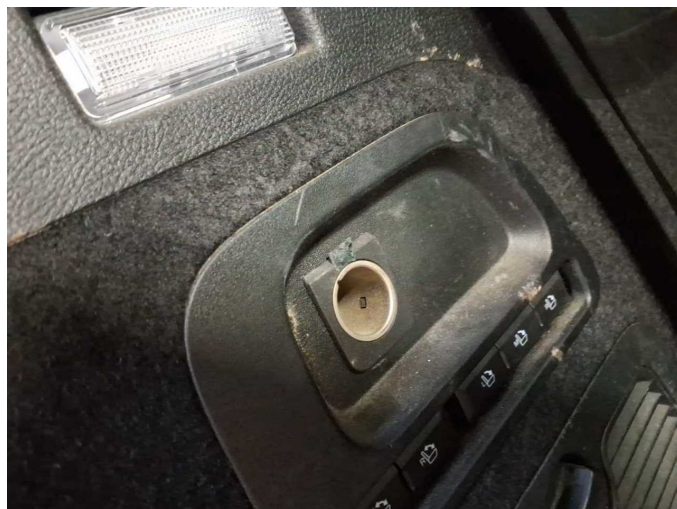
| No. | Component group | Description |
|---|---|---|
| 2 | Electrical system | Power socket (12V) - Broken / torn - Loss in value |

**Damage 2:** Electrical system: Power socket (12V) - Broken / torn - Loss in value

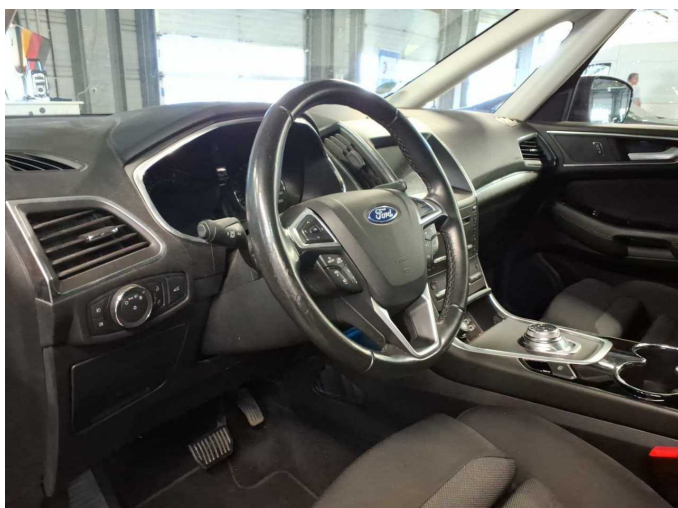
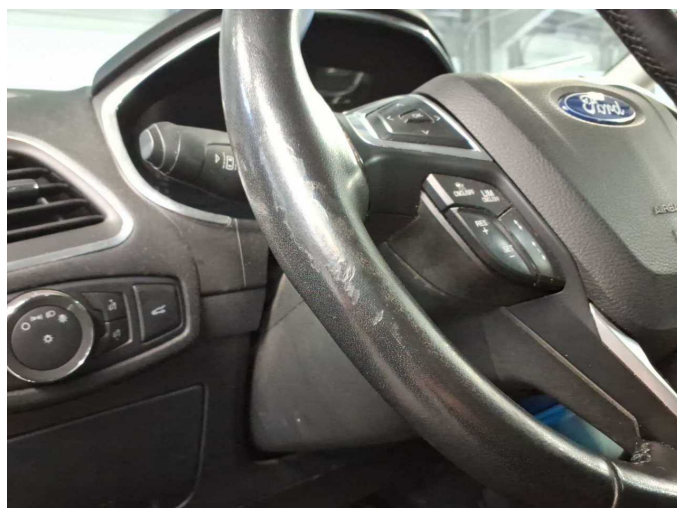
| No. | Component group | Description |
|---|---|---|
| 3 | Steering system | Steering wheel - Abrasion - Smart repair |

**Damage 3:** Steering system: Steering wheel - Abrasion - Smart repair

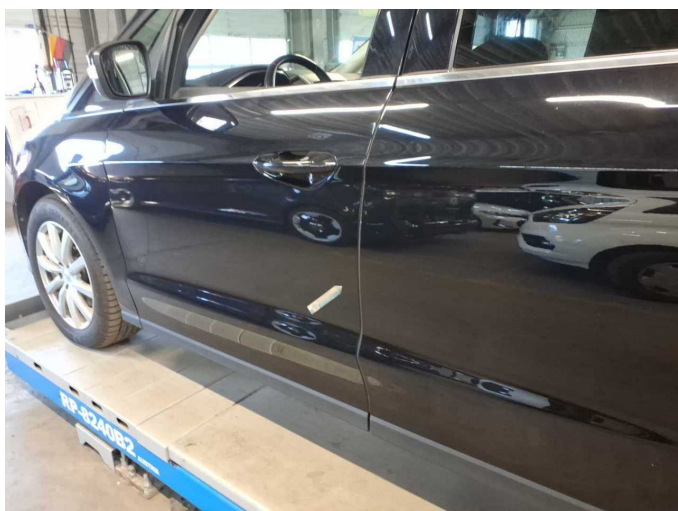
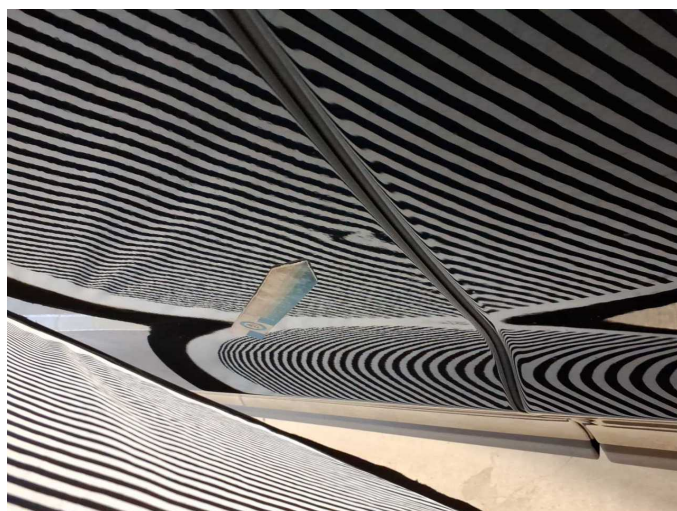
| No. | Component group | Description |
|---|---|---|
| 4 | Door - front left side | Door - dent(s) - Smooth repair work |

**Damage 4:** Door - front left side: Door - dent(s) - Smooth repair work

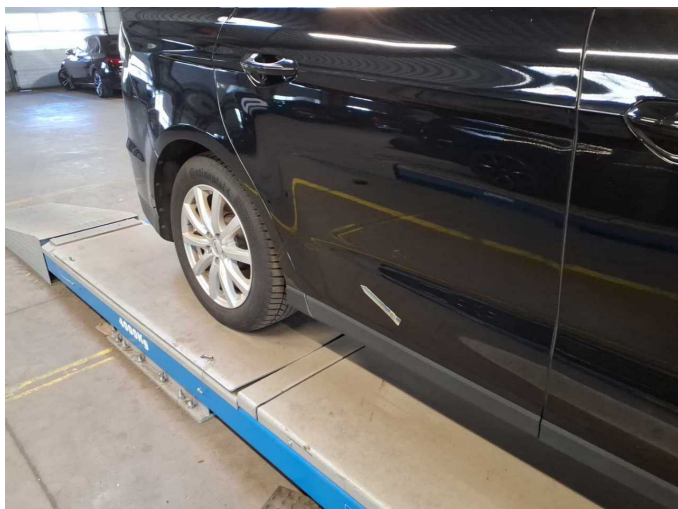
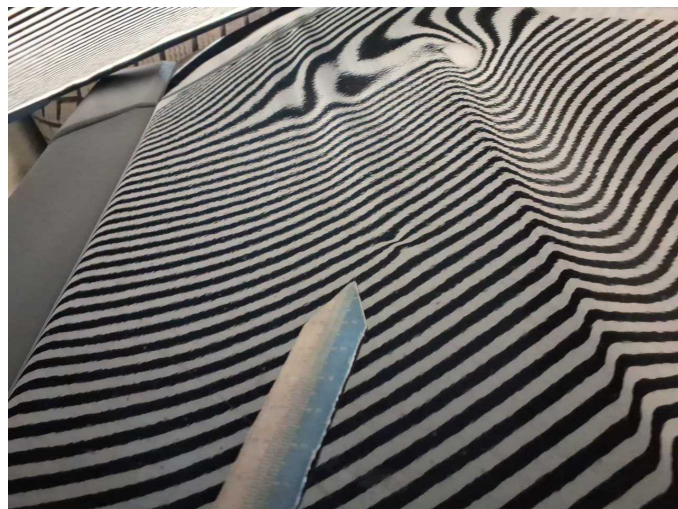
| No. | Component group | Description |
|---|---|---|
| 5 | Door - rear right side | Door - dent(s) - Smooth repair work |

**Damage 5:** Door - rear right side: Door - dent(s) - Smooth repair work

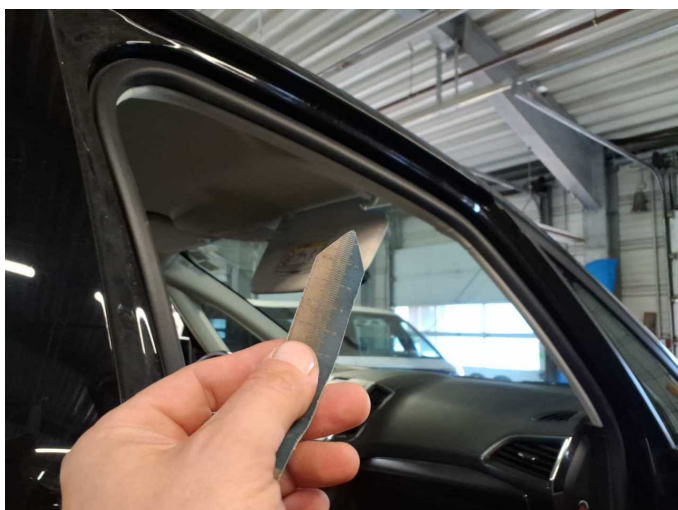
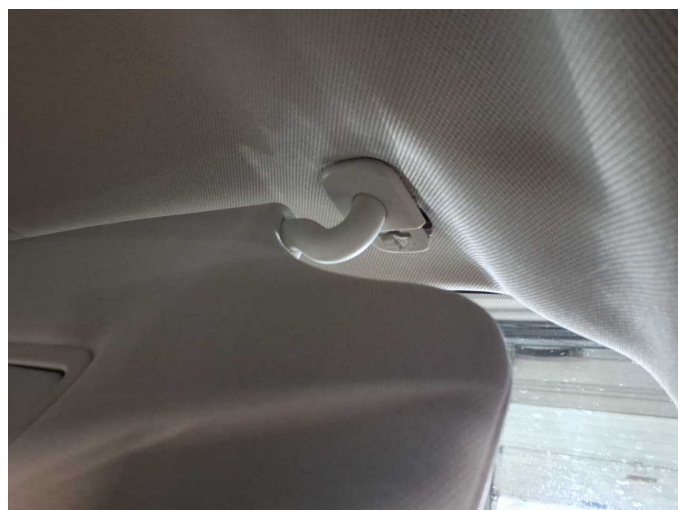
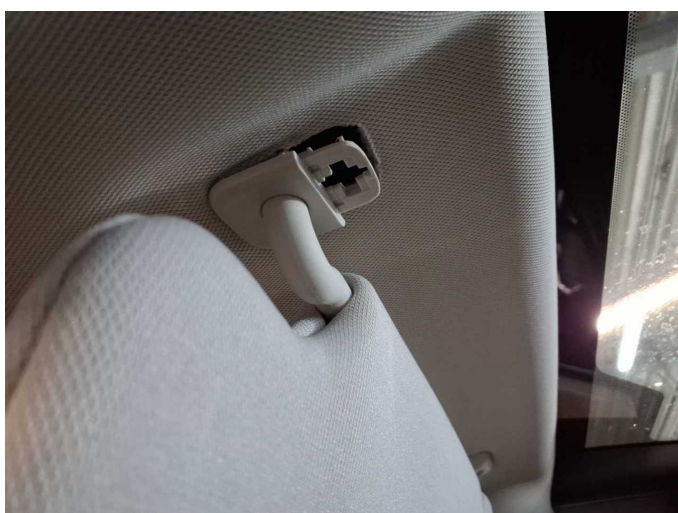
| No. | Component group | Description |
|---|---|---|
| 6 | Interior | Sun visor - right side - Loose - Replace |

**Damage 6:** Interior: Sun visor - right side - Loose - Replace

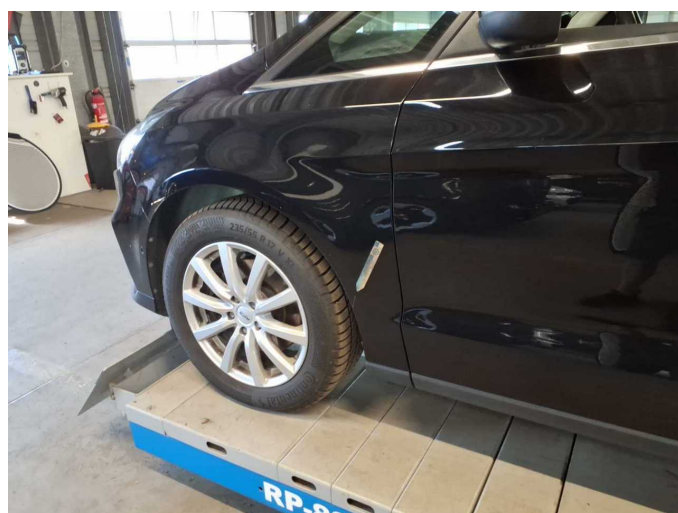
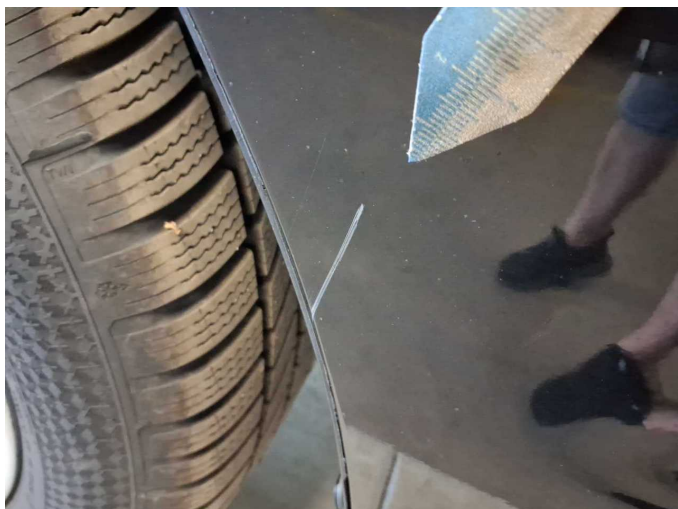
| No. | Component group | Description |
|---|---|---|
| 7 | Mudguard - left side | Mudguard - left side - Scratch(es) - Smart repair |

**Damage 7:** Mudguard - left side: Mudguard - left side - Scratch(es) - Smart repair

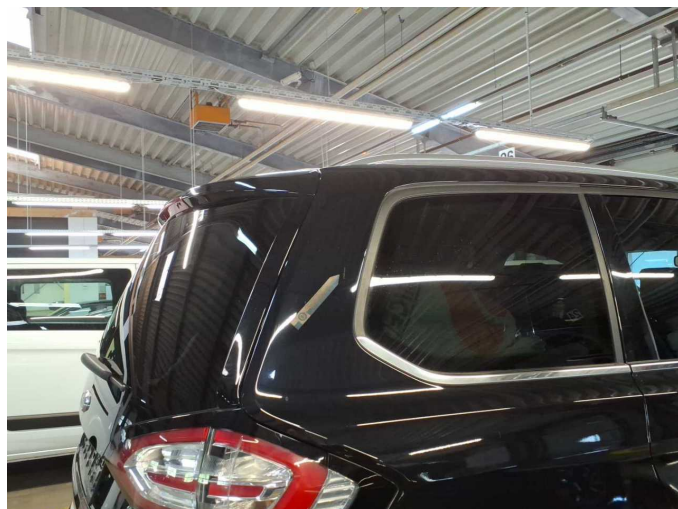
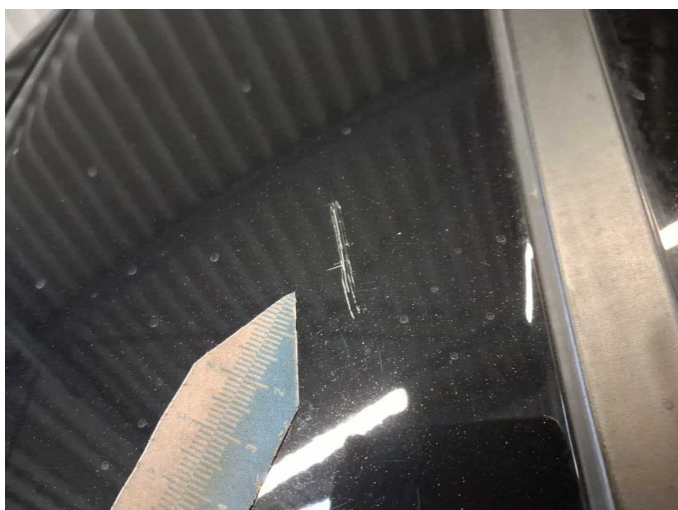
| No. | Component group | Description |
|---|---|---|
| 8 | Side panel - rear right side | Side panel - Scratch(es) - Smart repair |

**Damage 8:** Side panel - rear right side: Side panel - Scratch(es) - Smart repair

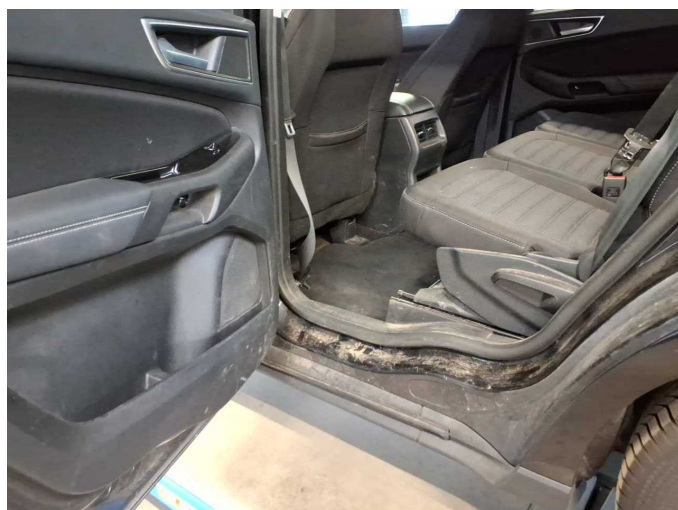
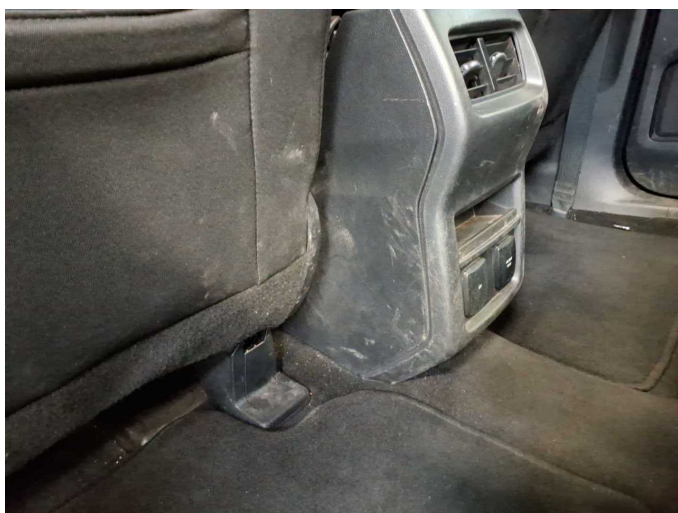
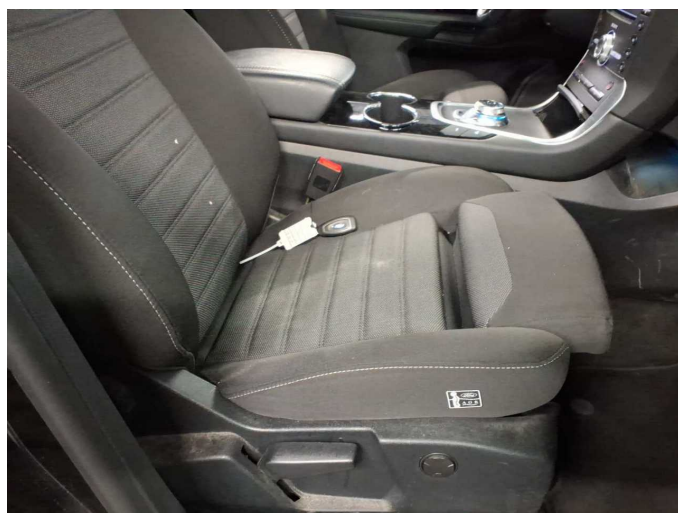
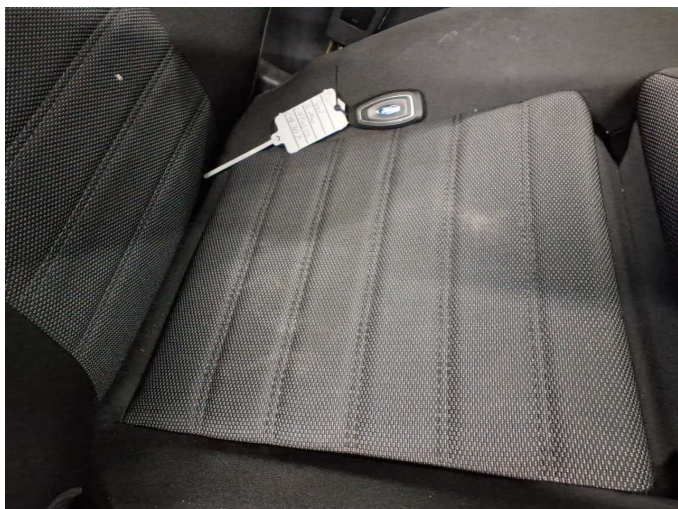
| No. | Component group | Description |
|---|---|---|
| 9 | Interior | Interior (Flecken) - Soiled - Clean |

**Damage 9:** Interior: Interior (Flecken) - Soiled - Clean

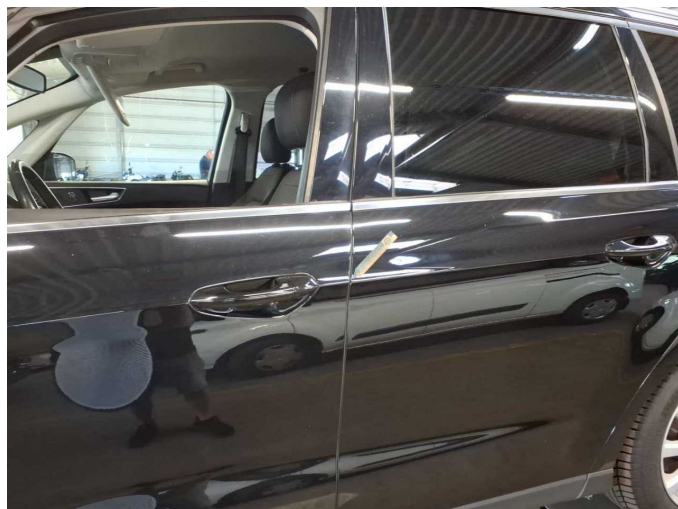
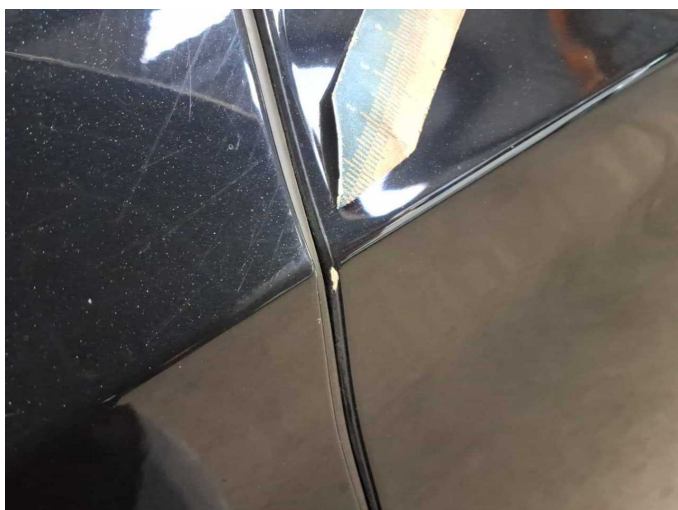
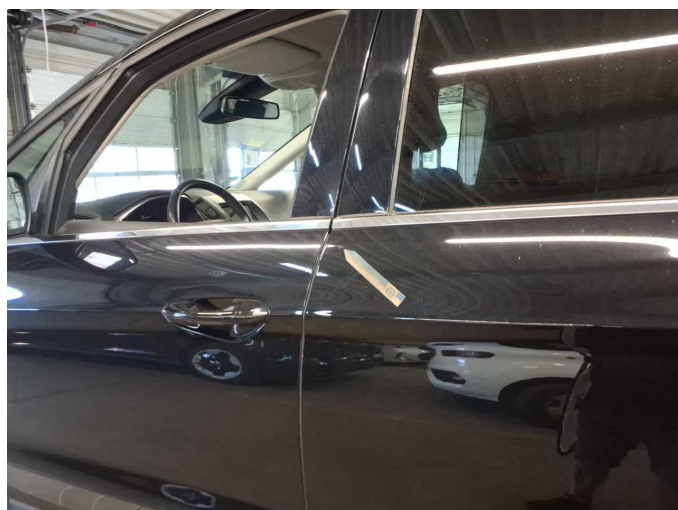
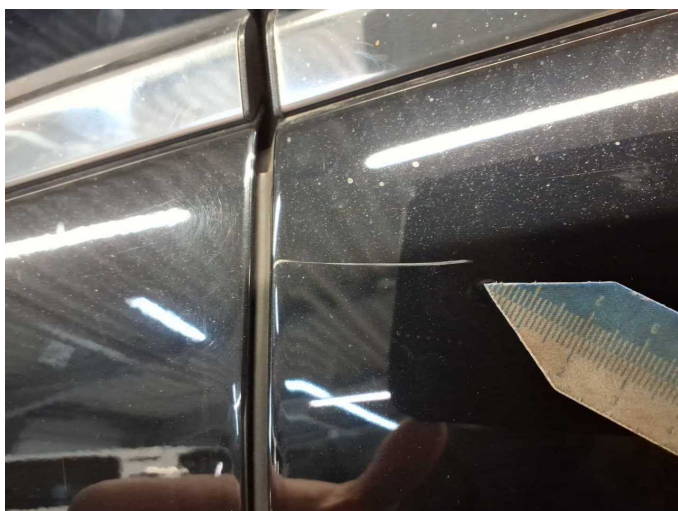
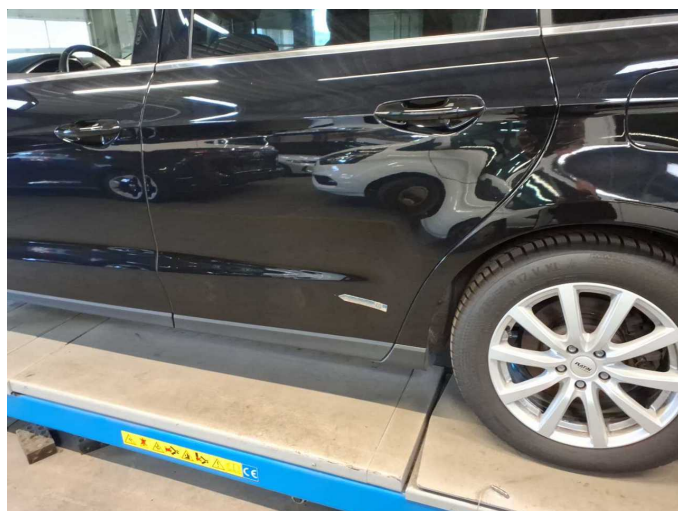
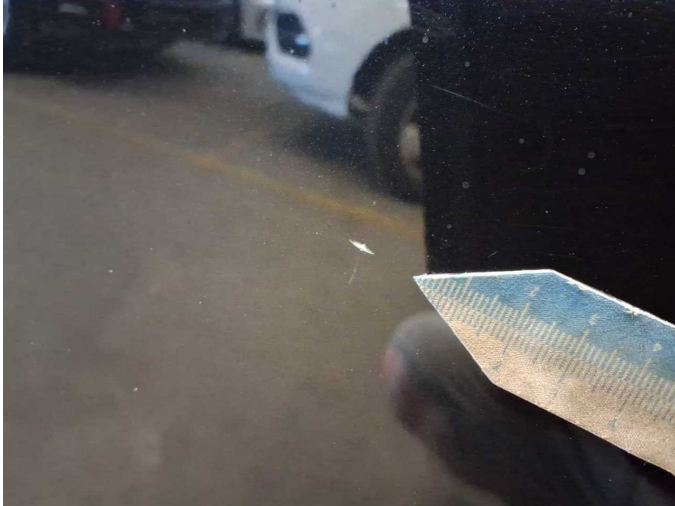
| No. | Component group | Description |
|---|---|---|
| 10 | Door - rear left side | Door - Scratch(es) - Paint |

**Damage 10:** Door - rear left side: Door - Scratch(es) - Paint

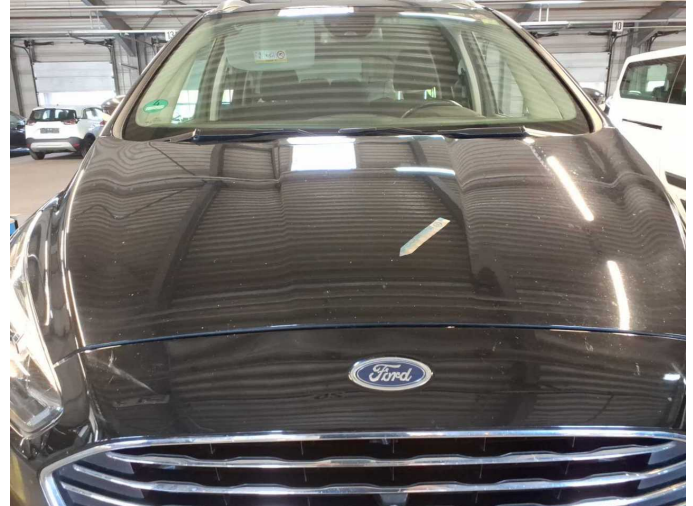
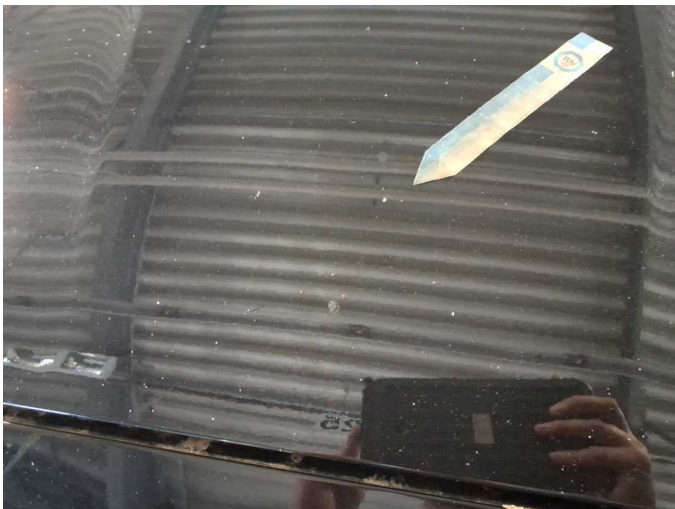
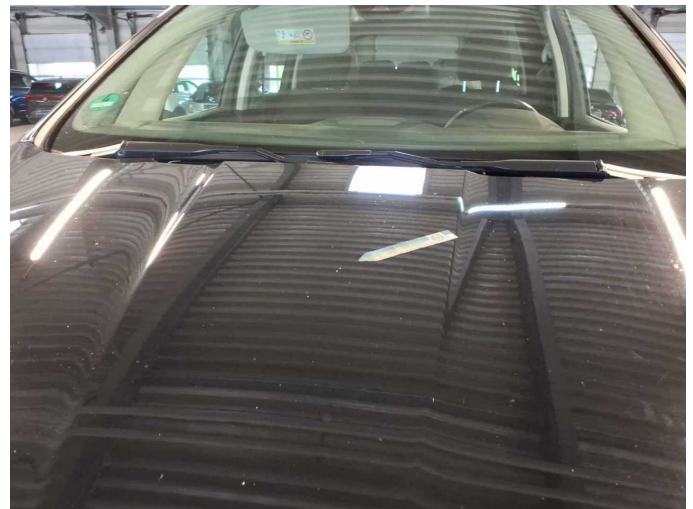
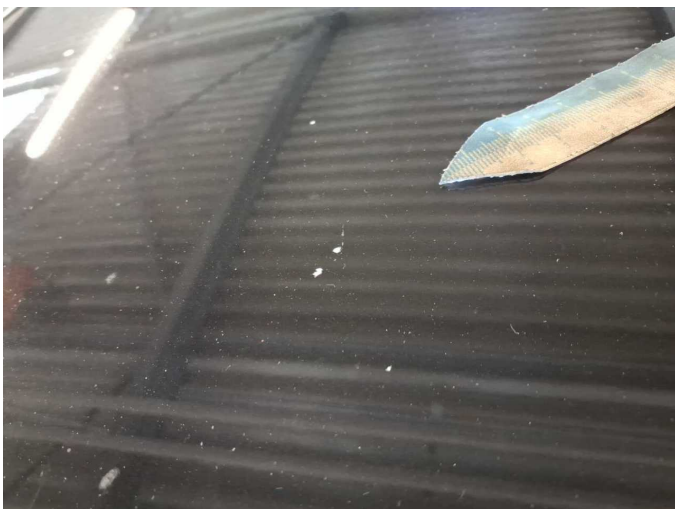
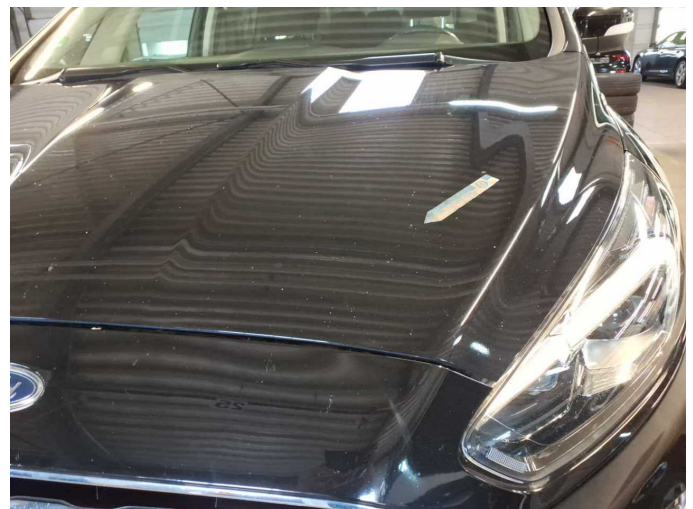
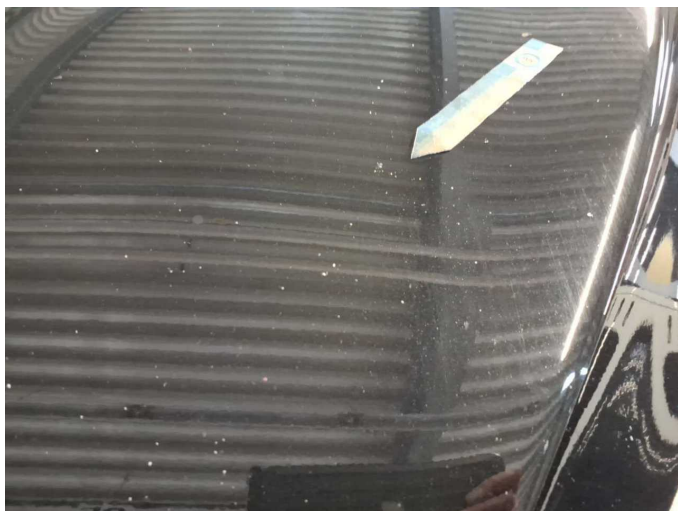
| No. | Component group | Description |
|---|---|---|
| 11 | Bonnet | Bonnet (Sandstrahleffekt) - Stone chips - Paint |

**Damage 11:** Bonnet: Bonnet (Sandstrahleffekt) - Stone chips - Paint

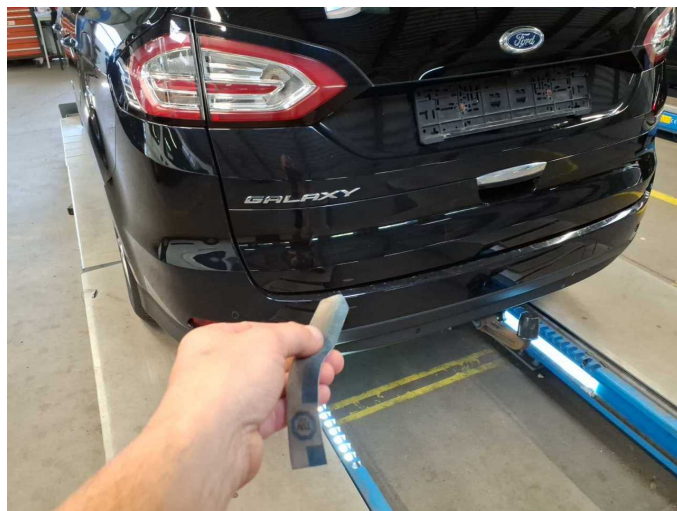
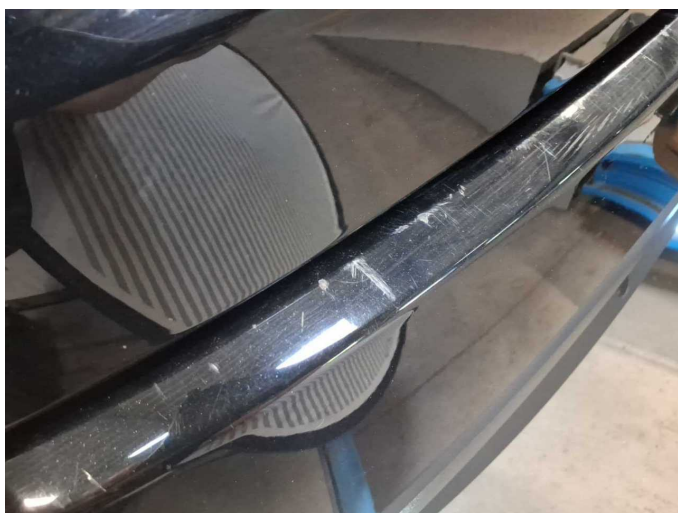
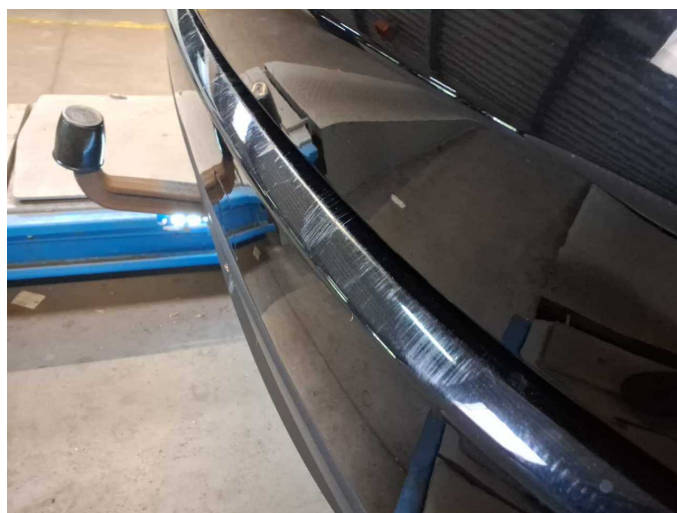
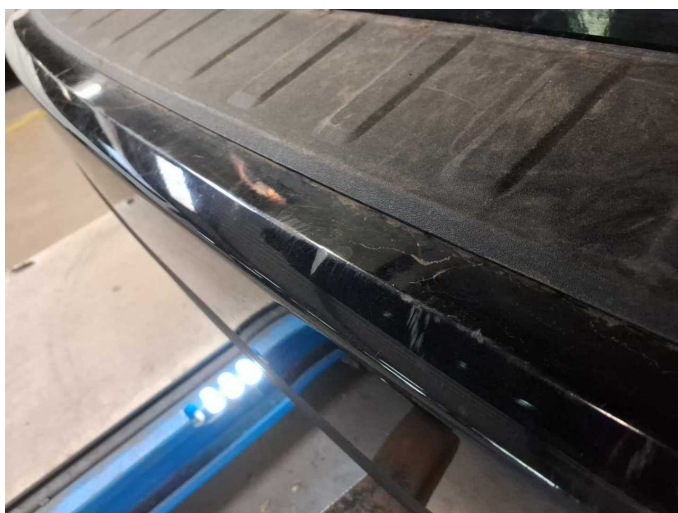
| No. | Component group | Description |
|---|---|---|
| 12 | Rear bumper | Rear bumper - Scratched - Paint |

**Damage 12:** Rear bumper: Rear bumper - Scratched - Paint

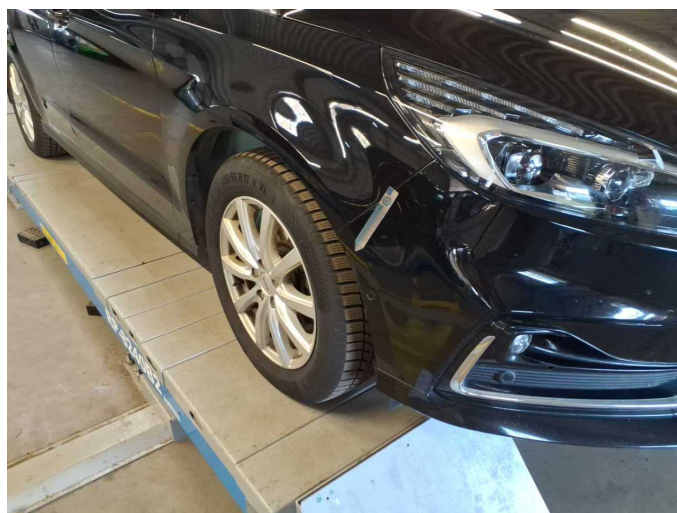
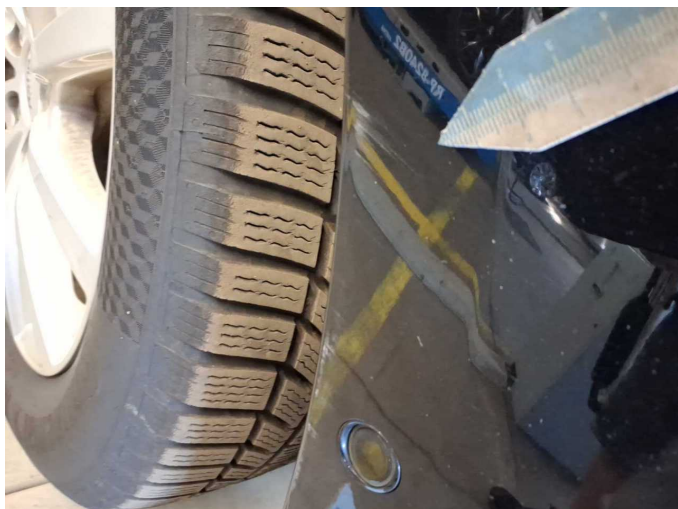
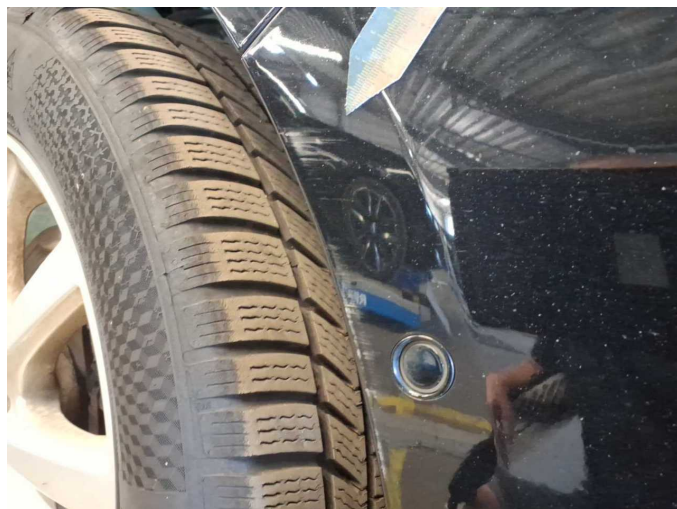
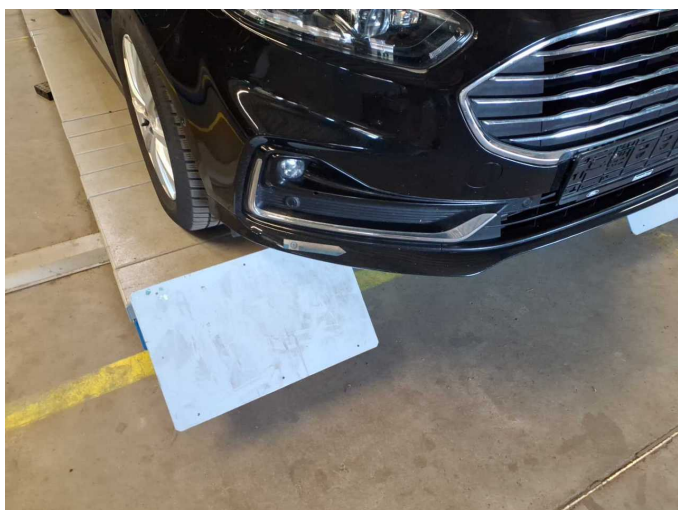
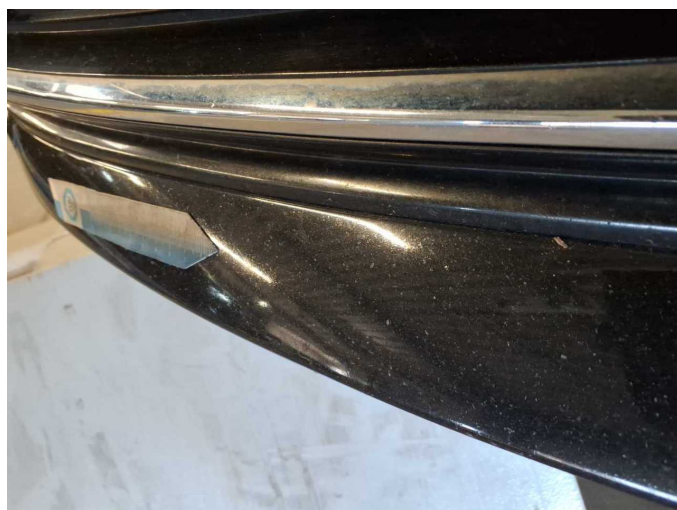
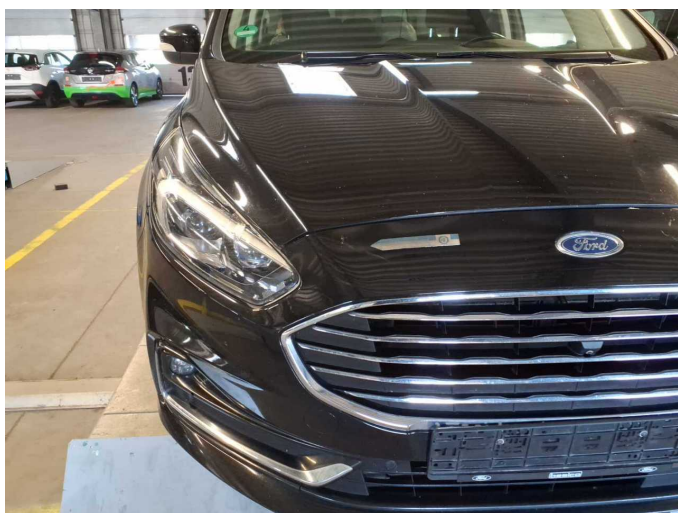
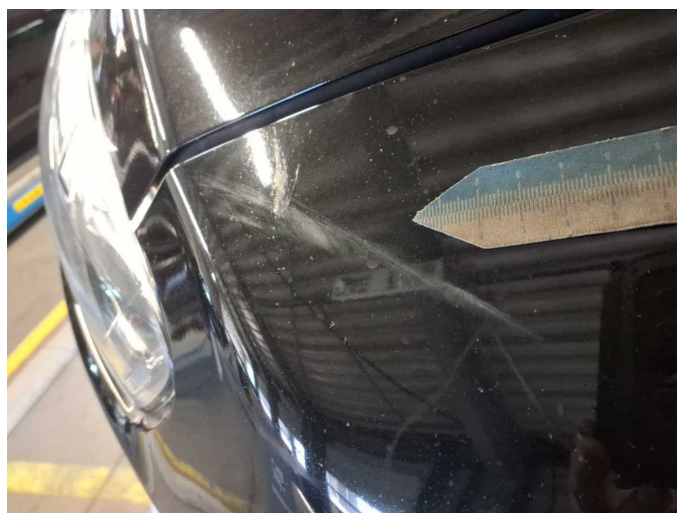
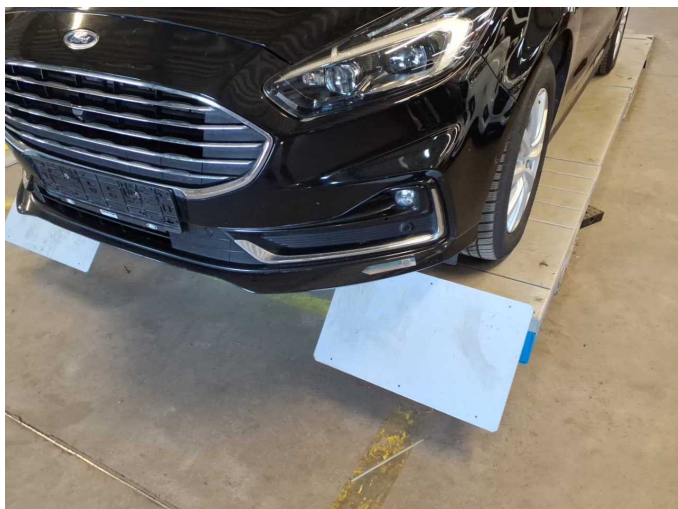
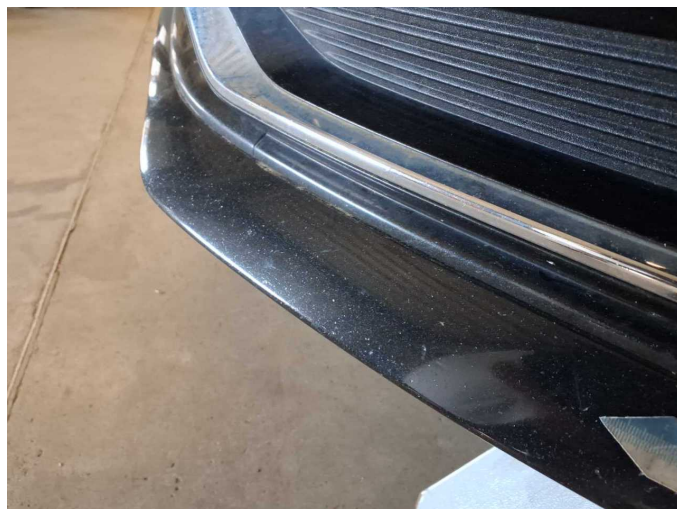
| No. | Component group | Description |
|---|---|---|
| 13 | Front bumper | Front bumper (Steinschlag) - Scratch(es) - Paint |

**Damage 13:** Front bumper: Front bumper (Steinschlag) - Scratch(es) - Paint

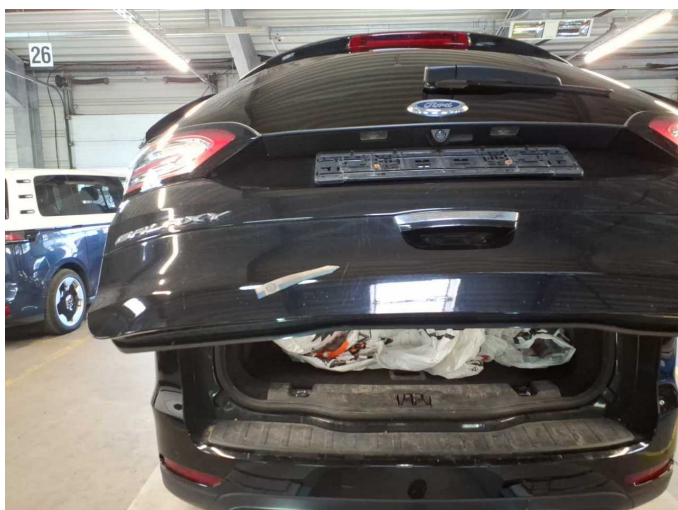
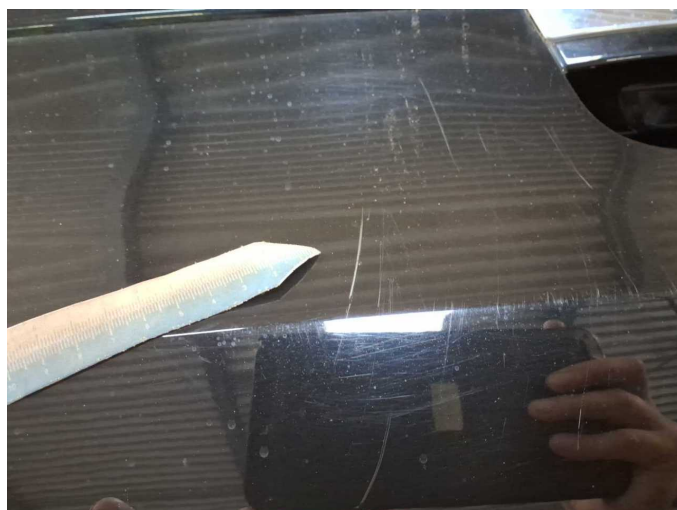
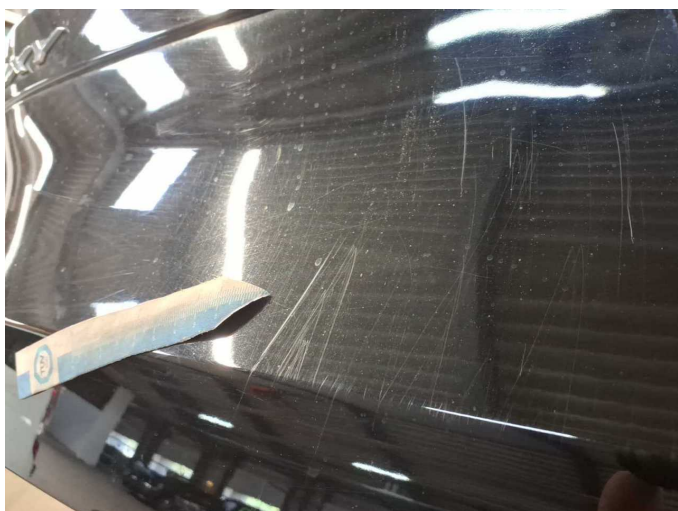
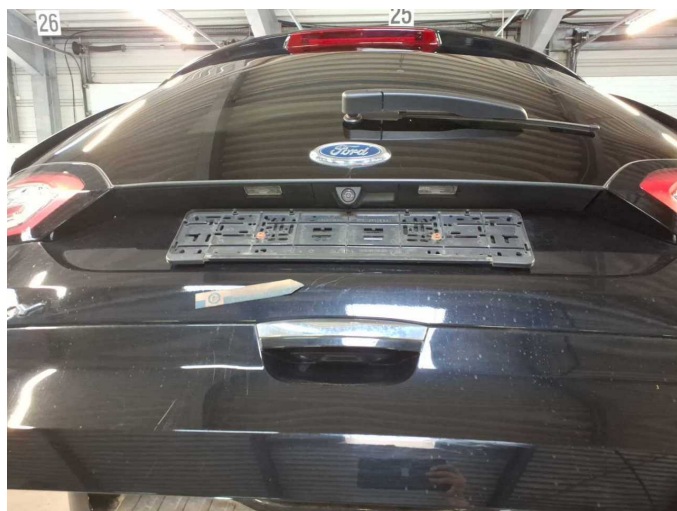
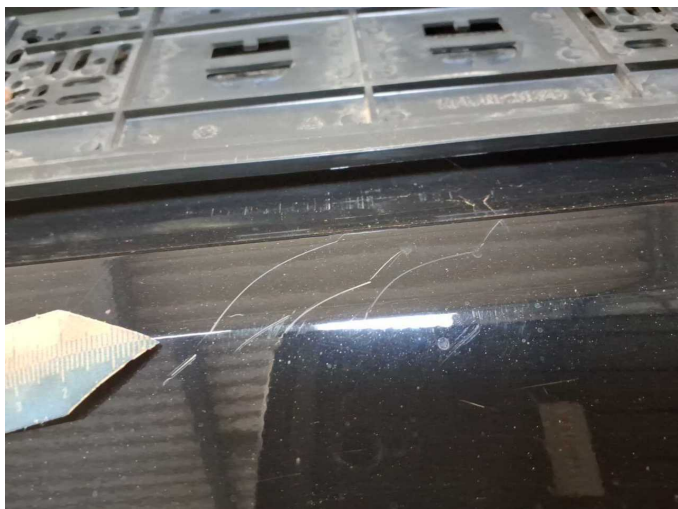
| No. | Component group | Description |
|---|---|---|
| 14 | Boot lid / rear door | Boot lid (+ Leiste unten) - Scratched - Paint |

**Damage 14:** Boot lid / rear door: Boot lid (+ Leiste unten) - Scratched - Paint

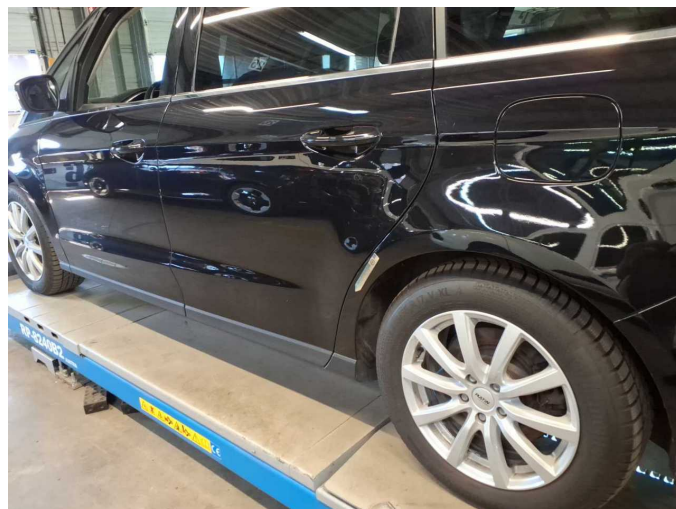
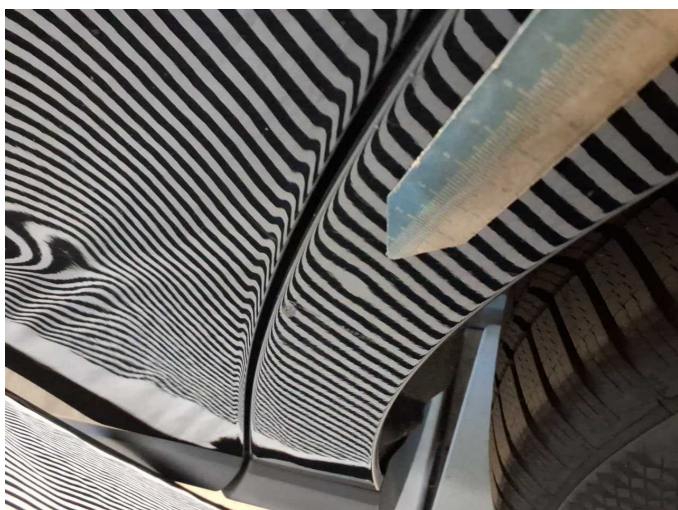
| No. | Component group | Description |
|---|---|---|
| 3 | Side panel - rear left side | Side panel - dent(s) - Smooth repair work |

**Wear and tear 3:** Side panel - rear left side: Side panel - dent(s) - Smooth repair work

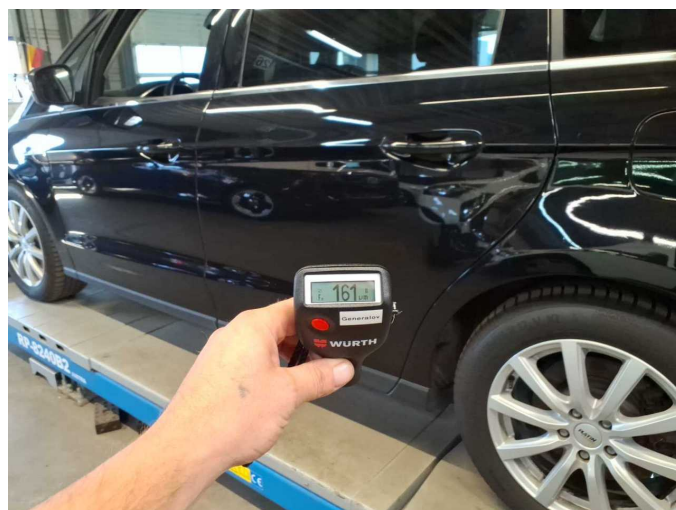
1 Door - rear left side, Professionally carried out, Invoice of repair done Non-existent

Door - rear left side 161 µm |

**Repainting 1:** Door - rear left side
