Expertise

Protocol number: 46461857  
Order No. / Reference: 26699334  
Inspection date: 9 Jul 2026

Manufacturer: Ford

Model: Mondeo Turnier 2.0 EcoBlue Trend

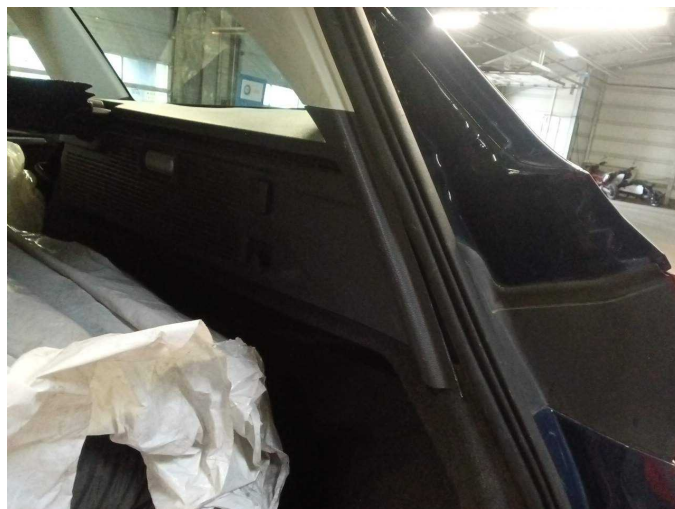
| No. | Component group | Description |
|---|---|---|
| 1 | Trim / covers | Boot lining - Malposition - Un- / install |

**Damage 1:** Trim / covers: Boot lining - Malposition - Un- / install

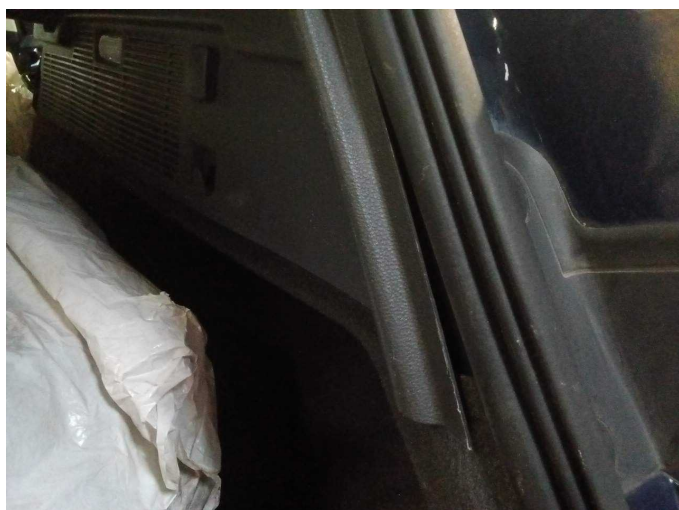
**Damage 1:** Trim / covers: Boot lining - Malposition - Un- / install

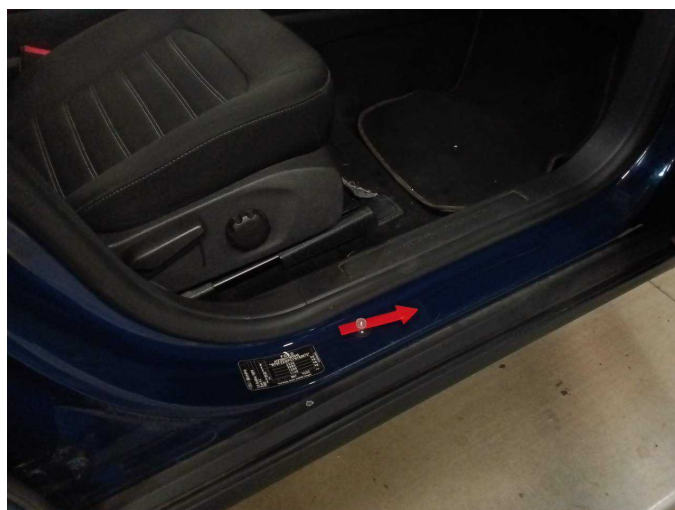
| No. | Component group | Description |
|---|---|---|
| 2 | Sill - right side | Sill - Scratch(es) - Smart repair |

**Damage 2:** Sill - right side: Sill - Scratch(es) - Smart repair

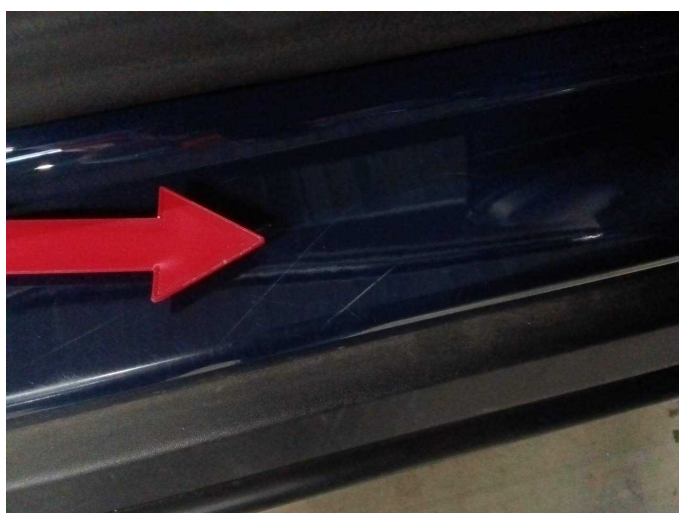
**Damage 2:** Sill - right side: Sill - Scratch(es) - Smart repair

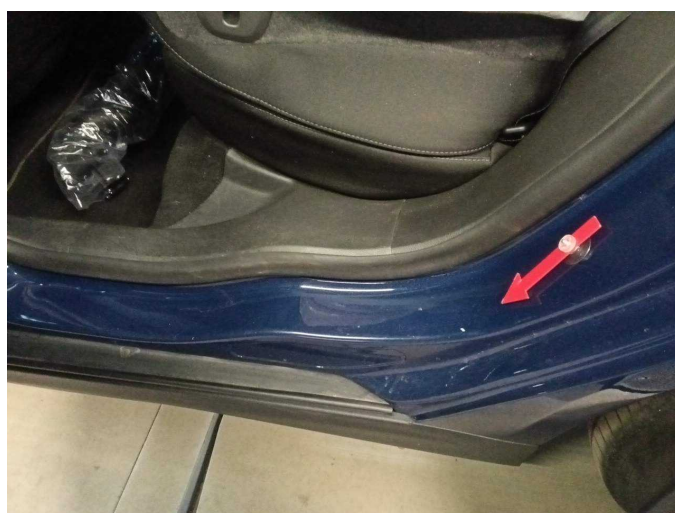
| No. | Component group | Description |
|---|---|---|
| 3 | Sill - left side | Sill - Scratch(es) - Smart repair |

**Damage 3:** Sill - left side: Sill - Scratch(es) - Smart repair

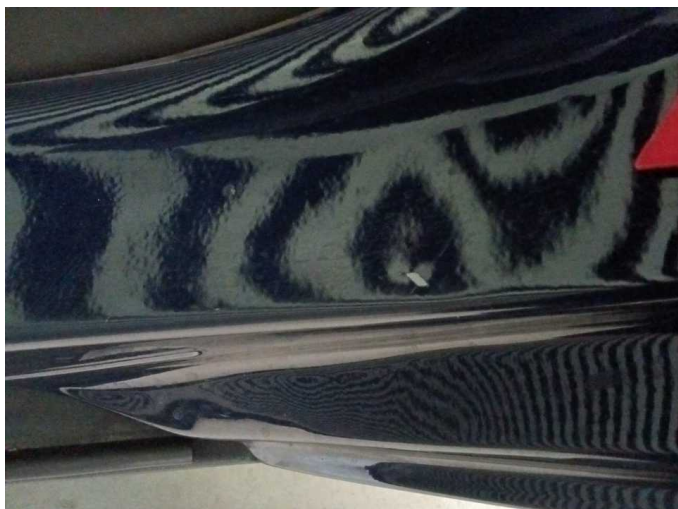
**Damage 3:** Sill - left side: Sill - Scratch(es) - Smart repair

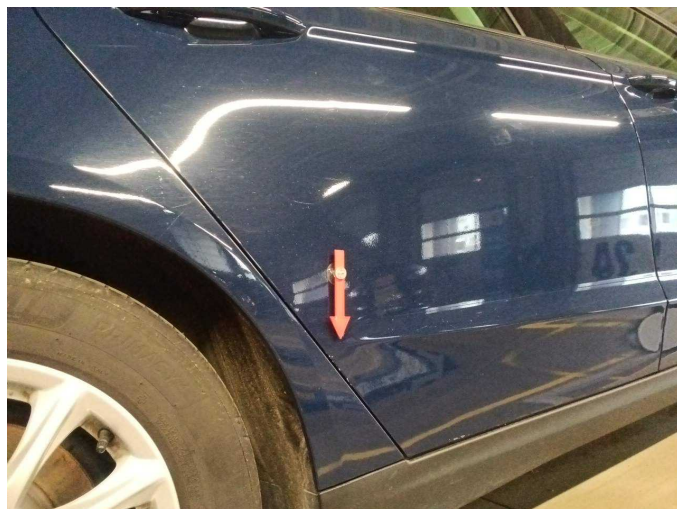
| No. | Component group | Description |
|---|---|---|
| 4 | Door - rear right side | Door edge - Scratch(es) - Smart repair |

**Damage 4:** Door - rear right side: Door edge - Scratch(es) - Smart repair

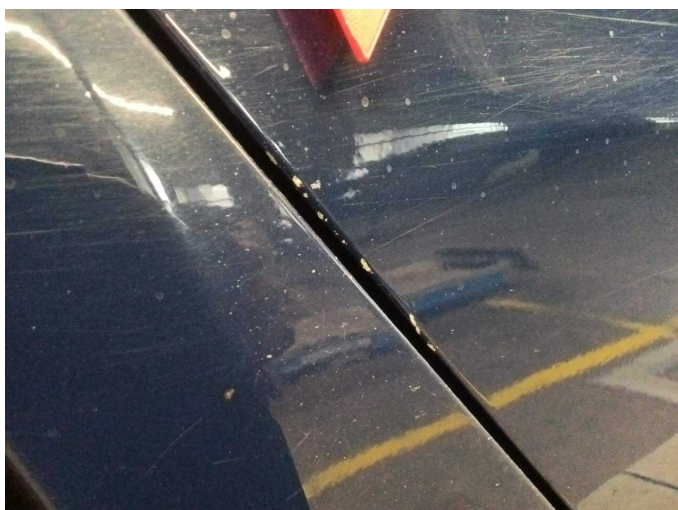
**Damage 4:** Door - rear right side: Door edge - Scratch(es) - Smart repair

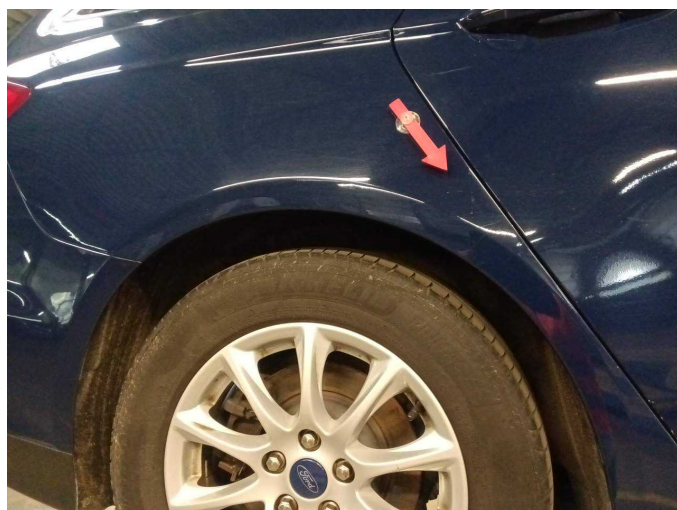
| No. | Component group | Description |
|---|---|---|
| 5 | Body | Body - Scratch(es) - Smart repair |

**Damage 5:** Body: Body - Scratch(es) - Smart repair

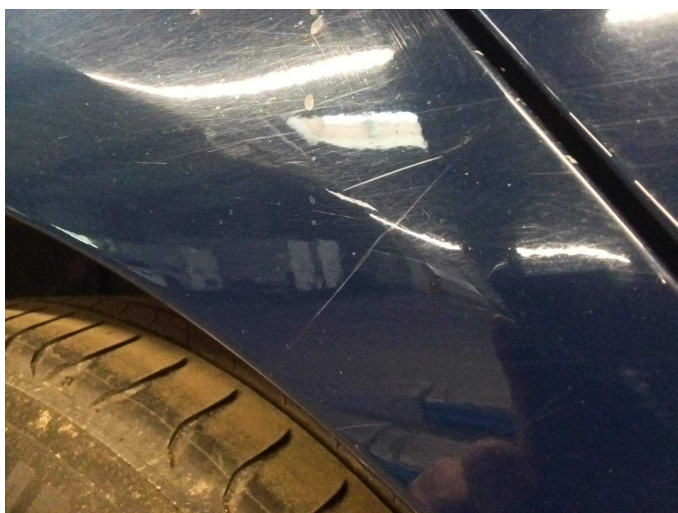
**Damage 5:** Body: Body - Scratch(es) - Smart repair

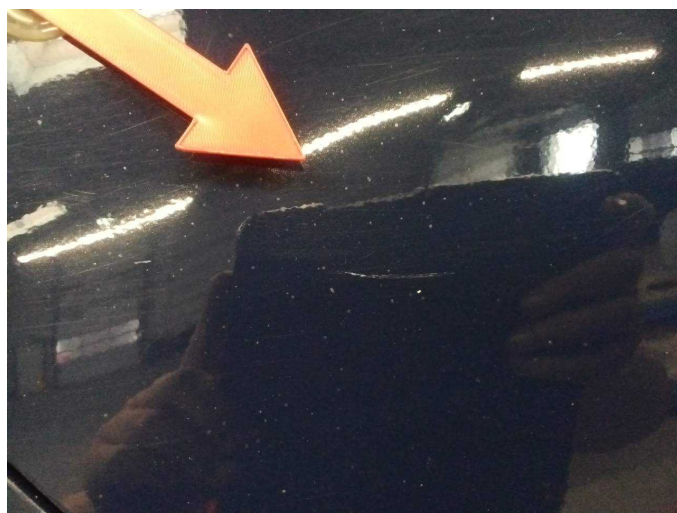
**Damage 5:** Body: Body - Scratch(es) - Smart repair

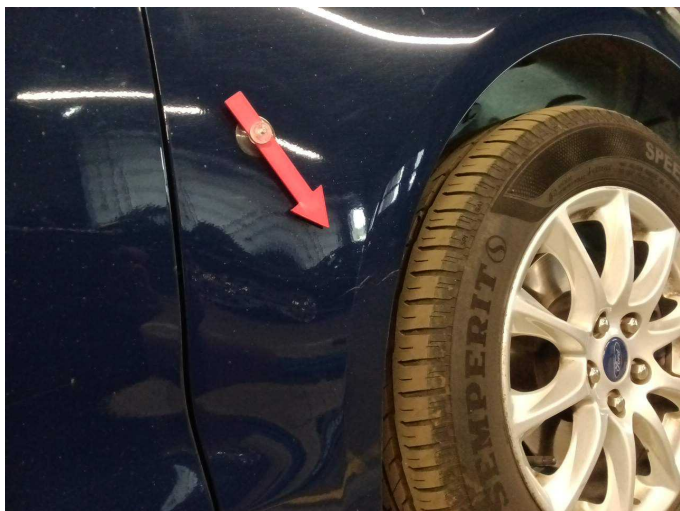
**Damage 5:** Body: Body - Scratch(es) - Smart repair

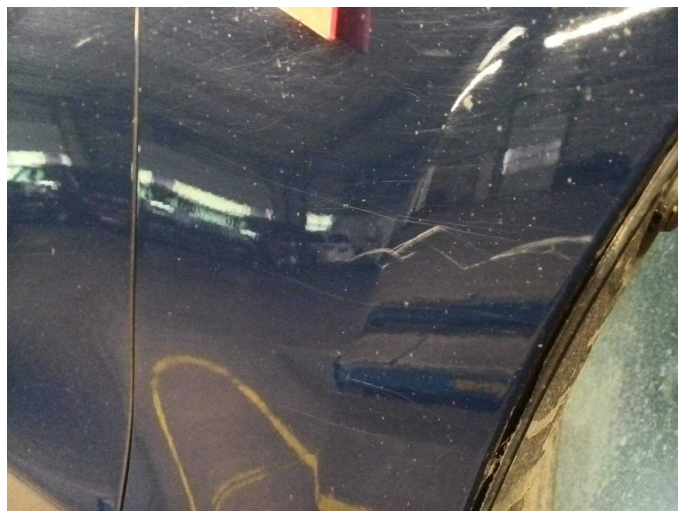
**Damage 5:** Body: Body - Scratch(es) - Smart repair

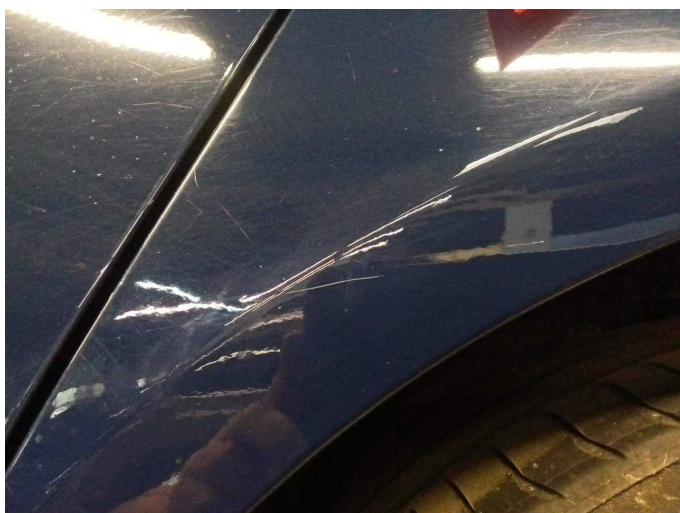
**Damage 5:** Body: Body - Scratch(es) - Smart repair

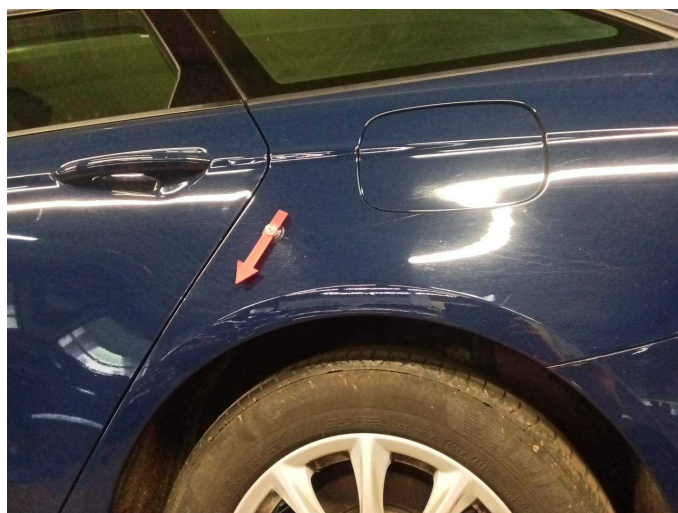
**Damage 5:** Body: Body - Scratch(es) - Smart repair

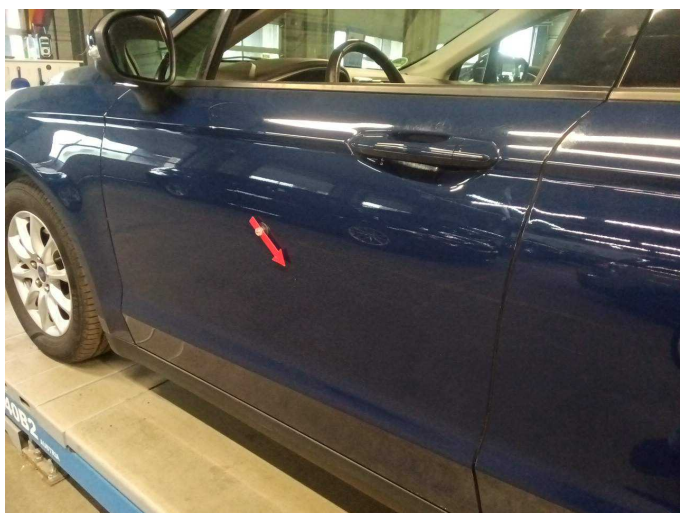
| No. | Component group | Description |
|---|---|---|
| 6 | Door - front left side | Door - Dent / paintcoat damage - Smart repair |

**Damage 6:** Door - front left side: Door - Dent / paintcoat damage - Smart repair

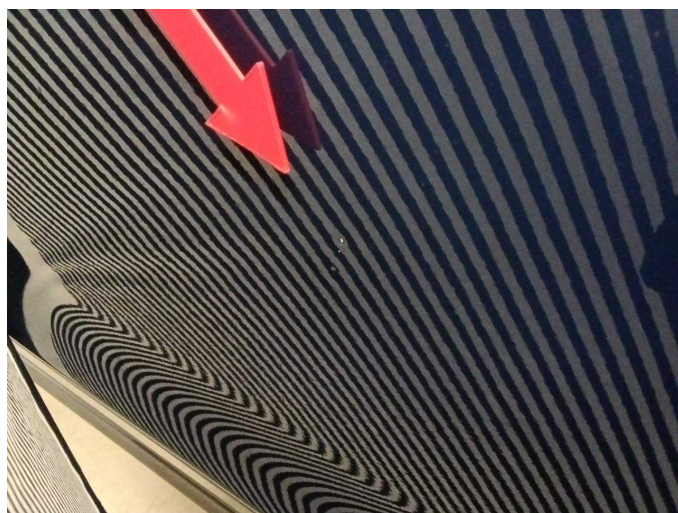
**Damage 6:** Door - front left side: Door - Dent / paintcoat damage - Smart repair

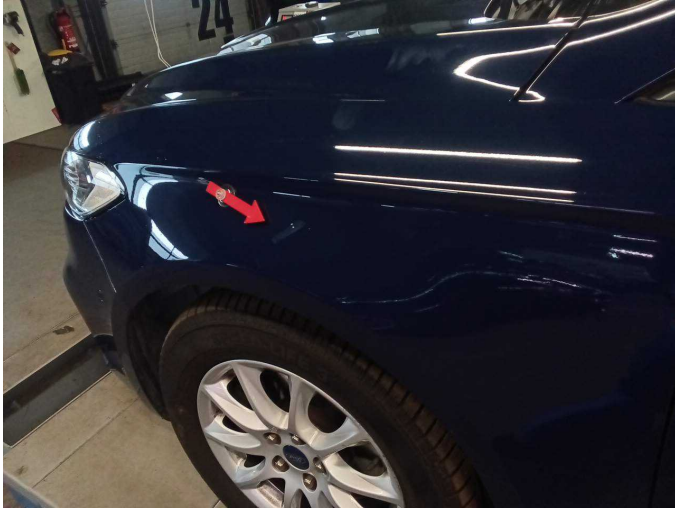
| No. | Component group | Description |
|---|---|---|
| 7 | Mudguard - left side | Mudguard - left side - Scratched - Paint |

**Damage 7:** Mudguard - left side: Mudguard - left side - Scratched - Paint

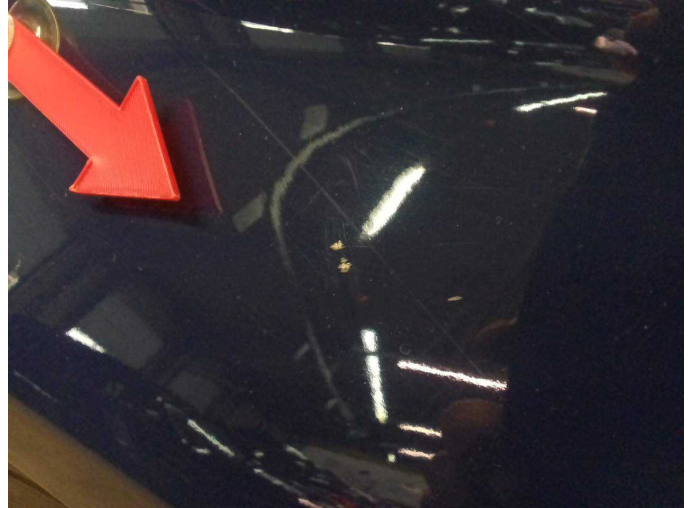
**Damage 7:** Mudguard - left side: Mudguard - left side - Scratched - Paint

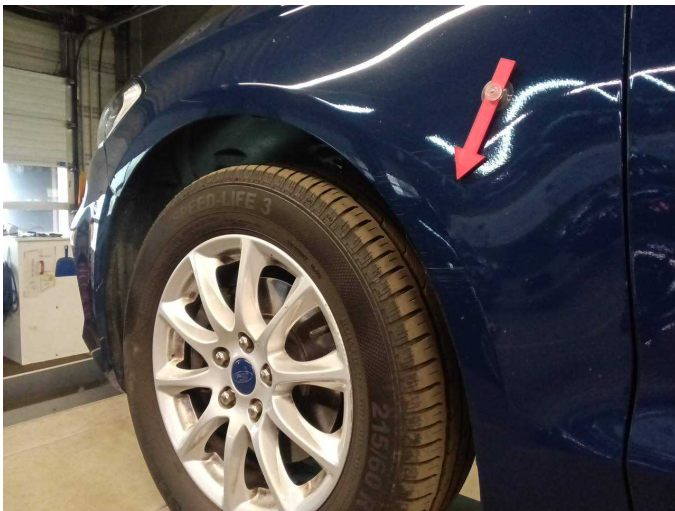
**Damage 7:** Mudguard - left side: Mudguard - left side - Scratched - Paint

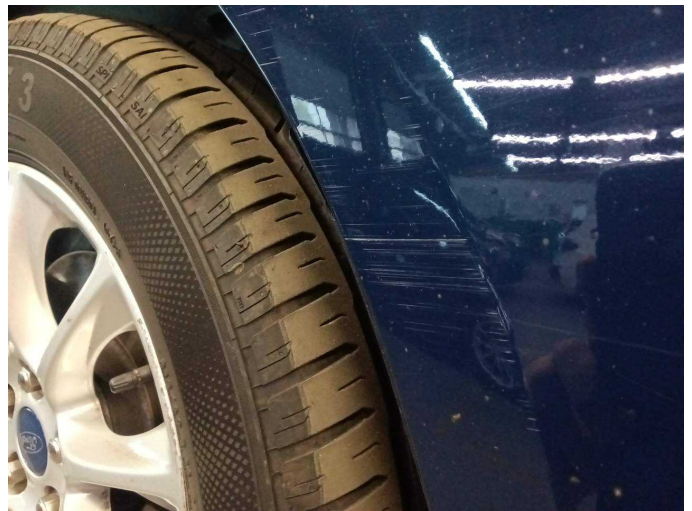
**Damage 7:** Mudguard - left side: Mudguard - left side - Scratched - Paint

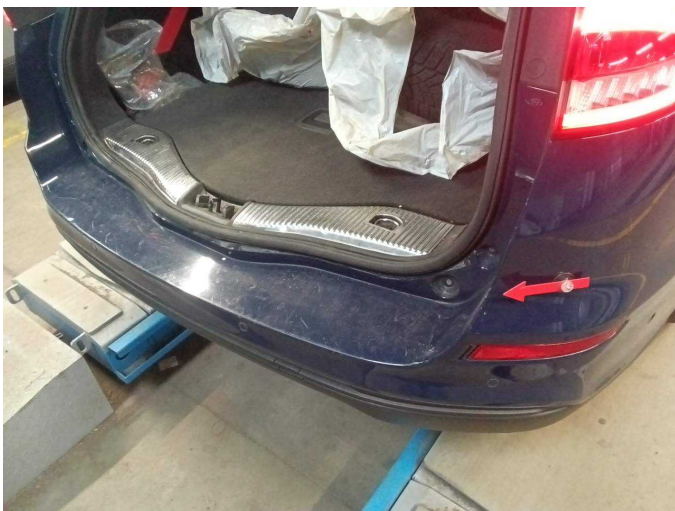
| No. | Component group | Description |
|---|---|---|
| 8 | Rear bumper | Rear bumper - Scratched - Paint |

**Damage 8:** Rear bumper: Rear bumper - Scratched - Paint

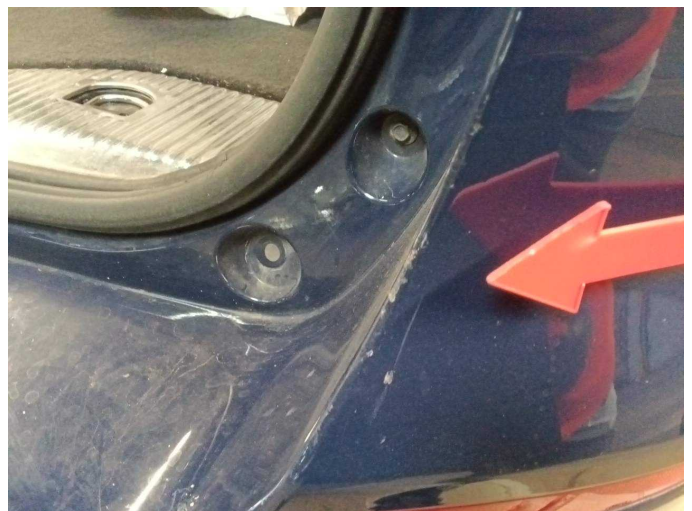
**Damage 8:** Rear bumper: Rear bumper - Scratched - Paint

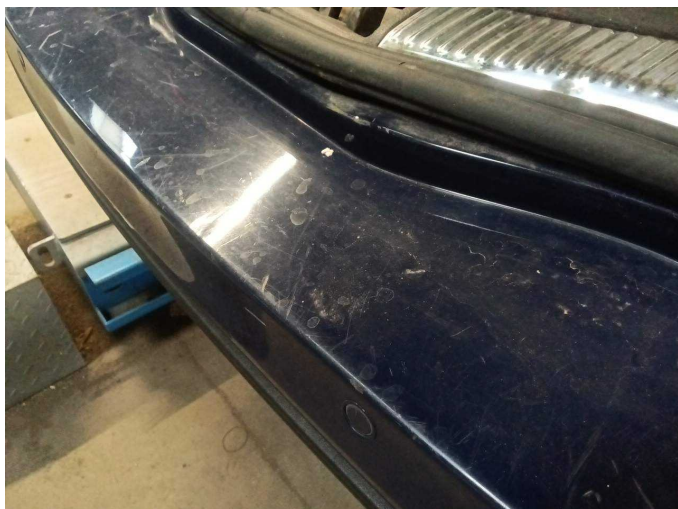
**Damage 8:** Rear bumper: Rear bumper - Scratched - Paint

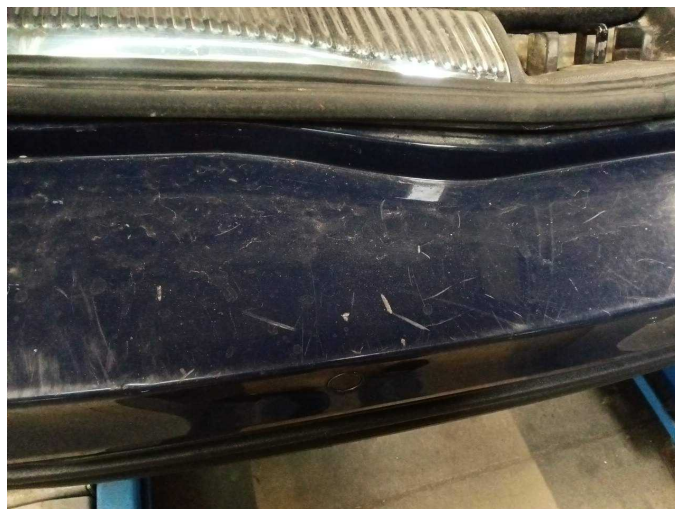
**Damage 8:** Rear bumper: Rear bumper - Scratched - Paint

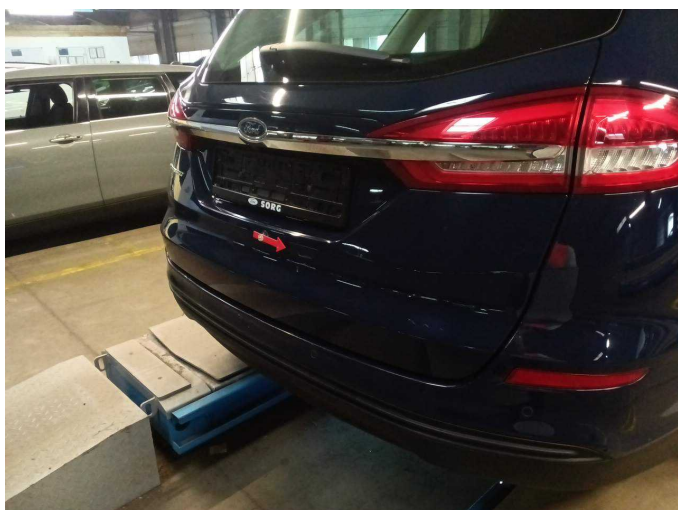
| No. | Component group | Description |
|---|---|---|
| 9 | Boot lid / rear door | Boot lid - Dent / paintcoat damage - Repair and paint |

**Damage 9:** Boot lid / rear door: Boot lid - Dent / paintcoat damage - Repair and paint

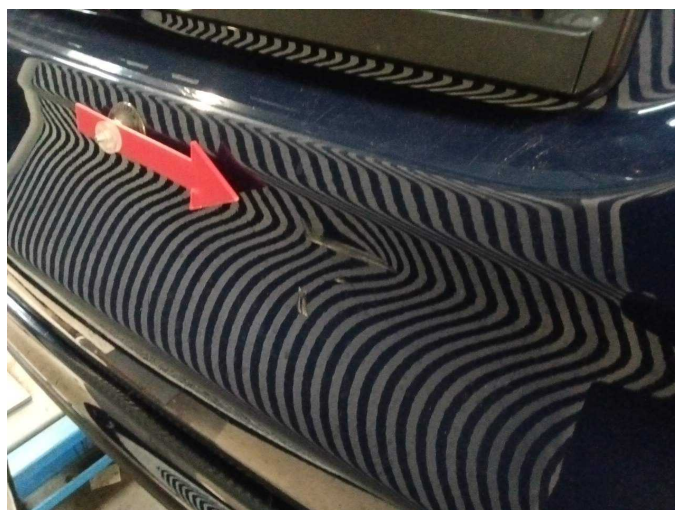
**Damage 9:** Boot lid / rear door: Boot lid - Dent / paintcoat damage - Repair and paint

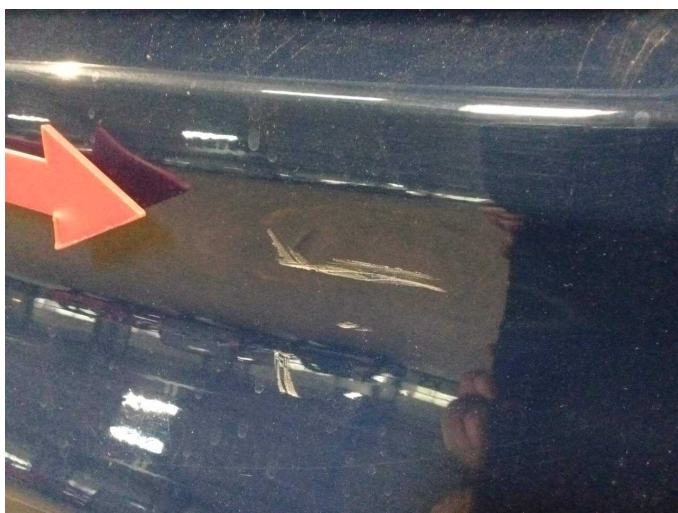
**Damage 9:** Boot lid / rear door: Boot lid - Dent / paintcoat damage - Repair and paint

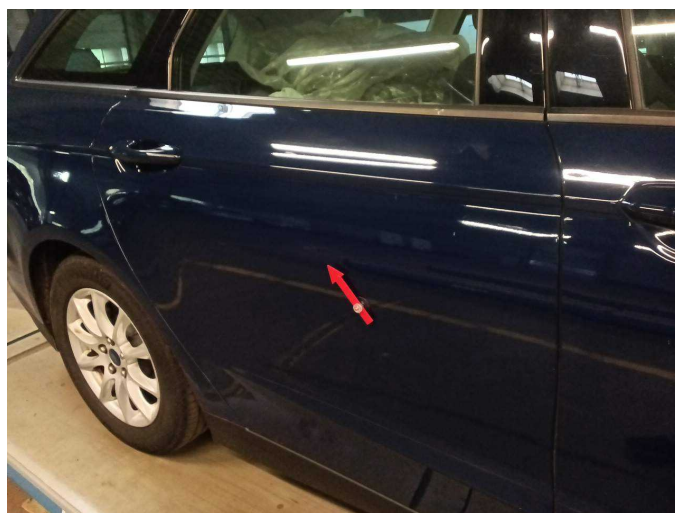
| No. | Component group | Description |
|---|---|---|
| 10 | Door - rear right side | Door - Scratch(es) - Paint |

**Damage 10:** Door - rear right side: Door - Scratch(es) - Paint

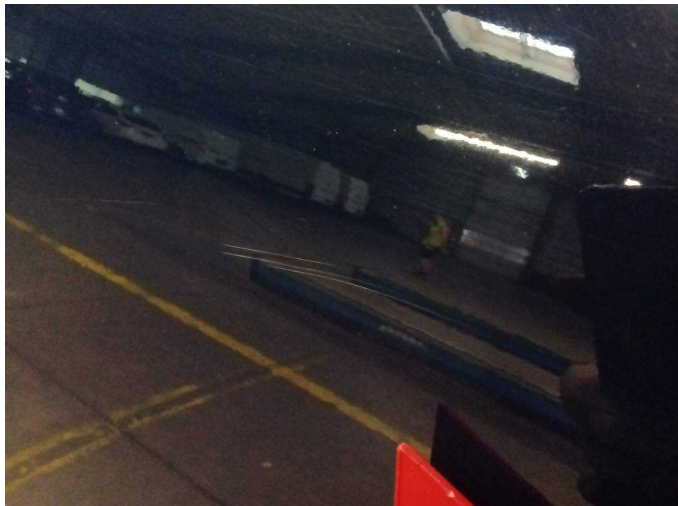
**Damage 10:** Door - rear right side: Door - Scratch(es) - Paint

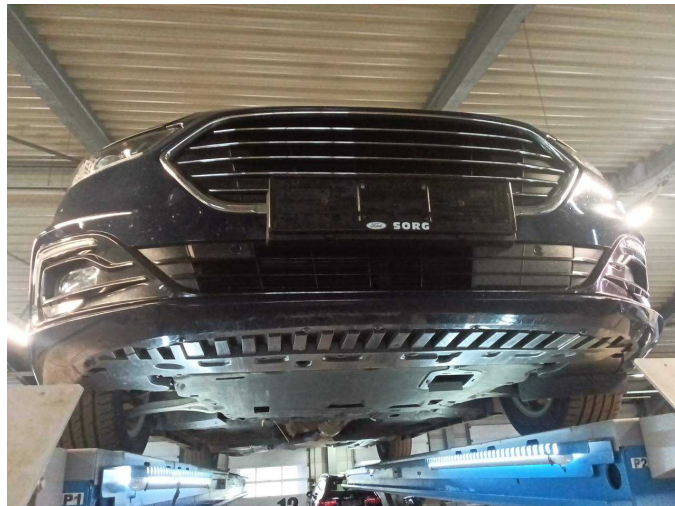
| No. | Component group | Description |
|---|---|---|
| 11 | Front bumper | Front bumper - Scratched - Paint |

**Damage 11:** Front bumper: Front bumper - Scratched - Paint

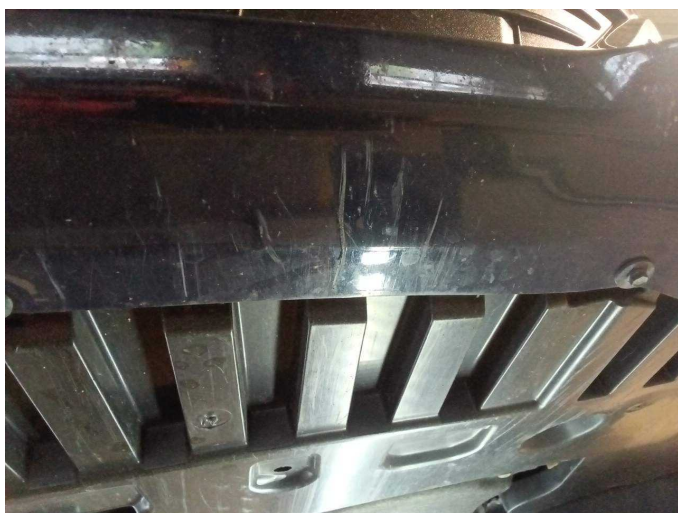
**Damage 11:** Front bumper: Front bumper - Scratched - Paint

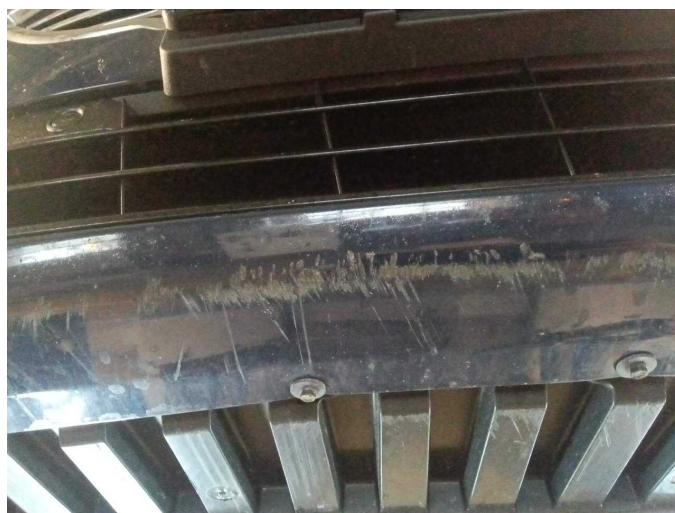
**Damage 11:** Front bumper: Front bumper - Scratched - Paint

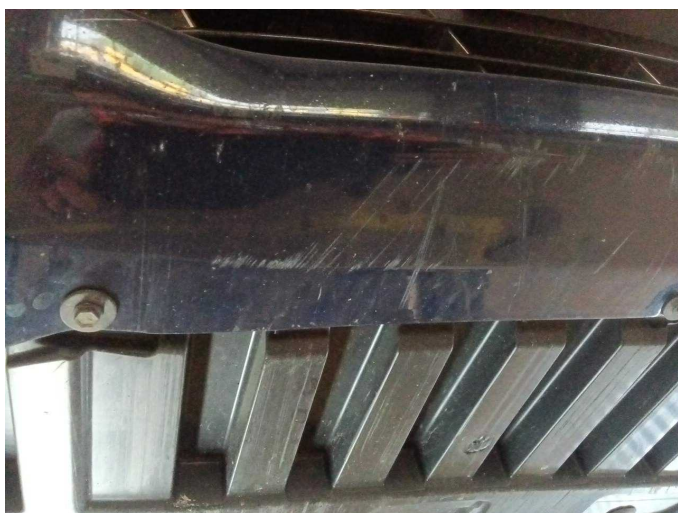
**Damage 11:** Front bumper: Front bumper - Scratched - Paint

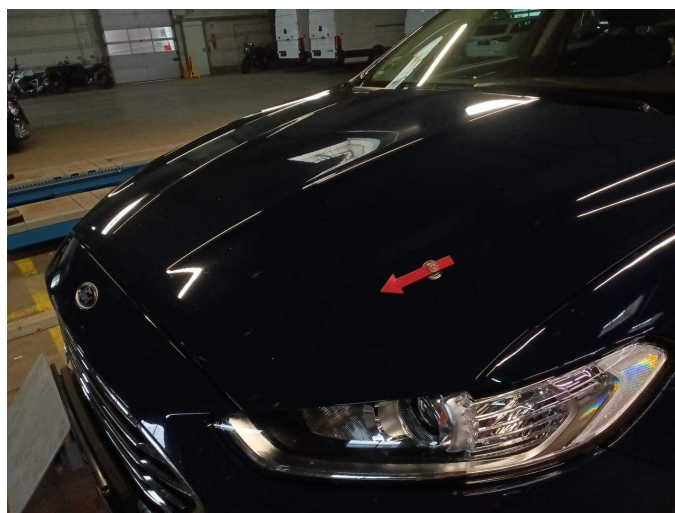
| No. | Component group | Description |
|---|---|---|
| 12 | Bonnet | Bonnet - Dent / paintcoat damage - Paint |

**Damage 12:** Bonnet: Bonnet - Dent / paintcoat damage - Paint

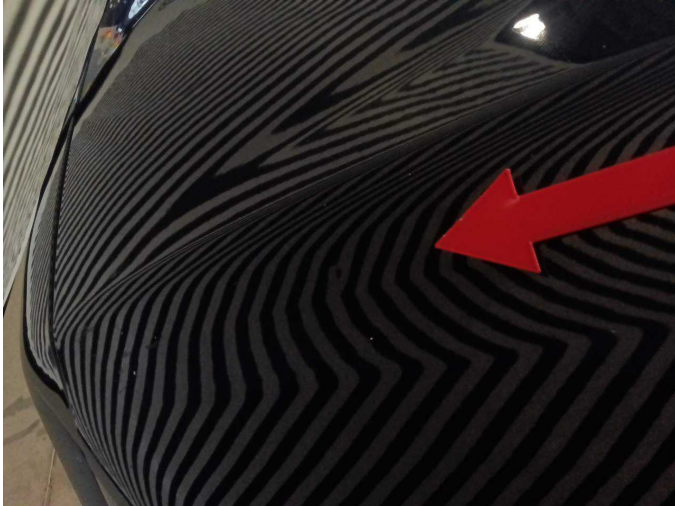
**Damage 12:** Bonnet: Bonnet - Dent / paintcoat damage - Paint

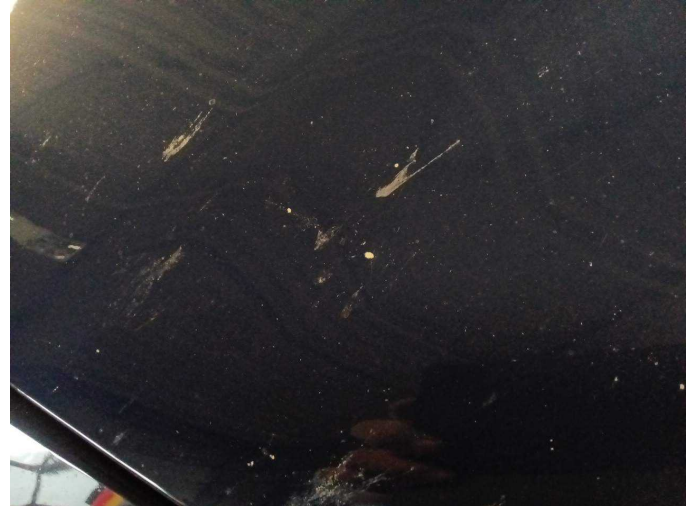
**Damage 12:** Bonnet: Bonnet - Dent / paintcoat damage - Paint

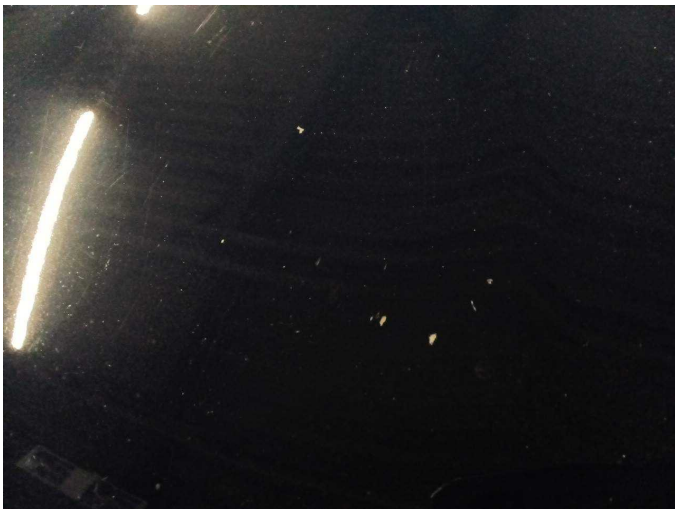
**Damage 12:** Bonnet: Bonnet - Dent / paintcoat damage - Paint

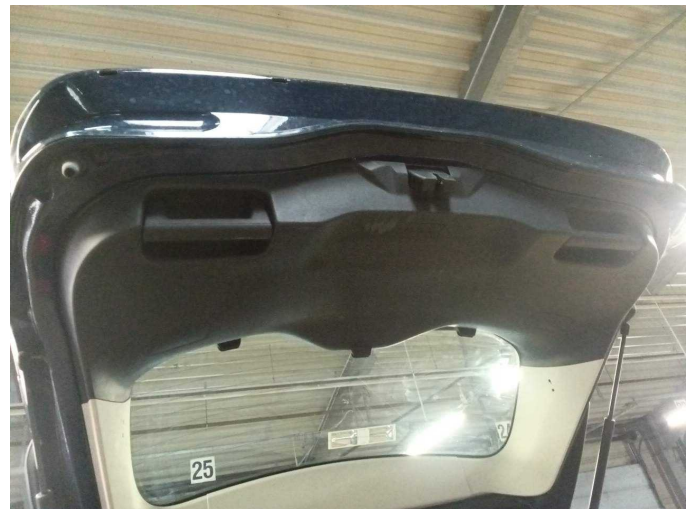
| No. | Component group | Description |
|---|---|---|
| 2 | Trim / covers | Boot lid - interior trim - Scratch(es) - No deduction |

**Wear and tear 2:** Trim / covers: Boot lid - interior trim - Scratch(es) - No deduction

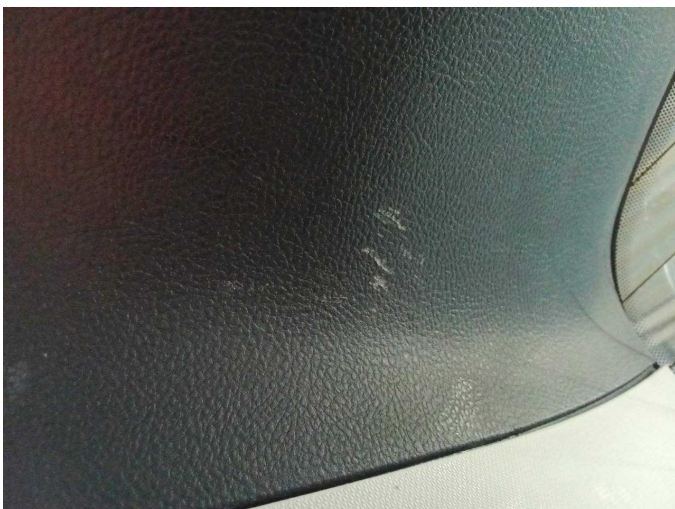
**Wear and tear 2:** Trim / covers: Boot lid - interior trim - Scratch(es) - No deduction

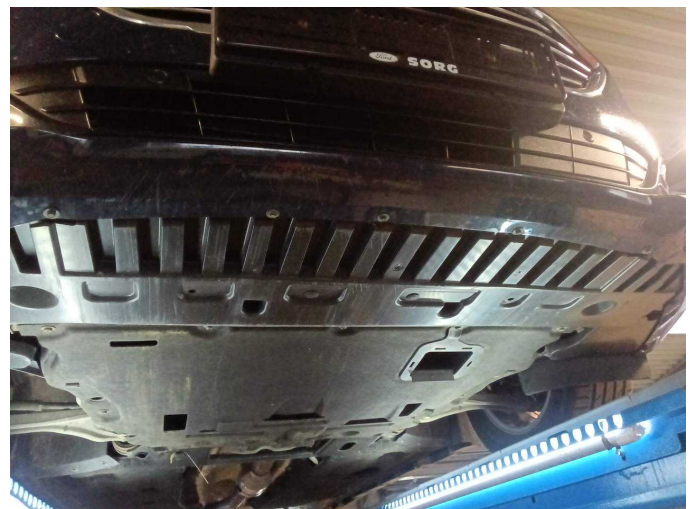
| No. | Component group | Description |
|---|---|---|
| 3 | Body | Underbody panelling - Scratched - No deduction |

**Wear and tear 3:** Body: Underbody panelling - Scratched - No deduction

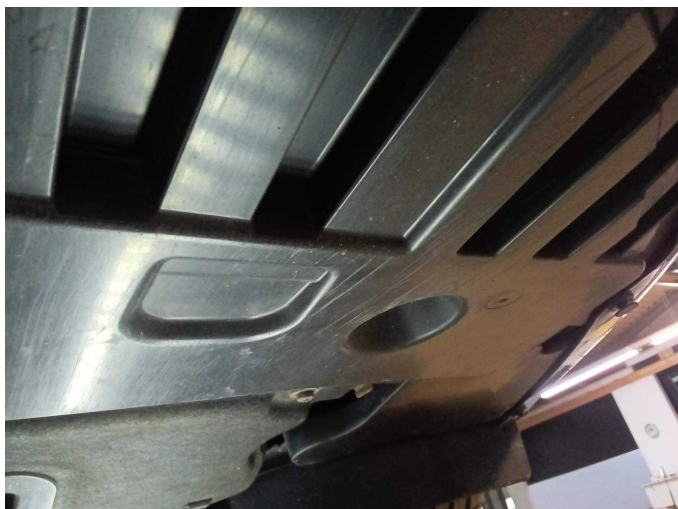
**Wear and tear 3:** Body: Underbody panelling - Scratched - No deduction

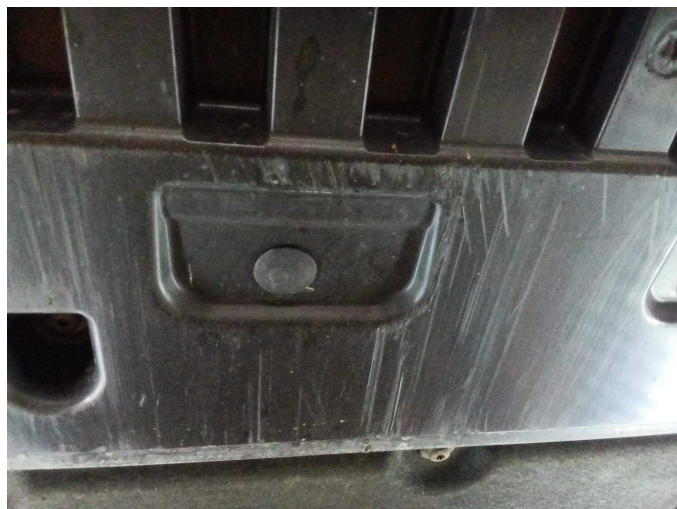
**Wear and tear 3:** Body: Underbody panelling - Scratched - No deduction

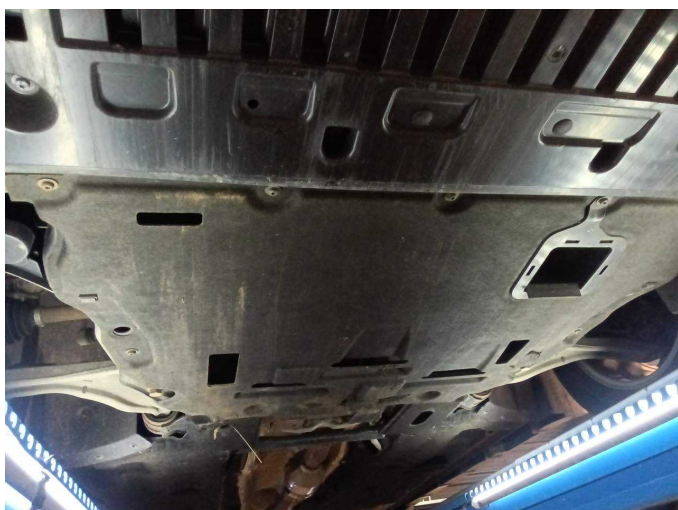
| No. | Component group | Description |
|---|---|---|
| 4 | Engine | Engine cowling - lower - Damaged - No deduction |

**Wear and tear 4:** Engine: Engine cowling - lower - Damaged - No deduction

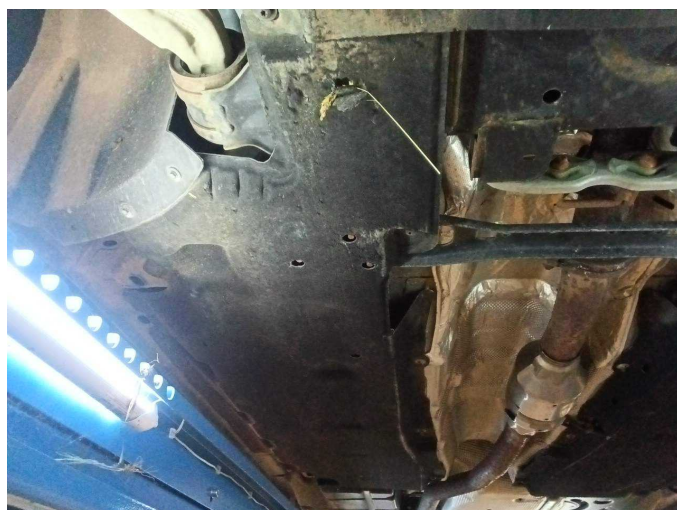
**Wear and tear 4:** Engine: Engine cowling - lower - Damaged - No deduction

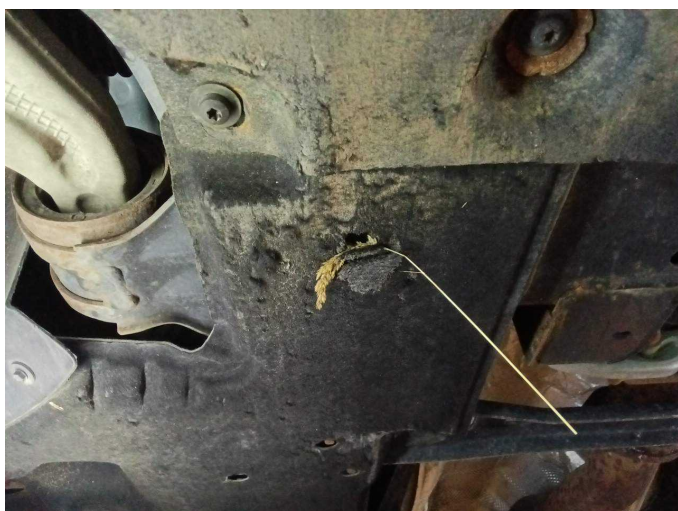
**Wear and tear 4:** Engine: Engine cowling - lower - Damaged - No deduction

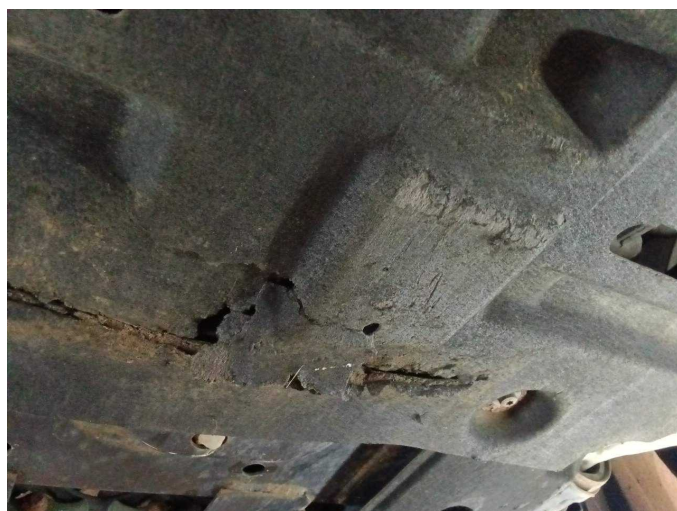
**Wear and tear 4:** Engine: Engine cowling - lower - Damaged - No deduction

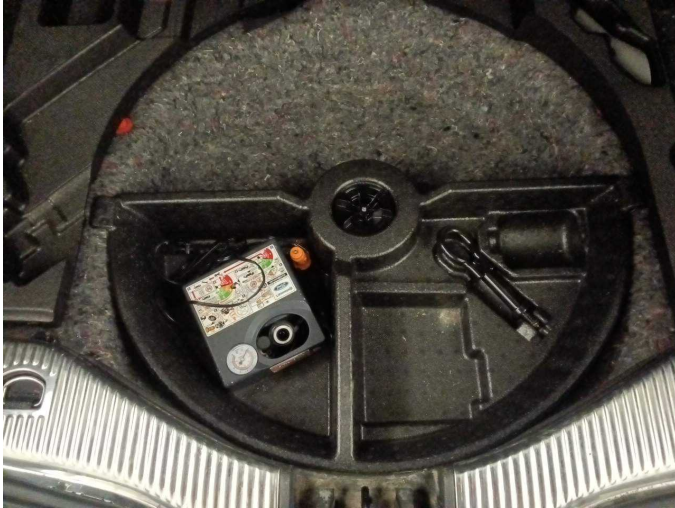
Equipment - Tirefit filler

**Missing part 1:** Equipment: Tirefit filler - Missing - Perform
